## Appendix C1

### ESEM/EDS Data for Test #4 Day-30 Fiberglass in Low-Flow Zones

This appendix shows the ESEM/EDS results on fiberglass samples submerged in a low-flow zone in the tank. The fiberglass samples were extracted on the date Test #4 was shut down (June 23, 2005). Both exterior and interior locations of the fiberglass samples were examined. ESEM was employed to analyze the hydrated fiberglass samples without any coating under a low vacuum condition (i.e., 80 Pa), to minimize the modification of the fiberglass samples through drying process. The results of Test #4 Day-30 low-flow fiberglass samples were obtained on June 24, 2005. EDS results provide a semi-quantitative elemental analysis of the debris attached on fiberglass.

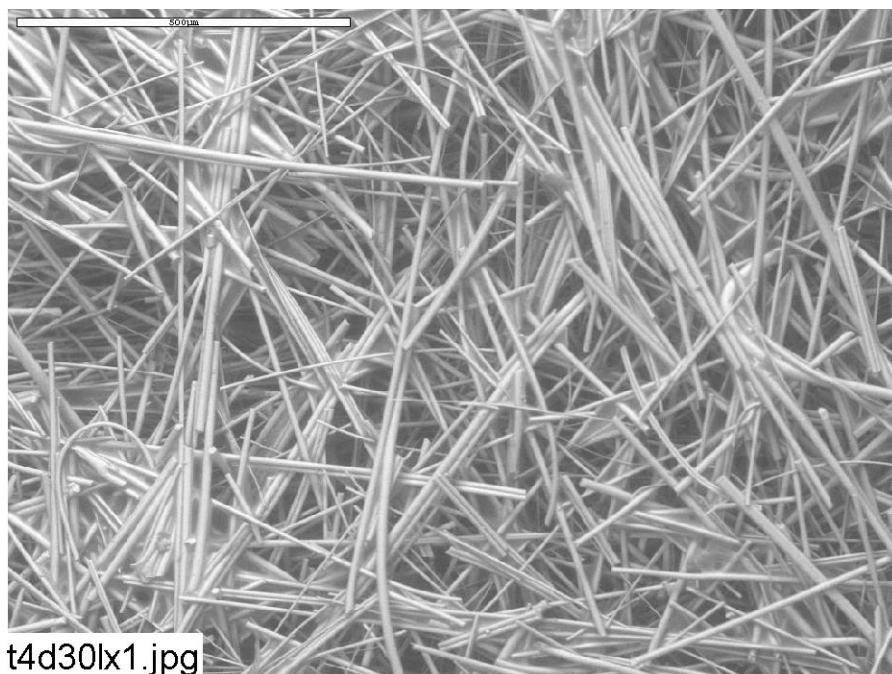
**Figure C1-1: Environmental SEM image magnified 100 times for a Test #4 Day-30 exterior low-flow fiberglass sample. (t4d30lx1.jpg)**

Image:	t4d30lx1	100 ×	ESEM image	Figure C1-1
	t4d30lx2	500 ×	ESEM image higher magnification	Figure C1-2
	t4d30lx5	1000 ×	ESEM annotated image	Figure C1-3
EDS:	t4d30lx4		Spot of coating substance for t4d30lx5	Figure C1-4

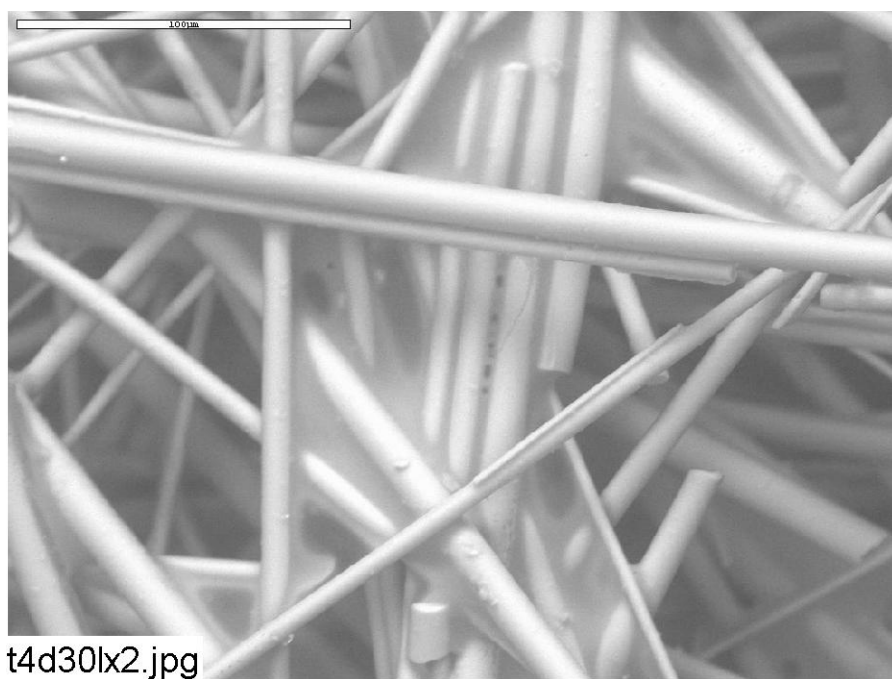
**Figure C1-2: Environmental SEM image magnified 500 times for a Test #4 Day-30 exterior low-flow fiberglass sample. (t4d30lx2.jpg)**

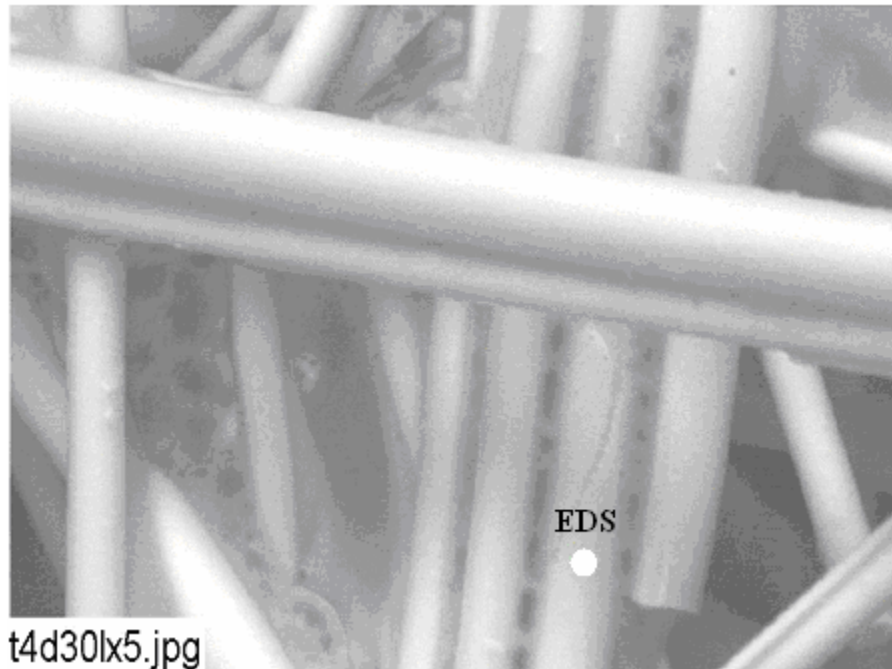
Figure C1-3: Annotated environmental SEM image magnified 1000 times for a Test #4 Day-30 exterior low-flow fiberglass sample. (t4d30lx5.jpg)

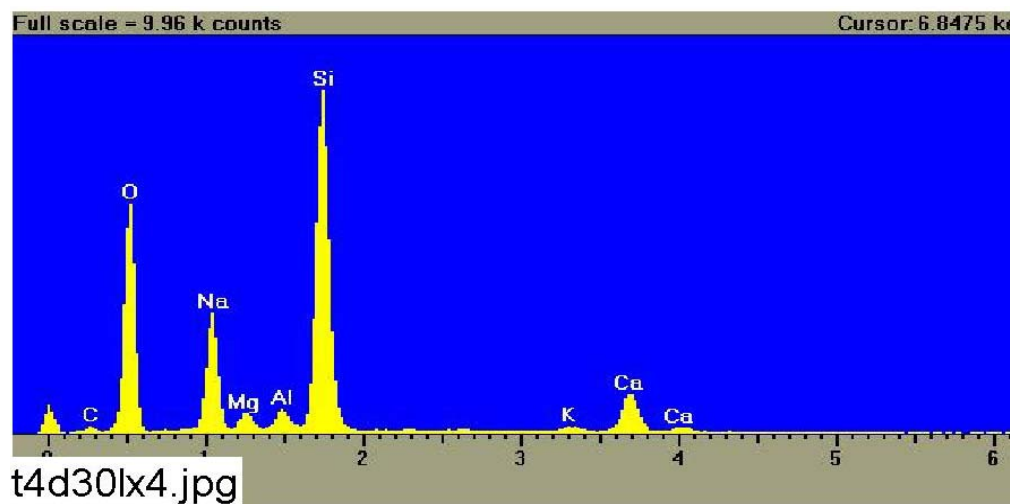
Figure C1-4: EDS counting spectrum for the spot of coating substance on fiberglass shown in Figure C1-3. (t4d30lx4.jpg)

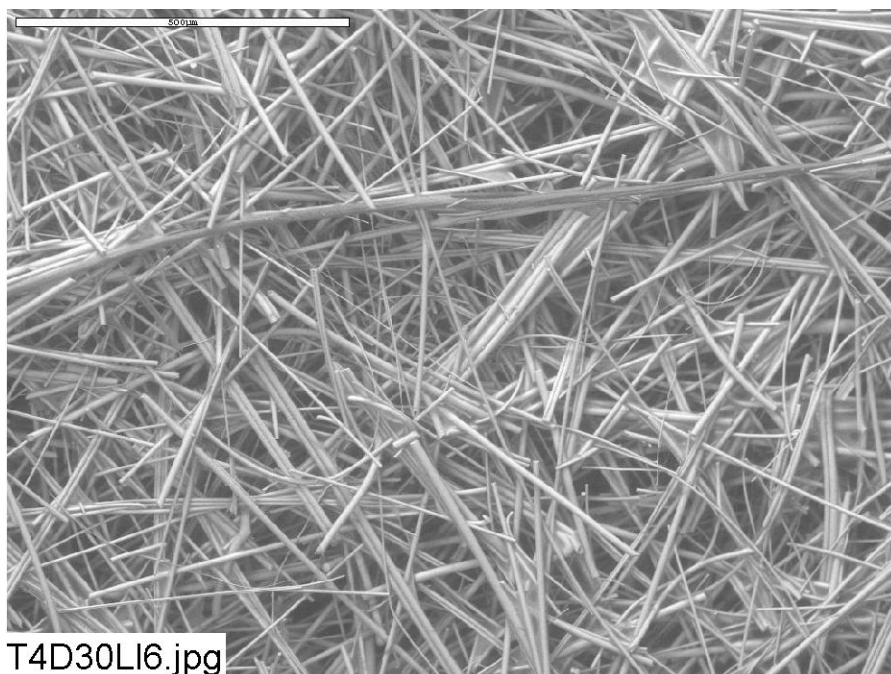
**Figure C1-5: Environmental SEM image magnified 100 times for a Test #4 Day-30 interior low-flow fiberglass sample. (T4D30LI6.jpg)**

Image:	T4D30LI6	100 ×	ESEM image of fiberglass	Figure C1-5
	t4d30li9	500 ×	ESEM annotated image	Figure C1-6
EDS:	t4d30li8		Film on fiberglass for t4d30li9	Figure C1-7

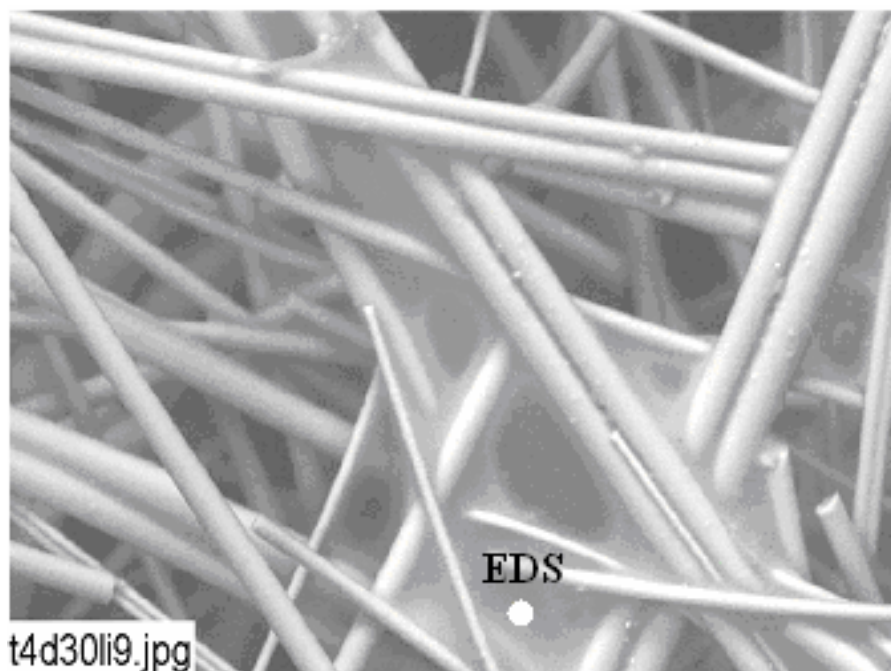
**Figure C1-6: Annotated environmental SEM image magnified 500 times for a Test #4 Day-30 interior low-flow fiberglass sample. EDS spot is shown in the picture (t4d30li9.jpg)**
