Appendix C4

ESEM/EDS Data for Test #4 Day-30 Fiberglass in High-Flow Zones

Test #4 Day-30 High-Flow Fiberglass.

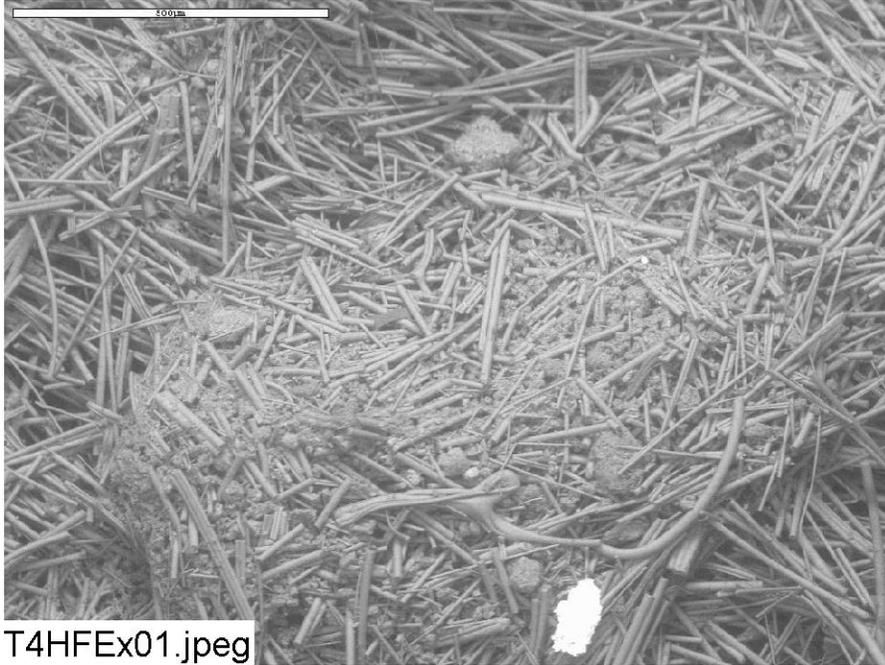
Figure C4-1: Environmental SEM image magnified 100 times for a Test #4 Day-30 exterior high-flow fiberglass sample. (T4HFEx01.jpg)

Image:	T4HFEx01	100 ×	ESEM image	Figure C4-1
	t4hfex02	100 ×	ESEM image	Figure C4-2
	t4hfex07	500 ×	ESEM image	Figure C4-3
	t4hfex06	800 ×	ESEM annotated image	Figure C4-4
EDS:	t4hfex05		Spot of film for t4hfex06	Figure C4-5

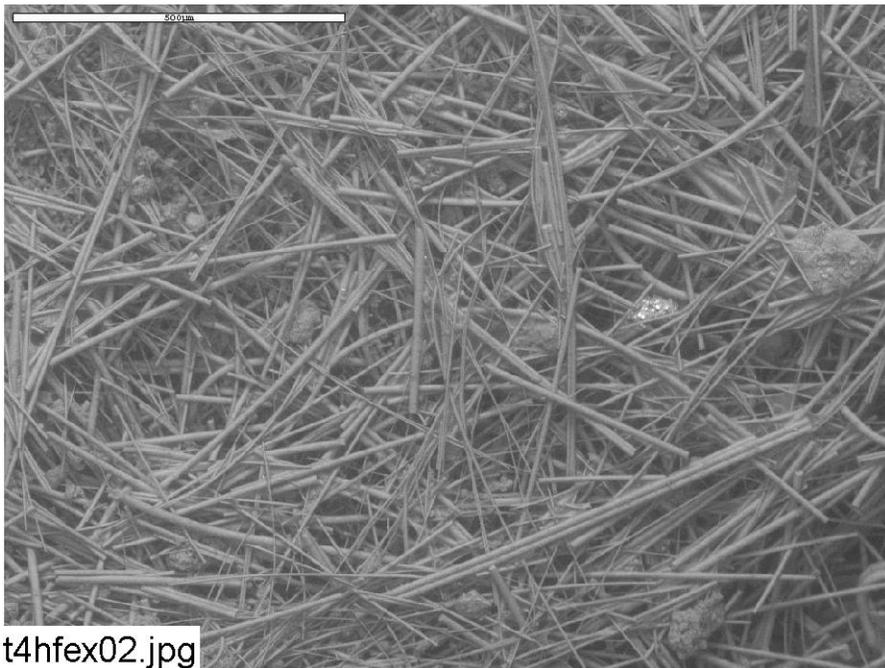
Figure C4-2: Environmental SEM image magnified 100 times for a Test #4 Day-30 exterior high-flow fiberglass sample. (t4hfex02.jpg)

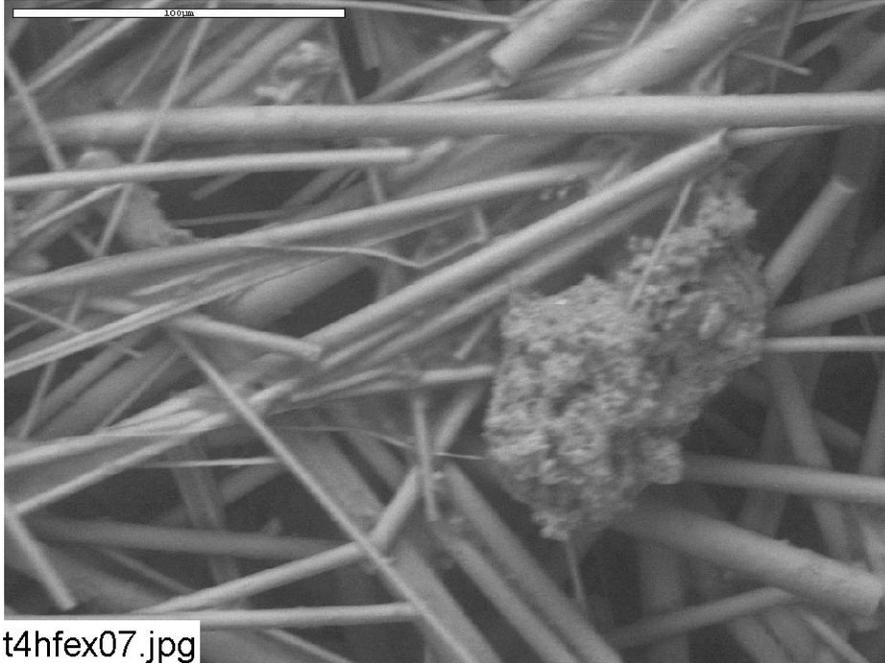
Figure C4-3: Environmental SEM image magnified 500 times for a Test #4 Day-30 exterior high-flow fiberglass sample. (t4hfex07.jpg)

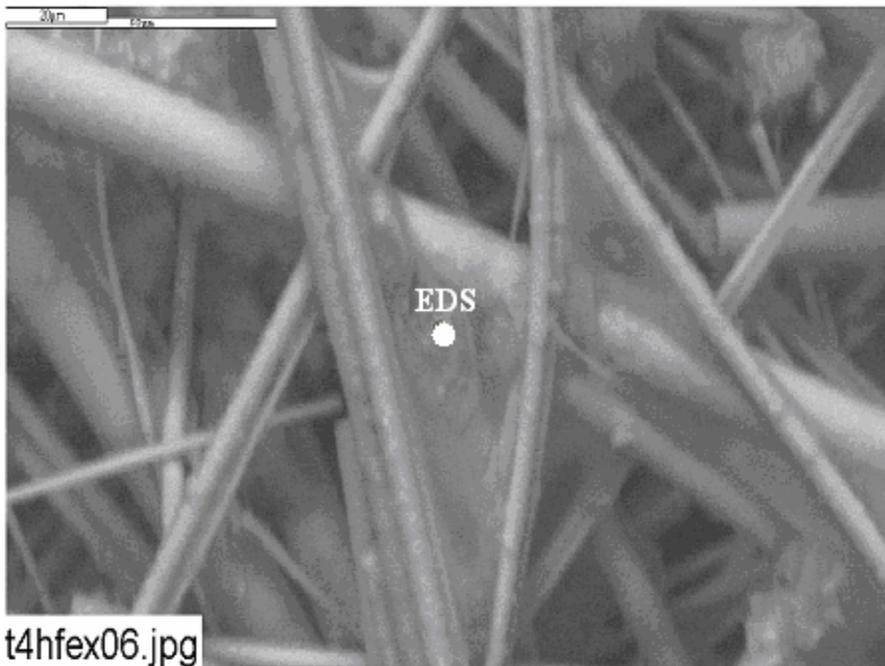
Figure C4-4: Annotated environmental SEM image magnified 800 times for a Test #4 Day-30 exterior high-flow fiberglass sample. EDS spot is shown in the picture. (t4hfex06.jpg)

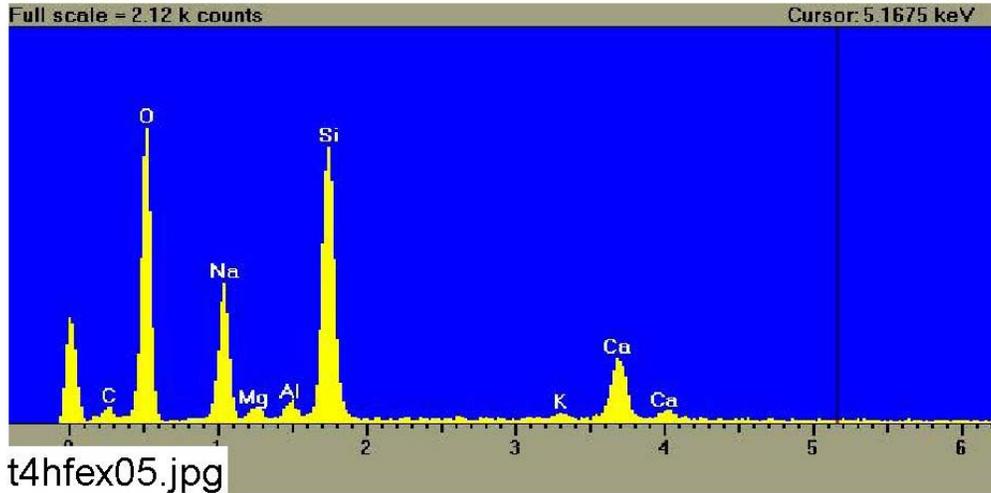
Figure C4-5: EDS counting spectrum for the spot of film between fibers shown in Figure C4-4. (t4hfex05.jpg)

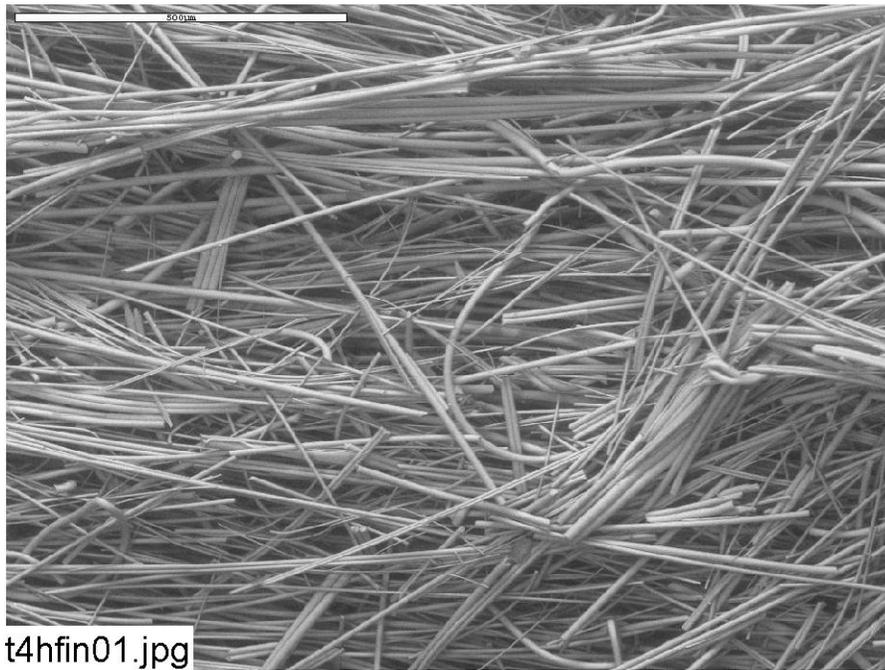
Figure C4-6: Environmental SEM image magnified 100 times for a Test #4 Day-30 interior high-flow fiberglass sample. (t4hfin01.jpg)

Image:	t4hfin01	100 ×	ESEM image of fiberglass	Figure C4-6
	t4hfin02	100 ×	ESEM image	Figure C4-7
	t4hfin03	500 ×	ESEM image high magnification	Figure C4-8
	t4hfin04	500 ×	ESEM image high magnification	Figure C4-9

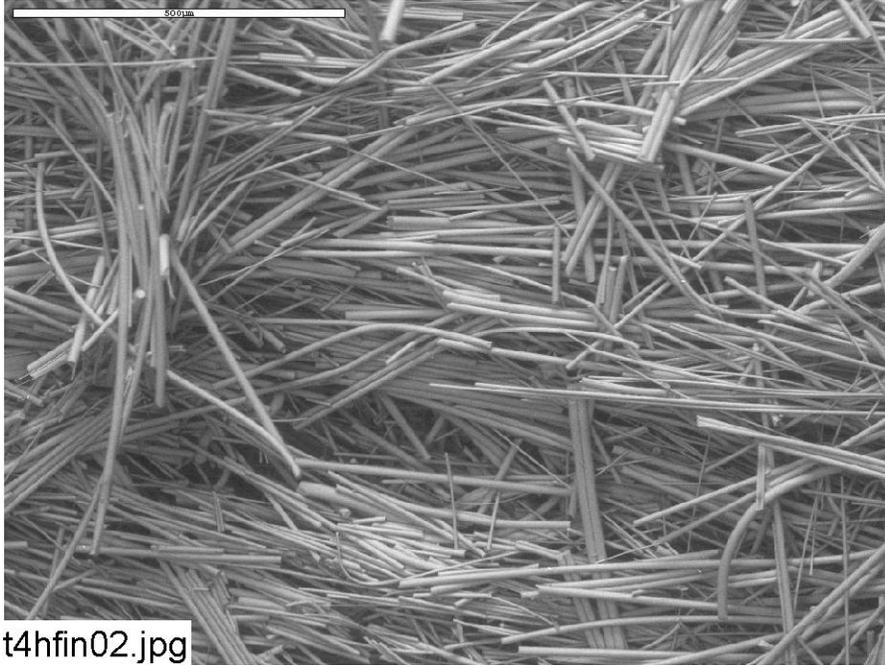
Figure C4-7: Environmental SEM image magnified 100 times for a Test #4 Day-30 interior high-flow fiberglass sample. (t4hfin02.jpg)

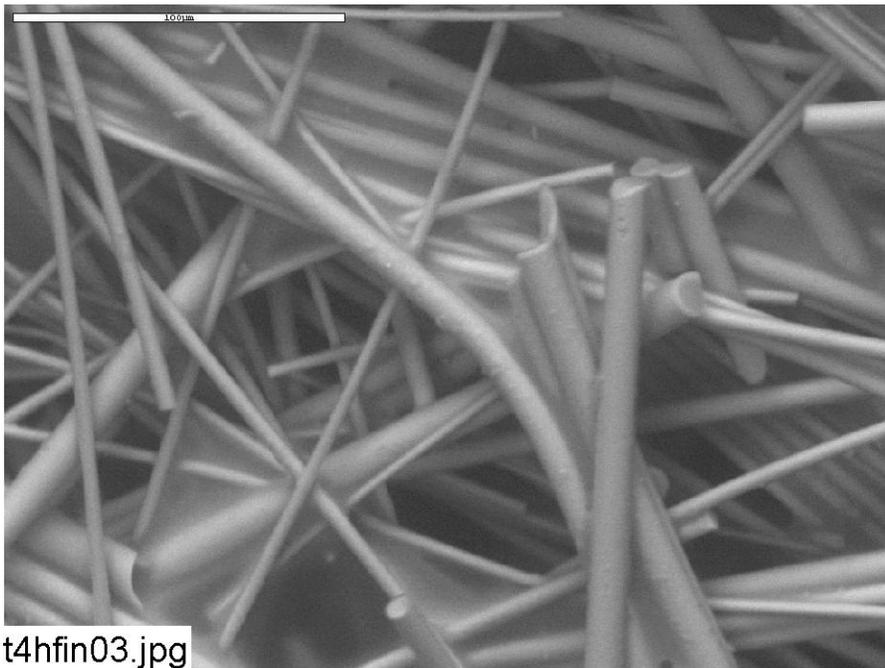
Figure C4-8: Environmental SEM image magnified 500 times for a Test #4 Day-30 interior high-flow fiberglass sample. (t4hfin03.jpg)

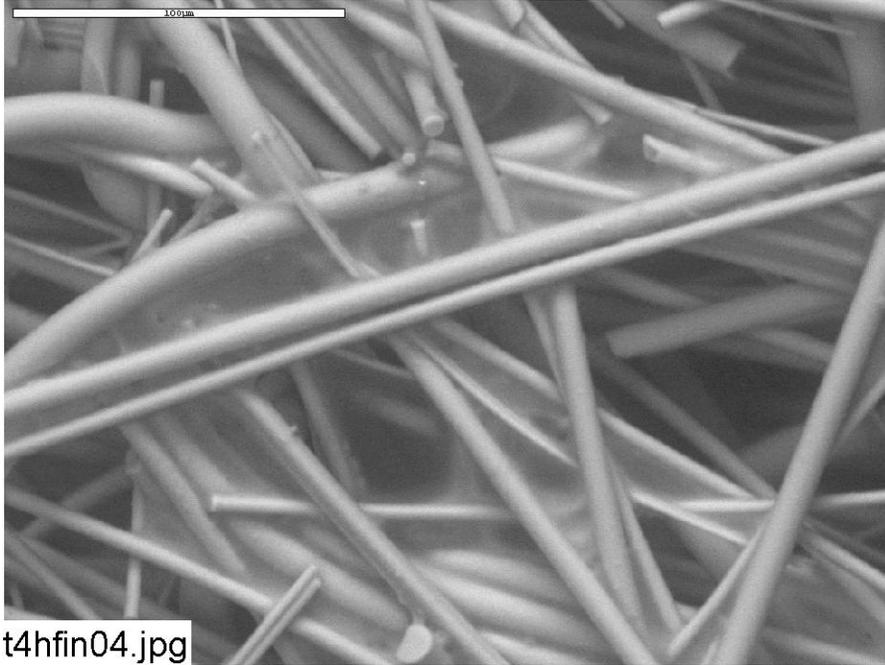
Figure C4-9: Environmental SEM image magnified 500 times for a Test #4 Day-30 interior high-flow fiberglass sample. (t4hfin04.jpg)

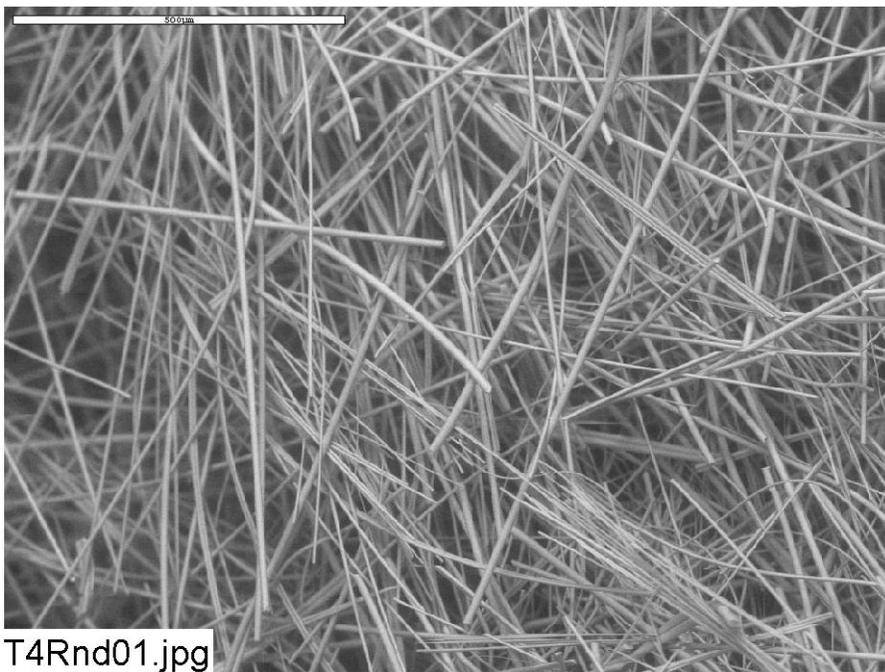
Figure C4-10: Environmental SEM image magnified 100 times for a Test #4 Day-30 interior high-flow fiberglass sample. The sample was gently pre-rinsed with RO water. (T4Rnd01.jpg)

Image:	T4Rnd01	100 ×	ESEM image	Figure C4-10
	t4rnd02	100 ×	ESEM image	Figure C4-11
	t4rnd03	500 ×	ESEM image	Figure C4-12
	t4rnd04	500 ×	ESEM image	Figure C4-13
	t4rnd05	500 ×	ESEM image	Figure C4-14
	t4rnd06	500 ×	ESEM image	Figure C4-15

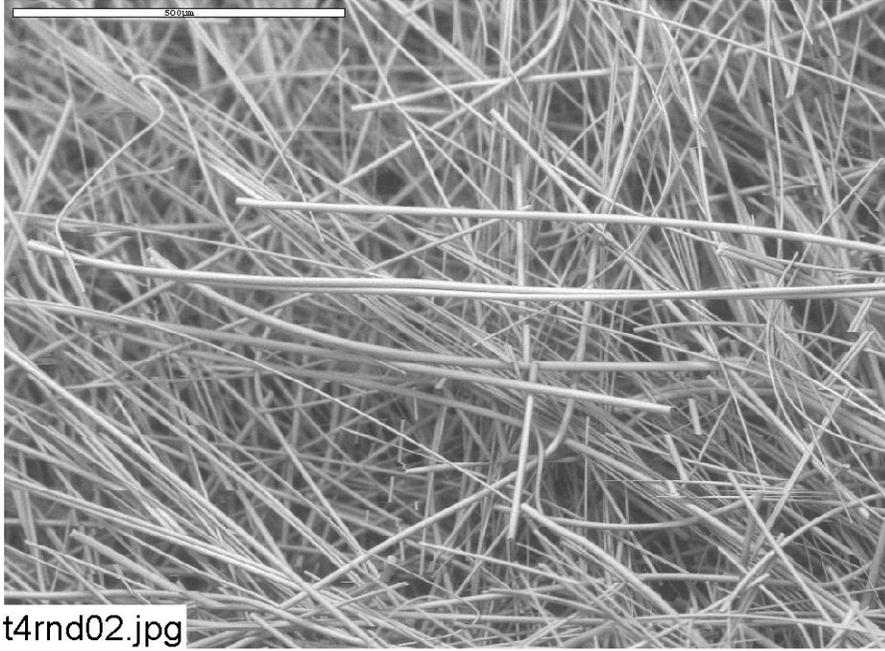
Figure C4-11: Environmental SEM image magnified 100 times for a Test #4 Day-30 interior high-flow fiberglass sample. The sample was gently pre-rinsed with RO water. (t4rnd02.jpg)

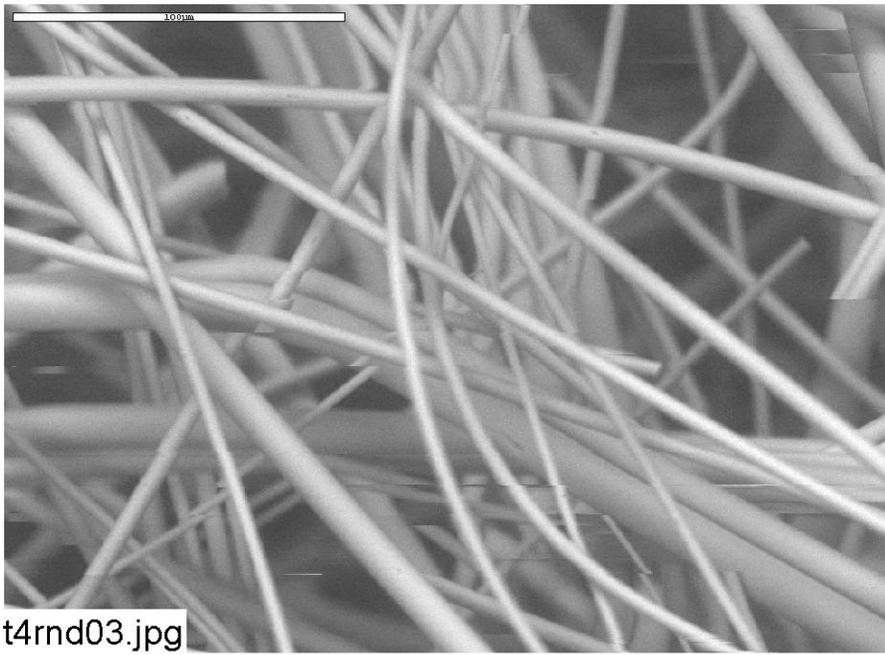
Figure C4-12: Environmental SEM image magnified 500 times for a Test #4 Day-30 interior high-flow fiberglass sample. The sample was gently pre-rinsed with RO water. (t4rnd03.jpg)

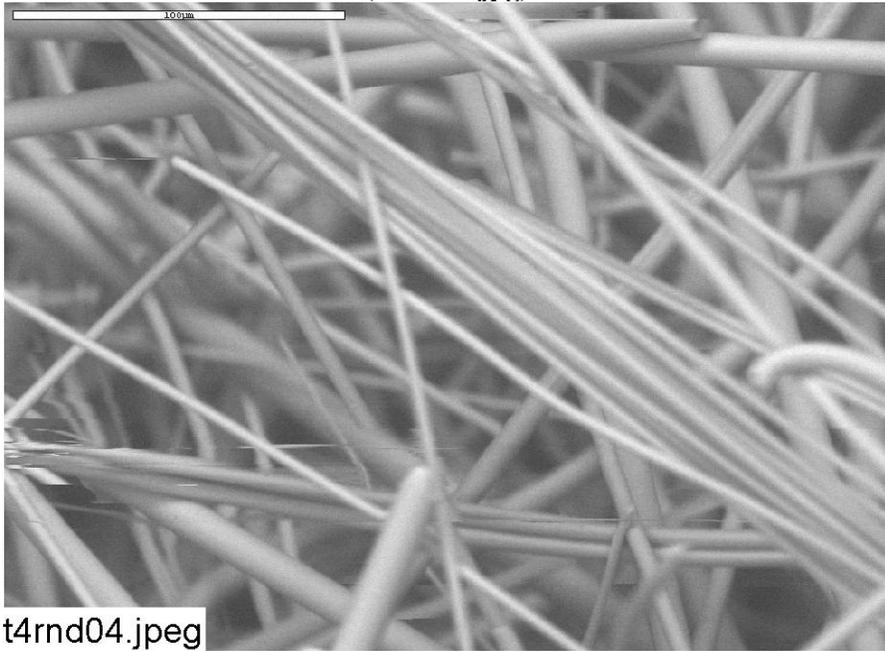
Figure C4-13: Environmental SEM image magnified 500 times for a Test #4 Day-30 interior high-flow fiberglass sample. The sample was gently pre-rinsed with RO water. (t4rnd04.jpg)

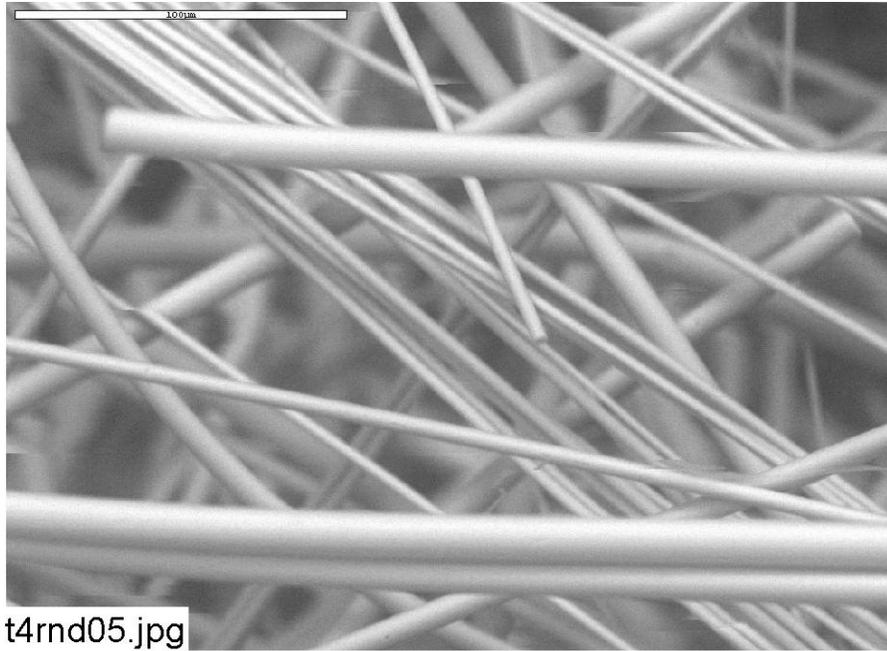
Figure C4-14: Environmental SEM image magnified 500 times for a Test #4 Day-30 interior high-flow fiberglass sample. The sample was gently pre-rinsed with RO water. (t4rnd05.jpg)

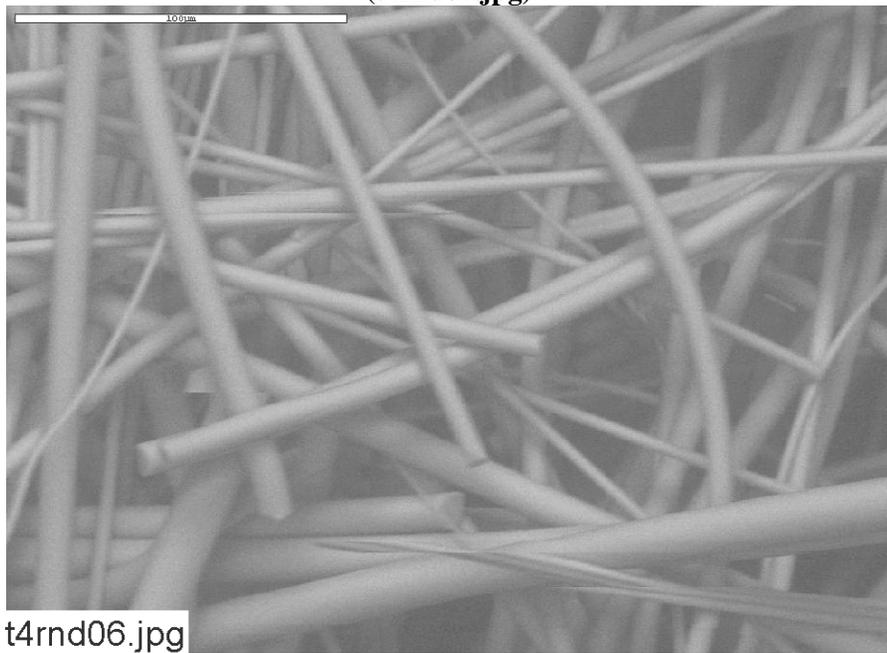
Figure C4-15: Environmental SEM image magnified 500 times for a Test #4 Day-30 interior high-flow fiberglass sample. The sample was gently pre-rinsed with RO water. (t4rnd06.jpg)
