**Safety Significance Evaluation of  
Kewaunee Power Station Turbine  
Building Internal Floods**

**Volume 1**

**Revision 1**

*December 1, 2005*

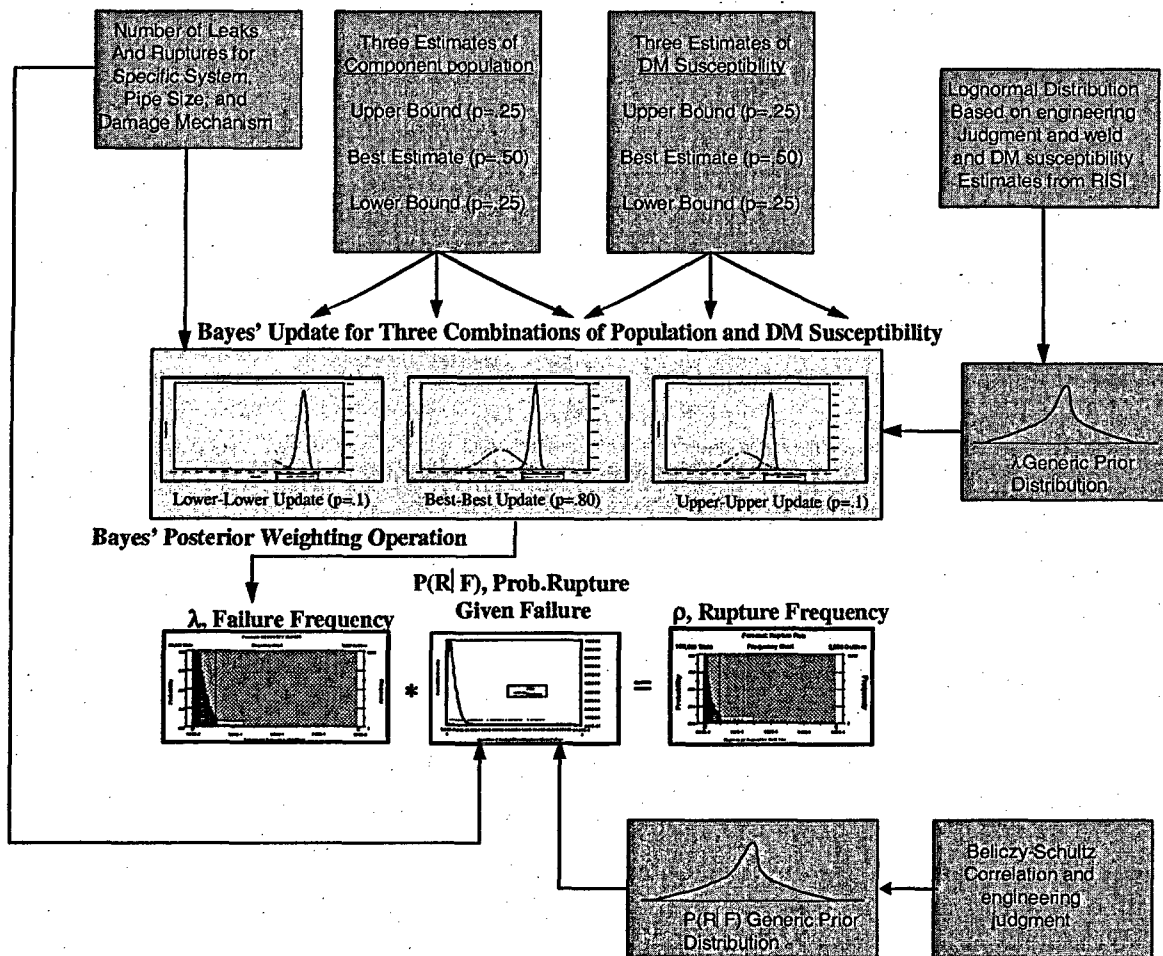
Figure 2-1 Flow Chart for Bayes' Estimates of System, Size, and Damage Mechanism Specific Pipe Failure Rates ( $\lambda$ ) and Rupture Frequencies ( $\rho$ )

In the development of Bayes' uncertainty distributions for these parameters, prior distributions are developed for the parameters  $\lambda_{ijk}$  and  $P_{ik}\{R/F\}$  and these prior distributions are updated using the evidence from the failure and exposure data as in standard Bayes' updating. The exposure terms (denominator of the fractions on the right hand side of Equation (2.3)) also have uncertainty as these terms must be estimated for the entire nuclear industry that provides the number of failures for the failure rate estimation. This uncertainty is treated in this process by adopting three hypotheses about the values of the exposure terms which requires three Bayes updates for each failure rate. The resulting posterior distributions for each parameter on the right hand side of Equation (2.3) are then combined using Monte Carlo sampling to obtain uncertainty distributions for the pipe rupture frequencies. A picture of this process is shown in Figure 2-1. This flow chart shows the full treatment of uncertainty needed for the RISI formulation in Equation (2.2). For the internal flooding formulation of Equation (2.3) the damage

mechanism susceptibility fractions ( $f_{ijk}$ ) do not come into play. The specific way in which this flow chart is applied is discussed in Section 4 for each system and failure mode.

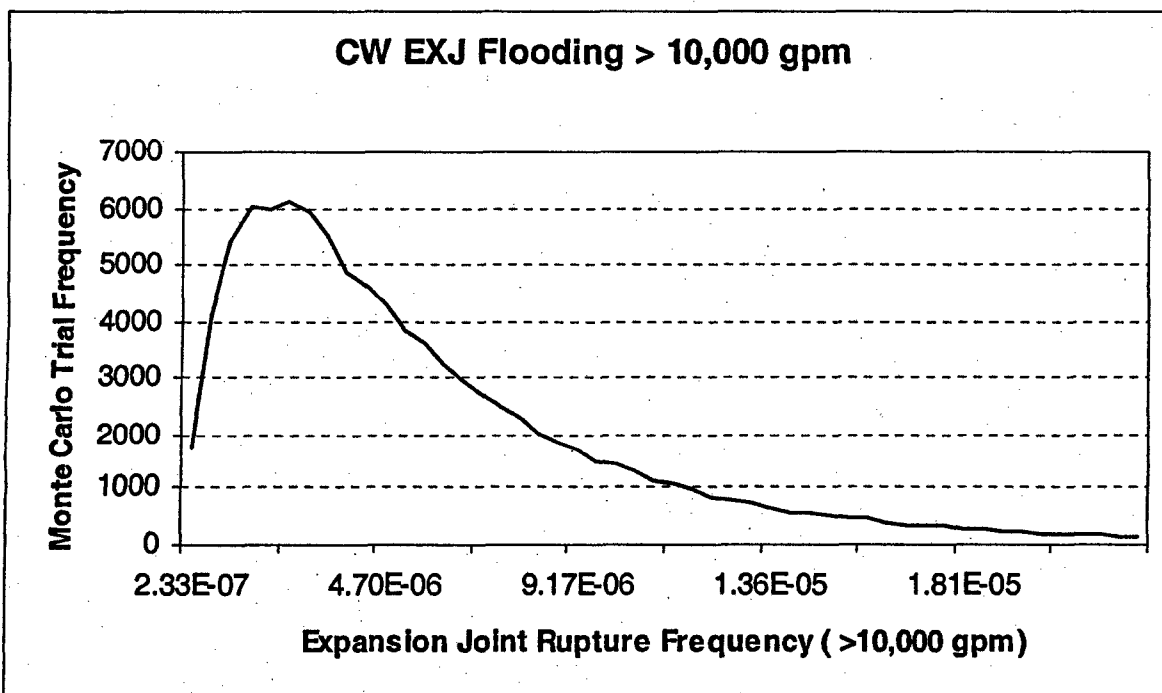
**Figure 3-1 Uncertainty Distribution Expansion Joint Rupture Frequency (>10,000 gpm)**

The results using the methodology of Reference [1] and summarized in Section 2 were obtained using Crystal Ball and yielded the failure rates and rupture frequencies for the Circulating Water system rubber expansion joints given in Table 3-3. The frequency distribution from the Monte Carlo analysis for the expansion joint rupture frequency with leak flows greater than 10,000 gpm is shown in Figure 3-1.

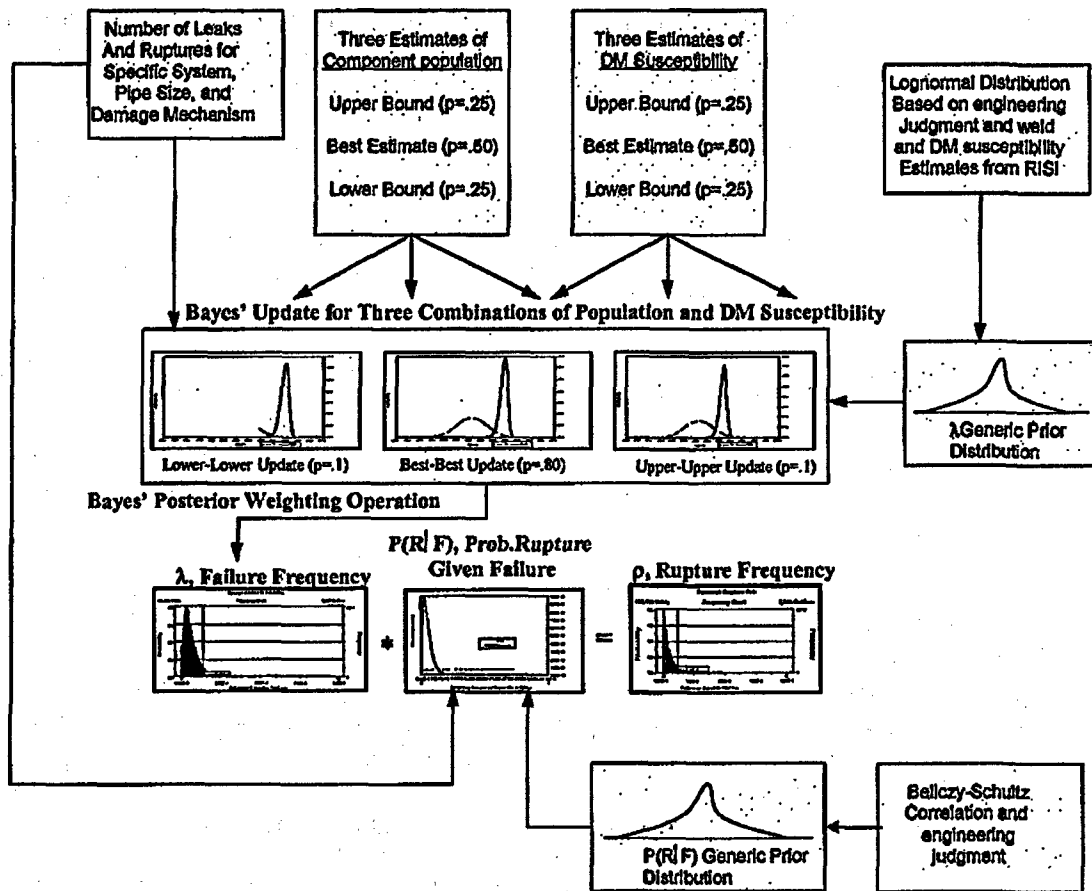
Figure 2-1 Flow Chart for Bayes' Estimates of System, Size, and Damage Mechanism Specific Pipe Failure Rates ( $\lambda$ ) and Rupture Frequencies ( $\rho$ )

In the development of Bayes' uncertainty distributions for these parameters, prior distributions are developed for the parameters  $\lambda_{ijk}$  and  $P_{ik}\{R_x|F\}$  and these prior distributions are updated using the evidence from the failure and exposure data as in standard Bayes' updating. The exposure terms (denominator of the fractions on the right hand side of Equation (2.3)) also have uncertainty as these terms must be estimated for the entire nuclear industry that provides the number of failures for the failure rate estimation. This uncertainty is treated in this process by adopting three hypotheses about the values of the exposure terms which requires three Bayes updates for each failure rate. The resulting posterior distributions for each parameter on the right hand side of Equation (2.3) are then combined using Monte Carlo sampling to obtain uncertainty distributions for the pipe rupture frequencies. A picture of this process is shown in Figure 2-1. This flow chart shows the full treatment of uncertainty needed for the RISI formulation in Equation (2.2). For the Internal flooding and HELB formulation of Equation (2.3) the damage mechanism susceptibility fractions ( $f_{ijk}$ ) do not come into play. The specific way in which this flow chart is applied is discussed in Section 4 for each system and failure mode.

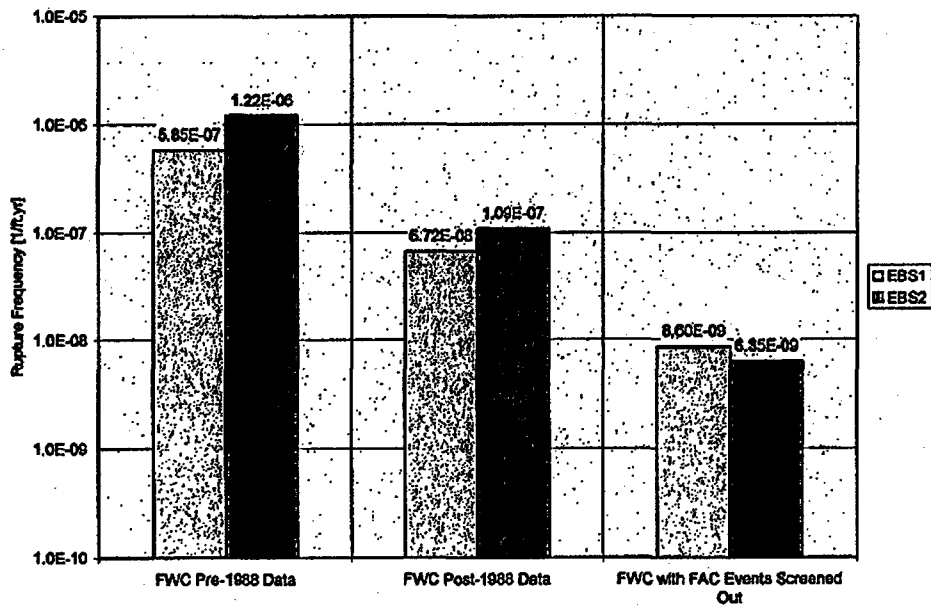
**Figure 4-4**  
Impact of Different Data Screening Assumptions on FWC Piping Reliability

To support sensitivity calculations that are summarized in Section 5, comparisons were made among the data screening sensitivity cases for each system group that were identified. As seen in Figures 4-4 and 4-5 the results for the case using only data from prior to 1988 before FAC programs became effective would increase by more than an order of magnitude. Stated another way, the failure rates and rupture frequencies based on the service data before 1988 are more than an order of magnitude greater than those considering only data from events after 1988 when the FAC programs were in effect. Conversely, if all the FAC-related events were precluded by some type of plant change, an order of magnitude reduction in the relevant pipe failure rates and rupture frequencies would be expected.

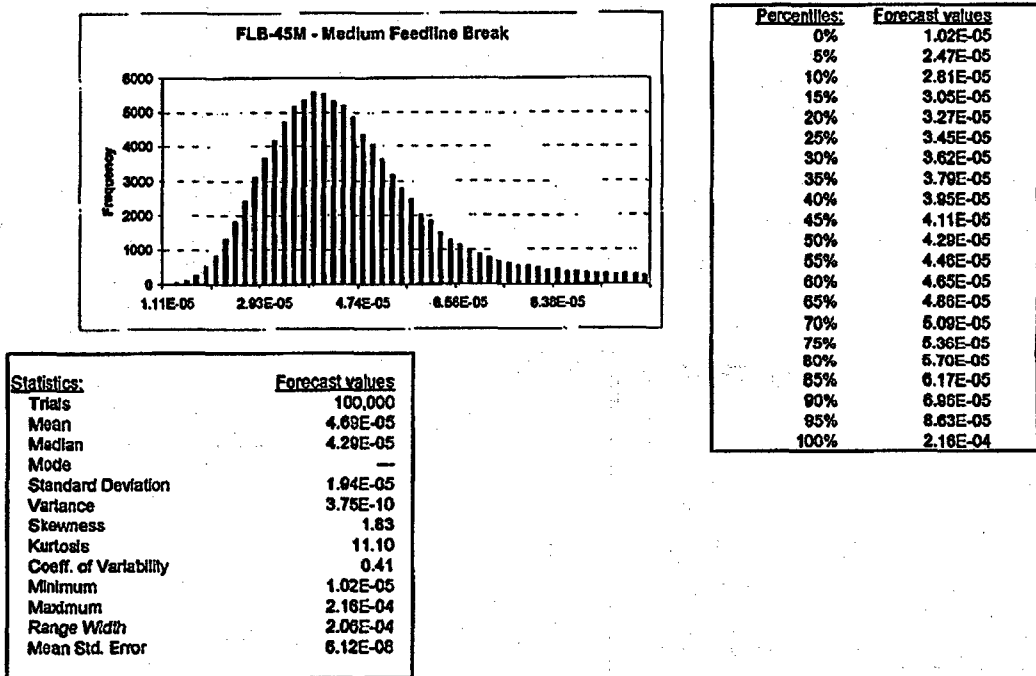
Figure 5-2 Crystal Ball Results for Intermediate Feedline Break Frequency

In Figures 5-1 through 5-4 the details of the uncertainty analysis are provided for Large Feedline Breaks, Moderate Feedline Breaks, Large Steamline Breaks, and Moderate Steamline breaks, respectively using as input reports that are generated by Crystal Ball™.

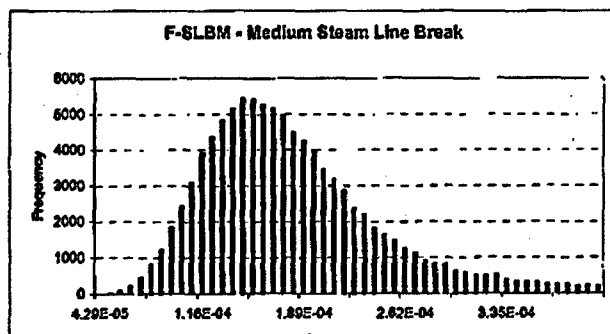
Percentiles:	Forecast values
0%	3.93E-05
5%	9.84E-05
10%	1.11E-04
15%	1.21E-04
20%	1.29E-04
25%	1.36E-04
30%	1.43E-04
35%	1.50E-04
40%	1.57E-04
45%	1.64E-04
50%	1.71E-04
55%	1.78E-04
60%	1.86E-04
65%	1.95E-04
70%	2.04E-04
75%	2.16E-04
80%	2.30E-04
85%	2.49E-04
90%	2.78E-04
95%	3.37E-04
100%	1.02E-03

Statistics:	Forecast values
Trials	100,000
Mean	1.87E-04
Median	1.71E-04
Mode	—
Standard Deviation	7.75E-05
Variance	6.01E-09
Skewness	1.89
Kurtosis	12.03
Coeff. of Variability	0.41
Minimum	3.93E-05
Maximum	1.02E-03
Range Width	9.82E-04
Mean Std. Error	2.45E-07

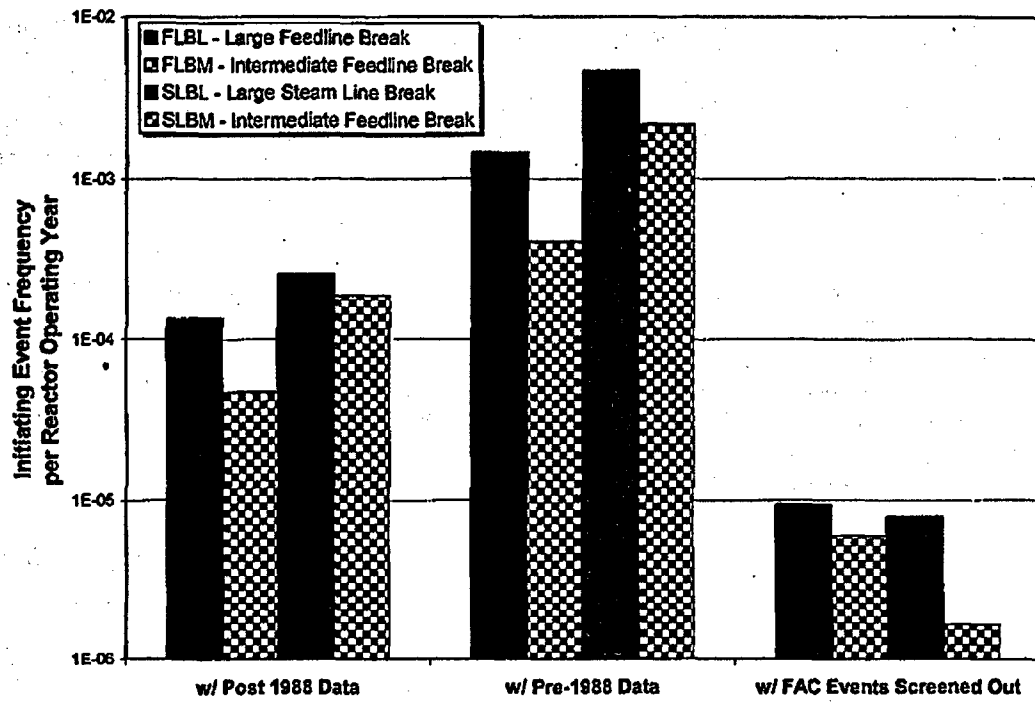
Figure 5-5 Impact of Alternative Data Screening Regarding FAC

As a sensitivity study, the initiating event frequencies were recalculated using different assumptions regarding how the data was screened as discussed in Section 4. This study was performed by propagating the results for the pipe failure rates and rupture frequencies for the different data screening strategies through the equations for the initiating event frequencies in Section 3. The results are summarized in Table 5-2 and Figure 5-5. As seen in these exhibits, the impact of using the service data from 1988 to represent the current industry practice and as a basis to predict the HELB-initiated internal flooding frequencies is approximately an order of magnitude compared with the case of using pre-1988 data. This shows the impact of industry improvement programs, particularly the FAC programs, which were responsible for reducing the frequency of pipe breaks since about 1988. Although these programs were effective in reducing the pipe break frequencies, as seen in the third case in which all the FAC related failures since 1988 were removed, FAC is still a dominant failure mechanism for these systems. The initiating event frequencies would be an order of magnitude lower if all the FAC related failures were removed from the data analysis.

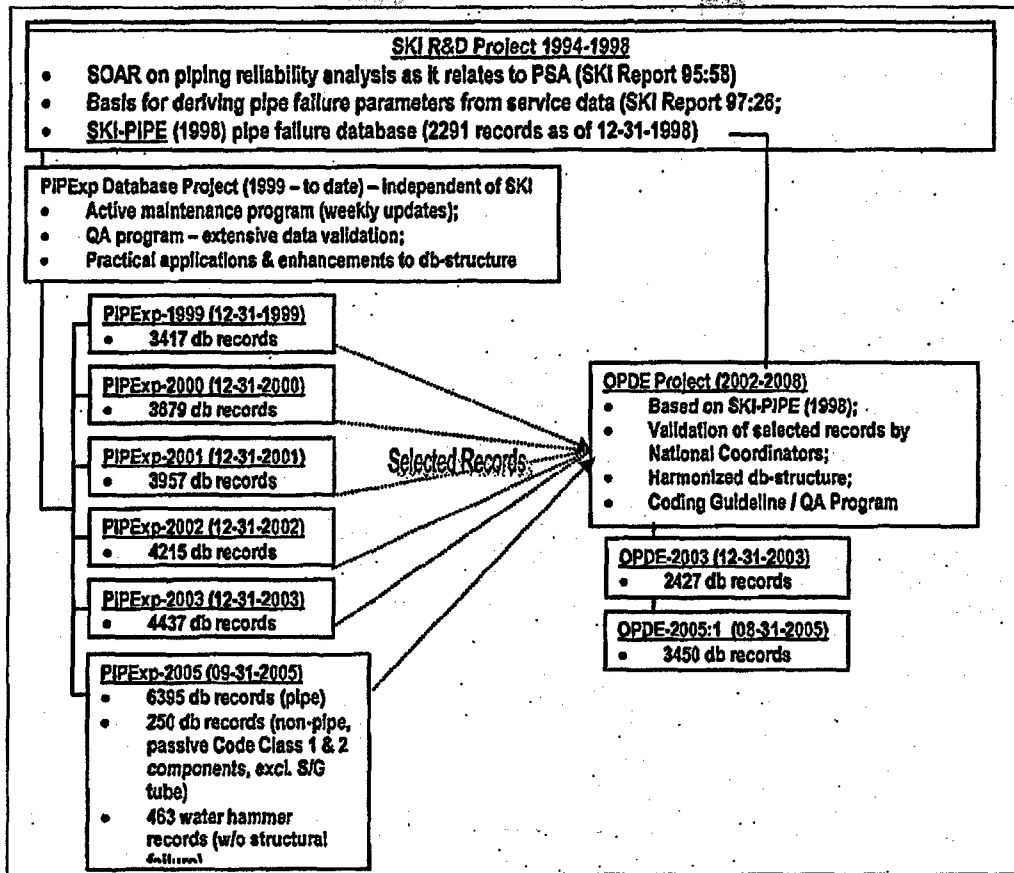
Figure A-1  
Evolution of PIPEXP Pipe Failure Database

- A pipe failure database in Microsoft ACCESS. At the time this database was referred to as "SKI-PIPE", a proprietary database. It included 2291 pipe failure records as of 31-Dec-1998. This version formed the basis of OPDE in 2002 (Figure A-1).
- A series of technical reports (e.g., SKI Reports 95:58, 97:26, 97:32 and 98:30, all available from [www.ski.se](http://www.ski.se)).

Independent of SKI and in preparation for and support of an international cooperative effort, the maintenance and update of the pipe failure database has continued post-1998. Figure A-1 is a top-level summary of this post-1998 maintenance and update program including the relationship between PIPExp and OPDE. Insights from practical database applications have played a significant role in enhancing and restructuring the database to become tool for piping reliability assessments.
