**FLORIDA POWER & LIGHT
ST. LUCIE UNIT 2
STEAM GENERATOR INSPECTION**

PLANNING FOR SL2-16, APRIL 2006

**St. Lucie Unit 2 - Steam Generator
Inspection Planning for SL2-16**

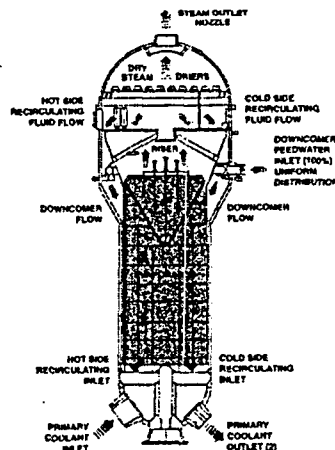
- S/G Design
- CE Model 3410
- 8411 Tubes / SG
- ~19.3 EFPY @ SL2-16
- A-600 HTMA Tubing
- CS Lattice Support System (eggcrates)
- Tubesheet Joint - Explosive
- Total Tubes Plugged
 - SG A - 1469 (17.5%)
 - SG B - 1709 (20.3%)
- T-Hot ~600°F
