NUREG/CR-3122
ORNL/NSIC-213

Potentially Damaging Failure Modes of High- and Medium-Voltage Electrical Equipment

Prepared by H. C. Hoy

Oak Ridge National Laboratory

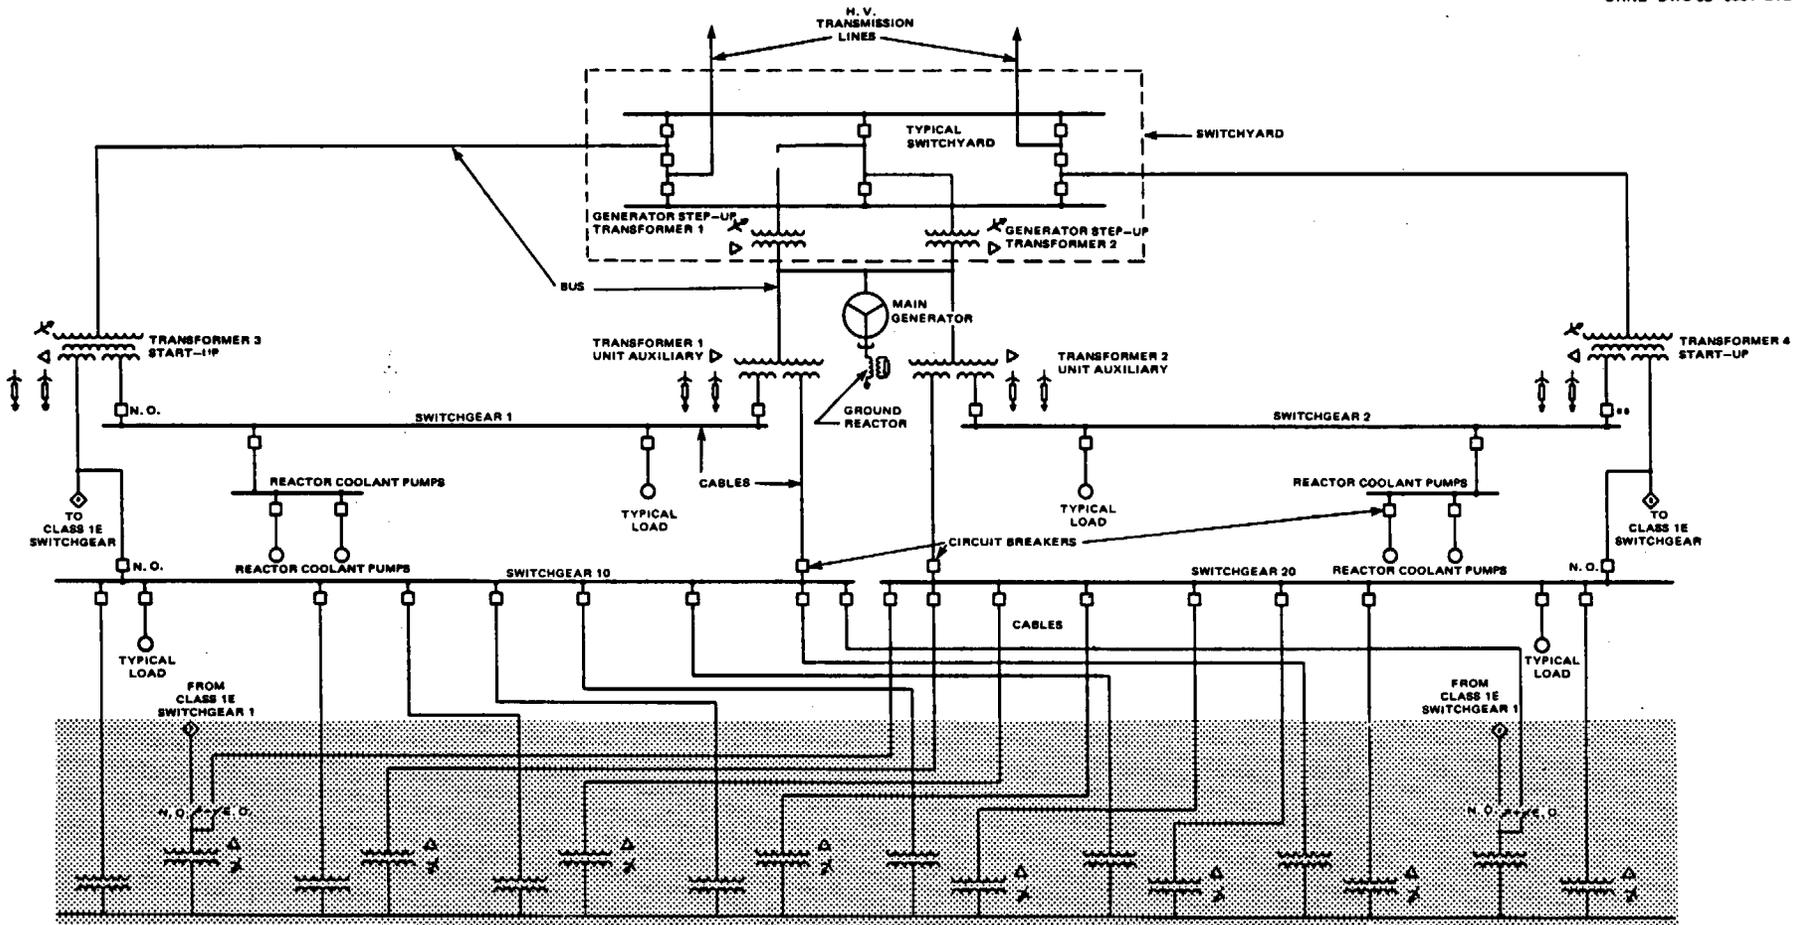
Fig. 1. Schematic of a nuclear power plant generic medium- and high-voltage electrical circuitry.

The major electrical equipment used in nuclear power generation (see Fig. 1 in Chap. 2) is basically the same as that used in coal-, gas-, and oil-burning plants; however, the nuclear plant's electrical equipment is often purchased under specifications that include seismic effects and tighter quality control than the fossil plants, even though the functional engineering design is the same. Therefore, the literature dealing with both nuclear and nonnuclear thermal power plants was considered in a study of all the possible disruptive failure modes of electrical equipment in nuclear power plant installations. The only restriction was that the study was limited to power equipment of 4100 V ac or higher, which eliminated instrumentation and control circuitry unless they were directly involved in the events.

The electrical components studied were part of the generic nuclear plant electrical schematic (Fig. 1). This system is the source of power for plant auxiliaries during startup, normal operation, and shutdown. It is also the source of power for Class 1E electric loads,* which include the reactor protection system and the engineered safety feature loads under normal and emergency loads. The switchyard is the station's connection with the utilities grid for startup power and distribution of the plant's generated power. When the station is on line and supplying power to the transmission network, the internal loads are supplied directly from the generator unit through auxiliary transformers. Station loads are supplied during startup or shutdown through startup and service transformers that receive power from the transmission network.

The equipment considered in this report is 4100 V ac or higher, and its directly associated auxiliaries are shown by the unshaded portion of Fig. 1. The energy available and the rapidity with which it is discharged are always of concern and must be as much a part of the engineering and design factors as any other consideration.
