Subject: Response to NRC Request for Additional Information to Byron Station Relief Request I3R-08

Response to Request for Additional Information to
Inservice Inspection Interval, Relief Request I3R-08

RRA 00-04, BC 04-1000, Revise Code Case N-638-2 to Address Limitations on Size of Repairs

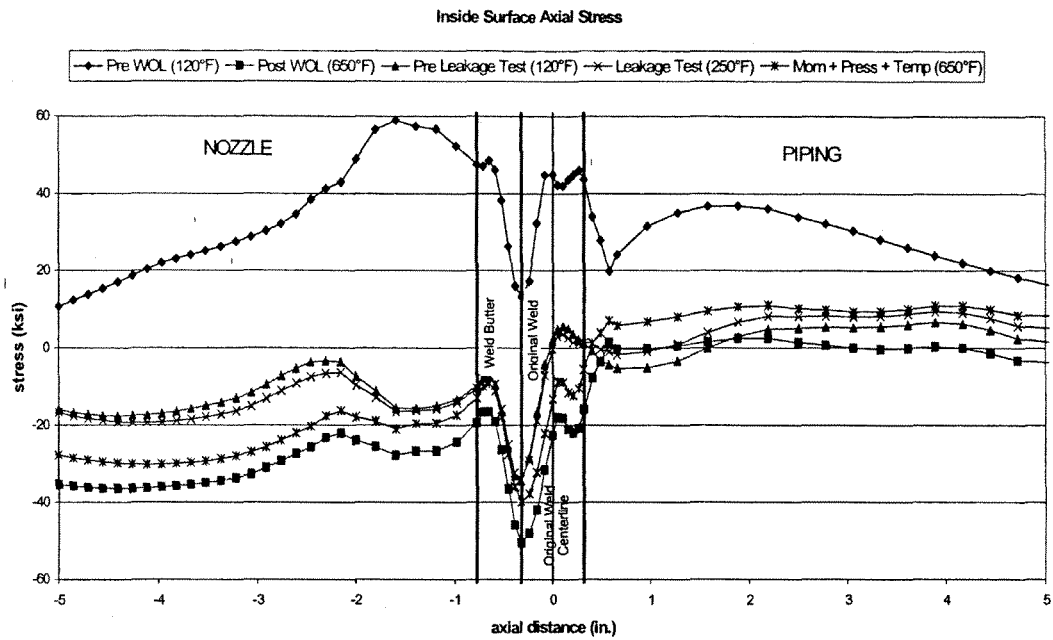
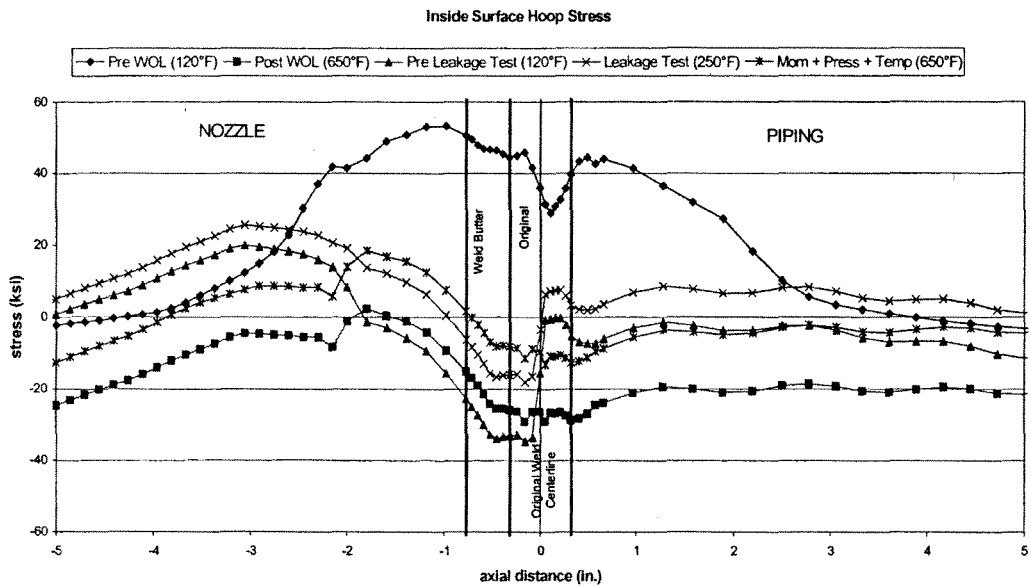
Fig. 15 Inside Surface Stresses at Different Conditions, 5 Layers, Long Overlay, Water Inside Pipe
