Title: Advisory Committee on Reactor Safeguards
Plant License Renewal Subcommittee

ADVISORY COMMITTEE ON REACTOR SAFEGUARDS (ACRS)
MEETING OF PLANT LICENSE RENEWAL SUBCOMMITTEE

Description of Oyster Creek

Drywell Corrosion

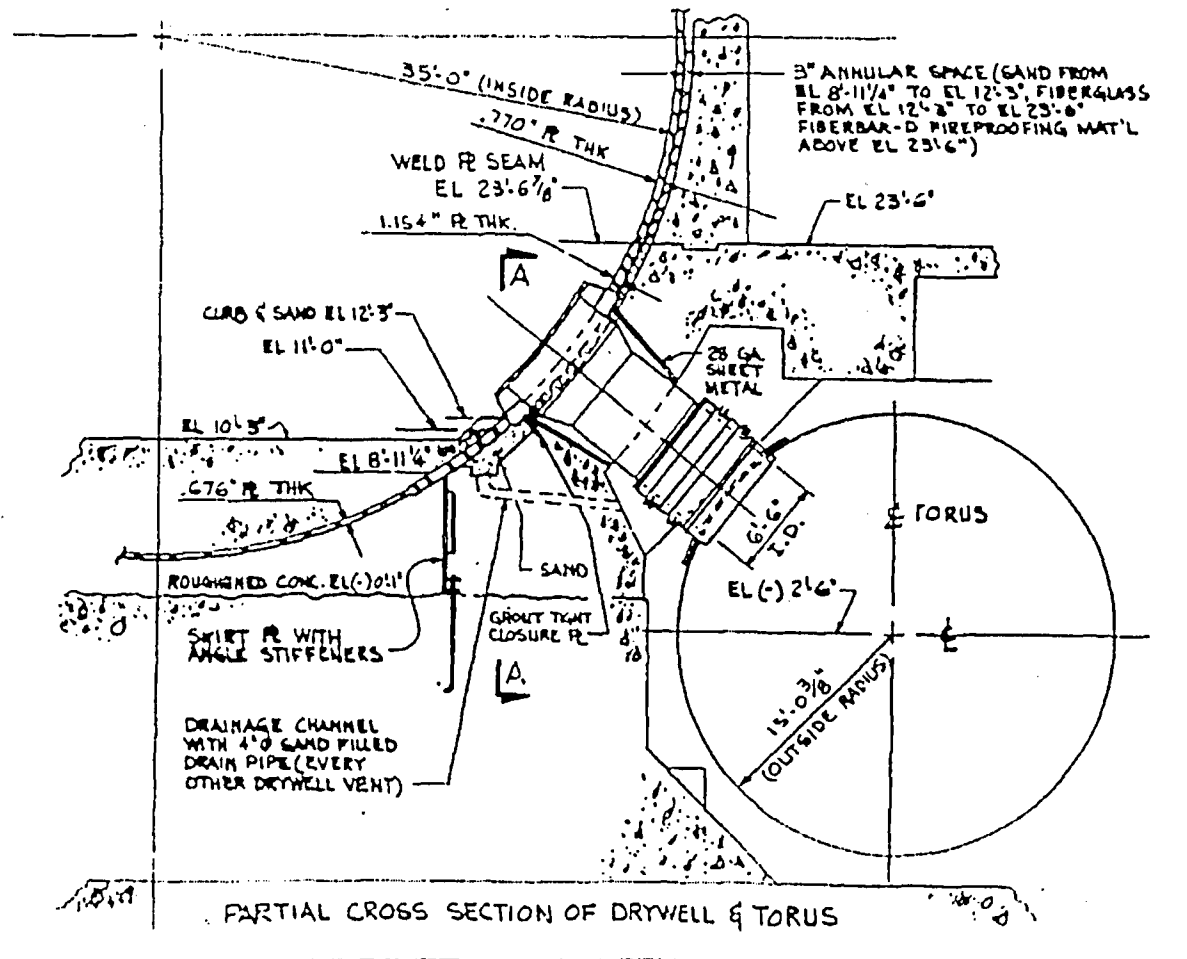
Embedded Region in 1992

- When sand was removed in 1992 the sand bed floor was unfinished, water had ponded on the floor, and the floor had deep craters, probably due to corrosion of rebar
- Until 1992 no seal was present between the shell and the concrete to reduce penetration of water into gaps
- Moisture from groundwater has not been ruled out

- Conditions in the embedded region from the early 60s through to 1992 were favorable for crevice corrosion, which could then self-accelerate
- Since 1992, it has been assumed, but not verified that the elastomer seal has kept the embedded region dry
- Assumption of dry conditions since 1992 not valid because seal could be leaking and water could be coming from below

- Removal of sand could have accelerated corrosion in the embedded region because of differential aeration, if wet conditions persisted
- Corrosion rates in the sandbed region do not bound corrosion rates in the embedded region
- Steel thickness in the lower embedded region was nominally 0.676 inches and corrosion rates could be up to 0.33 inches per year
