## TABLE OF CONTENTS

## I. INTRODUCTION

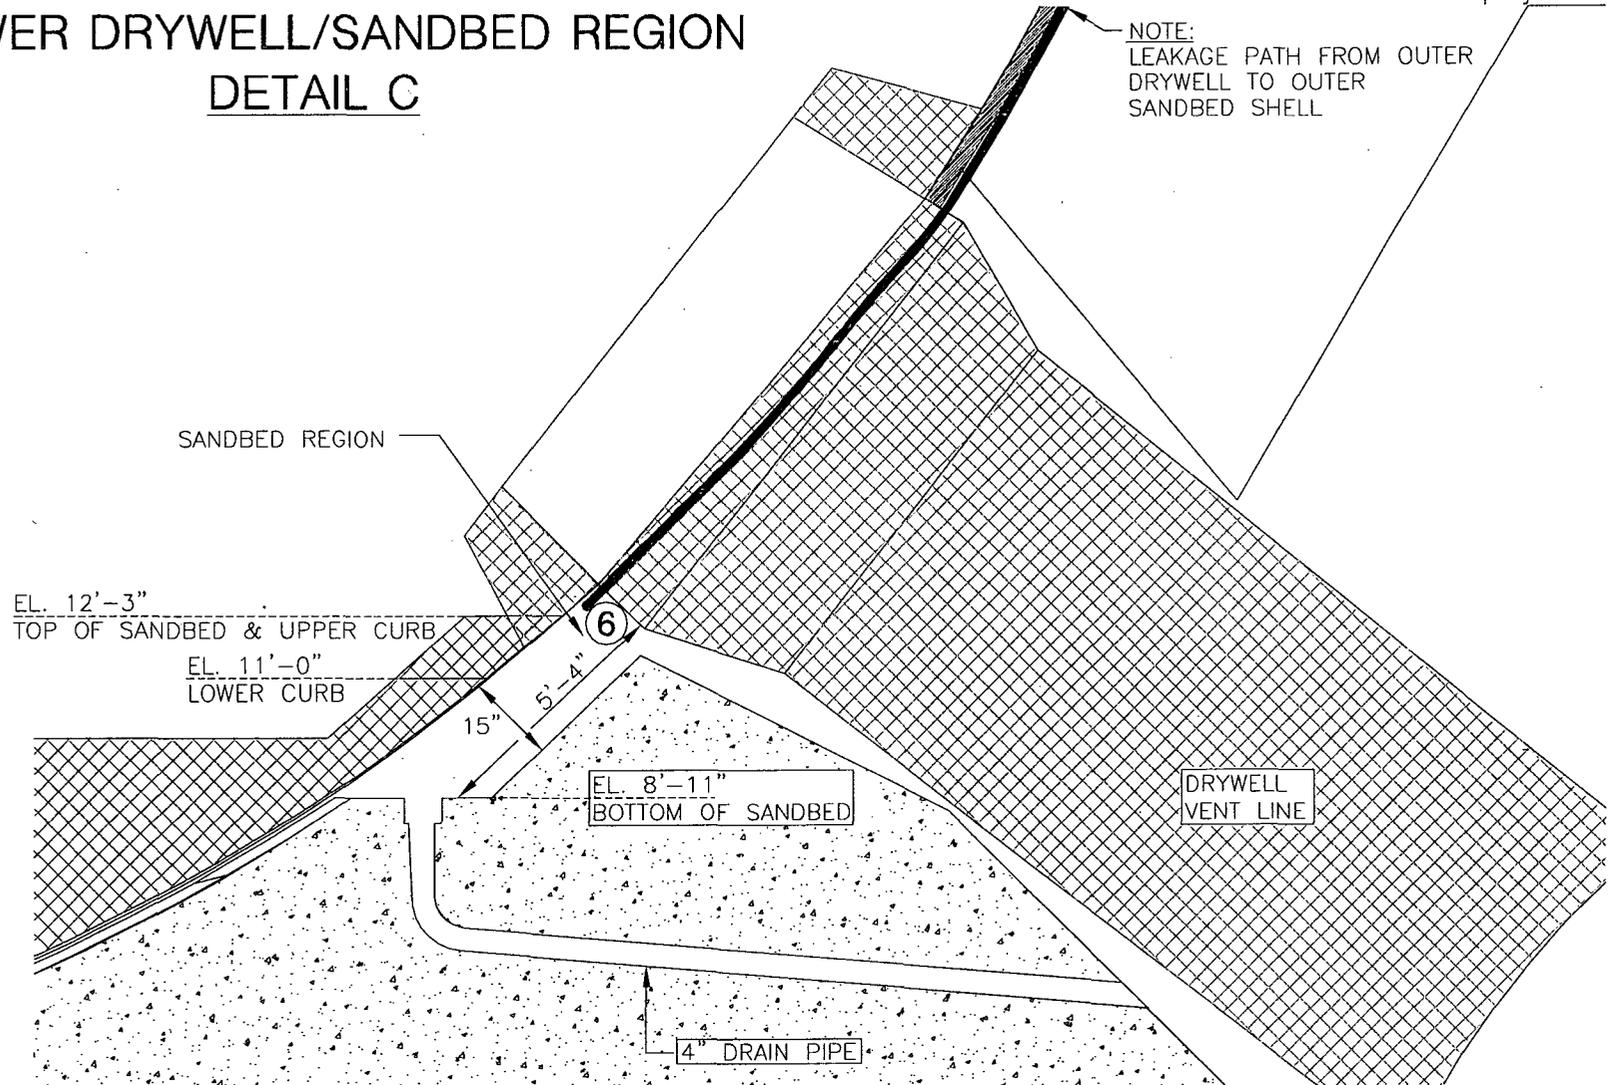
## LOWER DRYWELL/SANDBED REGION DETAIL C

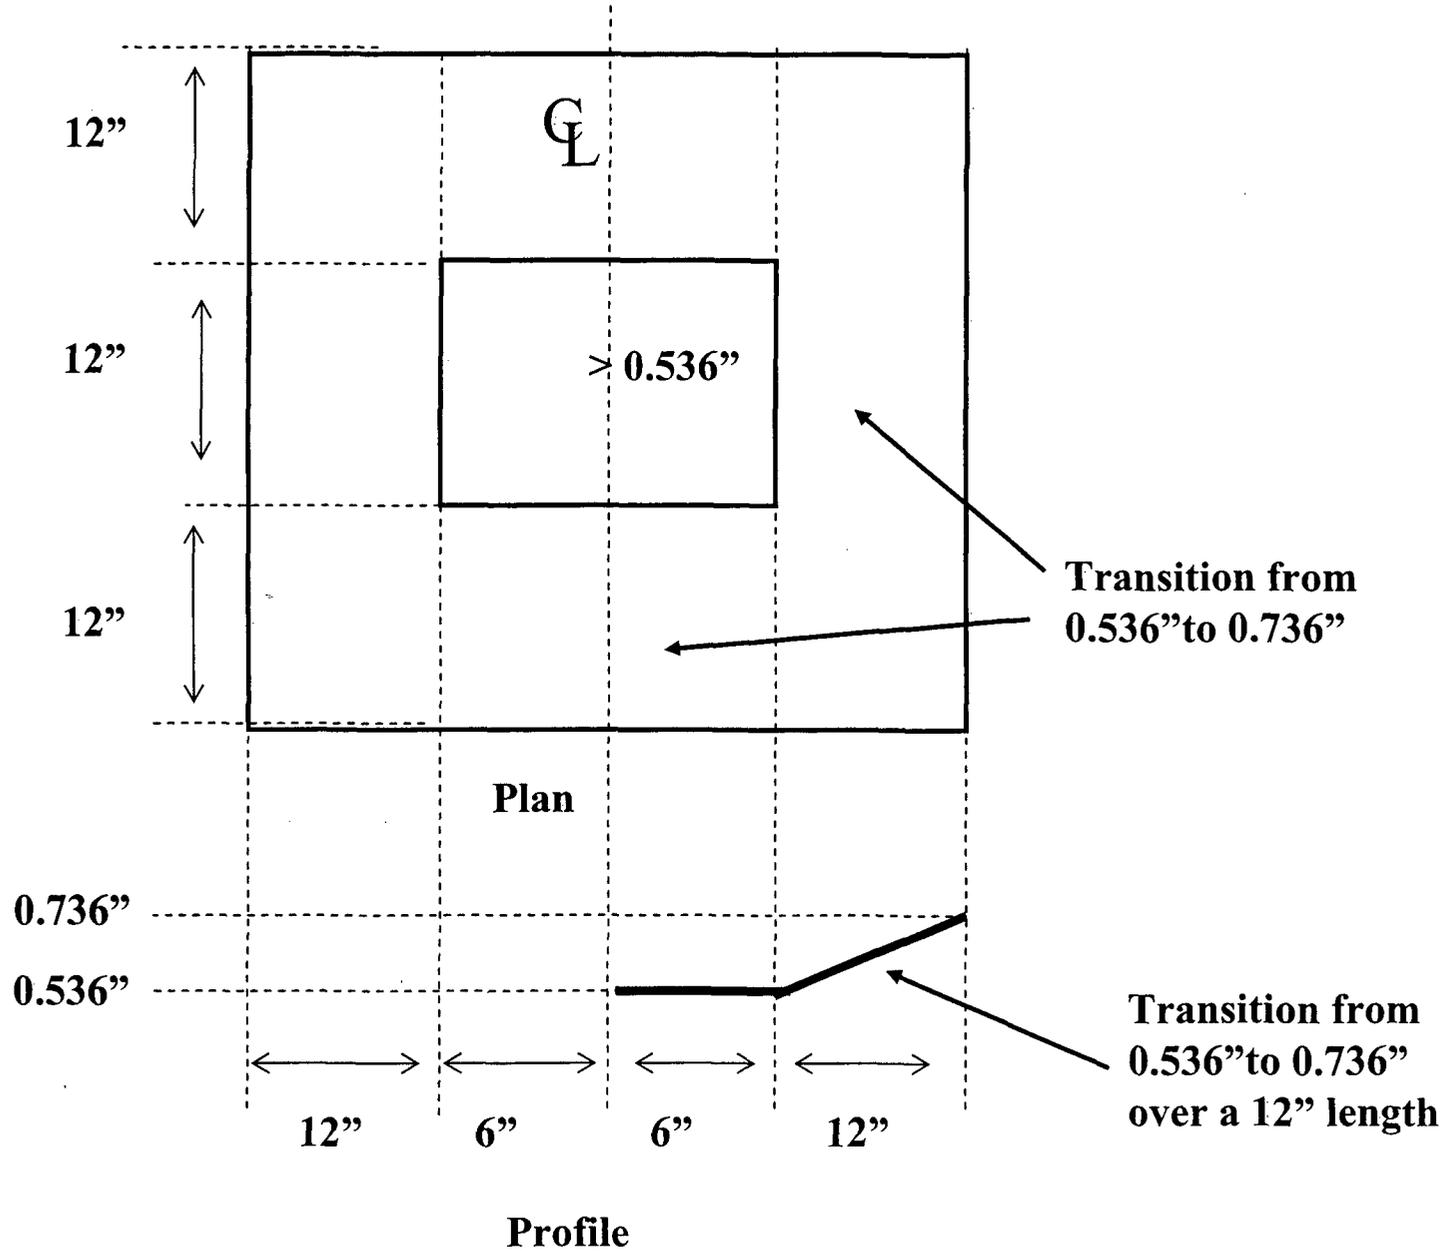
**Figure 1**

**Schematic Demonstrating Local Area Average Acceptance Criterion**

area criterion includes a one-foot *transition area* to 0.736” on all four sides of the 0.536” area, such that the total allowable contiguous area with thickness below 0.736 is *nine square feet*. This is clearly shown on Figure 1 which I created, and which is based on the GE Nuclear report that was attached to the AmerGen submittal to the ACRS on December 8, 2006, as Reference 22.

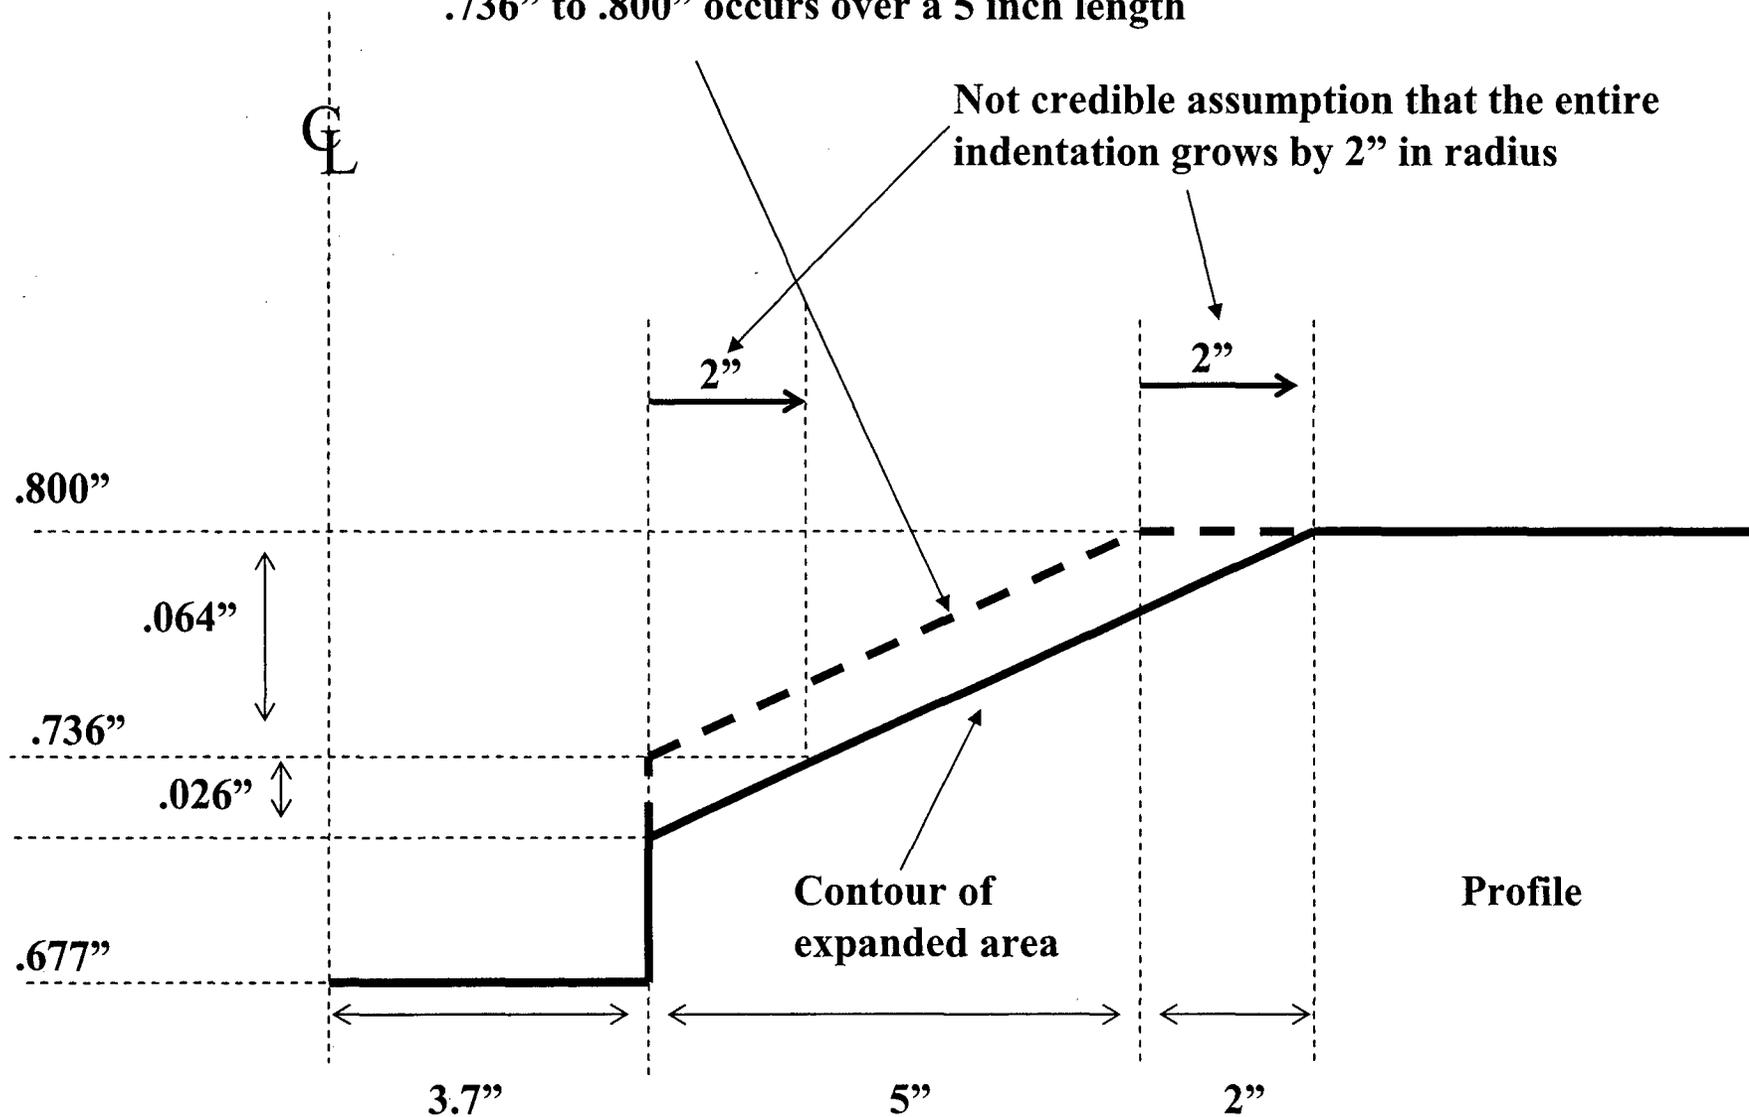
Assumption that the transition from  
.736" to .800" occurs over a 5 inch length

Regardless, by expanding the radius of the indentation by 2", the diameter of the indentation would increase by 4", for a total diameter of 21.7" (this is larger than Dr. Haulser's memo which mentions 17.4" diameter). I have created Figure 3 to show the increase of the radius of the hypothetical indentation by 2".
