**Re: 2006 Annual Report for University of California Davis/ McClellan Nuclear
Radiation Center, Docket No. 50-607, License No. R-130**

2006

ANNUAL REPORT

Docket Number 50-607
License Number R-130

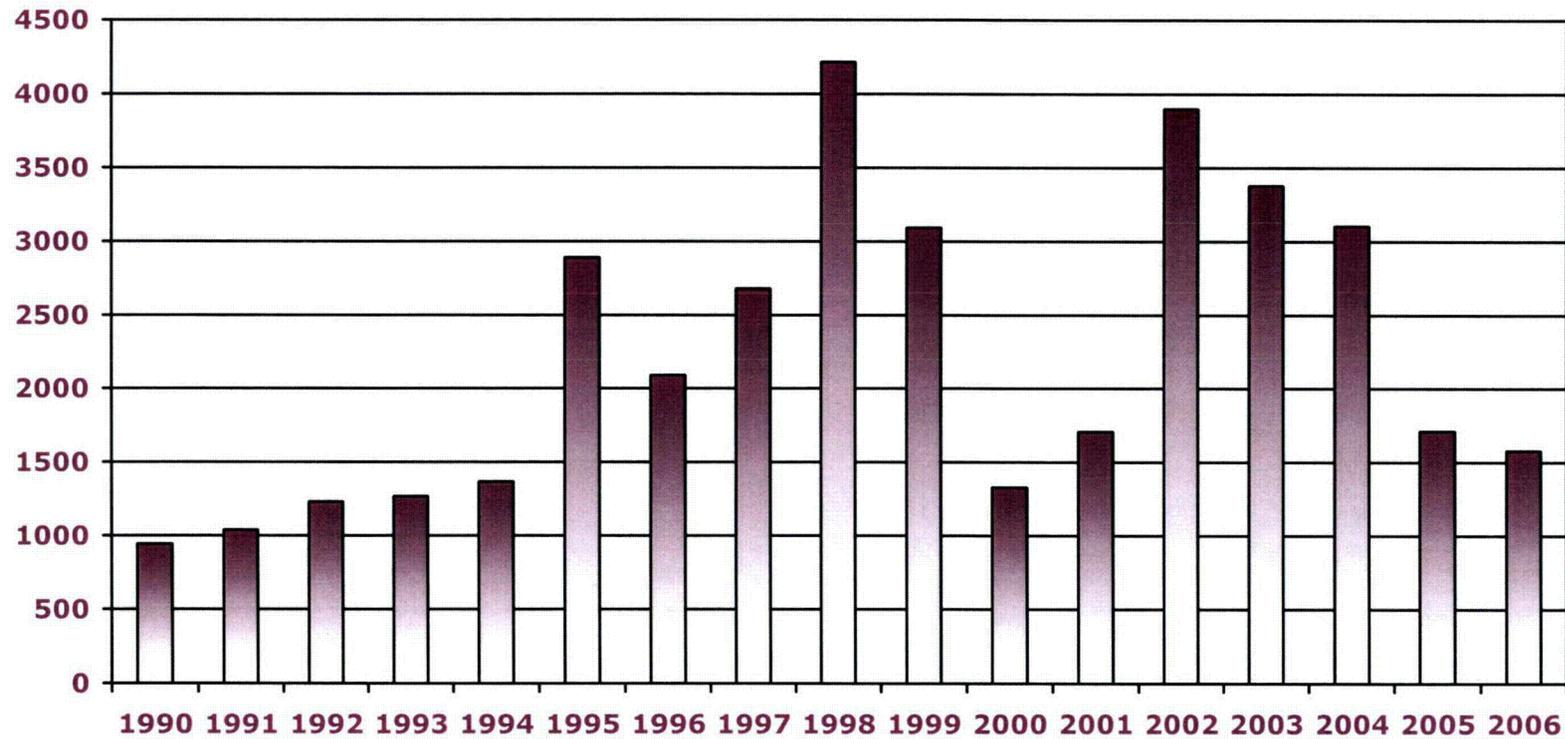
UCD/MNRC Operating History

■ Operating Hours

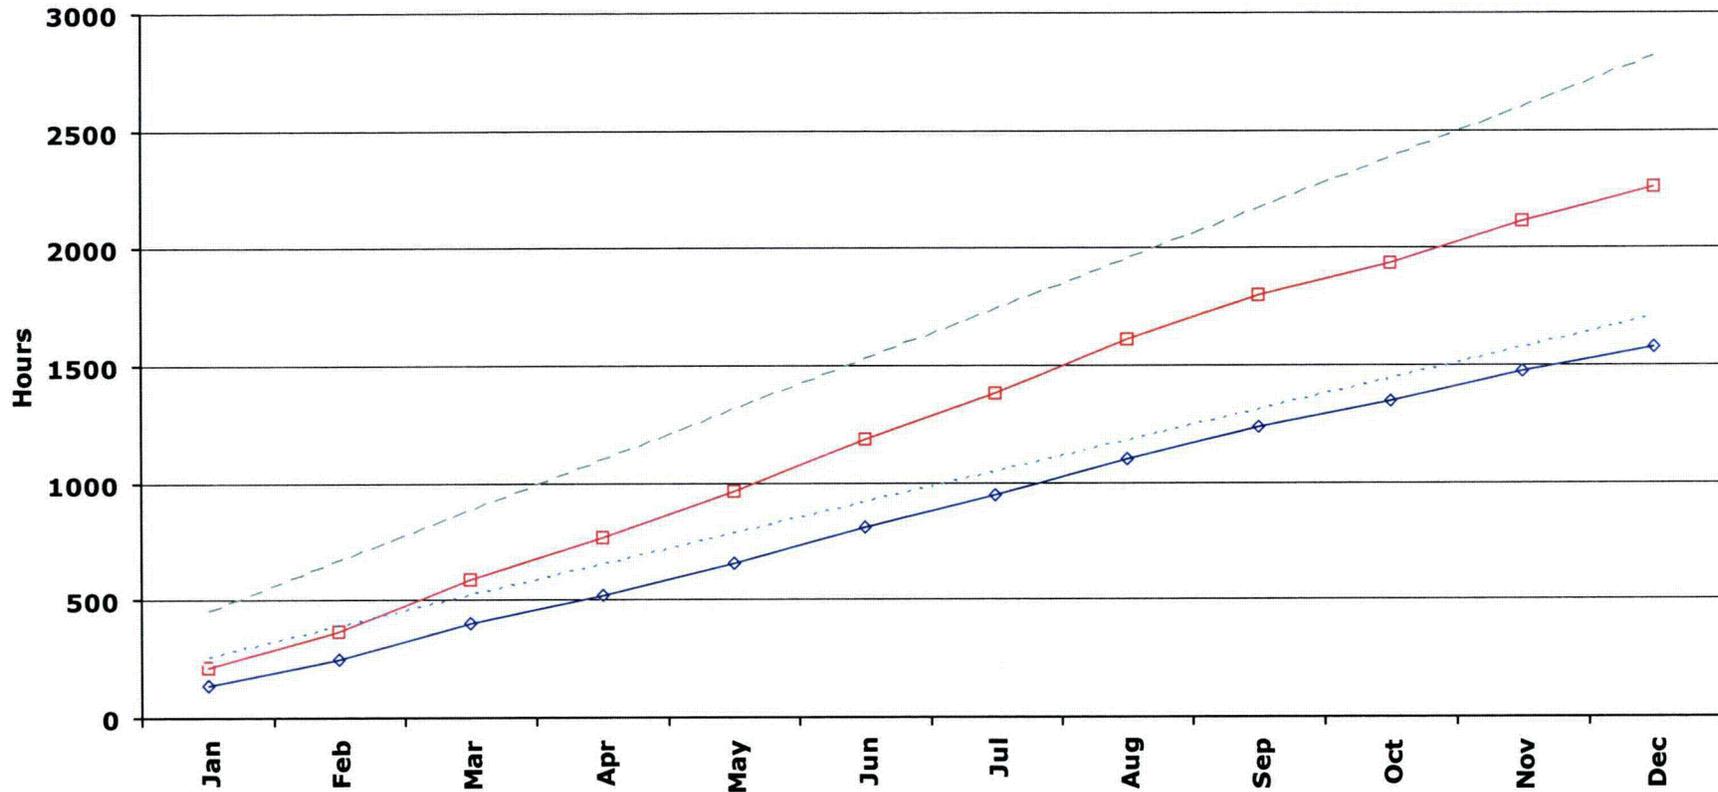
◆ Total Op-Hrs
 □ Total MW-hrs
 Linear (2005 Op-Hrs)
 - - - Linear (2005 MW-Hrs)

Reactor Hours (2006)

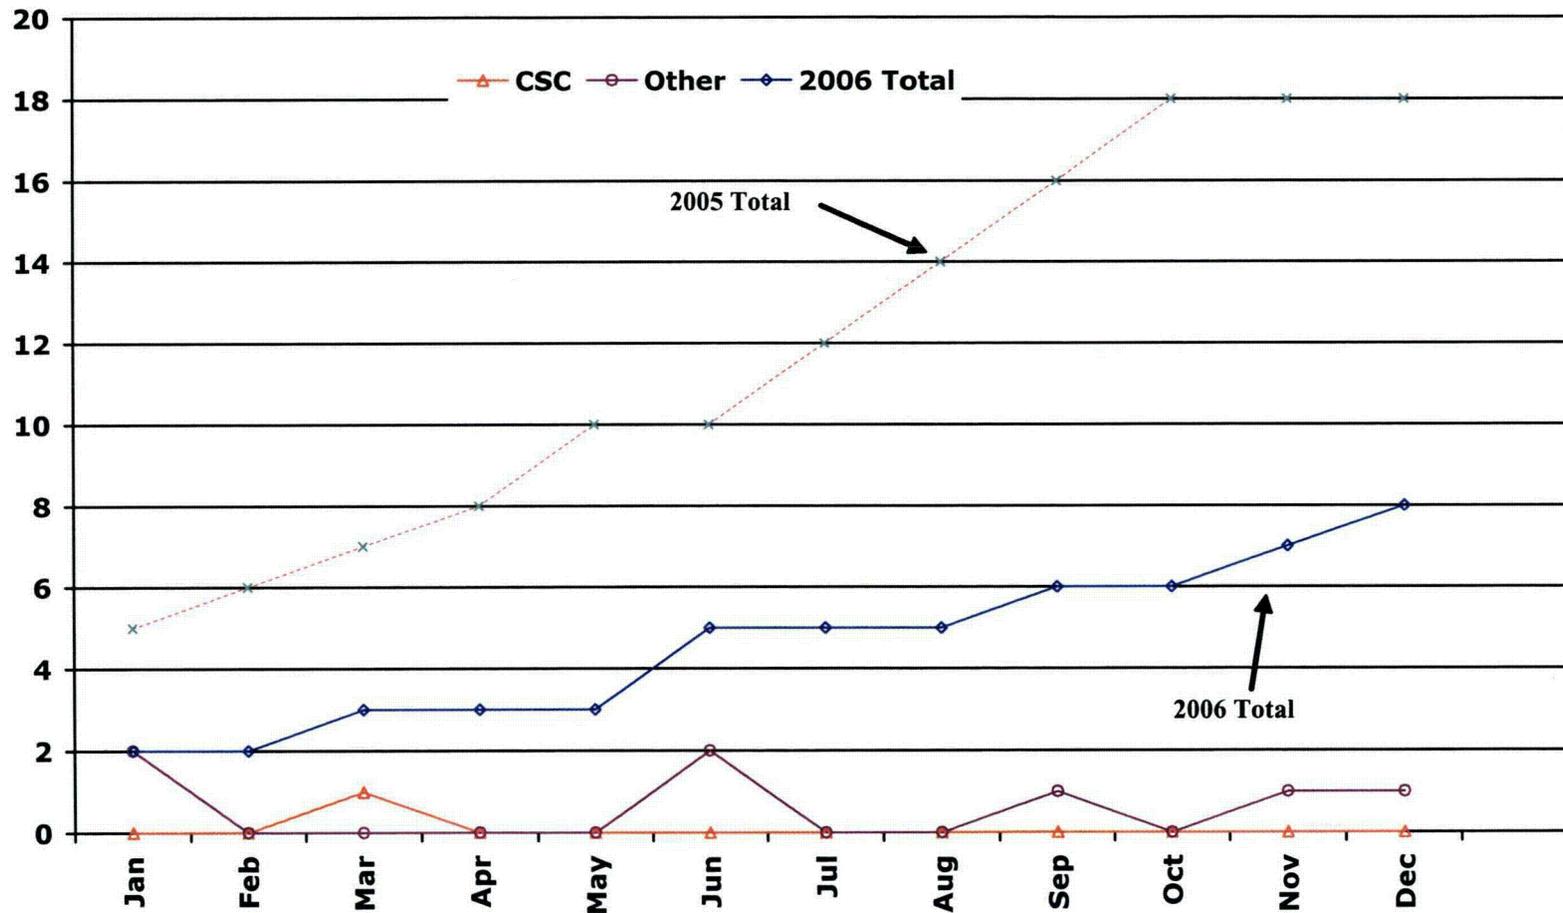
Unscheduled Shutdowns-- Total 2006

Type of Failures	Total Number
CSC	1
Other	7
TOTAL NUMBER OF SHUTDOWNS IN 2004	8

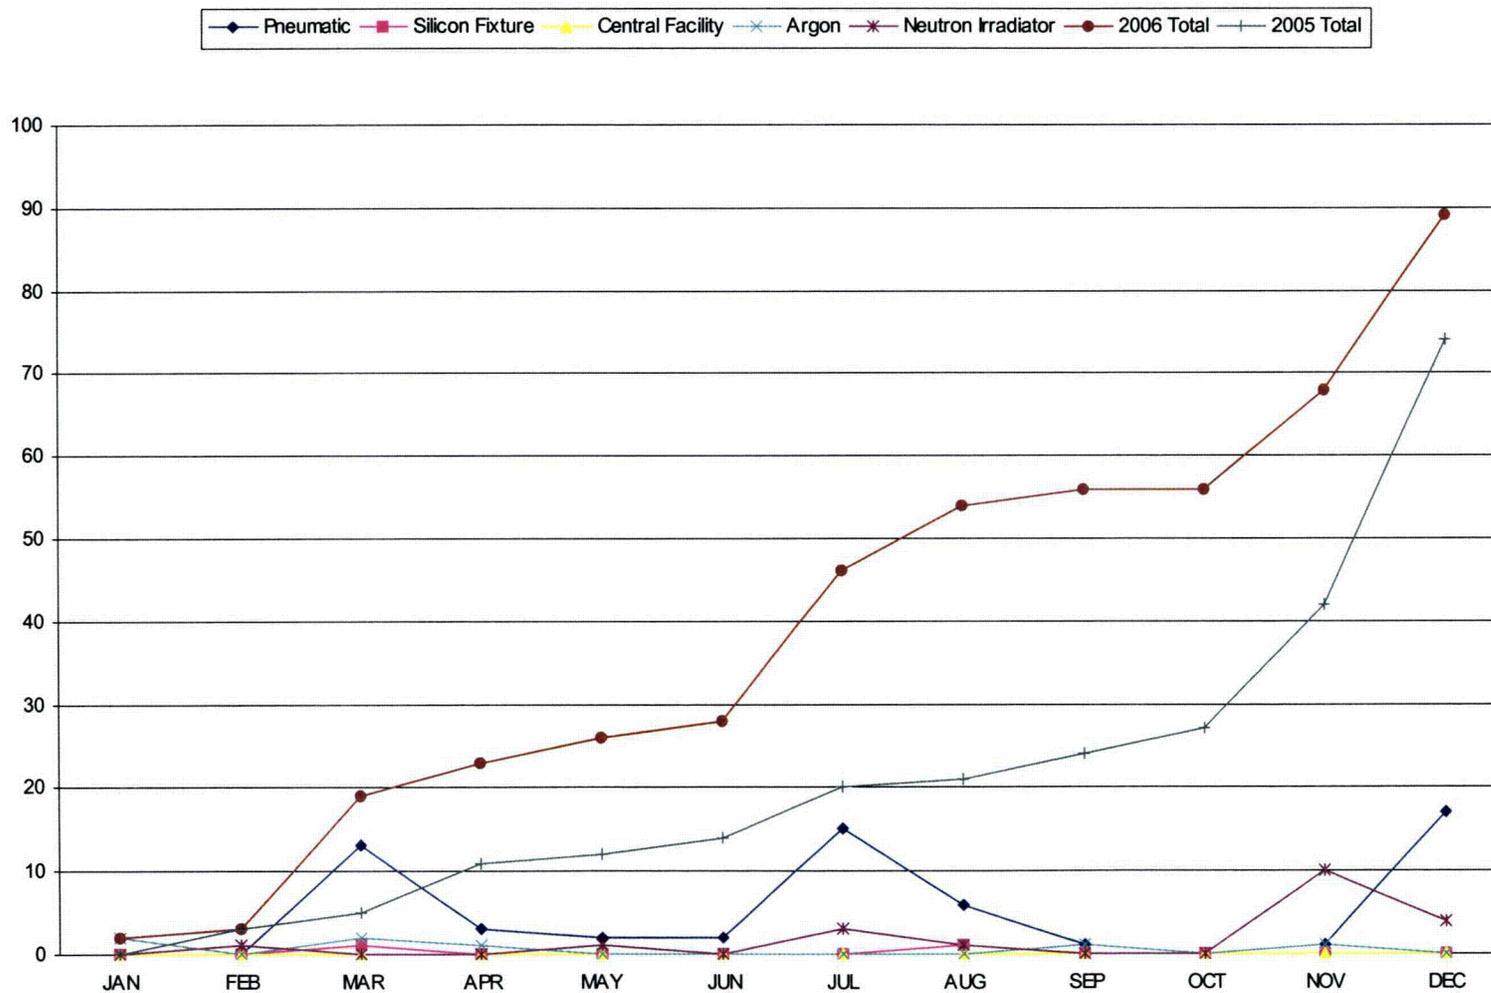
Reactor Tank Irradiation Facilities Total Number of Irradiations Completed (2006)

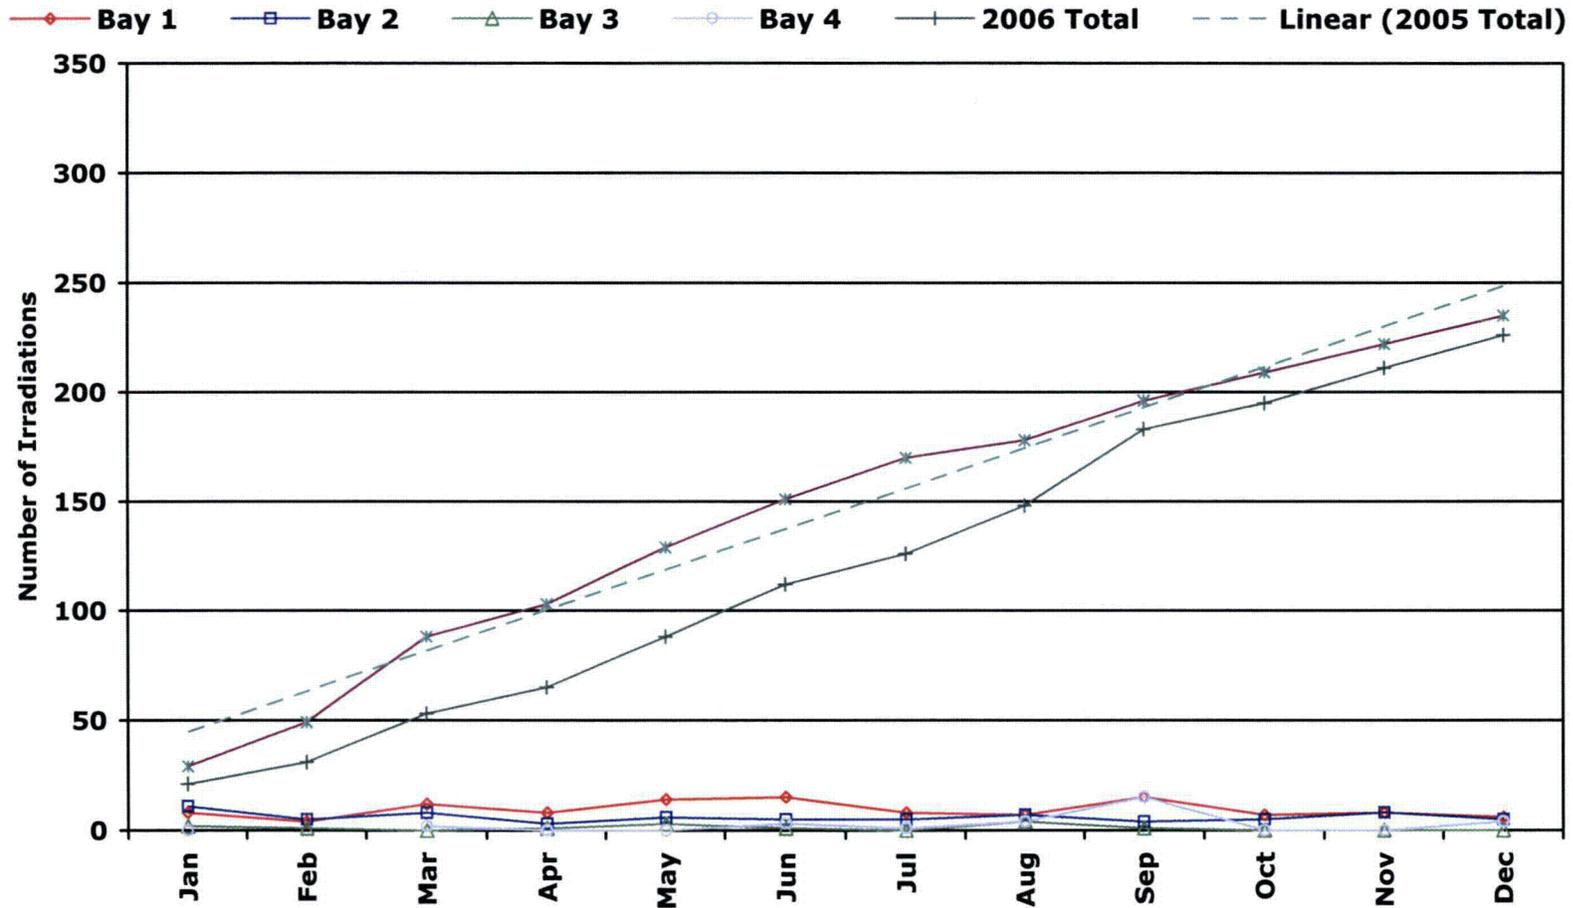
Bay Irradiations Completed (2006)

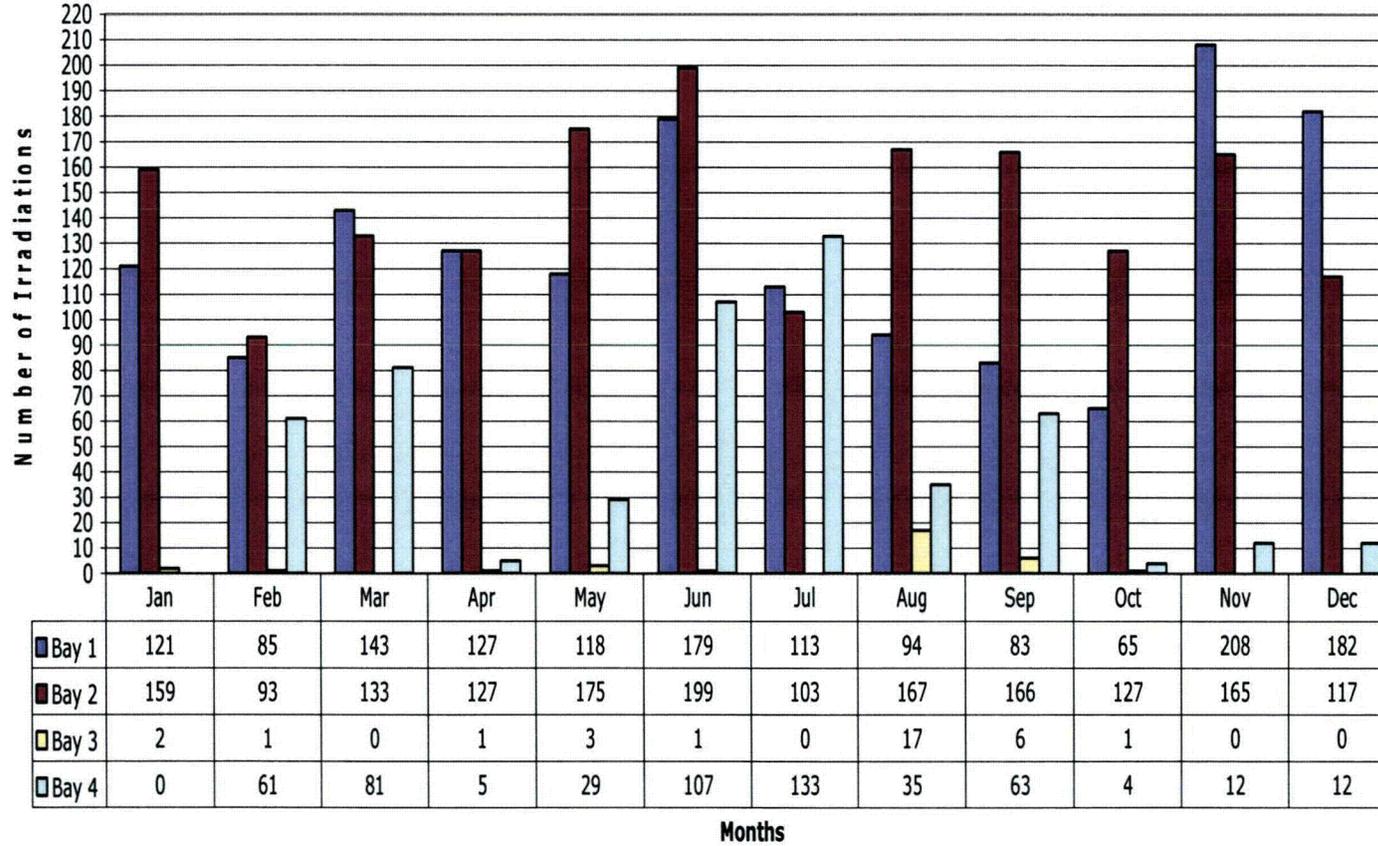
Bay Utilization (Shutter Operations) 2006
