Appendix A

ESEM/EDS Data for Test #4, Day-5 Fiberglass in Low-Flow Zone

During ICET Test #4, work was continued for the purpose of identifying the origin and chemical composition of the products that were formed during the test. One objective of ICET is to identify the composition of debris on fiberglass and the particulate substances in the test solution. To address this question partially, low-flow fiberglass samples on Test #4, Day 5 were examined by ESEM/EDS, including both of the exterior and the interior location of the fiberglass samples.

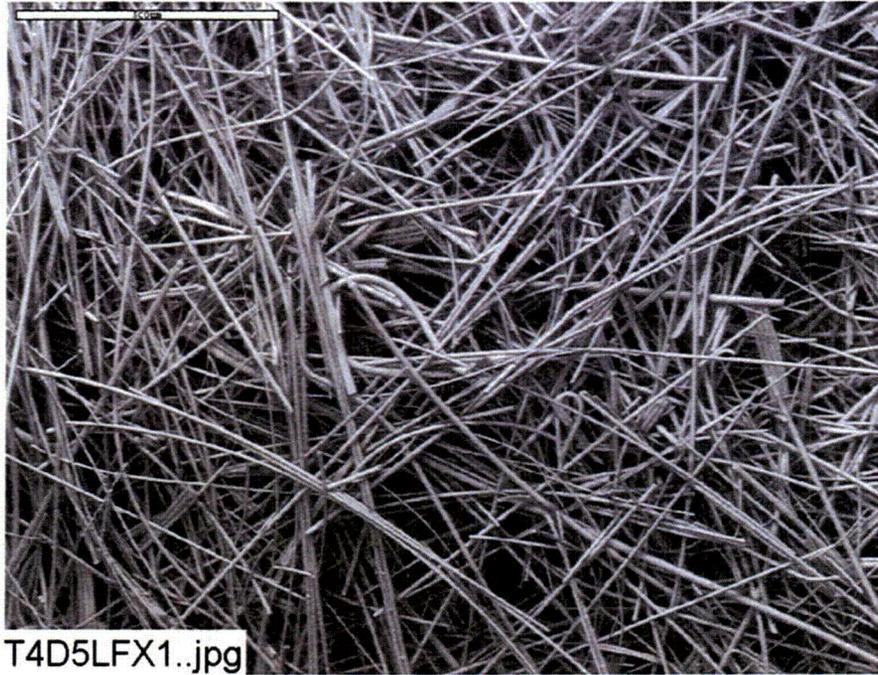
Figure A-1. Environmental SEM image magnified 80 times for a Test #4, Day-5 low-flow exterior fiberglass sample. (T4D5LFX1.jpg)

Image:	T4D5LFX1	80 ×	ESEM image	Figure A-1
	t4d5lfx4	80 ×	ESEM at higher magnification	Figure A-2
	t4d5lfx2	500 ×		Figure A-3
	t4d5lfx3	1000 ×		Figure A-4
	t4d5lx11	1000 ×		Figure A-5
	t4d5lx14	500 ×		Figure A-6
	t4d5lx12	1000 ×		Figure A-7
EDS:	t4d5lx13			Figure A-8

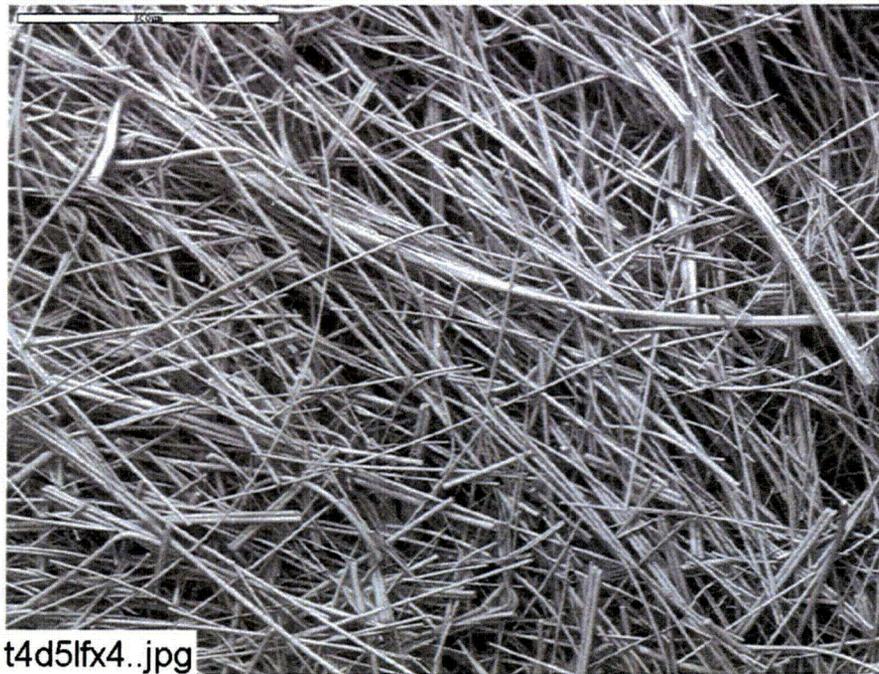
Figure A-2. Environmental SEM image magnified 80 times for a Test #4, Day-5 low-flow exterior fiberglass sample. (t4d5lfx4.jpg)

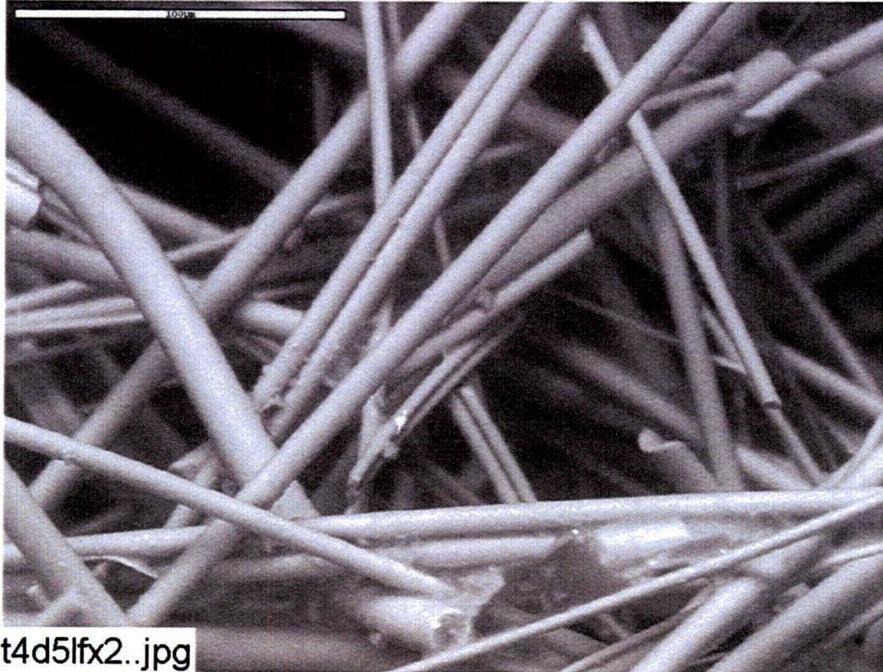
t4d5lfx2..jpg

Figure A-3. Environmental SEM image magnified 500 times for a Test #4, Day-5 low-flow exterior fiberglass sample. (t4d5lfx2.jpg)

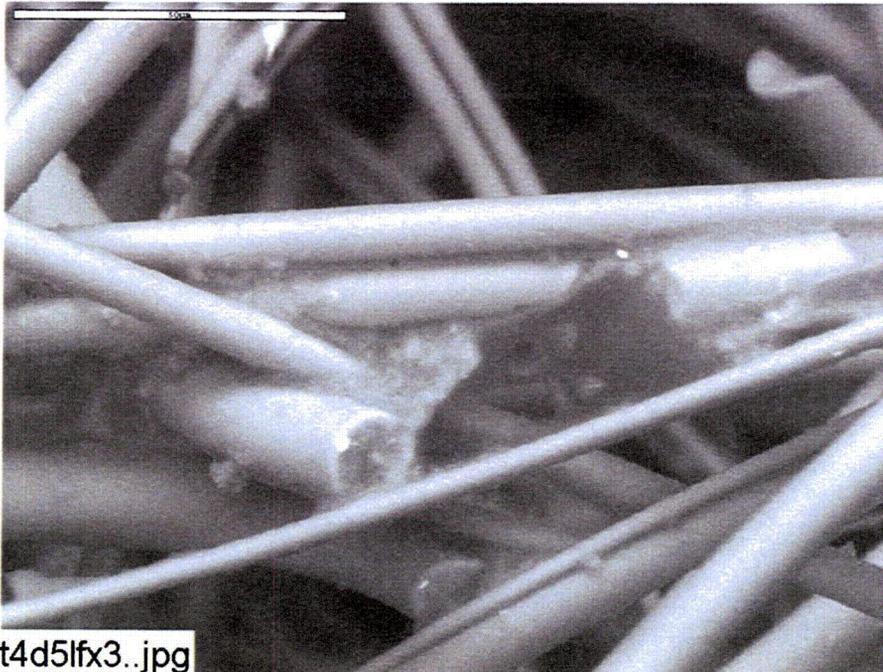
t4d5lfx3..jpg

Figure A-4. Environmental SEM image magnified 1000 times for a Test #4, Day-5 low-flow exterior fiberglass sample. (t4d5lfx3.jpg)

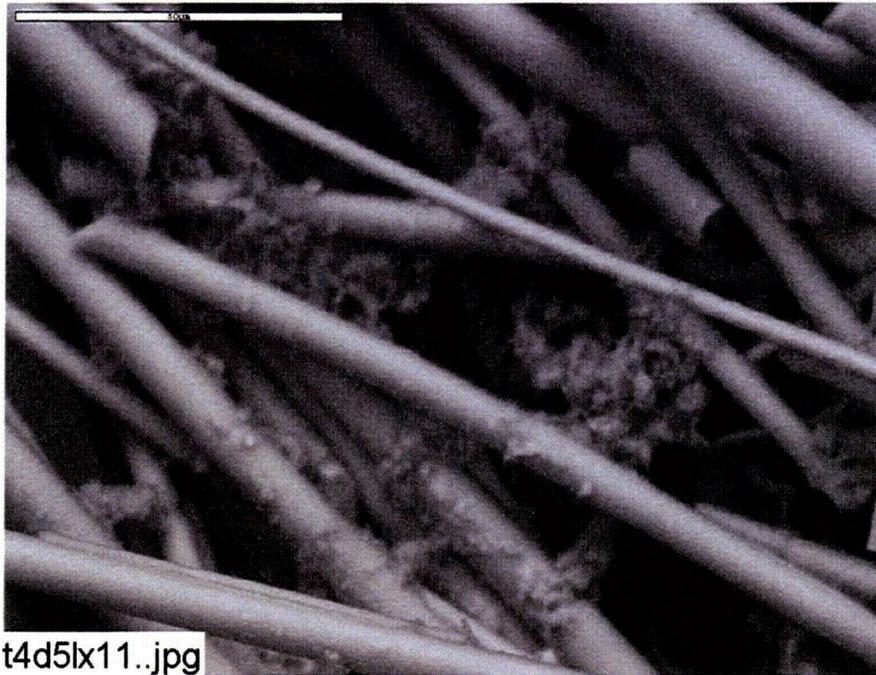
t4d5lx11..jpg

Figure A-5. Environmental SEM image magnified 1000 times for a Test #4, Day-5 low-flow exterior fiberglass sample. (t4d5lx11.jpg)

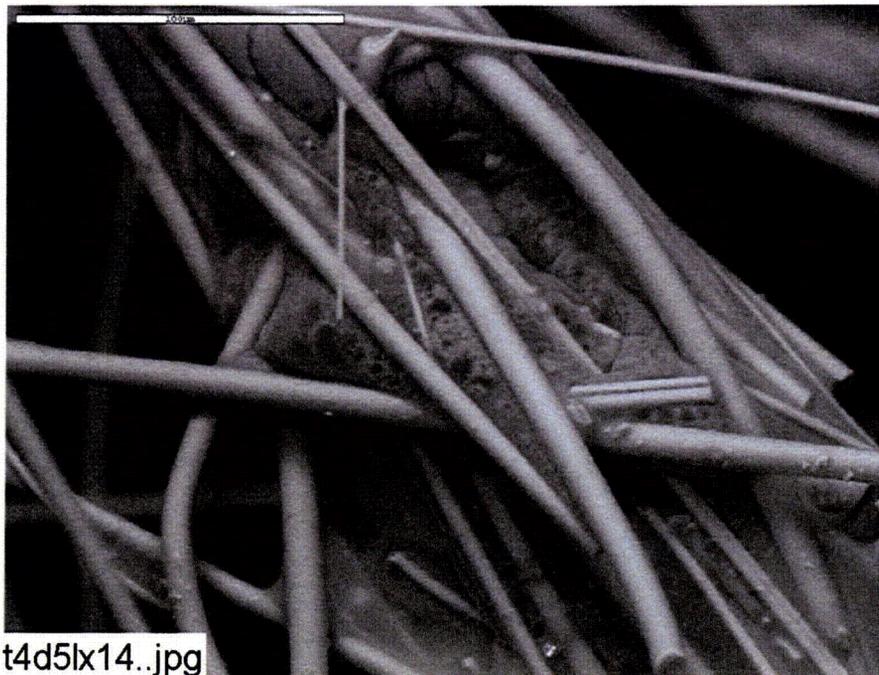
t4d5lx14..jpg

Figure A-6. Environmental SEM image magnified 500 times for a Test #4, Day-5 low-flow exterior fiberglass sample. (t4d5lx14.jpg)

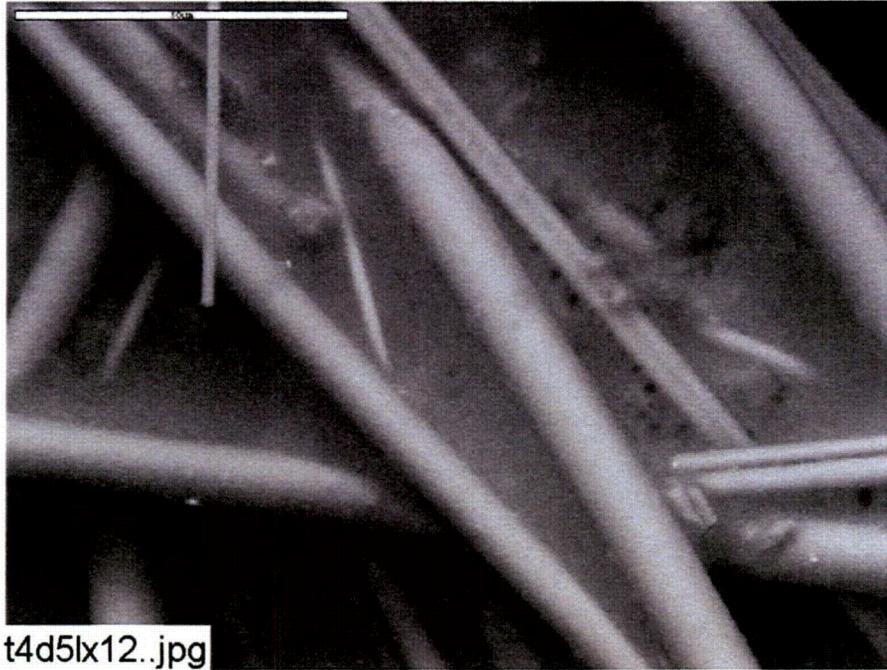
Figure A-7. Environmental SEM image magnified 1000 times for a Test #4, Day-5 low-flow exterior fiberglass sample. (t4d5lx12.jpg)

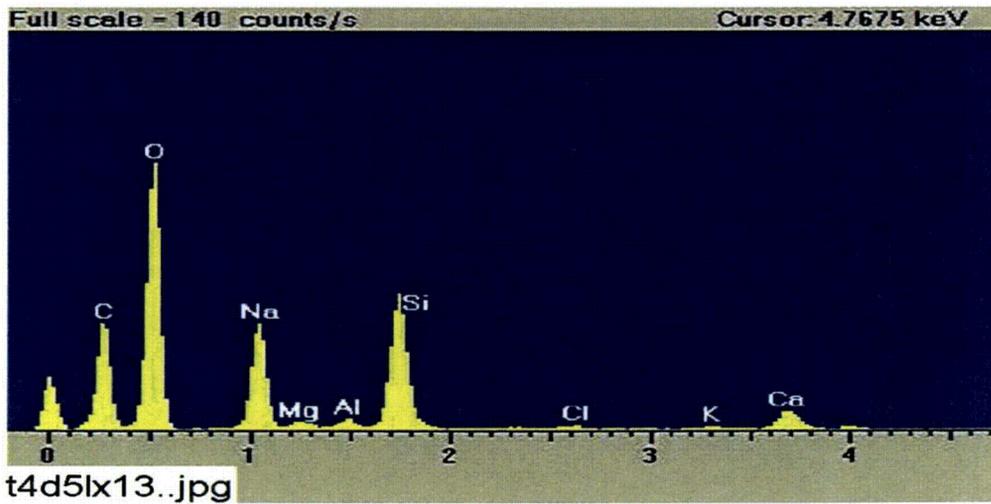
Figure A-8. EDS counting spectrum for the film between the fibers shown in Figure A-7. (t4d5lx13.jpg)

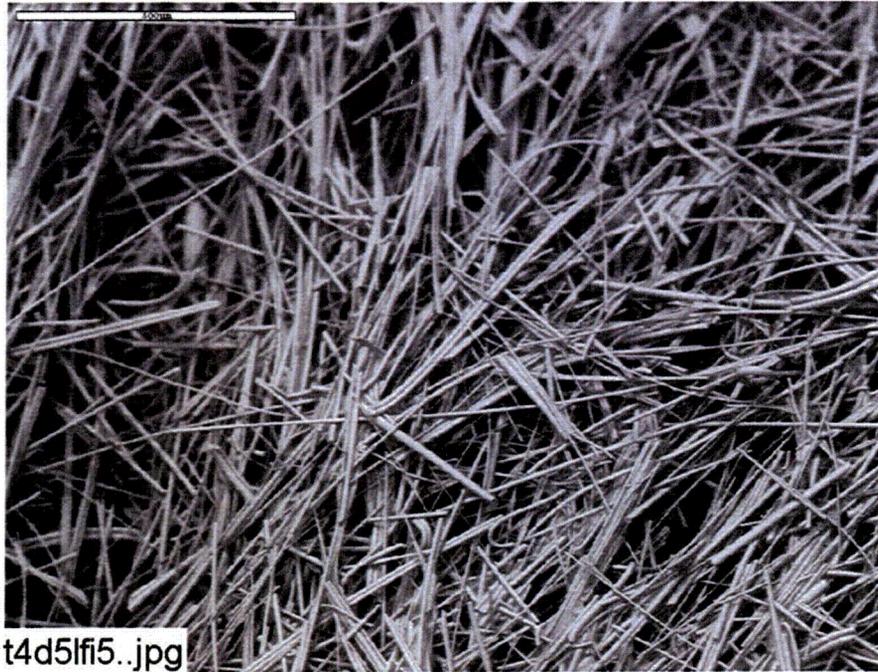
Figure A-9. Environmental SEM image magnified 80 times for a Test #4, Day-5 low-flow interior fiberglass sample. (t4d5lf5.jpg)

Image:	t4d5lfi5	80 ×	ESEM image	Figure A-9
	t4d5lfi6	500 ×	ESEM at higher magnification	Figure A-10
	t4d5lfi7	500 ×		Figure A-11
	t4d5lfi8	2000 ×		Figure A-12
	t4d5lfi9	1000 ×		Figure A-13
	t4d5li10	1000 ×		Figure A-14
	t4d5li15	500 ×		Figure A-15

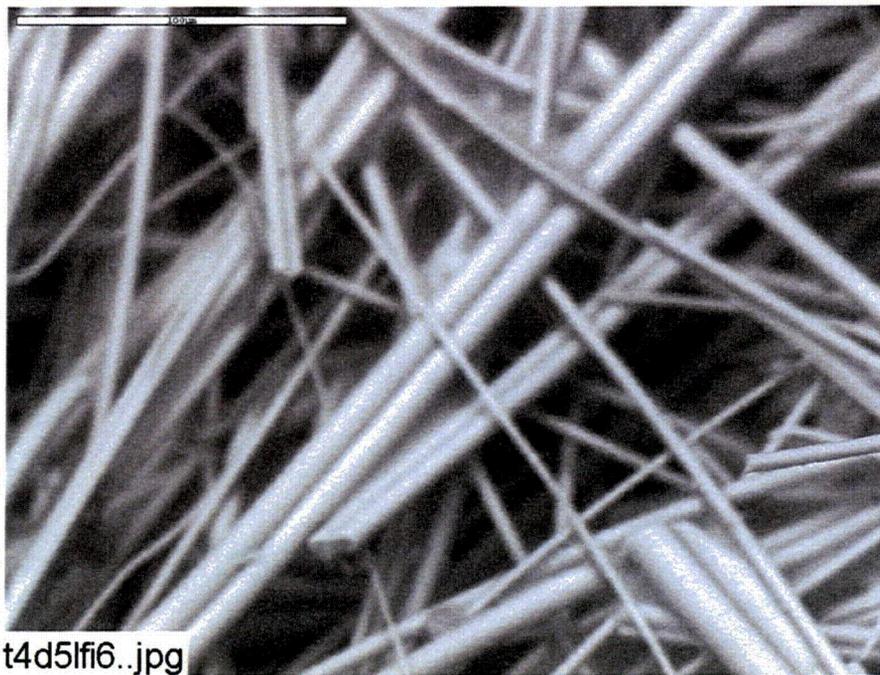
Figure A-10. Environmental SEM image magnified 500 times for a Test #4, Day-5 low-flow interior fiberglass sample. (t4d5lf6.jpg)

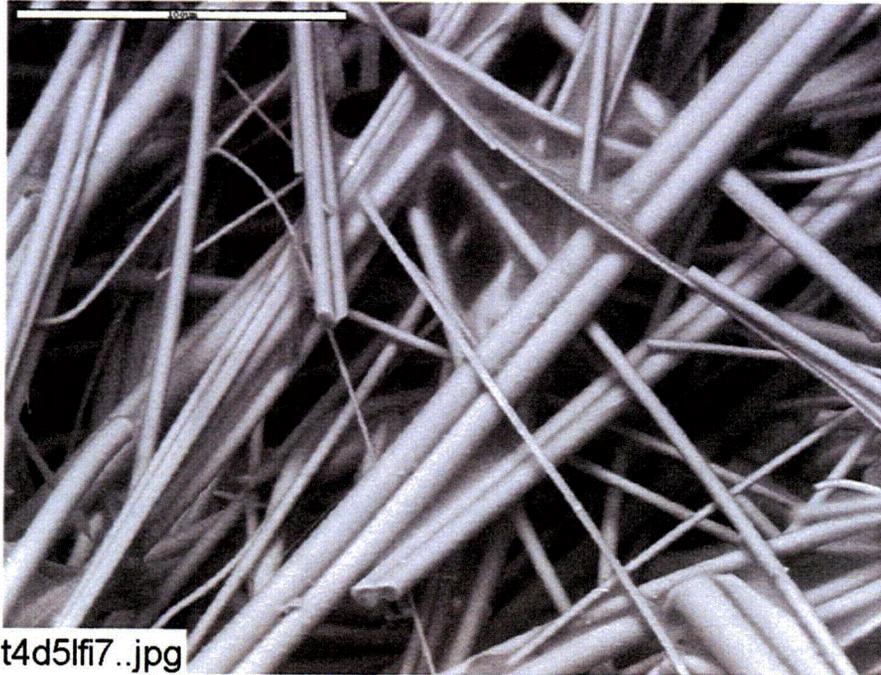
t4d5lf17..jpg

Figure A-11. Environmental SEM image magnified 500 times for a Test #4, Day-5 low-flow interior fiberglass sample. (t4d5lf17.jpg)

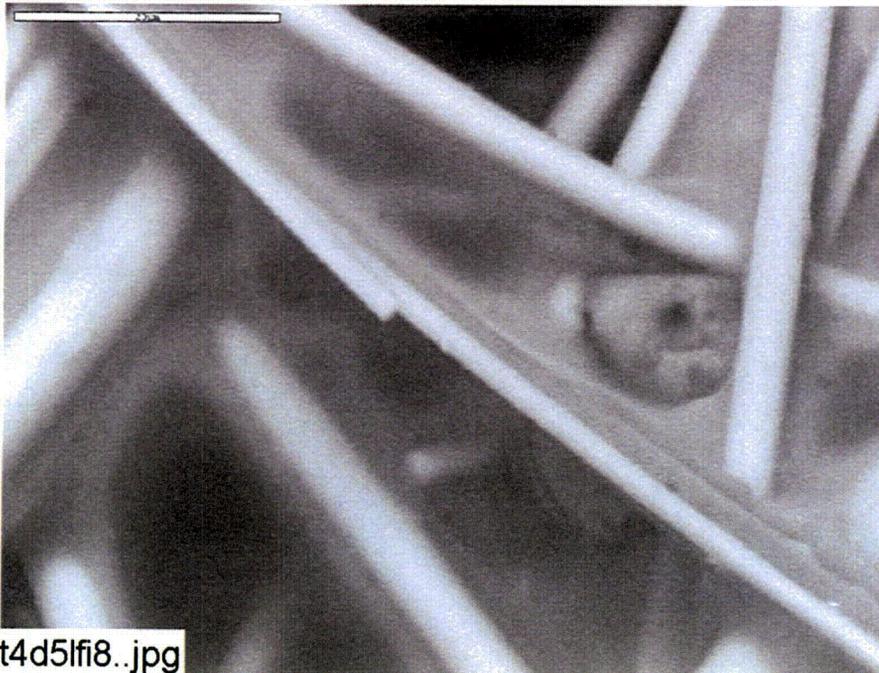
t4d5lf18..jpg

Figure A-12. Environmental SEM image magnified 2000 times for a Test #4, Day-5 low-flow interior fiberglass sample. (t4d5lf18.jpg)

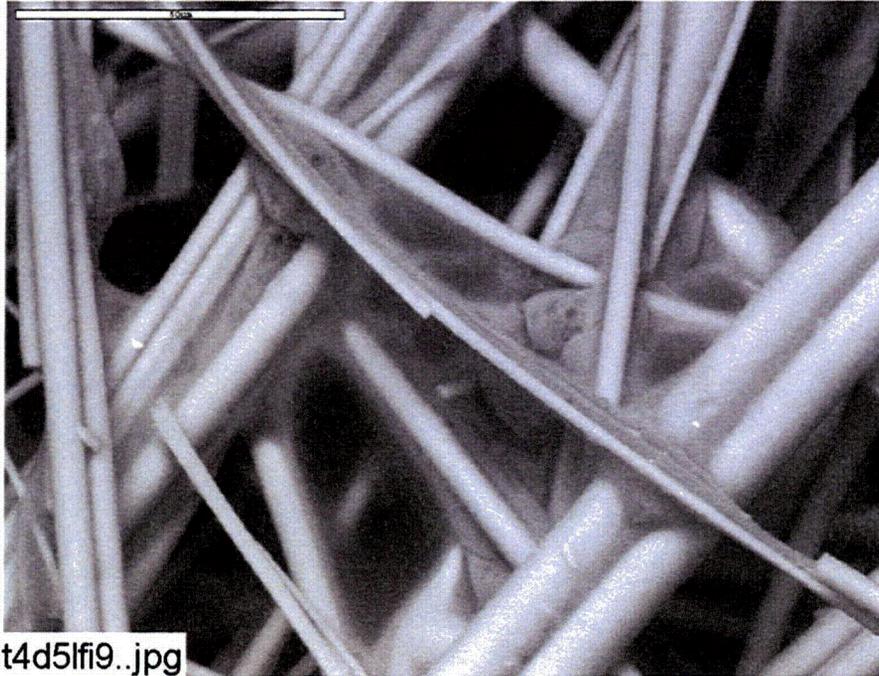
Figure A-13. Environmental SEM image magnified 1000 times for a Test #4, Day-5 low-flow interior fiberglass sample. (t4d5lf9.jpg)

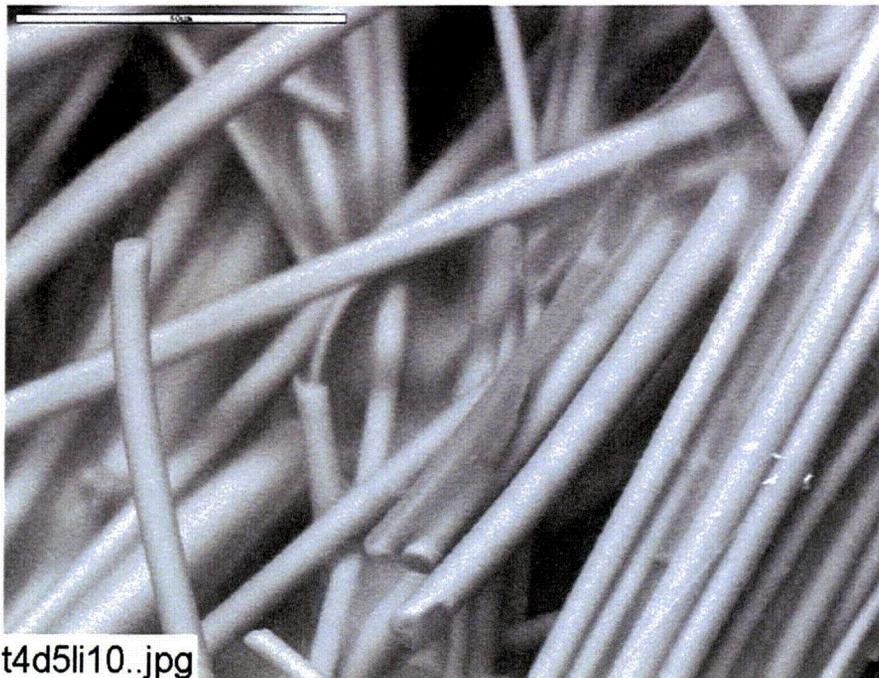
Figure A-14. Environmental SEM image magnified 1000 times for a Test #4, Day-5 low-flow interior fiberglass sample. (t4d5li10.jpg)

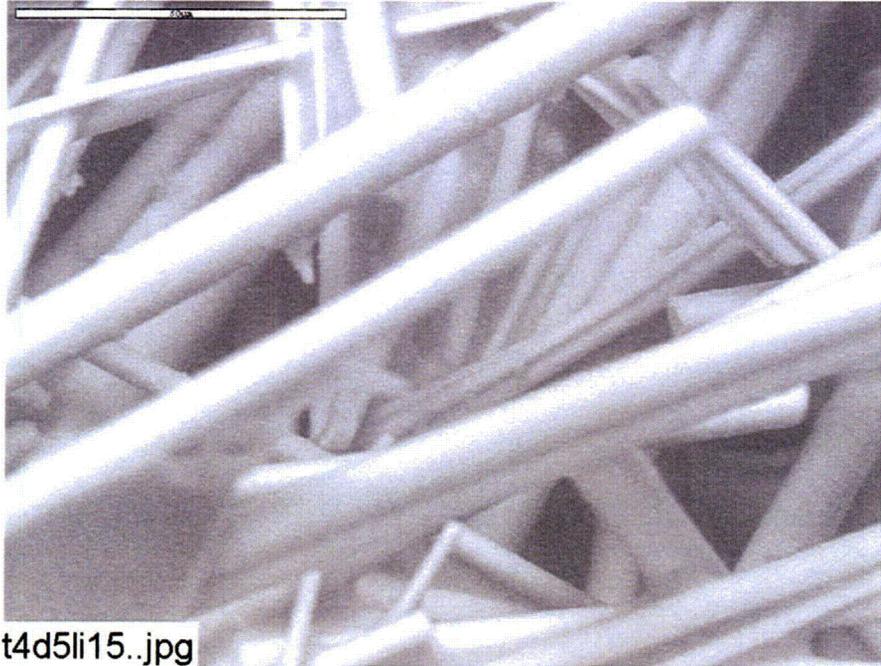
t4d5li15..jpg

Figure A-15. Environmental SEM image magnified 500 times for a Test #4, Day-5 low-flow interior fiberglass sample. (t4d5li15)

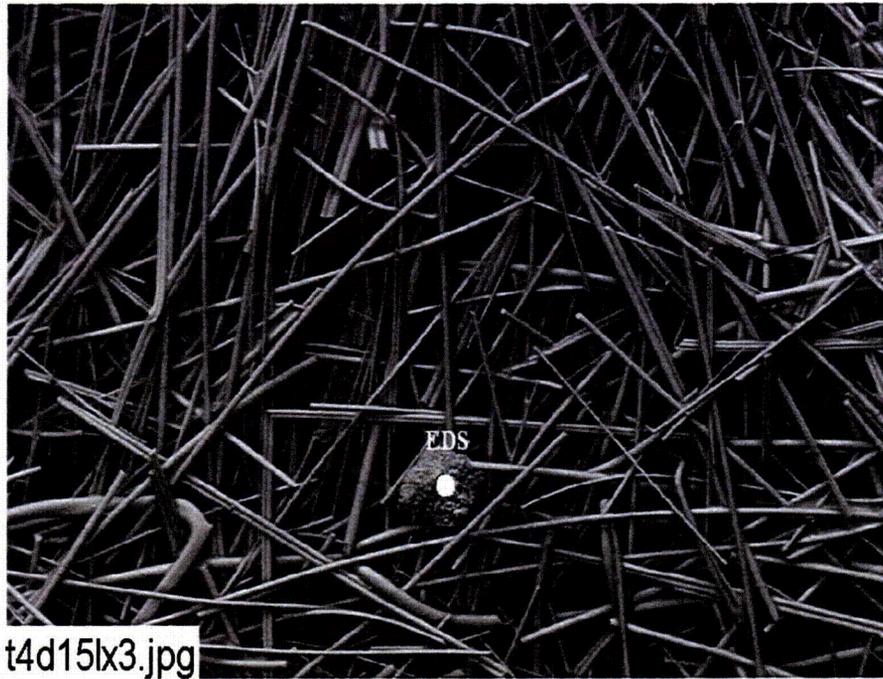
Figure B1-1. Annotated environmental SEM image magnified 100 times for a Test #4, Day-15 exterior low-flow fiberglass sample. (t4d15lx3.jpg)

Image: t4d15lx3	100 ×	ESEM annotated image	Figure B1-1
EDS: t4d15lx2		EDS image on particles in t4d15lx3	Figure B1-2
Image: t4d15lx4	500 ×	ESEM image of fiberglass	Figure B1-3
t4d15lx5	1000 ×	ESEM image at higher magnification	Figure B1-4

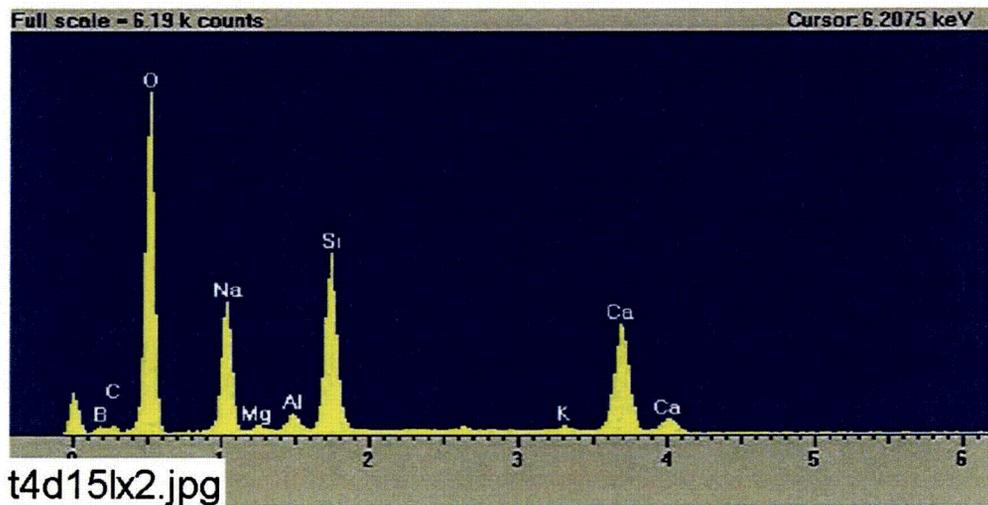
Figure B1-2. EDS counting spectrum for the particulate deposit on fiberglass shown in Figure B1-1. (t4d15lx2.jpg)

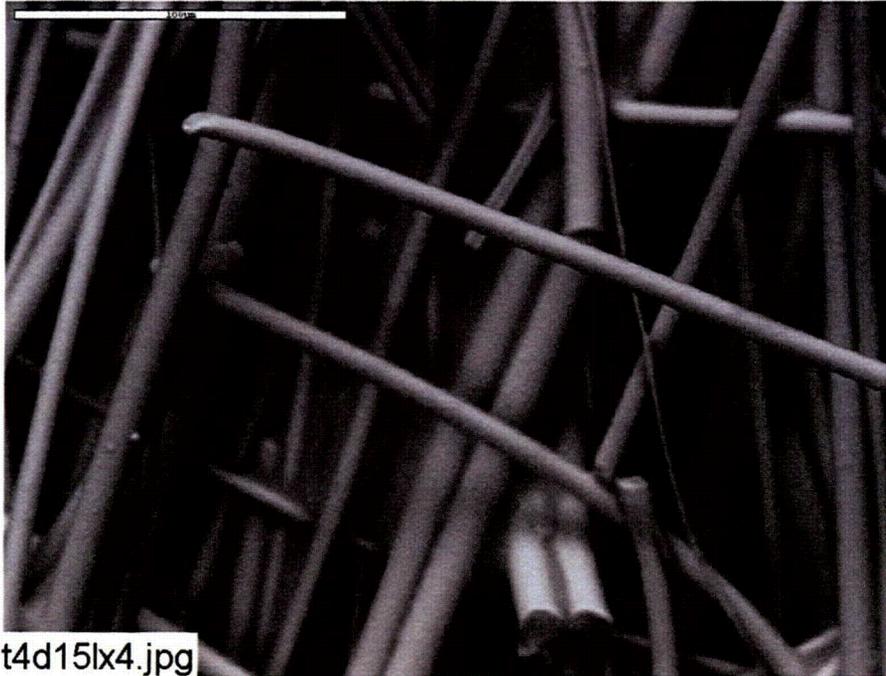
t4d15lx4.jpg

Figure B1-3. Environmental SEM image magnified 500 times for a Test #4, Day-15 exterior low-flow fiberglass sample. (t4d15lx4.jpg)

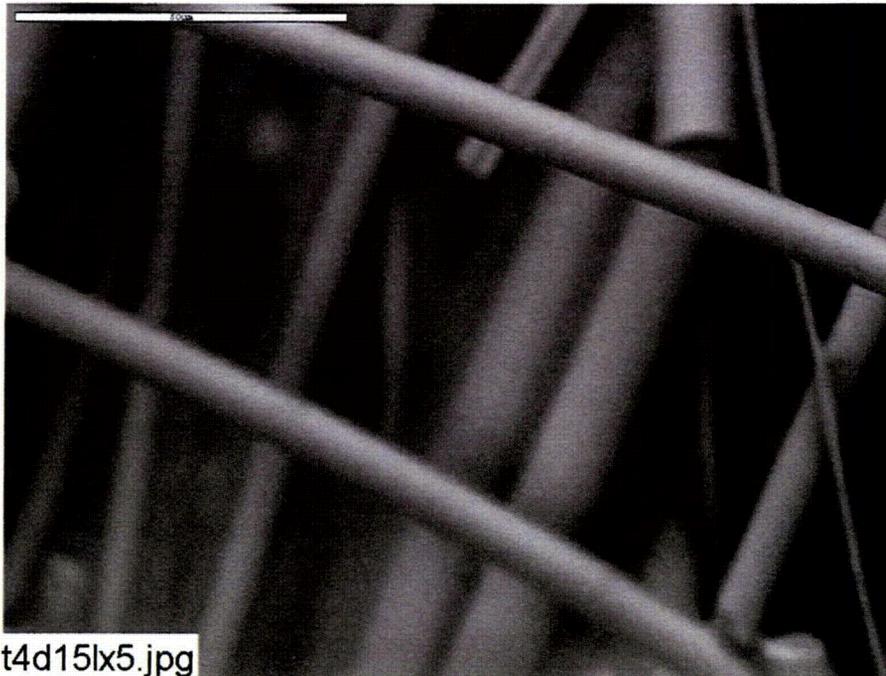
t4d15lx5.jpg

Figure B1-4. Environmental SEM image magnified 1000 times for a Test #4, Day-15 exterior low-flow fiberglass sample. (t4d15lx5.jpg)

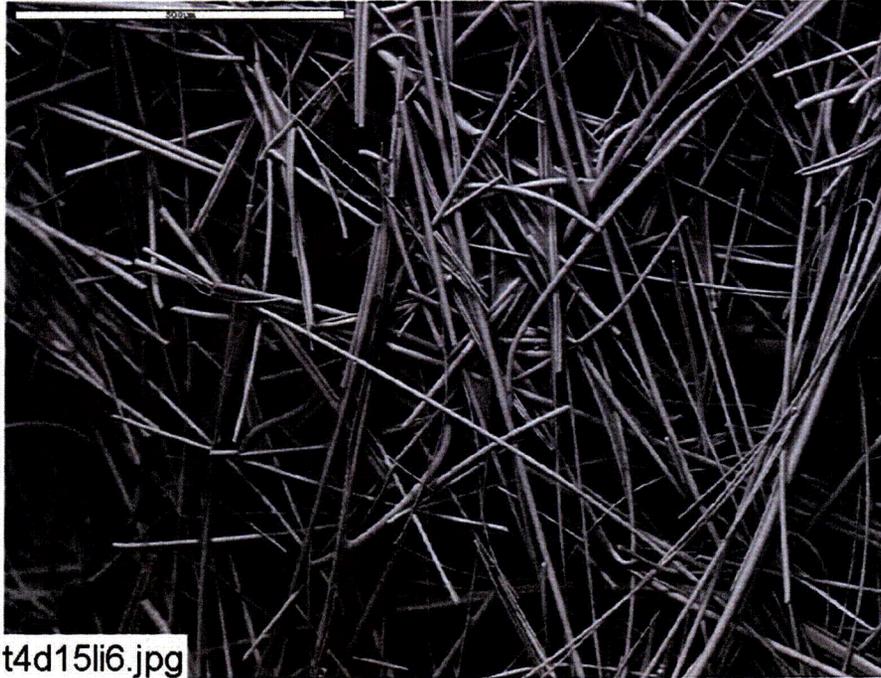
t4d15li6.jpg

Figure B1-5. Environmental SEM image magnified 100 times for a Test #4, Day-15 interior low-flow fiberglass sample. (t4d15li6.jpg)

Image: t4d15li6	100 ×	ESEM image of fiberglass	Figure B1-5
t4d15li7	500 ×	ESEM image of fiberglass	Figure B1-6
t4d15li8	1000 ×	ESEM image at higher magnification	Figure B1-7

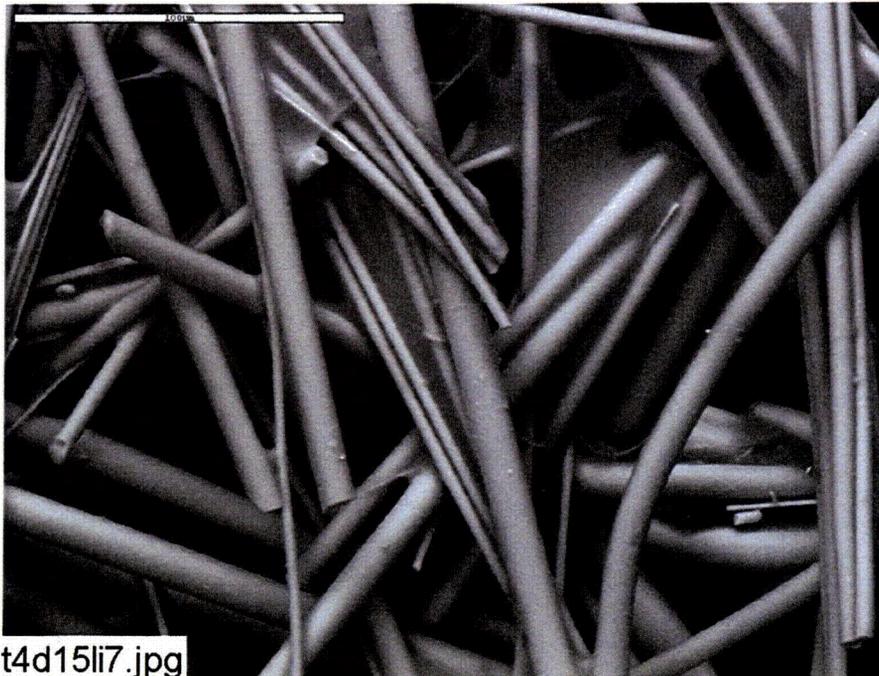
t4d15li7.jpg

Figure B1-6. Environmental SEM image magnified 500 times for a Test #4, Day-15 interior low-flow fiberglass sample. (t4d15li7.jpg)

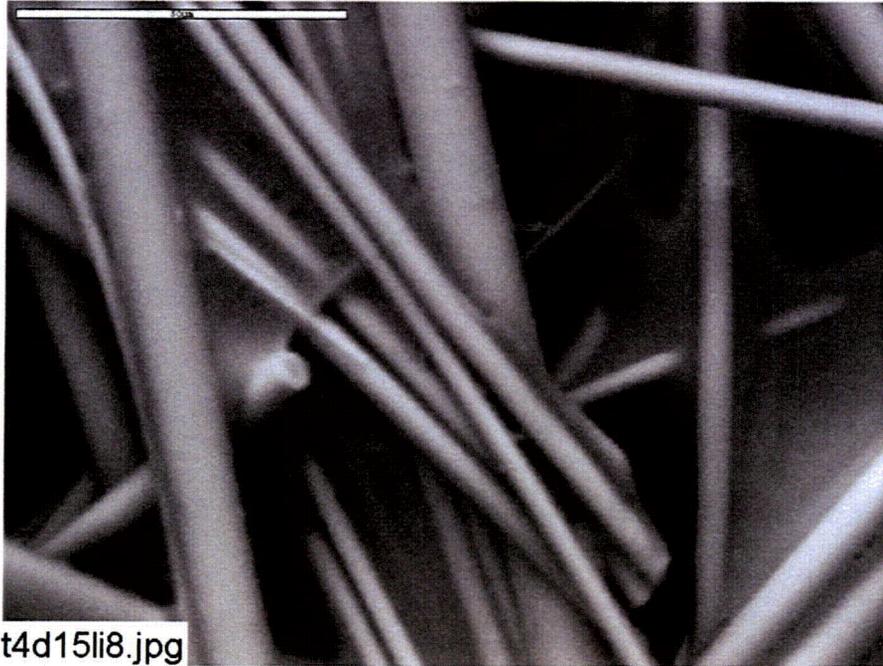
t4d15li8.jpg

Figure B1-7. Environmental SEM image magnified 1000 times for a Test #4, Day-15 interior low-flow fiberglass sample. (t4d15li8.jpg)

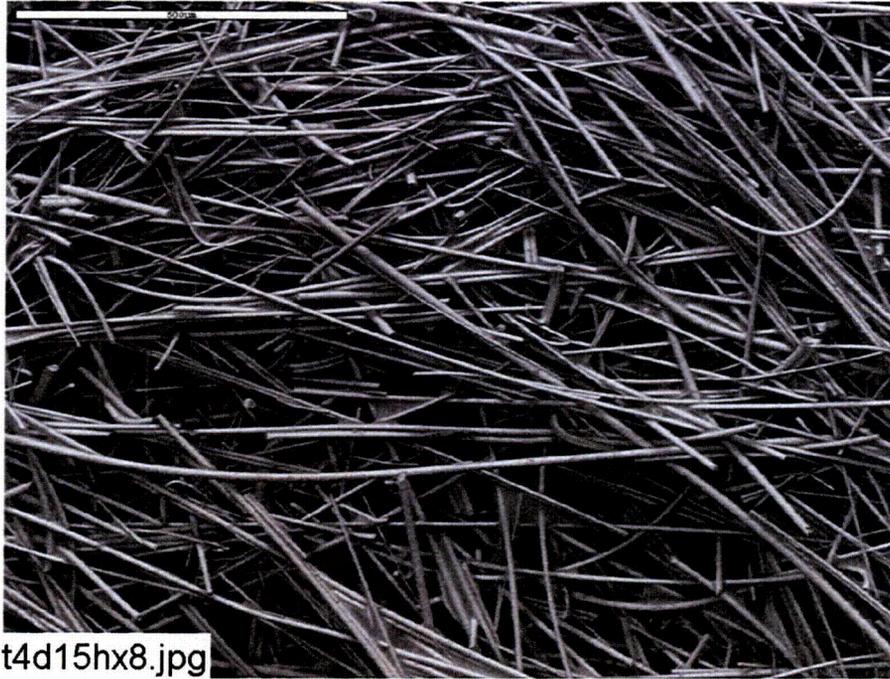
Figure B2-1. Environmental SEM image magnified 100 times for a Test #4, Day-15 exterior high-flow fiberglass sample. (t4d15hx8.jpg)

Image: t4d15hx8	100 ×	ESEM image	Figure B2-1
t4d15hx9	400 ×		Figure B2-2
t4d15hx7	750 ×	ESEM Annotated Image	Figure B2-3
EDS: t4d15hx6		EDS on web material for t4d15hx7	Figure B2-4

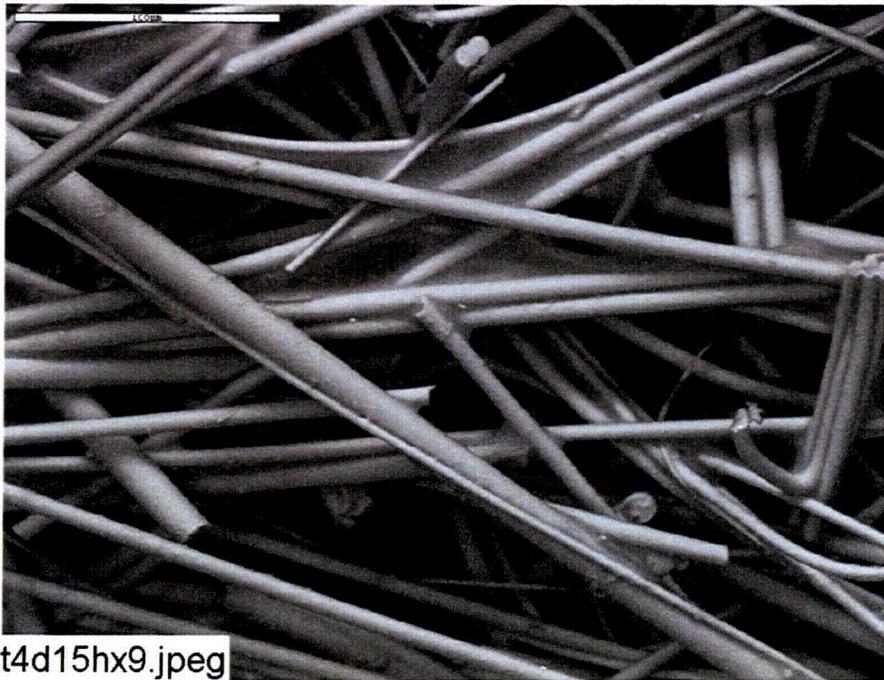
Figure B2-2. Environmental SEM image magnified 400 times for a Test #4, Day-15 exterior high-flow fiberglass sample. (t4d15hx9.jpeg)

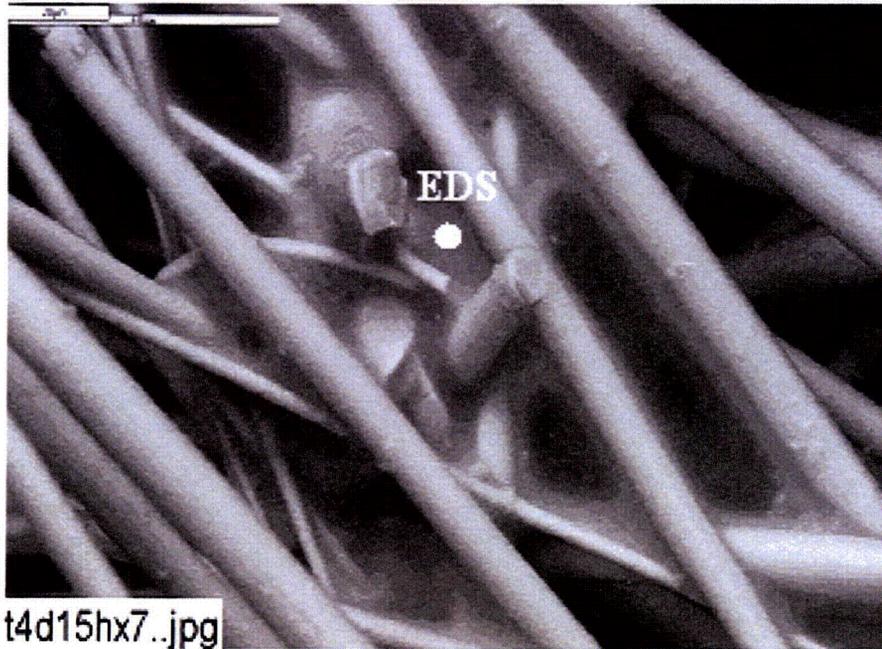
Figure B2-3. Annotated environmental SEM image magnified 750 times for a Test #4, Day-15 exterior high-flow fiberglass sample. The white spot shows the area for EDS analysis. (t4d15hx7.jpg)

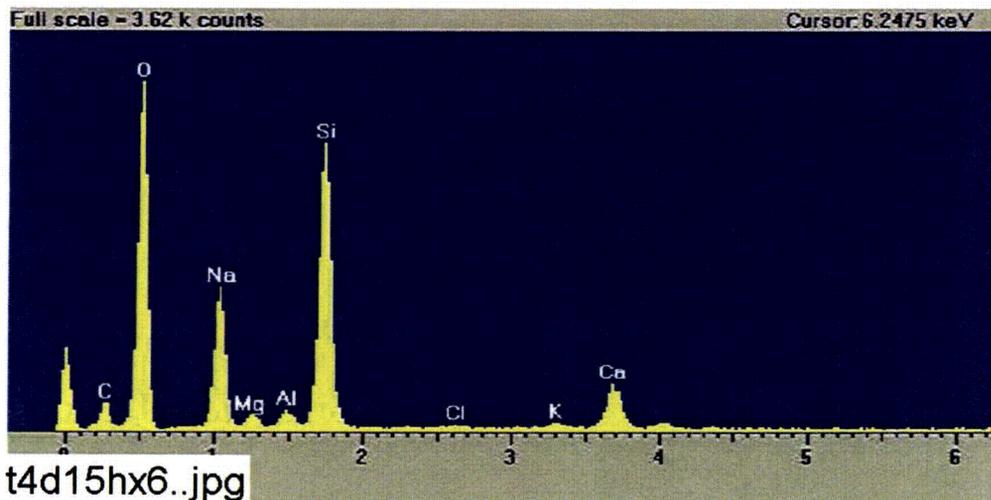
Figure B2-4. EDS counting spectrum for the spot of the film between the fibers shown in Figure B2-3. (t4d15hx6.jpg)

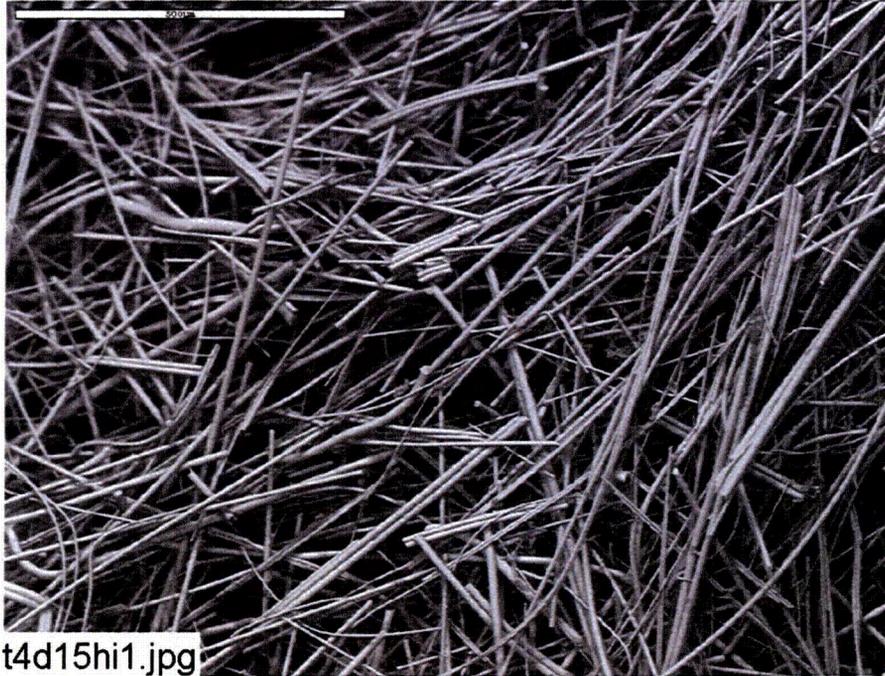
Figure B2-5. Environmental SEM image magnified 100 times for a Test #4, Day-15 interior high-flow fiberglass sample. (t4d15hi1.jpg)

Image: t4d15hi1	100 ×	ESEM image	Figure B2-5
t4d15hi3	100 ×		Figure B2-6
t4d15hi2	800 ×		Figure B2-7

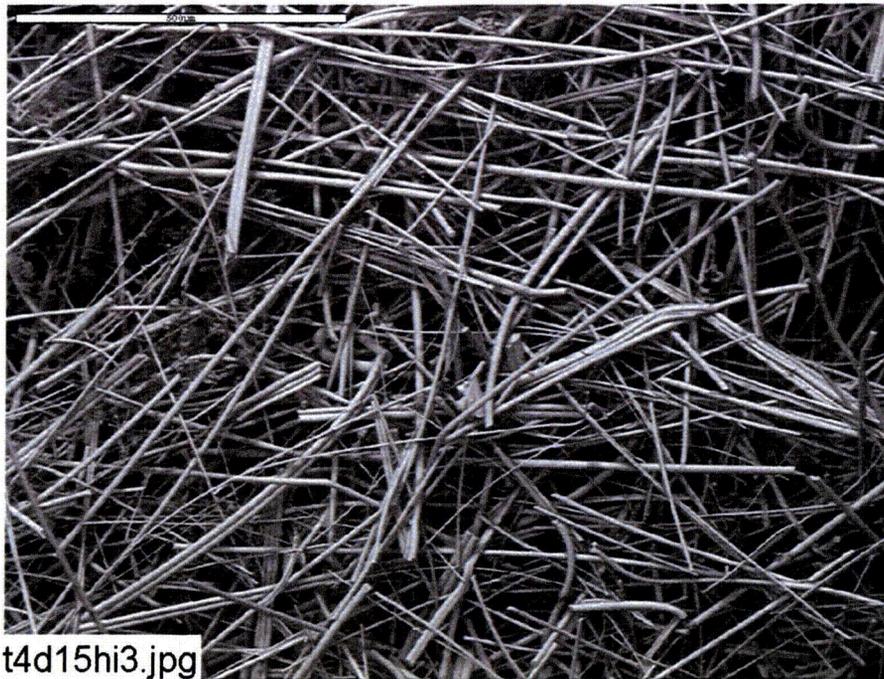
Figure B2-6. Environmental SEM image magnified 100 times for a Test #4, Day-15 interior high-flow fiberglass sample. (t4d15hi3.jpg)

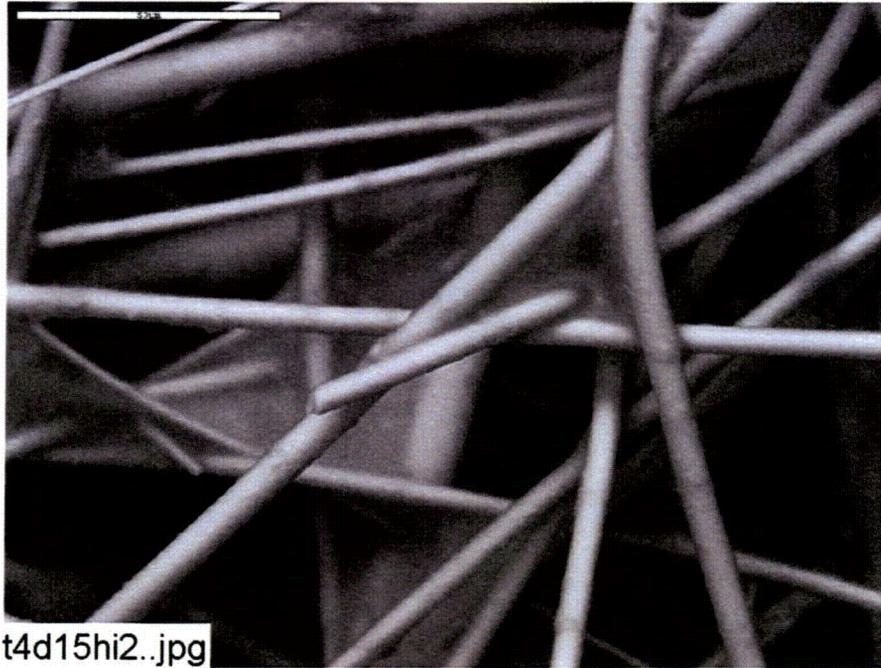
Figure B2-7. Environmental SEM image magnified 800 times for a Test #4, Day-15 interior high-flow fiberglass sample. (t4d15hi2.jpg)

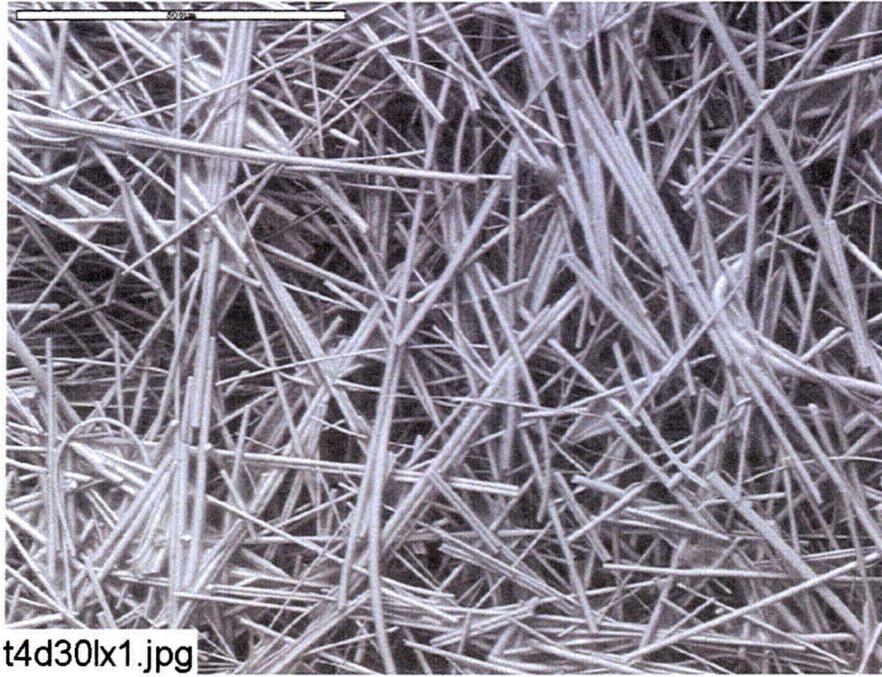
Figure C1-1. Environmental SEM image magnified 100 times for a Test #4, Day-30 exterior low-flow fiberglass sample. (t4d30lx1.jpg)

Image: t4d30lx1	100 ×	ESEM image	Figure C1-1
t4d30lx2	500 ×	ESEM image higher magnification	Figure C1-2
t4d30lx5	1000 ×	ESEM annotated image	Figure C1-3
EDS: t4d30lx4		Spot of coating substance for t4d30lx5	Figure C1-4

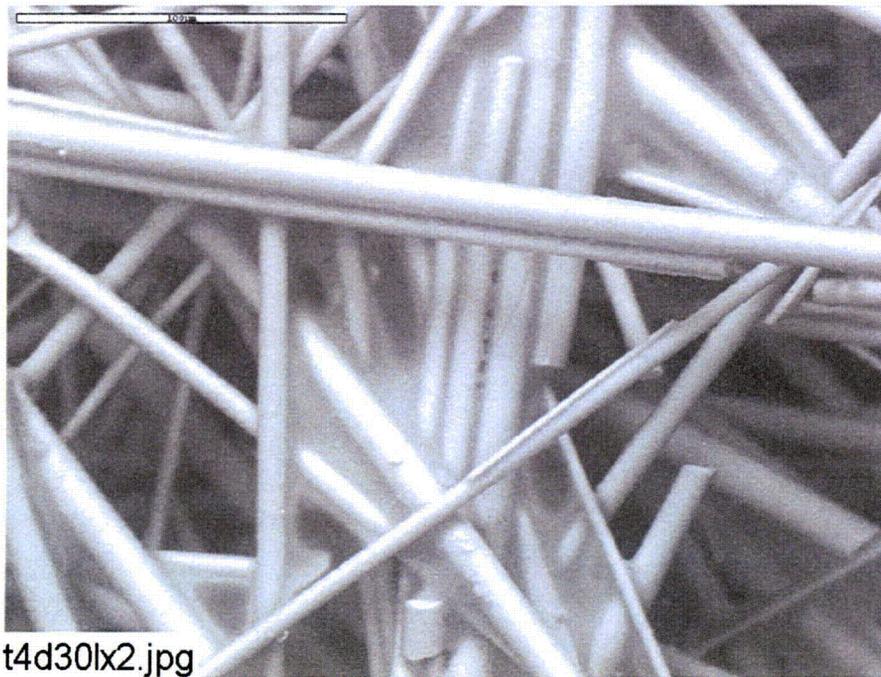
Figure C1-2. Environmental SEM image magnified 500 times for a Test #4, Day-30 exterior low-flow fiberglass sample. (t4d30lx2.jpg)

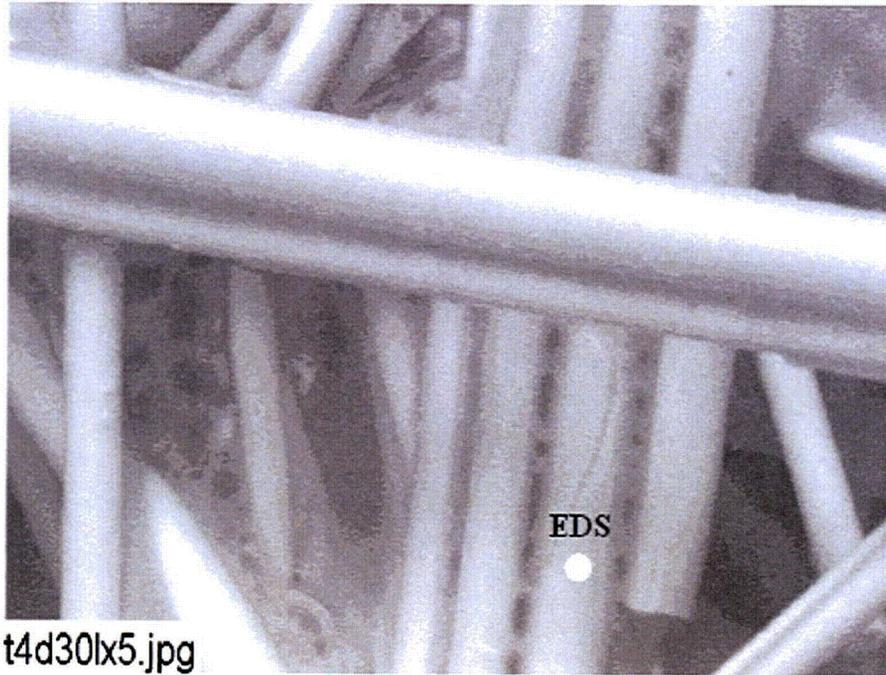
Figure C1-3. Annotated environmental SEM image magnified 1000 times for a Test #4, Day-30 exterior low-flow fiberglass sample. (t4d30lx5.jpg)

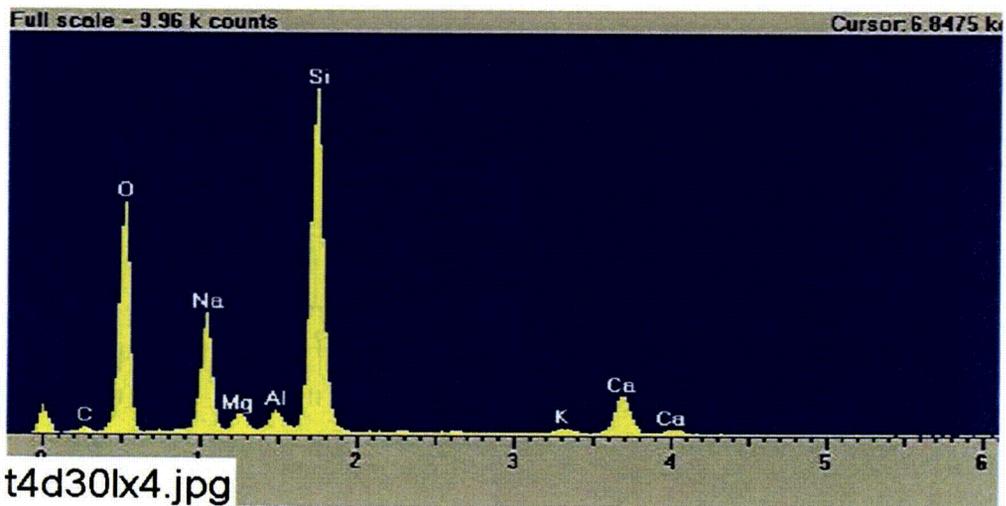
Figure C1-4. EDS counting spectrum for the spot of coating substance on fiberglass shown in Figure C1-3. (t4d30lx4.jpg)

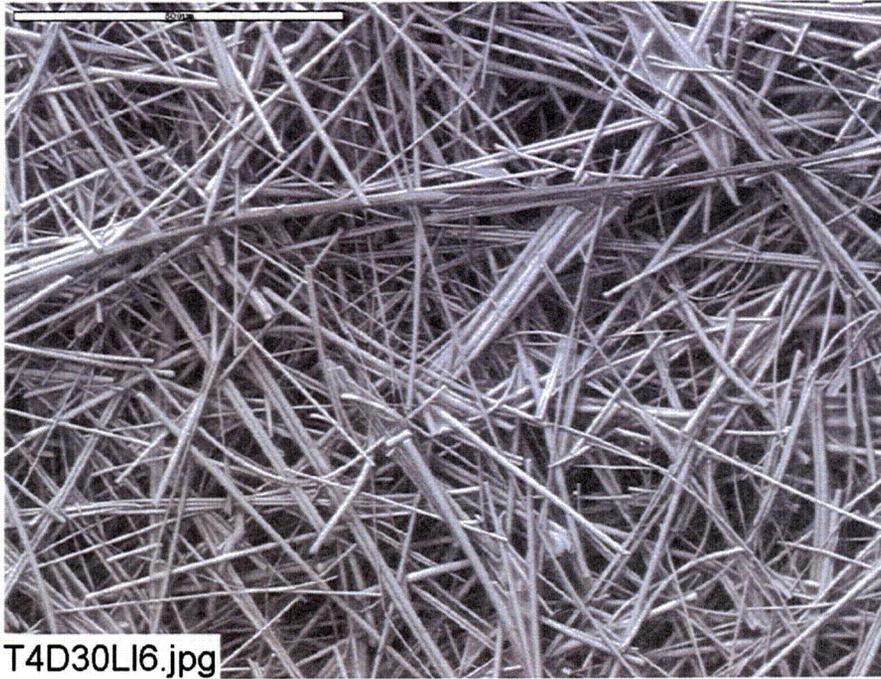
Figure C1-5. Environmental SEM image magnified 100 times for a Test #4, Day-30 interior low-flow fiberglass sample. (T4D30LI6.jpg)

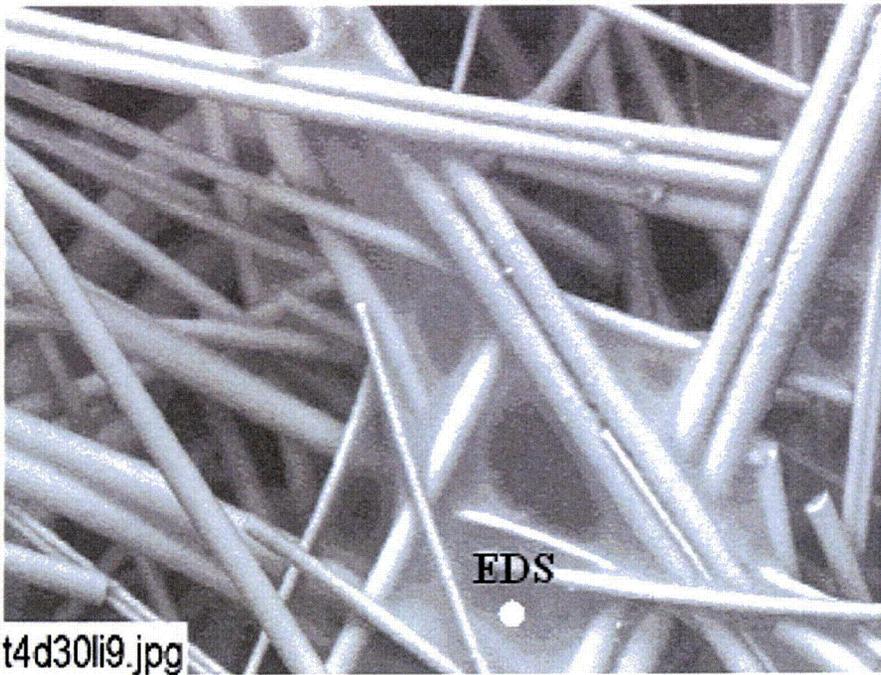
Figure C1-6. Annotated environmental SEM image magnified 500 times for a Test #4, Day-30 interior low-flow fiberglass sample. EDS spot is shown in the picture (t4d30li9.jpg)

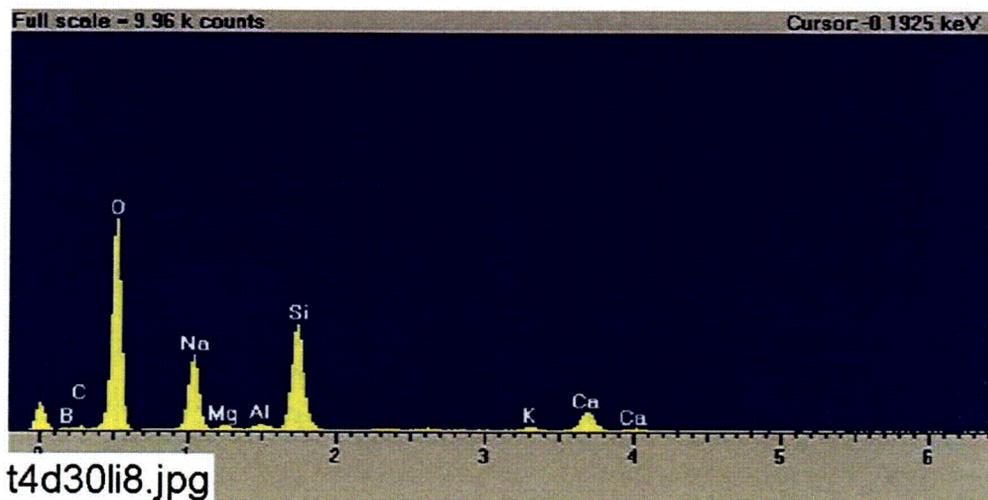
Figure C1-7. EDS counting spectrum for the film between fibers shown in Figure C1-6. (t4d30li8.jpg)
