Appendix A

ESEM/EDS Data for Test #4, Day-5 Fiberglass in Low-Flow Zone

During ICET Test #4, work was continued for the purpose of identifying the origin and chemical composition of the products that were formed during the test. One objective of ICET is to identify the composition of debris on fiberglass and the particulate substances in the test solution. To address this question partially, low-flow fiberglass samples on Test #4, Day 5 were examined by ESEM/EDS, including both of the exterior and the interior location of the fiberglass samples.

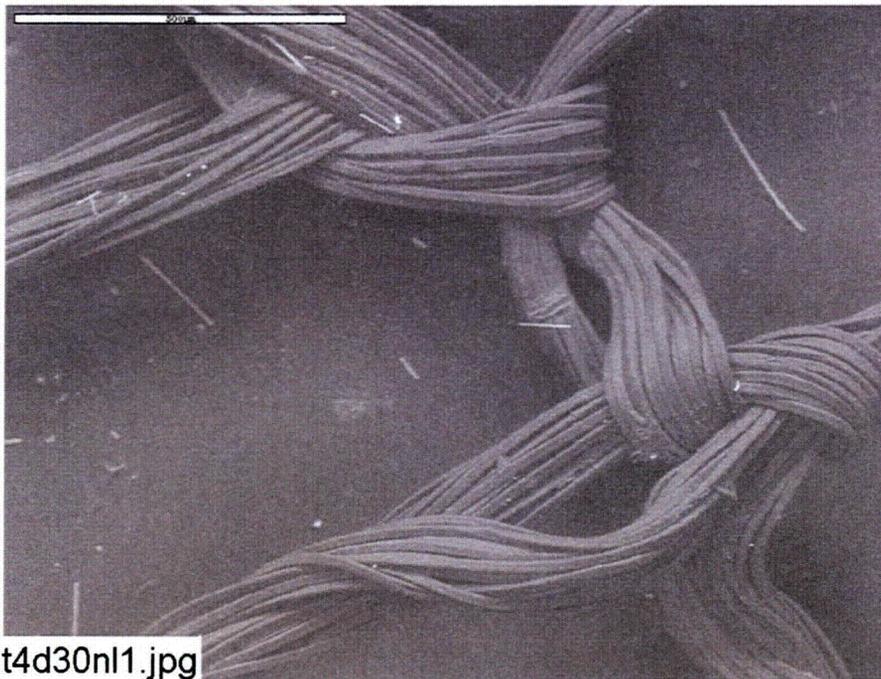
t4d30nl1.jpg

Figure C2-1. Environmental SEM image magnified 100 times for a Test #4, Day-30 nylon mesh submerged in low-flow area (inserted on Day 4). (t4d30nl1.jpg)

Image: t4d30n11	100 ×	ESEM image	Figure C2-1
t4d30n14	500 ×	ESEM annotated image	Figure C2-2
EDS: t4d30n13		EDS on spot on mesh, t4d30n14	Figure C2-3
Image: t4d30n15	1000 ×	ESEM high magnification	Figure C2-4

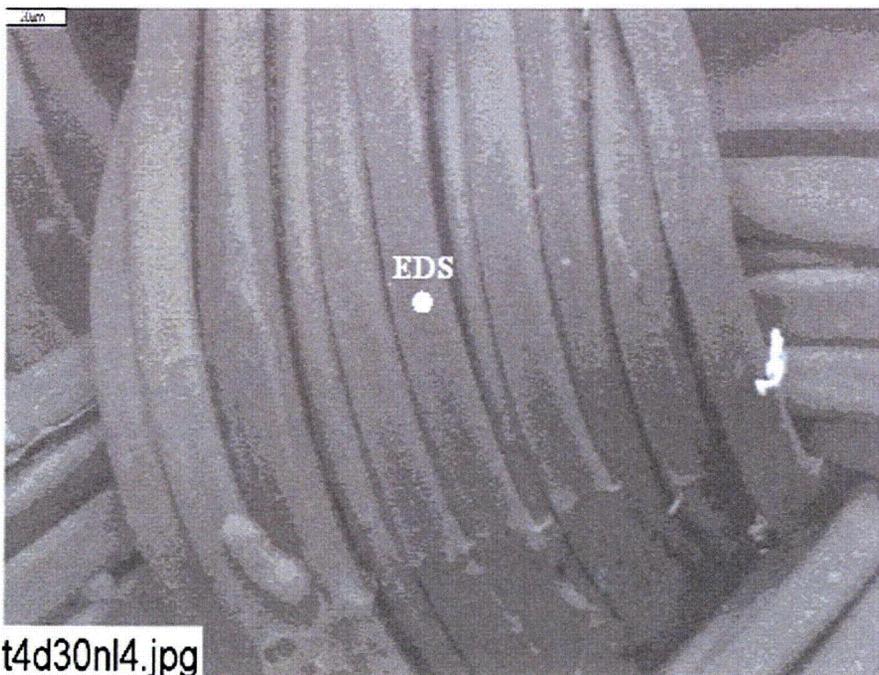
t4d30nl4.jpg

Figure C2-2. Annotated environmental SEM image magnified 500 times for a Test #4, Day-30 nylon mesh submerged in low-flow area (inserted on Day 4). The EDS spot is shown in the picture. (t4d30nl4.jpg)

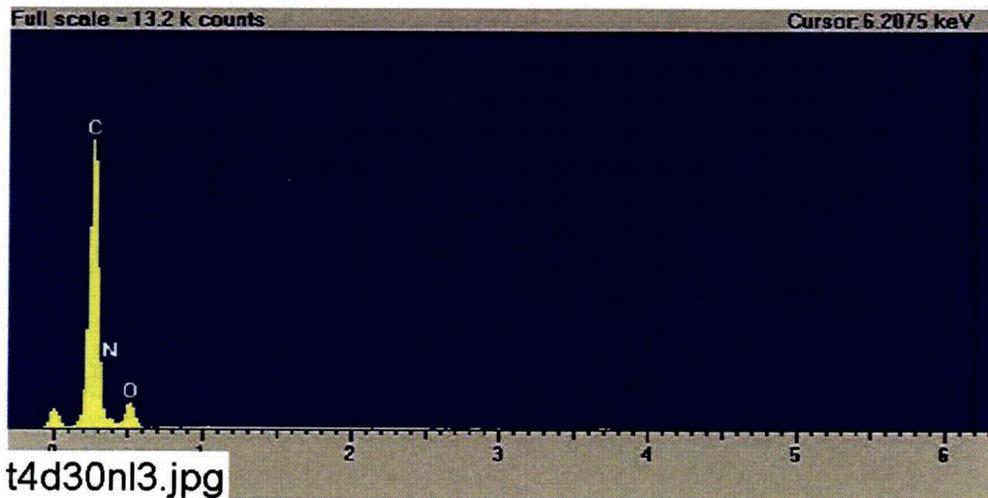
Figure C2-3. EDS counting spectrum for the spot of nylon mesh shown in Figure C2-2. (t4d30nl3.jpg)

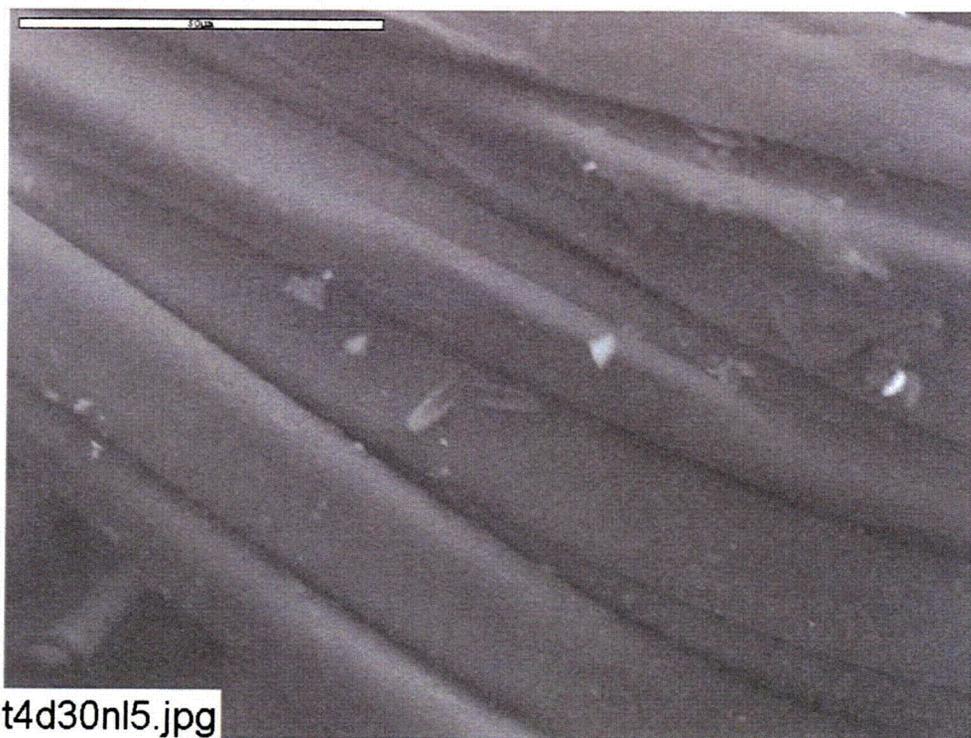
Figure C2-4. Environmental SEM image magnified 1000 times for a Test #4, Day-30 nylon mesh submerged in low-flow area (inserted on Day 4). (t4d30nl5.jpg)

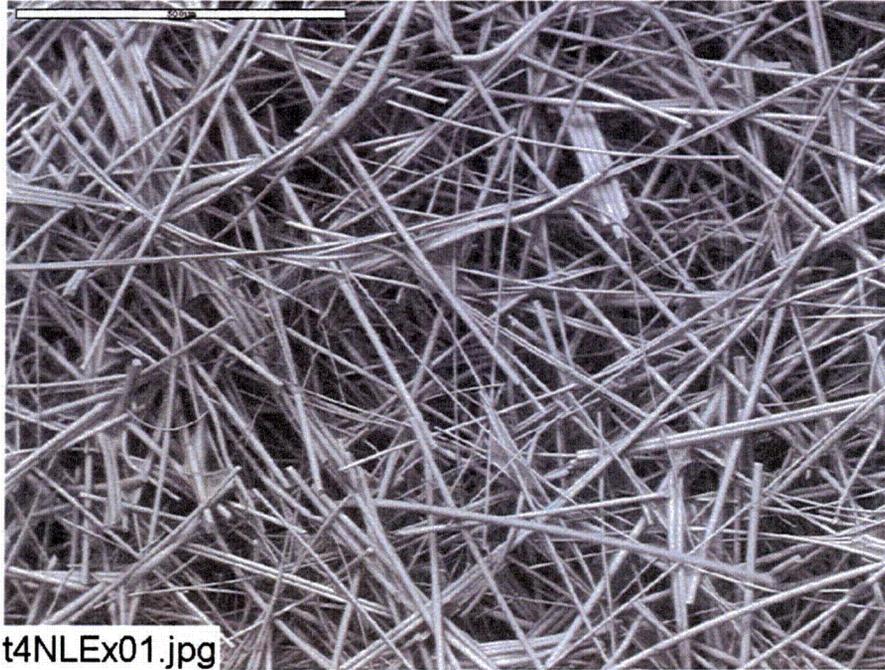
Figure C2-5. Environmental SEM image magnified 100 times for a Test #4, Day-30 exterior low-flow fiberglass sample contained in a nylon mesh (inserted on Day 4). (t4NLEx01.jpg)

Image: t4NLEx01	100 ×	ESEM image	Figure C2-5
t4nlex03	100 ×	ESEM image higher magnification	Figure C2-6
t4nlex02	500 ×	ESEM image	Figure C2-7

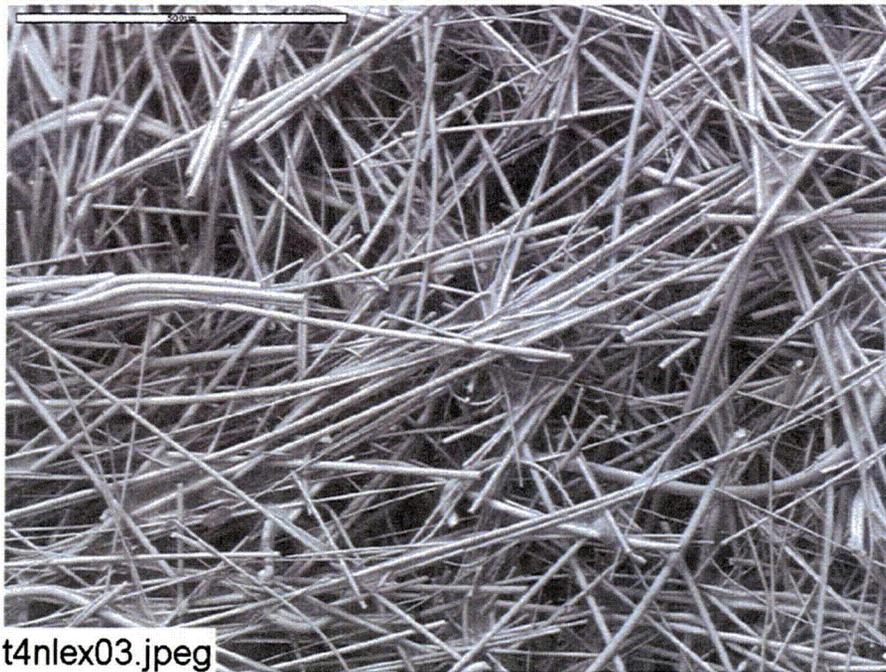
Figure C2-6. Environmental SEM image magnified 100 times for a Test #4, Day-30 exterior low-flow fiberglass sample contained in a nylon mesh (inserted on Day 4). (t4nlex03.jpeg)

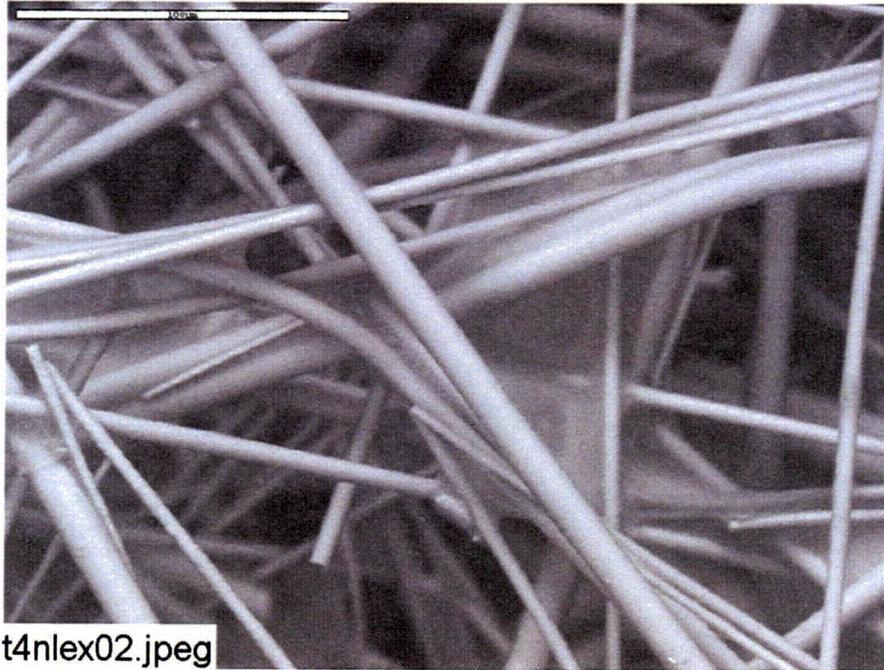
Figure C2-7. Environmental SEM image magnified 500 times for a Test #4, Day-30 exterior low-flow fiberglass sample contained in a nylon mesh (inserted on Day 4). (t4nlex02.jpg)

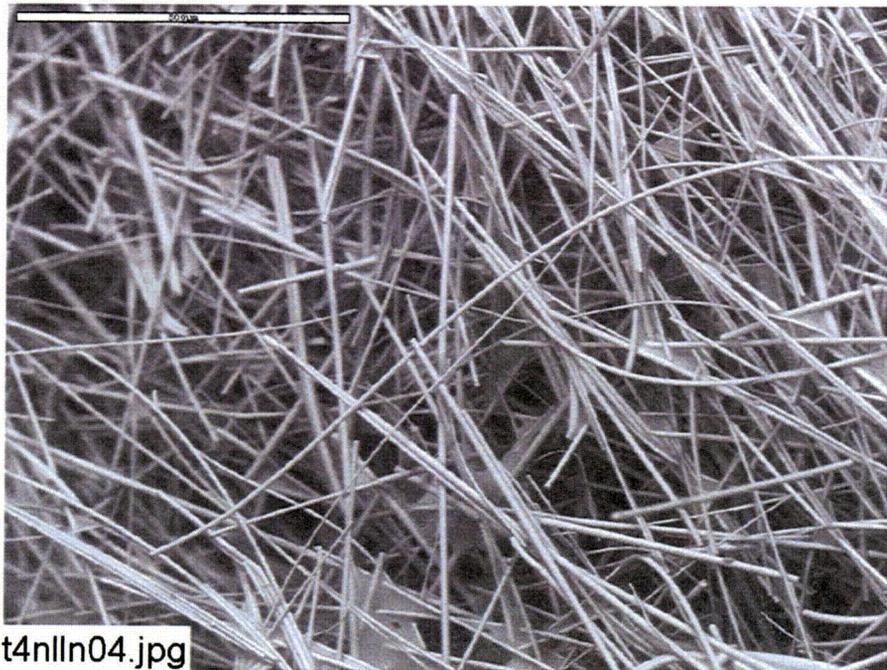
Figure C2-8. Environmental SEM image magnified 100 times for a Test #4, Day-30 interior low-flow fiberglass sample contained in a nylon mesh (inserted on Day 4). (t4nlln04.jpg)

Image: t4nlin04	100 ×	ESEM image	Figure C2-8
t4nlin06	100 ×	ESEM image	Figure C2-9
t4nlin05	500 ×	ESEM image higher magnification	Figure C2-10

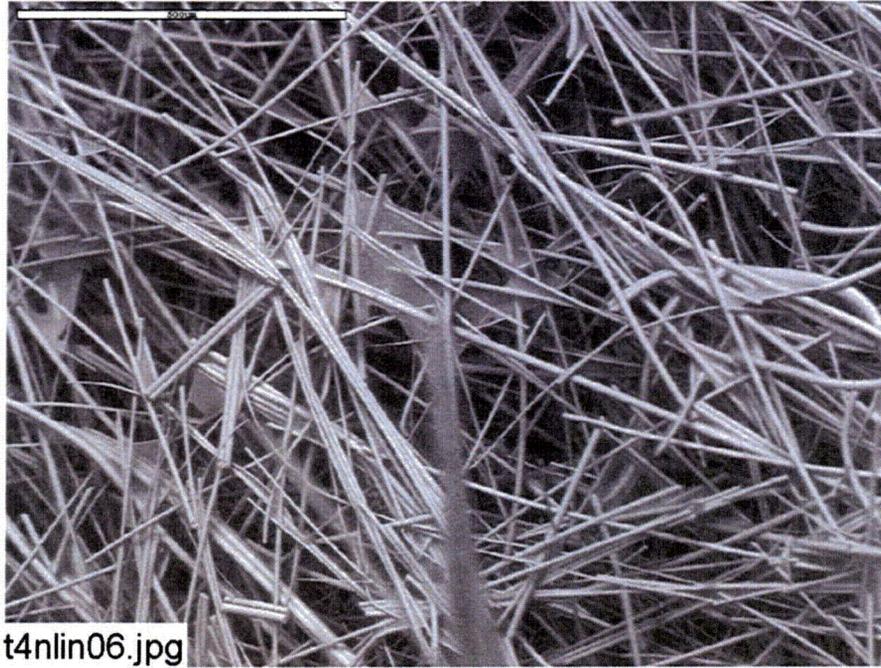
t4nlin06.jpg

Figure C2-9. Environmental SEM image magnified 100 times for a Test #4, Day-30 interior low-flow fiberglass sample contained in a nylon mesh (inserted on Day 4). (t4nlin06.jpg)

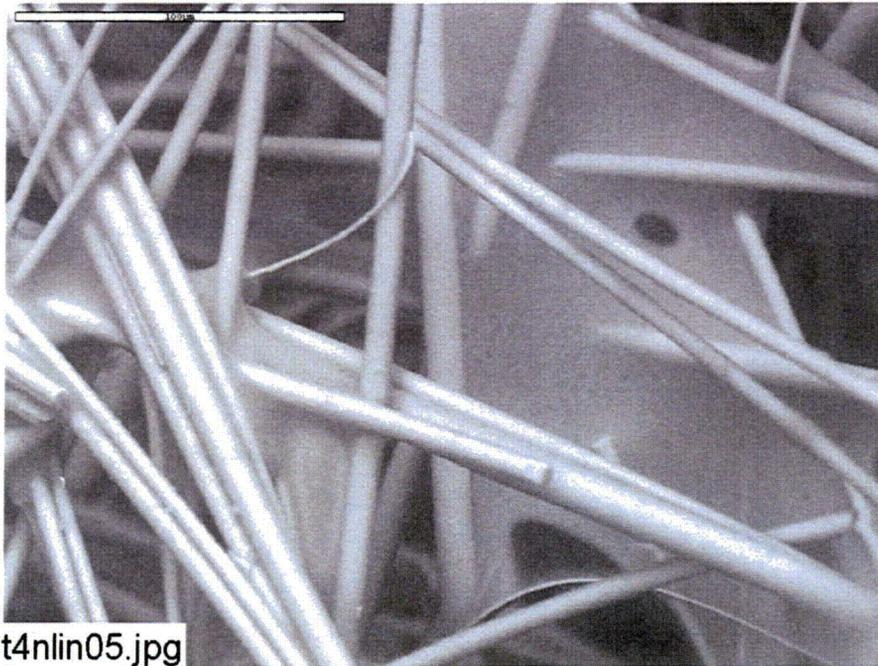
t4nlin05.jpg

Figure C2-10. Environmental SEM image magnified 500 times for a Test #4, Day-30 interior low-flow fiberglass sample contained in a nylon mesh (inserted on Day 4). (t4nlin05.jpg)

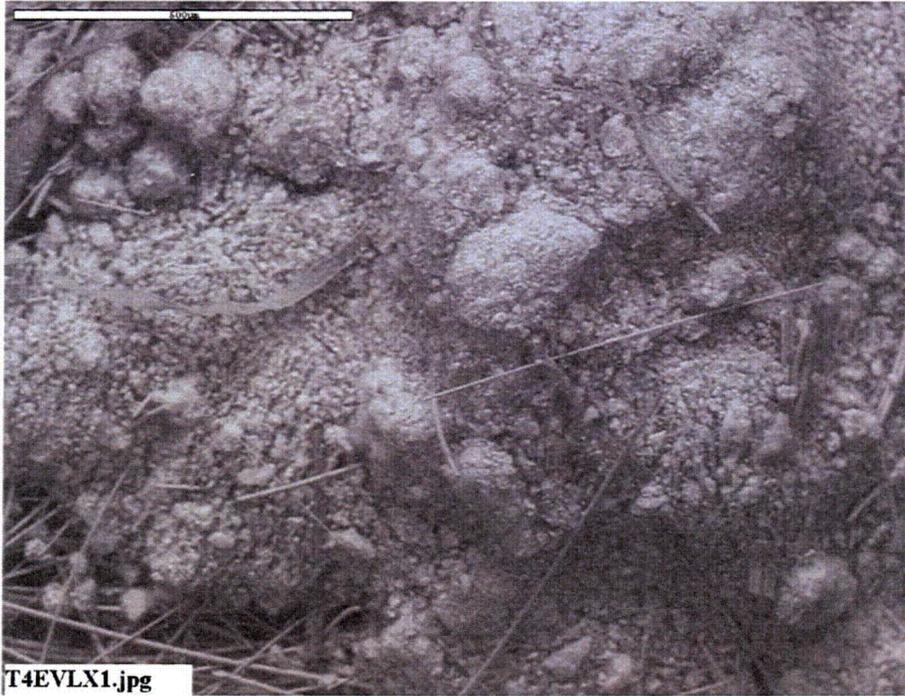
Figure C3-1. Environmental SEM image magnified 100 times for a Test #4, Day-30 exterior low-flow fiberglass sample in a big envelope. (T4EVLX1.jpg)

Image: T4EVLX1	100 ×	ESEM image	Figure C3-1
t4evlx3	100 ×	ESEM image	Figure C3-2
t4evlx2	500 ×	ESEM image higher magnification	Figure C3-3

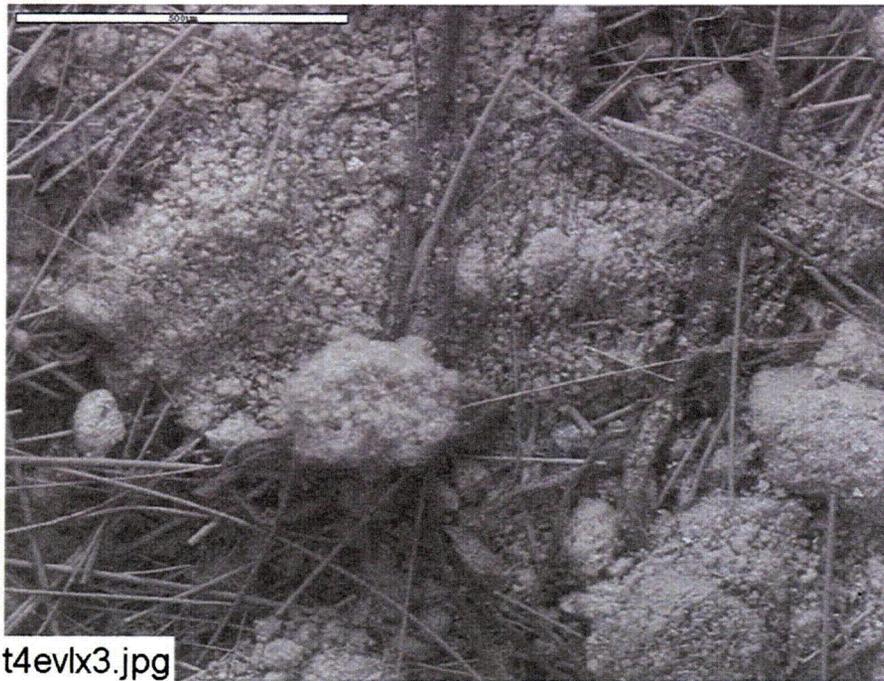
Figure C3-2. Environmental SEM image magnified 100 times for a Test #4, Day-30 exterior low-flow fiberglass sample in a big envelope. (t4evlx3.jpg)

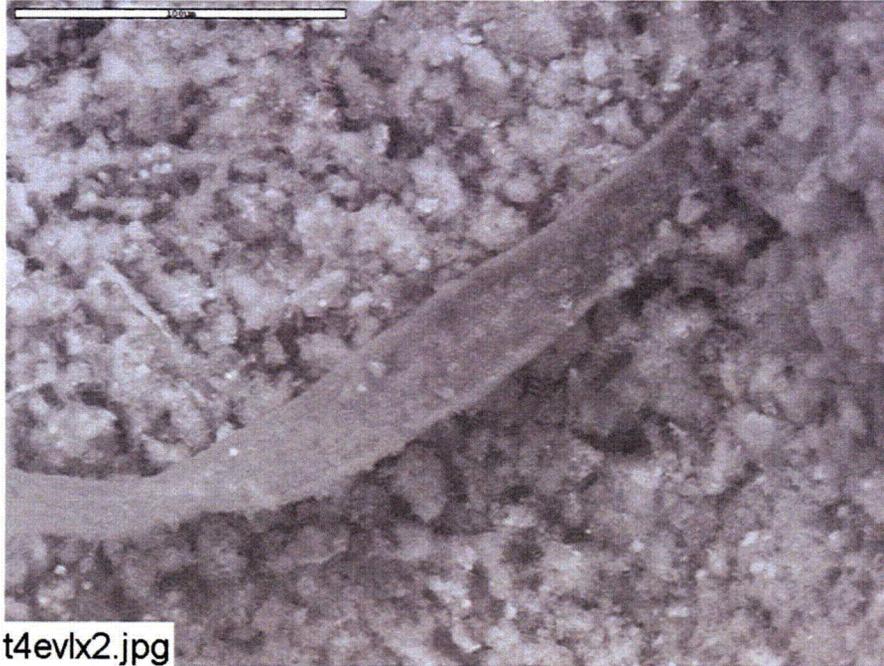
Figure C3-3. Environmental SEM image magnified 500 times for a Test #4, Day-30 exterior low-flow fiberglass sample in a big envelope. (t4evlx2.jpg)

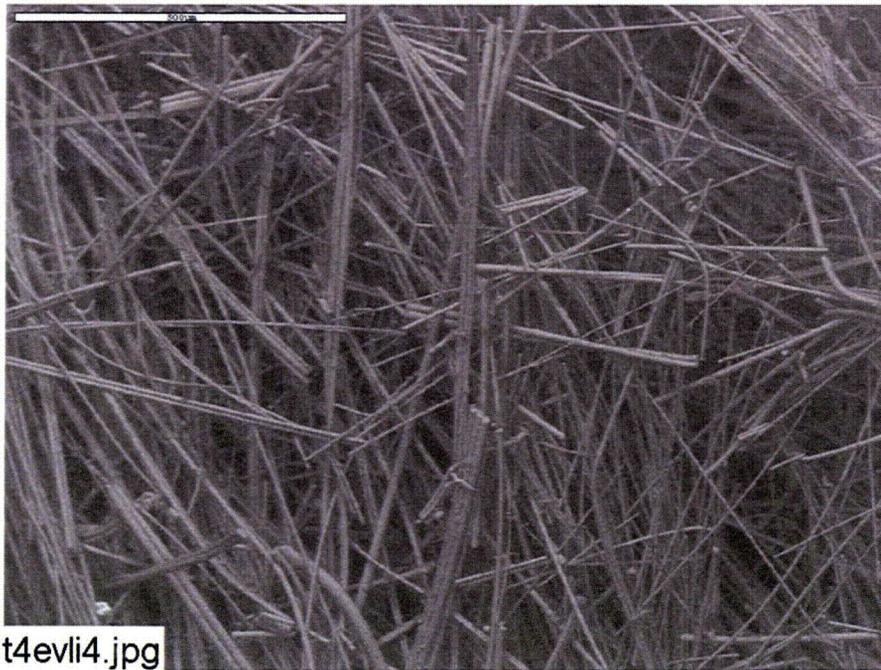
Figure C3-4. Environmental SEM image magnified 100 times for a Test #4, Day-30 interior low-flow fiberglass sample in a big envelope. (t4evli4.jpg)

Image: t4evli4	100 ×	ESEM image	Figure C3-4
t4evli5	100 ×	ESEM image	Figure C3-5
t4evli6	100 ×	ESEM image	Figure C3-6
t4evli7	500 ×	ESEM image higher magnification	Figure C3-7

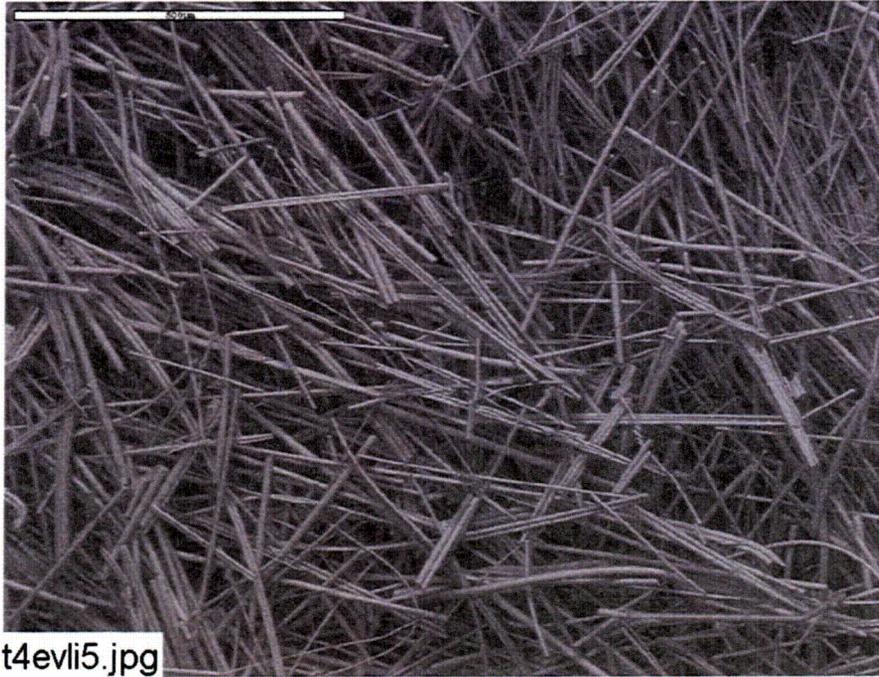
Figure C3-5. Environmental SEM image magnified 100 times for a Test #4, Day-30 interior low-flow fiberglass sample in a big envelope. (t4evli5.jpg)

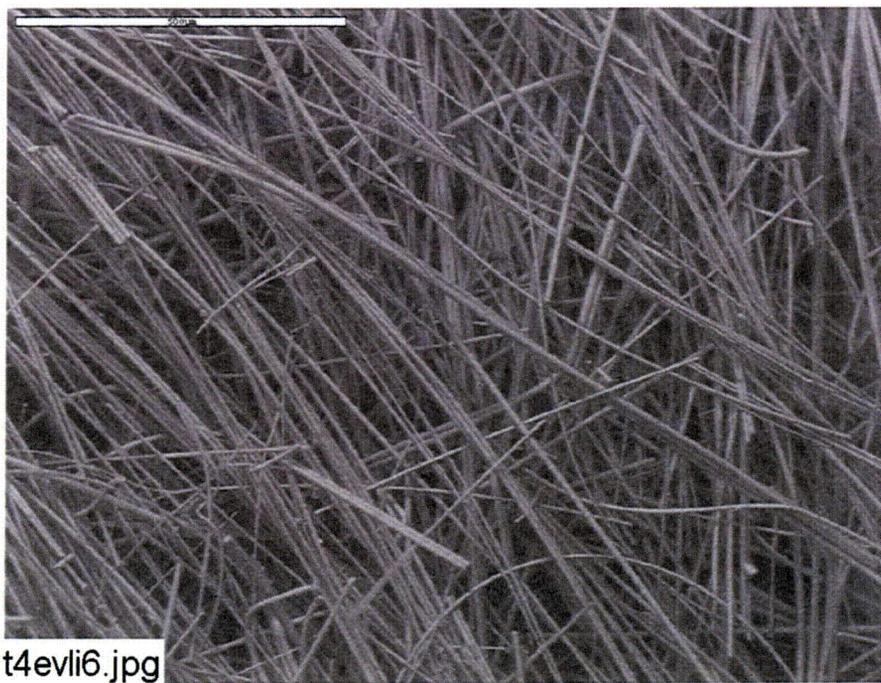
Figure C3-6. Environmental SEM image magnified 100 times for a Test #4, Day-30 interior low-flow fiberglass sample in a big envelope. (t4evli6.jpg)

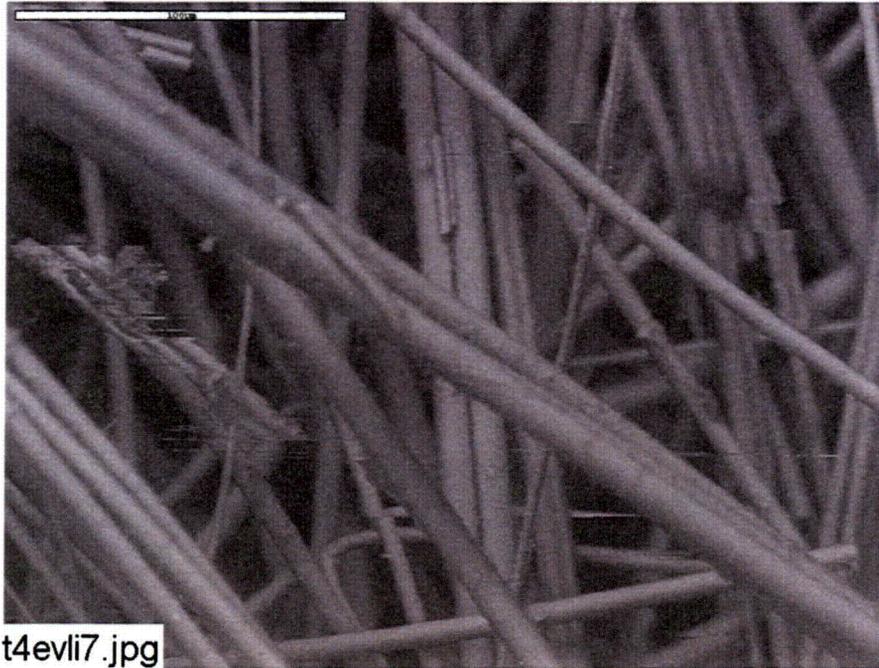
Figure C3-7. Environmental SEM image magnified 500 times for a Test #4, Day-30 interior low-flow fiberglass sample in a big envelope. (t4evli7.jpg)

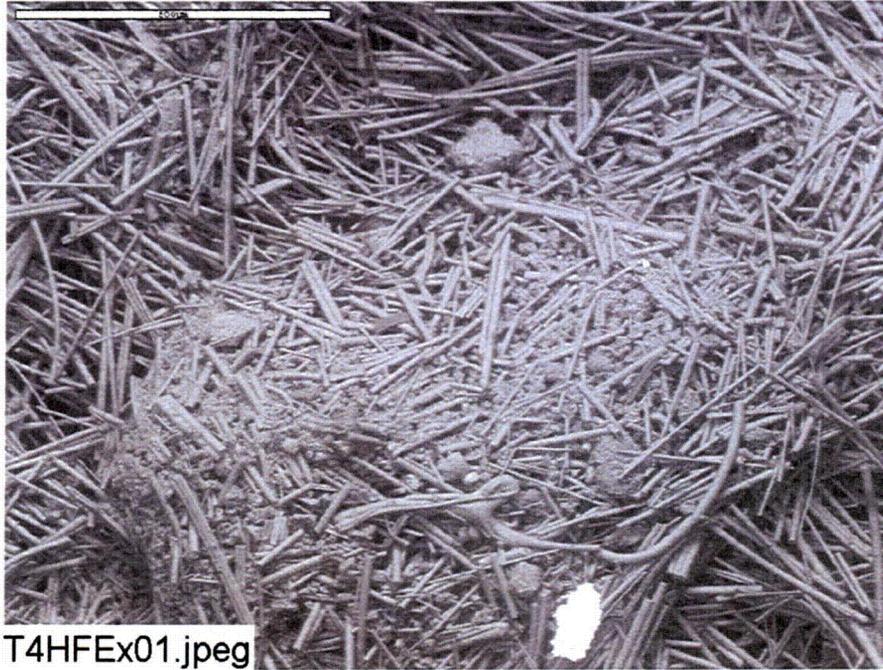
Figure C4-1. Environmental SEM image magnified 100 times for a Test #4, Day-30 exterior high-flow fiberglass sample. (T4HFEx01.jpeg)

Image:	T4HFEx01	100 ×	ESEM image	Figure C4-1
	t4hfex02	100 ×	ESEM image	Figure C4-2
	t4hfex07	500 ×	ESEM image	Figure C4-3
	t4hfex06	800 ×	ESEM annotated image	Figure C4-4
EDS:	t4hfex05		Spot of film for t4hfex06	Figure C4-5

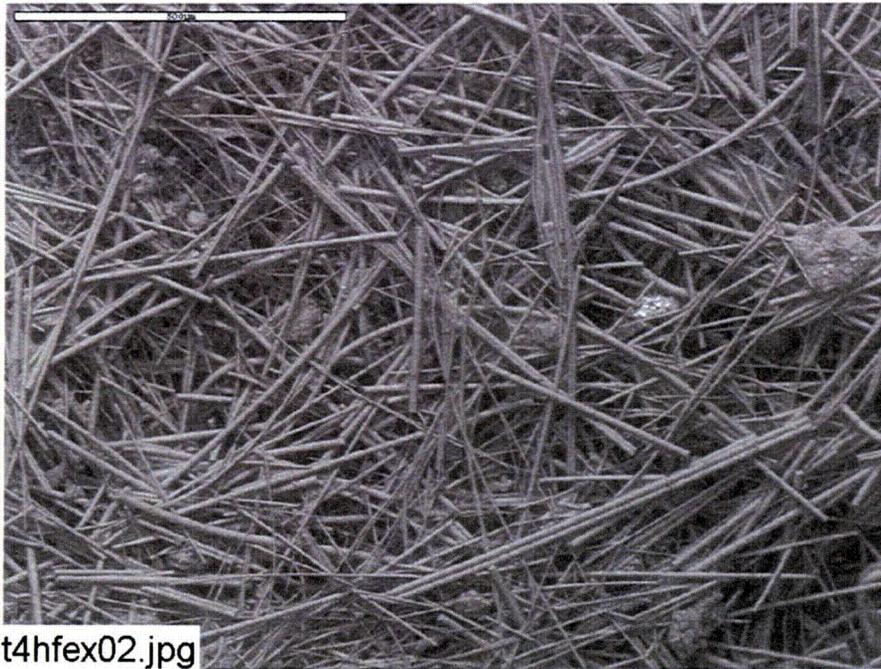
Figure C4-2. Environmental SEM image magnified 100 times for a Test #4, Day-30 exterior high-flow fiberglass sample. (t4hfex02.jpg)

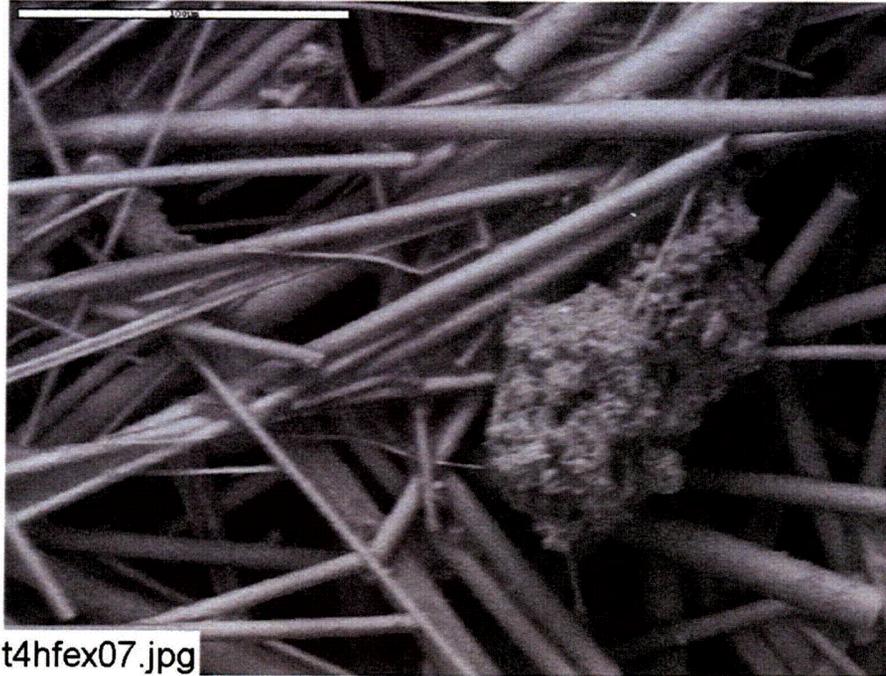
Figure C4-3. Environmental SEM image magnified 500 times for a Test #4, Day-30 exterior high-flow fiberglass sample. (t4hfex07.jpg)

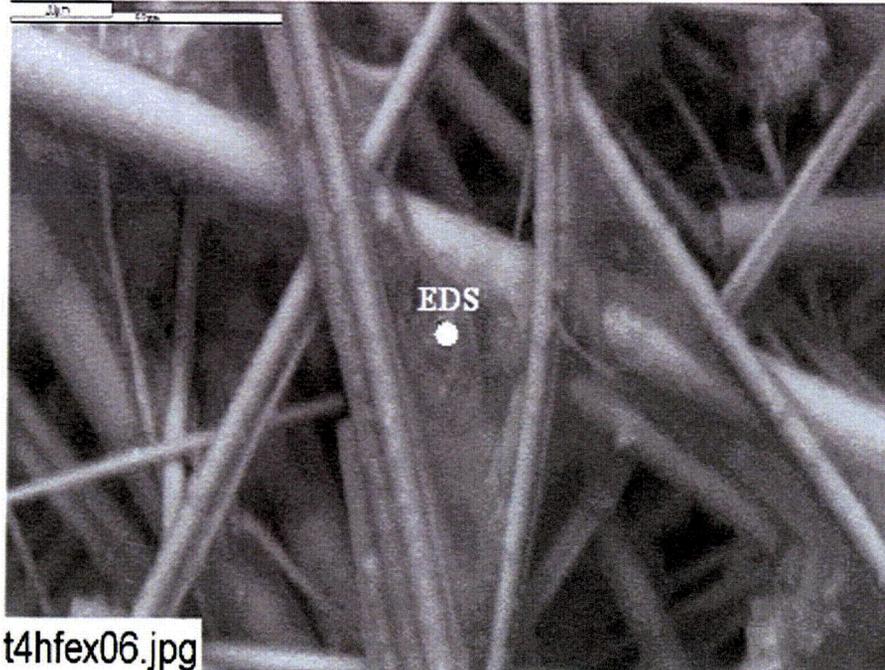
Figure C4-4. Annotated environmental SEM image magnified 800 times for a Test #4, Day-30 exterior high-flow fiberglass sample. EDS spot is shown in the picture. (t4hfex06.jpg)

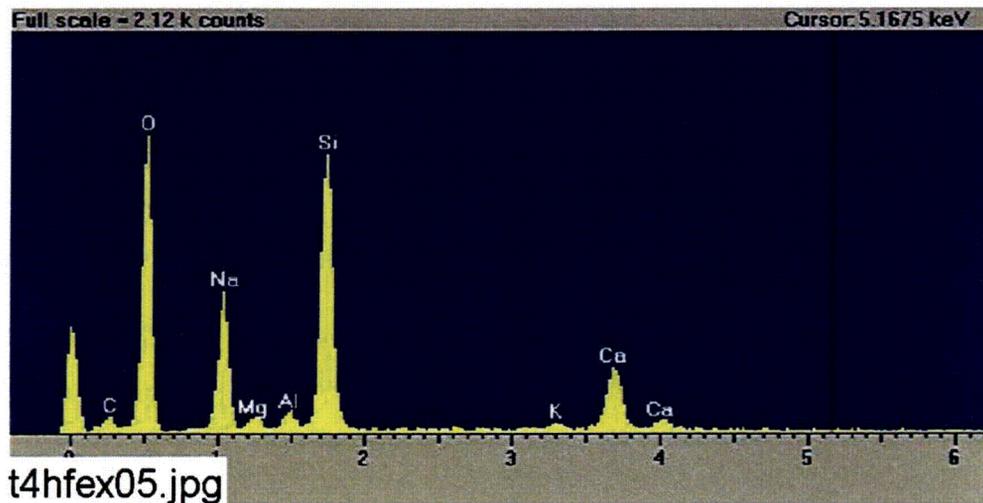
Figure C4-5. EDS counting spectrum for the spot of film between fibers shown in Figure C4-4. (t4hfex05.jpg)

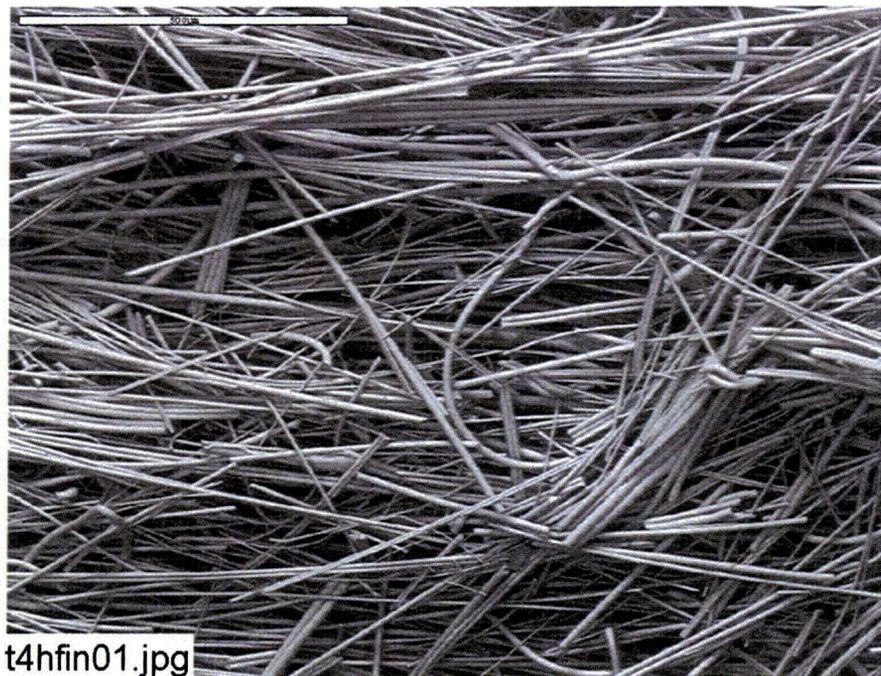
Figure C4-6. Environmental SEM image magnified 100 times for a Test #4, Day-30 interior high-flow fiberglass sample. (t4hfin01.jpg)

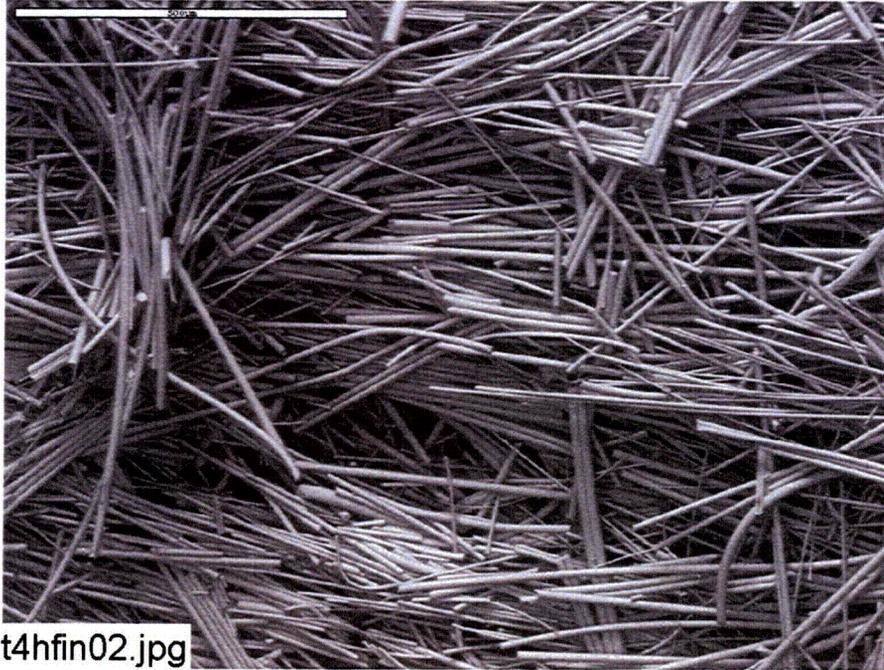
Figure C4-7. Environmental SEM image magnified 100 times for a Test #4, Day-30 interior high-flow fiberglass sample. (t4hfin02.jpg)

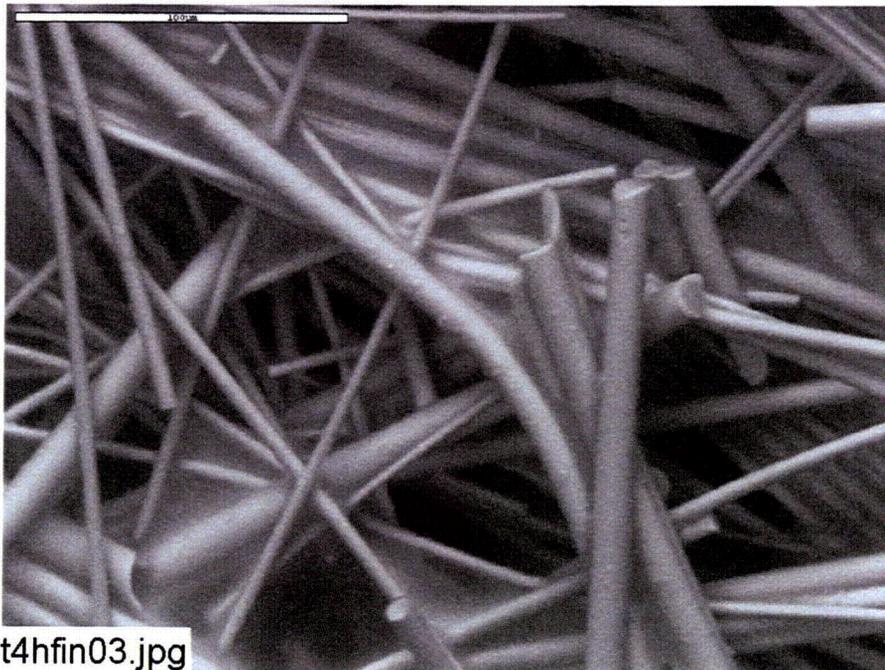
Figure C4-8. Environmental SEM image magnified 500 times for a Test #4, Day-30 interior high-flow fiberglass sample. (t4hfin03.jpg)

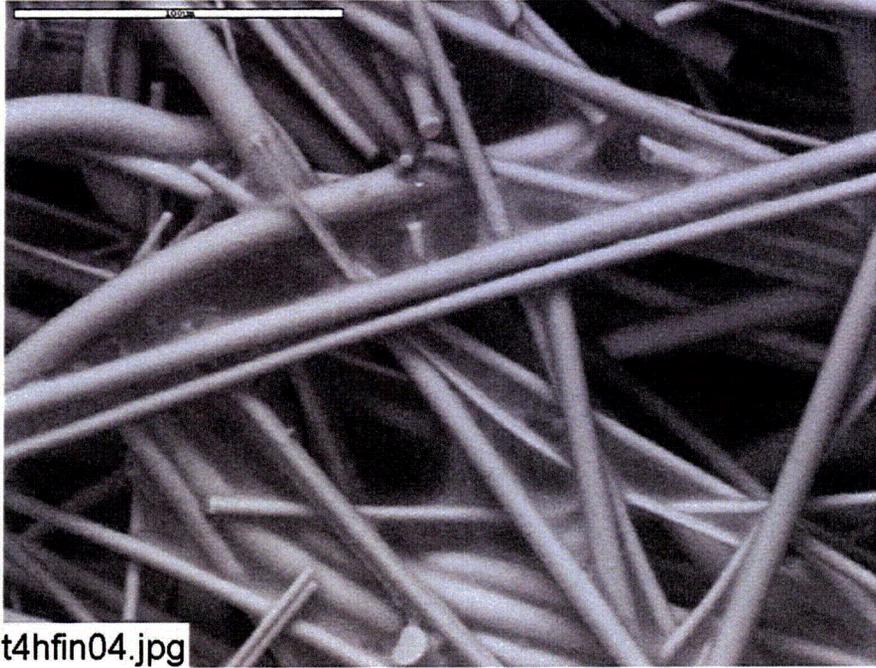
Figure C4-9. Environmental SEM image magnified 500 times for a Test #4, Day-30 interior high-flow fiberglass sample. (t4hfin04.jpg)

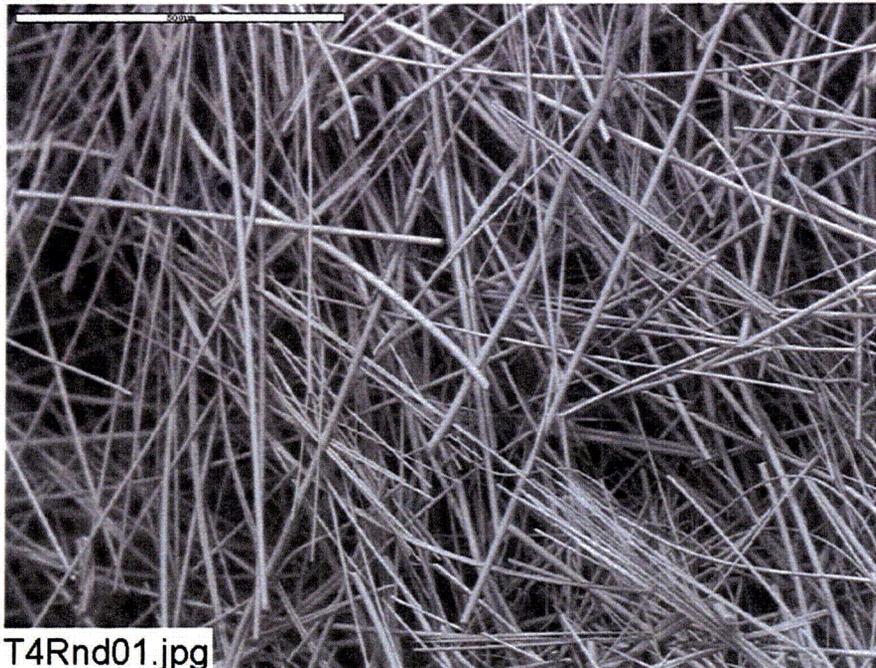
Figure C4-10. Environmental SEM image magnified 100 times for a Test #4, Day-30 interior high-flow fiberglass sample. The sample was gently prerinsed with RO water. (T4Rnd01.jpg)

Image:	T4Rnd01	100 ×	ESEM image	Figure C4-10
	t4rnd02	100 ×	ESEM image	Figure C4-11
	t4rnd03	500 ×	ESEM image	Figure C4-12
	t4rnd04	500 ×	ESEM image	Figure C4-13
	t4rnd05	500 ×	ESEM image	Figure C4-14
	t4rnd06	500 ×	ESEM image	Figure C4-15

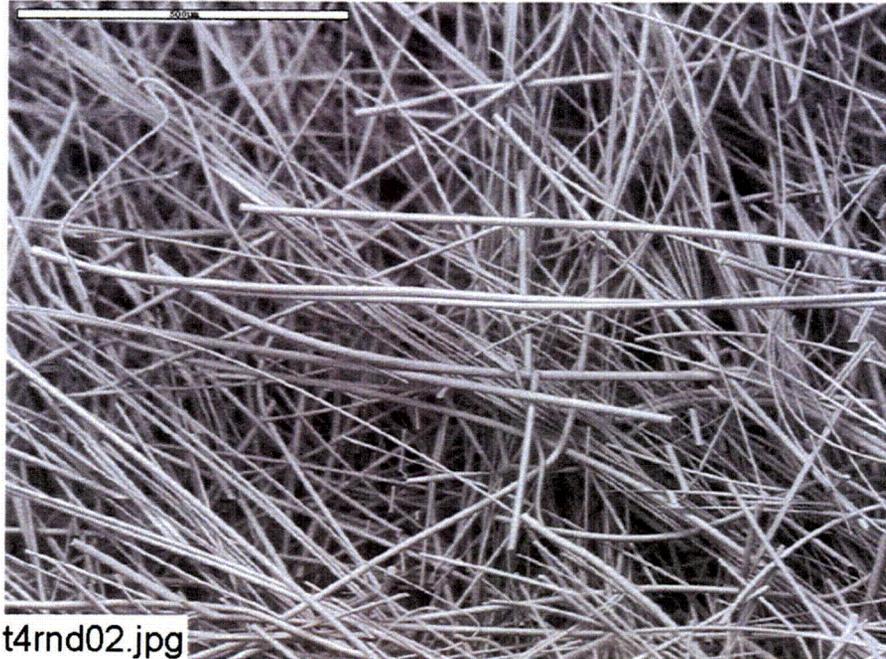
Figure C4-11. Environmental SEM image magnified 100 times for a Test #4, Day-30 interior high-flow fiberglass sample. The sample was gently prerinsed with RO water. (t4rnd02.jpg)

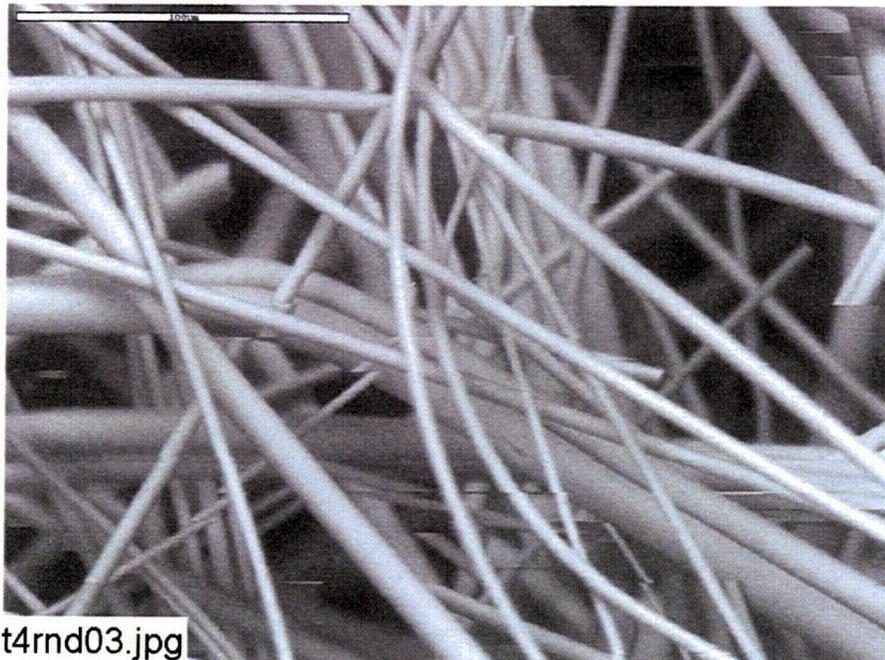
Figure C4-12. Environmental SEM image magnified 500 times for a Test #4, Day-30 interior high-flow fiberglass sample. The sample was gently prerinsed with RO water. (t4rnd03.jpg)

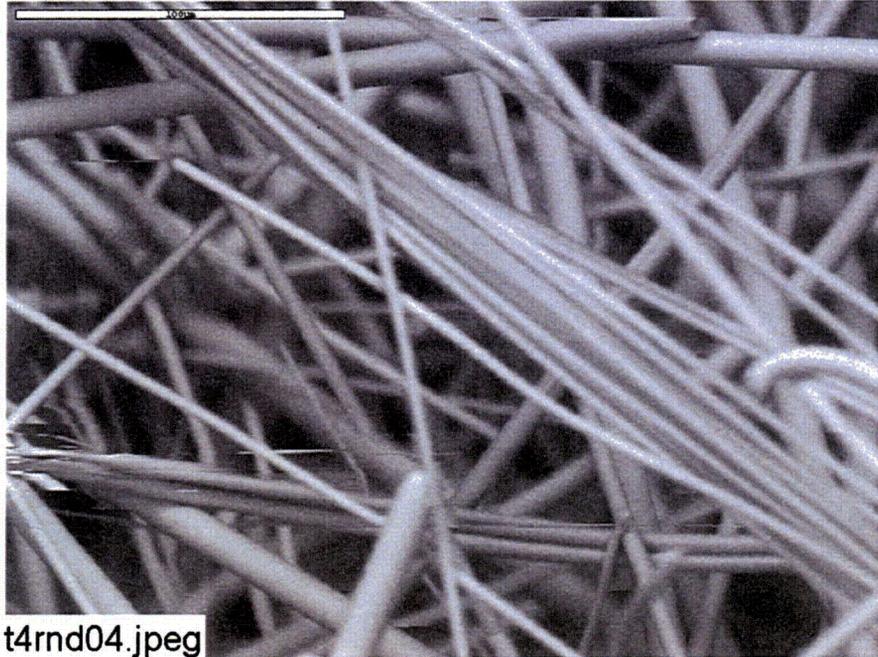
Figure C4-13. Environmental SEM image magnified 500 times for a Test #4, Day-30 interior high-flow fiberglass sample. The sample was gently prerinsed with RO water. (t4rnd04.jpeg)

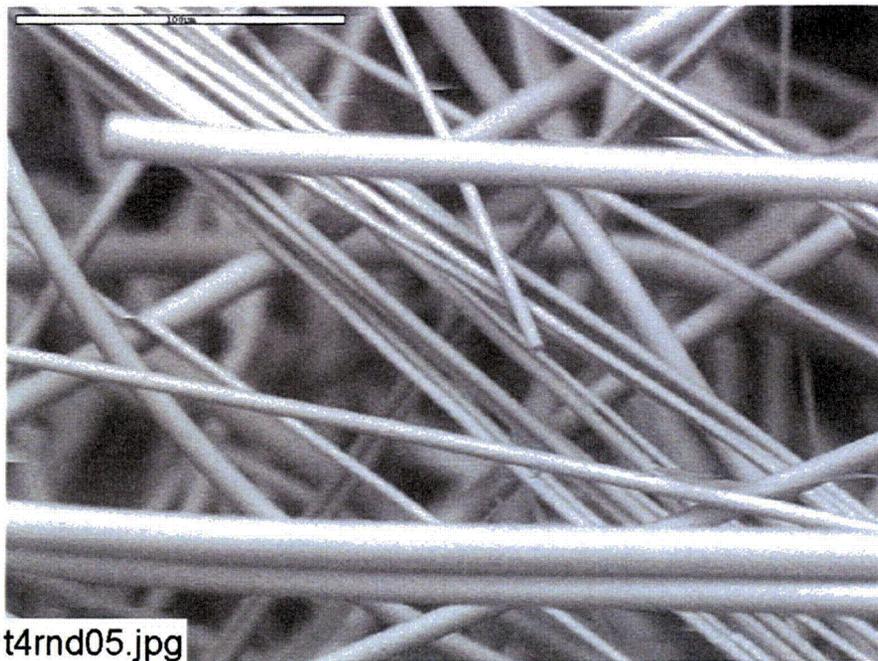
Figure C4-14. Environmental SEM image magnified 500 times for a Test #4, Day-30 interior high-flow fiberglass sample. The sample was gently prerinsed with RO water. (t4rnd05.jpg)

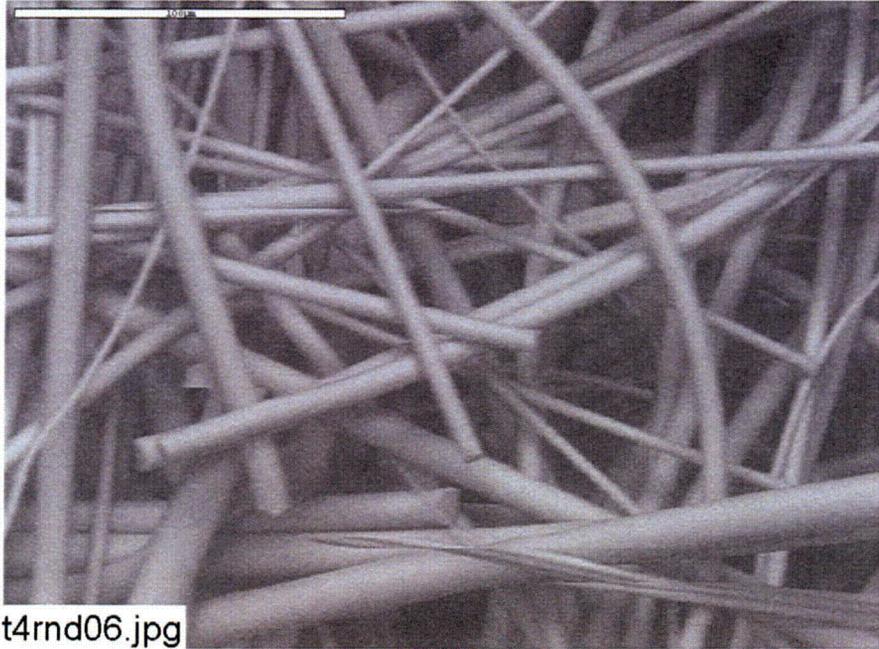
Figure C4-15. Environmental SEM image magnified 500 times for a Test #4, Day-30 interior high-flow fiberglass sample. The sample was gently prerinsed with RO water. (t4rnd06.jpg)

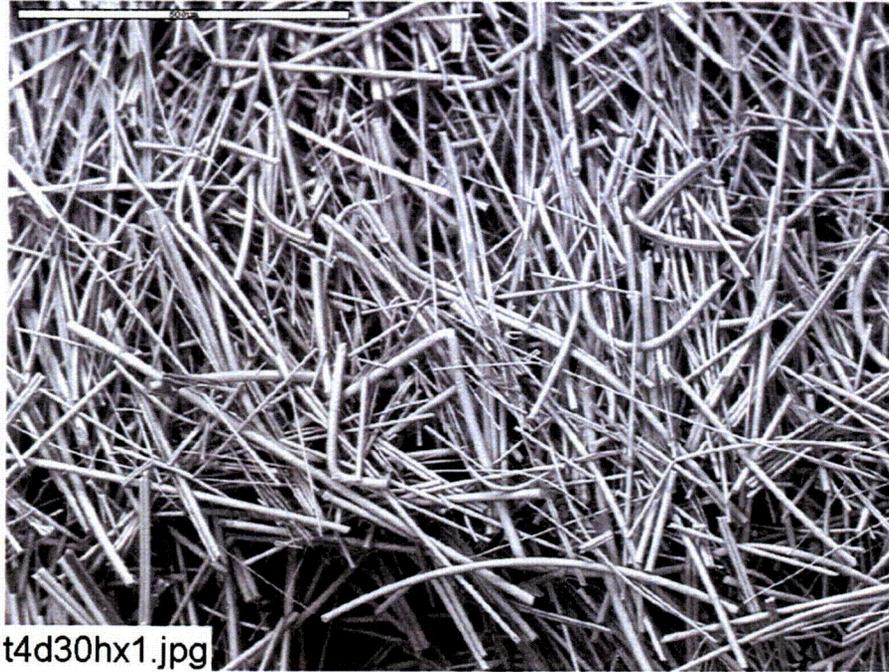
Figure C5-1. Environmental SEM image magnified 100 times for a Test #4, Day-30 exterior high-flow fiberglass sample in front of the header (inserted on Day 4). (t4d30hx1.jpg)

Image:	t4d30hx1	100 ×	ESEM image	Figure C5-1
	t4d30hx2	500 ×	ESEM image	Figure C5-2
	t4d30hx5	1000 ×	ESEM annotated image	Figure C5-3
EDS:	t4d30hx4		EDS on coating of fiberglass shown in t4d30hx5	Figure C5-4

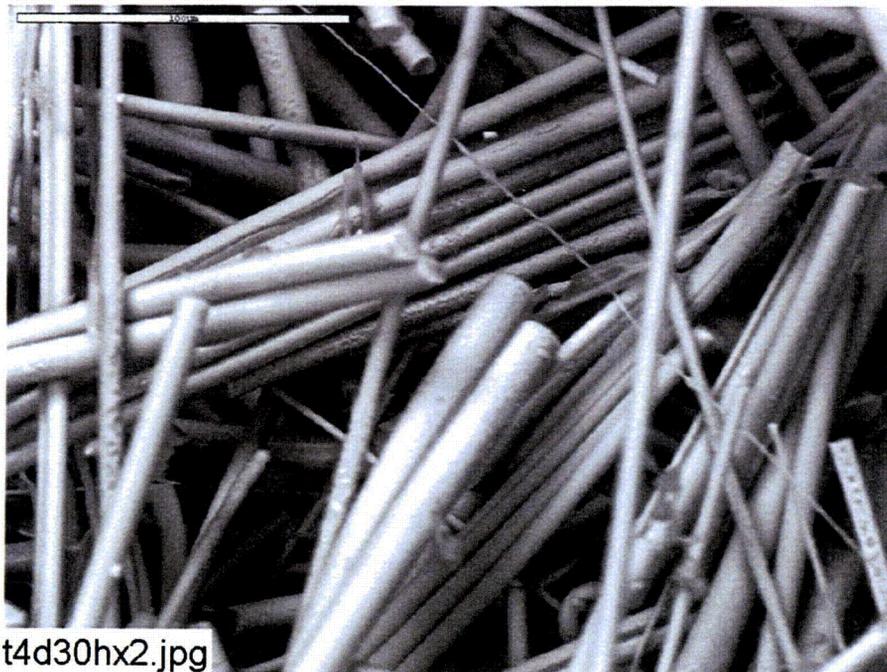
Figure C5-2. Environmental SEM image magnified 500 times for a Test #4, Day-30 exterior high-flow fiberglass sample in front of the header (inserted on Day 4). (t4d30hx2.jpg)

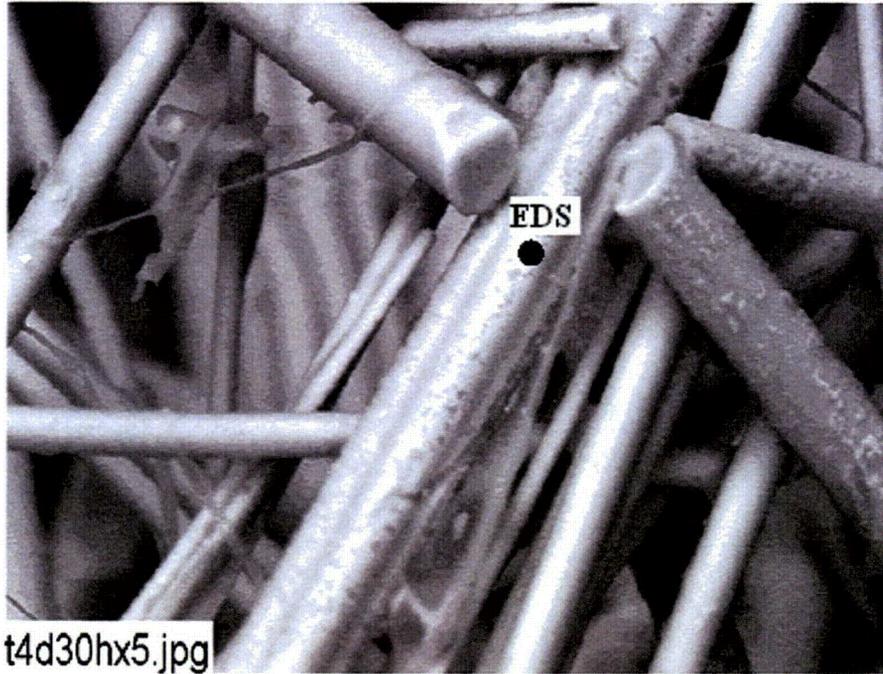
Figure C5-3. Annotated environmental SEM image magnified 1000 times for a Test #4, Day-30 exterior high-flow fiberglass sample in front of the header (inserted on Day 4). The EDS spot is shown in the picture. (t4d30hx5.jpg)
