Appendix A

ESEM/EDS Data for Test #4, Day-5 Fiberglass in Low-Flow Zone

During ICET Test #4, work was continued for the purpose of identifying the origin and chemical composition of the products that were formed during the test. One objective of ICET is to identify the composition of debris on fiberglass and the particulate substances in the test solution. To address this question partially, low-flow fiberglass samples on Test #4, Day 5 were examined by ESEM/EDS, including both of the exterior and the interior location of the fiberglass samples.

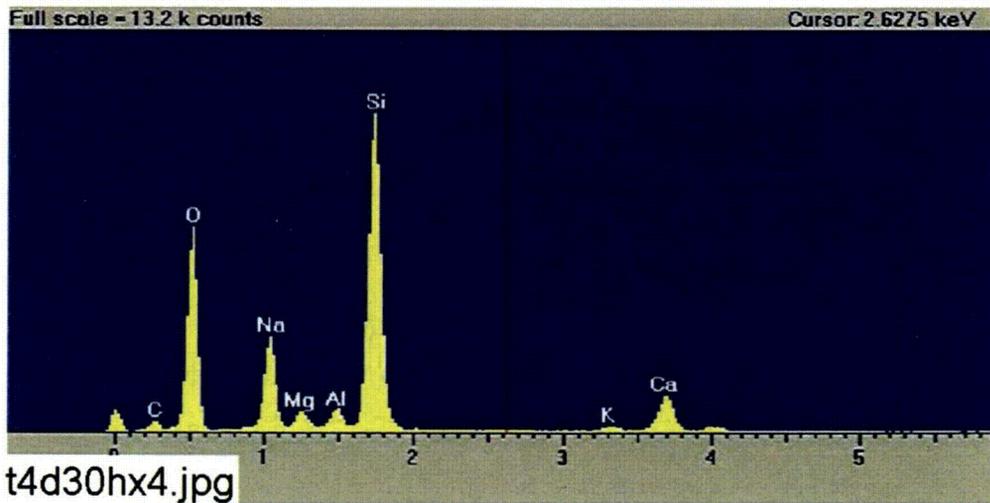
Figure C5-4. EDS counting spectrum for the spot of coating substance on fiberglass shown in Figure C5-3. (t4d30hx4.jpg)

Image:	t4d30hx1	100 ×	ESEM image	Figure C5-1
	t4d30hx2	500 ×	ESEM image	Figure C5-2
	t4d30hx5	1000 ×	ESEM annotated image	Figure C5-3
EDS:	t4d30hx4		EDS on coating of fiberglass shown in t4d30hx5	Figure C5-4

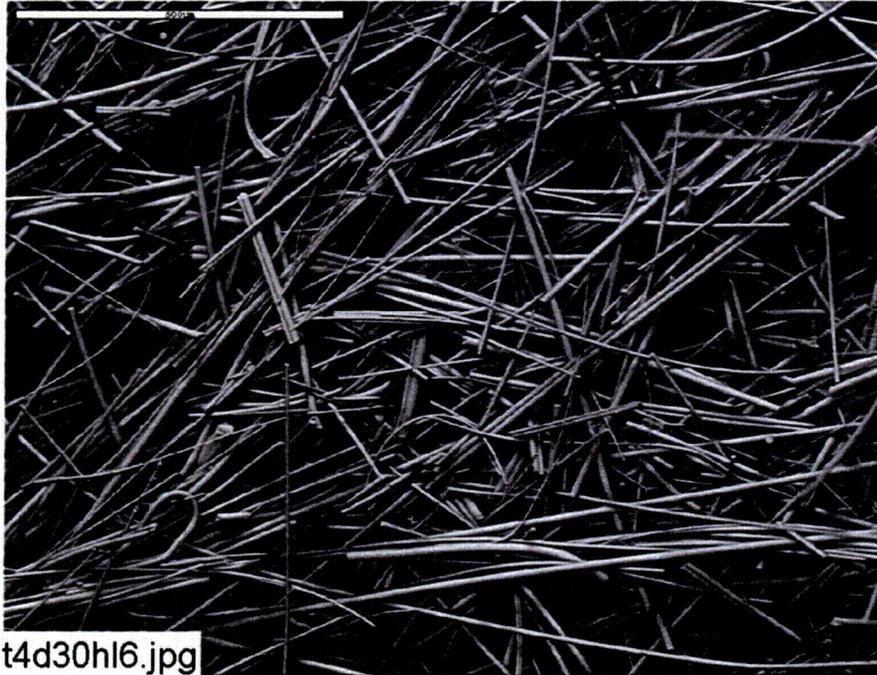
Figure C5-5. Environmental SEM image magnified 100 times for a Test #4, Day-30 interior high-flow fiberglass sample in front of the header (inserted on Day 4). (t4d30h16.jpg)

Image:	t4d30hi6	100 ×	ESEM image of fiberglass	Figure C5-5
	t4d30hi9	500 ×	ESEM annotated image	Figure C5-6
EDS	t4d30hi8		EDS on web in t4d30hi9	Figure C5-7
Image	t4d30hi	1000 ×	ESEM annotated image	Figure C5-8
EDS	t4d30hi0		EDS on spot in t4d30hi	Figure C5-9

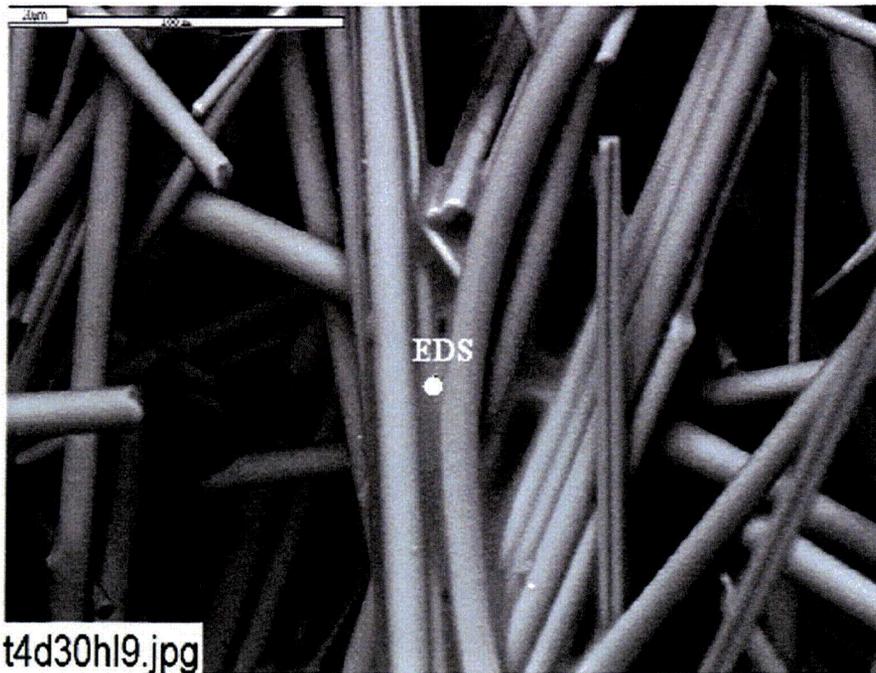
Figure C5-6. Annotated environmental SEM image magnified 500 times for a Test #4, Day-30 interior high-flow fiberglass sample in front of the header (inserted on Day 4). The EDS spot is shown in the picture. (t4d30h19.jpg)

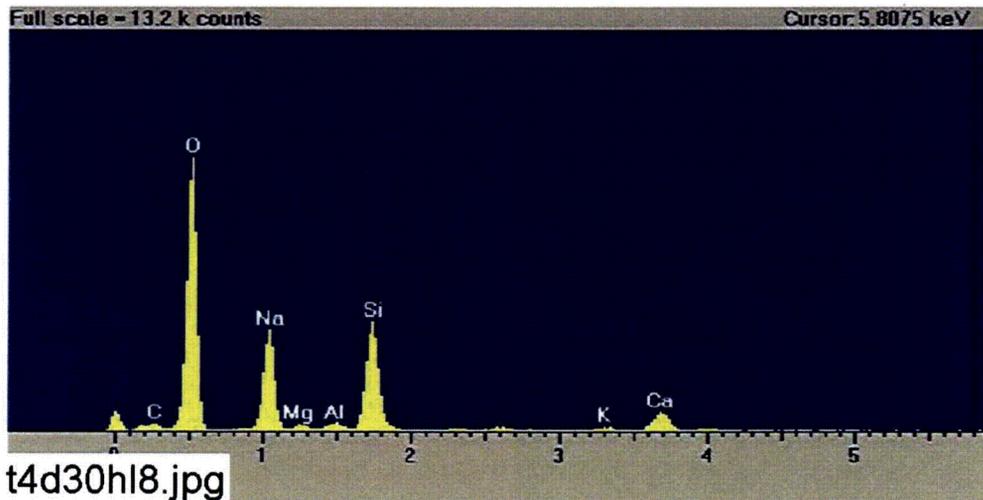
Figure C5-7. EDS counting spectrum for the spot of substance attached on fiberglass shown in Figure C5-6. (t4d30h18.jpg)

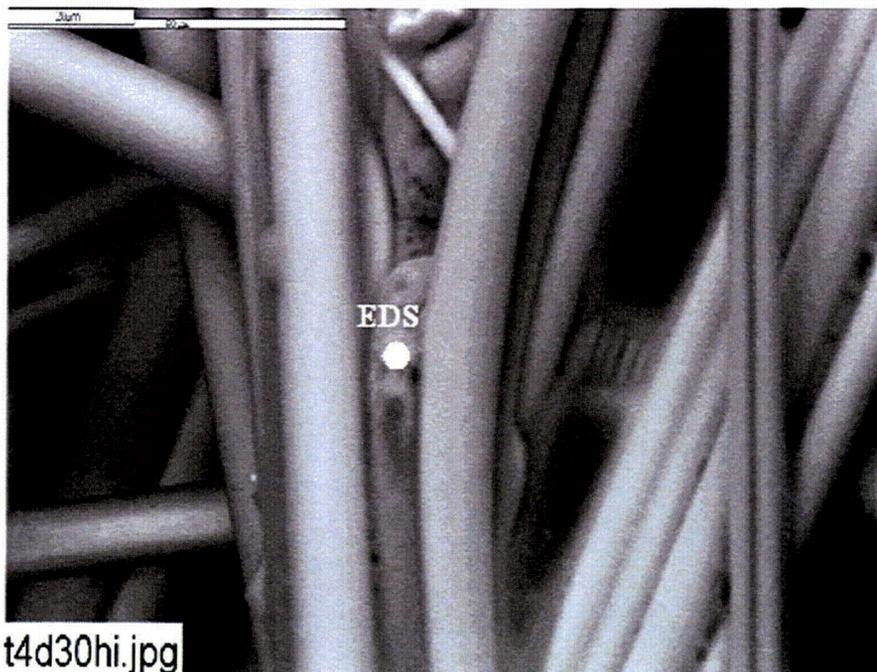
Figure C5-8. Annotated environmental SEM image magnified 1000 times for a Test #4, Day-30 interior high-flow fiberglass sample in front of the header (inserted on Day 4). The EDS spot is shown in the picture. (t4d30hi.jpg)

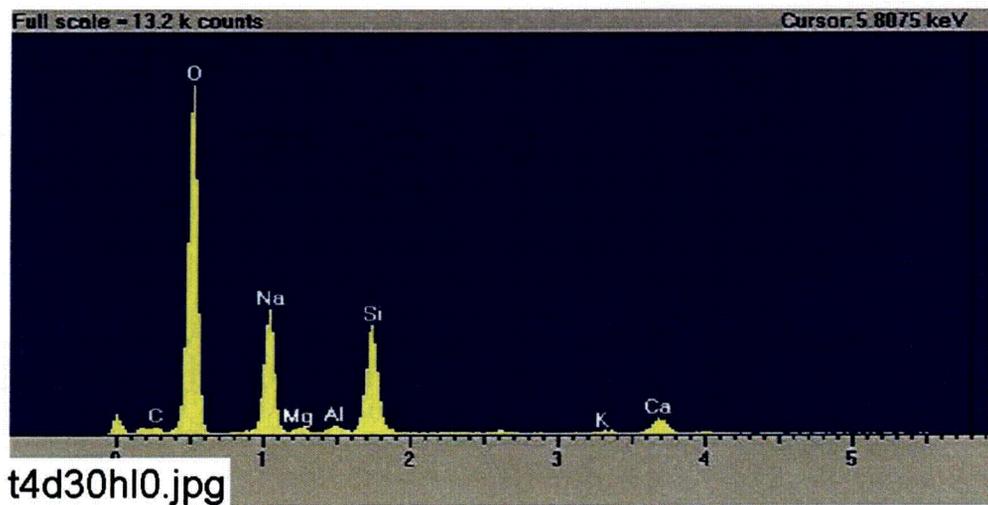
Figure C5-9. EDS counting spectrum for the spot of substance attached on fiberglass shown in Figure C5-8. (t4d30h10.jpg)

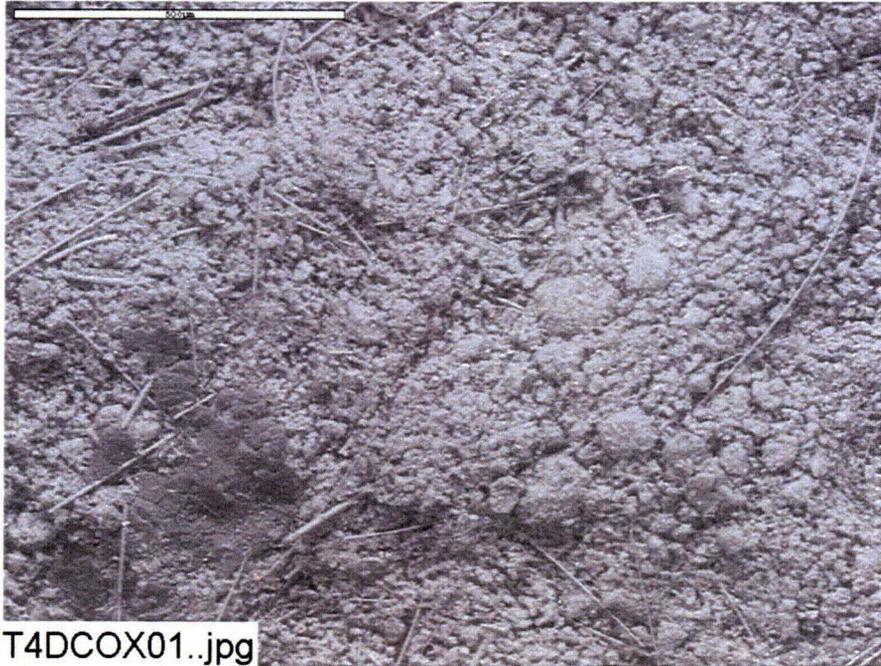
Figure C6-1. Environmental SEM image magnified 100 times for a Test #4, Day-30 exterior fiberglass sample on the drain collar (away from the drain screen). (T4DCOX01.jpg)

Image:	T4DCOX01	100 ×	ESEM image	Figure C6-1
	t4dcox05	100 ×	ESEM image	Figure C6-2
	t4dcox02	500 ×	ESEM image	Figure C6-3
	t4dcox03	1000 ×	ESEM at higher magnification	Figure C6-4
EDS:	t4dcox04		EDS on particles in t4dcox03	Figure C6-5

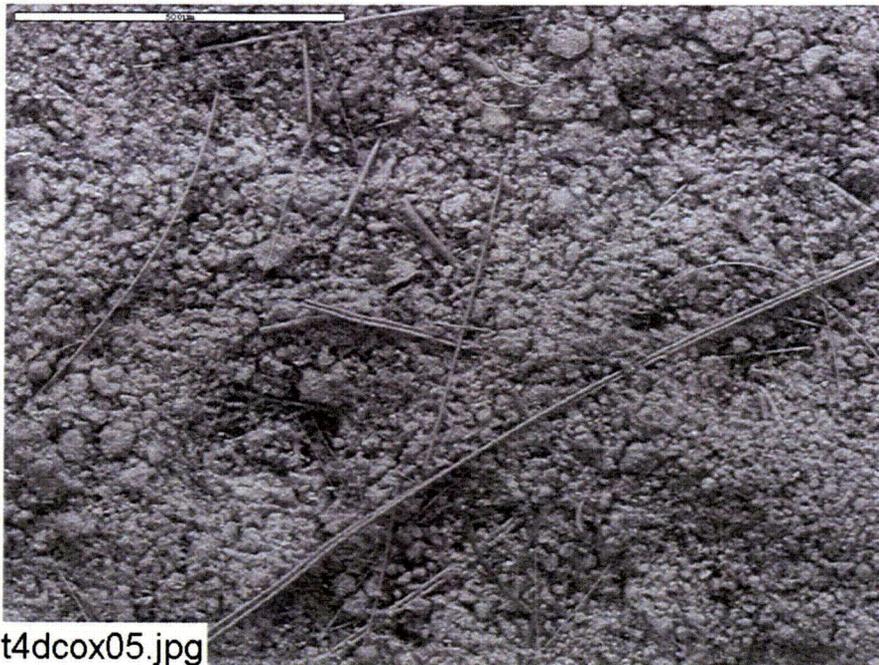
Figure C6-2. Environmental SEM image magnified 100 times for a Test #4, Day-30 exterior fiberglass sample on the drain collar (away from the drain screen). (t4dcox05.jpg)

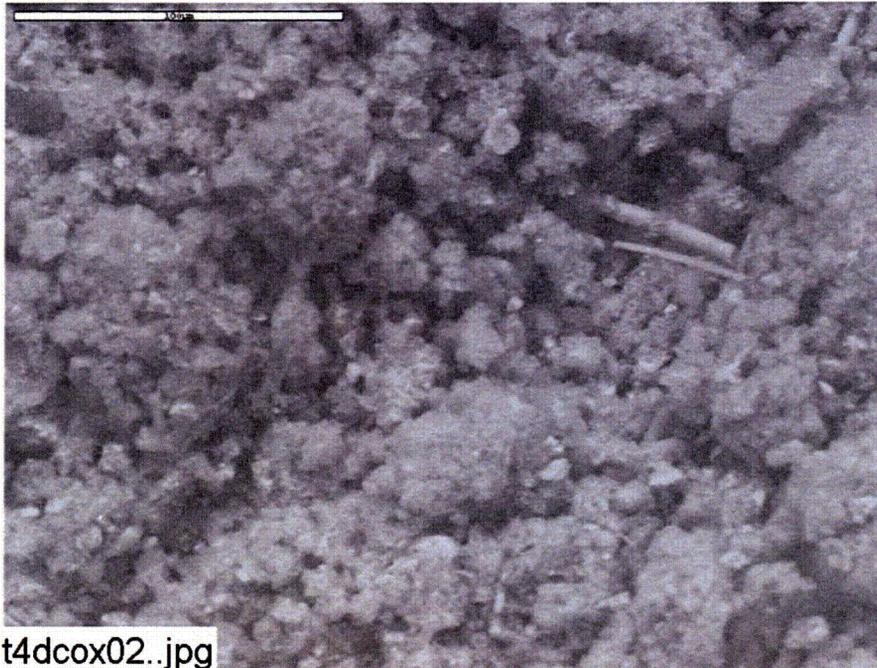
t4dcox02..jpg

Figure C6-3. Environmental SEM image magnified 500 times for a Test #4, Day-30 exterior fiberglass sample on the drain collar (away from the drain screen). (t4dcox02.jpg)

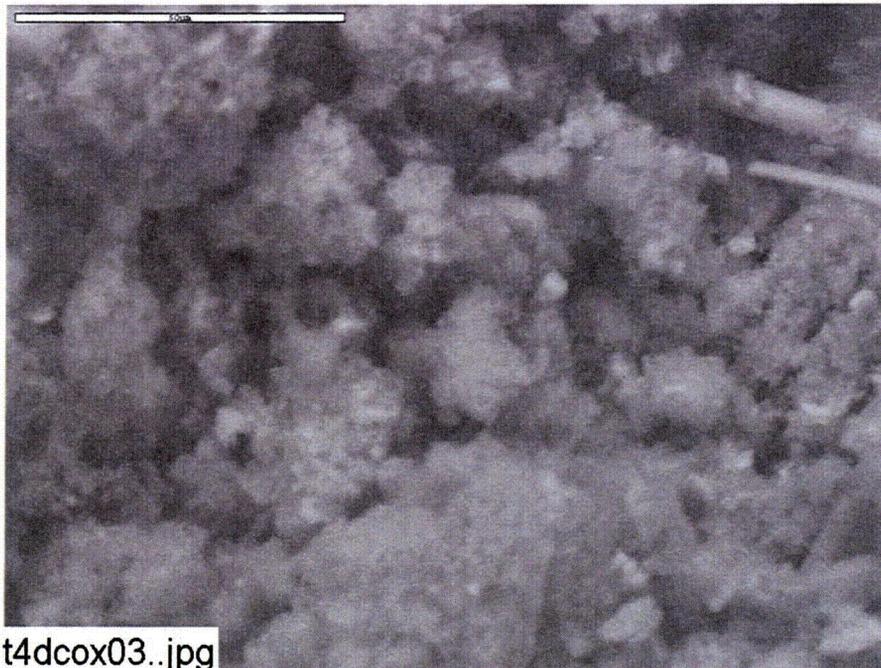
t4dcox03..jpg

Figure C6-4. Environmental SEM image magnified 1000 times for a Test #4, Day-30 exterior fiberglass sample on the drain collar (away from the drain screen). (t4dcox03.jpg)

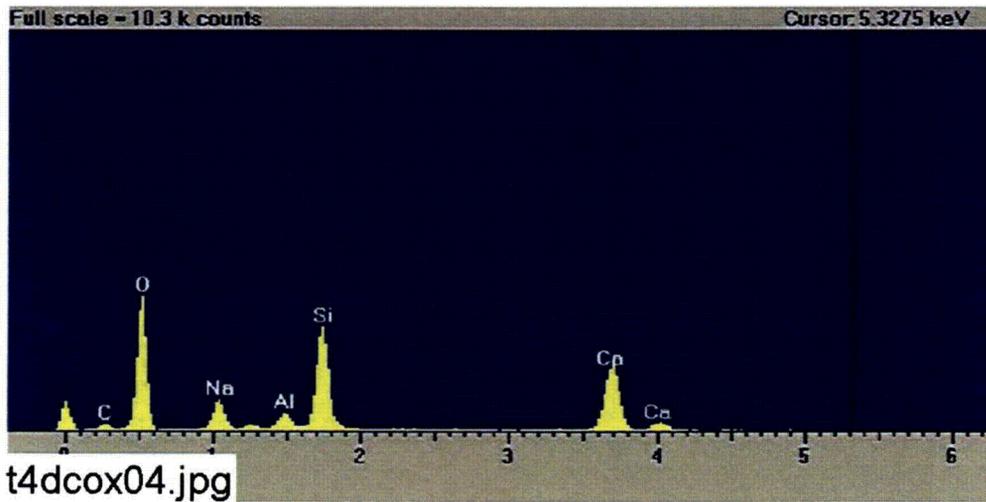
Figure C6-5. EDS counting spectrum for the large mass of particulate deposits on fiberglass shown in Figure C6-4. (t4dcox04.jpg)

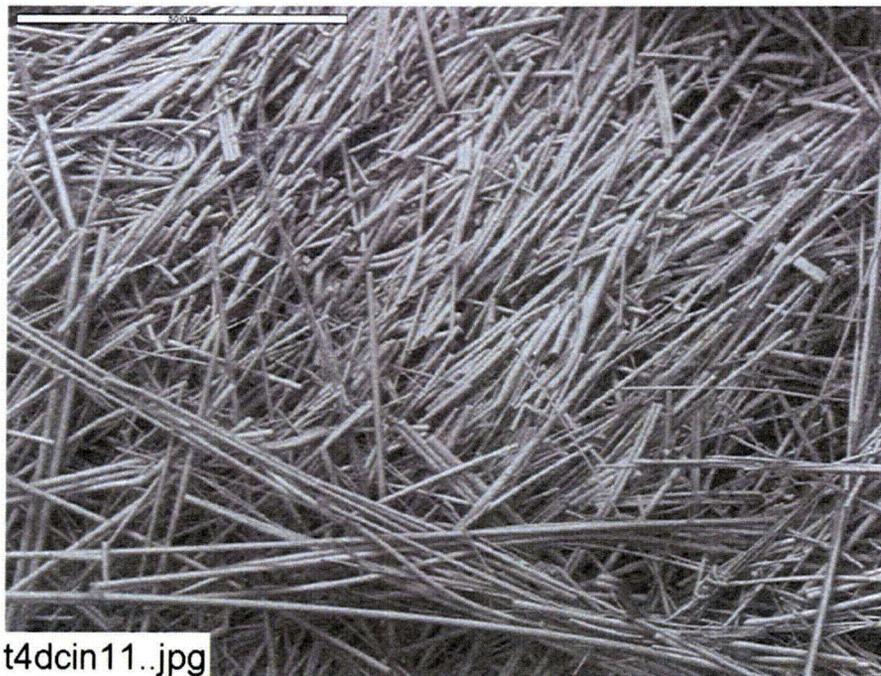
Figure C6-6. Environmental SEM image magnified 100 times for a Test #4, Day-30 interior fiberglass sample on the drain collar. (t4dcin11..jpg)

Image:	t4dcin11	100 ×	ESEM image	Figure C6-6
	t4dcin14	100 ×	ESEM image	Figure C6-7
	t4dcin12	500 ×	ESEM image higher magnification	Figure C6-8
	t4dcin13	500 ×	ESEM image high magnification	Figure C6-9
	t4dcin15	500 ×	ESEM image high magnification	Figure C6-10

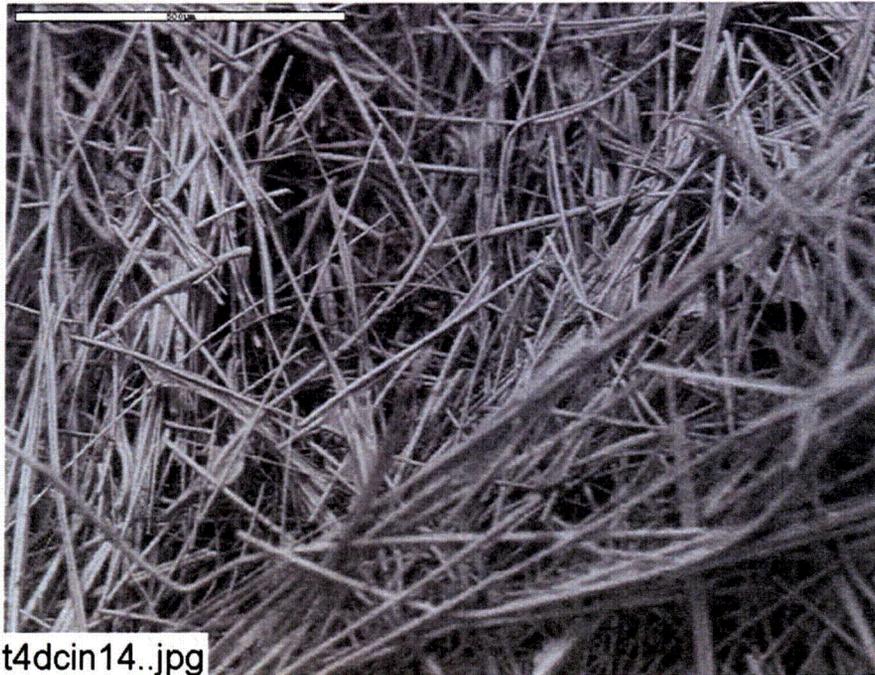
t4dcin14..jpg

Figure C6-7. Environmental SEM image magnified 100 times for a Test #4, Day-30 interior fiberglass sample on the drain collar. (t4dcin14.jpg)

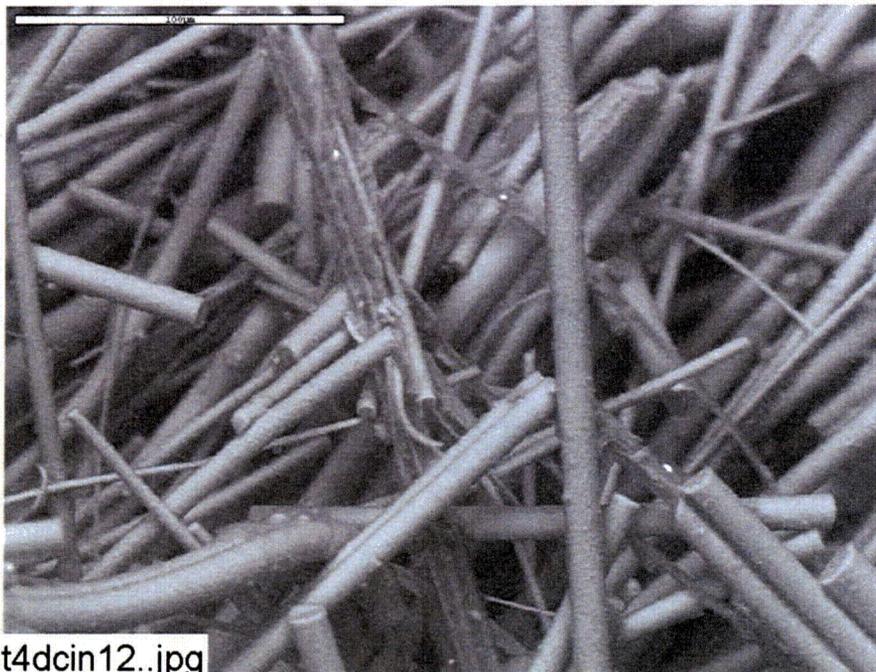
t4dcin12..jpg

Figure C6-8. Environmental SEM image magnified 500 times for a Test #4, Day-30 interior fiberglass sample on the drain collar. (t4dcin12.jpg)

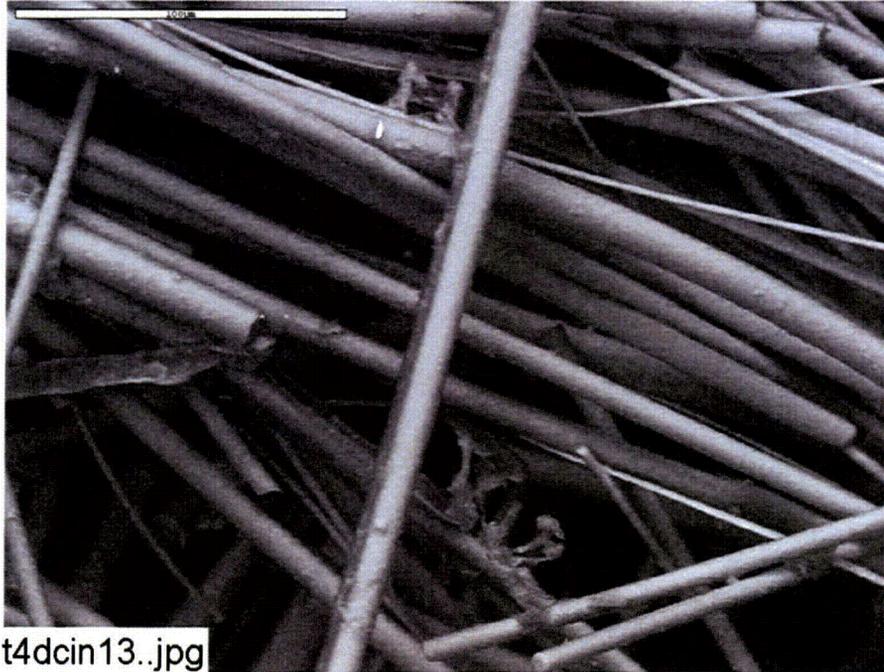
Figure C6-9. Environmental SEM image magnified 500 times for a Test #4, Day-30 interior fiberglass sample on the drain collar. (t4dcin13.jpg)

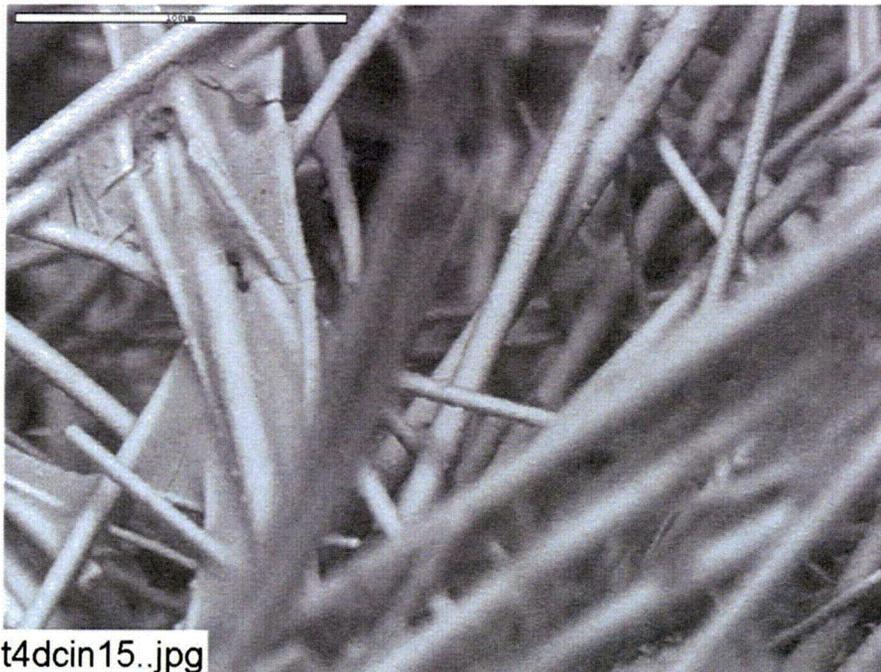
Figure C6-10. Environmental SEM image magnified 500 times for a Test #4, Day-30 interior fiberglass sample on the drain collar. (t4dcin15.jpg)

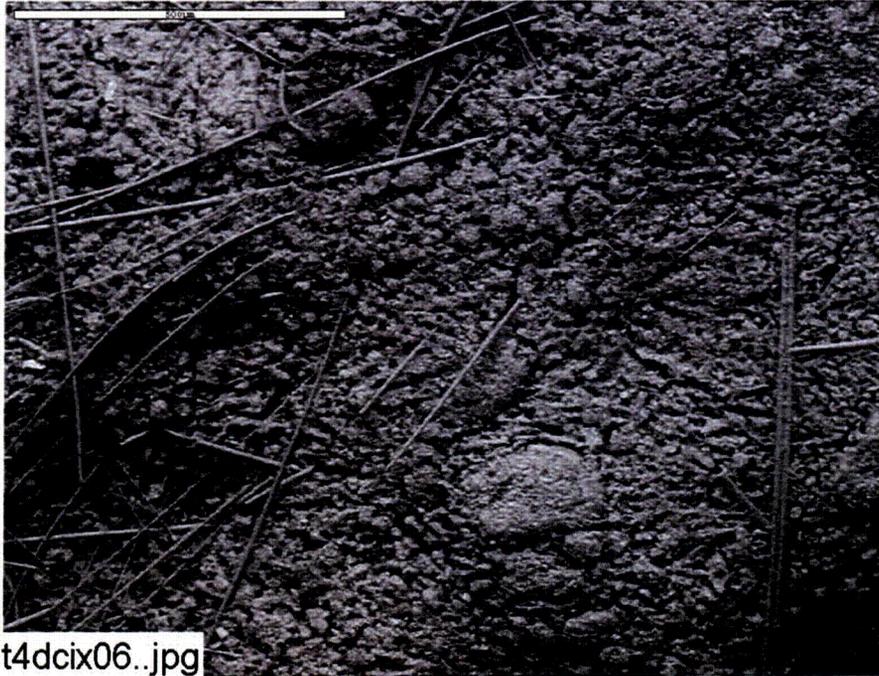
t4dcix06..jpg

Figure C6-11. Environmental SEM image magnified 100 times for a Test #4, Day-30 exterior fiberglass sample on the drain collar (next to the drain screen). (t4dcix06.jpg)

Image:	t4dcix06	100 ×	ESEM image	Figure C6-11
	t4dcix10	100 ×	ESEM image	Figure C6-12
	t4dcix07	500 ×	ESEM image	Figure C6-13
	t4dcix08	1000 ×	ESEM image higher magnification	Figure C6-14
EDS:	t4dcix09		EDS on particles in t4dcix08	Figure C6-15

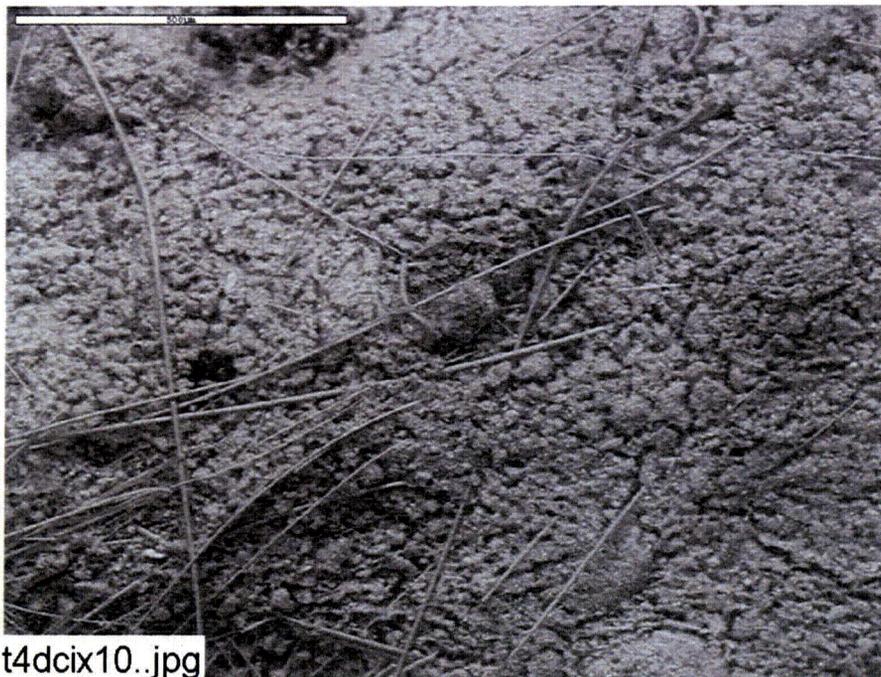
t4dcix10..jpg

Figure C6-12. Environmental SEM image magnified 100 times for a Test #4, Day-30 exterior fiberglass sample on the drain collar (next to the drain screen). (t4dcix10.jpg)

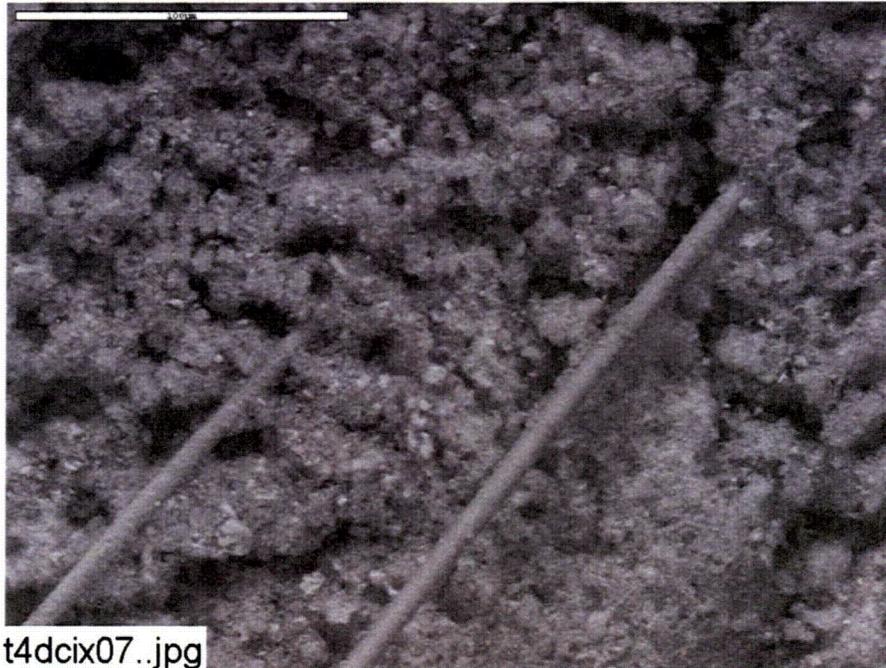
t4dcix07..jpg

Figure C6-13. Environmental SEM image magnified 500 times for a Test #4, Day-30 exterior fiberglass sample on the drain collar (next to the drain screen). (t4dcix07.jpg)

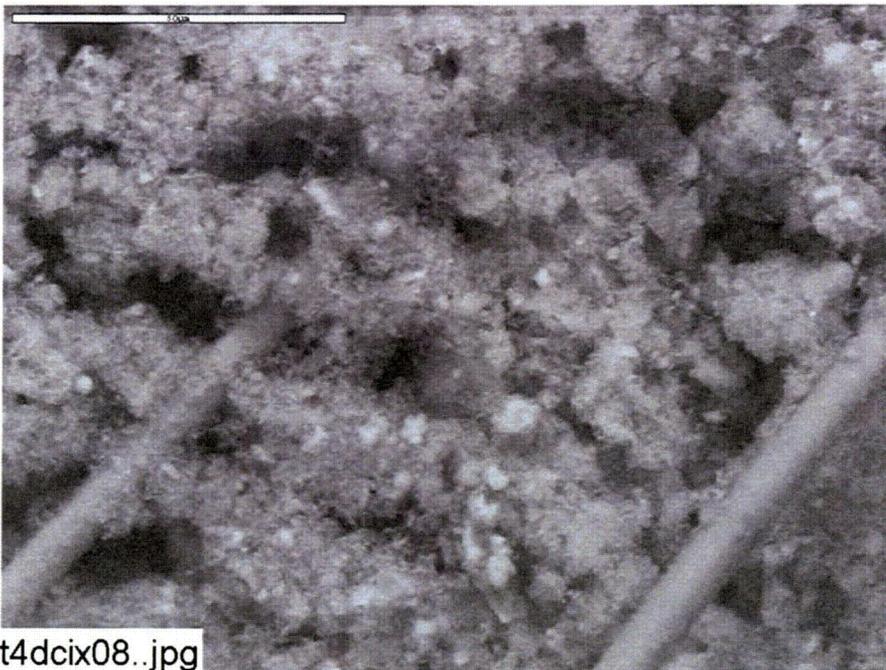
t4dcix08..jpg

Figure C6-14. Environmental SEM image magnified 1000 times for a Test #4, Day-30 exterior fiberglass sample on the drain collar (next to the drain screen). (t4dcix08.jpg)

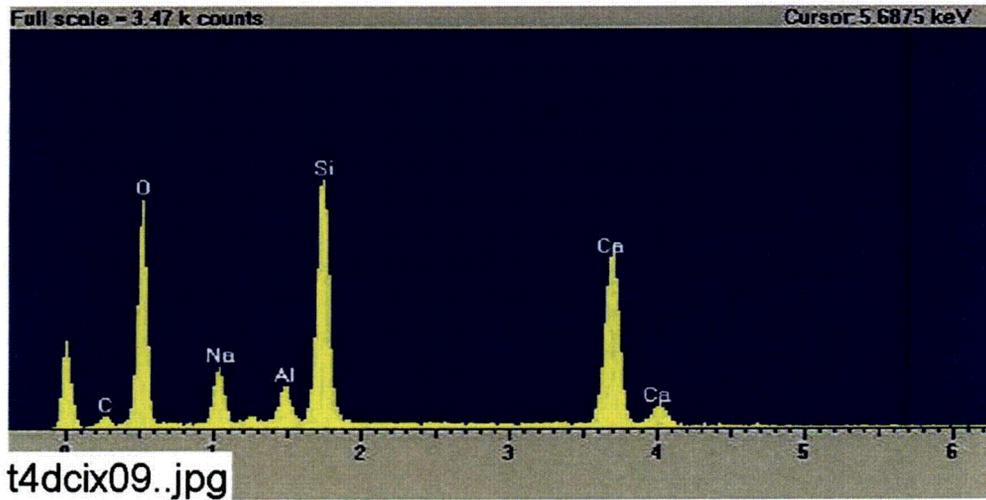
Figure C6-15. EDS counting spectrum for the large mass of particulate deposits on fiberglass shown in Figure C6-14. (t4dcix09.jpg)

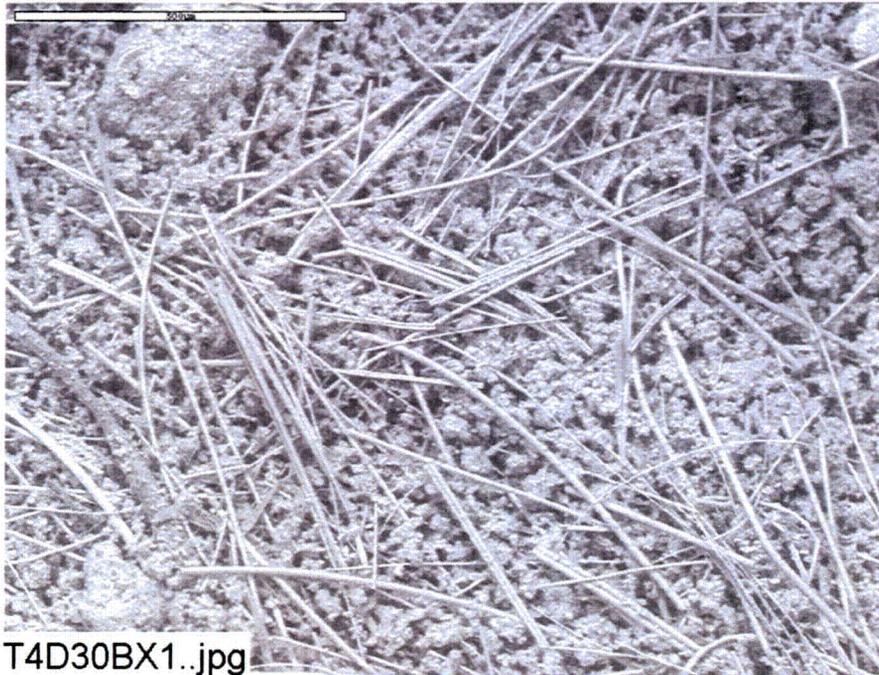
Figure C7-1. Environmental SEM image magnified 100 times for a Test #4, Day-30 exterior fiberglass sample within the birdcage. (T4D30BX1.jpg)

Image: T4D30BX1	100 ×	ESEM image	Figure C7-1
t4d30bx4	500 ×	ESEM annotated image	Figure C7-2
EDS: t4d30bx3		EDS on particles in t4d30bx4	Figure C7-3

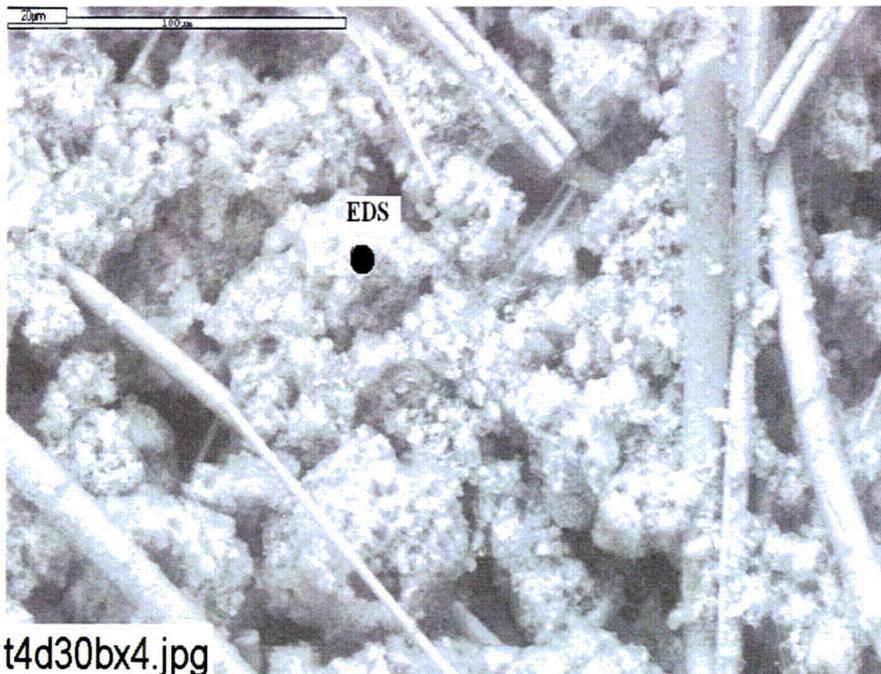
Figure C7-2. Annotated environmental SEM image magnified 500 times for a Test #4, Day-30 exterior fiberglass sample within the birdcage. (t4d30bx4.jpg)

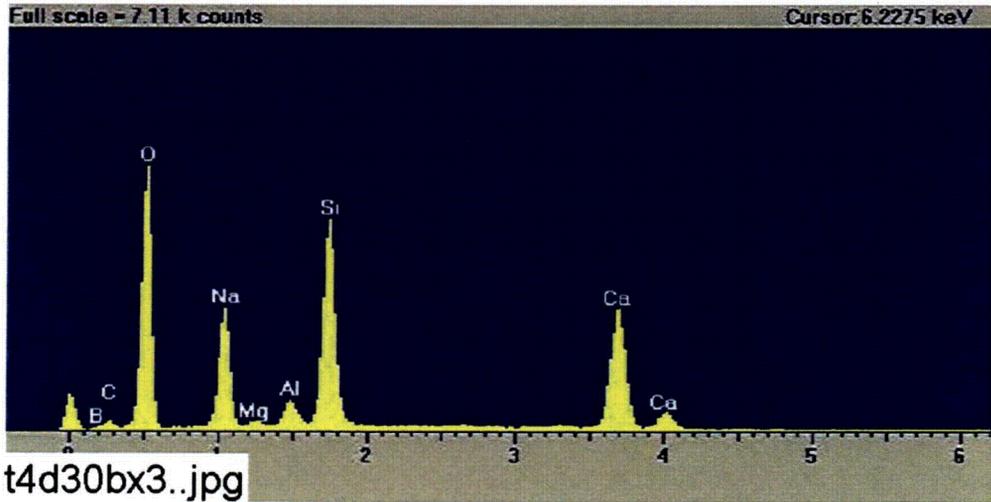
Figure C7-3. EDS counting spectrum for the particulate deposits on fiberglass shown in Figure C7-2. (T4D30bx3.jpg)

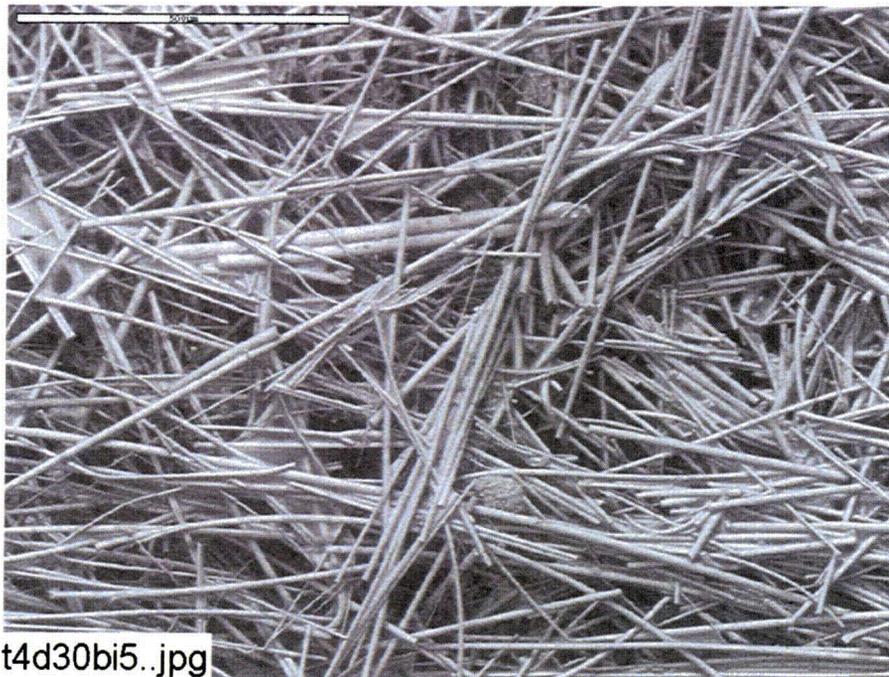
Figure C7-4. Environmental SEM image magnified 100 times for a Test #4, Day-30 interior fiberglass sample within the birdcage. (t4d30bi5.jpg)

Image: t4d30bi5	100 ×	ESEM image of fiberglass	Figure C7-4
t4d30bi6	500 ×	ESEM image higher magnification	Figure C7-5
t4d30bi7	500 ×	ESEM image	Figure C7-6

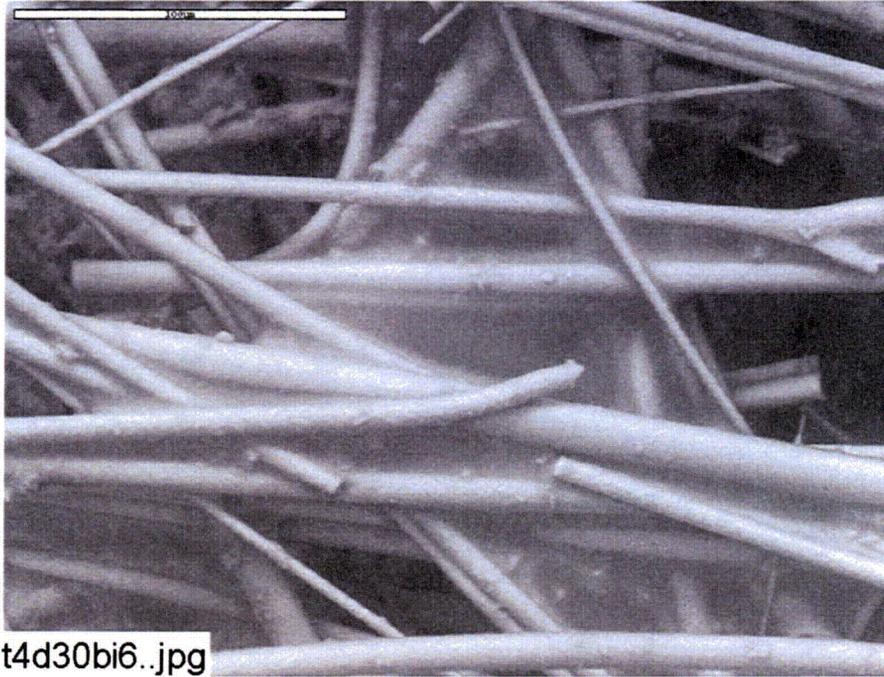
t4d30bi6.jpg

Figure C7-5. Environmental SEM image magnified 500 times for a Test #4, Day-30 interior fiberglass sample within the birdcage. (t4d30bi6.jpg)

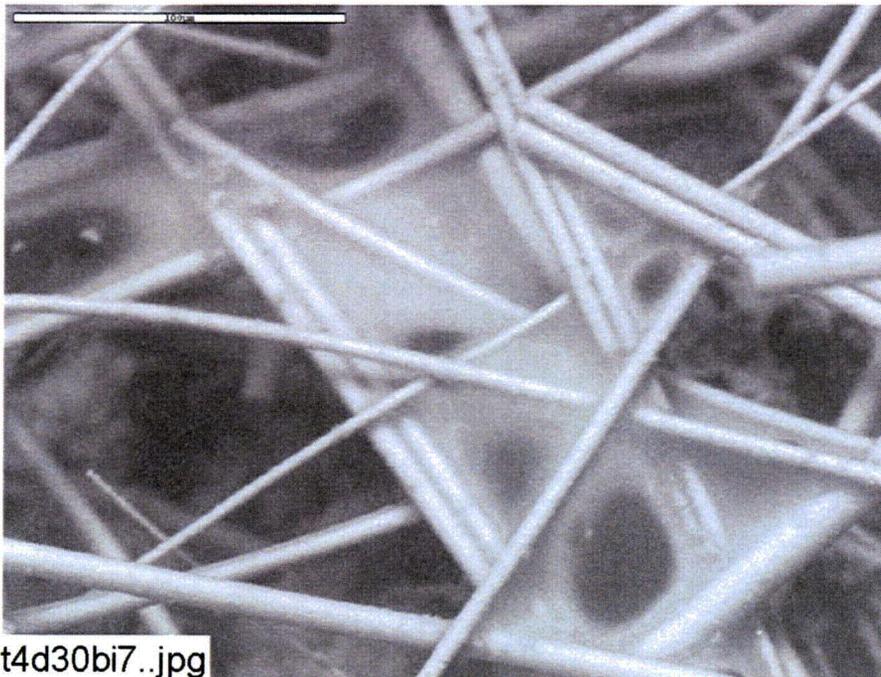
t4d30bi7.jpg

Figure C7-6. Environmental SEM image magnified 500 times for a Test #4, Day-30 interior fiberglass sample within the birdcage. (t4d30bi7.jpg)

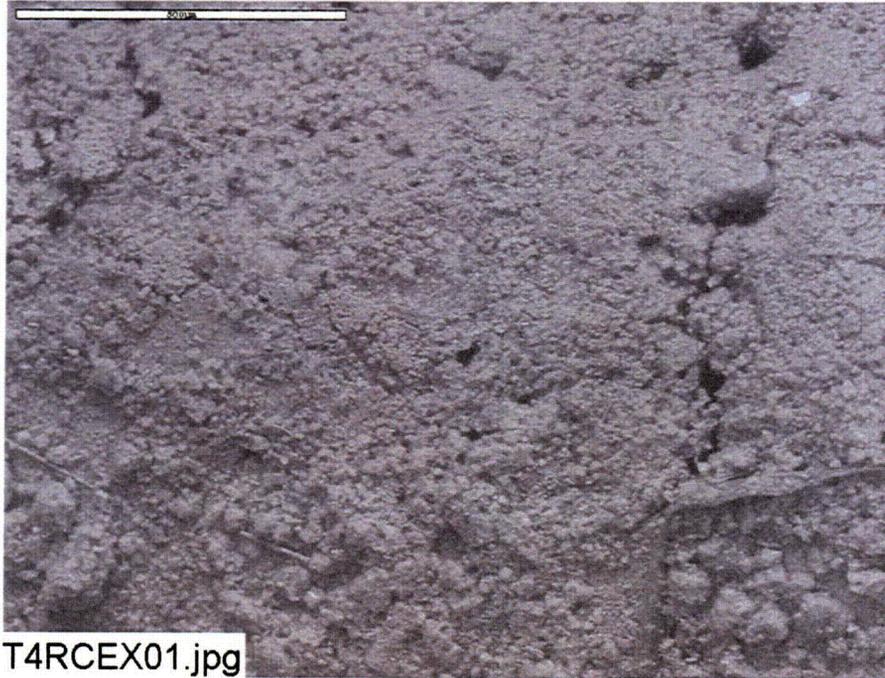
Figure D-1. ESEM image magnified 100 times for a Test #4, Day-30 low-flow exterior raw cal-sil sample. (T4RCEX01.jpg)

Image:	T4RCEX01	100 ×	ESEM image	Figure D-1
	t4rcex02	500 ×	ESEM at higher magnification	Figure D-2
EDS:	t4rcex03		EDS on whole image t4rcex02	Figure D-3

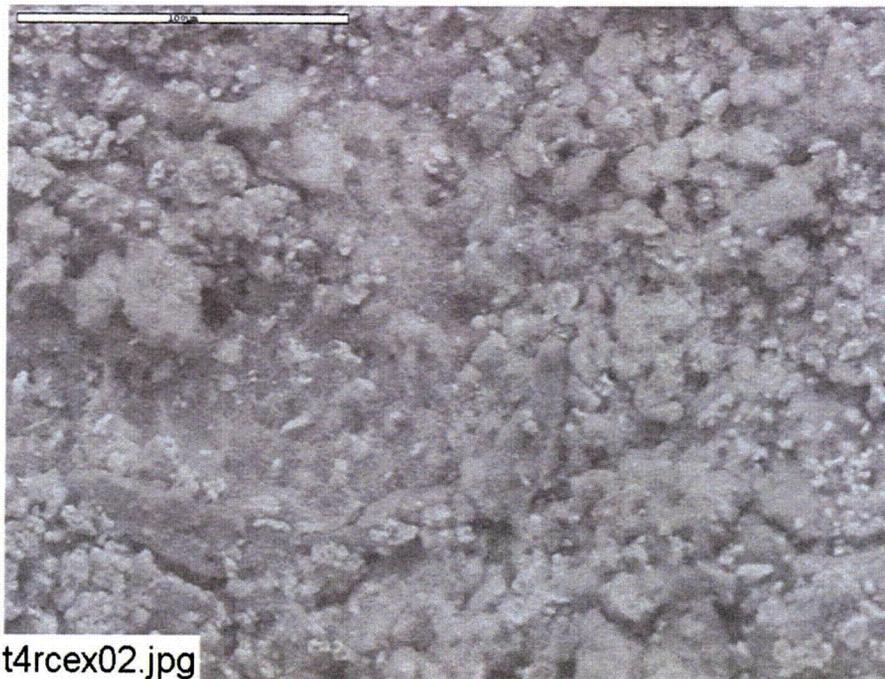
Figure D-2. ESEM image magnified 500 times for a Test #4, Day-30 low-flow exterior raw cal-sil sample. (t4rcex02.jpg)

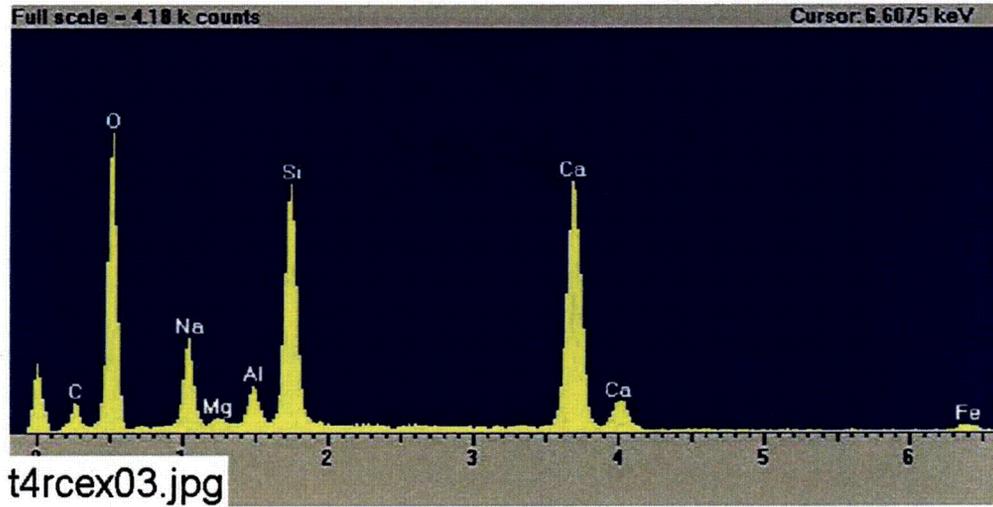
Figure D-3. EDS counting spectrum for the whole image shown in Figure D-2. (t4rcex03.jpg)

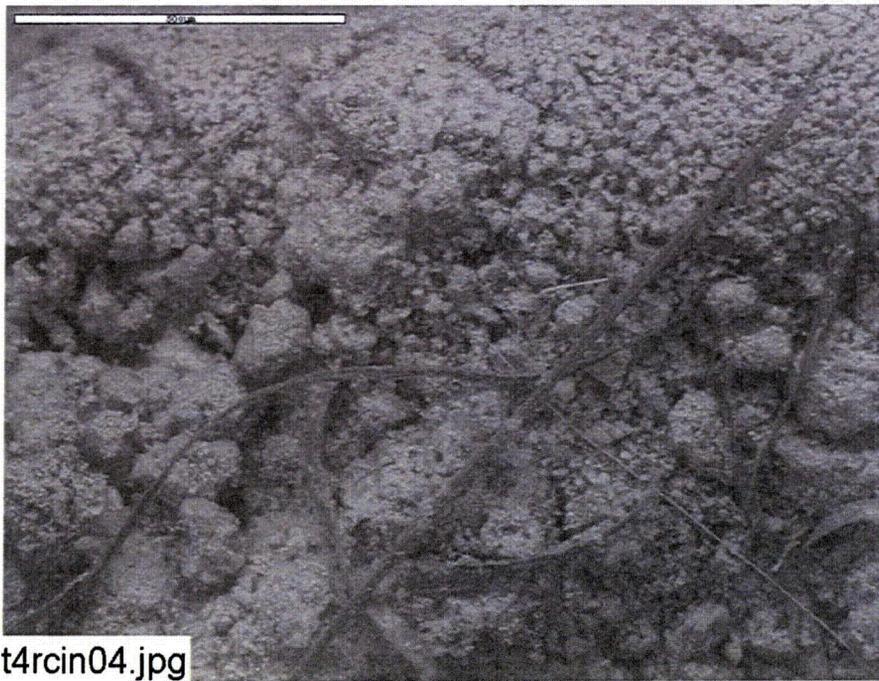
Figure D-4. ESEM image magnified 100 times for a Test #4, Day-30 low-flow interior raw cal-sil sample. (t4rcin04.jpg)

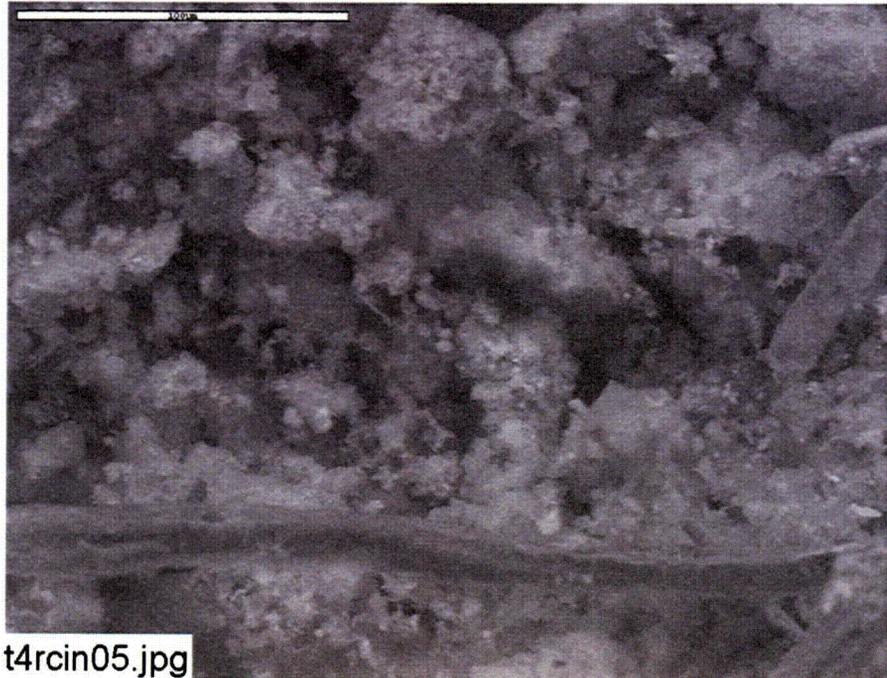
Figure D-5. ESEM image magnified 500 times for a Test #4, Day-30 low-flow interior raw cal-sil sample. (t4rcin05.jpg)

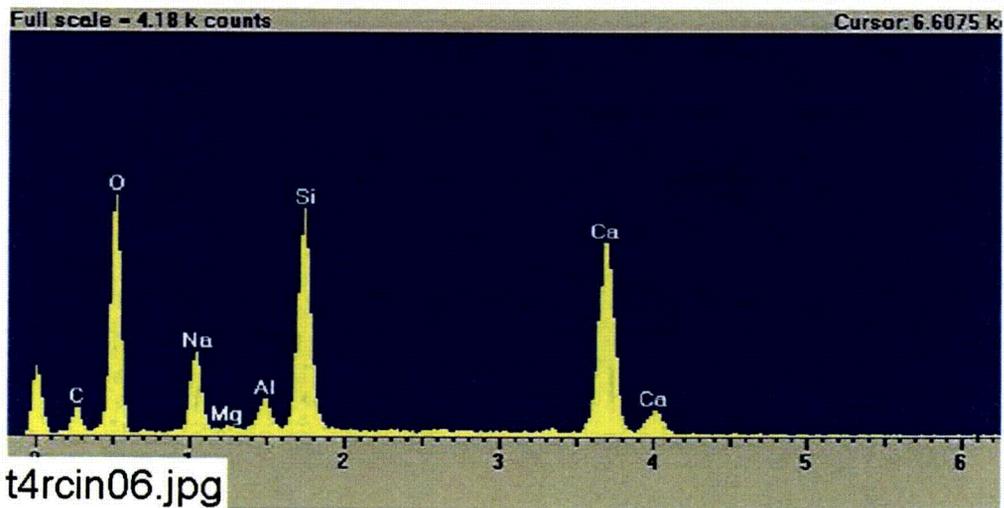
Figure D-6. EDS counting spectrum for the whole image shown in Figure D-5. (t4rcin06.jpg)

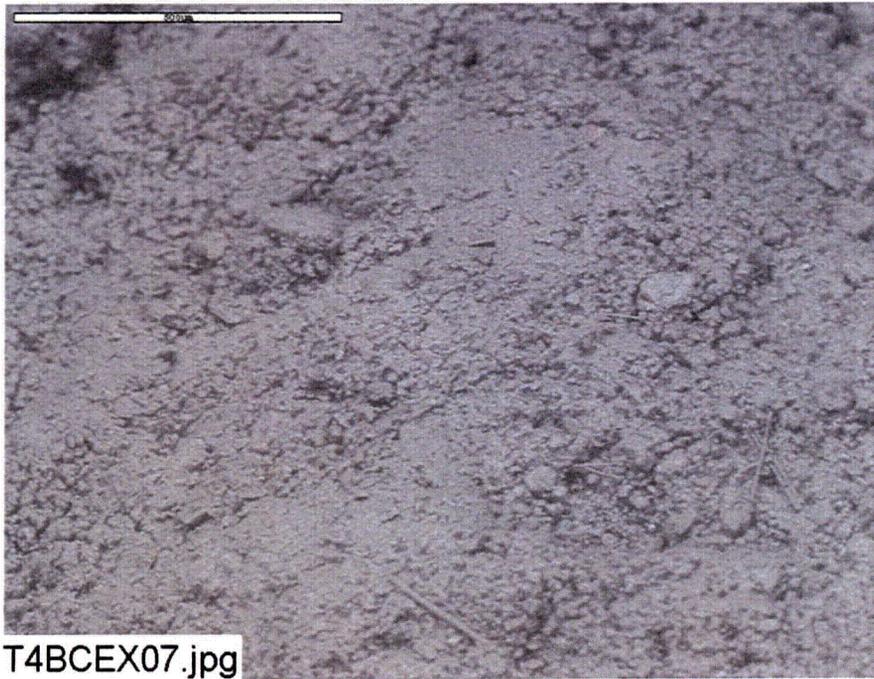
Figure D-7. ESEM image magnified 100 times for a Test #4, Day-30 low-flow exterior baked cal-sil sample. (T4BCEX07.jpg)

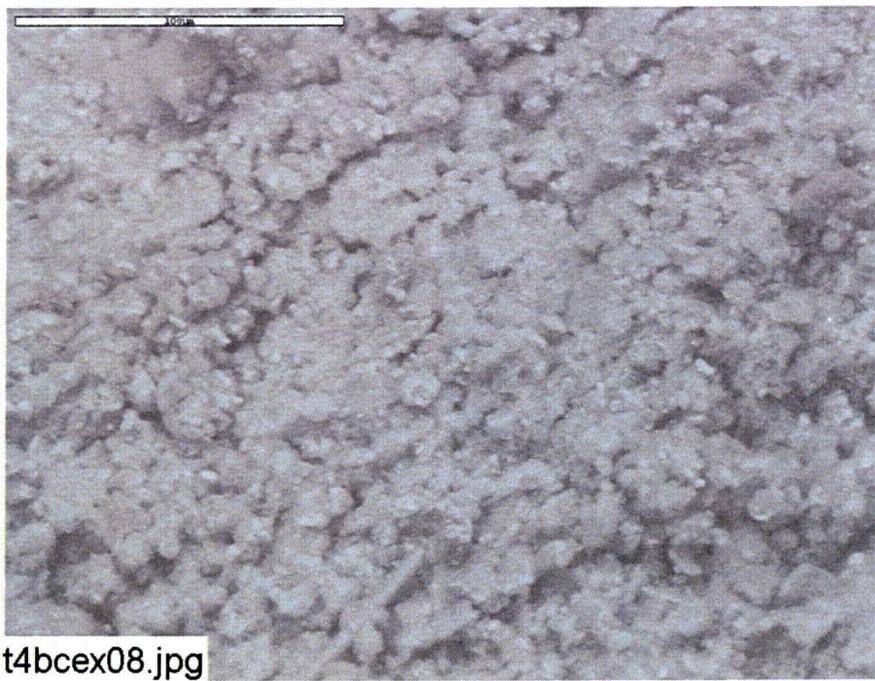
Figure D-8. ESEM image magnified 500 times for a Test #4, Day-30 low-flow exterior baked cal-sil sample. (t4bcex08.jpg)

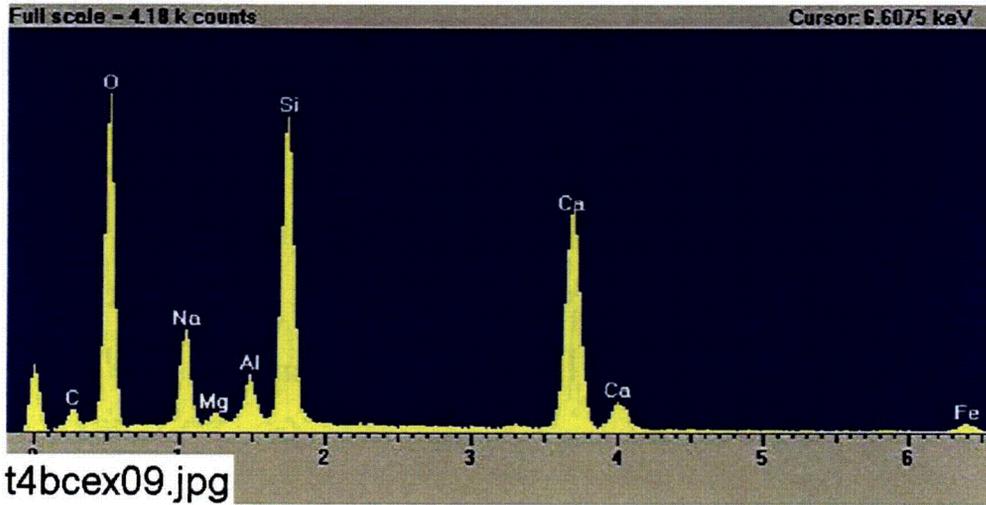
Figure D-9. EDS counting spectrum for the whole image shown in Figure D-7. (t4bcex09.jpg)

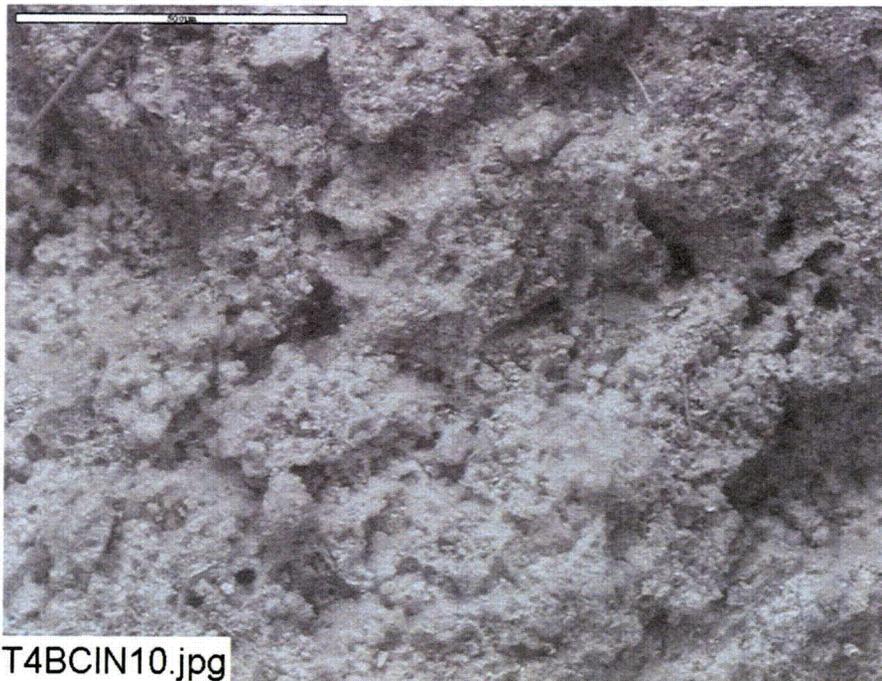
Figure D-10. ESEM image magnified 100 times for a Test #4, Day-30 low-flow interior baked cal-sil sample. (T4BCIN10.jpg)
