Appendix A

ESEM/EDS Data for Test #4, Day-5 Fiberglass in Low-Flow Zone

During ICET Test #4, work was continued for the purpose of identifying the origin and chemical composition of the products that were formed during the test. One objective of ICET is to identify the composition of debris on fiberglass and the particulate substances in the test solution. To address this question partially, low-flow fiberglass samples on Test #4, Day 5 were examined by ESEM/EDS, including both of the exterior and the interior location of the fiberglass samples.

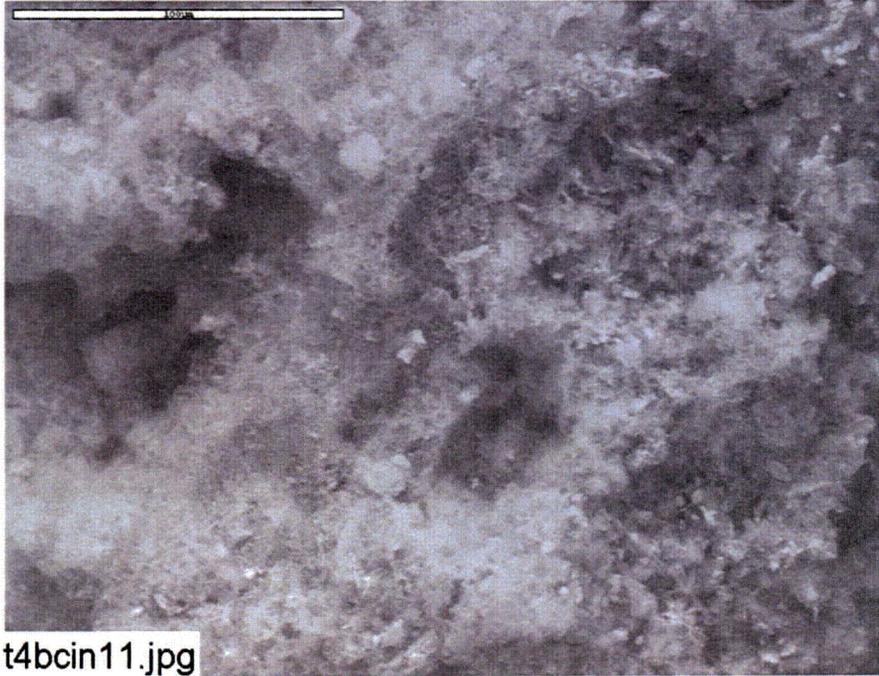
Figure D-11. ESEM image magnified 500 times for a Test #4, Day-30 low-flow interior baked cal-sil sample. (t4bcin11.jpg)

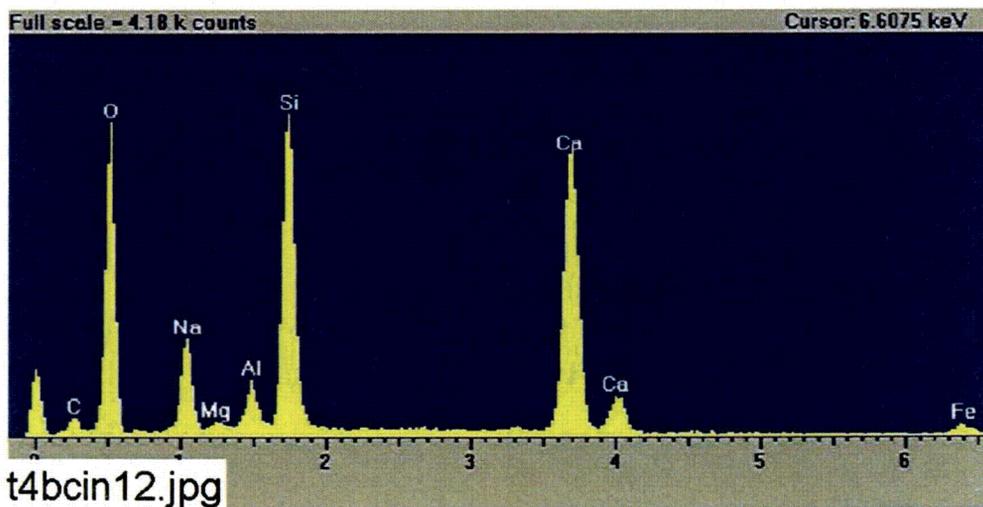
Figure D-12. EDS counting spectrum for the whole image shown in Figure D-11. (t4bcin12.jpg)

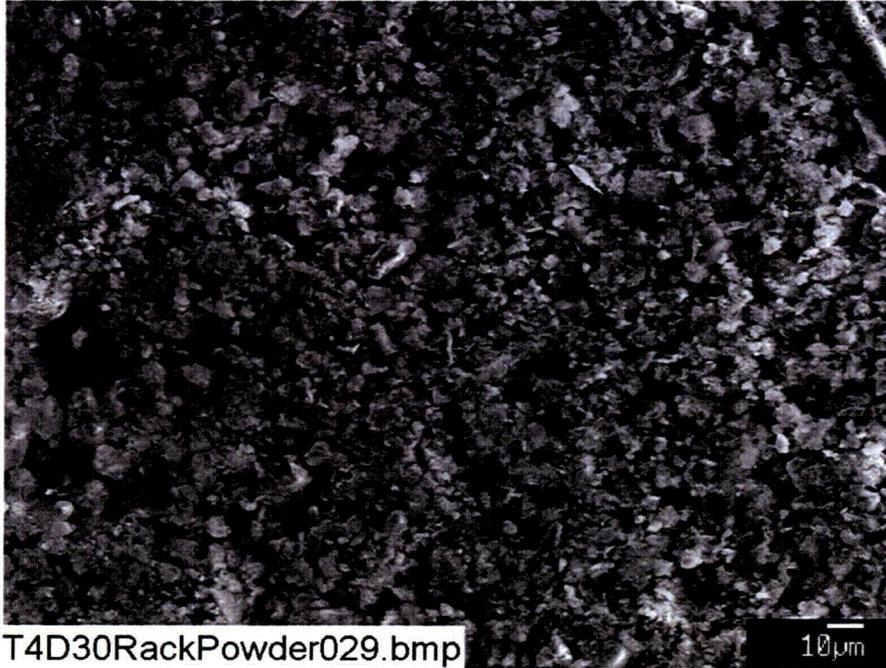
T4D30RackPowder029.bmp

Figure E-1. SEM image magnified 500 times for a Test #4, Day-30 fine powder on the submerged rack. (T4D30RackPowder029.bmp)

Image:	T4D30RackPowder029	500 ×	ESEM image	Figure E-1
	T4D30RackPowder030	1000 ×	ESEM at higher magnification	Figure E-2
EDS:	T4D30RackPowder018		EDS of whole of image 30	Figure E-3

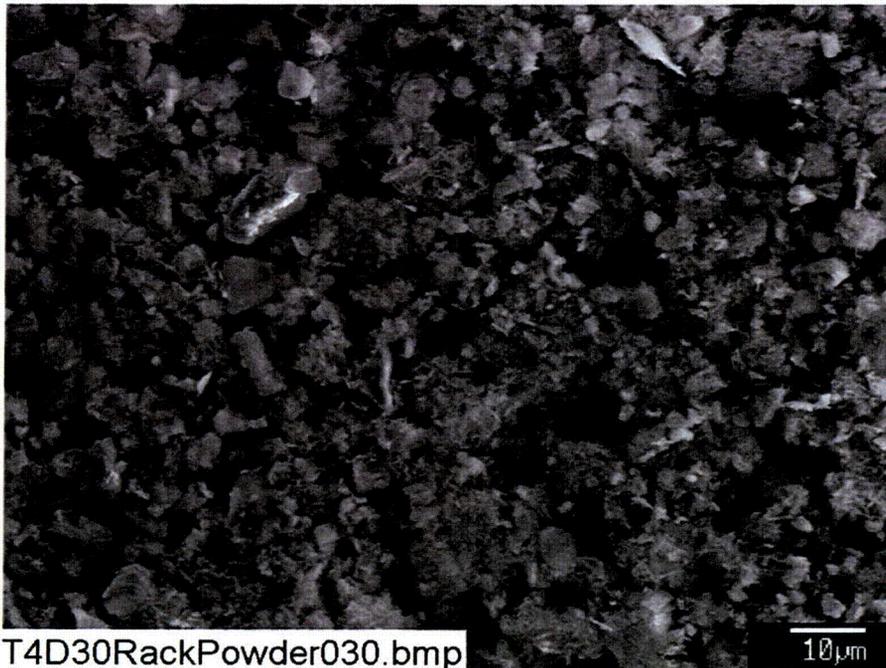
T4D30RackPowder030.bmp

Figure E-2. SEM image magnified 1000 times for a Test #4, Day-30 fine powder on the submerged rack. (T4D30RackPowder030.bmp)

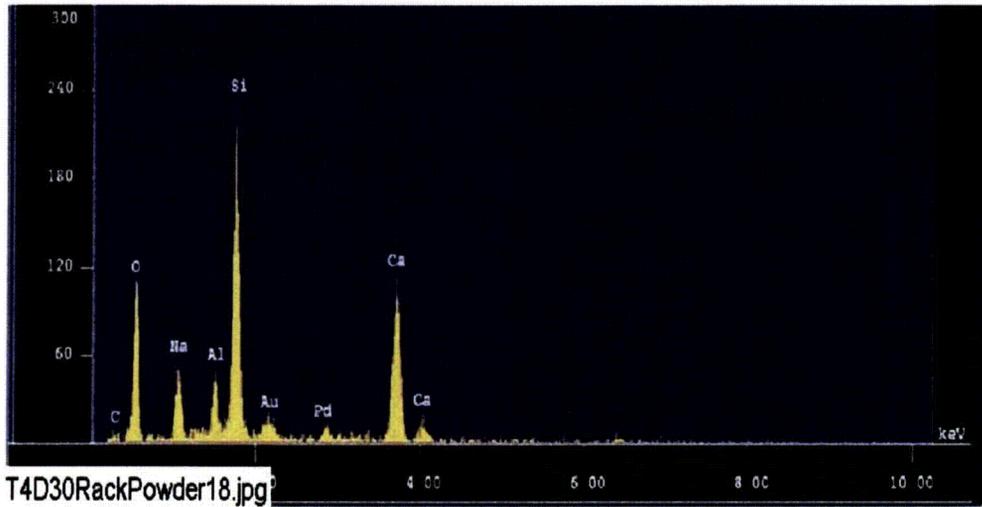
Figure E-3. EDS counting spectrum for the particles (whole image) shown in Figure E-2. (T4D30RackPowder18.jpg)

The results from the chemical composition analysis for T4D30RackPowder18.jpg are given in Table E-1.

Group : NRC
 Sample : T4D30 ID# : 18
 Comment : powder on submerged rack
 Condition : Full Scale : 20KeV(10eV/ch,2Kch)
 Live Time : 60.000 sec Aperture # : 2
 Acc. Volt : 15.0 KV Probe Current : 1.068E-09 A
 Stage Point : X=86.234 Y=59.512 Z=11.000
 Acq. Date : Wed Jun 29 15:53:49 2005
