Appendix A

ESEM/EDS Data for Test #4, Day-5 Fiberglass in Low-Flow Zone

During ICET Test #4, work was continued for the purpose of identifying the origin and chemical composition of the products that were formed during the test. One objective of ICET is to identify the composition of debris on fiberglass and the particulate substances in the test solution. To address this question partially, low-flow fiberglass samples on Test #4, Day 5 were examined by ESEM/EDS, including both of the exterior and the interior location of the fiberglass samples.

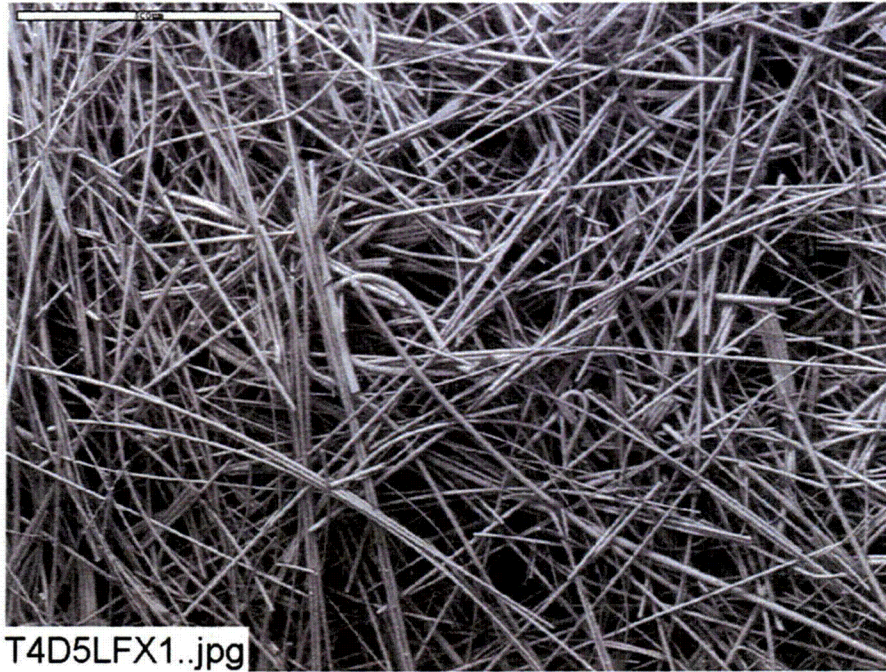
Figure A-1. Environmental SEM image magnified 80 times for a Test #4, Day-5 low-flow exterior fiberglass sample. (T4D5LFX1.jpg)

Image: T4D5LFX1	80 ×	ESEM image	Figure A-1
t4d5lfx4	80 ×	ESEM at higher magnification	Figure A-2
t4d5lfx2	500 ×		Figure A-3
t4d5lfx3	1000 ×		Figure A-4
t4d5lx11	1000 ×		Figure A-5
t4d5lx14	500 ×		Figure A-6
t4d5lx12	1000 ×		Figure A-7
EDS: t4d5lx13			Figure A-8

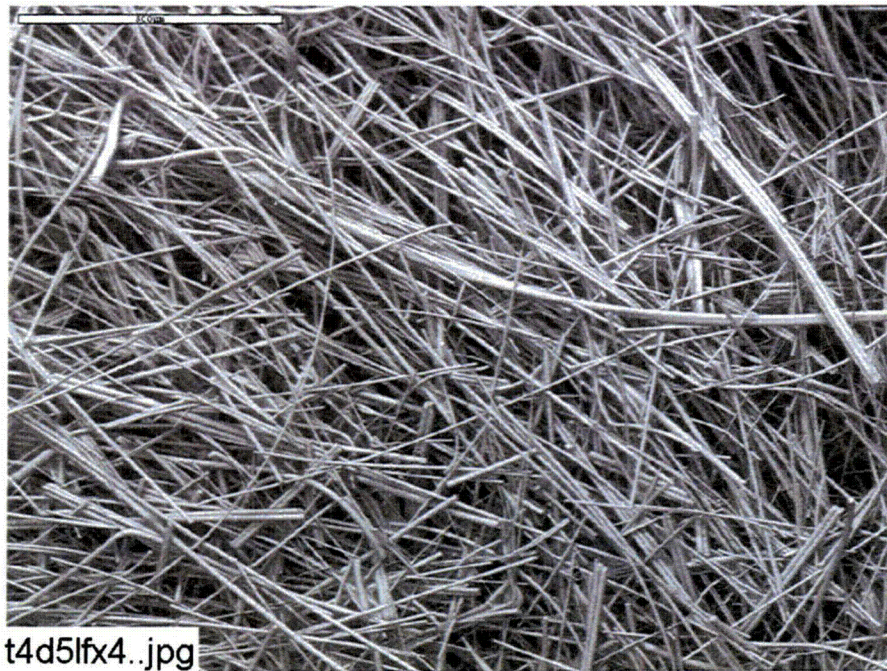
Figure A-2. Environmental SEM image magnified 80 times for a Test #4, Day-5 low-flow exterior fiberglass sample. (t4d5lfx4.jpg)

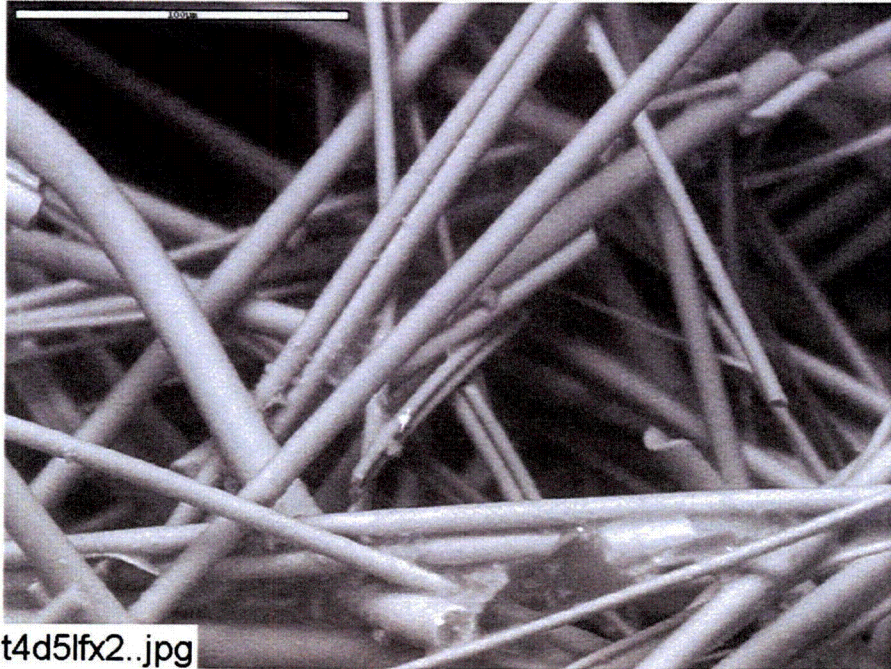
t4d5lfx2..jpg

Figure A-3. Environmental SEM image magnified 500 times for a Test #4, Day-5 low-flow exterior fiberglass sample. (t4d5lfx2.jpg)

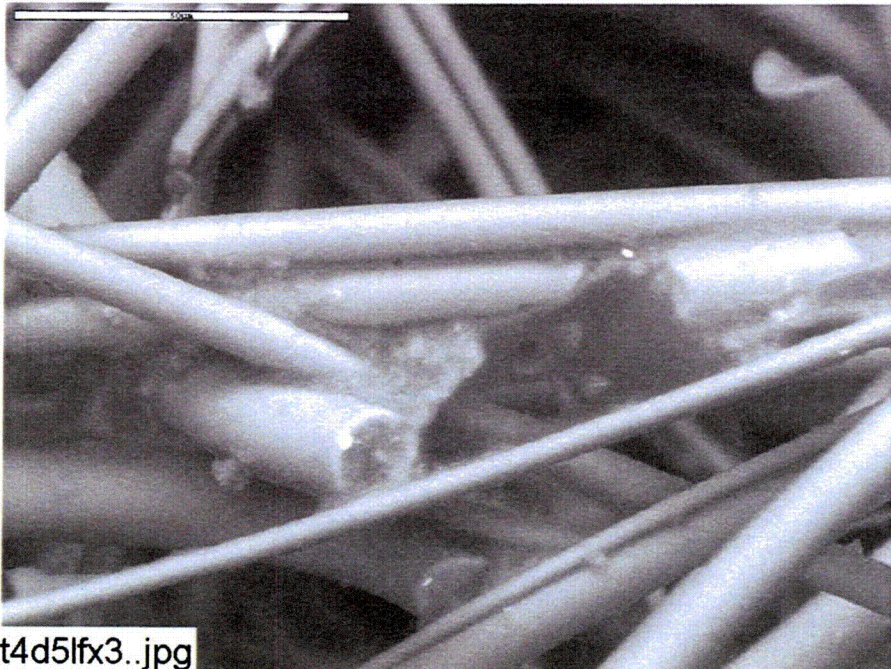
t4d5lfx3..jpg

Figure A-4. Environmental SEM image magnified 1000 times for a Test #4, Day-5 low-flow exterior fiberglass sample. (t4d5lfx3.jpg)

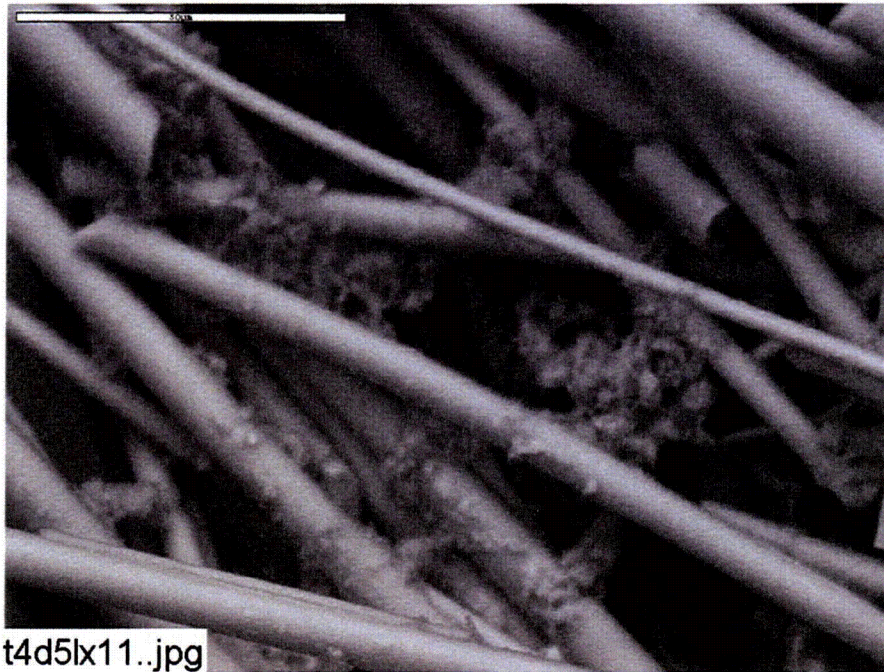
t4d5lx11..jpg

Figure A-5. Environmental SEM image magnified 1000 times for a Test #4, Day-5 low-flow exterior fiberglass sample. (t4d5lx11.jpg)

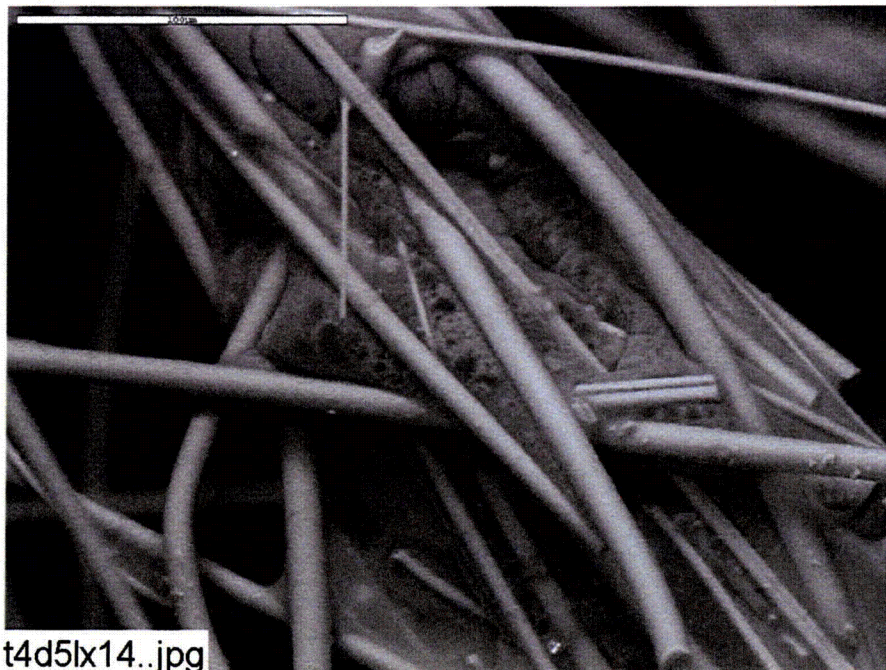
t4d5lx14..jpg

Figure A-6. Environmental SEM image magnified 500 times for a Test #4, Day-5 low-flow exterior fiberglass sample. (t4d5lx14.jpg)

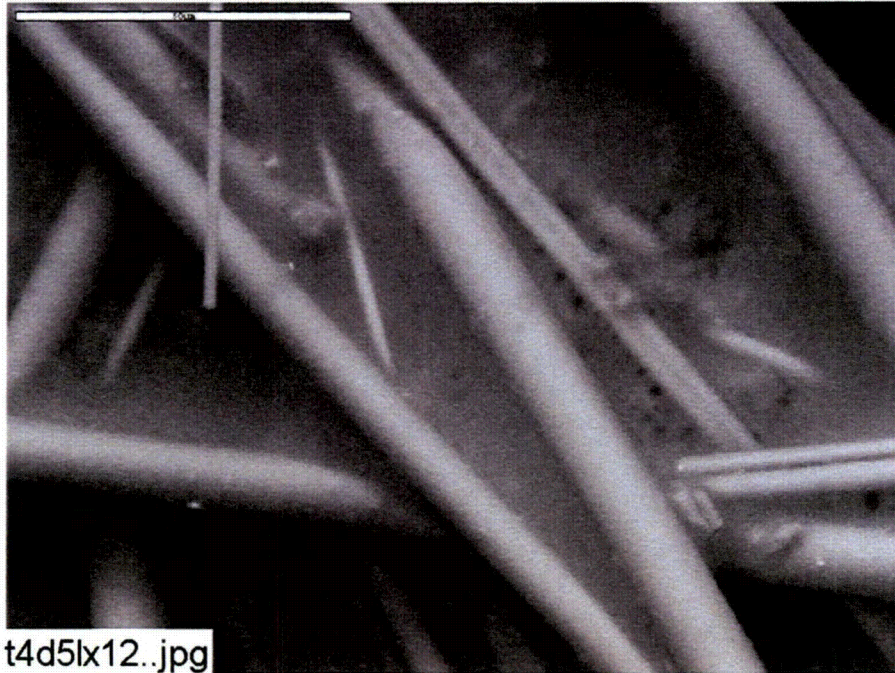
Figure A-7. Environmental SEM image magnified 1000 times for a Test #4, Day-5 low-flow exterior fiberglass sample. (t4d5lx12.jpg)

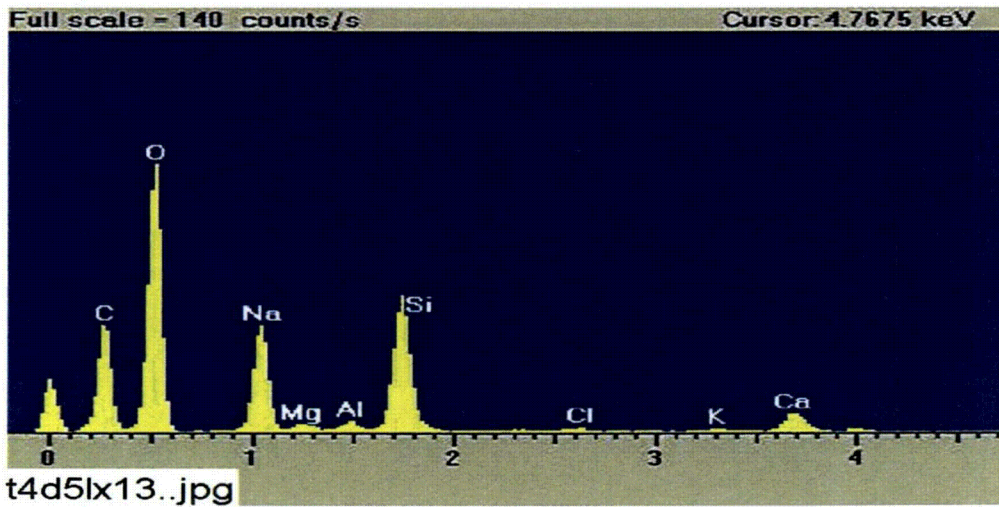
Figure A-8. EDS counting spectrum for the film between the fibers shown in Figure A-7. (t4d5lx13.jpg)

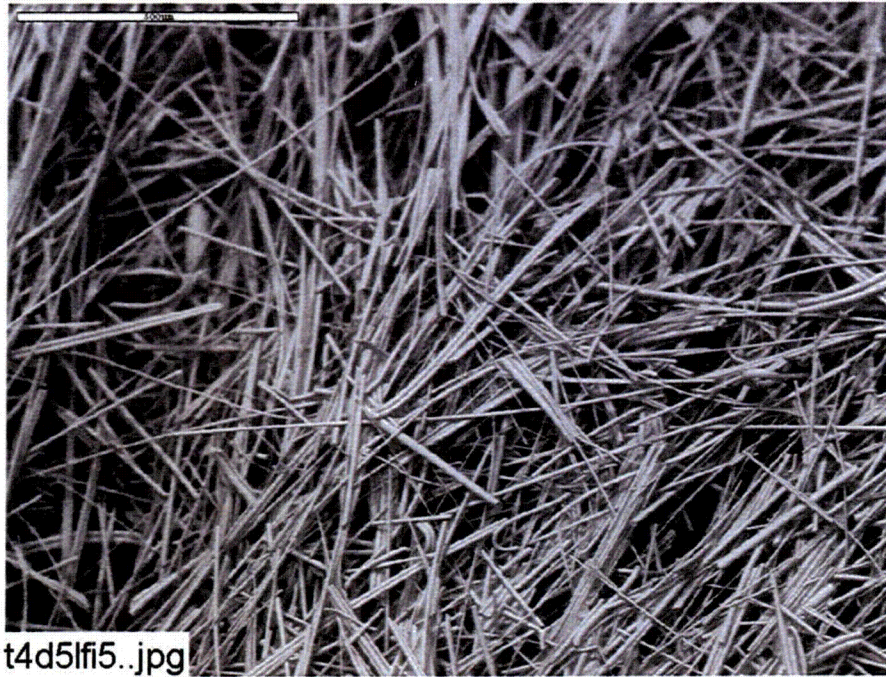
Figure A-9. Environmental SEM image magnified 80 times for a Test #4, Day-5 low-flow interior fiberglass sample. (t4d5lf5.jpg)

Image: t4d5lfi5	80 ×	ESEM image	Figure A-9
t4d5lfi6	500 ×	ESEM at higher magnification	Figure A-10
t4d5lfi7	500 ×		Figure A-11
t4d5lfi8	2000 ×		Figure A-12
t4d5lfi9	1000 ×		Figure A-13
t4d5li10	1000 ×		Figure A-14
t4d5li15	500 ×		Figure A-15

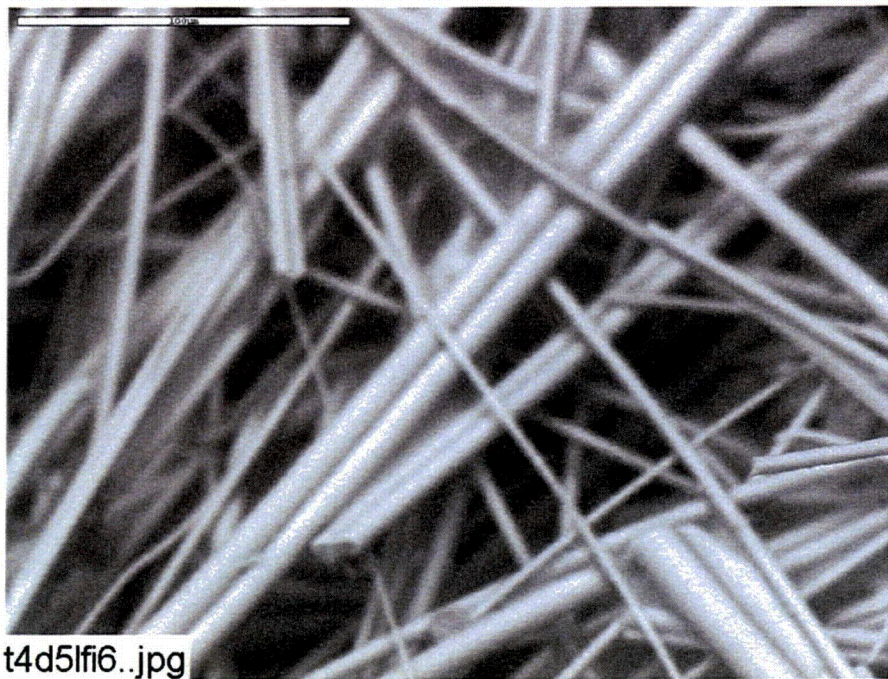
Figure A-10. Environmental SEM image magnified 500 times for a Test #4, Day-5 low-flow interior fiberglass sample. (t4d5lf6.jpg)

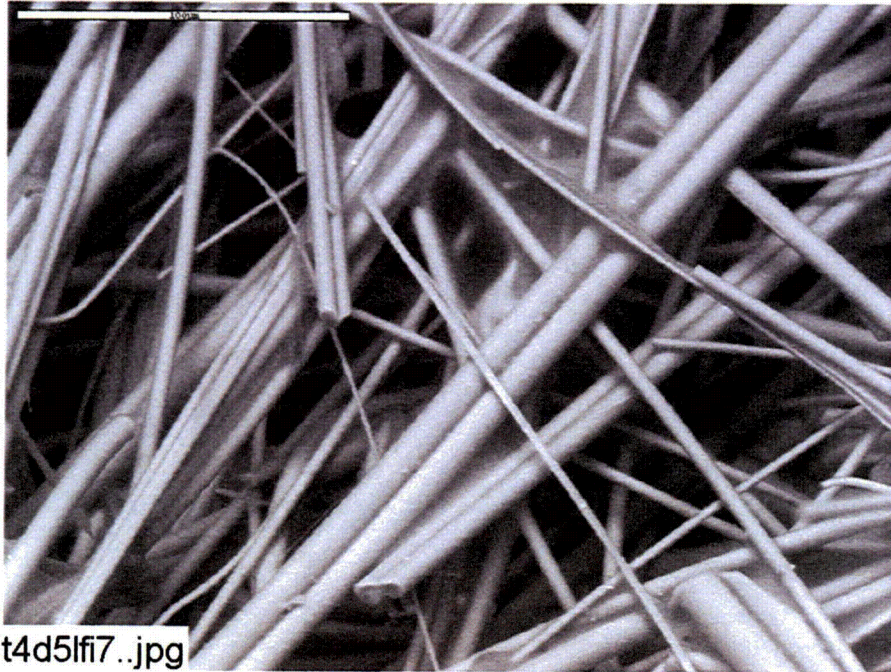
t4d5lf17..jpg

Figure A-11. Environmental SEM image magnified 500 times for a Test #4, Day-5 low-flow interior fiberglass sample. (t4d5lf17.jpg)

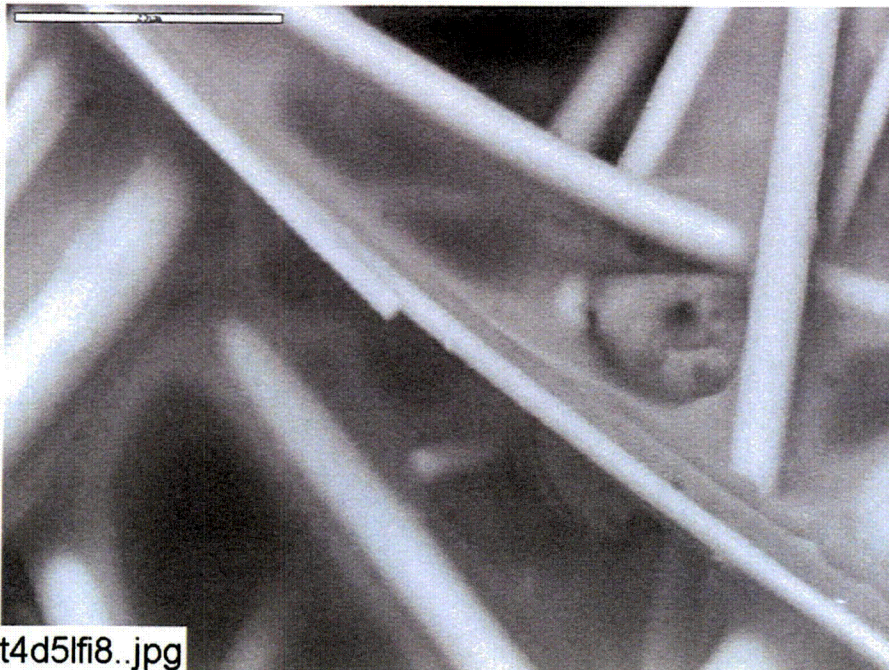
t4d5lf18..jpg

Figure A-12. Environmental SEM image magnified 2000 times for a Test #4, Day-5 low-flow interior fiberglass sample. (t4d5lf18.jpg)

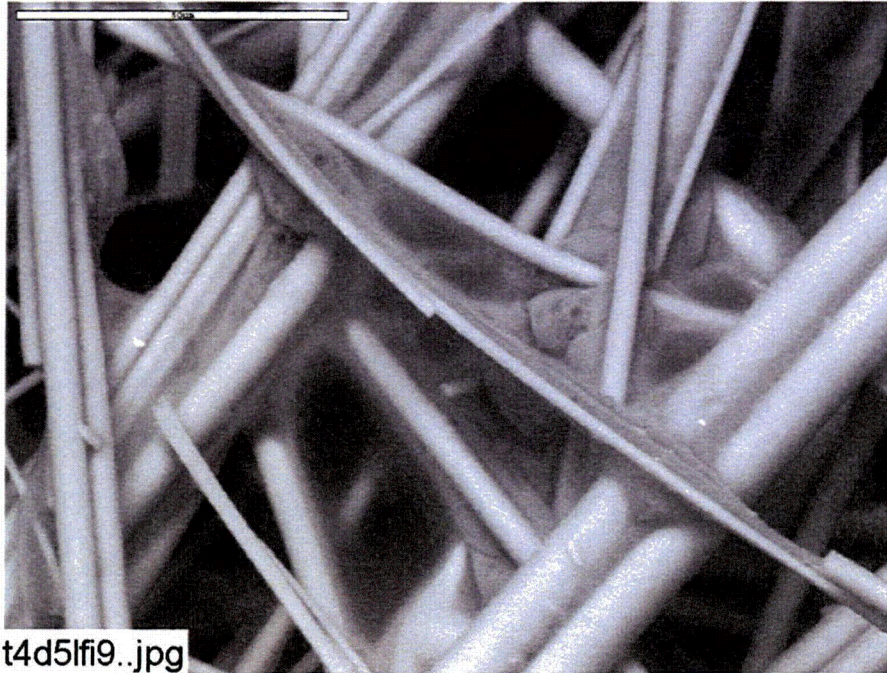
Figure A-13. Environmental SEM image magnified 1000 times for a Test #4, Day-5 low-flow interior fiberglass sample. (t4d5lf9.jpg)

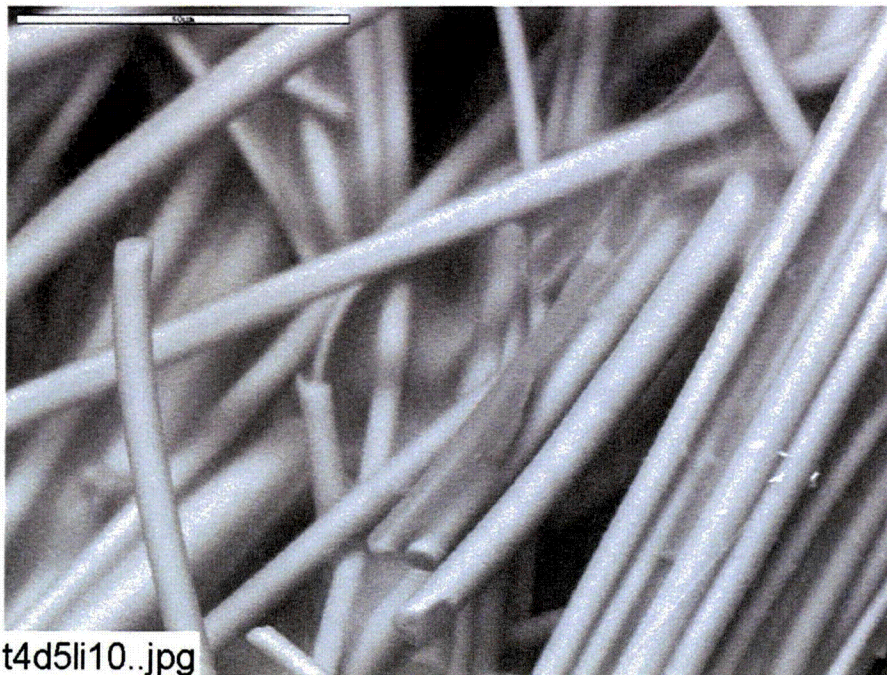
Figure A-14. Environmental SEM image magnified 1000 times for a Test #4, Day-5 low-flow interior fiberglass sample. (t4d5li10.jpg)

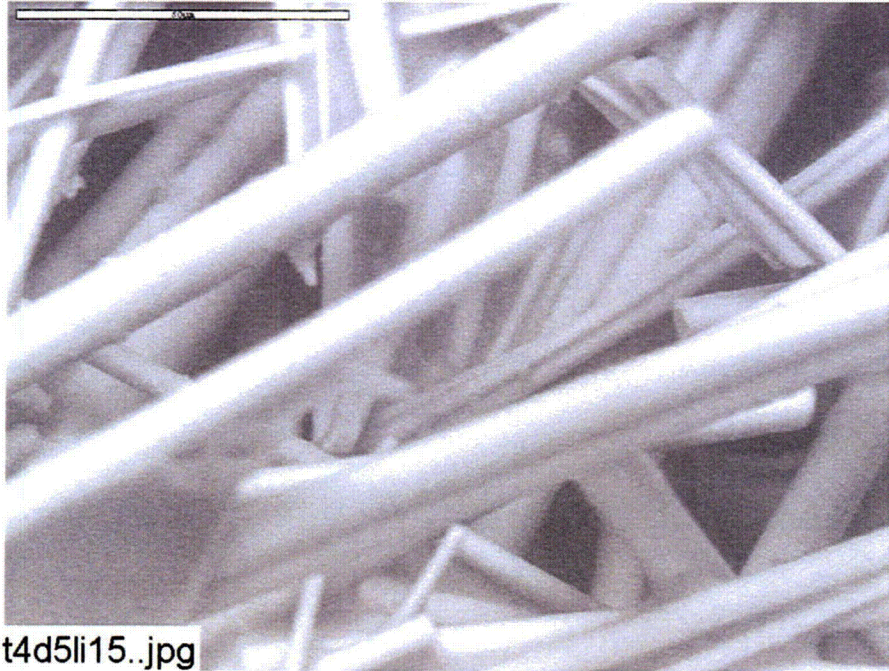
t4d5li15..jpg

Figure A-15. Environmental SEM image magnified 500 times for a Test #4, Day-5 low-flow interior fiberglass sample. (t4d5li15)

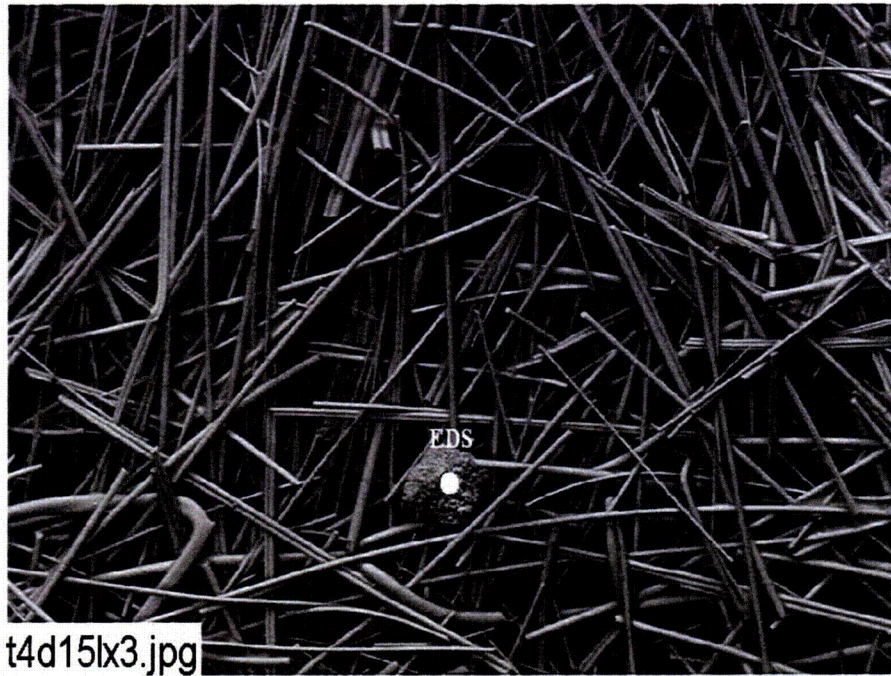
Figure B1-1. Annotated environmental SEM image magnified 100 times for a Test #4, Day-15 exterior low-flow fiberglass sample. (t4d15lx3.jpg)

Image: t4d15lx3	100 ×	ESEM annotated image	Figure B1-1
EDS: t4d15lx2		EDS image on particles in t4d15lx3	Figure B1-2
Image: t4d15lx4	500 ×	ESEM image of fiberglass	Figure B1-3
t4d15lx5	1000 ×	ESEM image at higher magnification	Figure B1-4

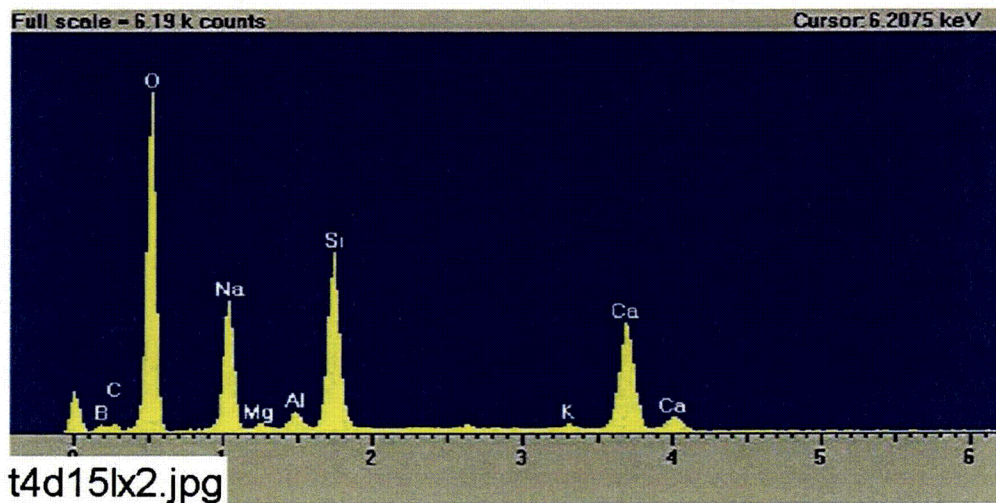
Figure B1-2. EDS counting spectrum for the particulate deposit on fiberglass shown in Figure B1-1. (t4d15lx2.jpg)

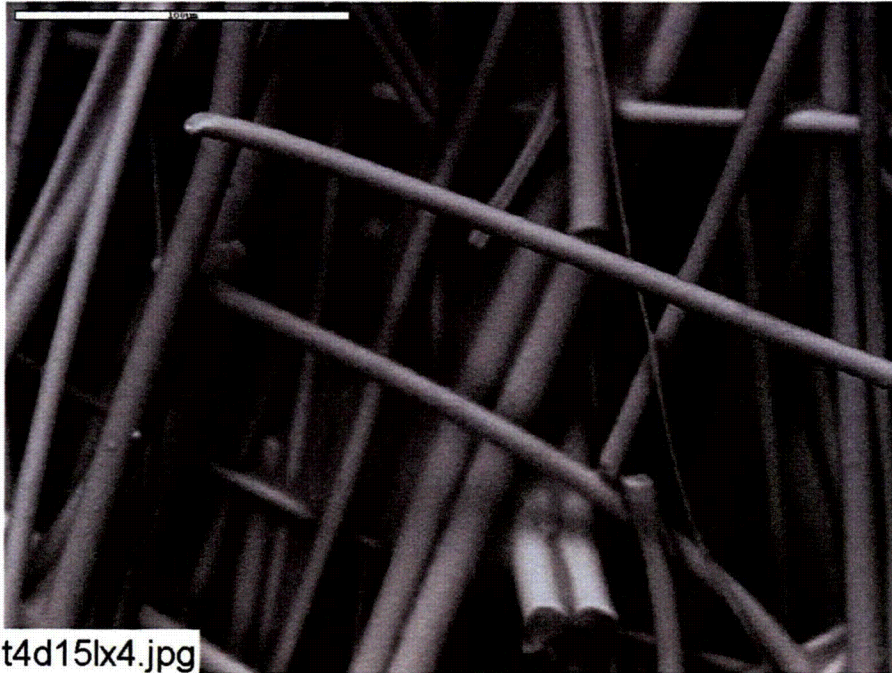
t4d15lx4.jpg

Figure B1-3. Environmental SEM image magnified 500 times for a Test #4, Day-15 exterior low-flow fiberglass sample. (t4d15lx4.jpg)

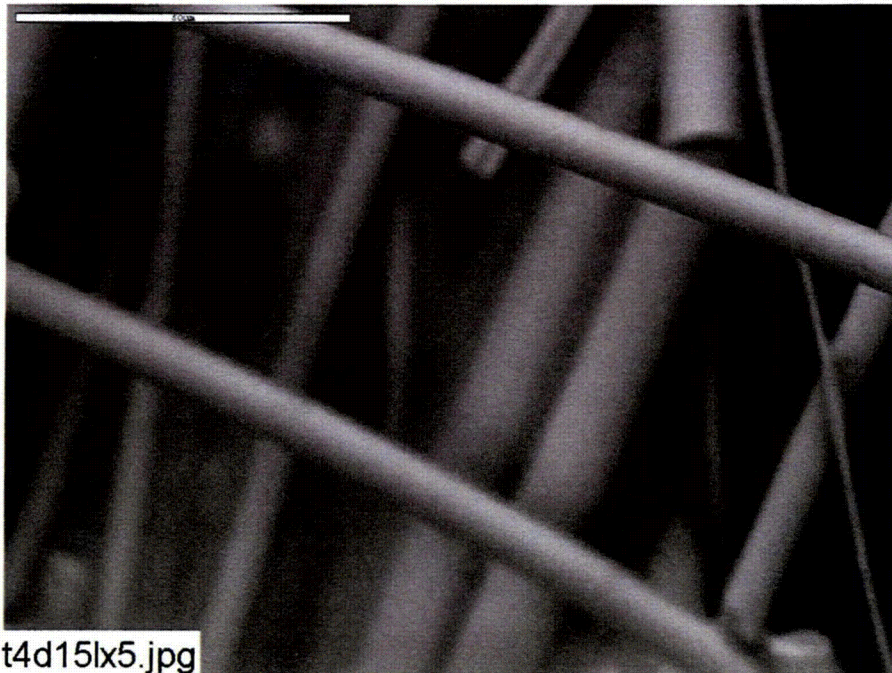
t4d15lx5.jpg

Figure B1-4. Environmental SEM image magnified 1000 times for a Test #4, Day-15 exterior low-flow fiberglass sample. (t4d15lx5.jpg)

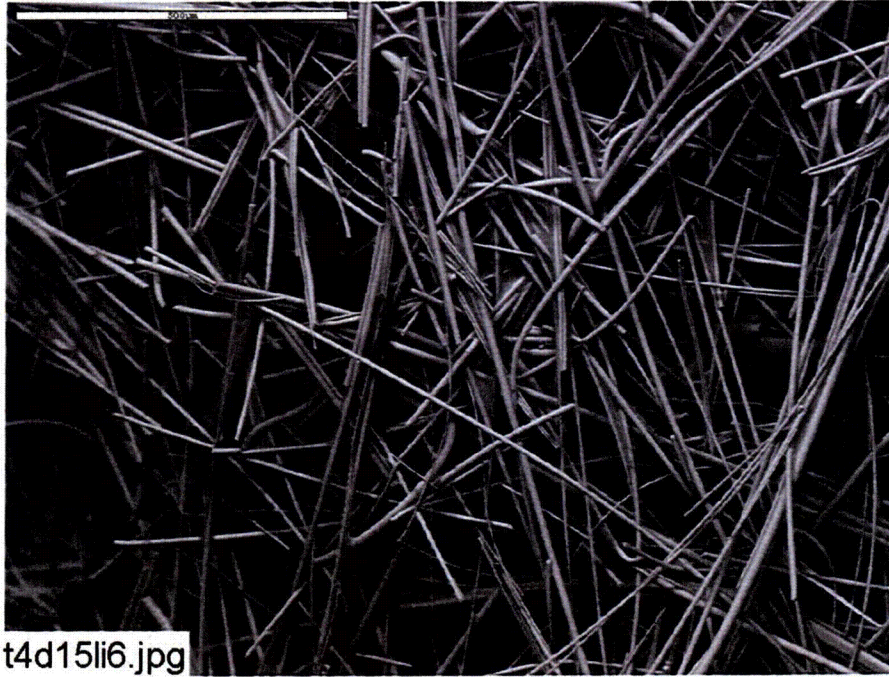
Figure B1-5. Environmental SEM image magnified 100 times for a Test #4, Day-15 interior low-flow fiberglass sample. (t4d15li6.jpg)

Image: t4d15li6	100 ×	ESEM image of fiberglass	Figure B1-5
t4d15li7	500 ×	ESEM image of fiberglass	Figure B1-6
t4d15li8	1000 ×	ESEM image at higher magnification	Figure B1-7

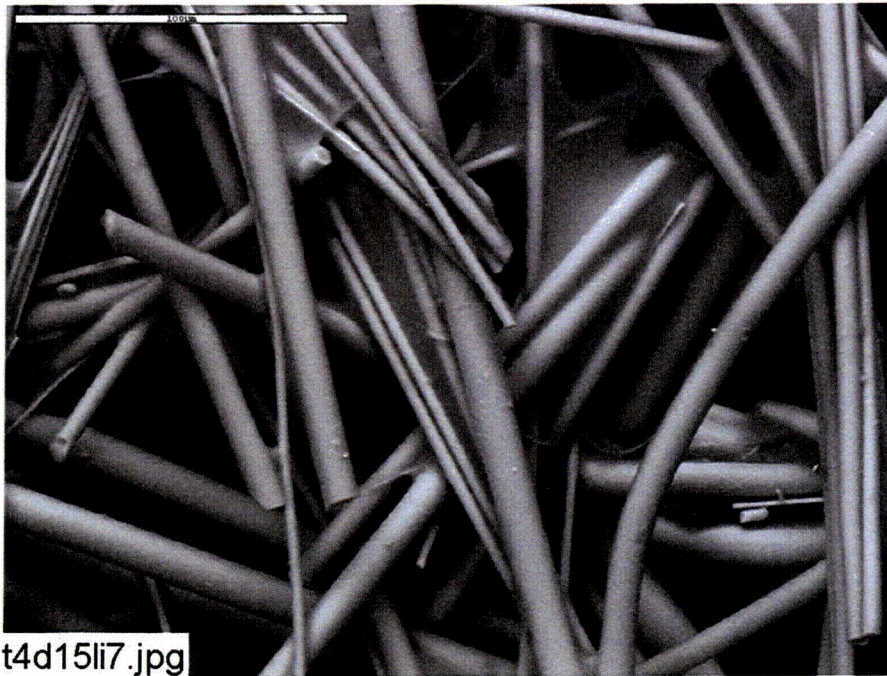
Figure B1-6. Environmental SEM image magnified 500 times for a Test #4, Day-15 interior low-flow fiberglass sample. (t4d15li7.jpg)

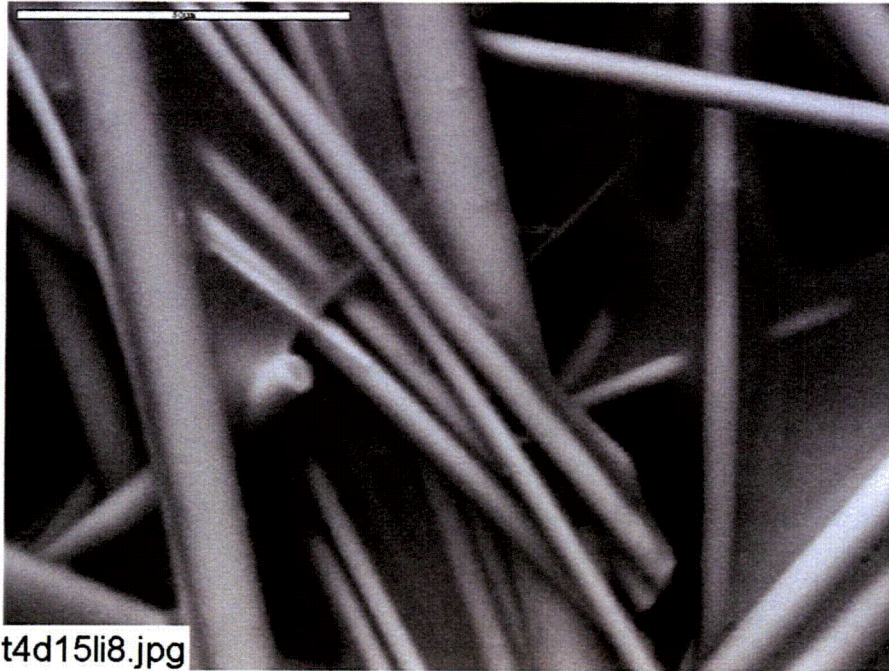
t4d15li8.jpg

Figure B1-7. Environmental SEM image magnified 1000 times for a Test #4, Day-15 interior low-flow fiberglass sample. (t4d15li8.jpg)

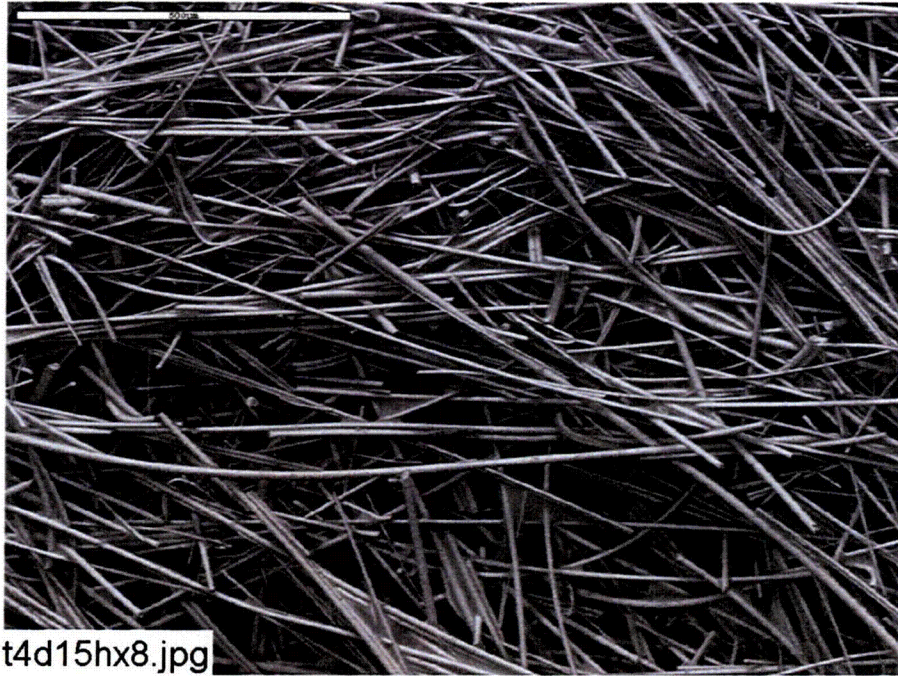
Figure B2-1. Environmental SEM image magnified 100 times for a Test #4, Day-15 exterior high-flow fiberglass sample. (t4d15hx8.jpg)

Image: t4d15hx8	100 ×	ESEM image	Figure B2-1
t4d15hx9	400 ×		Figure B2-2
t4d15hx7	750 ×	ESEM Annotated Image	Figure B2-3
EDS: t4d15hx6		EDS on web material for t4d15hx7	Figure B2-4

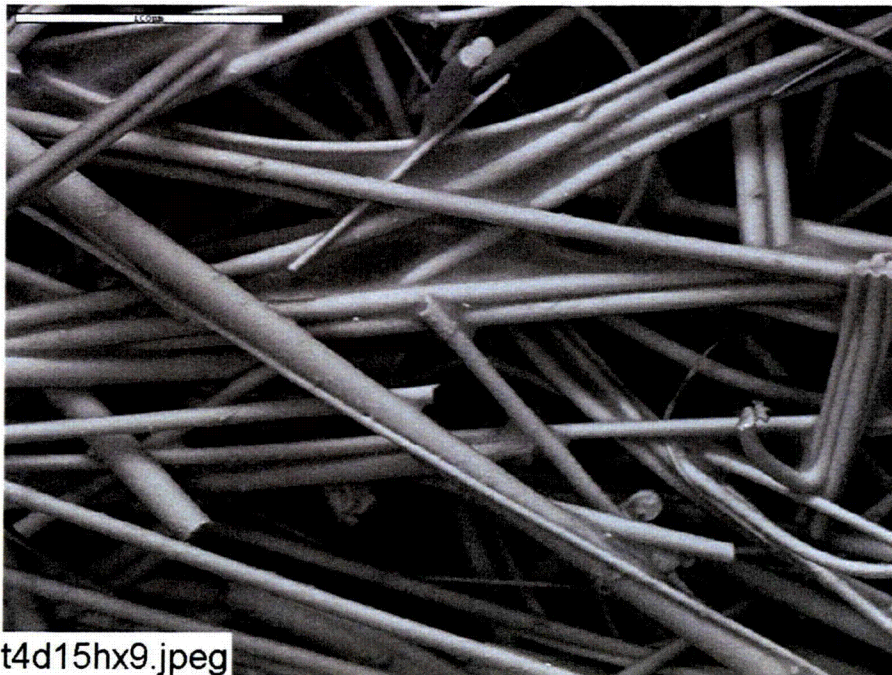
Figure B2-2. Environmental SEM image magnified 400 times for a Test #4, Day-15 exterior high-flow fiberglass sample. (t4d15hx9.jpeg)

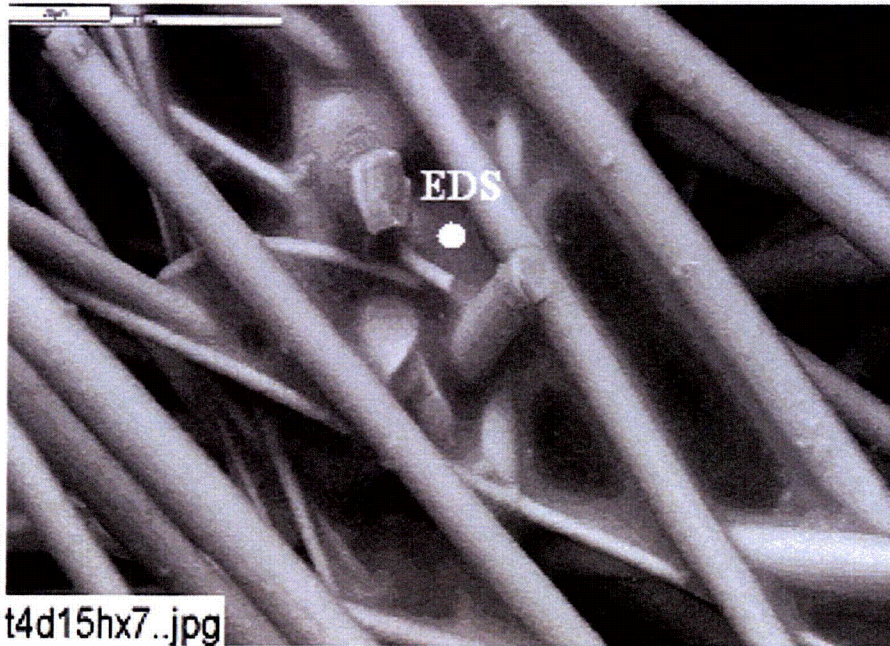
Figure B2-3. Annotated environmental SEM image magnified 750 times for a Test #4, Day-15 exterior high-flow fiberglass sample. The white spot shows the area for EDS analysis. (t4d15hx7.jpg)

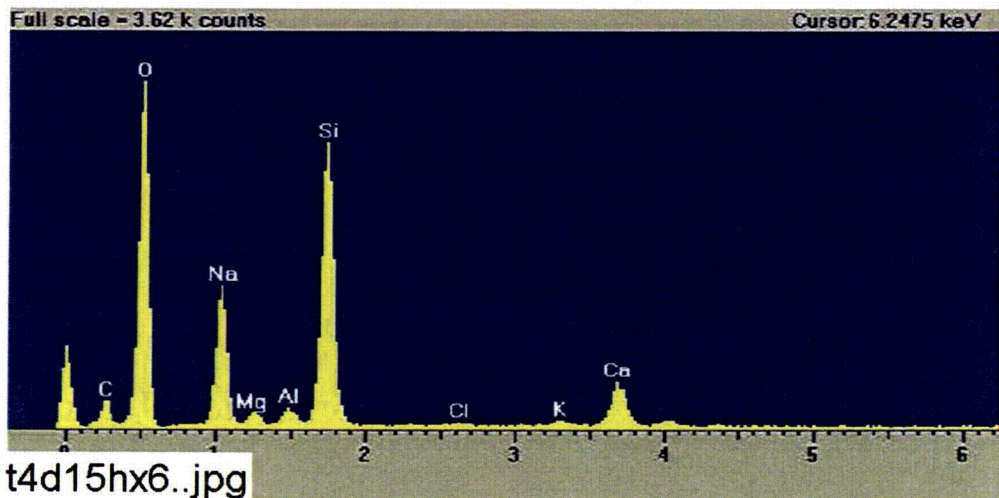
Figure B2-4. EDS counting spectrum for the spot of the film between the fibers shown in Figure B2-3. (t4d15hx6.jpg)

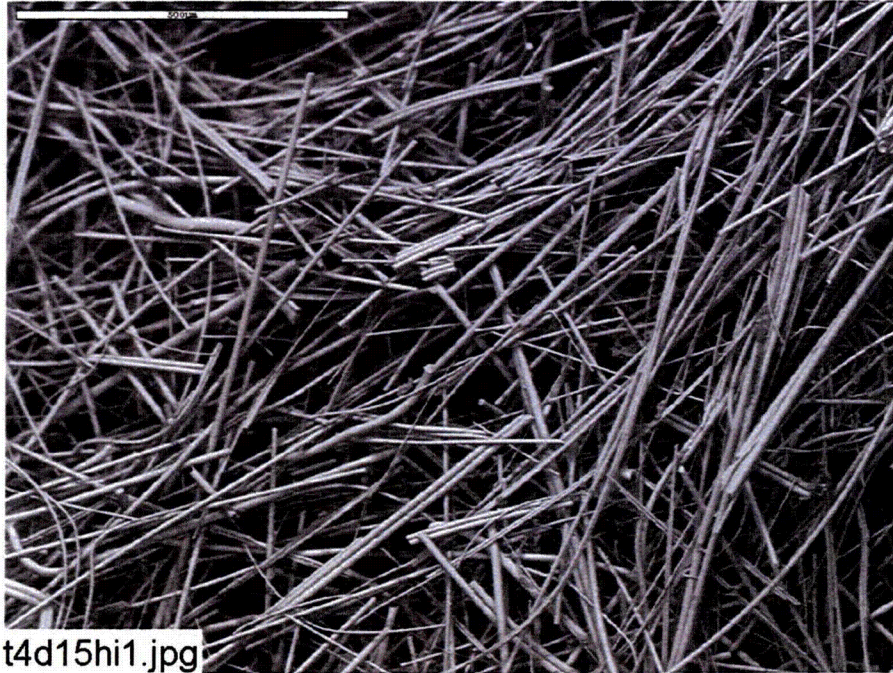
Figure B2-5. Environmental SEM image magnified 100 times for a Test #4, Day-15 interior high-flow fiberglass sample. (t4d15hi1.jpg)

Image: t4d15hi1	100 ×	ESEM image	Figure B2-5
t4d15hi3	100 ×		Figure B2-6
t4d15hi2	800 ×		Figure B2-7

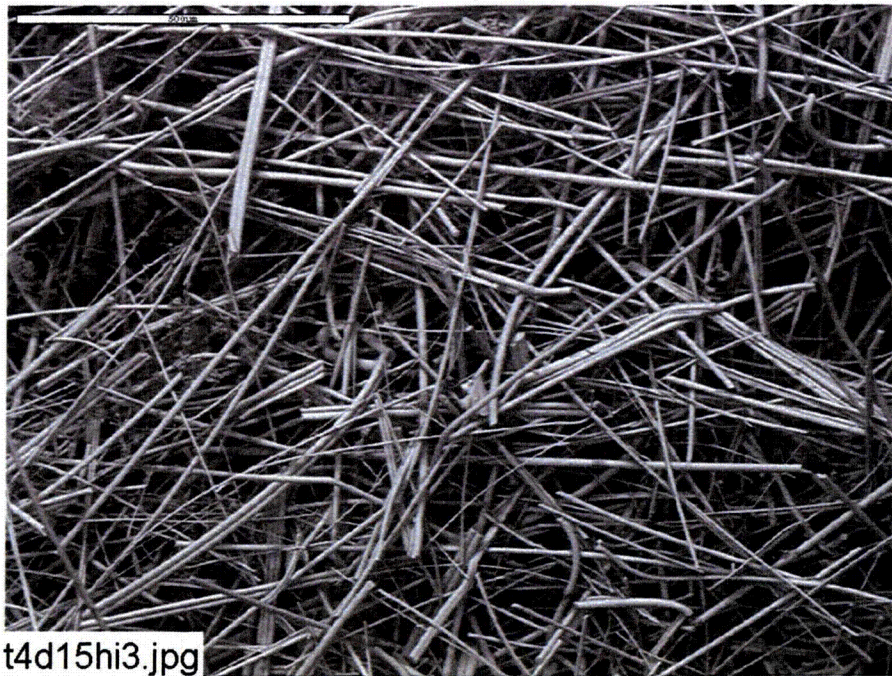
Figure B2-6. Environmental SEM image magnified 100 times for a Test #4, Day-15 interior high-flow fiberglass sample. (t4d15hi3.jpg)

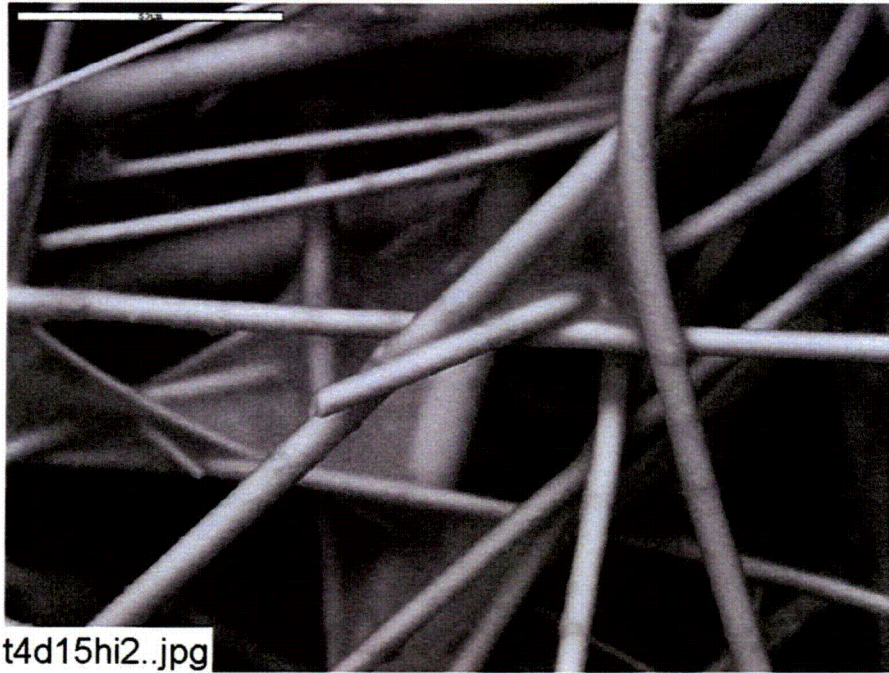
Figure B2-7. Environmental SEM image magnified 800 times for a Test #4, Day-15 interior high-flow fiberglass sample. (t4d15hi2.jpg)

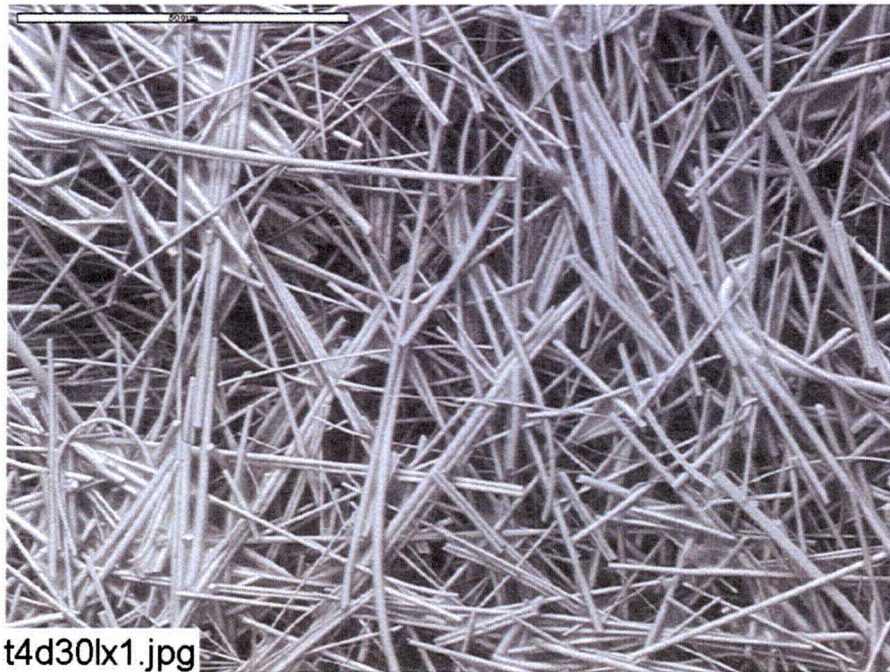
Figure C1-1. Environmental SEM image magnified 100 times for a Test #4, Day-30 exterior low-flow fiberglass sample. (t4d30lx1.jpg)

Image: t4d30lx1	100 ×	ESEM image	Figure C1-1
t4d30lx2	500 ×	ESEM image higher magnification	Figure C1-2
t4d30lx5	1000 ×	ESEM annotated image	Figure C1-3
EDS: t4d30lx4		Spot of coating substance for t4d30lx5	Figure C1-4

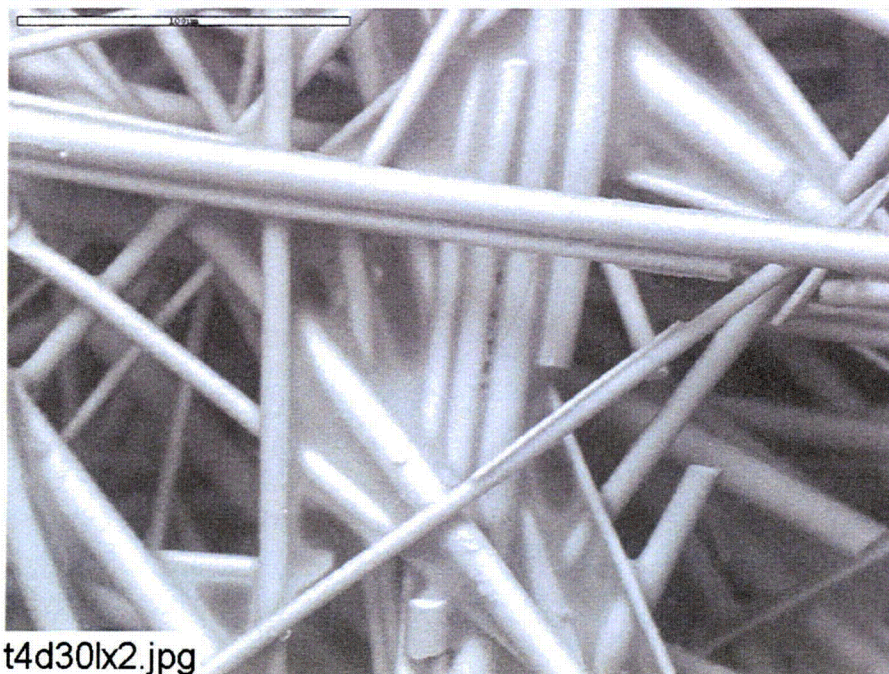
Figure C1-2. Environmental SEM image magnified 500 times for a Test #4, Day-30 exterior low-flow fiberglass sample. (t4d30lx2.jpg)

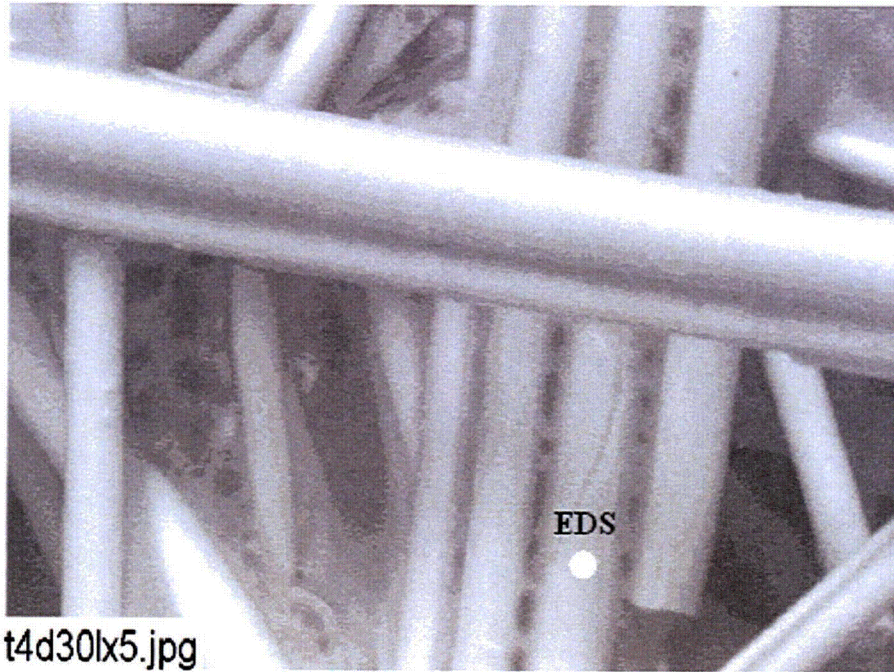
Figure C1-3. Annotated environmental SEM image magnified 1000 times for a Test #4, Day-30 exterior low-flow fiberglass sample. (t4d30lx5.jpg)

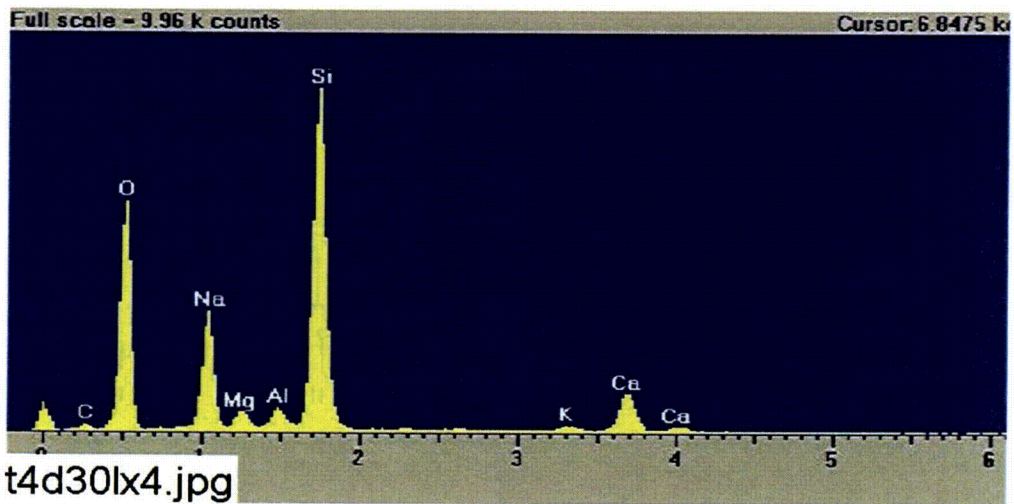
Figure C1-4. EDS counting spectrum for the spot of coating substance on fiberglass shown in Figure C1-3. (t4d30lx4.jpg)

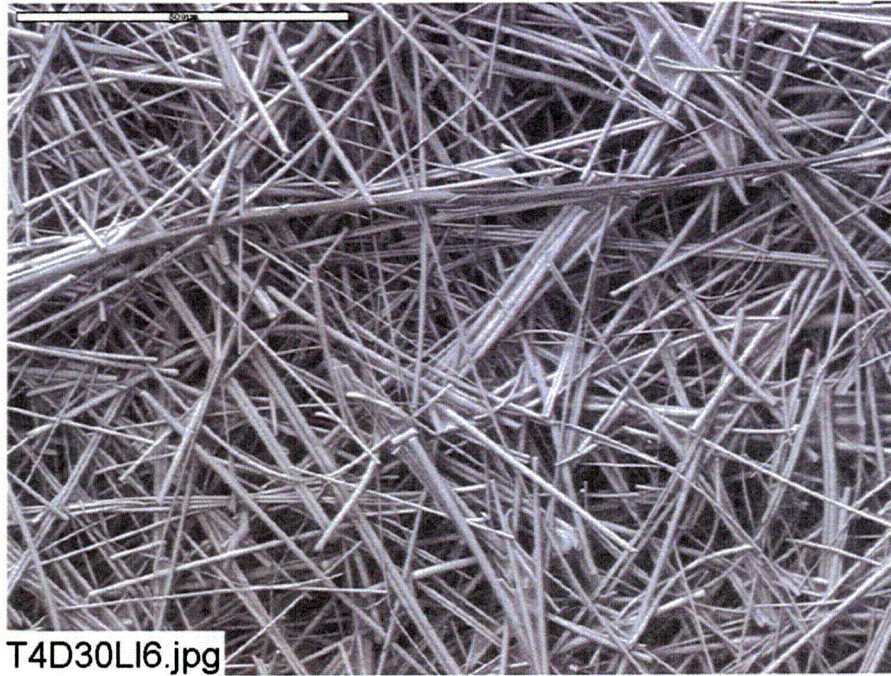
Figure C1-5. Environmental SEM image magnified 100 times for a Test #4, Day-30 interior low-flow fiberglass sample. (T4D30LI6.jpg)

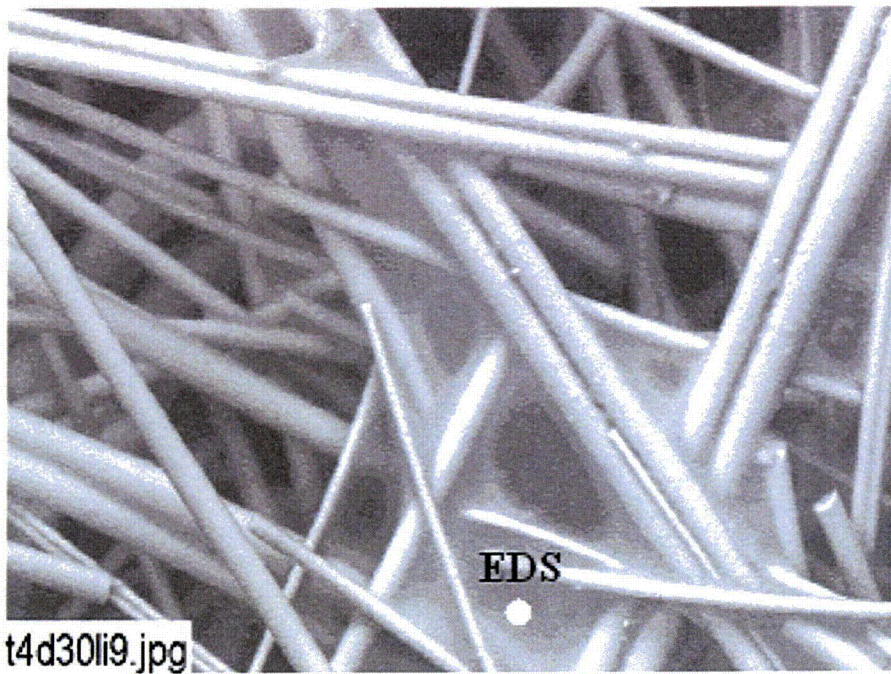
Figure C1-6. Annotated environmental SEM image magnified 500 times for a Test #4, Day-30 interior low-flow fiberglass sample. EDS spot is shown in the picture (t4d30li9.jpg)

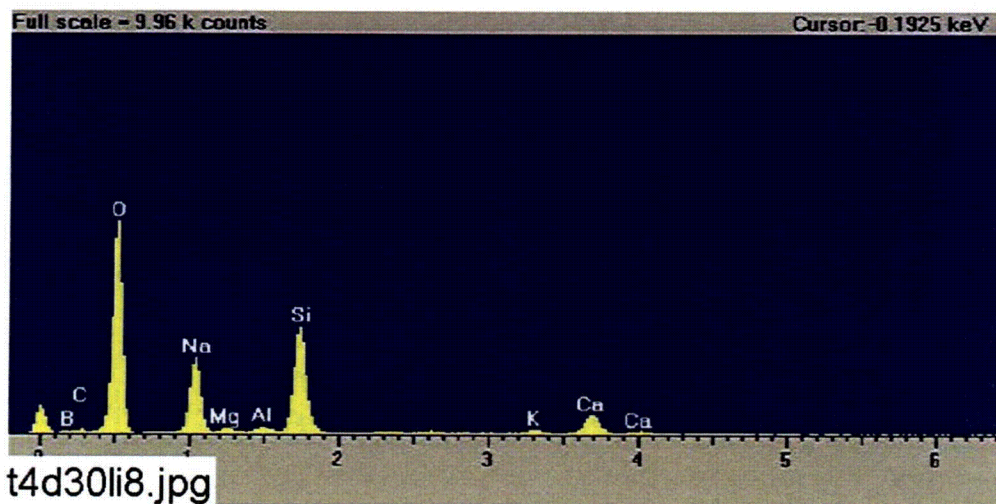
Figure C1-7. EDS counting spectrum for the film between fibers shown in Figure C1-6. (t4d30li8.jpg)
