Appendix A

ESEM/EDS Data for Test #4, Day-5 Fiberglass in Low-Flow Zone

During ICET Test #4, work was continued for the purpose of identifying the origin and chemical composition of the products that were formed during the test. One objective of ICET is to identify the composition of debris on fiberglass and the particulate substances in the test solution. To address this question partially, low-flow fiberglass samples on Test #4, Day 5 were examined by ESEM/EDS, including both of the exterior and the interior location of the fiberglass samples.

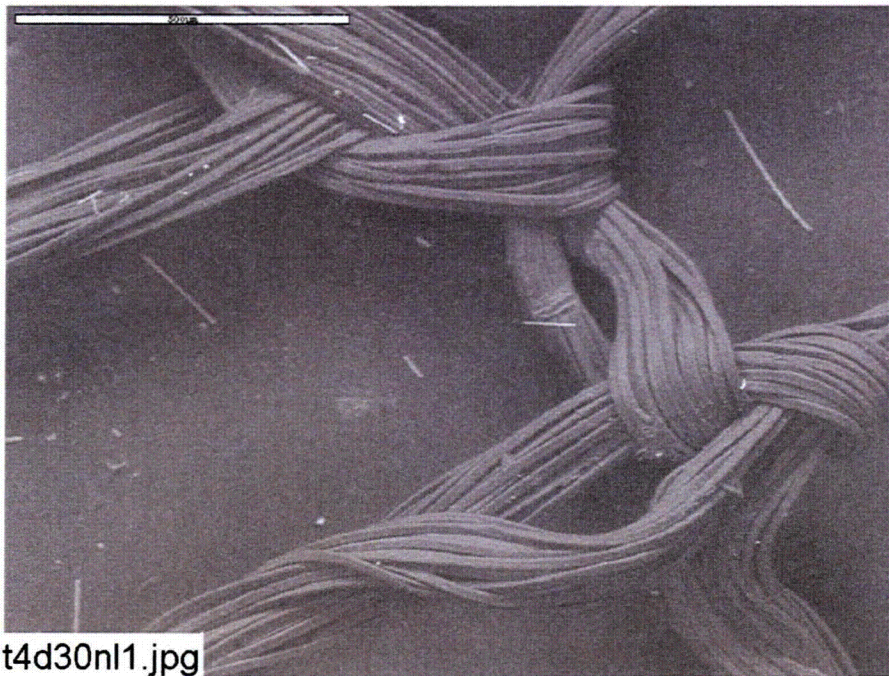
t4d30nl1.jpg

Figure C2-1. Environmental SEM image magnified 100 times for a Test #4, Day-30 nylon mesh submerged in low-flow area (inserted on Day 4). (t4d30nl1.jpg)

Image: t4d30n11	100 ×	ESEM image	Figure C2-1
t4d30n14	500 ×	ESEM annotated image	Figure C2-2
EDS: t4d30n13		EDS on spot on mesh, t4d30n14	Figure C2-3
Image: t4d30n15	1000 ×	ESEM high magnification	Figure C2-4

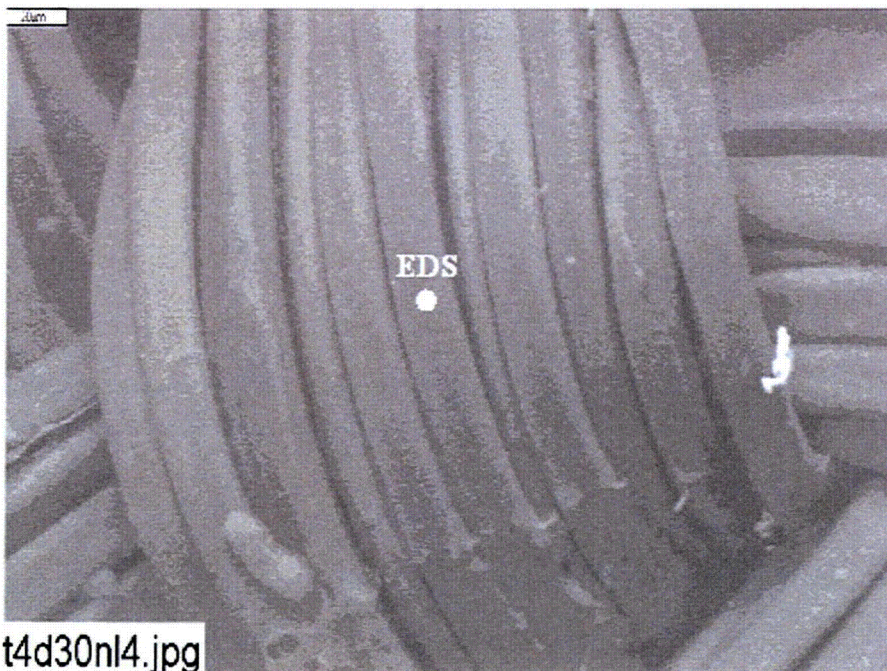
t4d30nl4.jpg

Figure C2-2. Annotated environmental SEM image magnified 500 times for a Test #4, Day-30 nylon mesh submerged in low-flow area (inserted on Day 4). The EDS spot is shown in the picture. (t4d30nl4.jpg)

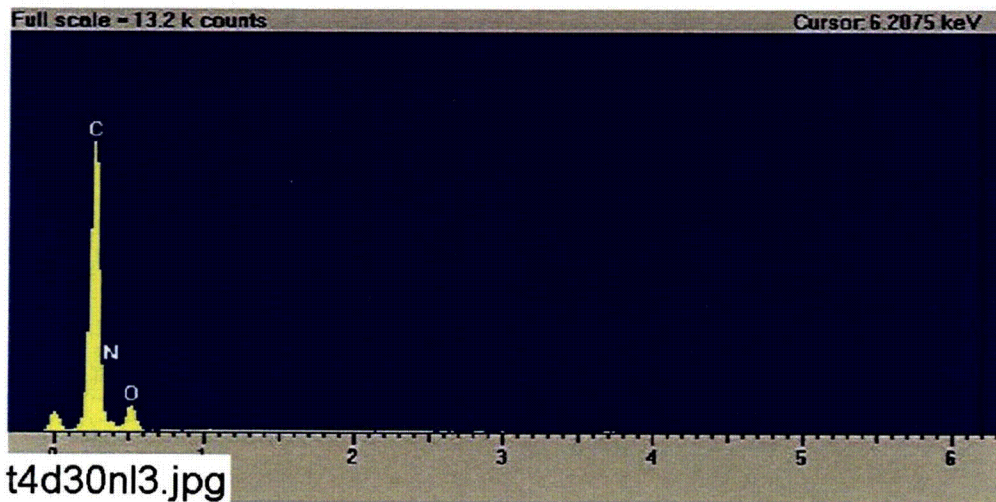
Figure C2-3. EDS counting spectrum for the spot of nylon mesh shown in Figure C2-2. (t4d30nl3.jpg)

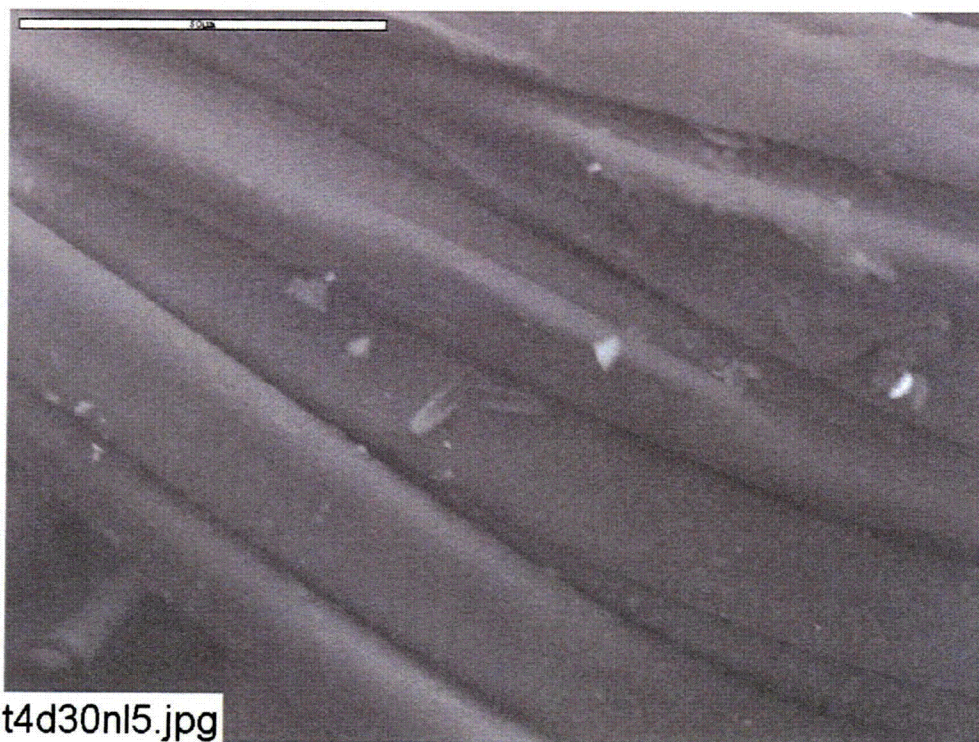
Figure C2-4. Environmental SEM image magnified 1000 times for a Test #4, Day-30 nylon mesh submerged in low-flow area (inserted on Day 4). (t4d30nl5.jpg)

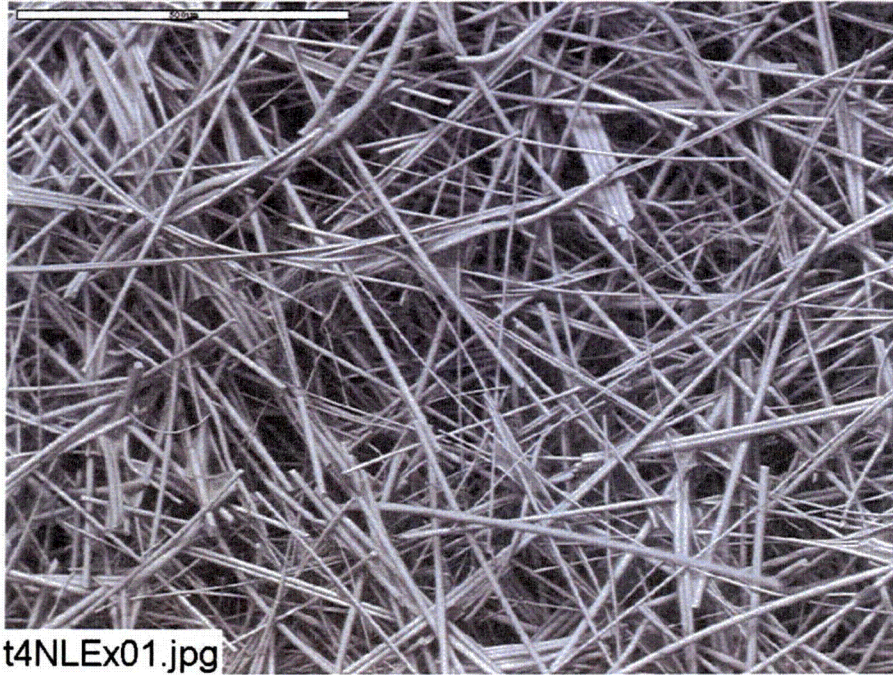
Figure C2-5. Environmental SEM image magnified 100 times for a Test #4, Day-30 exterior low-flow fiberglass sample contained in a nylon mesh (inserted on Day 4). (t4NLEx01.jpg)

Image: t4NLEx01	100 ×	ESEM image	Figure C2-5
t4nlex03	100 ×	ESEM image higher magnification	Figure C2-6
t4nlex02	500 ×	ESEM image	Figure C2-7

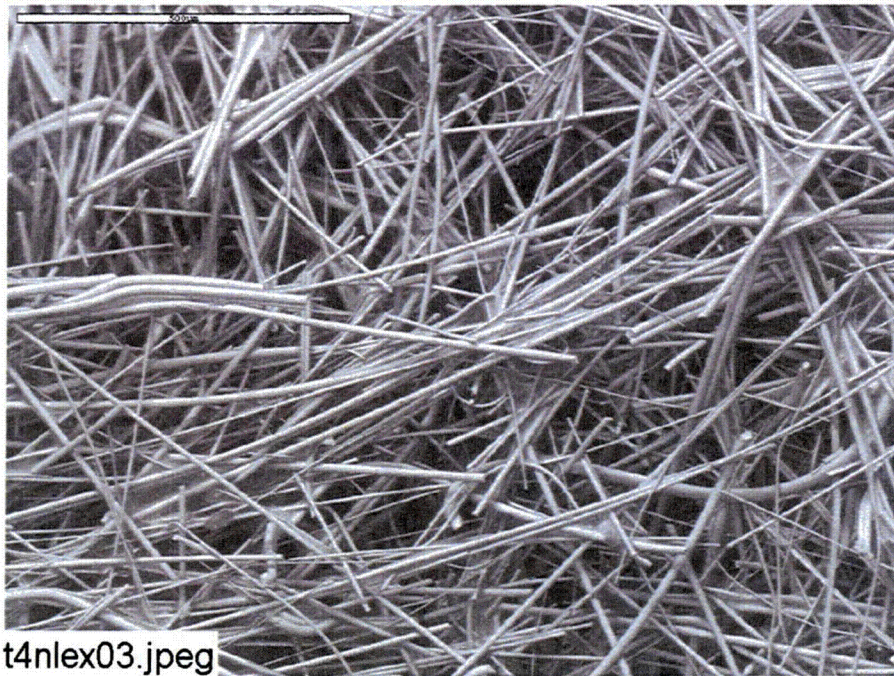
Figure C2-6. Environmental SEM image magnified 100 times for a Test #4, Day-30 exterior low-flow fiberglass sample contained in a nylon mesh (inserted on Day 4). (t4nlex03.jpeg)

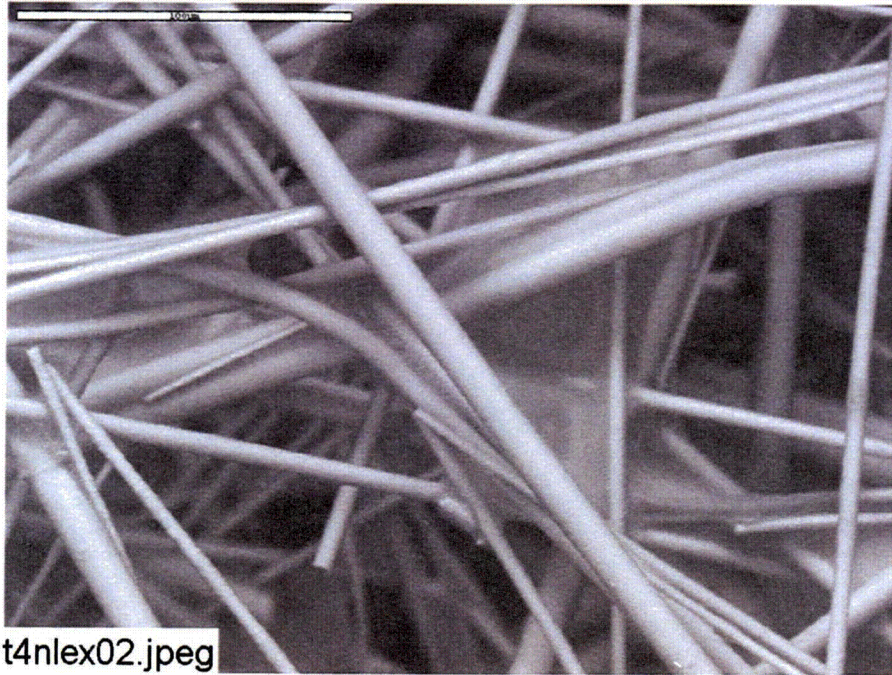
Figure C2-7. Environmental SEM image magnified 500 times for a Test #4, Day-30 exterior low-flow fiberglass sample contained in a nylon mesh (inserted on Day 4). (t4nlex02.jpg)

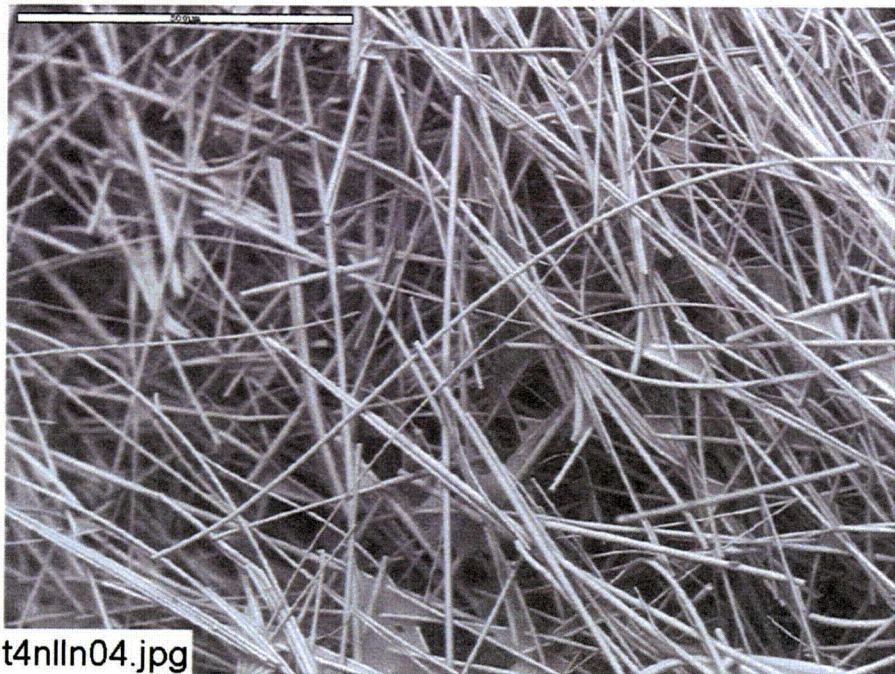
Figure C2-8. Environmental SEM image magnified 100 times for a Test #4, Day-30 interior low-flow fiberglass sample contained in a nylon mesh (inserted on Day 4). (t4nlln04.jpg)

Image: t4nlin04	100 ×	ESEM image	Figure C2-8
t4nlin06	100 ×	ESEM image	Figure C2-9
t4nlin05	500 ×	ESEM image higher magnification	Figure C2-10

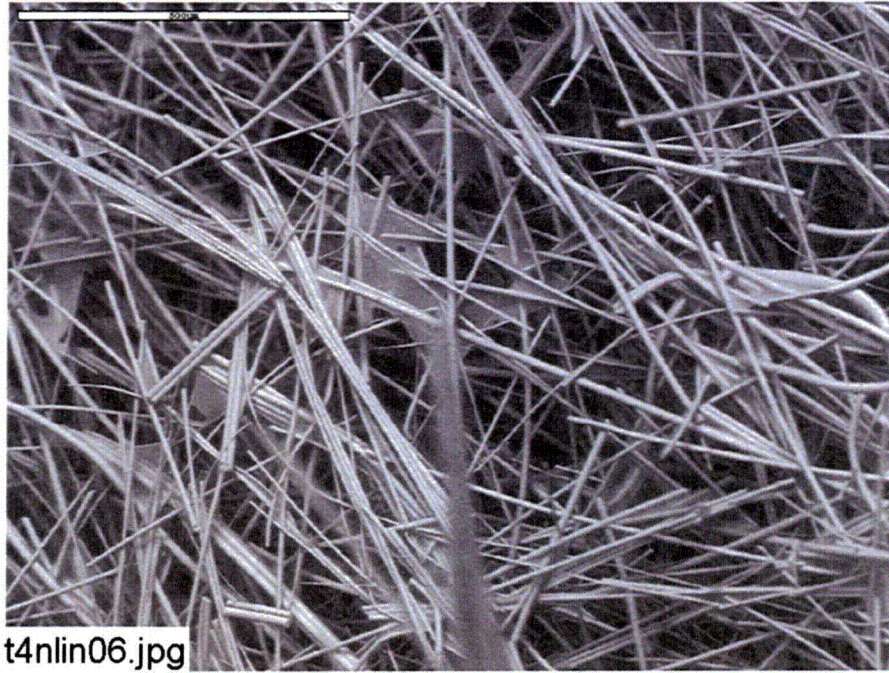
Figure C2-9. Environmental SEM image magnified 100 times for a Test #4, Day-30 interior low-flow fiberglass sample contained in a nylon mesh (inserted on Day 4). (t4nlin06.jpg)

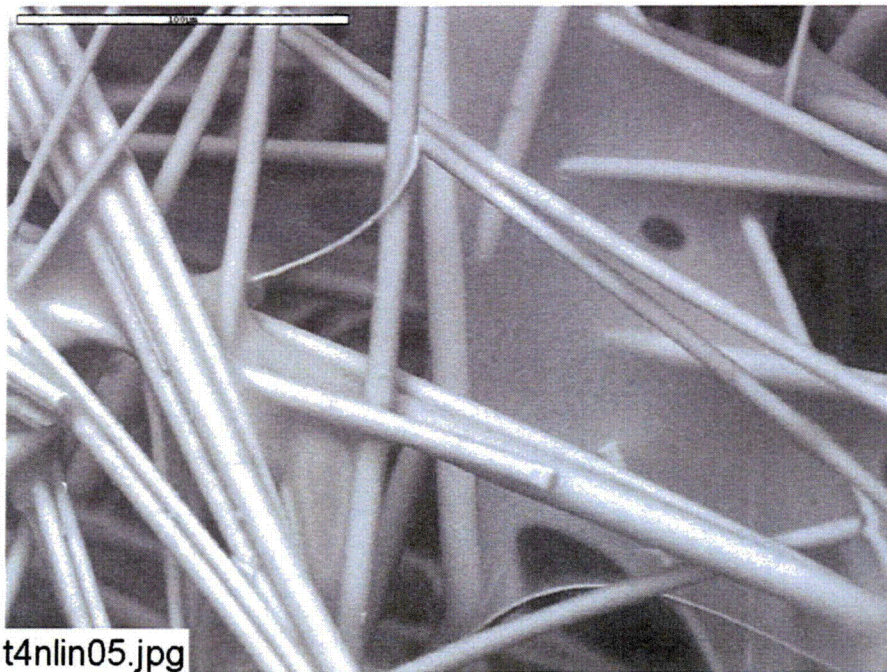
Figure C2-10. Environmental SEM image magnified 500 times for a Test #4, Day-30 interior low-flow fiberglass sample contained in a nylon mesh (inserted on Day 4). (t4nlin05.jpg)

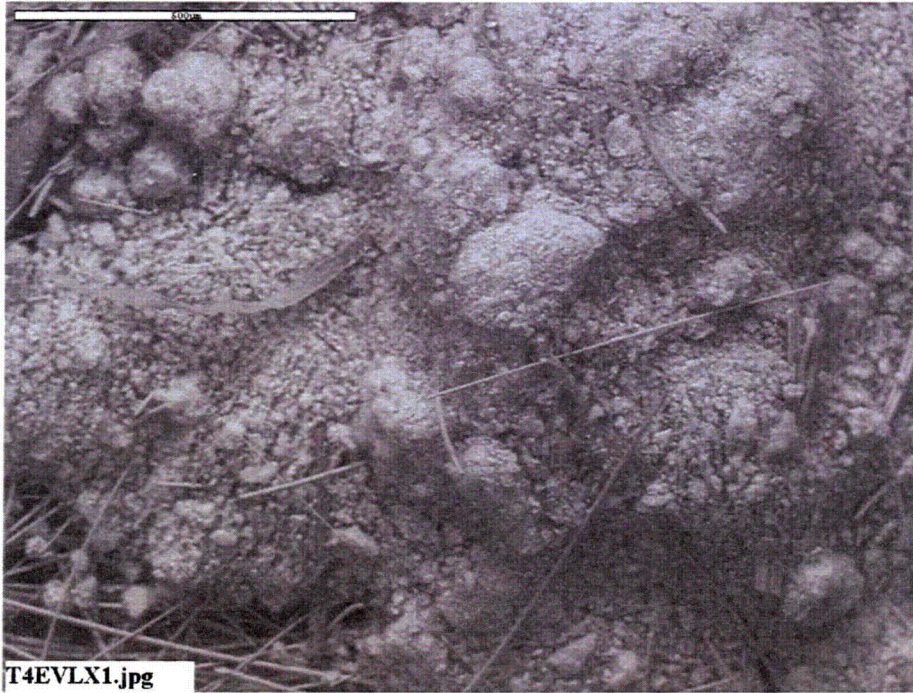
Figure C3-1. Environmental SEM image magnified 100 times for a Test #4, Day-30 exterior low-flow fiberglass sample in a big envelope. (T4EVLX1.jpg)

Image: T4EVLX1	100 ×	ESEM image	Figure C3-1
t4evlx3	100 ×	ESEM image	Figure C3-2
t4evlx2	500 ×	ESEM image higher magnification	Figure C3-3

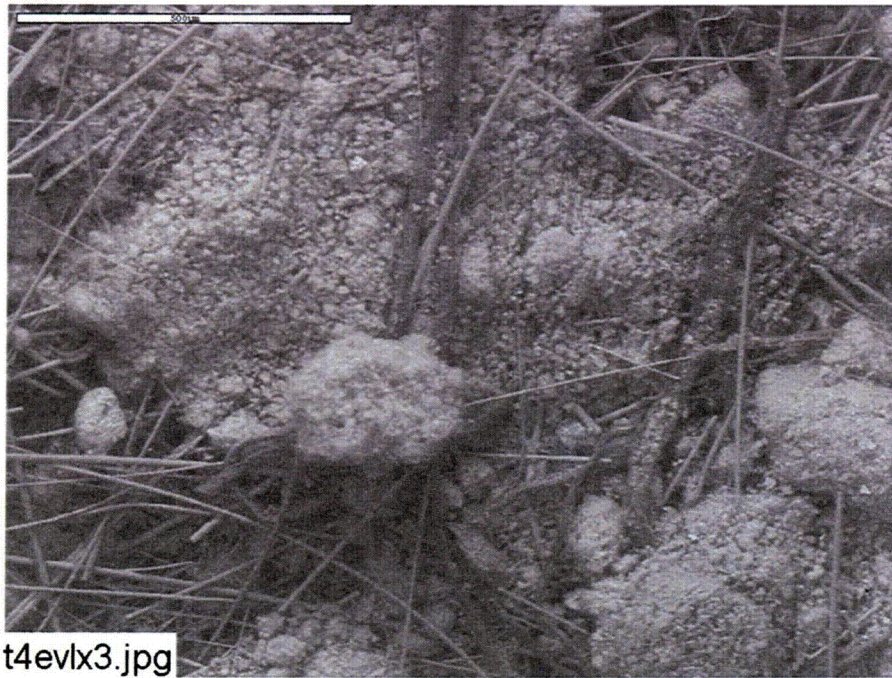
Figure C3-2. Environmental SEM image magnified 100 times for a Test #4, Day-30 exterior low-flow fiberglass sample in a big envelope. (t4evlx3.jpg)

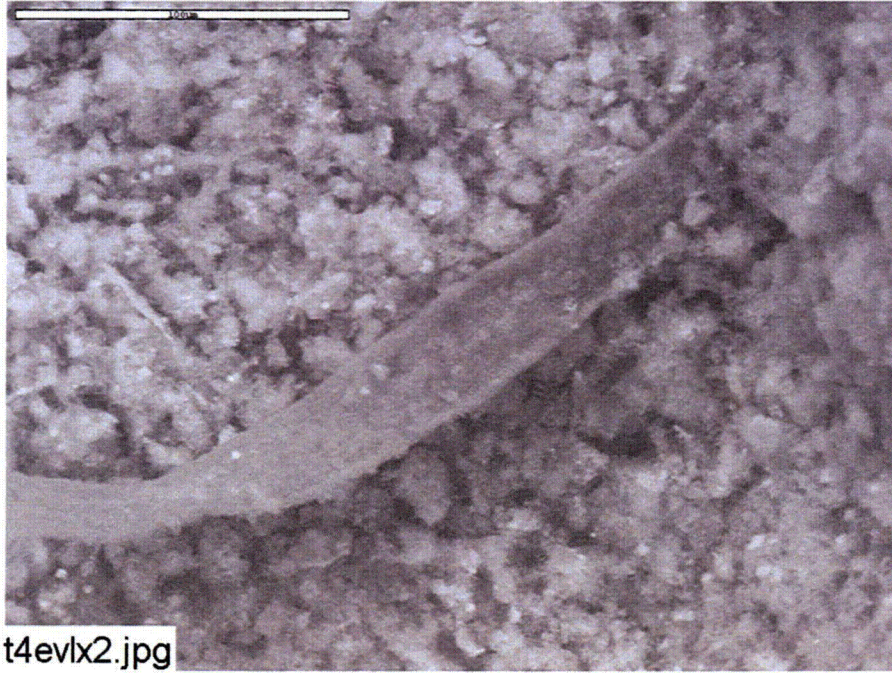
Figure C3-3. Environmental SEM image magnified 500 times for a Test #4, Day-30 exterior low-flow fiberglass sample in a big envelope. (t4evlx2.jpg)

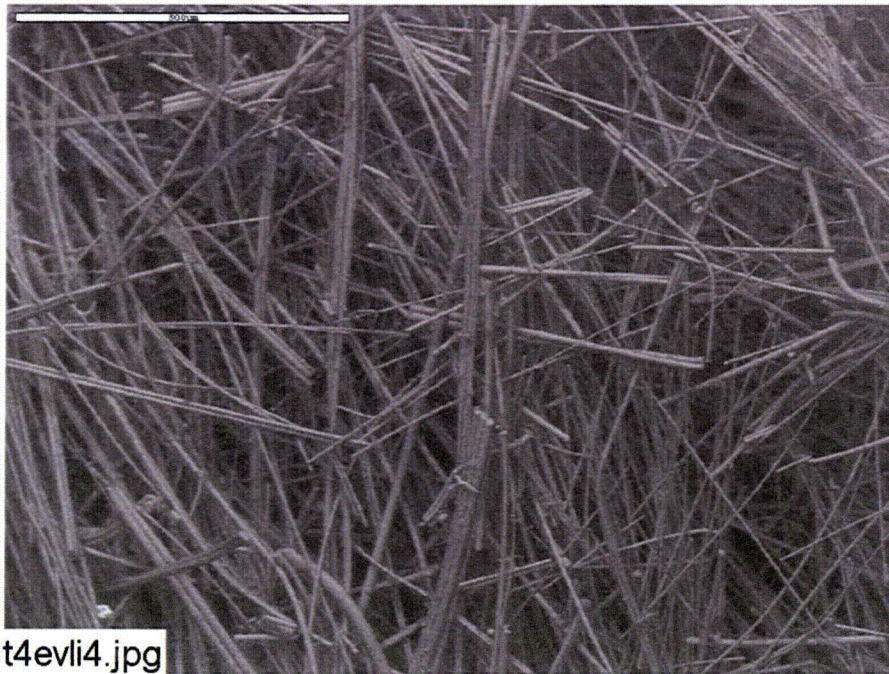
Figure C3-4. Environmental SEM image magnified 100 times for a Test #4, Day-30 interior low-flow fiberglass sample in a big envelope. (t4evli4.jpg)

Image: t4evli4	100 ×	ESEM image	Figure C3-4
t4evli5	100 ×	ESEM image	Figure C3-5
t4evli6	100 ×	ESEM image	Figure C3-6
t4evli7	500 ×	ESEM image higher magnification	Figure C3-7

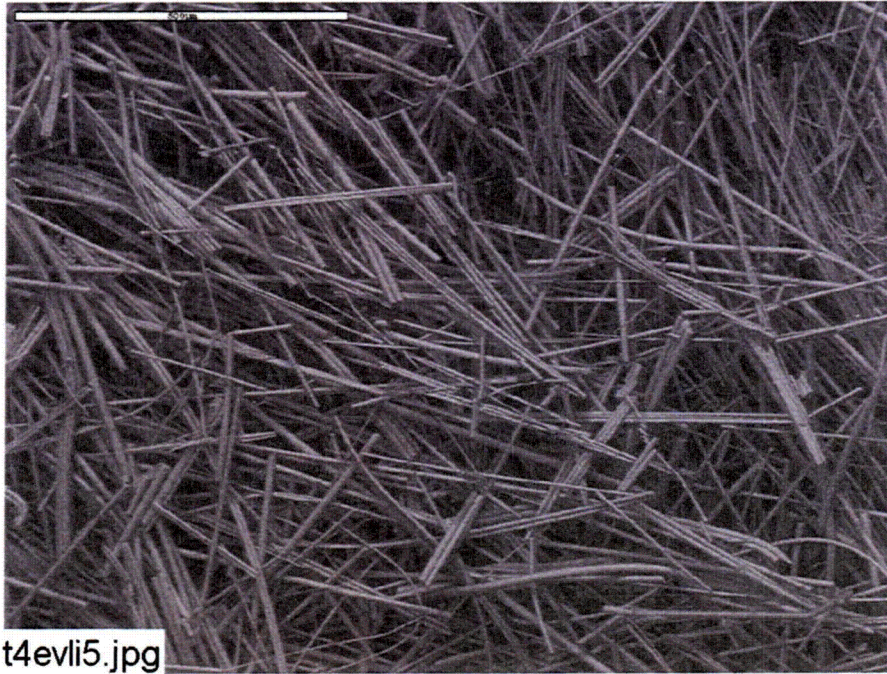
Figure C3-5. Environmental SEM image magnified 100 times for a Test #4, Day-30 interior low-flow fiberglass sample in a big envelope. (t4evli5.jpg)

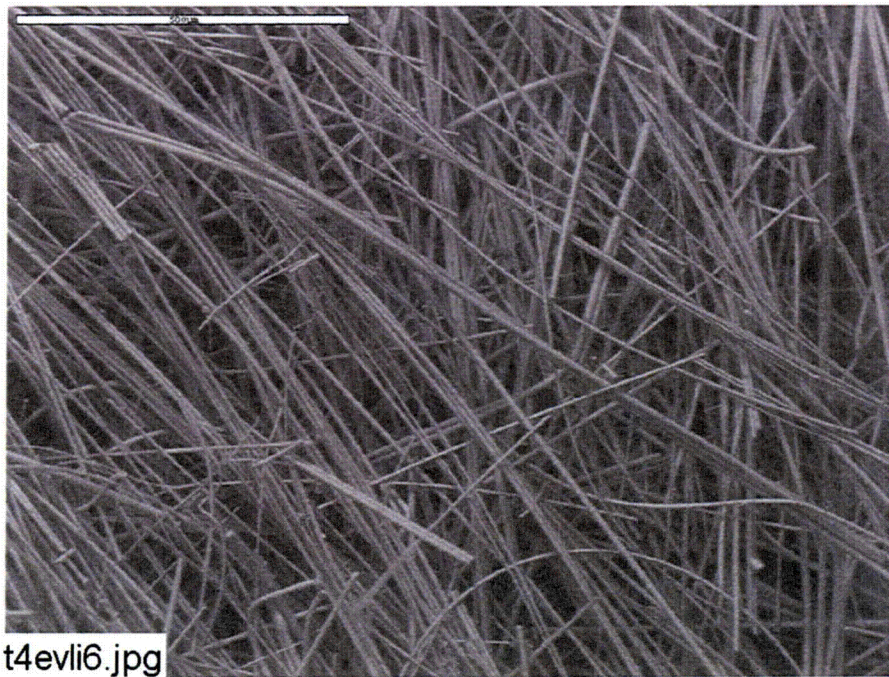
Figure C3-6. Environmental SEM image magnified 100 times for a Test #4, Day-30 interior low-flow fiberglass sample in a big envelope. (t4evli6.jpg)

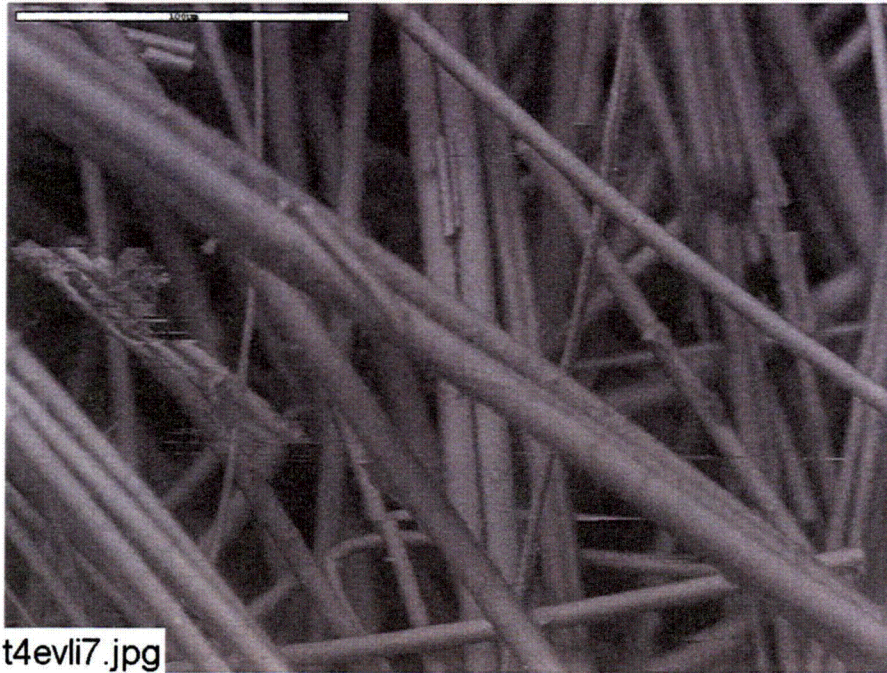
Figure C3-7. Environmental SEM image magnified 500 times for a Test #4, Day-30 interior low-flow fiberglass sample in a big envelope. (t4evli7.jpg)

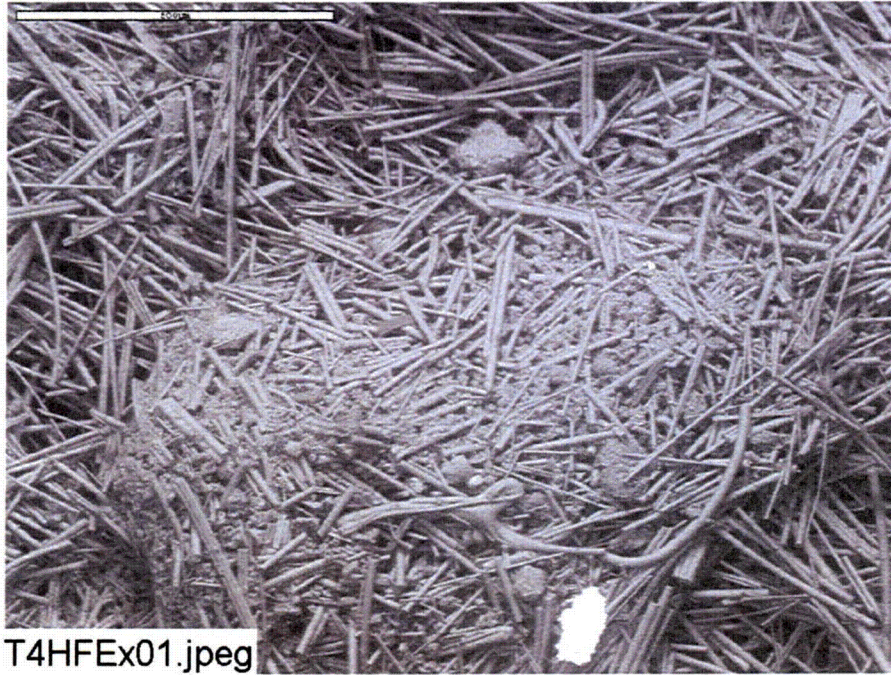
Figure C4-1. Environmental SEM image magnified 100 times for a Test #4, Day-30 exterior high-flow fiberglass sample. (T4HFEx01.jpeg)

Image:	T4HFEx01	100 ×	ESEM image	Figure C4-1
	t4hfex02	100 ×	ESEM image	Figure C4-2
	t4hfex07	500 ×	ESEM image	Figure C4-3
	t4hfex06	800 ×	ESEM annotated image	Figure C4-4
EDS:	t4hfex05		Spot of film for t4hfex06	Figure C4-5

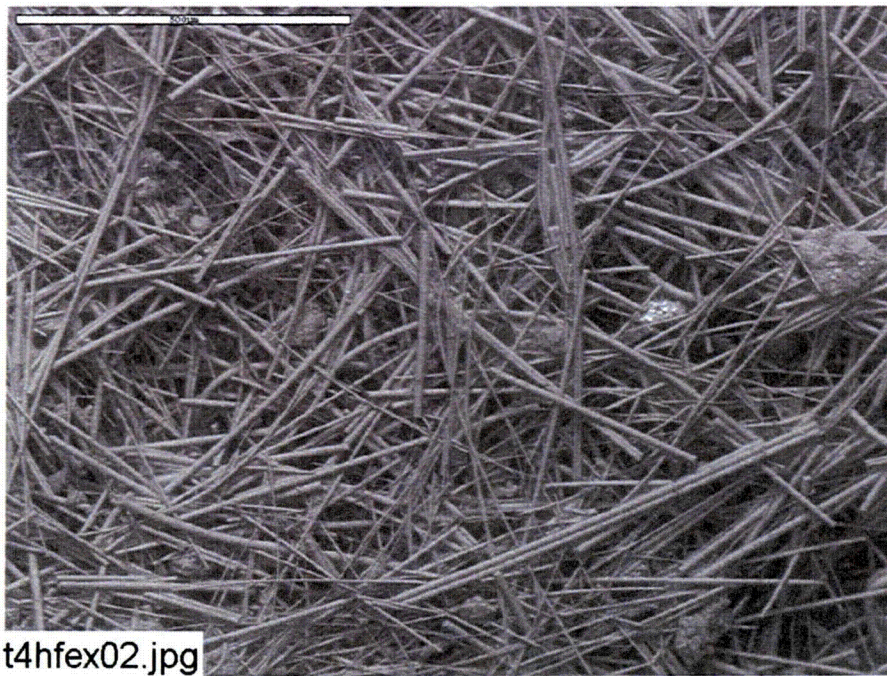
Figure C4-2. Environmental SEM image magnified 100 times for a Test #4, Day-30 exterior high-flow fiberglass sample. (t4hfex02.jpg)

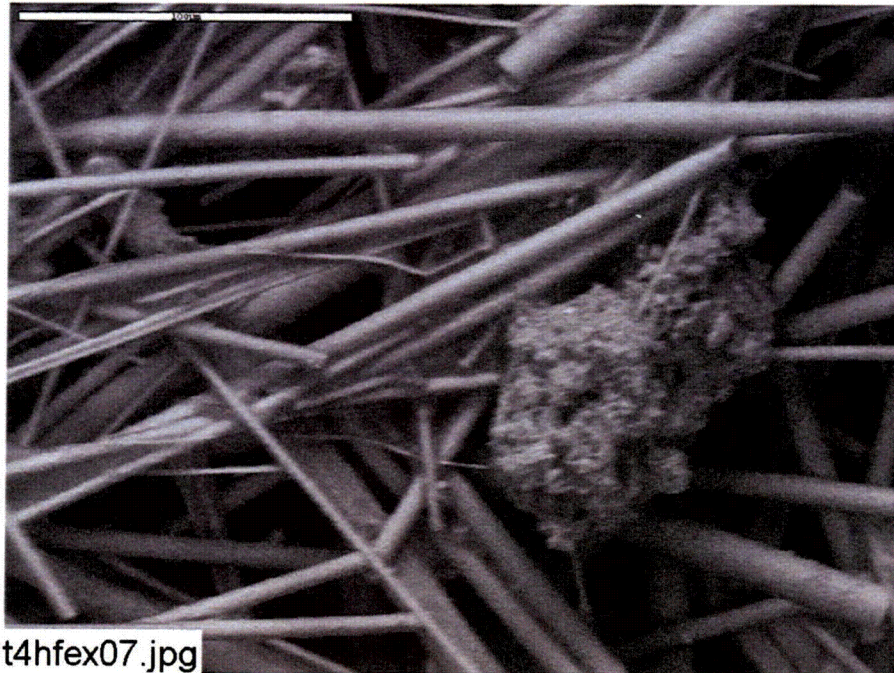
t4hfex07.jpg

Figure C4-3. Environmental SEM image magnified 500 times for a Test #4, Day-30 exterior high-flow fiberglass sample. (t4hfex07.jpg)

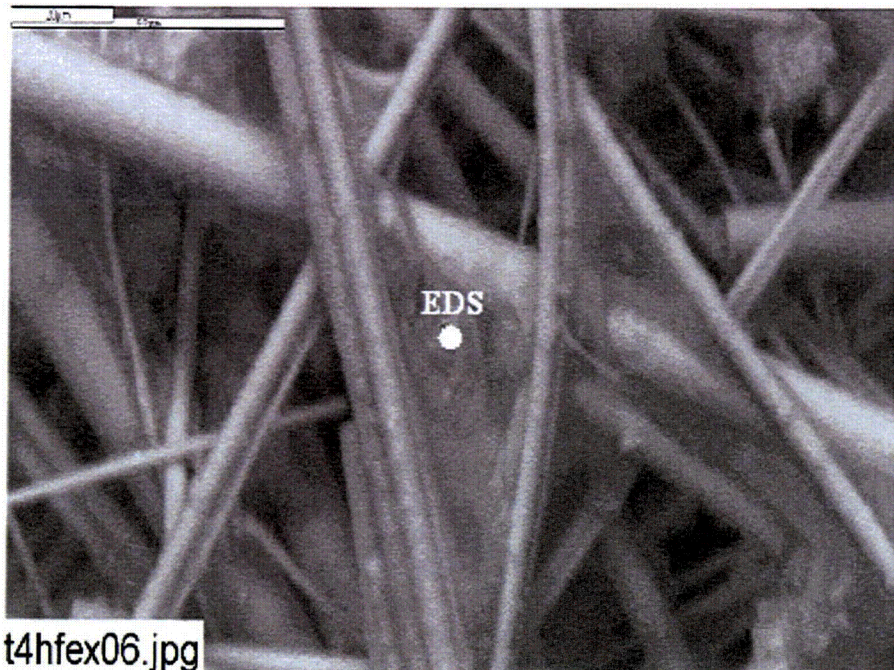
t4hfex06.jpg

Figure C4-4. Annotated environmental SEM image magnified 800 times for a Test #4, Day-30 exterior high-flow fiberglass sample. EDS spot is shown in the picture. (t4hfex06.jpg)

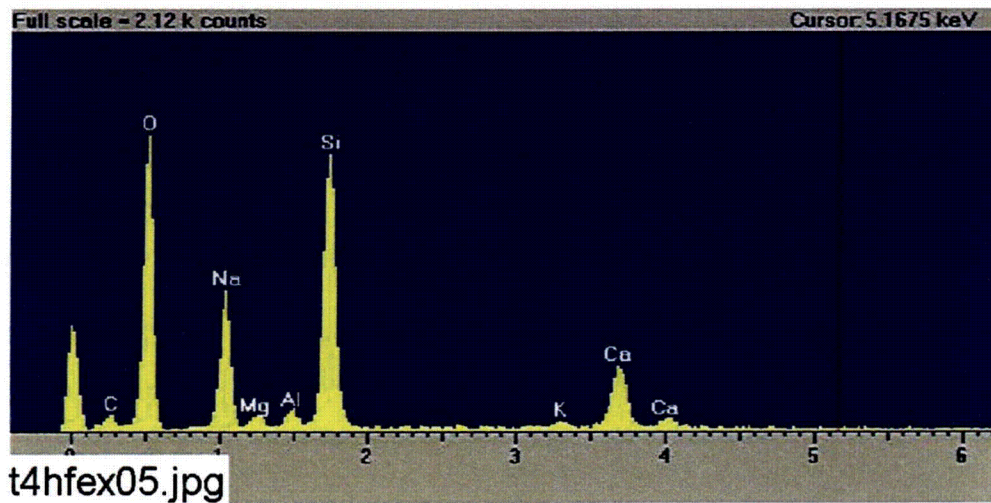
Figure C4-5. EDS counting spectrum for the spot of film between fibers shown in Figure C4-4. (t4hfex05.jpg)

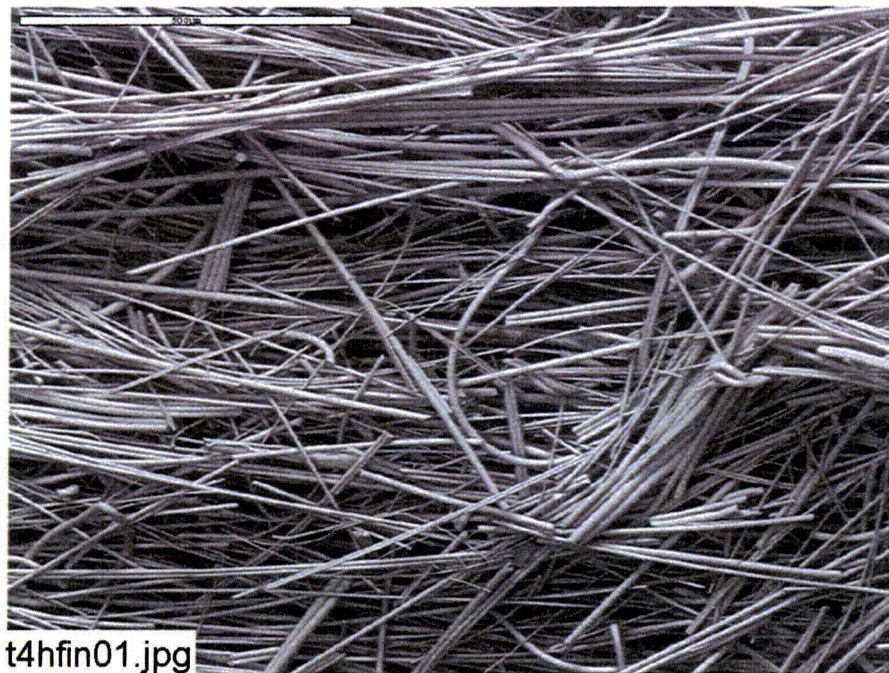
Figure C4-6. Environmental SEM image magnified 100 times for a Test #4, Day-30 interior high-flow fiberglass sample. (t4hfin01.jpg)

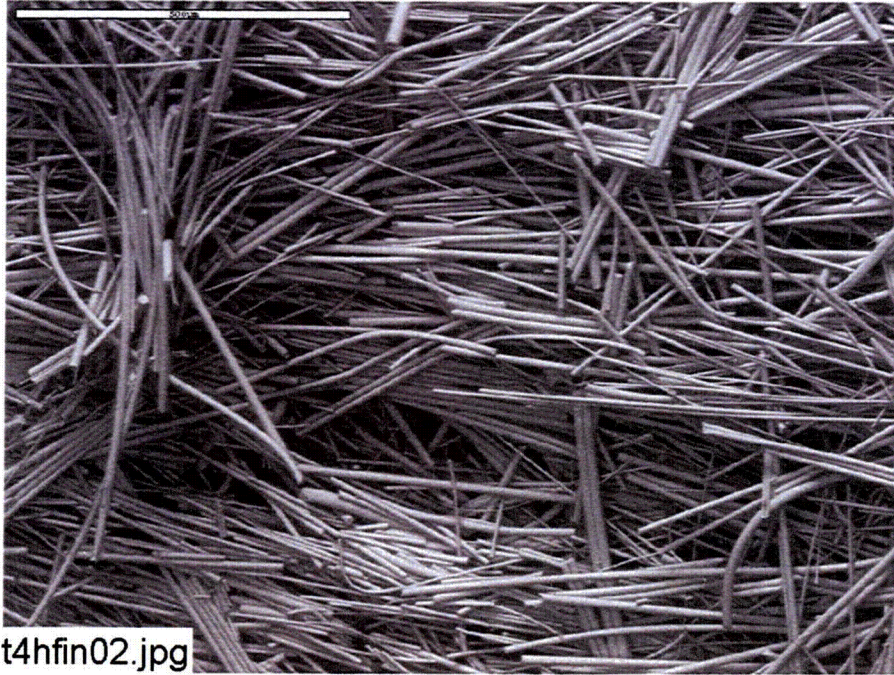
t4hfin02.jpg

Figure C4-7. Environmental SEM image magnified 100 times for a Test #4, Day-30 interior high-flow fiberglass sample. (t4hfin02.jpg)

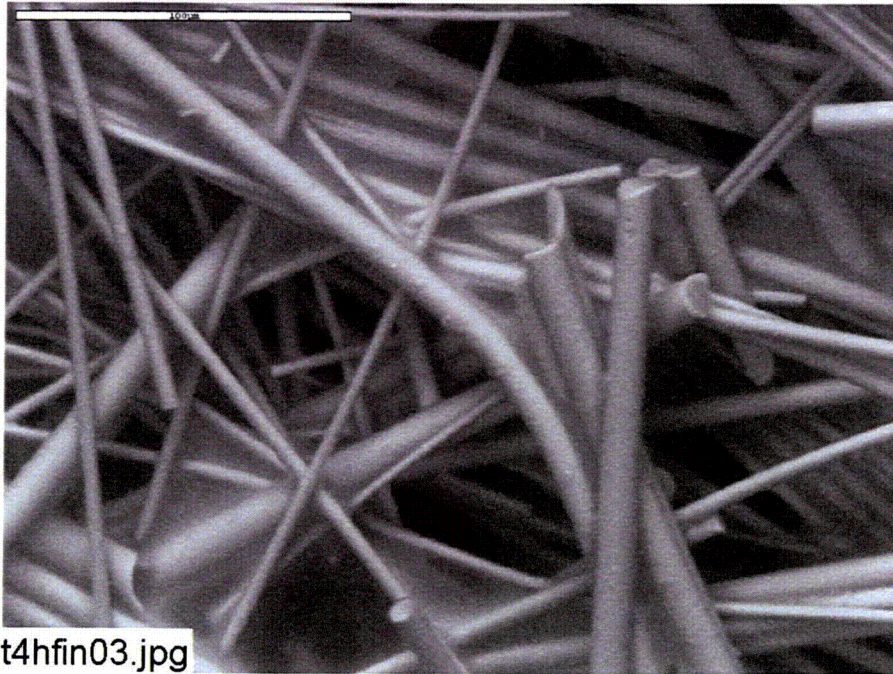
t4hfin03.jpg

Figure C4-8. Environmental SEM image magnified 500 times for a Test #4, Day-30 interior high-flow fiberglass sample. (t4hfin03.jpg)

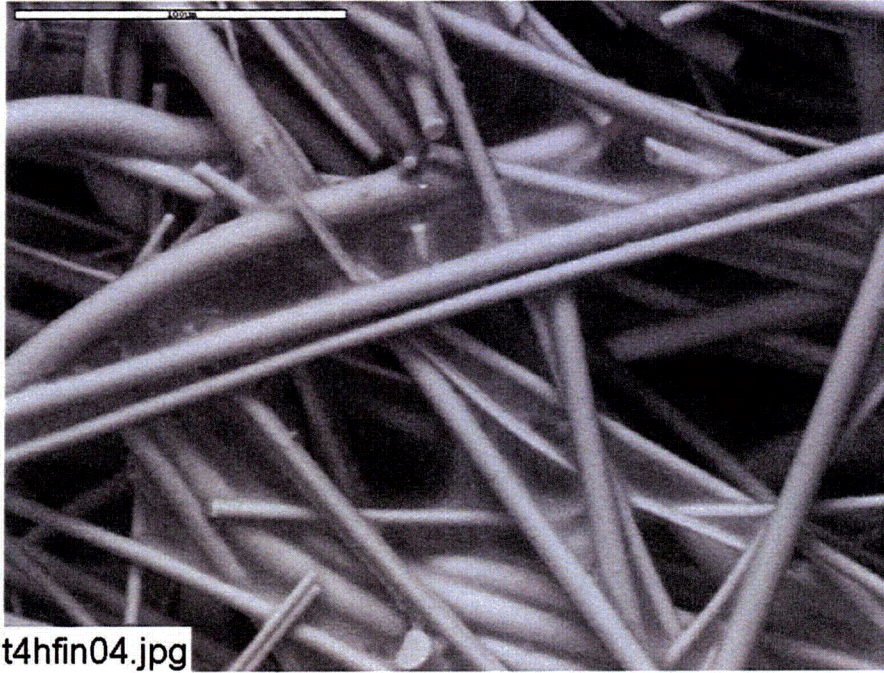
Figure C4-9. Environmental SEM image magnified 500 times for a Test #4, Day-30 interior high-flow fiberglass sample. (t4hfin04.jpg)

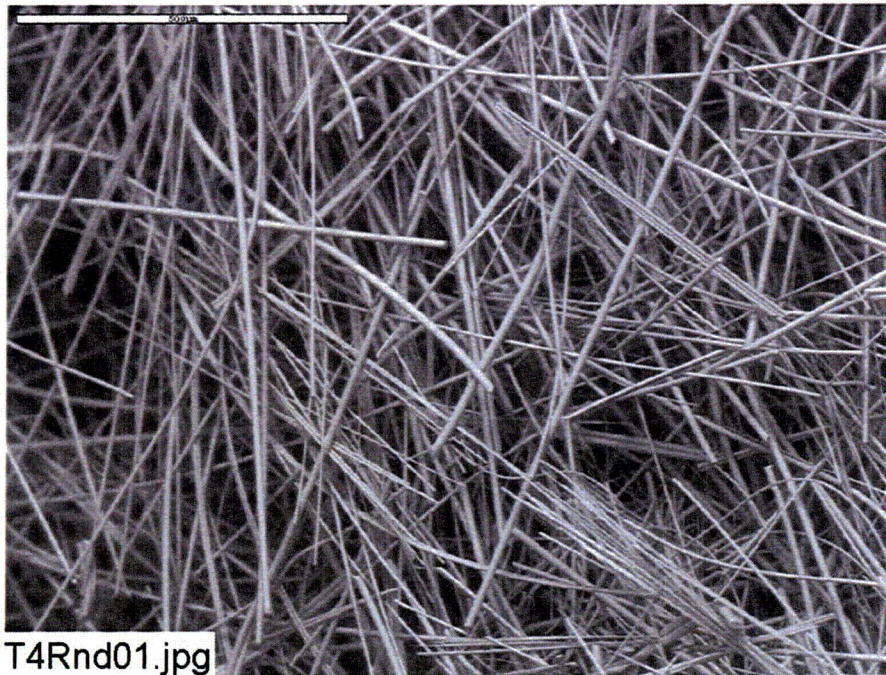
Figure C4-10. Environmental SEM image magnified 100 times for a Test #4, Day-30 interior high-flow fiberglass sample. The sample was gently prerinsed with RO water. (T4Rnd01.jpg)

Image:	T4Rnd01	100 ×	ESEM image	Figure C4-10
	t4rnd02	100 ×	ESEM image	Figure C4-11
	t4rnd03	500 ×	ESEM image	Figure C4-12
	t4rnd04	500 ×	ESEM image	Figure C4-13
	t4rnd05	500 ×	ESEM image	Figure C4-14
	t4rnd06	500 ×	ESEM image	Figure C4-15

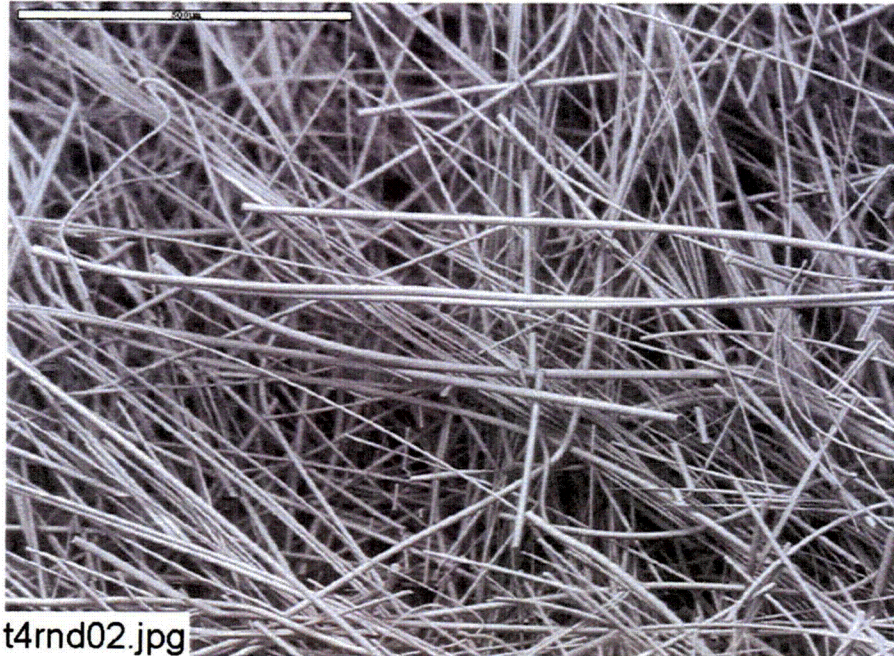
Figure C4-11. Environmental SEM image magnified 100 times for a Test #4, Day-30 interior high-flow fiberglass sample. The sample was gently prerinsed with RO water. (t4rnd02.jpg)

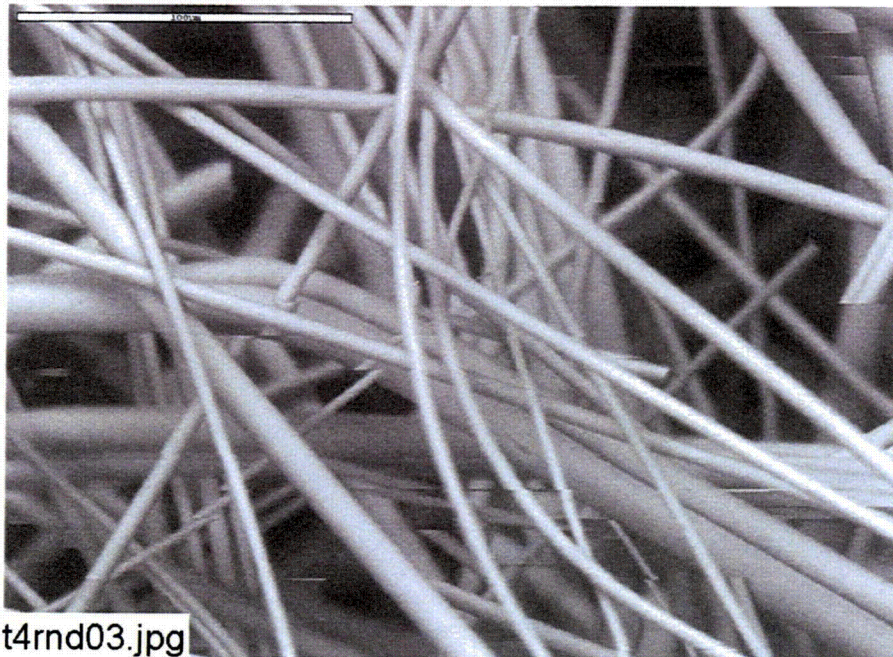
Figure C4-12. Environmental SEM image magnified 500 times for a Test #4, Day-30 interior high-flow fiberglass sample. The sample was gently prerinsed with RO water. (t4rnd03.jpg)

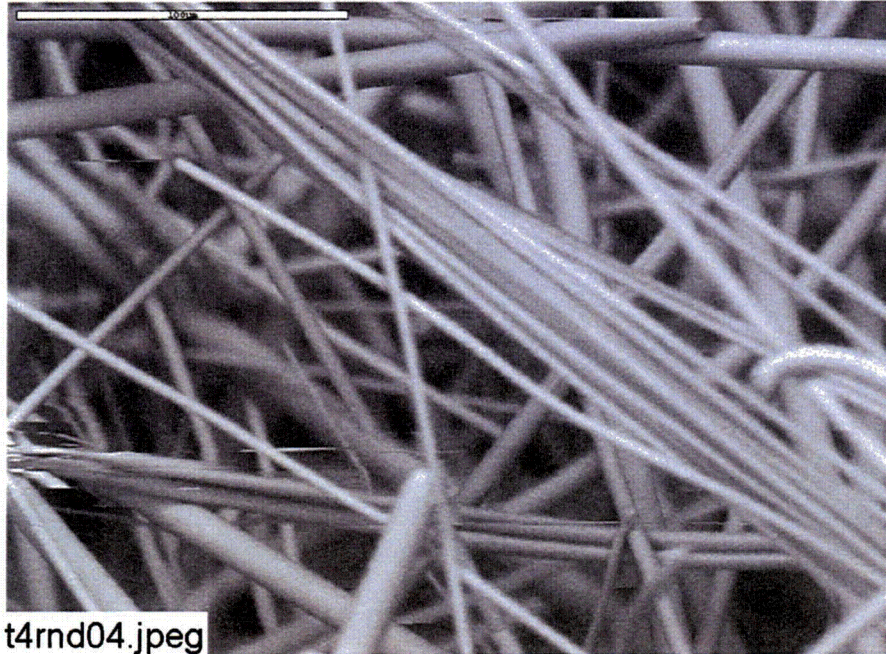
Figure C4-13. Environmental SEM image magnified 500 times for a Test #4, Day-30 interior high-flow fiberglass sample. The sample was gently prerinsed with RO water. (t4rnd04.jpeg)

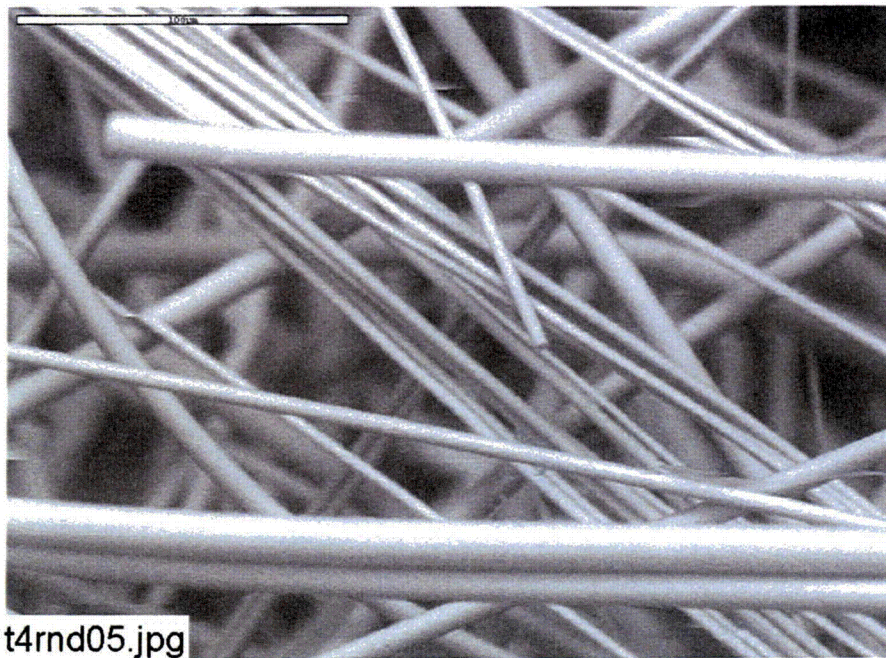
Figure C4-14. Environmental SEM image magnified 500 times for a Test #4, Day-30 interior high-flow fiberglass sample. The sample was gently prerinsed with RO water. (t4rnd05.jpg)

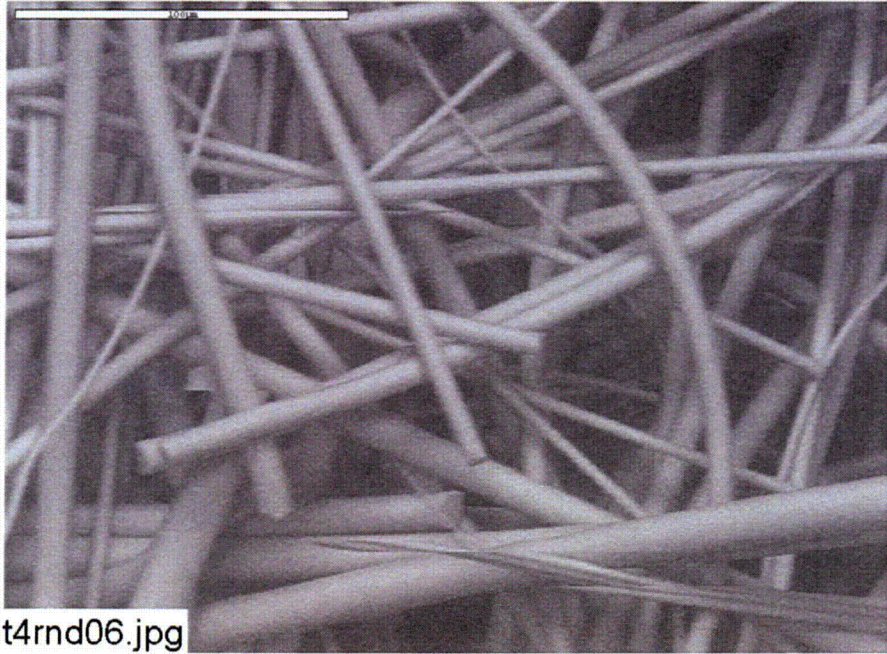
Figure C4-15. Environmental SEM image magnified 500 times for a Test #4, Day-30 interior high-flow fiberglass sample. The sample was gently prerinsed with RO water. (t4rnd06.jpg)

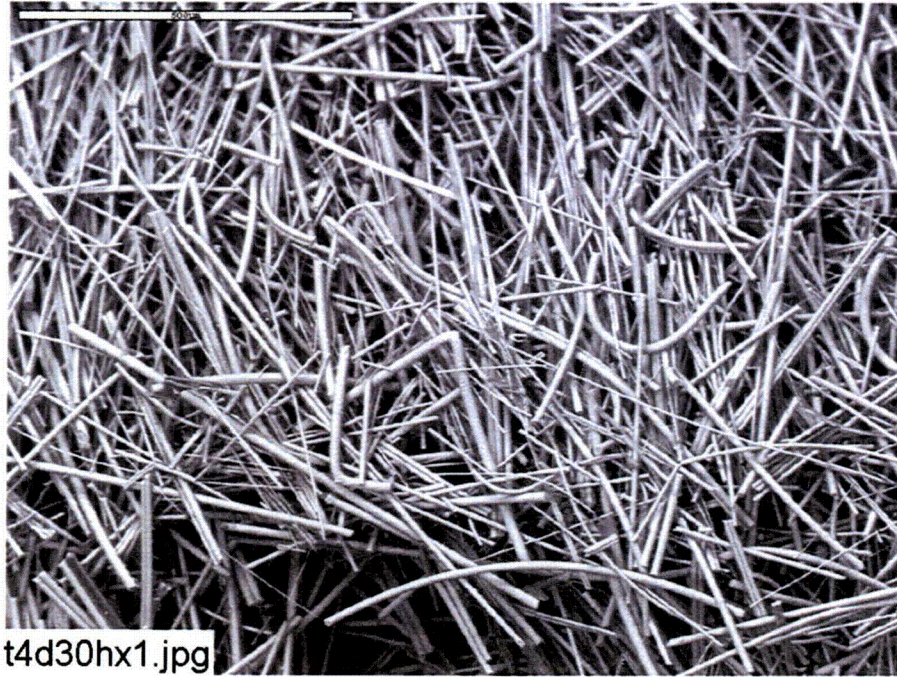
Figure C5-1. Environmental SEM image magnified 100 times for a Test #4, Day-30 exterior high-flow fiberglass sample in front of the header (inserted on Day 4). (t4d30hx1.jpg)

Image:	t4d30hx1	100 ×	ESEM image	Figure C5-1
	t4d30hx2	500 ×	ESEM image	Figure C5-2
	t4d30hx5	1000 ×	ESEM annotated image	Figure C5-3
EDS:	t4d30hx4		EDS on coating of fiberglass shown in t4d30hx5	Figure C5-4

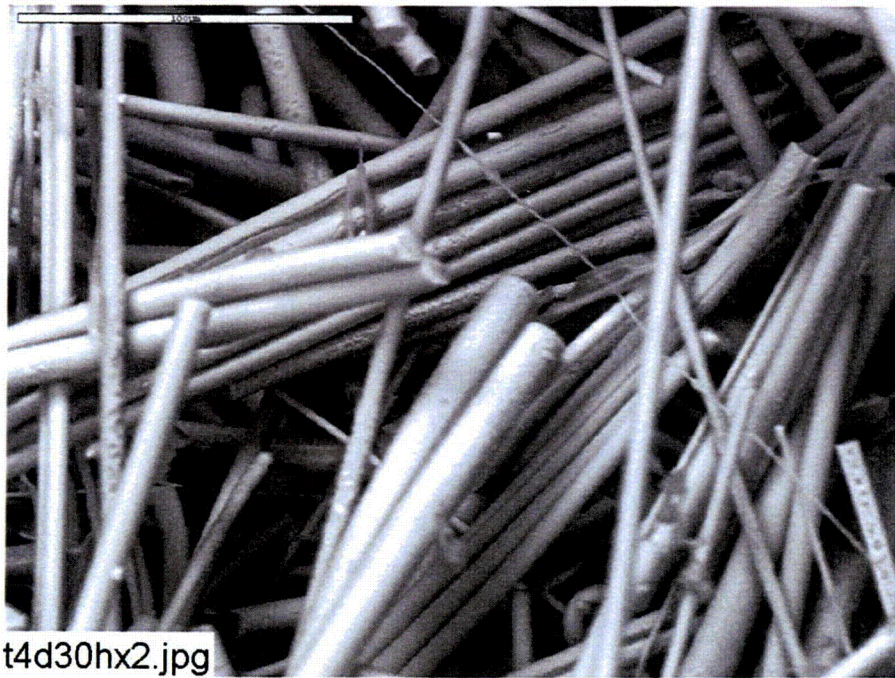
Figure C5-2. Environmental SEM image magnified 500 times for a Test #4, Day-30 exterior high-flow fiberglass sample in front of the header (inserted on Day 4). (t4d30hx2.jpg)

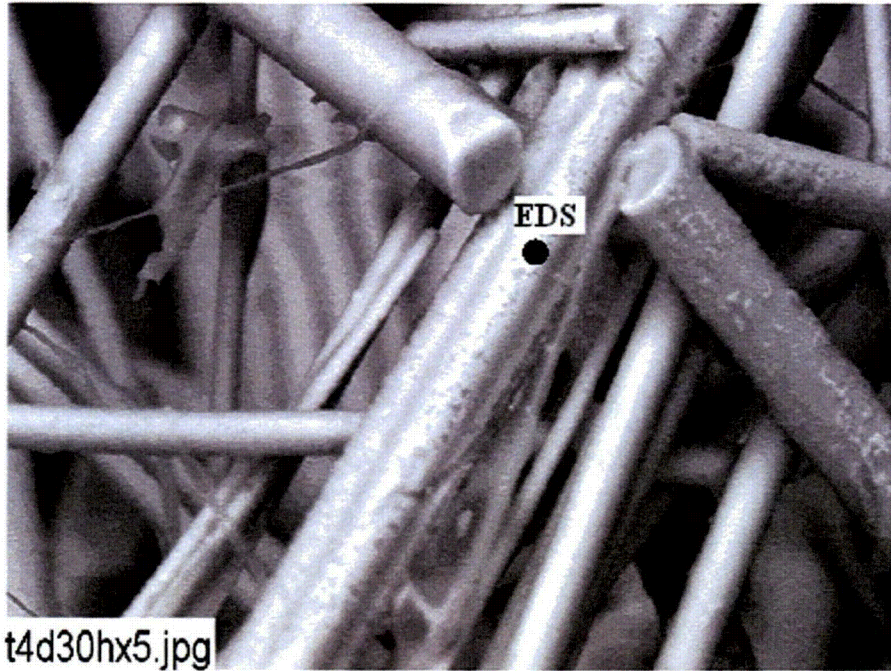
Figure C5-3. Annotated environmental SEM image magnified 1000 times for a Test #4, Day-30 exterior high-flow fiberglass sample in front of the header (inserted on Day 4). The EDS spot is shown in the picture. (t4d30hx5.jpg)
