Appendix A

ESEM/EDS Data for Test #4, Day-5 Fiberglass in Low-Flow Zone

During ICET Test #4, work was continued for the purpose of identifying the origin and chemical composition of the products that were formed during the test. One objective of ICET is to identify the composition of debris on fiberglass and the particulate substances in the test solution. To address this question partially, low-flow fiberglass samples on Test #4, Day 5 were examined by ESEM/EDS, including both of the exterior and the interior location of the fiberglass samples.

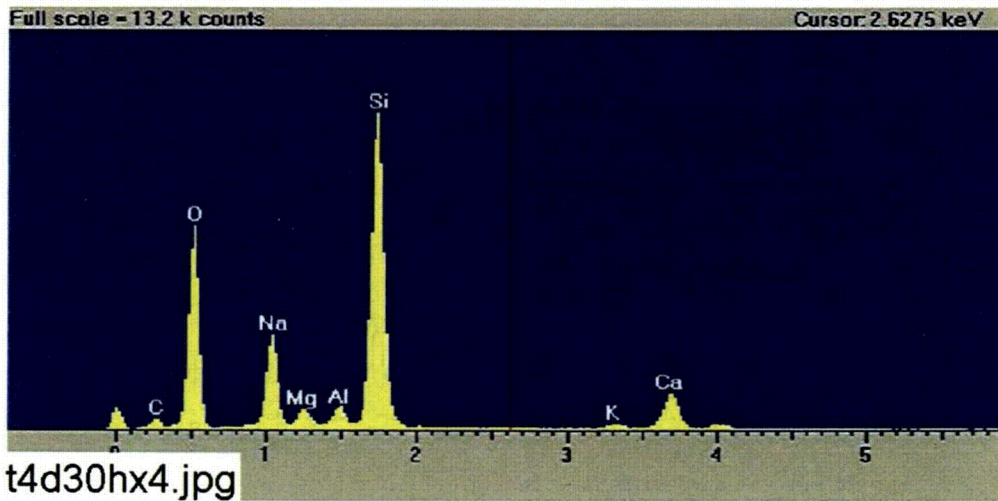
Figure C5-4. EDS counting spectrum for the spot of coating substance on fiberglass shown in Figure C5-3. (t4d30hx4.jpg)

Image:	t4d30hx1	100 ×	ESEM image	Figure C5-1
	t4d30hx2	500 ×	ESEM image	Figure C5-2
	t4d30hx5	1000 ×	ESEM annotated image	Figure C5-3
EDS:	t4d30hx4		EDS on coating of fiberglass shown in t4d30hx5	Figure C5-4

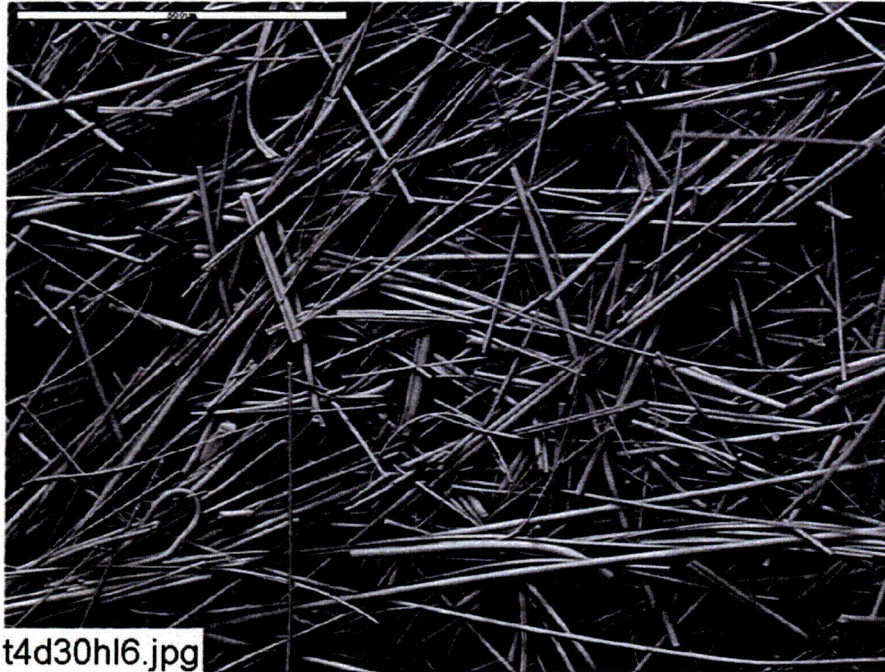
Figure C5-5. Environmental SEM image magnified 100 times for a Test #4, Day-30 interior high-flow fiberglass sample in front of the header (inserted on Day 4). (t4d30h16.jpg)

Image:	t4d30hi6	100 ×	ESEM image of fiberglass	Figure C5-5
	t4d30hi9	500 ×	ESEM annotated image	Figure C5-6
EDS	t4d30hi8		EDS on web in t4d30hi9	Figure C5-7
Image	t4d30hi	1000 ×	ESEM annotated image	Figure C5-8
EDS	t4d30hi0		EDS on spot in t4d30hi	Figure C5-9

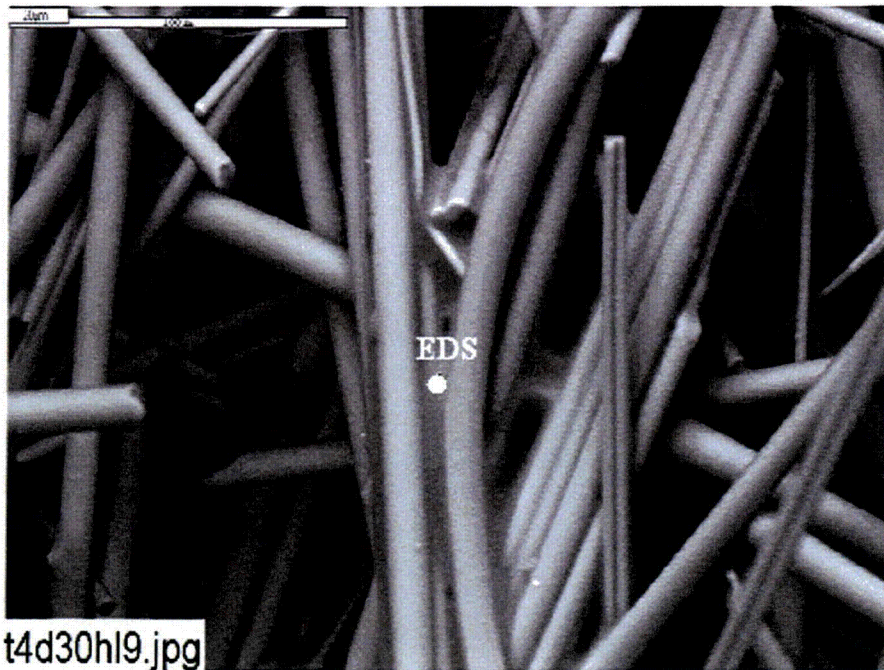
Figure C5-6. Annotated environmental SEM image magnified 500 times for a Test #4, Day-30 interior high-flow fiberglass sample in front of the header (inserted on Day 4). The EDS spot is shown in the picture. (t4d30h19.jpg)

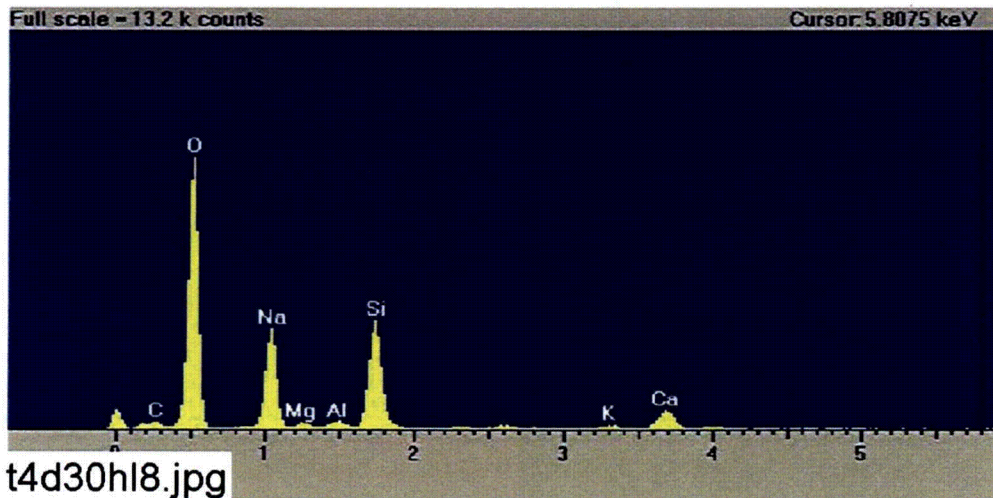
Figure C5-7. EDS counting spectrum for the spot of substance attached on fiberglass shown in Figure C5-6. (t4d30hl8.jpg)

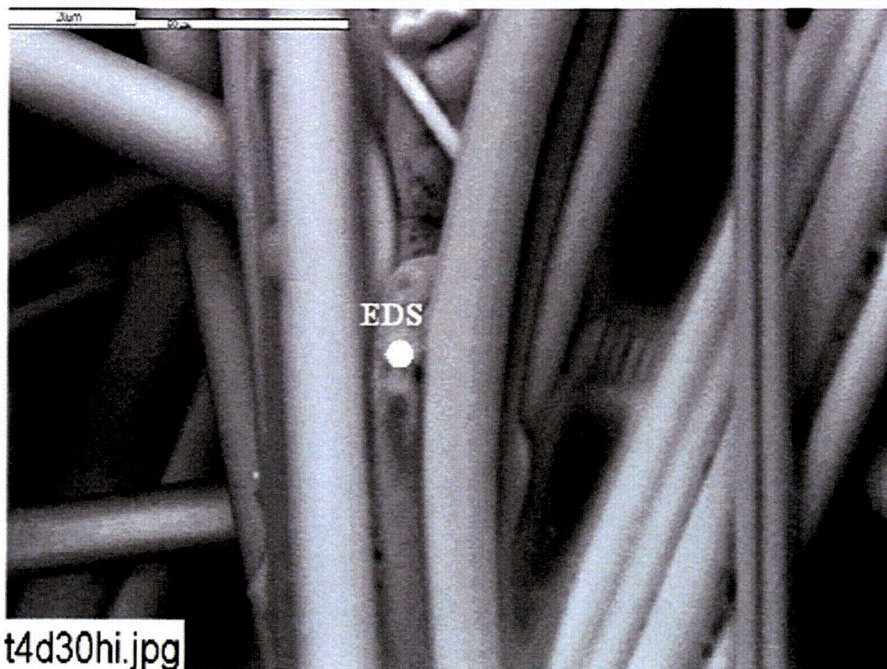
Figure C5-8. Annotated environmental SEM image magnified 1000 times for a Test #4, Day-30 interior high-flow fiberglass sample in front of the header (inserted on Day 4). The EDS spot is shown in the picture. (t4d30hi.jpg)

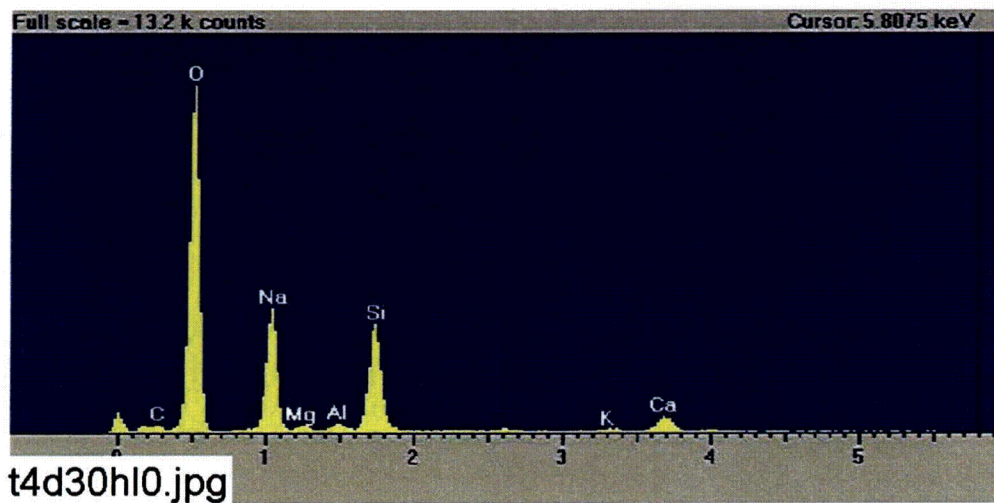
Figure C5-9. EDS counting spectrum for the spot of substance attached on fiberglass shown in Figure C5-8. (t4d30h10.jpg)

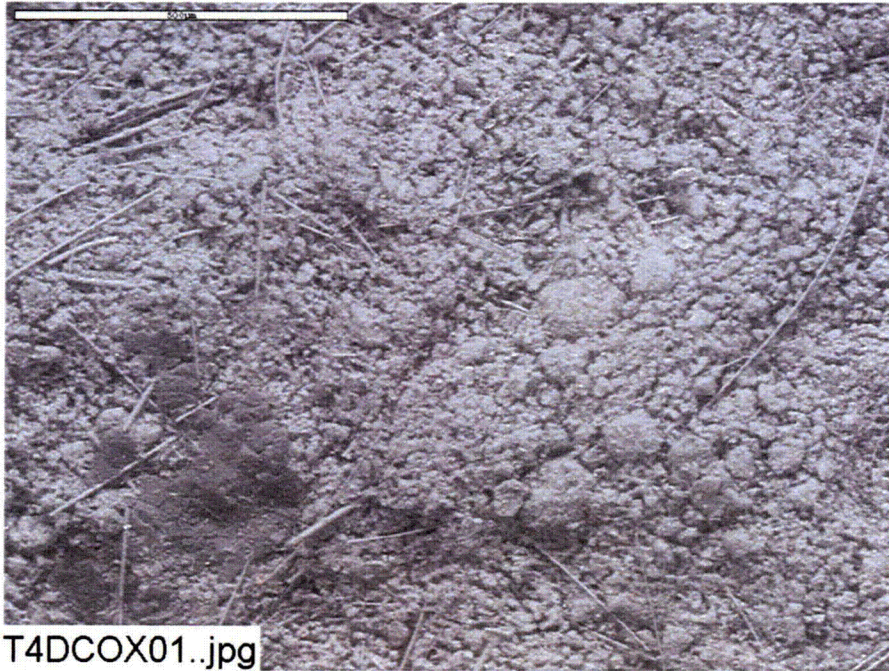
Figure C6-1. Environmental SEM image magnified 100 times for a Test #4, Day-30 exterior fiberglass sample on the drain collar (away from the drain screen). (T4DCOX01.jpg)

Image:	T4DCOX01	100 ×	ESEM image	Figure C6-1
	t4dcox05	100 ×	ESEM image	Figure C6-2
	t4dcox02	500 ×	ESEM image	Figure C6-3
	t4dcox03	1000 ×	ESEM at higher magnification	Figure C6-4
EDS:	t4dcox04		EDS on particles in t4dcox03	Figure C6-5

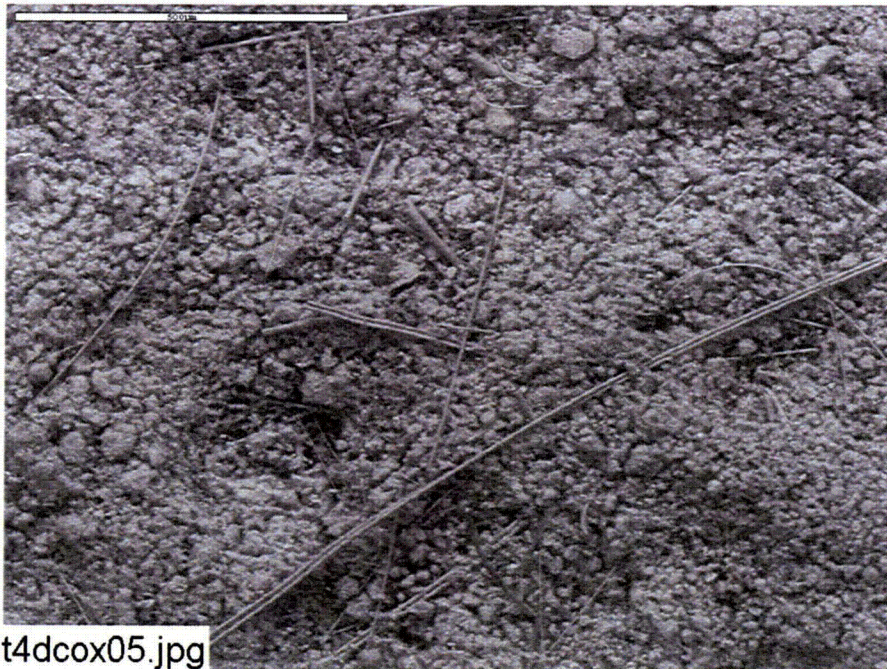
Figure C6-2. Environmental SEM image magnified 100 times for a Test #4, Day-30 exterior fiberglass sample on the drain collar (away from the drain screen). (t4dcox05.jpg)

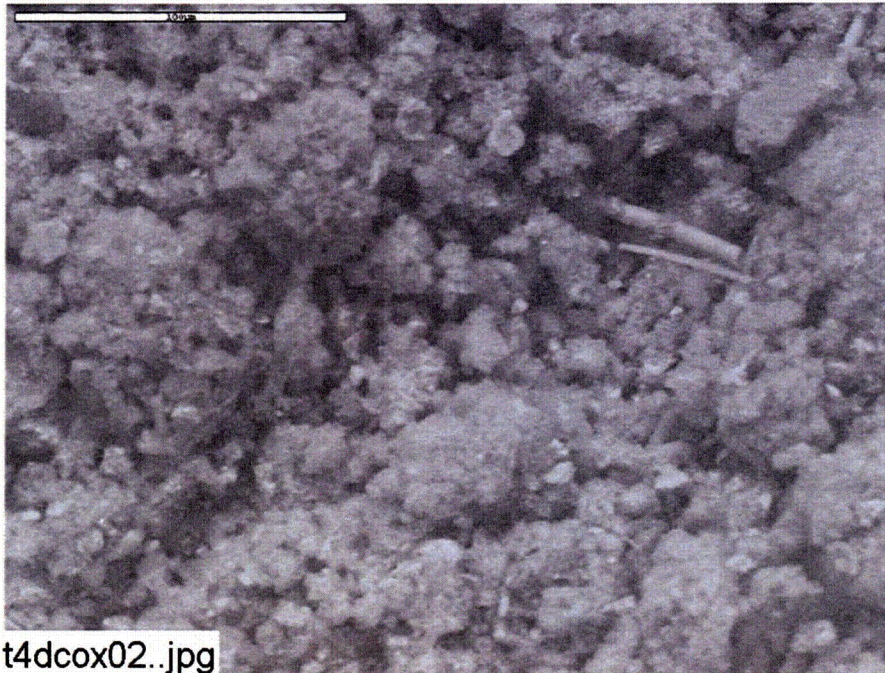
t4dcox02..jpg

Figure C6-3. Environmental SEM image magnified 500 times for a Test #4, Day-30 exterior fiberglass sample on the drain collar (away from the drain screen). (t4dcox02.jpg)

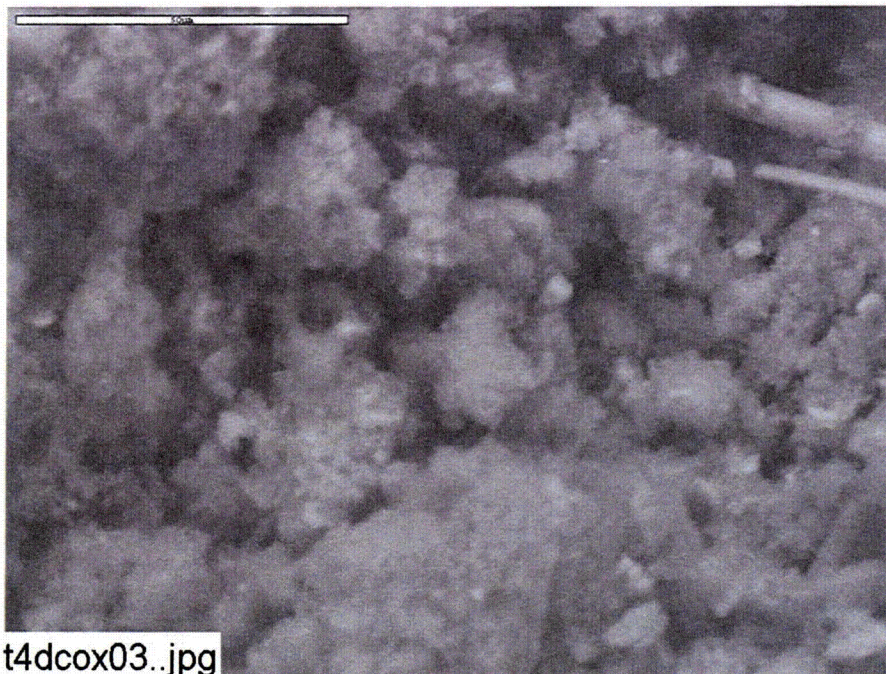
t4dcox03..jpg

Figure C6-4. Environmental SEM image magnified 1000 times for a Test #4, Day-30 exterior fiberglass sample on the drain collar (away from the drain screen). (t4dcox03.jpg)

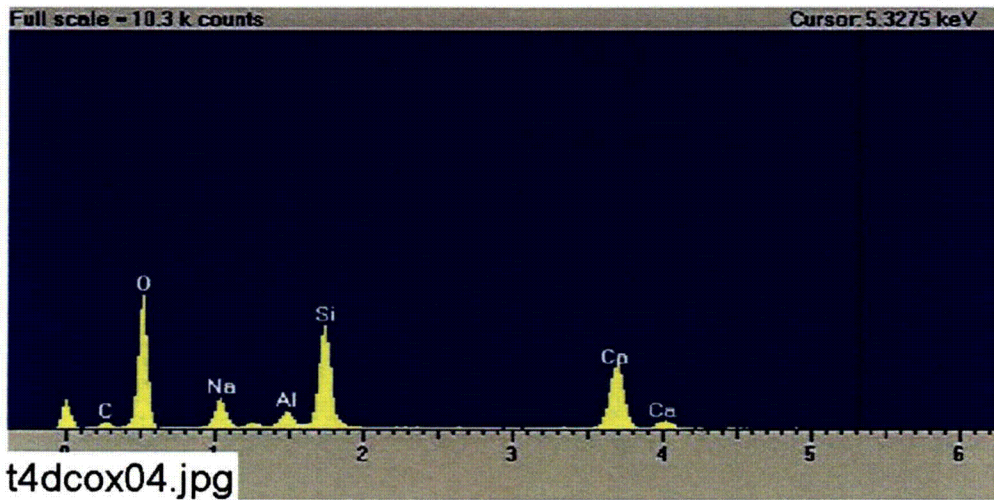
Figure C6-5. EDS counting spectrum for the large mass of particulate deposits on fiberglass shown in Figure C6-4. (t4dcox04.jpg)

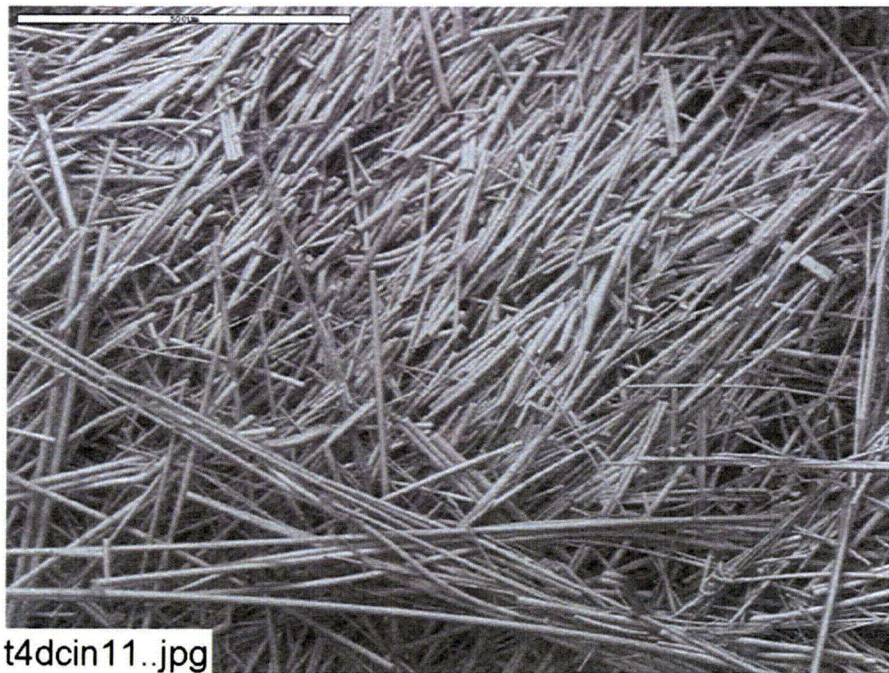
Figure C6-6. Environmental SEM image magnified 100 times for a Test #4, Day-30 interior fiberglass sample on the drain collar. (t4dcin11.jpg)

Image:	t4dcin11	100 ×	ESEM image	Figure C6-6
	t4dcin14	100 ×	ESEM image	Figure C6-7
	t4dcin12	500 ×	ESEM image higher magnification	Figure C6-8
	t4dcin13	500 ×	ESEM image high magnification	Figure C6-9
	t4dcin15	500 ×	ESEM image high magnification	Figure C6-10

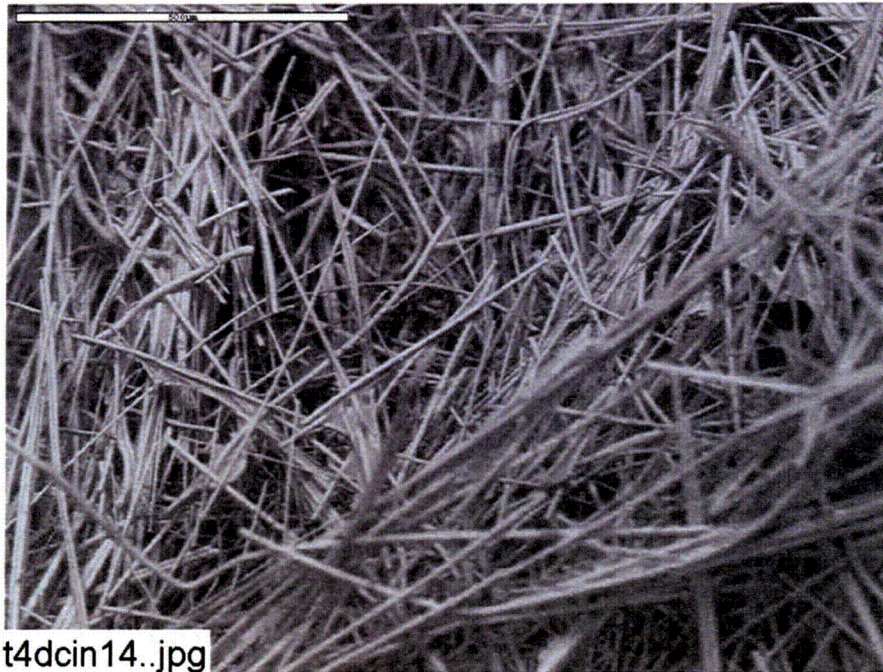
t4dcin14..jpg

Figure C6-7. Environmental SEM image magnified 100 times for a Test #4, Day-30 interior fiberglass sample on the drain collar. (t4dcin14.jpg)

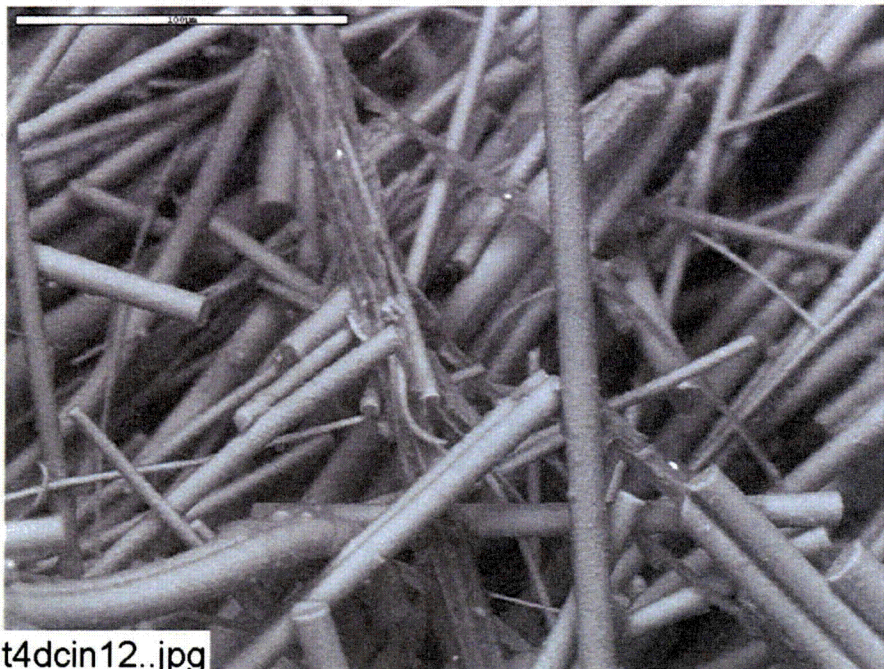
t4dcin12..jpg

Figure C6-8. Environmental SEM image magnified 500 times for a Test #4, Day-30 interior fiberglass sample on the drain collar. (t4dcin12.jpg)

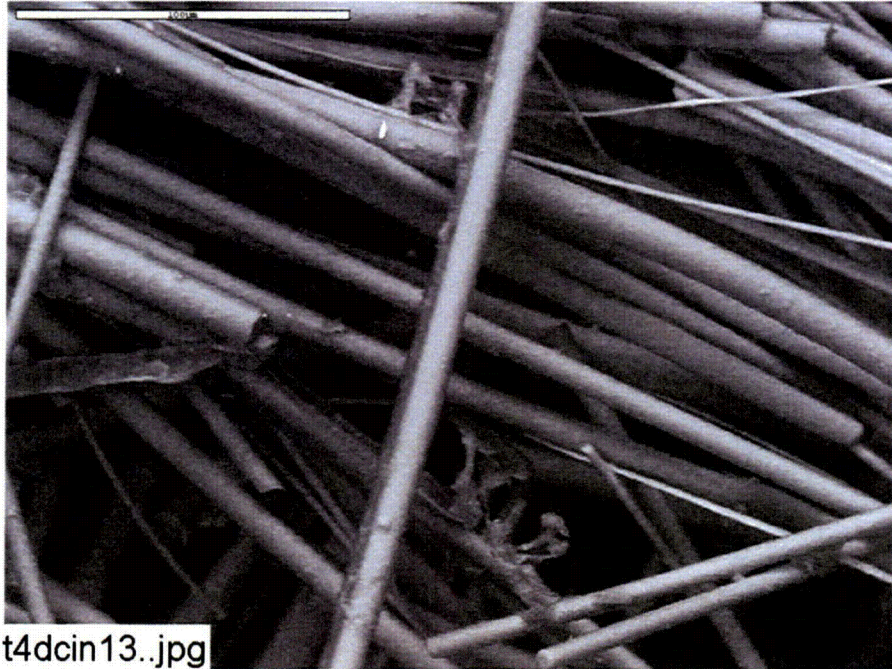
Figure C6-9. Environmental SEM image magnified 500 times for a Test #4, Day-30 interior fiberglass sample on the drain collar. (t4dcin13.jpg)

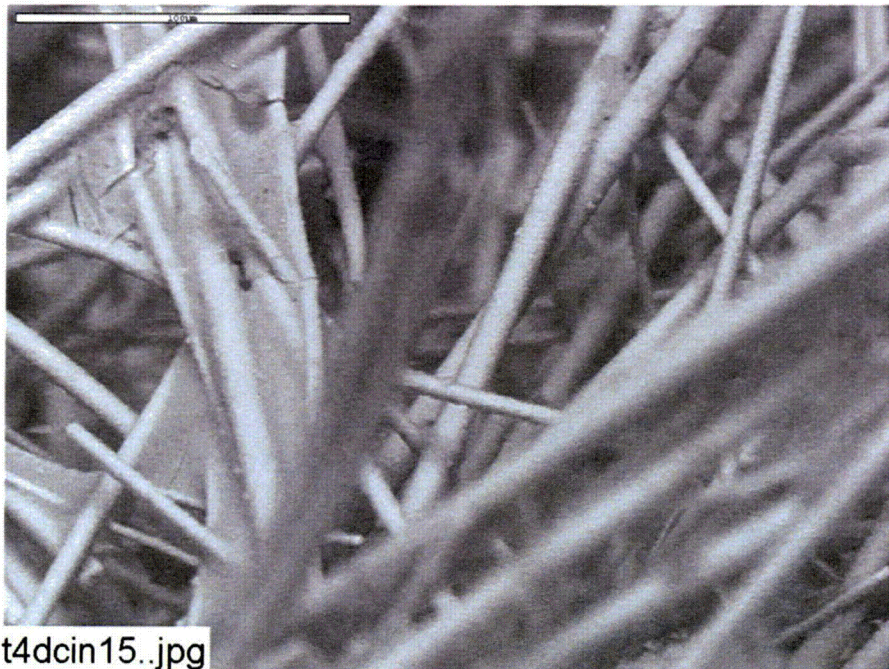
Figure C6-10. Environmental SEM image magnified 500 times for a Test #4, Day-30 interior fiberglass sample on the drain collar. (t4dcin15.jpg)

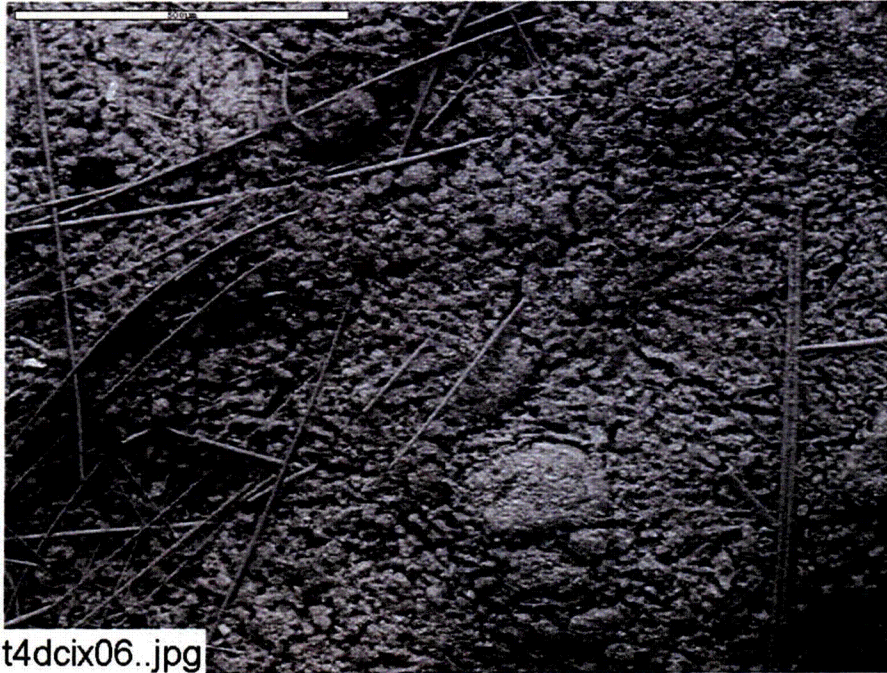
t4dcix06..jpg

Figure C6-11. Environmental SEM image magnified 100 times for a Test #4, Day-30 exterior fiberglass sample on the drain collar (next to the drain screen). (t4dcix06.jpg)

Image:	t4dcix06	100 ×	ESEM image	Figure C6-11
	t4dcix10	100 ×	ESEM image	Figure C6-12
	t4dcix07	500 ×	ESEM image	Figure C6-13
	t4dcix08	1000 ×	ESEM image higher magnification	Figure C6-14
EDS:	t4dcix09		EDS on particles in t4dcix08	Figure C6-15

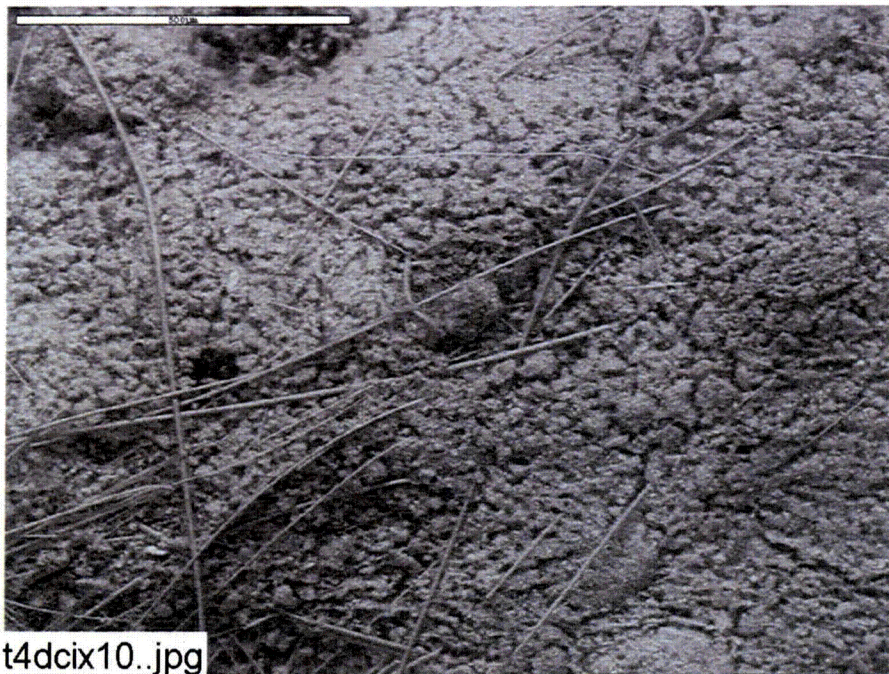
t4dcix10..jpg

Figure C6-12. Environmental SEM image magnified 100 times for a Test #4, Day-30 exterior fiberglass sample on the drain collar (next to the drain screen). (t4dcix10.jpg)

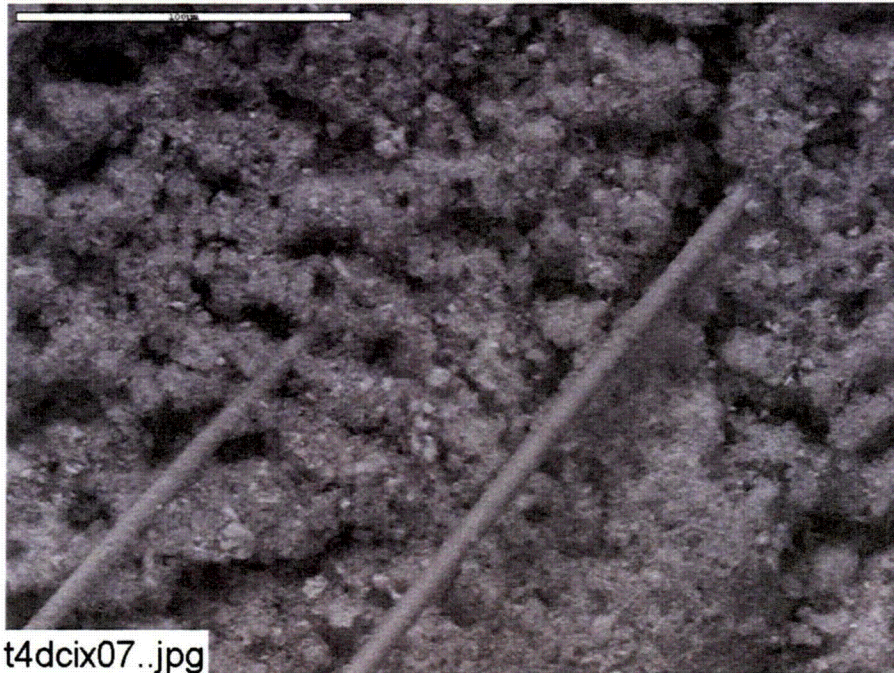
t4dcix07..jpg

Figure C6-13. Environmental SEM image magnified 500 times for a Test #4, Day-30 exterior fiberglass sample on the drain collar (next to the drain screen). (t4dcix07.jpg)

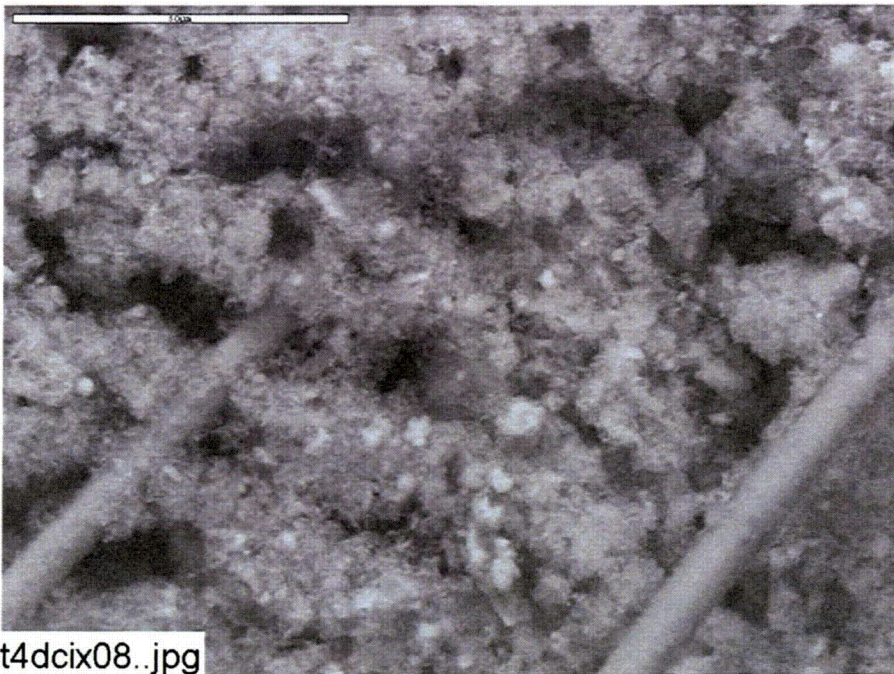
t4dcix08..jpg

Figure C6-14. Environmental SEM image magnified 1000 times for a Test #4, Day-30 exterior fiberglass sample on the drain collar (next to the drain screen). (t4dcix08.jpg)

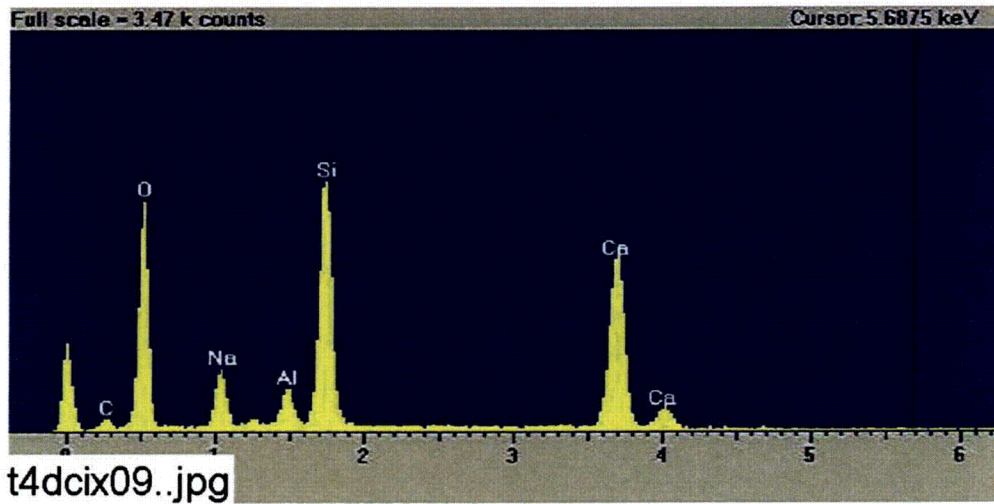
Figure C6-15. EDS counting spectrum for the large mass of particulate deposits on fiberglass shown in Figure C6-14. (t4dcix09.jpg)

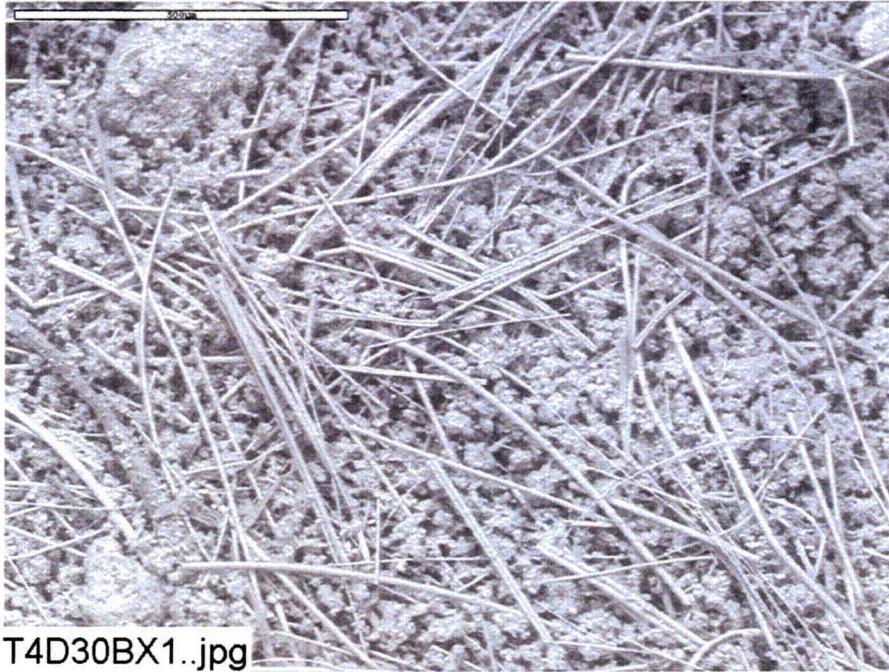
Figure C7-1. Environmental SEM image magnified 100 times for a Test #4, Day-30 exterior fiberglass sample within the birdcage. (T4D30BX1.jpg)

Image: T4D30BX1	100 ×	ESEM image	Figure C7-1
t4d30bx4	500 ×	ESEM annotated image	Figure C7-2
EDS: t4d30bx3		EDS on particles in t4d30bx4	Figure C7-3

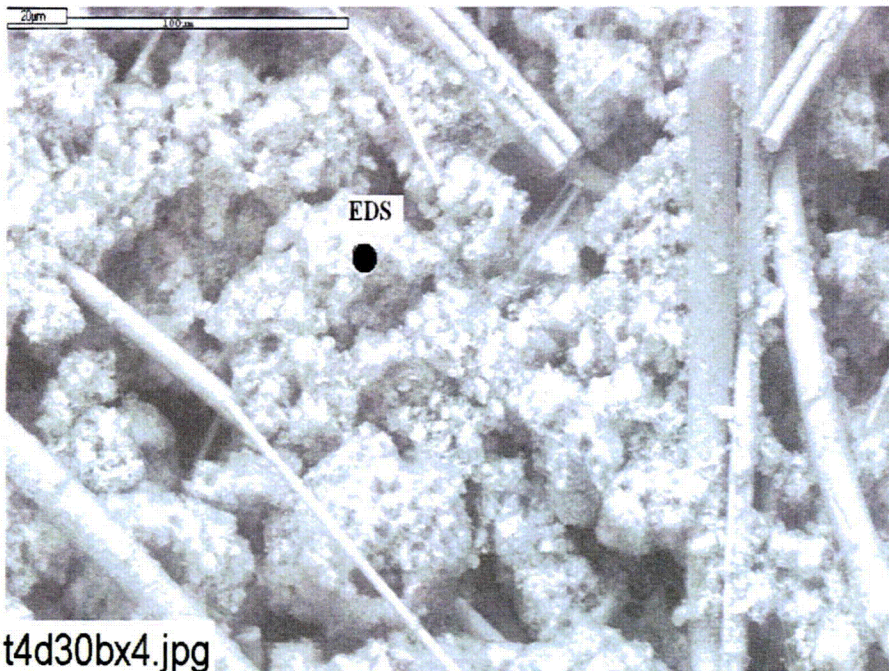
Figure C7-2. Annotated environmental SEM image magnified 500 times for a Test #4, Day-30 exterior fiberglass sample within the birdcage. (t4d30bx4.jpg)

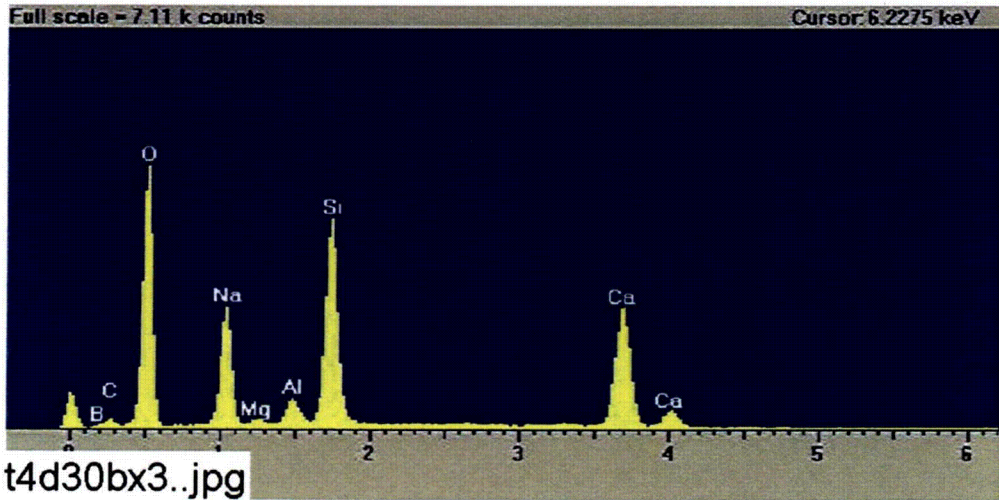
Figure C7-3. EDS counting spectrum for the particulate deposits on fiberglass shown in Figure C7-2. (T4D30bx3.jpg)

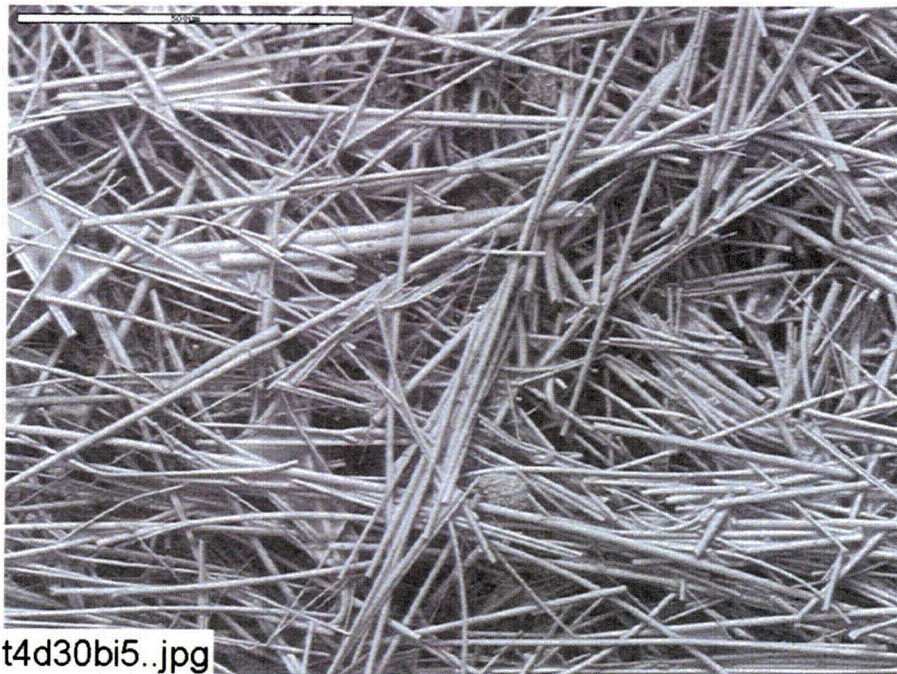
Figure C7-4. Environmental SEM image magnified 100 times for a Test #4, Day-30 interior fiberglass sample within the birdcage. (t4d30bi5.jpg)

Image: t4d30bi5	100 ×	ESEM image of fiberglass	Figure C7-4
t4d30bi6	500 ×	ESEM image higher magnification	Figure C7-5
t4d30bi7	500 ×	ESEM image	Figure C7-6

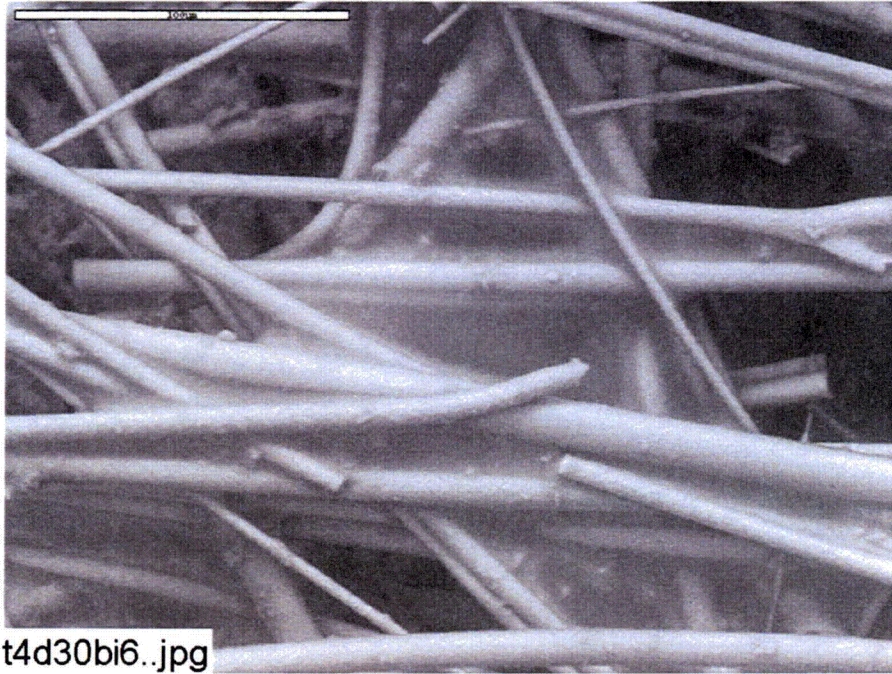
t4d30bi6.jpg

Figure C7-5. Environmental SEM image magnified 500 times for a Test #4, Day-30 interior fiberglass sample within the birdcage. (t4d30bi6.jpg)

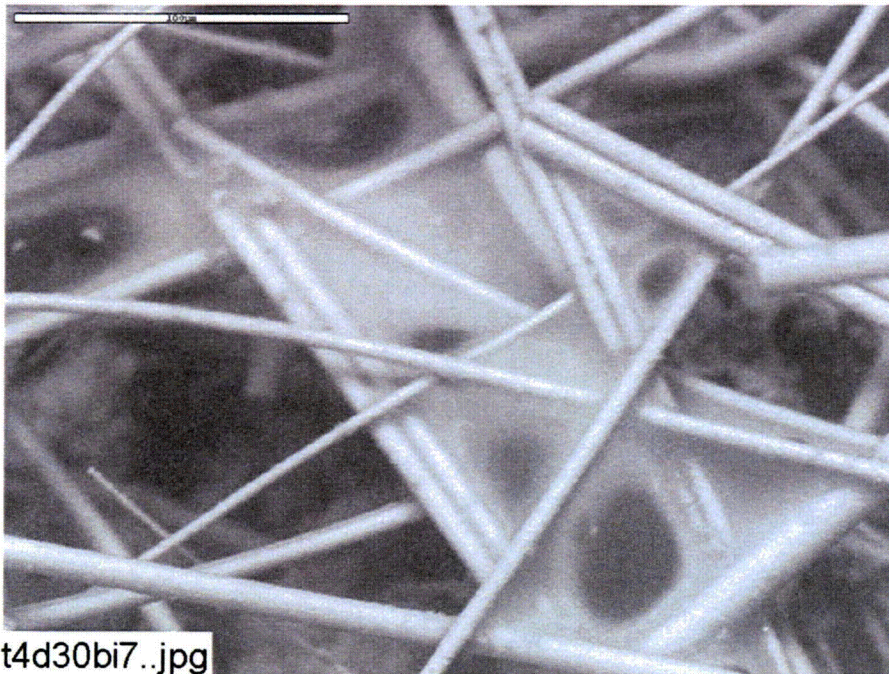
t4d30bi7.jpg

Figure C7-6. Environmental SEM image magnified 500 times for a Test #4, Day-30 interior fiberglass sample within the birdcage. (t4d30bi7.jpg)

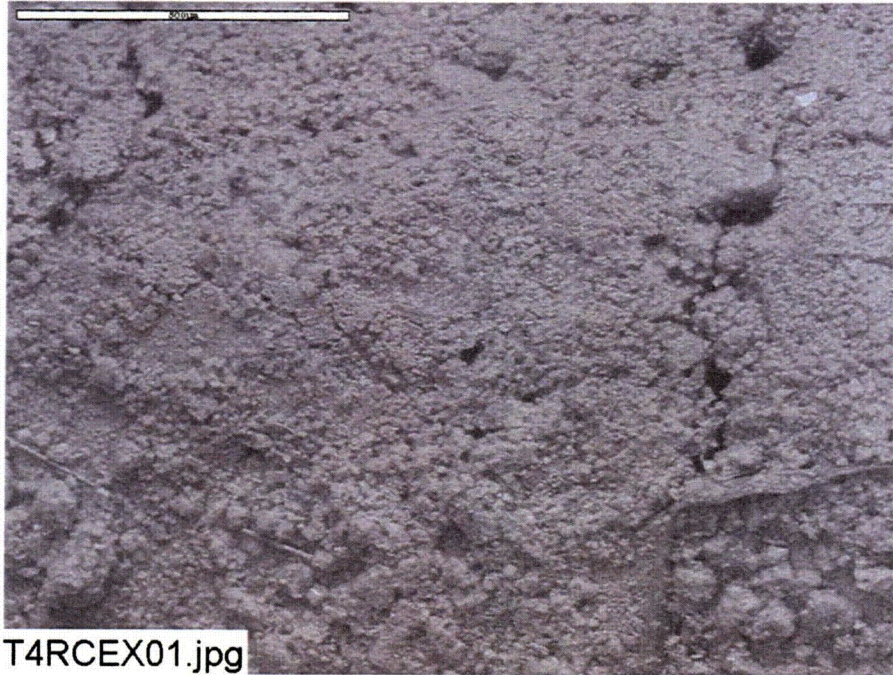
Figure D-1. ESEM image magnified 100 times for a Test #4, Day-30 low-flow exterior raw cal-sil sample. (T4RCEX01.jpg)

Image:	T4RCEX01	100 ×	ESEM image	Figure D-1
	t4rcex02	500 ×	ESEM at higher magnification	Figure D-2
EDS:	t4rcex03		EDS on whole image t4rcex02	Figure D-3

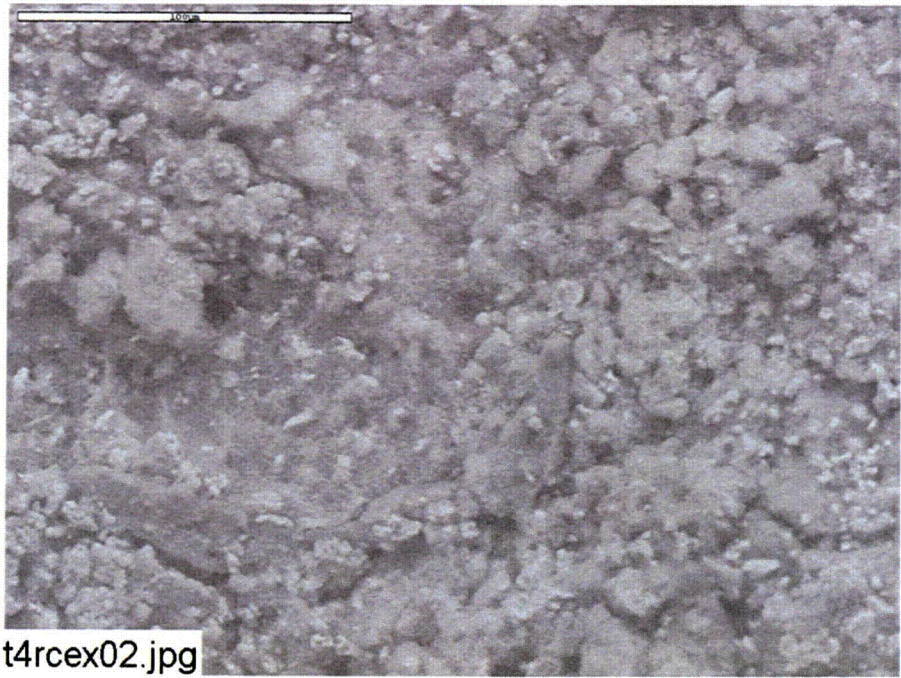
Figure D-2. ESEM image magnified 500 times for a Test #4, Day-30 low-flow exterior raw cal-sil sample. (t4rcex02.jpg)

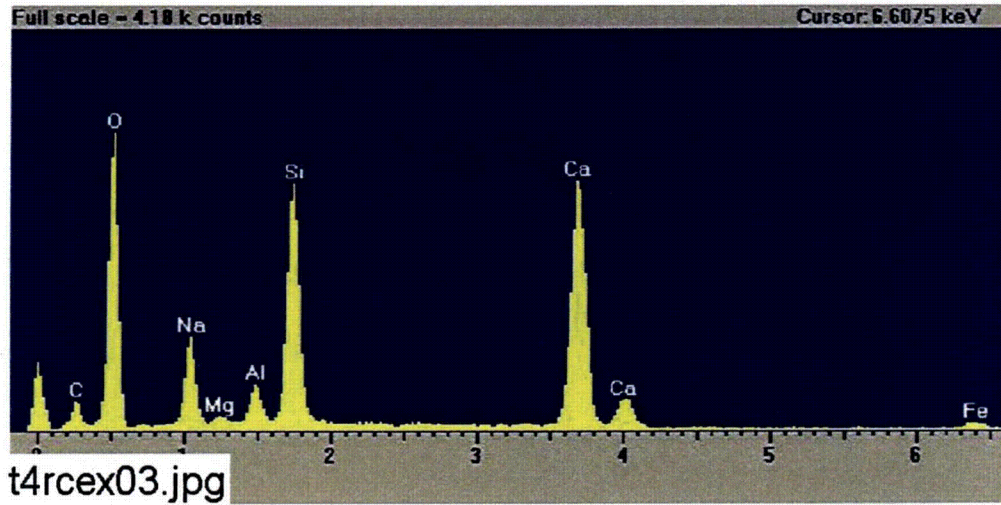
Figure D-3. EDS counting spectrum for the whole image shown in Figure D-2. (t4rcex03.jpg)

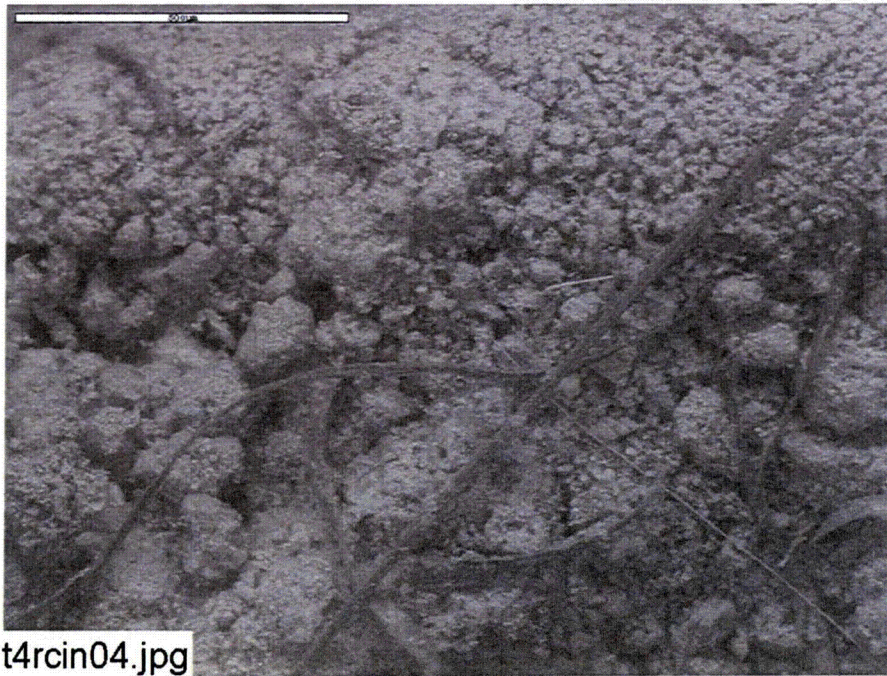
Figure D-4. ESEM image magnified 100 times for a Test #4, Day-30 low-flow interior raw cal-sil sample. (t4rcin04.jpg)

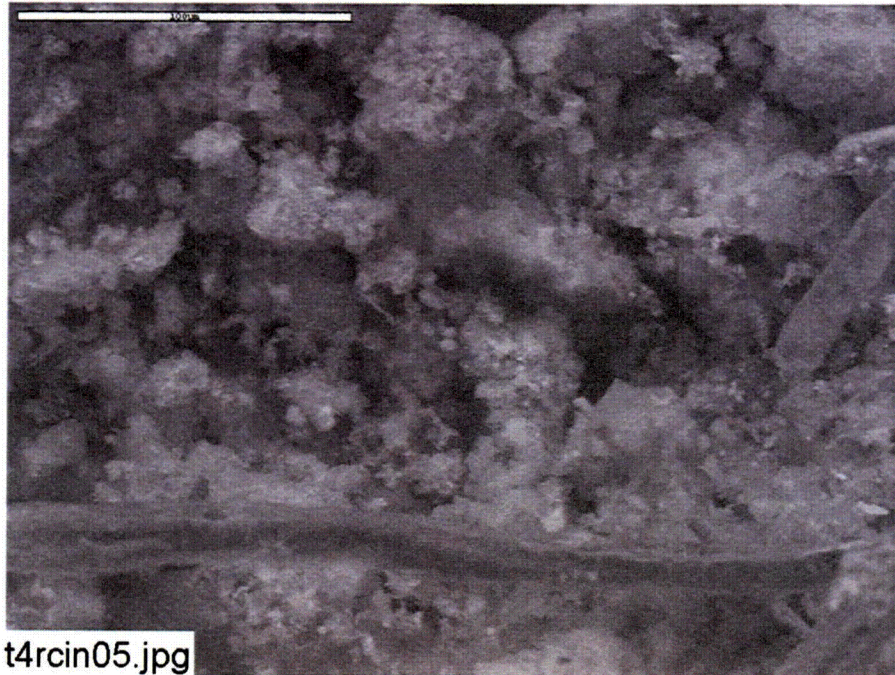
Figure D-5. ESEM image magnified 500 times for a Test #4, Day-30 low-flow interior raw cal-sil sample. (t4rcin05.jpg)

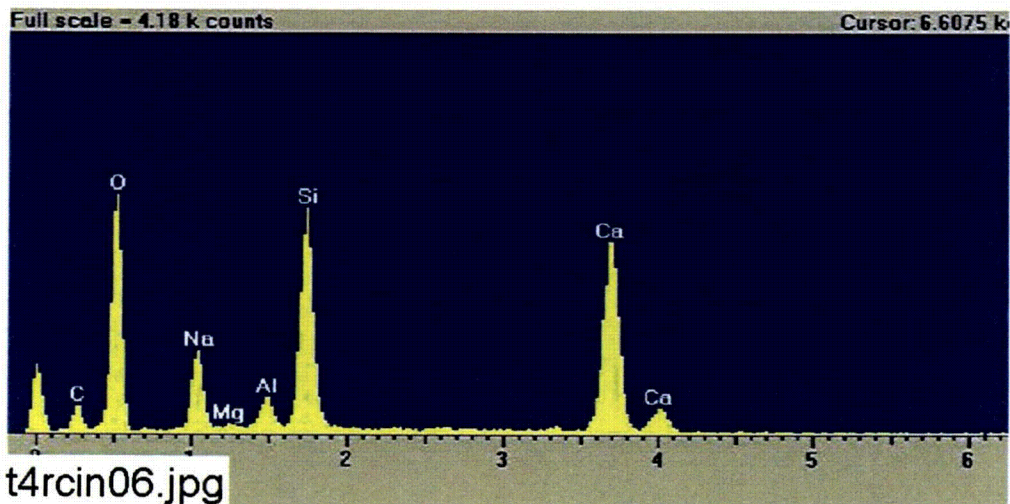
Figure D-6. EDS counting spectrum for the whole image shown in Figure D-5. (t4rcin06.jpg)

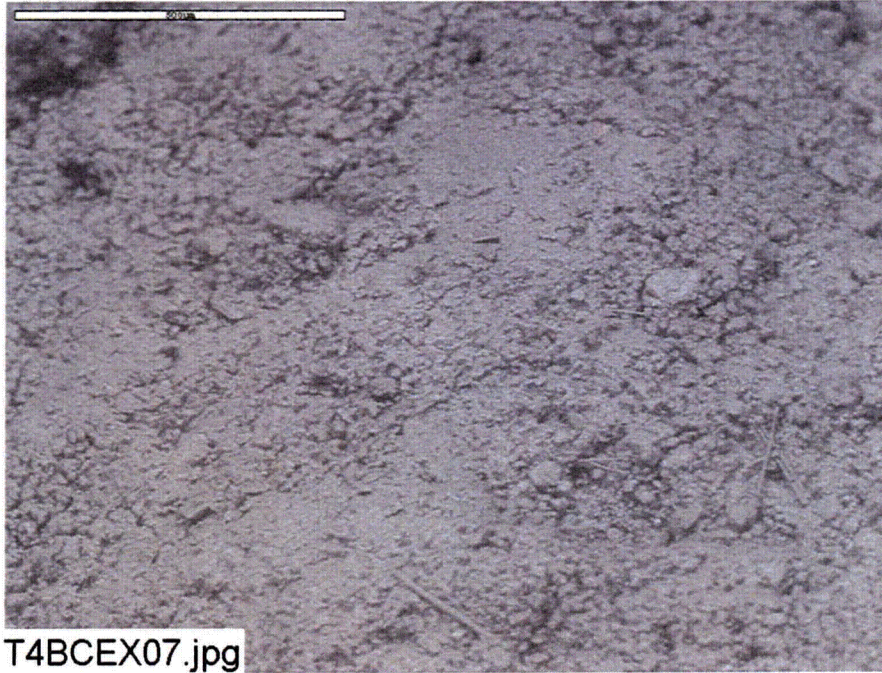
Figure D-7. ESEM image magnified 100 times for a Test #4, Day-30 low-flow exterior baked cal-sil sample. (T4BCEX07.jpg)

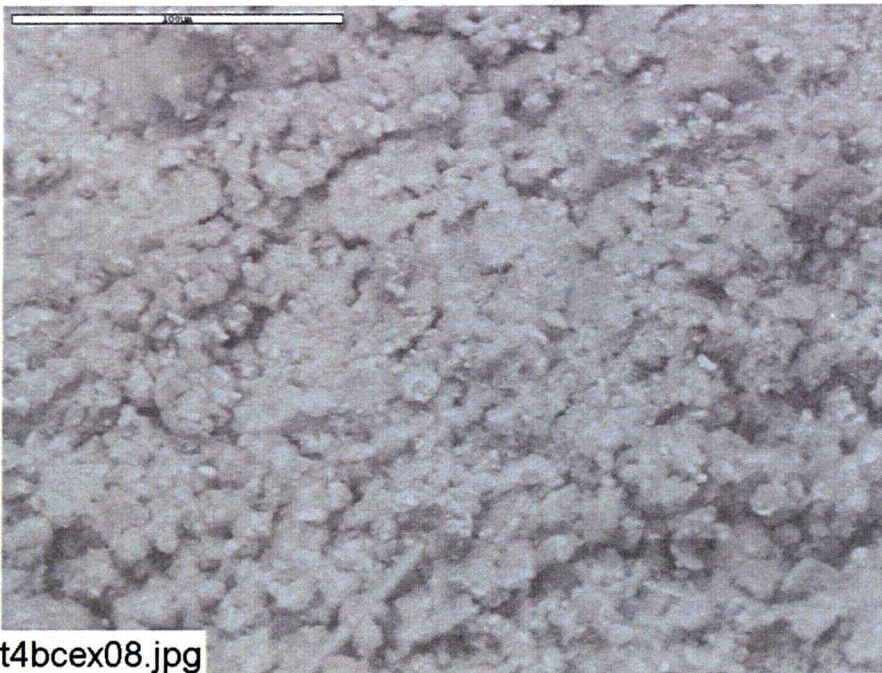
Figure D-8. ESEM image magnified 500 times for a Test #4, Day-30 low-flow exterior baked cal-sil sample. (t4bcex08.jpg)

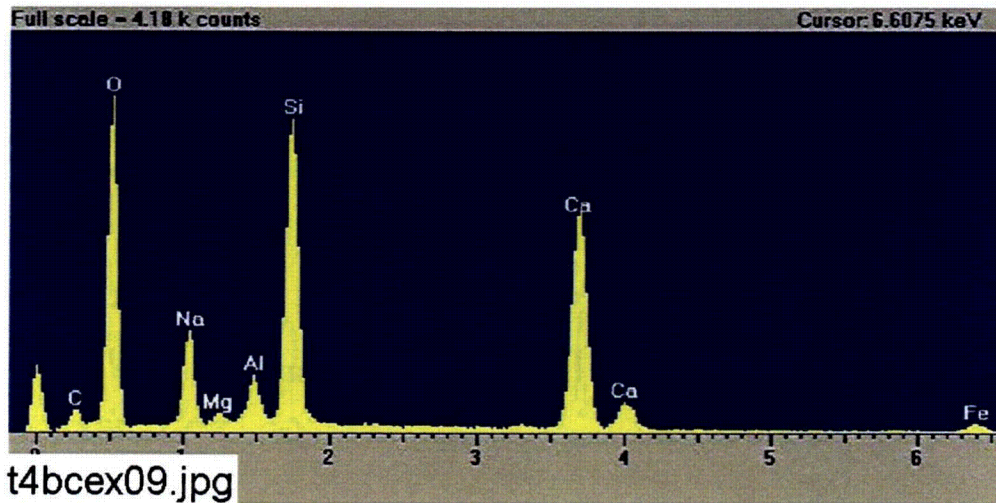
Figure D-9. EDS counting spectrum for the whole image shown in Figure D-7. (t4bcex09.jpg)
