Appendix A

ESEM/EDS Data for Test #4, Day-5 Fiberglass in Low-Flow Zone

During ICET Test #4, work was continued for the purpose of identifying the origin and chemical composition of the products that were formed during the test. One objective of ICET is to identify the composition of debris on fiberglass and the particulate substances in the test solution. To address this question partially, low-flow fiberglass samples on Test #4, Day 5 were examined by ESEM/EDS, including both of the exterior and the interior location of the fiberglass samples.

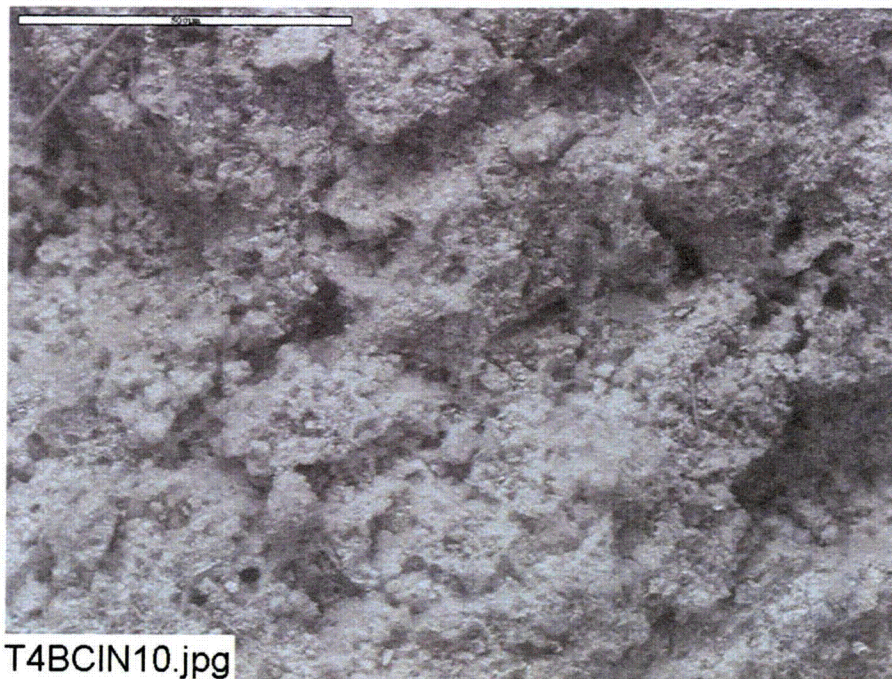
Figure D-10. ESEM image magnified 100 times for a Test #4, Day-30 low-flow interior baked cal-sil sample. (T4BCIN10.jpg)

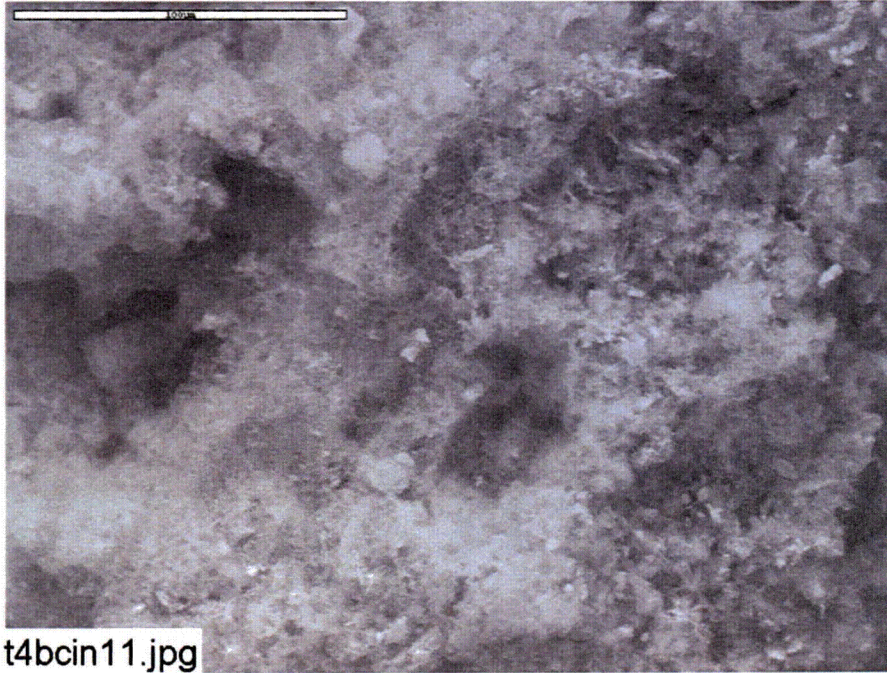
Figure D-11. ESEM image magnified 500 times for a Test #4, Day-30 low-flow interior baked cal-sil sample. (t4bcin11.jpg)

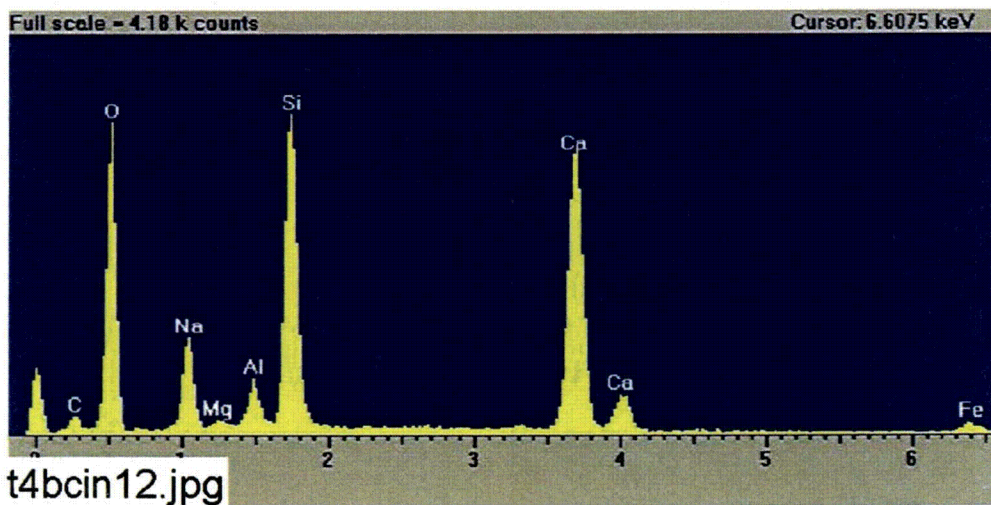
Figure D-12. EDS counting spectrum for the whole image shown in Figure D-11. (t4bcin12.jpg)

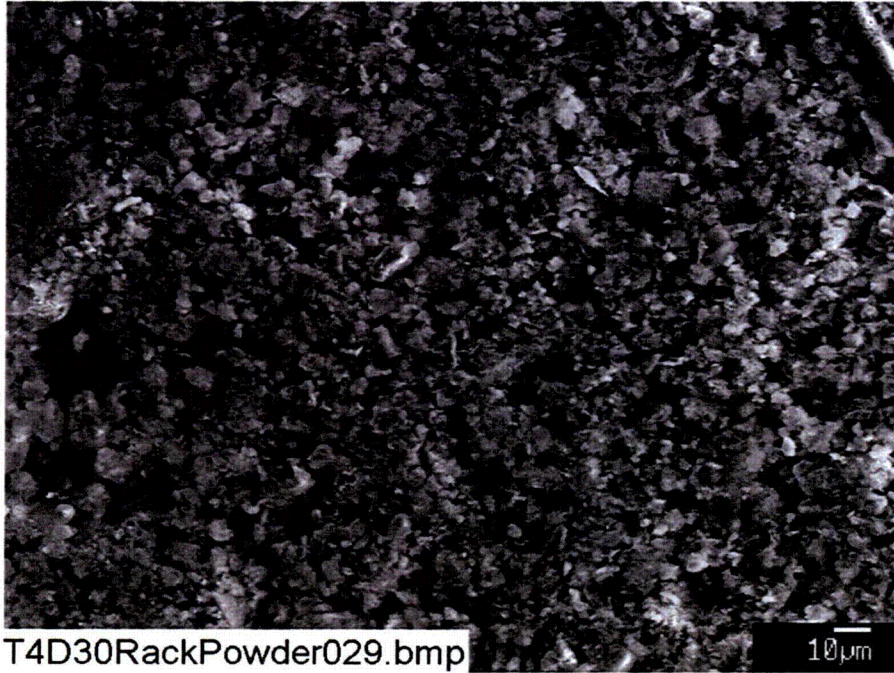
T4D30RackPowder029.bmp

Figure E-1. SEM image magnified 500 times for a Test #4, Day-30 fine powder on the submerged rack. (T4D30RackPowder029.bmp)

Image:	T4D30RackPowder029	500 ×	ESEM image	Figure E-1
	T4D30RackPowder030	1000 ×	ESEM at higher magnification	Figure E-2
EDS:	T4D30RackPowder018		EDS of whole of image 30	Figure E-3

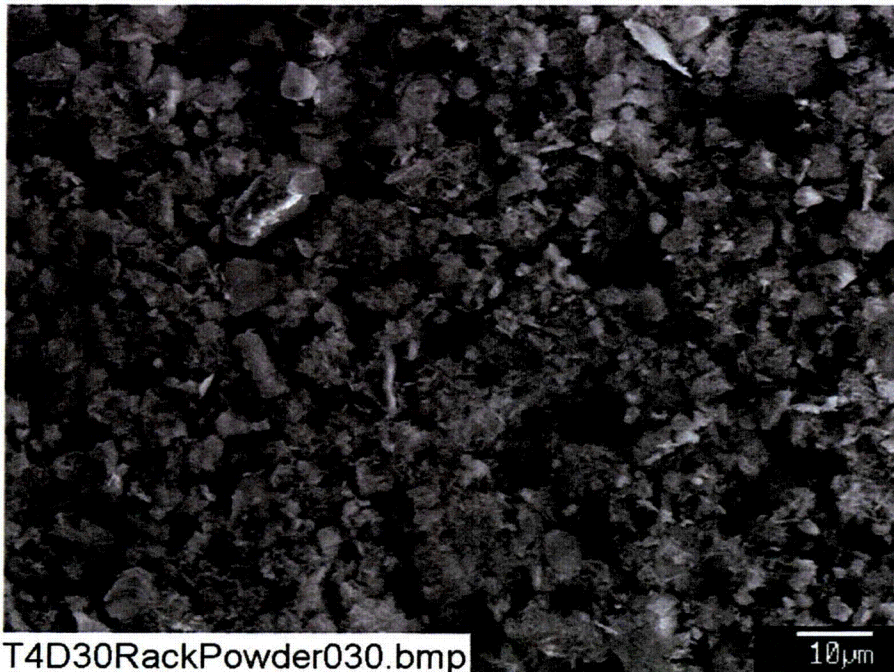
T4D30RackPowder030.bmp

Figure E-2. SEM image magnified 1000 times for a Test #4, Day-30 fine powder on the submerged rack. (T4D30RackPowder030.bmp)

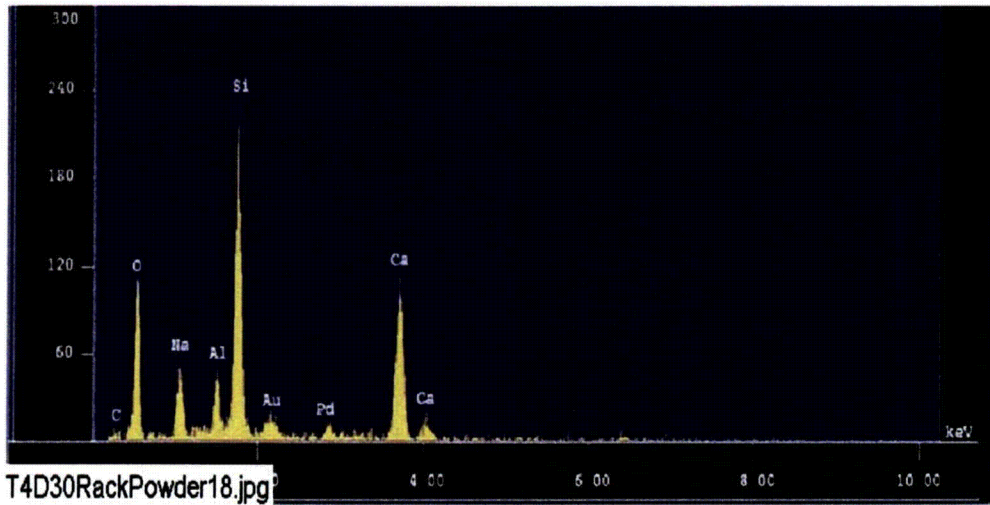
Figure E-3. EDS counting spectrum for the particles (whole image) shown in Figure E-2. (T4D30RackPowder18.jpg)

The results from the chemical composition analysis for T4D30RackPowder18.jpg are given in Table E-1.
