UNITED STATES OF AMERICA
NUCLEAR REGULATORY COMMISSION

In the Matter of)
)
AMERGEN ENERGY COMPANY, LLC) Docket No. 50-219-LR
)
(Oyster Creek Nuclear Generating Station))

NRC STAFF INITIAL STATEMENT
OF POSITION ON THE DRYWELL CONTENTION

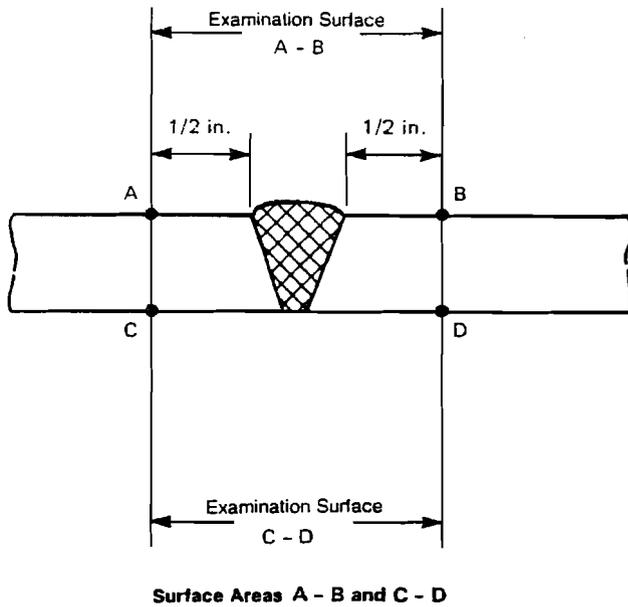
FIG. IWE-2500-1 DISSIMILAR METAL WELDS

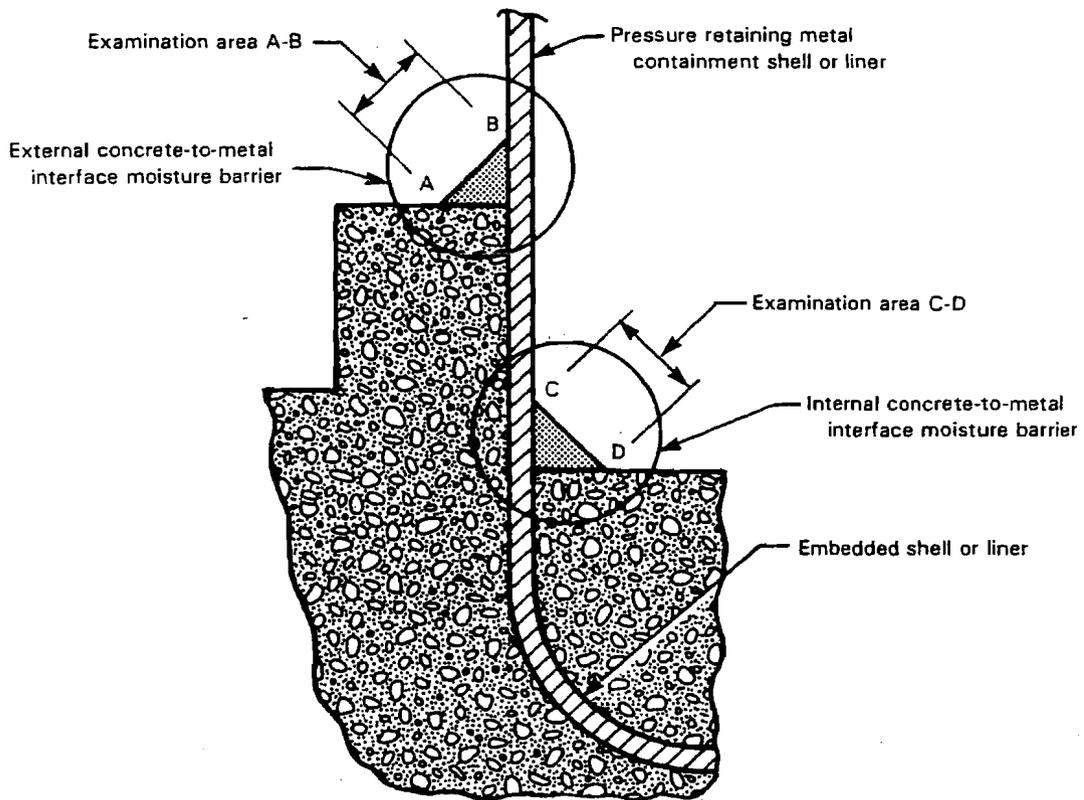
FIG. IWE-2500-2 EXAMINATION AREAS FOR MOISTURE BARRIERS

- (1) Examination shall include seals and gaskets on airlocks, hatches, and other devices that are required to assure containment leak-tight integrity.
- (2) Examination shall include internal and external containment moisture barrier materials at concrete-to-metal interfaces intended to prevent intrusion of moisture against the pressure retaining metal containment shell or liner.
- (3) Containment moisture barrier materials include caulking, flashing, and other sealants used for this application.
- (4) Examination shall include all accessible surfaces of internal and external containment moisture barriers.
- (5) Deferral of inspection is not permissible in the 4th and successive inspection intervals.
