UNITED STATES OF AMERICA
NUCLEAR REGULATORY COMMISSION

In the Matter of)
)
AMERGEN ENERGY COMPANY, LLC) Docket No. 50-219-LR
)
(Oyster Creek Nuclear Generating Station))

NRC STAFF INITIAL STATEMENT
OF POSITION ON THE DRYWELL CONTENTION

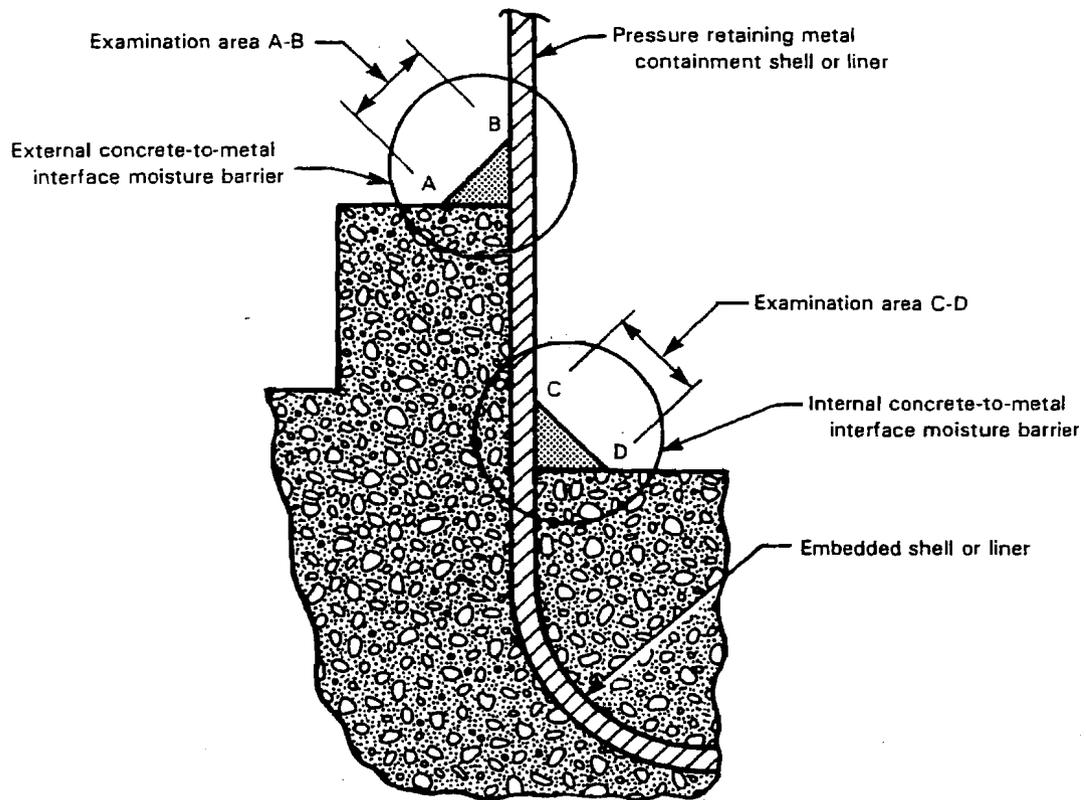
FIG. IWE-2500-2 EXAMINATION AREAS FOR MOISTURE BARRIERS

EXAMINATION CATEGORY E-D, SEALS, GASKETS, AND MOISTURE BARRIERS							
Item No.	Parts Examined ¹	Examination Requirements/ Fig. No.	Examination Method	Acceptance Standard	Extent and Frequency of Examination		Deferral of Inspection to End of Interval ⁵
					1st Inspection Interval	Successive Inspection Intervals	
E5.10	Seals ¹	IWE-2500-2	Visual, VT-3	IWE-3513	100% of each item	100% of each item	Not permissible
E5.20	Gaskets ¹		Visual, VT-3	IWE-3513	100% of each item	100% of each item	Not permissible
E5.30	Moisture Barriers ^{2,3,4}		Visual, VT-3	IWE-3513	100% of each item	100% of each item	Not permissible

- (1) Examination shall include seals and gaskets on airlocks, hatches, and other devices that are required to assure containment leak-tight integrity.
- (2) Examination shall include internal and external containment moisture barrier materials at concrete-to-metal interfaces intended to prevent intrusion of moisture against the pressure retaining metal containment shell or liner.
- (3) Containment moisture barrier materials include caulking, flashing, and other sealants used for this application.
- (4) Examination shall include all accessible surfaces of internal and external containment moisture barriers.
- (5) Deferral of inspection is not permissible in the 4th and successive inspection intervals.
