Integrated Chemical Effects Test Project: Test #5 Data Report

Los Alamos National Laboratory

**U.S. Nuclear Regulatory Commission
Office of Nuclear Regulatory Research
Washington, DC 20555-0001**

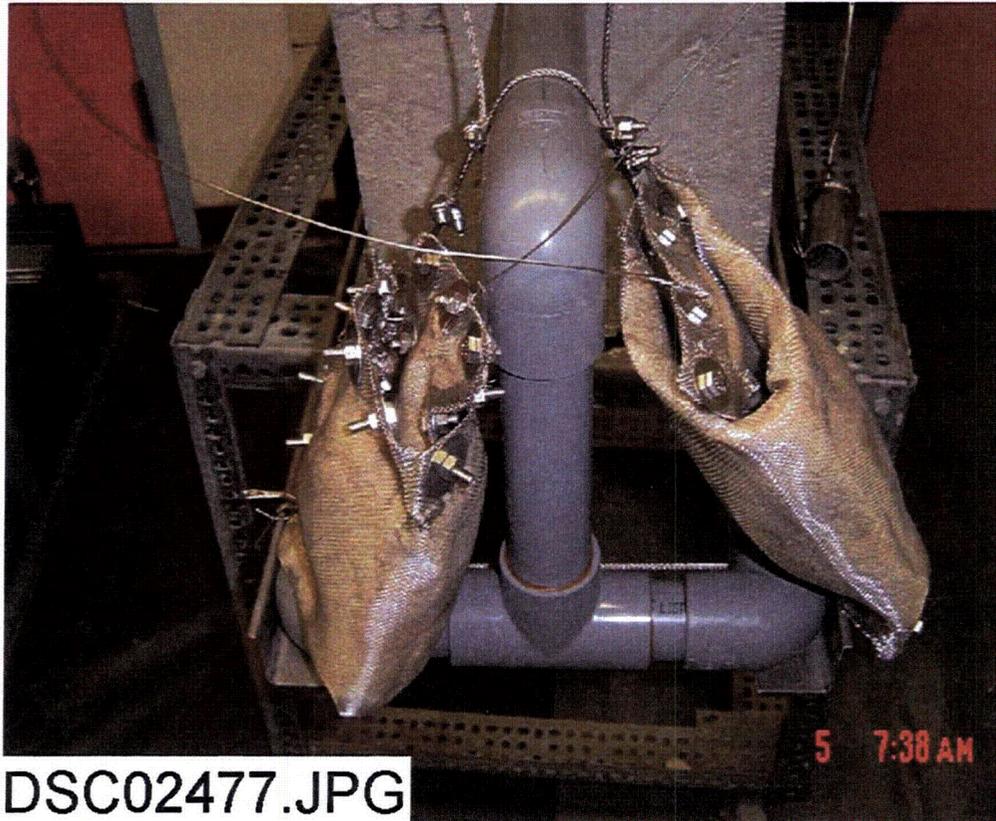
Several fiberglass samples were placed in the ICET tank. Samples were either submerged or held above the water level. The unsubmerged fiberglass samples were positioned so they would be exposed to sprays. The fiberglass samples were contained in SS wire mesh that allowed water flow while confining the fiberglass material. Both loosely packed and more tightly packed samples were used. In addition, some submerged fiberglass samples were located where they would be exposed to relatively high-flow conditions, and others were located in quiescent regions of the tank. Figure 2-4 shows the so-called “sacrificial” fiberglass samples in wire mesh pouches attached to the submerged coupon rack (Rack 1 in Figure 2-2). Each pouch contains approximately 5 g of fiberglass. Those samples were attached with SS wire; removed from the tank on Days 4, 15, and 30; and examined. As shown in the figure, bigger insulation bags were wrapped around the sacrificial specimens during the test. In addition, small, sacrificial samples called fiber pucks were added to the solution. The fiber pucks are described in Ref. 4. Subsection 2.4.1.1 contains descriptions of other fiberglass samples.

Figure 2-4. Fiberglass samples attached to a coupon rack.

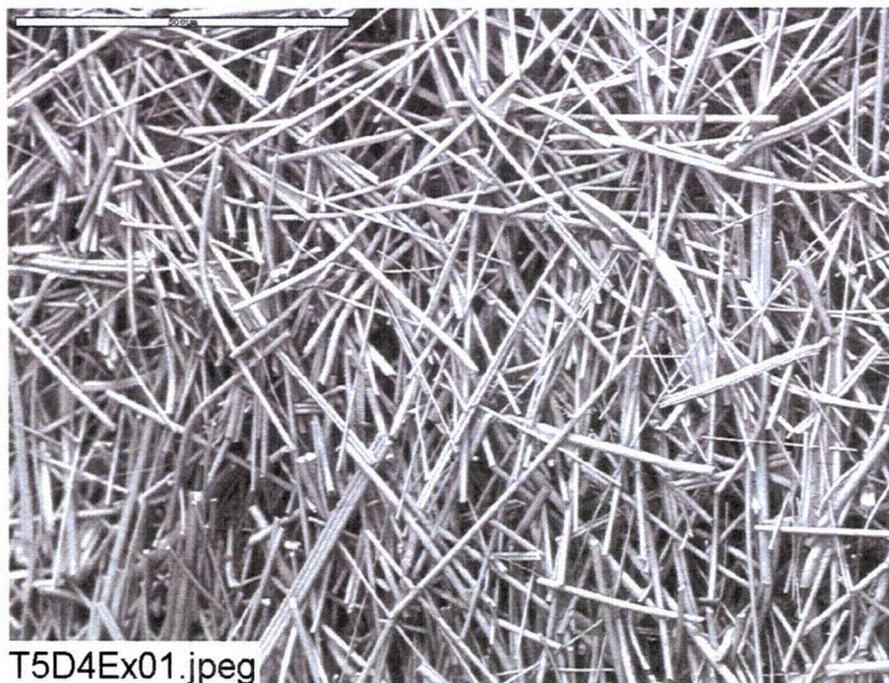
Figure 3-16. ESEM image magnified 100 times for a Test #5, Day-4 low-flow exterior fiberglass sample.

Since there was no significant water flowing through the fiberglass samples during the test, the migration of particulate deposits from the solution into the fiberglass interior was insignificant. ESEM results revealed some deposits on both the exterior and the interior of the low-flow fiberglass samples after 4 days of the test. These deposits were either formed like a webbing among glass fibers (see Figures 3-17 and 3-21) or flocculent (see Figure 3-19). The deposits are likely of chemical origin instead of being physically attached/retained. They may be formed during the drying process (semi-dehydrated) of the samples during ESEM analysis. EDS results indicated that both types of deposits were commonly composed of O, Na, Ca, Mg, Al, B, C, and possibly Si. Comparing the amount of the deposits on fiberglass revealed no significant difference between the interior and exterior samples. Again, this fact may be explained by the likely chemical origin of the deposits, since chemical precipitation would occur to a similar degree on both the exterior and the interior fiberglass samples if the concentrations were similar. Figures 3-16 through 3-22 show the Day-4 low-flow fiberglass results.

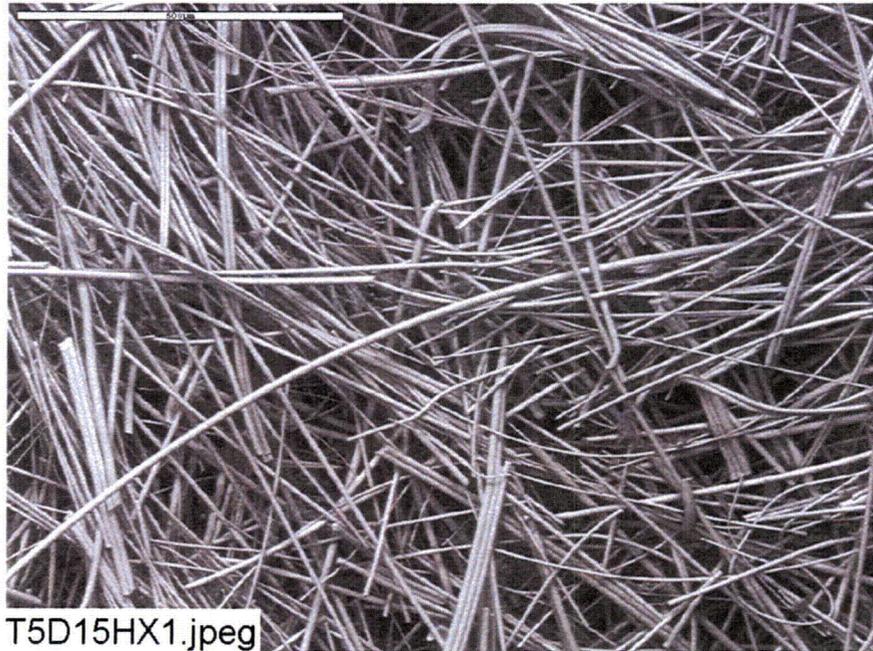
Figure 3-29. ESEM image magnified 100 times for a Test #5, Day-15 high-flow exterior fiberglass sample.

In contrast to the Day-15 low-flow samples, no web-like deposits were found in the Day-15 high-flow fiberglass samples. However, flocculent deposits were found on both the exterior and interior Day-15 high-flow fiberglass samples. There was no significant difference regarding the amount of the flocculent deposits between the exterior and the interior fiberglass samples, suggesting the deposits' likely chemical origin. The visual

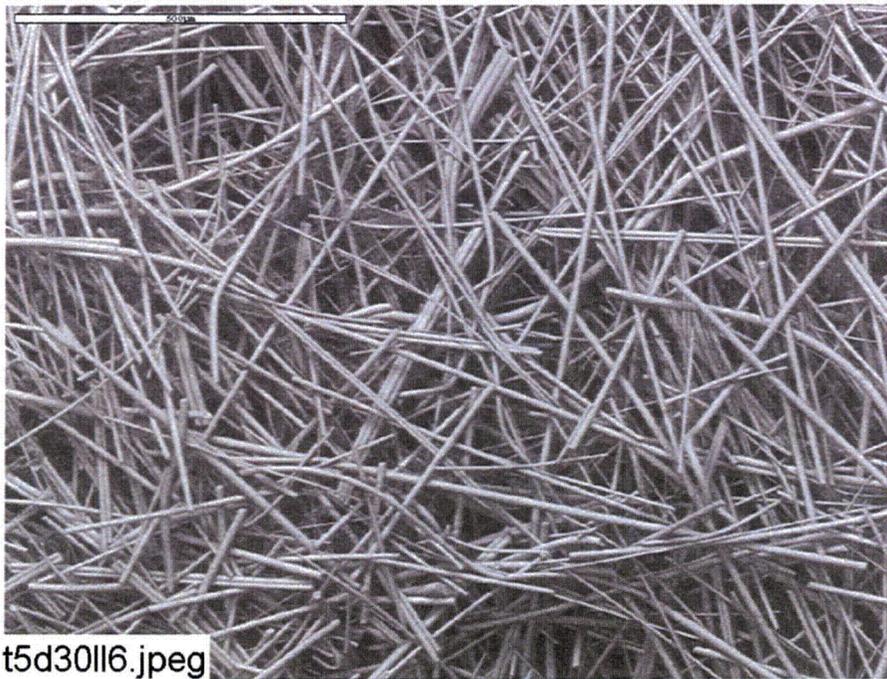
Figure 3-35. ESEM image magnified 100 times for a Test #5, Day-30 low-flow interior fiberglass sample.

No observable increase in the flocculent deposits was found with the Day-30 low-flow fiberglass samples compared with Day-4 and Day-15 low-flow fiberglass samples. No significant difference was found regarding the amount of the flocculent deposits between the exterior and the interior of the Day-30 low-flow fiberglass samples. No web-like deposits were found on either the exterior or interior of the Day-30 low-flow fiberglass samples. Furthermore, no particulate deposits were observed on either the exterior or interior fiberglass samples. Figures 3-33 through 3-36 show the Day-30 low-flow fiberglass results.

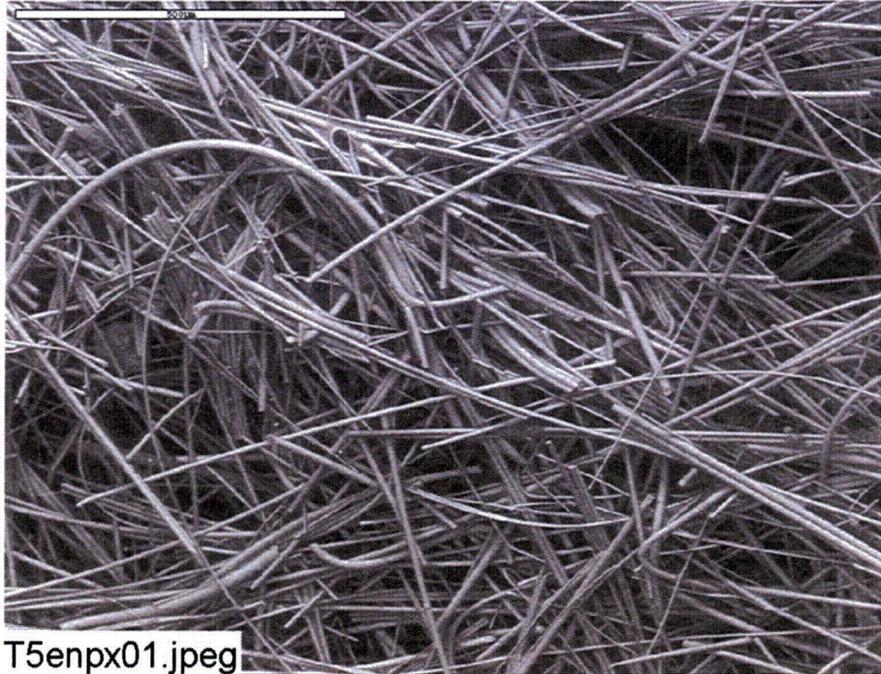
Figure 3-37. ESEM image magnified 100 times for a Test #5, Day-30 low-flow exterior fiberglass sample in a big envelope.

The big envelope was located on the tank bottom, contacting the test sediment on the bottom of the tank. In contrast to Day-4, Day-15, and other Day-30 low-flow fiberglass samples, a small amount of particulate deposits were observed on the fiberglass exterior of the Day-30 low-flow samples in the big envelope. EDS results show that the particulate deposits (see Figure 3-39) were composed of O, Na, Ca, Mg, Al, and possibly Si. However, no particulate deposits were observed on the fiberglass interior. Instead, flocculent deposits were found on the fiberglass interior, as they were with other interior fiberglass samples. Figures 3-37 through 3-41 illustrate these deposits for the Day-30 low-flow fiberglass in the big envelope.

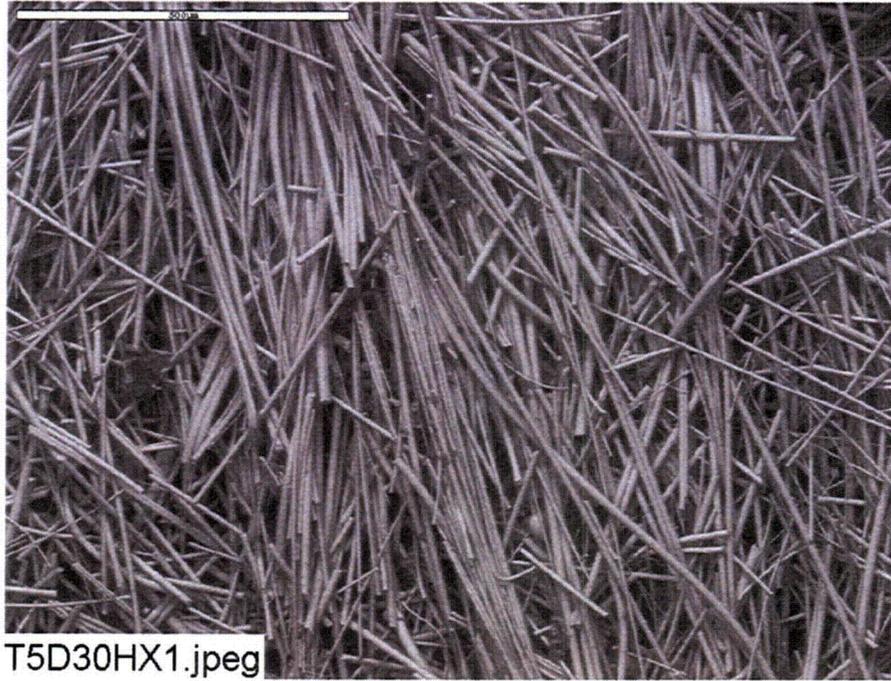
Figure 3-42. ESEM image magnified 100 times for a Test #5, Day-30 high-flow exterior fiberglass sample.

Compared with the Day-30 low-flow fiberglass samples, no significant amount of particulate deposits was found on high-flow exterior samples. In addition, consistent with the findings for other fiberglass interior samples, no particulate deposits were found on the interior. However, similar flocculent deposits were found on both the fiberglass exterior and interior. Figures 3-42 through 3-45 show the Day-30 high-flow fiberglass results.

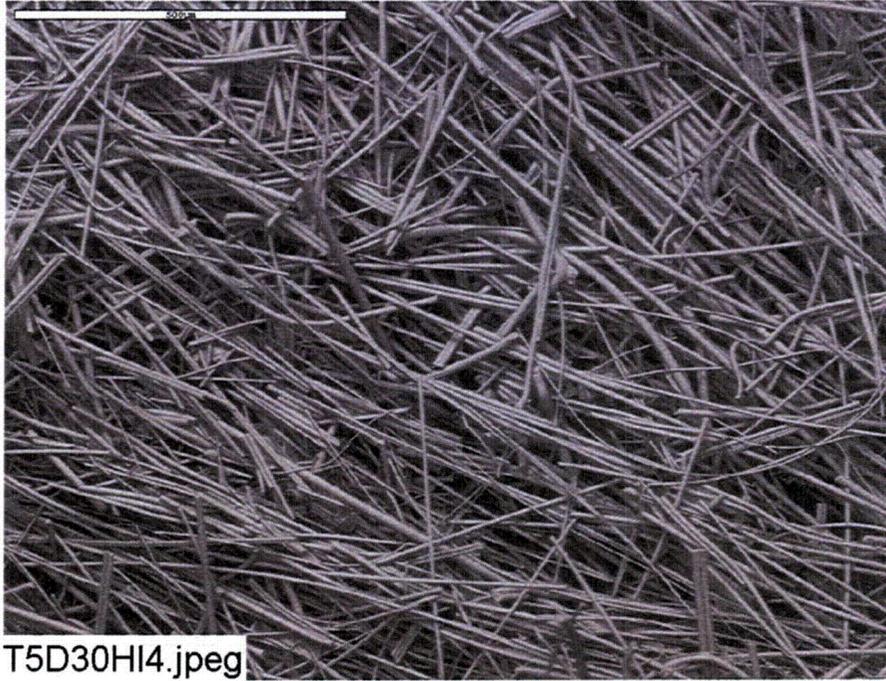
Figure 3-44. ESEM image magnified 100 times for a Test #5, Day-30 high-flow interior fiberglass sample.

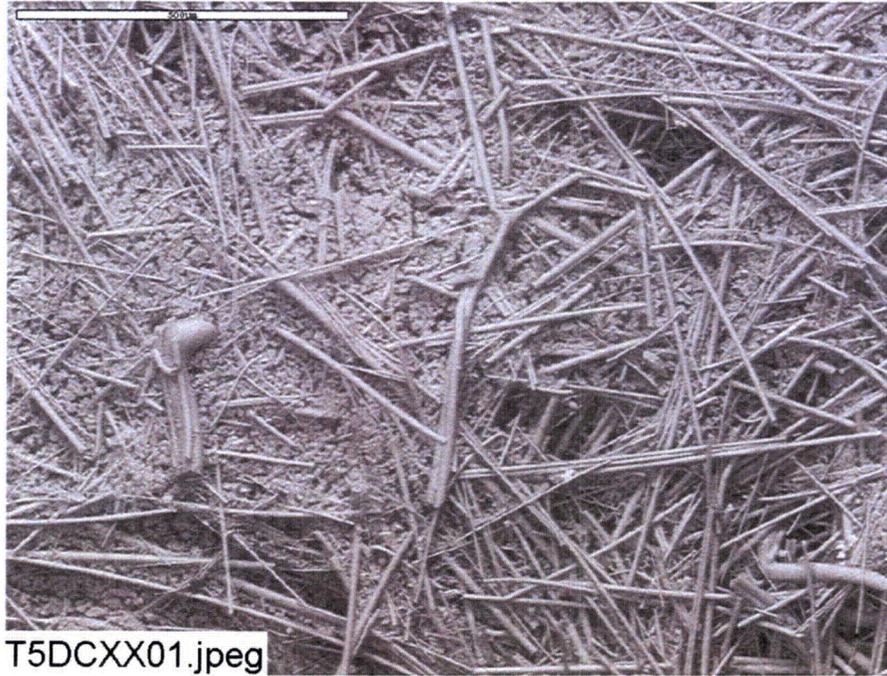
Figure 3-55. ESEM image magnified 100 times for a Test #5, Day-30 exterior drain collar fiberglass sample farthest from the drain screen.

Figure 3-94 shows the drain collar after it was removed from the tank. Both the exterior fiberglass sample that was farthest from the drain screen and the exterior sample that was next to the drain screen have significant amounts of particulate deposits. The amount of deposits on the drain collar exterior was much greater than on the high- and low-flow fiberglass samples. However, the exterior farthest from the drain screen had the most particulate deposits. ESEM results show that the development of a continuous coating on the drain collar exterior farthest from the drain screen, which includes particulate deposits that were likely physically retained or attached. EDS results indicate that the particulate deposits were composed mainly of O, Al, Na, Ca, Mg, C, and possibly Si, for both the drain collar exterior farthest from the drain screen and the exterior next to the drain screen. In addition to the particulate deposits, deposits rich in carbon were also found on the exterior farthest from the drain screen (see Figure 3-57). In contrast to the exterior, no significant particulate deposits were found in the drain collar interior sample, and only flocculent deposits were found (see image Figure 3-64). The drain collar interior is as clean as other high- or low-flow fiberglass interior samples. This result suggests that almost all of the particulate deposits were physically retained at the fiberglass exterior. Figures 3-55 through 3-64 show the drain collar fiberglass results.

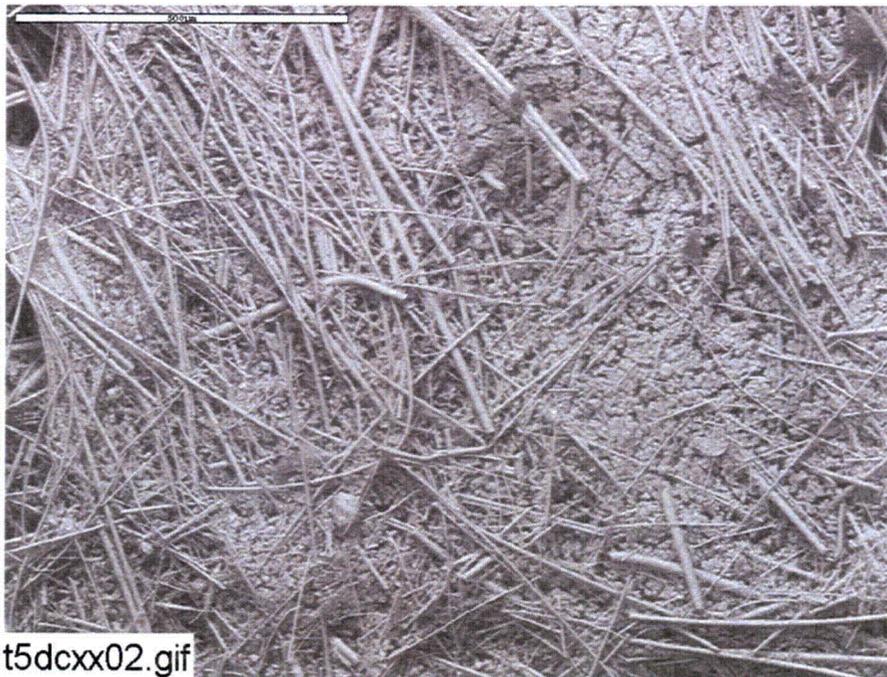
Figure 3-56. ESEM image magnified 100 times for a Test #5, Day-30 exterior drain collar fiberglass sample farthest from the drain screen.

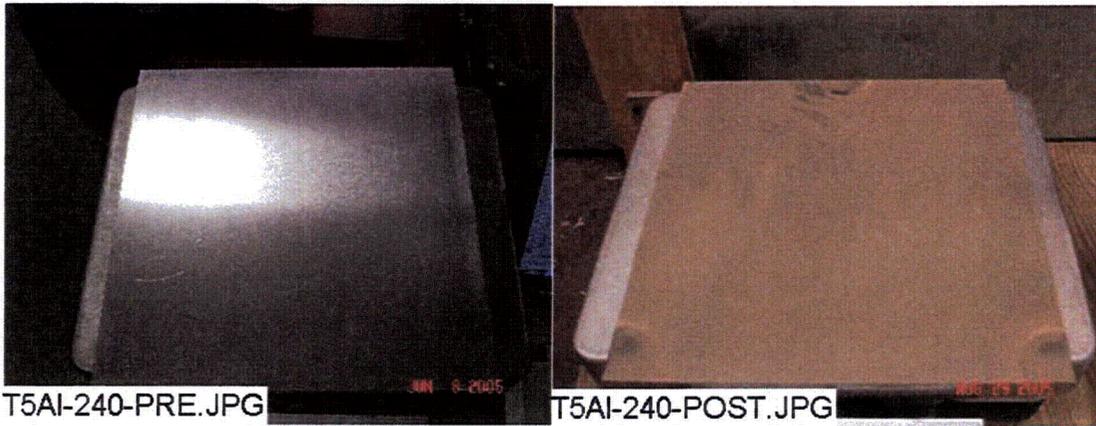
Figure 3-71. AI-240 submerged, pre-test (left) and post-test (right).

There are three submerged aluminum coupons in each test. Figures 3-71 through 3-73 are the pre- and post-test pictures of the Test #5 coupons. The aluminum coupons A1-240, A1-241, and A1-242 (see Figures 3-71 through 3-73) were located from east to west, respectively, in the tank. The submerged aluminum coupons turned brown, and they developed a brown, powdery film on the surface. The film resulted in the surface of the coupon becoming rough to the touch.

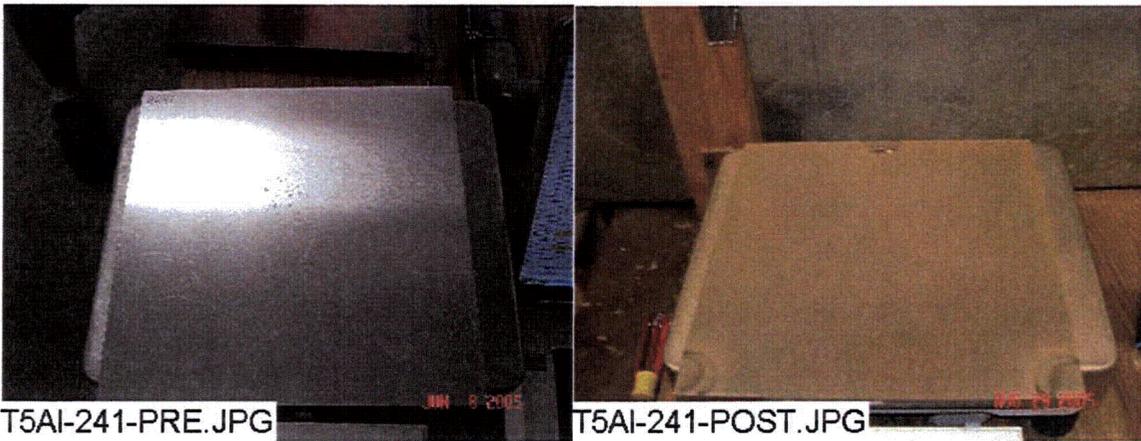
Figure 3-72. AI-241 submerged, pre-test (left) and post-test (right).

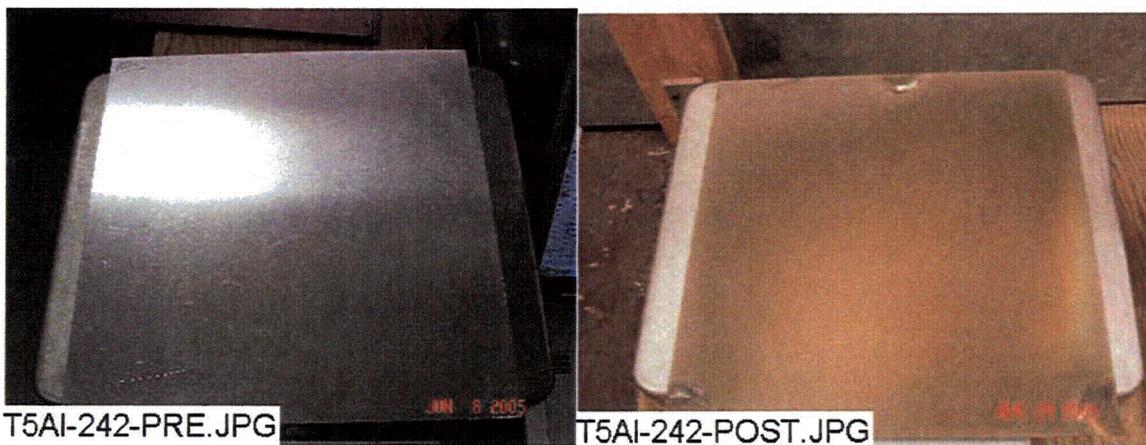
Figure 3-73. AI-242 submerged, pre-test (left) and post-test (right).

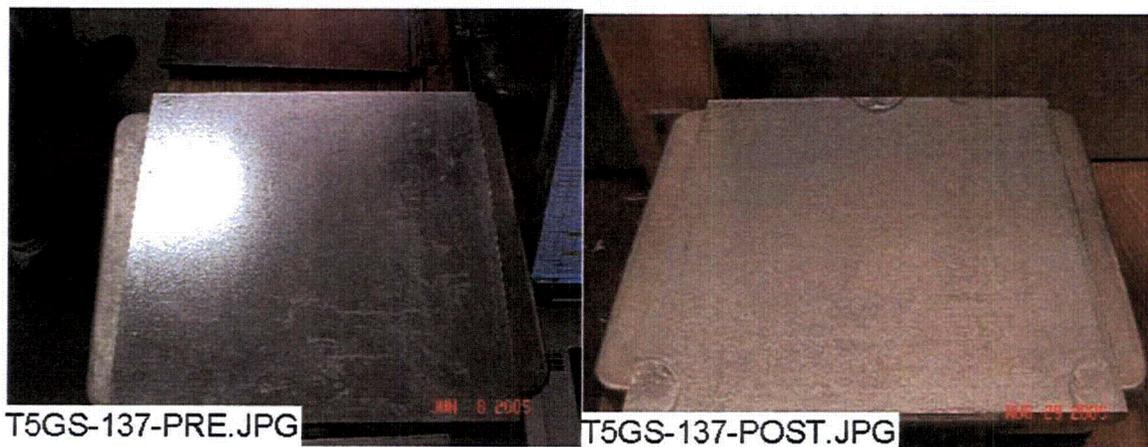
Figure 3-74. GS-137 submerged, pre-test (left) and post-test (right).

Figures 3-74 through 3-76 present the pre- and post-test pictures of three submerged galvanized steel coupons. The galvanized steel coupons developed a white precipitate on the surface of the coupons, which caused the surfaces to have a coarse feel. The surfaces of the coupons had horizontal lines composed of this same white precipitate. The horizontal deposits may have been left during the slow draining of the tank solution.

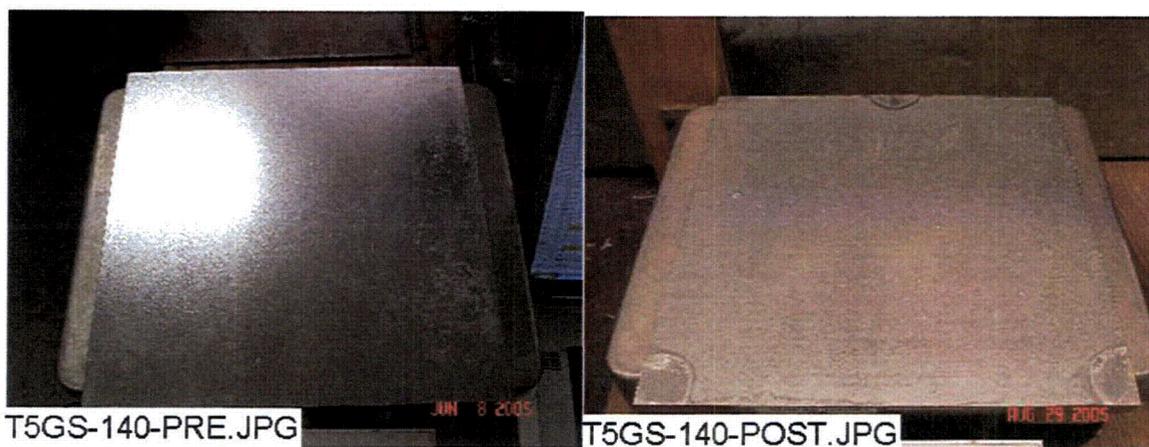
Figure 3-75. GS-140 submerged, pre-test (left) and post-test (right).

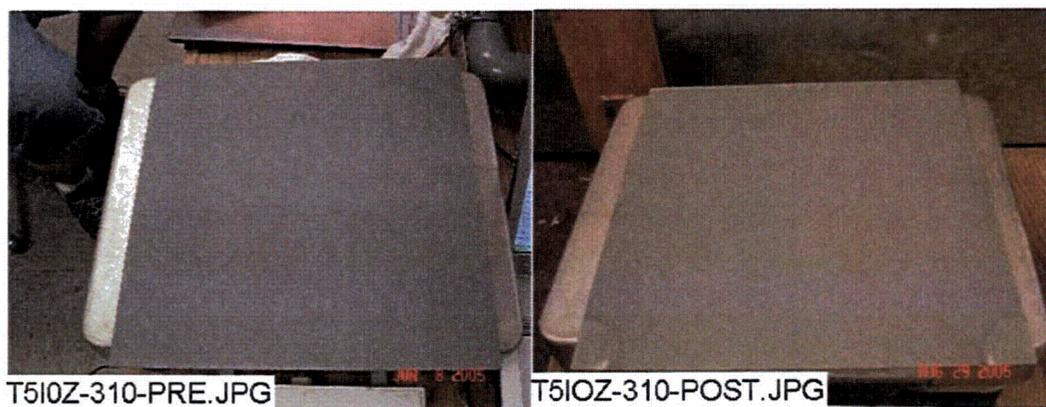
Figure 3-77. IOZ-310 submerged, pre-test (left) and post-test (right).

Figures 3-77 and 3-78 present the pre- and post-test pictures of two submerged IOZ-coated steel coupons. Both submerged IOZ-coated steel coupons have similar light particulate deposits. These coupons were covered with a brown coating over their entire surfaces.

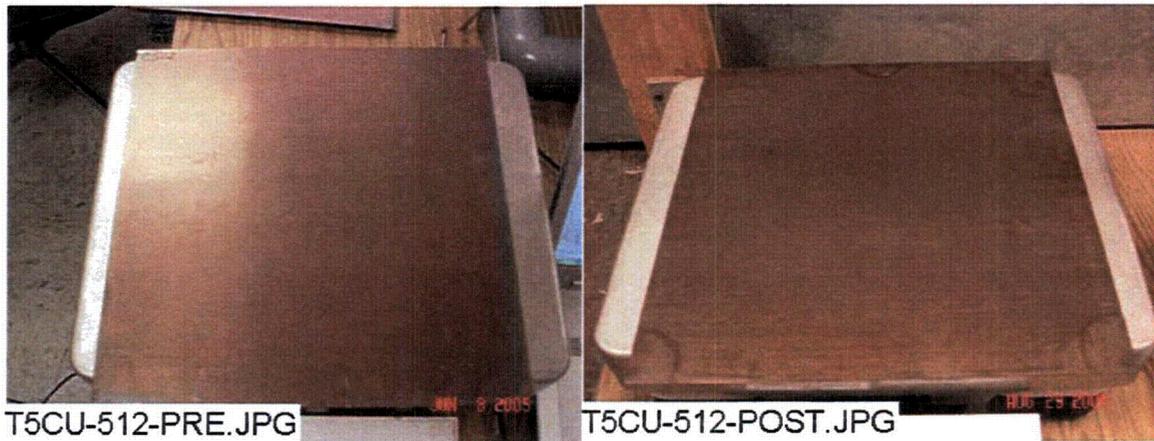
Figure 3-79. CU-512 submerged, pre-test (left) and post-test (right).

Figures 3-79 and 3-80 present the pre- and post-test pictures of two submerged copper coupons. The submerged copper coupons developed very light horizontal white deposits, which may be due to the slow tank draining process.

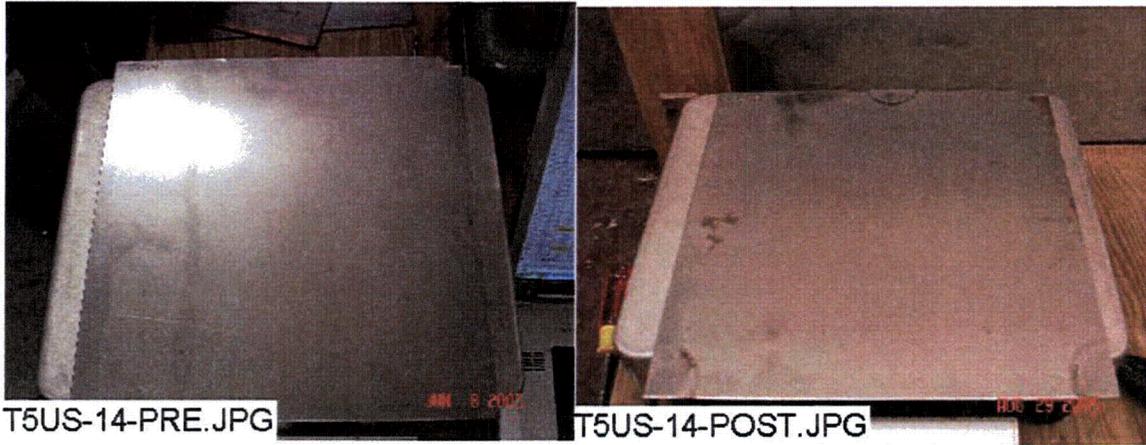
Figure 3-81. US-14 submerged, pre-test (left) and post-test (right).

Figure 3-81 presents the pre- and post-test pictures of the submerged carbon steel coupon. The surface of the coupon was roughened by the deposition of white precipitate. There were also areas of rust on the coupon.

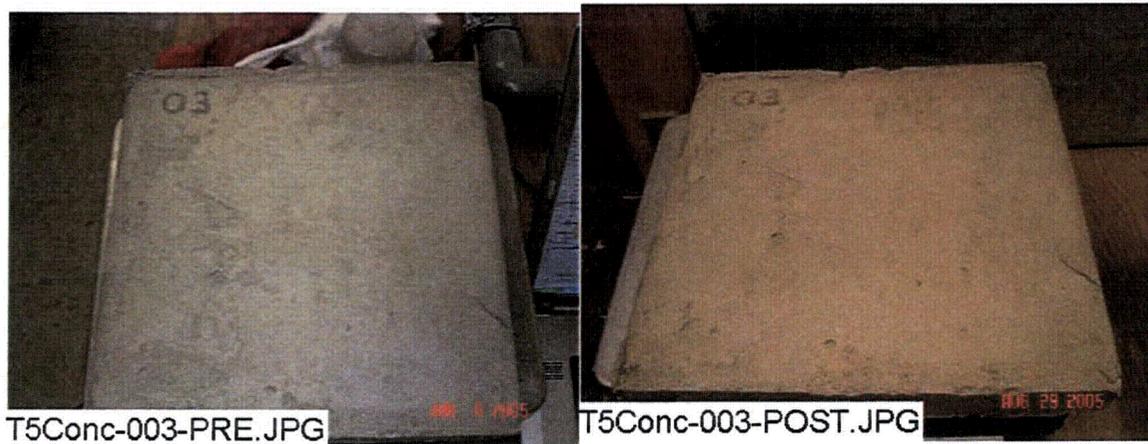
Figure 3-82. Conc-003 submerged, pre-test (left) and post-test (right).

Figure 3-82 presents the pre- and post-test pictures of the submerged concrete coupon. The post-test concrete coupon exhibits a brownish color.

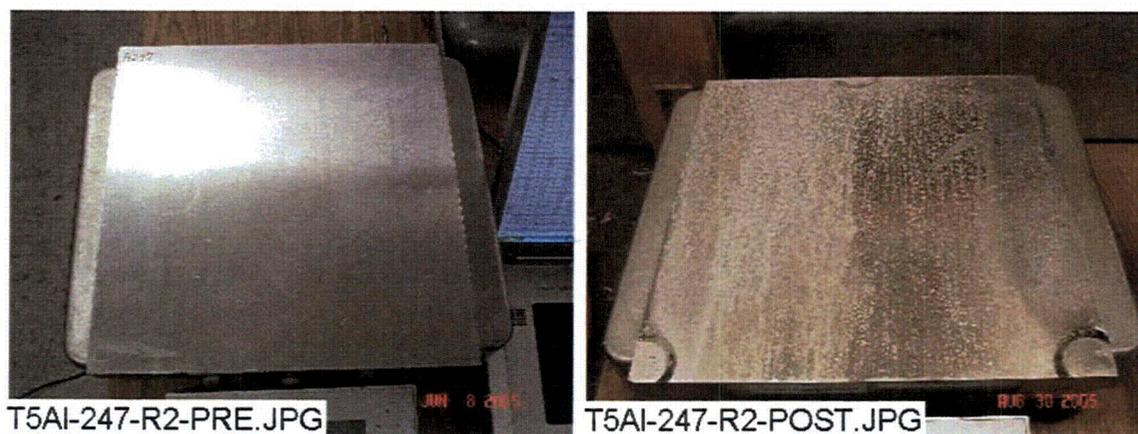
Figure 3-83. Al-247 unsubmerged, pre-test (left) and post-test (right).

Figures 3-83 and 3-84 show the pre- and post-test pictures of two unsubmerged aluminum coupons. Each unsubmerged aluminum coupon accumulated a white particle deposition along with some brownish areas. Also, the texture of each coupon is coarser, and the surface quality of each coupon is less lustrous than before the test. The reddish-brown color that was observed on the submerged coupons is absent on the unsubmerged coupons. The Al-247 coupon was loaded in Rack 2, which was located in the southern position of the middle tier of the tank. The Al-294 coupon was loaded in Rack 7, which was located in the northern position of the top tier of the tank.

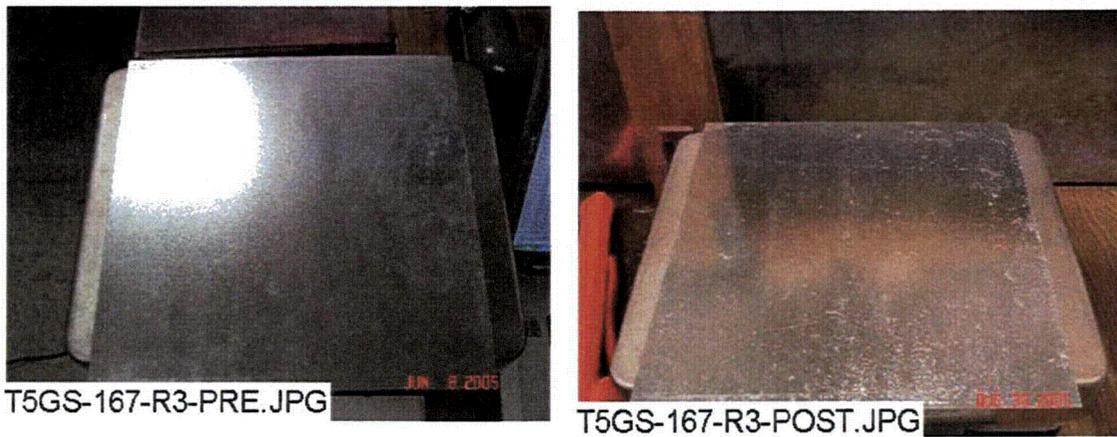
Figure 3-85. GS-167 unsubmerged, pre-test (left) and post-test (right).

Figures 3-85 and 3-86 show the pre- and post-test pictures of two unsubmerged galvanized steel coupons. There was some white deposition on the surface of these coupons, although it was in small amounts. This deposition is visibly different and less concentrated than that of the submerged coupons. The GS-167 coupon was loaded in Rack 3, which was located in the center position of the middle tier of the tank. The GS-638 coupon was loaded in Rack 6, which was located in the middle position of the top tier of the tank.

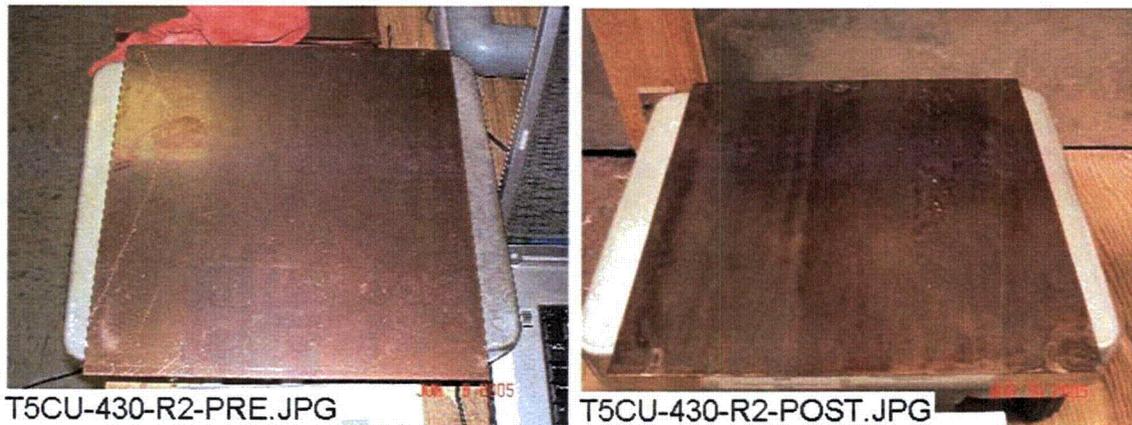
Figure 3-87. CU-430 unsubmerged, pre-test (left) and post-test (right).

Figures 3-87 and 3-88 present the pre- and post-test pictures of two unsubmerged copper coupons. All of the copper coupons had vertical water marks that were likely caused by water flowing downward on the coupon surface during the spray portion of the test. The copper coupons did not appear to accumulate any particle deposition. The CU-430 coupon was loaded in Rack 2, which was located in the southern position of the middle tier of the tank. The CU-587 coupon was loaded in Rack 7, which was located in the northern position of the top tier of the tank.

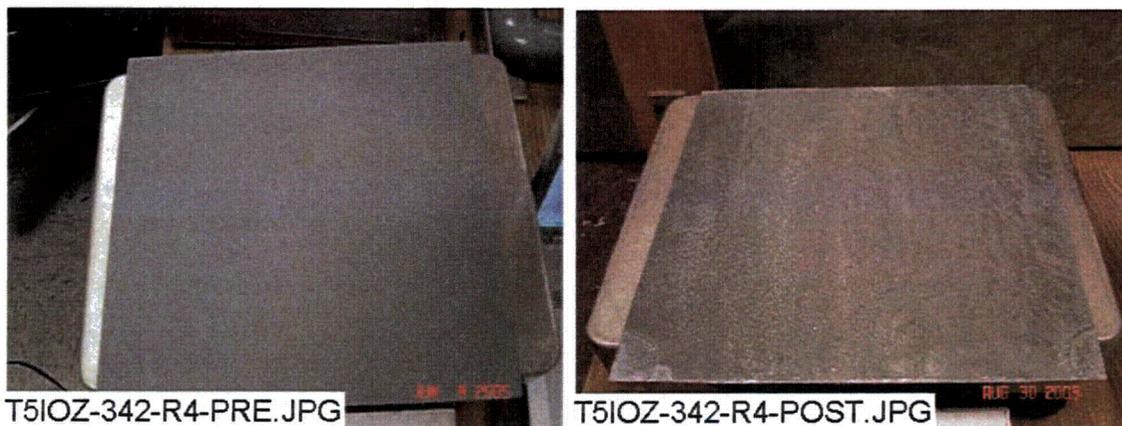
Figure 3-89. IOZ-342 unsubmerged, pre-test (left) and post-test (right).

Figures 3-89 and 3-90 present the pre- and post-test pictures of two unsubmerged IOZ-coated steel coupons. Each post-test coated steel coupon exhibits a similar pattern of deposition, which is less concentrated than that of the submerged coupons. The IOZ-342 coupon was loaded in Rack 4, which was located in the northern position of the middle tier of the tank. The IOZ-356 coupon was loaded in Rack 5, which was located in the southern position of the top tier of the tank.

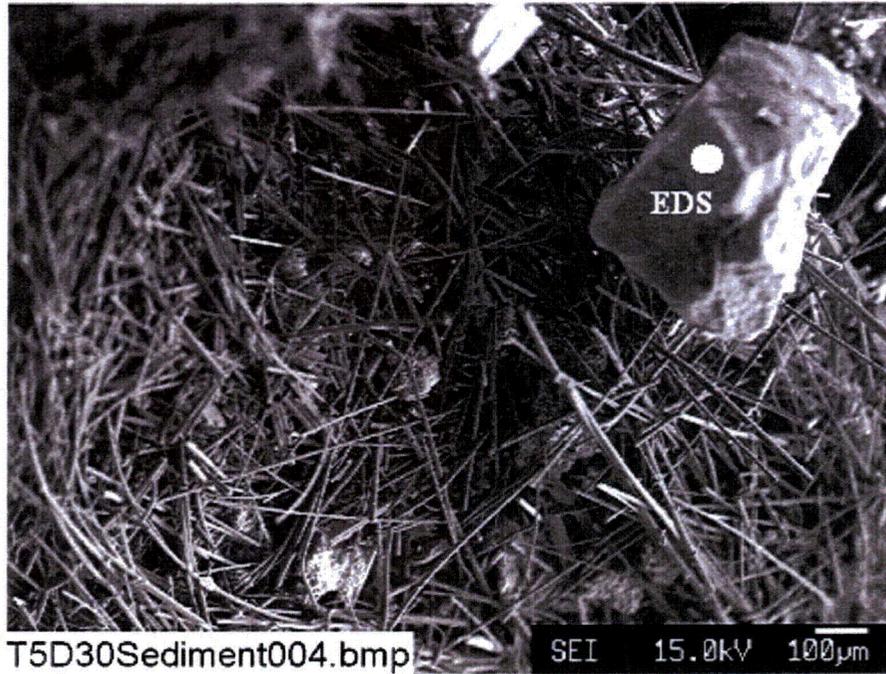
Figures 3-95 through 3-99 and Table 3-6 provide SEM/EDS and XRD/XRF analysis results. The SEM/EDS and XRD/XRF analyses provided information on the morphology and composition of Test #5 sediment. SEM images show that the sediments were mainly

Figure 3-95. SEM image magnified 70 times for the Test #5, Day-30 sediment at the bottom of the tank.

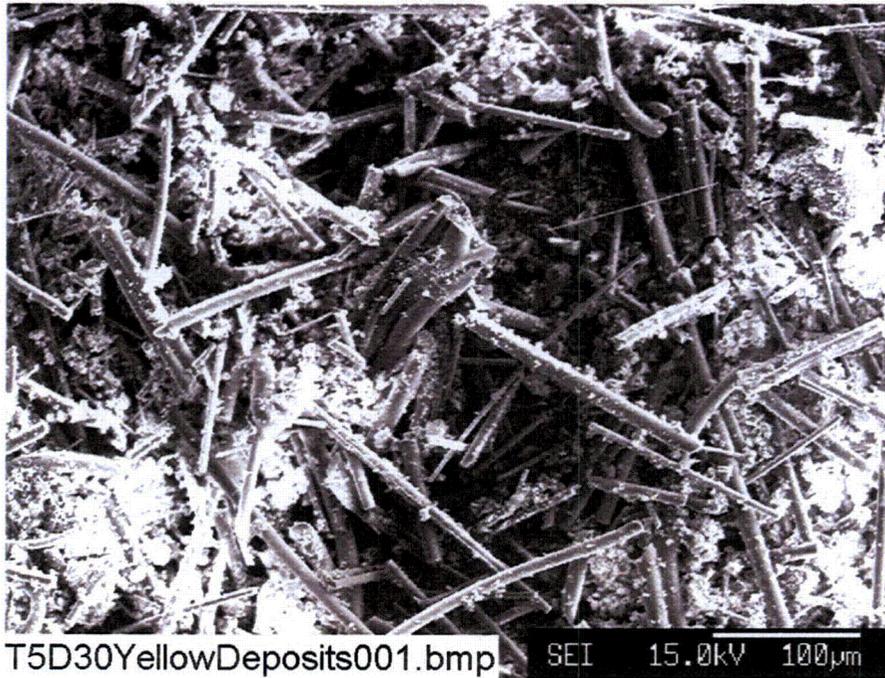
For the ICET tests, one concern is the deposition of debris/corrosion products in the tank. To help understand this problem, the corrosion/deposition products were collected after completion of the test. These products are fine yellow powders removed from the submerged CPVC rack. SEM/ EDS results shown in Figures 3-100 through 3-102 indicate that the fine yellow powders were mainly composed of fiberglass debris and particulate deposits containing O, Na, Al, C, Ca, Mg, and possibly Si.

Figure 3-100. SEM image magnified 200 times for the Test #5, Day-30 fine yellow powder on the submerged rack.

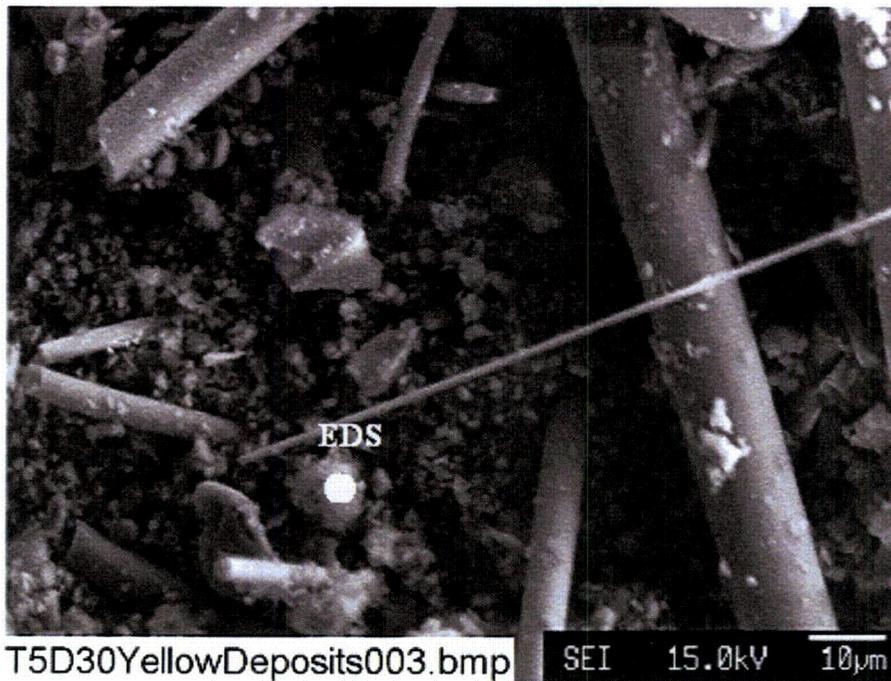
Figure 3-101. Annotated SEM image magnified 1000 times for the Test #5, Day-30 fine yellow powder on the submerged rack.
