Preface to Appendices

ESEM/EDS Test #5 Day-4 fiberglass in low-flow zone

ESEM/EDS Data for Test #5, Day-15 Fiberglass in Low-Flow Zones

ESEM Data for Test #5, Day-15 Fiberglass in High-Flow Zones

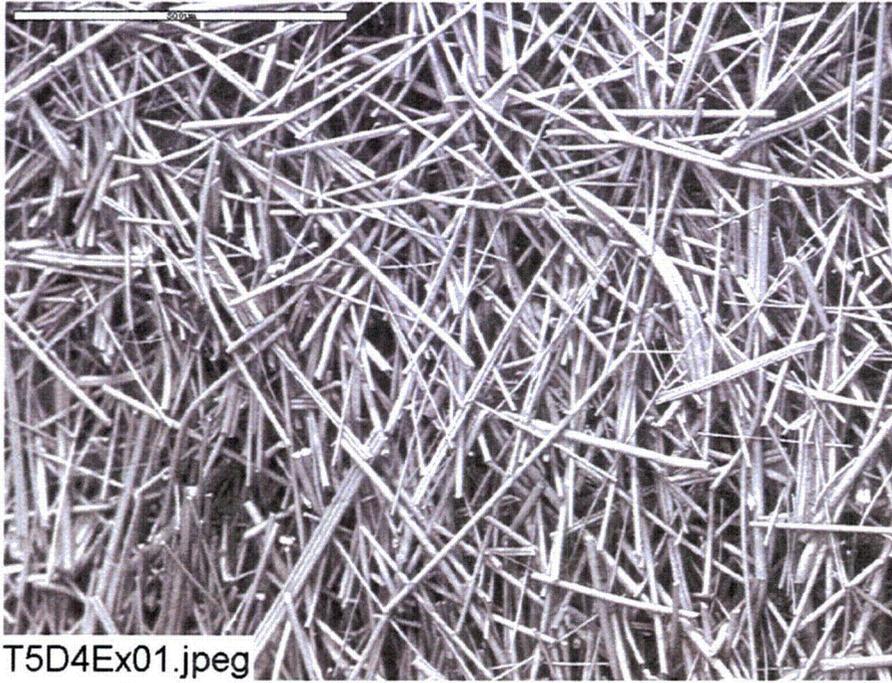
Figure A-1. ESEM image magnified 100 times for a Test #5, Day-4 low-flow exterior fiberglass sample. (T5D4Ex01.jpeg)

Image: T5D4Ex01	100 ×	ESEM image	Figure A-1
t5d4ex02	100 ×		Figure A-2
t5d4ex03	500 ×	ESEM at higher magnification	Figure A-3

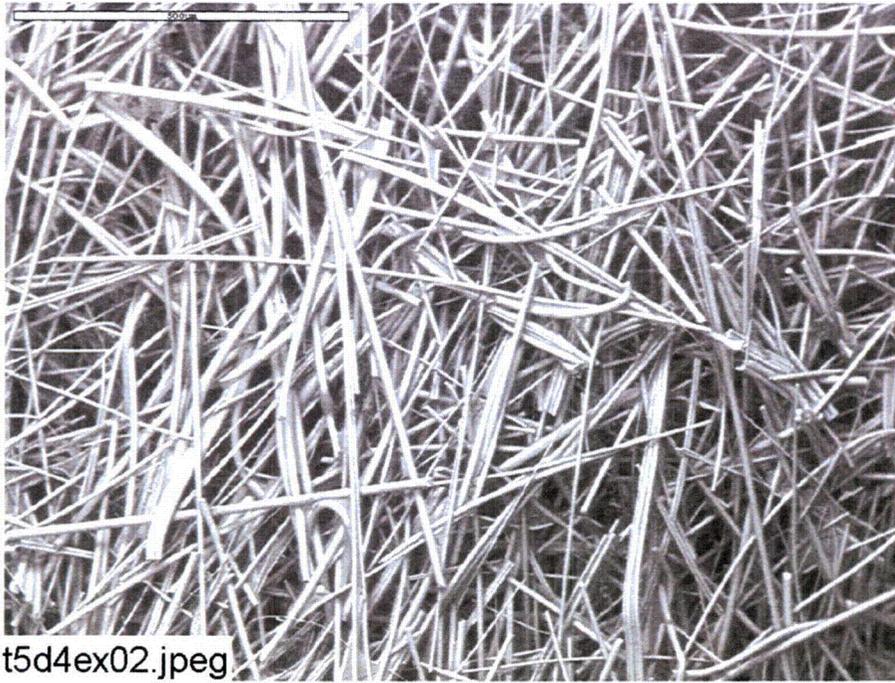
Figure A-2. ESEM image magnified 100 times for a Test #5, Day-4 low-flow exterior fiberglass sample. (t5d4ex02.jpeg)

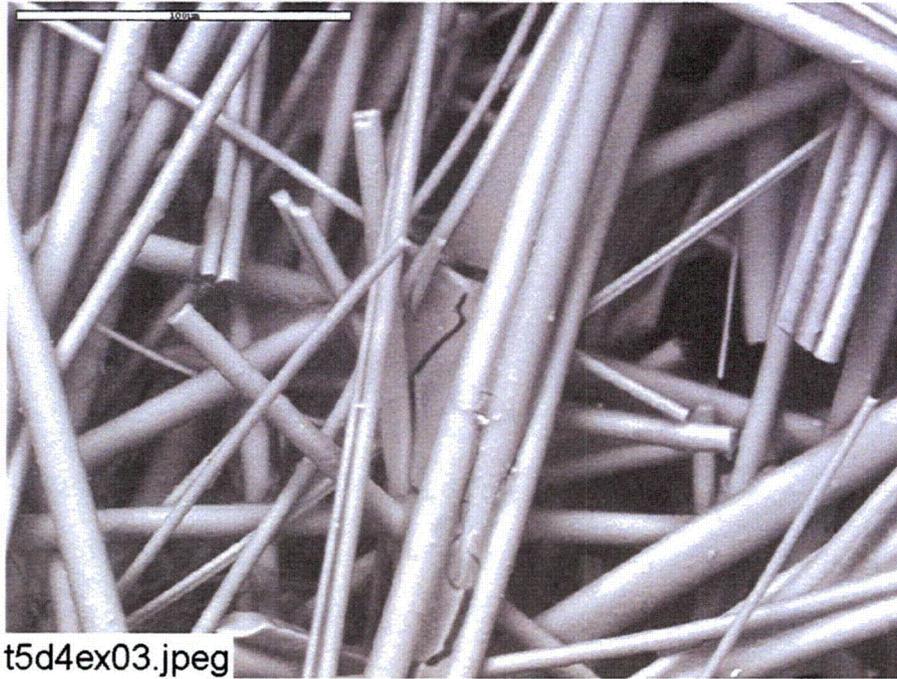
Figure A-3. ESEM image magnified 500 times for a Test #5, Day-4 low-flow exterior fiberglass sample. (t5d4ex03.jpeg)

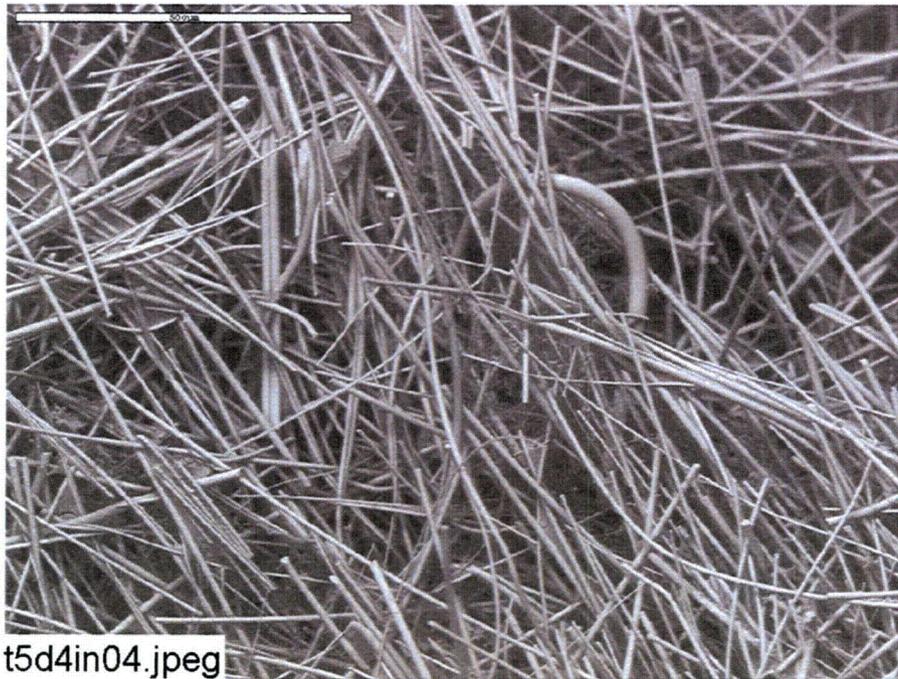
Figure A-4. ESEM image magnified 100 times for a Test #5, Day-4 low-flow interior fiberglass sample. (t5d4in04.jpeg)

Image: t5d4lfin04	100 ×	ESEM image	Figure A-4
t5d4lfin05	500 ×	ESEM of debris	Figure A-5
EDS: t5d4lfin06		EDS on flocculence deposits t5drlfin05	Figure A-6
Image: t5d4lfin07	500 ×	ESEM image	Figure A-7
EDS: t5d4lfin08		EDS on deposits on t5d4lfin07	Figure A-8

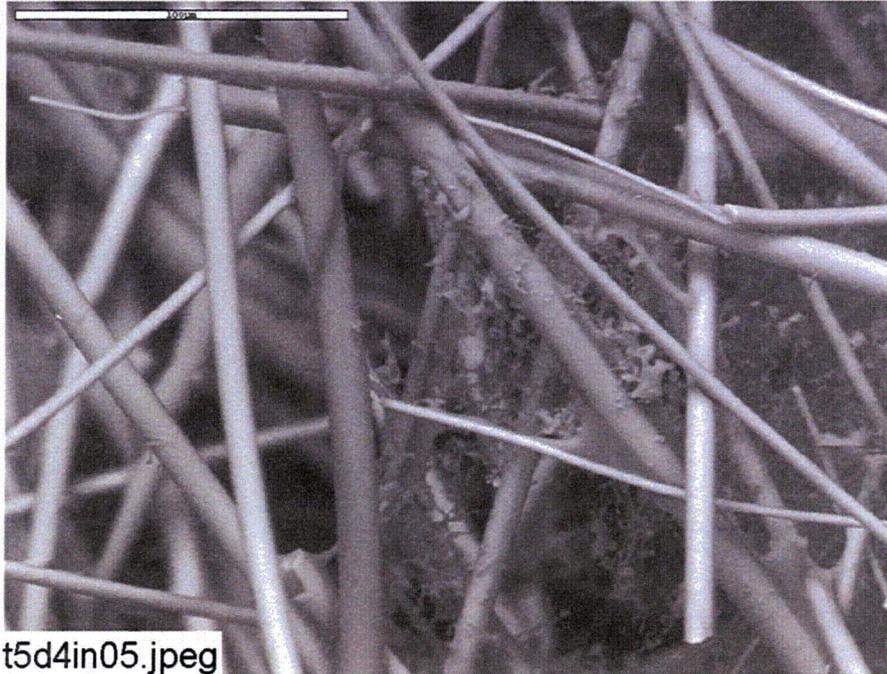
Figure A-5. ESEM image magnified 500 times for a Test #5, Day-4 low-flow interior fiberglass sample. (t5d4in05.jpeg)

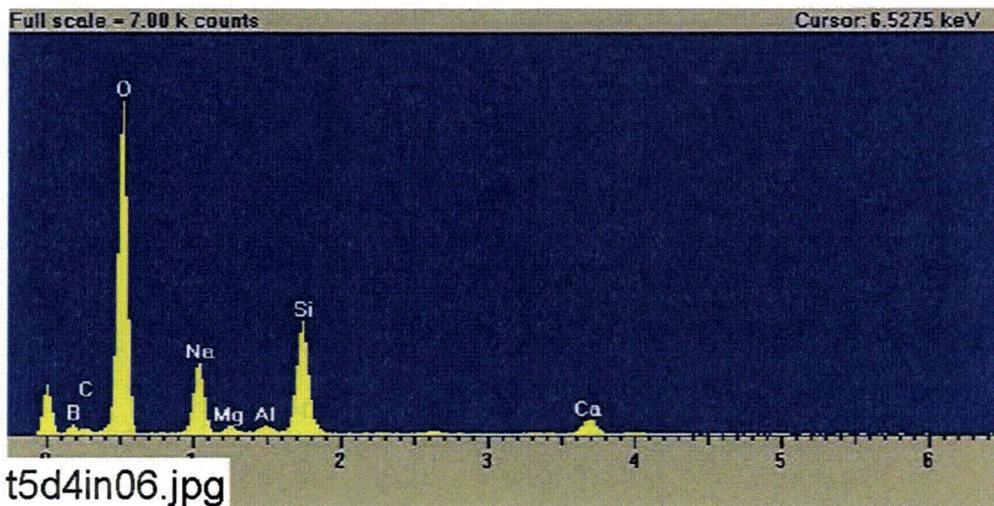
Figure A-6. EDS counting spectrum for the flocculence deposits between fibers shown in Figure A-5. (t5d4in06.jpg)

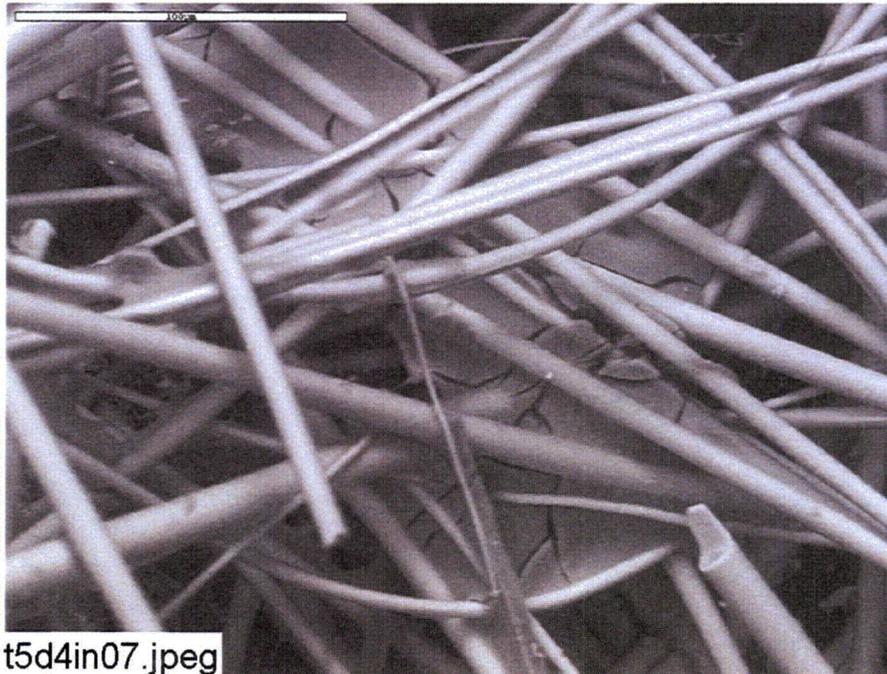
t5d4in07.jpeg

Figure A-7. ESEM image magnified 500 times for a Test #5, Day-4 low-flow interior fiberglass sample. (t5d4in07.jpeg)

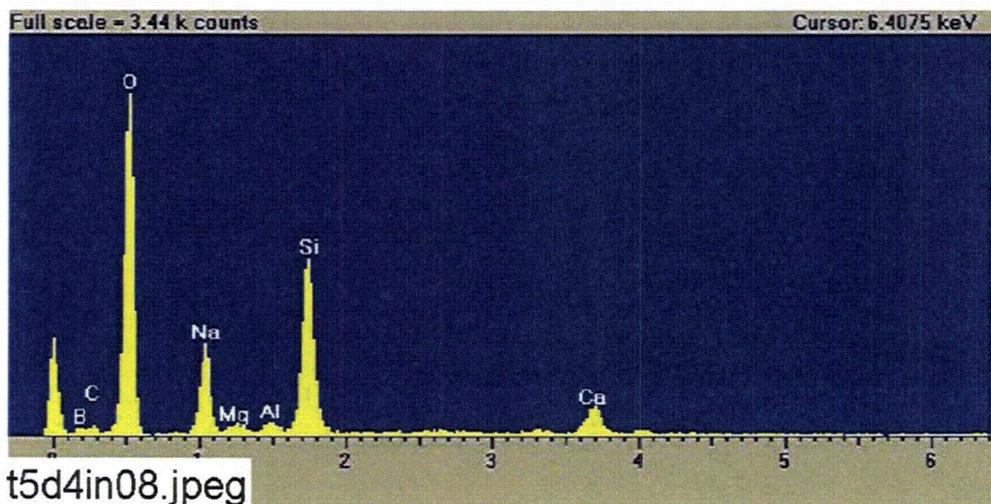
Figure A-8. EDS counting spectrum for the deposits between fibers shown in Figure A-7. (t5d4in08.jpeg)

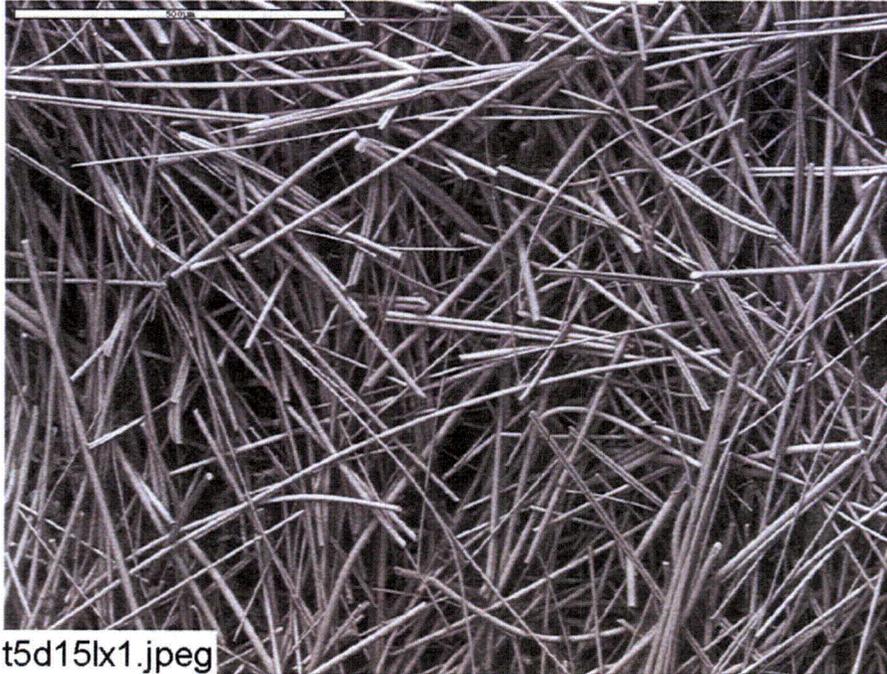
t5d15lx1.jpeg

Figure B1-1. ESEM image magnified 100 times for a Test #5, Day-15 low-flow exterior fiberglass sample. (T5D15lx1.jpeg)

Image: T5D15lx1 100 × ESEM image of fiberglass
t5d15lx2 500 × ESEM image of fiberglass

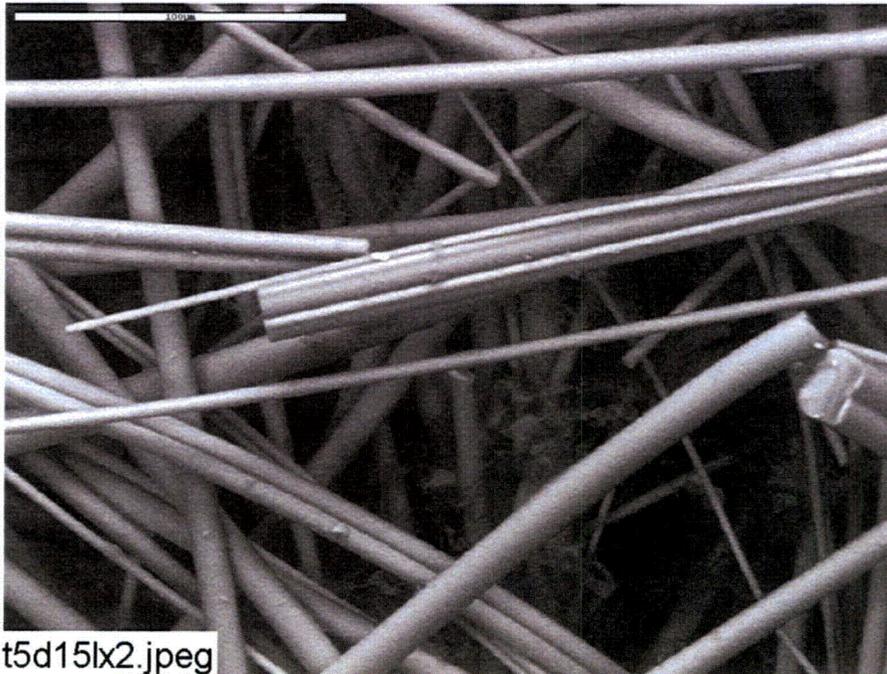
t5d15lx2.jpeg

Figure B1-2. ESEM image magnified 500 times for a Test #5, Day-15 low-flow exterior fiberglass sample. (t5d15lx2.jpeg)

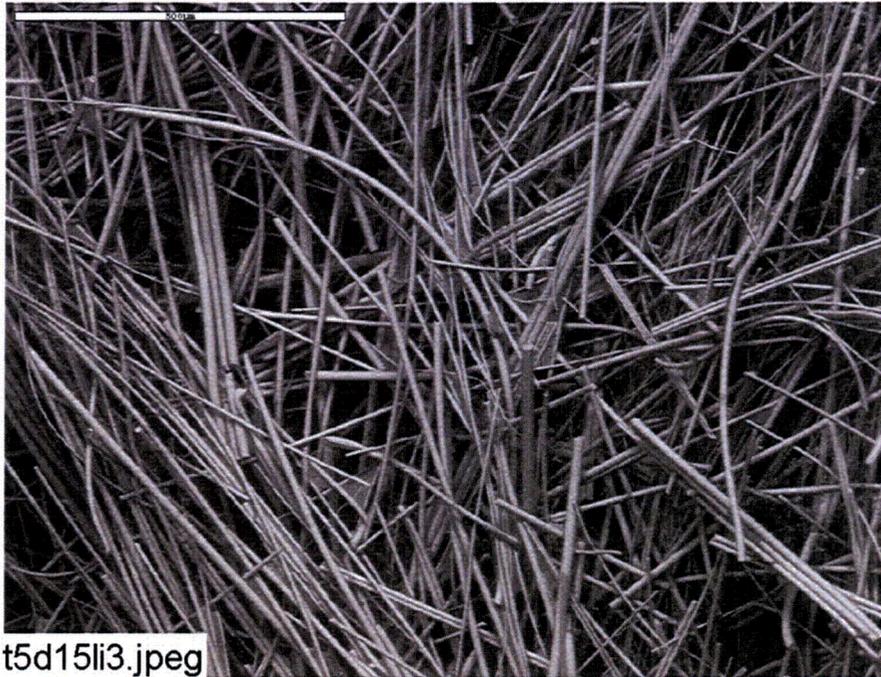
t5d15li3.jpeg

Figure B1-3. ESEM image magnified 100 times for a Test #5, Day-15 low-flow interior fiberglass sample. (t5d15li3.jpeg)

Image:	T5d15li3	100 ×	ESEM image of fiberglass	Figure B1-3
	t5d15li4	500 ×	ESEM image at higher magnification	Figure B1-4
	t5d15li5	500 ×	ESEM image	Figure B1-5
	t5d15li6	500 ×	Annotated ESEM image	Figure B1-6
EDS:	t5d15li7		EDS on deposits between fibers for t5d15li6	Figure B1-7

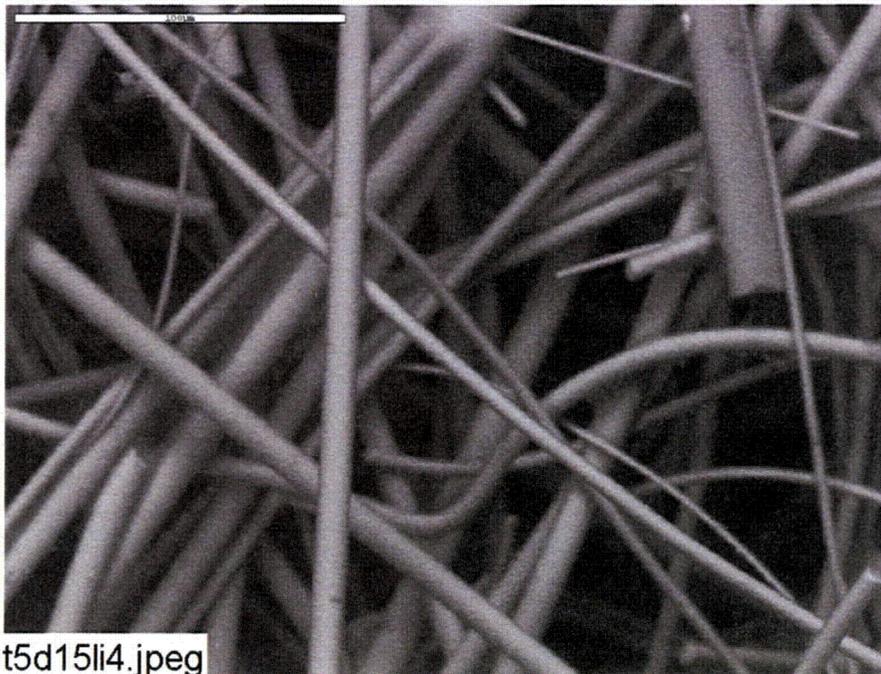
t5d15li4.jpeg

Figure B1-4. ESEM image magnified 500 times for a Test #5, Day-15 low-flow interior fiberglass sample. (t5d15li4.jpeg)

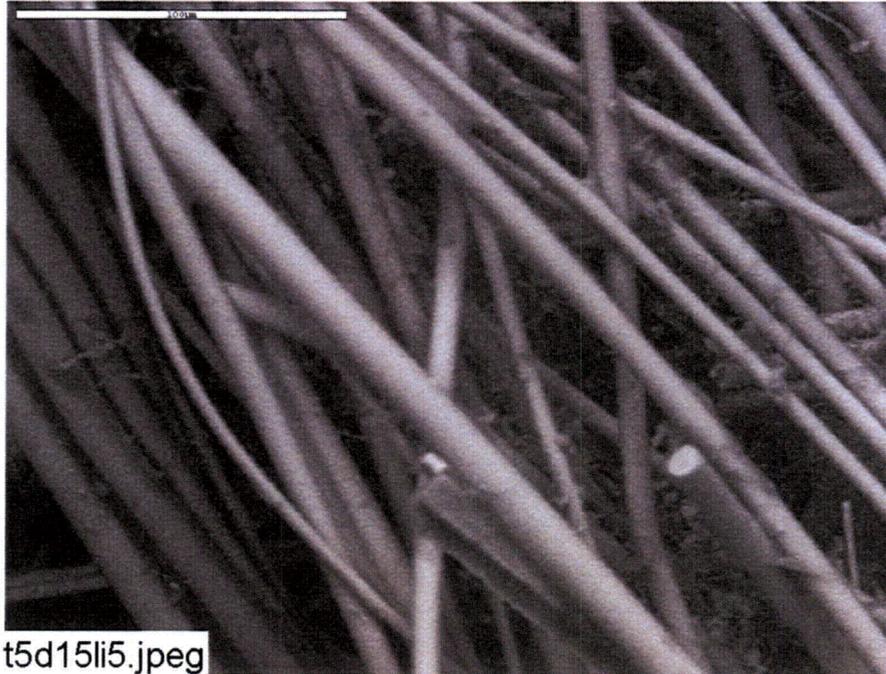
Figure B1-5. ESEM image magnified 500 times for a Test #5, Day-15 low-flow interior fiberglass sample. (t5d15li5.jpeg)

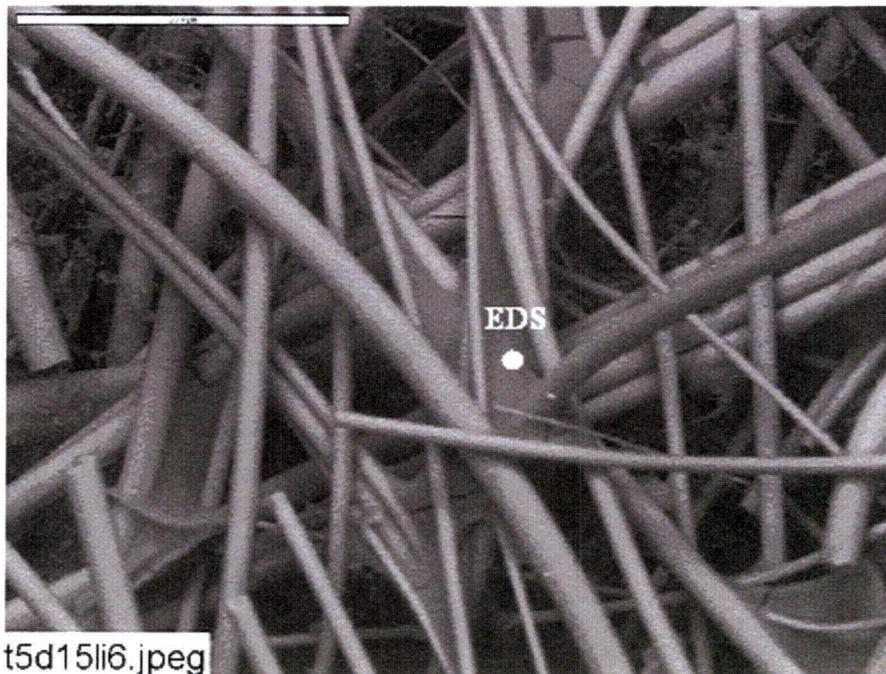
Figure B1-6. Annotated ESEM image magnified 500 times for a Test #5, Day-15 low-flow interior fiberglass sample. (t5d15li6.jpeg)

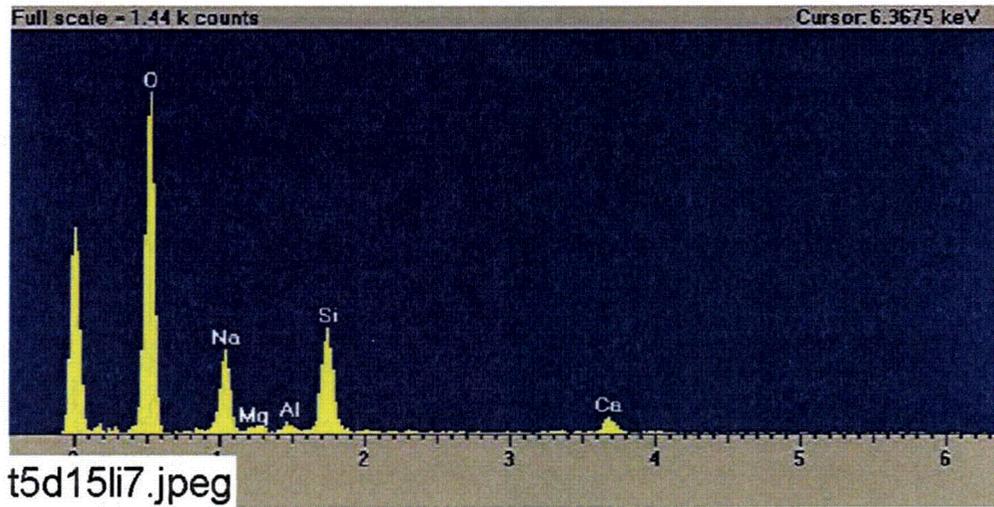
Figure B1-7. EDS counting spectrum for the deposits between fibers shown in Figure B1-6. (t5d15li7.jpeg)

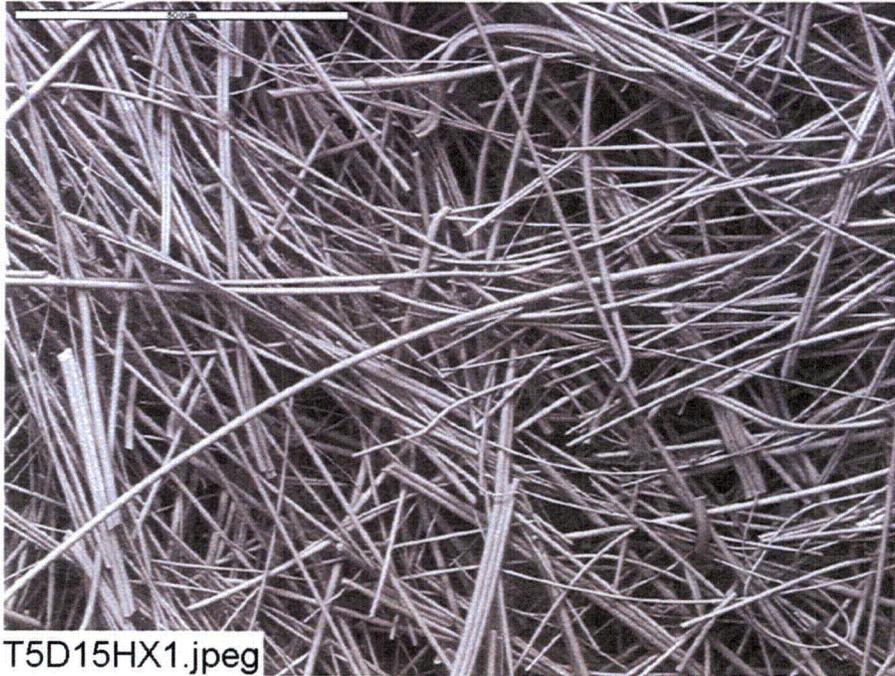
Figure B2-1. ESEM image magnified 100 times for a Test #5, Day-15 high-flow exterior fiberglass sample. (T5D15HX1.jpeg)

Image:	T5D15HX1	100 ×	ESEM image	Figure B2-1
	t5d15hx2	500 ×	ESEM image at higher magnification	Figure B2-2

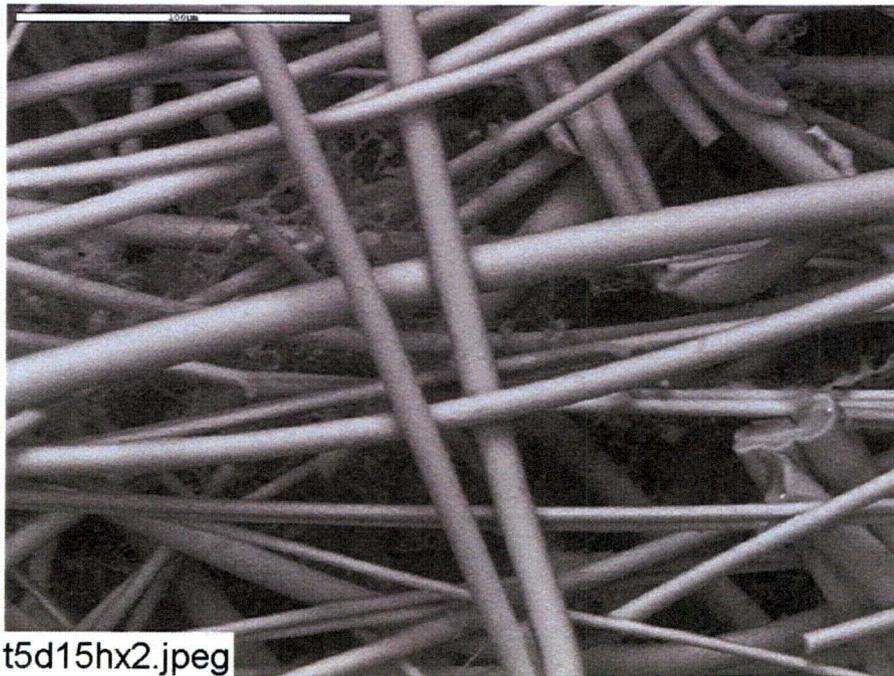
Figure B2-2. ESEM image magnified 500 times for a Test #5, Day-15 high-flow exterior fiberglass sample. (t5d15hx2.jpeg)

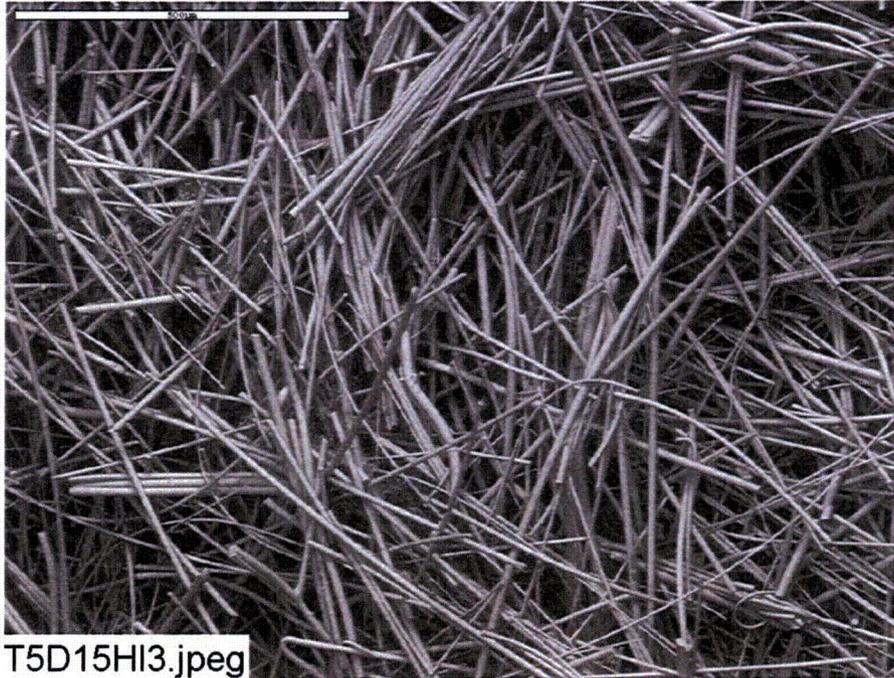
Figure B2-3. ESEM image magnified 100 times for a Test #5, Day-15 high-flow interior fiberglass sample. (T5D15HI3.jpeg)

Image:	T5D15HI3	100 ×	ESEM image	Figure B2-3
	t5d15hi4	500 ×	ESEM image at higher magnification	Figure B2-4

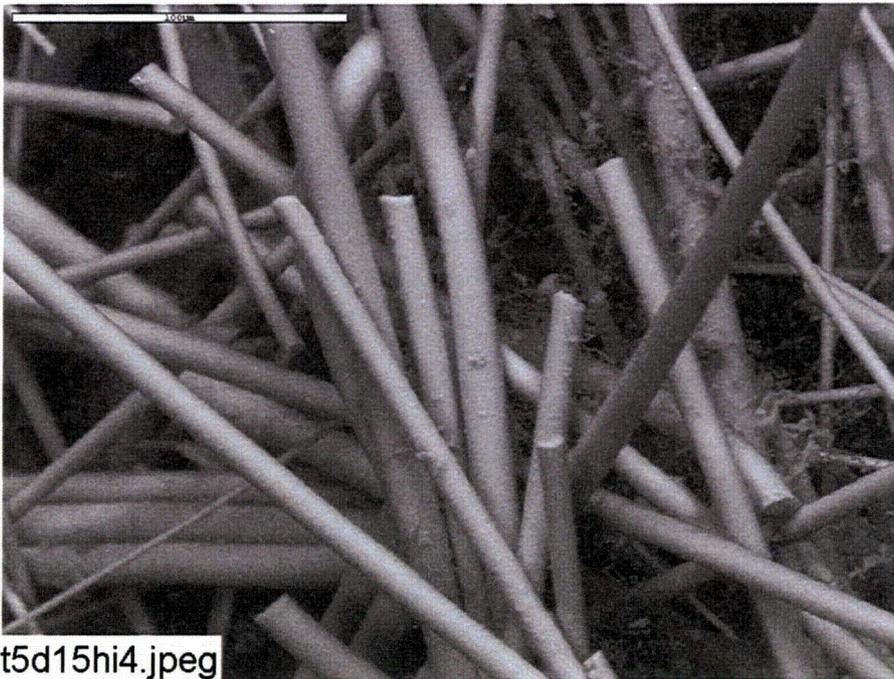
Figure B2-4. ESEM image magnified 500 times for a Test #5, Day-15 high-flow interior fiberglass sample. (t5d15hi4.jpeg)

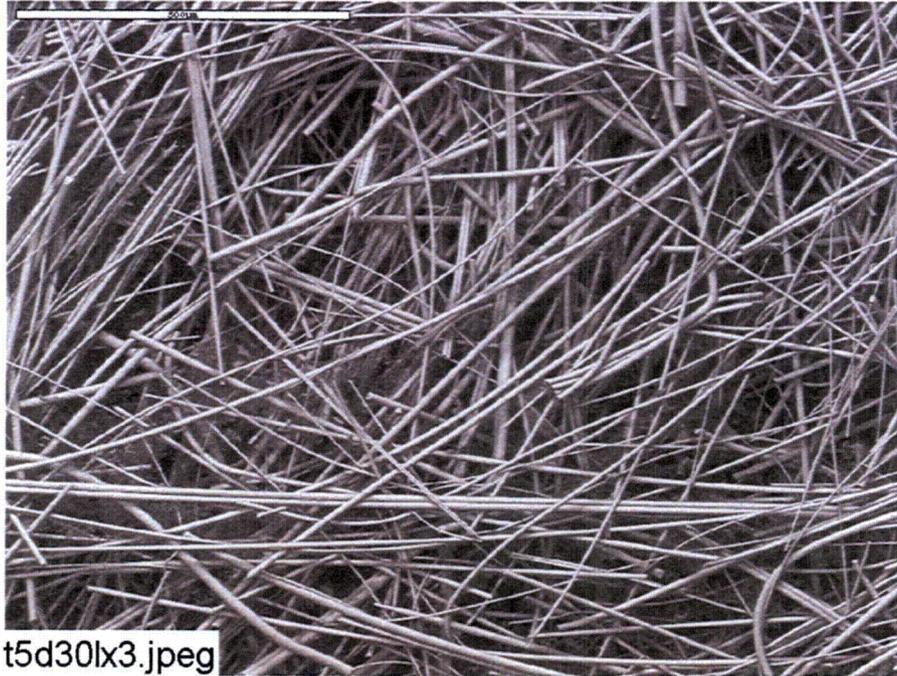
Figure C1-1. ESEM image magnified 100 times for a Test #5, Day-30 low-flow exterior fiberglass sample. (t5d30lx3.jpeg)

Image: t5d30lx3	100 ×	ESEM image	Figure C1-1
t5d30lx4	500 ×	ESEM image higher magnification	Figure C1-2
t5d30lx5	500 ×	ESEM image	Figure C1-3

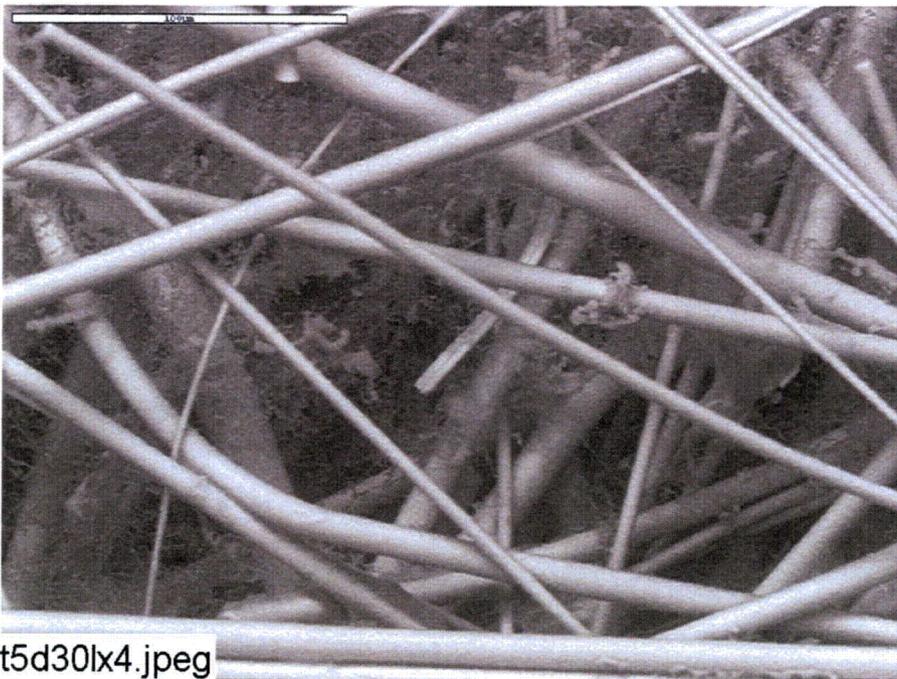
Figure C1-2. ESEM image magnified 500 times for a Test #5, Day-30 low-flow exterior fiberglass sample. (t5d30lx4.jpeg)

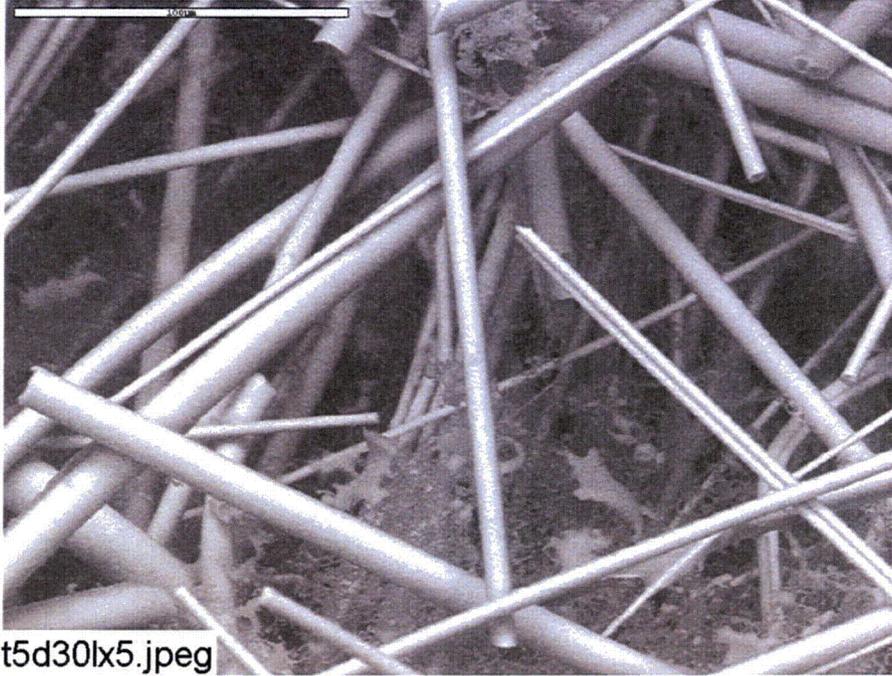
Figure C1-3. ESEM image magnified 500 times for a Test #5, Day-30 low-flow exterior fiberglass sample. (t5d30lx5.jpeg)

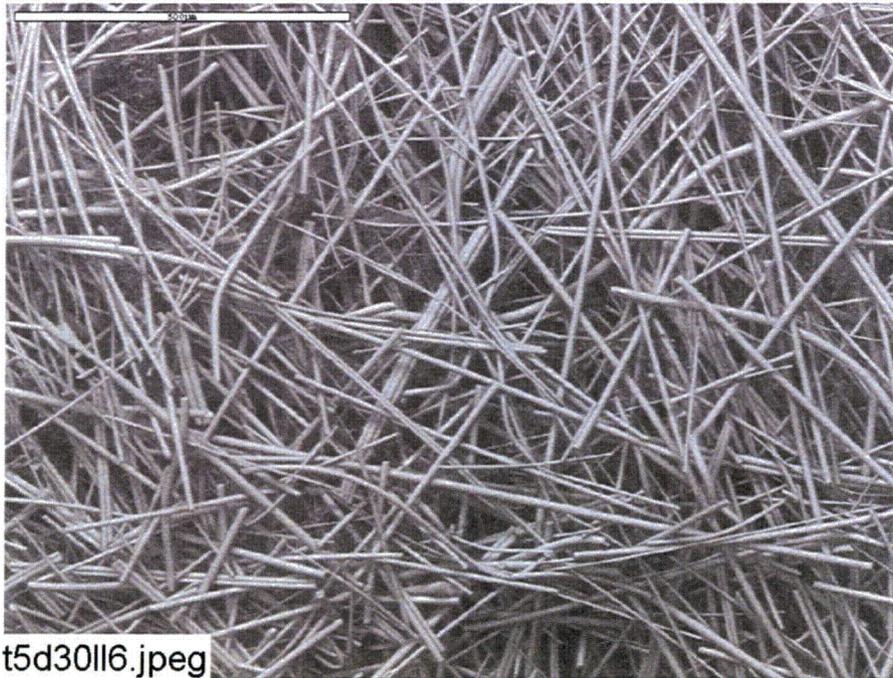
Figure C1-4. ESEM image magnified 100 times for a Test #5, Day-30 low-flow interior fiberglass sample. (t5d30ll6.jpeg)

Image: t5d30li6	100 ×	ESEM image of fiberglass	Figure C1-4
t5d30li7	500 ×	ESEM image higher magnification	Figure C1-5

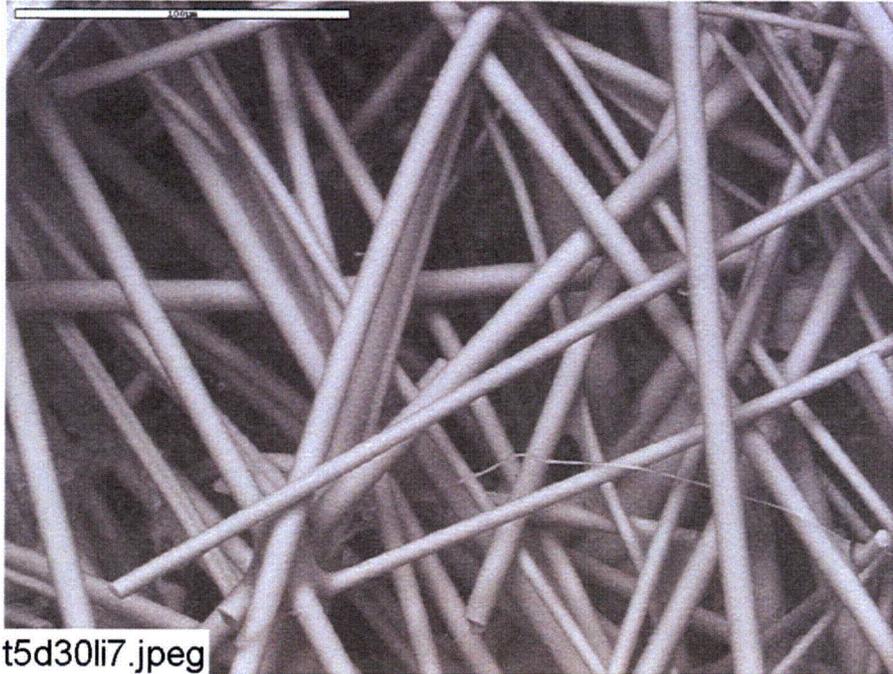
Figure C1-5. ESEM image magnified 500 times for a Test #5, Day-30 low-flow interior fiberglass sample. (t5d30li7.jpeg)

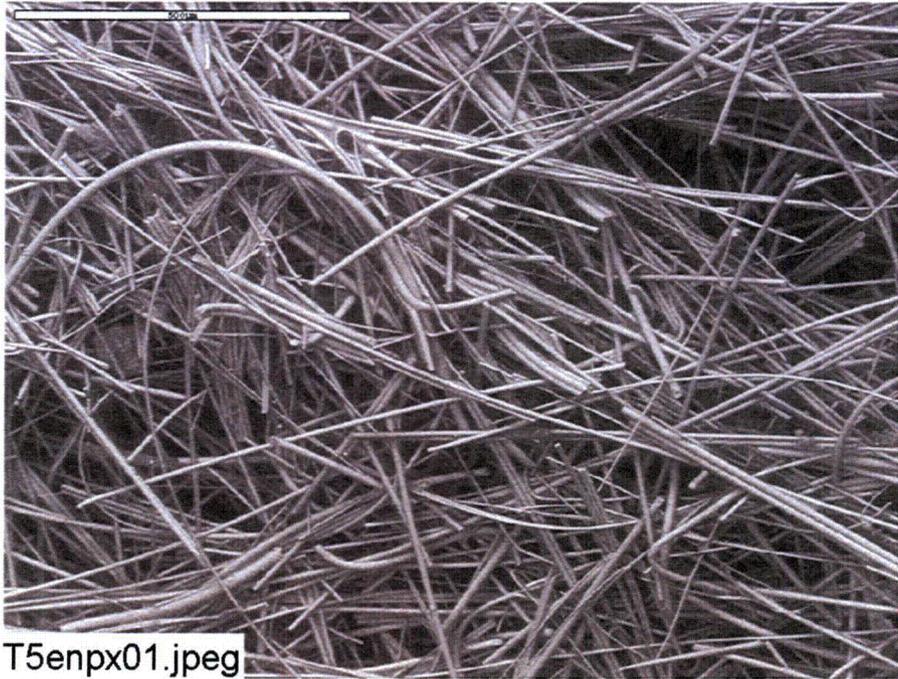
T5enpx01.jpeg

Figure C2-1. ESEM image magnified 100 times for a Test #5, Day-30 low-flow exterior fiberglass sample in a big envelope. (T5enpx01.jpeg)

Image: T5enpx01	100 ×	ESEM image	Figure C2-1
t5enpx02	500 ×	ESEM image higher magnification	Figure C2-2
EDS: t5enpx03		EDS on particle in image t5enpx02	Figure C2-3

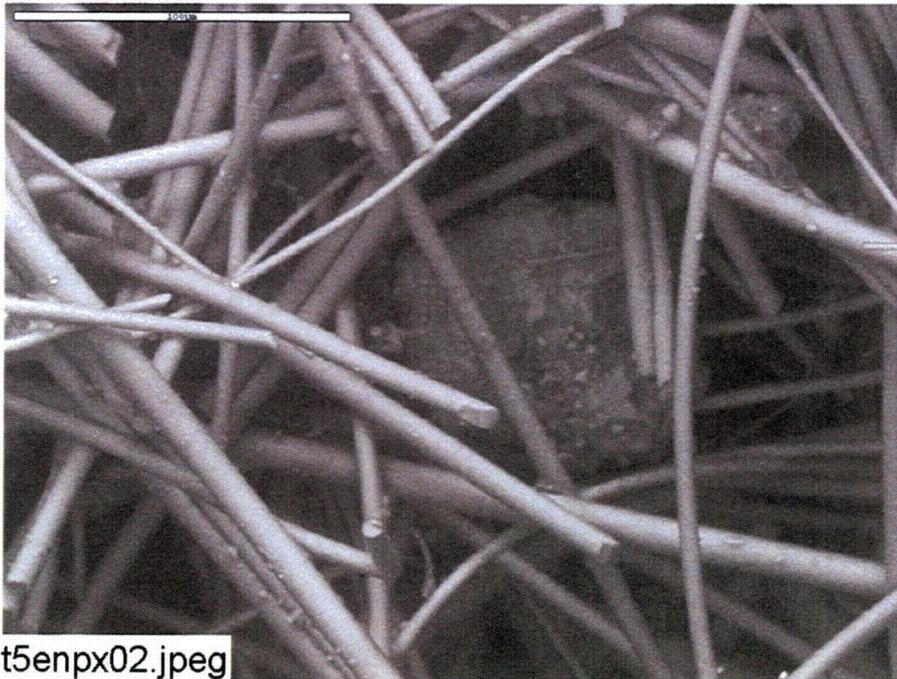
t5enpx02.jpeg

Figure C2-2. ESEM image magnified 500 times for a Test #5, Day-30 low-flow exterior fiberglass sample in a big envelope. (t5enpx02.jpeg)

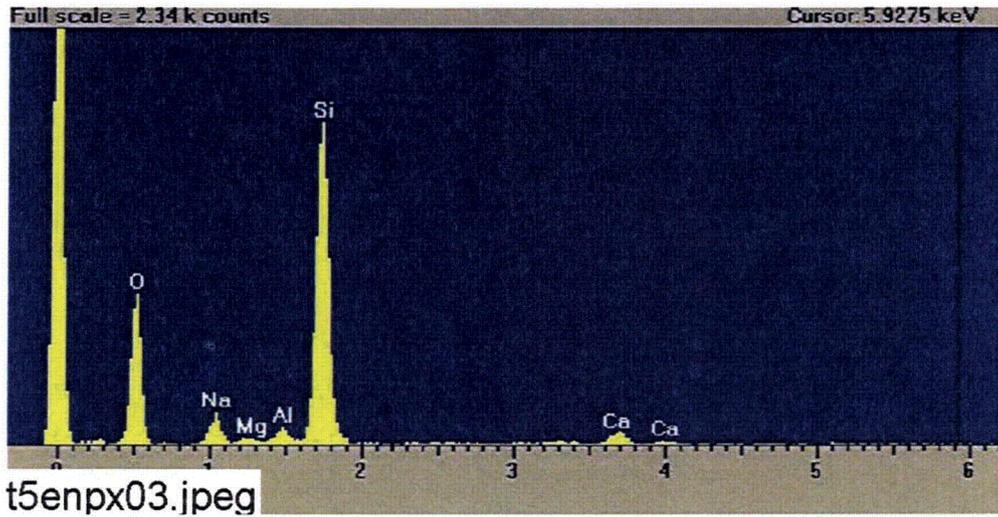
Figure C2-3. EDS counting spectrum for the particulate deposits between the fibers shown in Figure C2-2. (t5enpx03.jpeg)

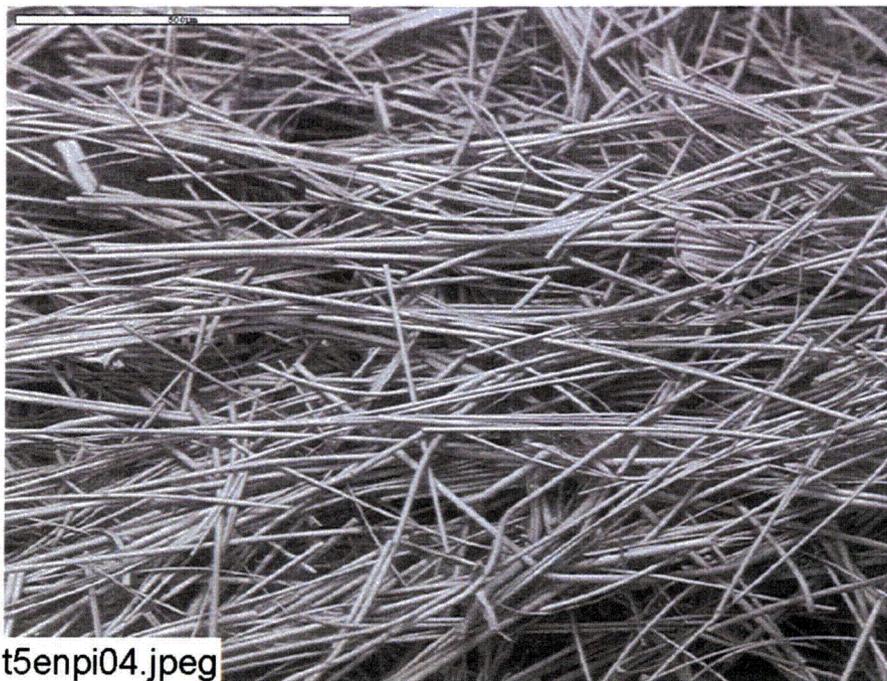
Figure C2-4. ESEM image magnified 100 times for a Test #5, Day-30 low-flow interior fiberglass sample in a big envelope. (T5enpi04.jpeg)

Image: T5empi04	100 ×	ESEM image	Figure C2-4
T5enpi05	500 ×	ESEM image higher magnification	Figure C2-5

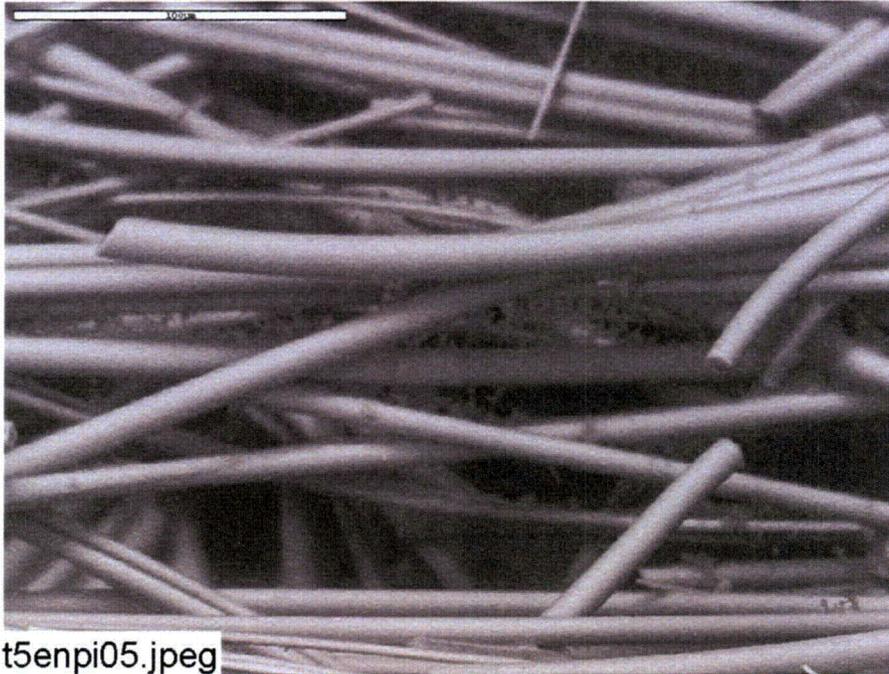
Figure C2-5. ESEM image magnified 500 times for a Test #5, Day-30 low-flow interior fiberglass sample in a big envelope. (T5enpi05.jpeg)

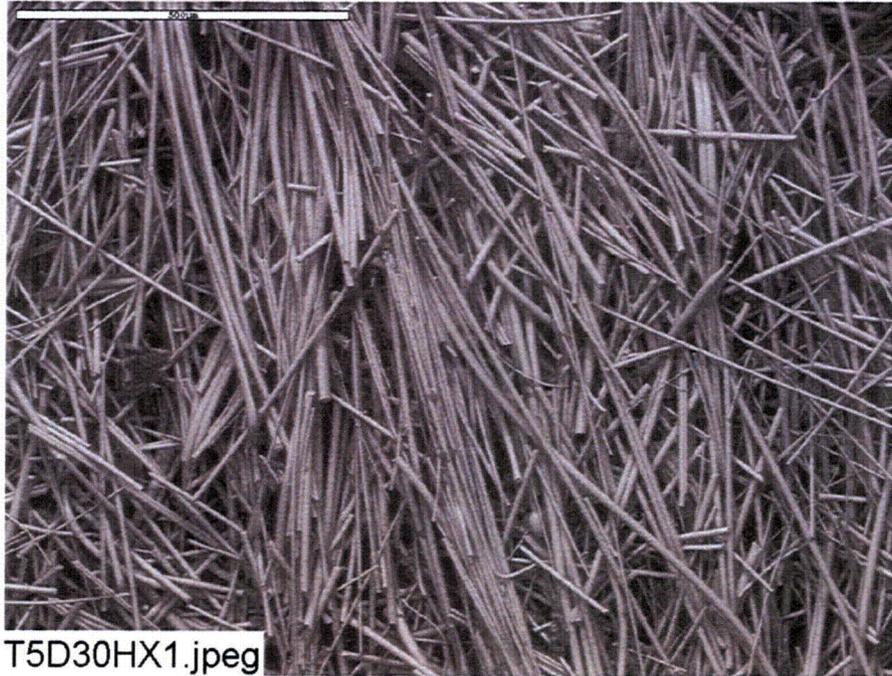
Figure C3-1. ESEM image magnified 100 times for a Test #5, Day-30 high-flow exterior fiberglass sample. (T5D30HX1.jpeg)

Image: T5D30HX1	100 ×	ESEM image	Figure C3-1
t5d30hx2	100 ×	ESEM image	Figure C3-2
t5d30hx3	500 ×	ESEM image higher magnification	Figure C3-3

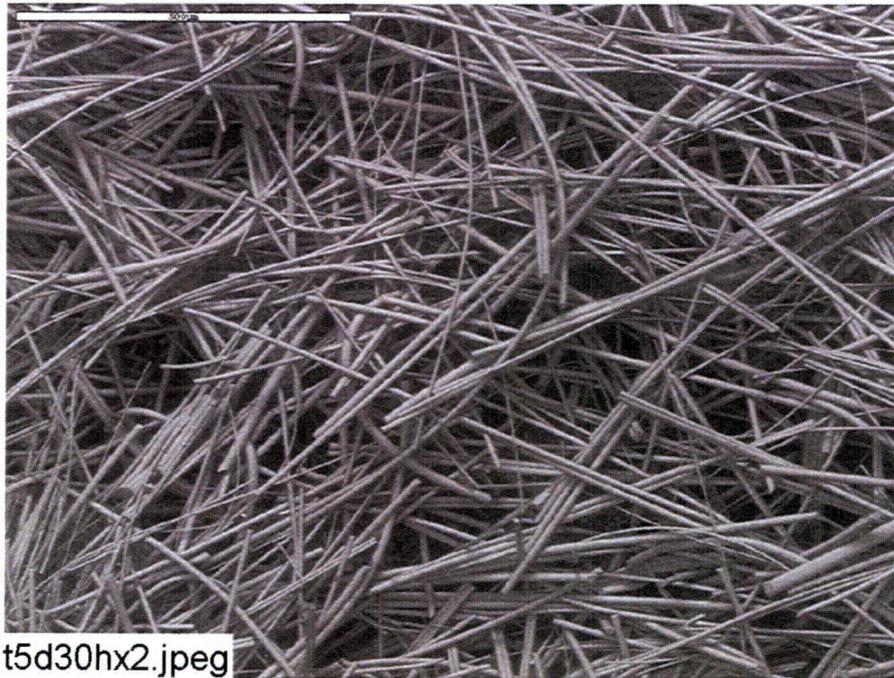
Figure C3-2. ESEM image magnified 100 times for a Test #5, Day-30 high-flow exterior fiberglass sample. (t5d30hx2.jpeg)

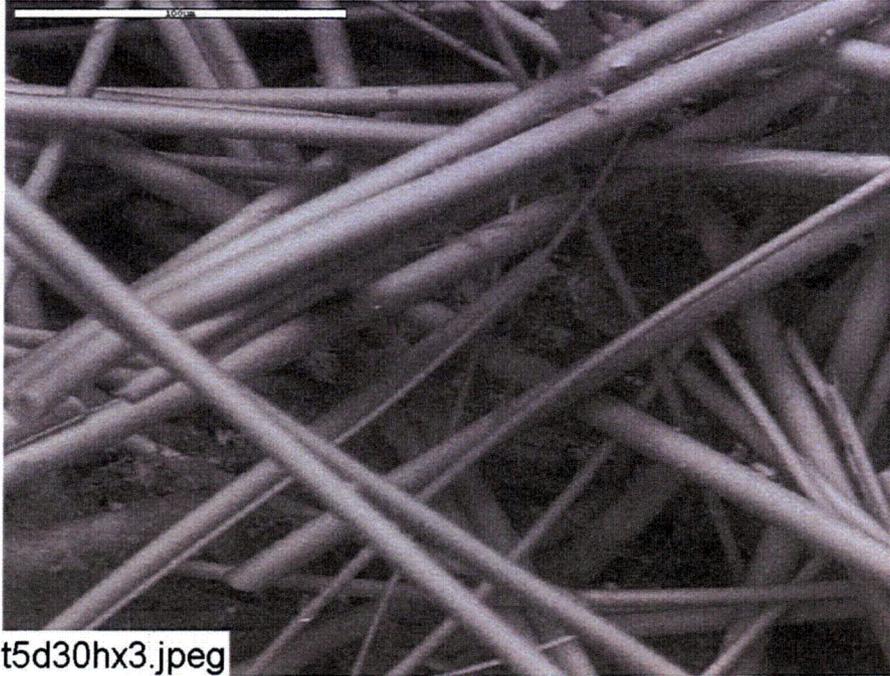
Figure C3-3. ESEM image magnified 500 times for a Test #5, Day-30 high-flow exterior fiberglass sample. (t5d30hx3.jpeg)

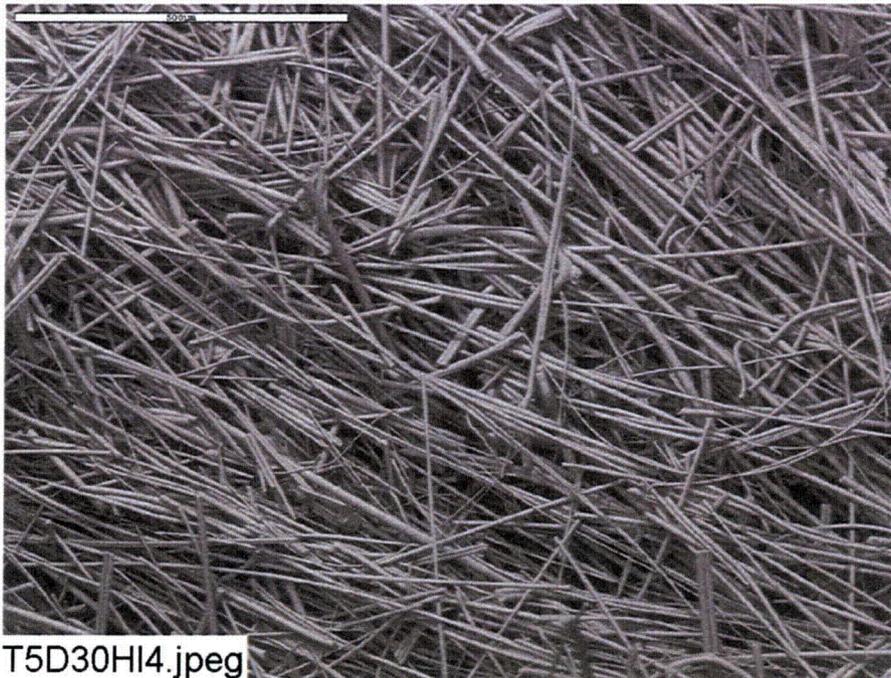
Figure C3-4. ESEM image magnified 100 times for a Test #5, Day-30 high-flow interior fiberglass sample. (T5D30HI4.jpeg)

Image: T5D30HI4	100 ×	ESEM image	Figure C3-4
t5d30hi5	100 ×	ESEM image	Figure C3-5
t5d30hi6	500 ×	ESEM image higher magnification	Figure C3-6

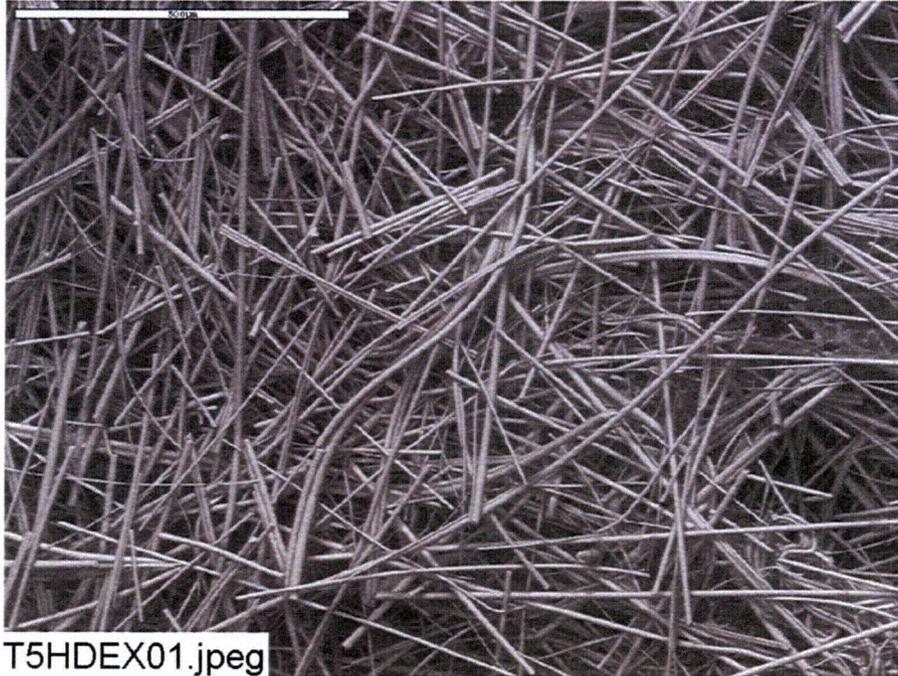
Figure C4-1. ESEM image magnified 100 times for a Test #5, Day-30 high-flow exterior fiberglass sample in front of the header. The sample was put in the tank on Day 6. (T5HDEX01.jpeg)

Image: T5HDEX01	100 ×	ESEM image	Figure C4-1
t5hdex02	100 ×	ESEM image	Figure C4-2
t5hdex03	500 ×	ESEM image higher magnification	Figure C4-3

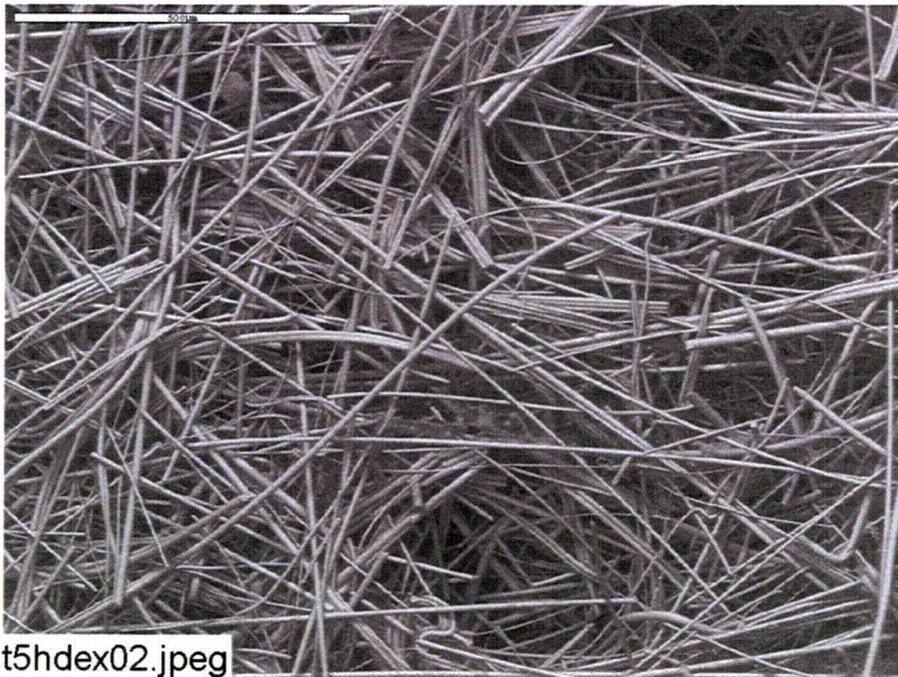
Figure C4-2. ESEM image magnified 100 times for a Test #5, Day-30 high-flow exterior fiberglass sample in front of the header. The sample was put in the tank on Day 6. (t5hdex02.jpeg)

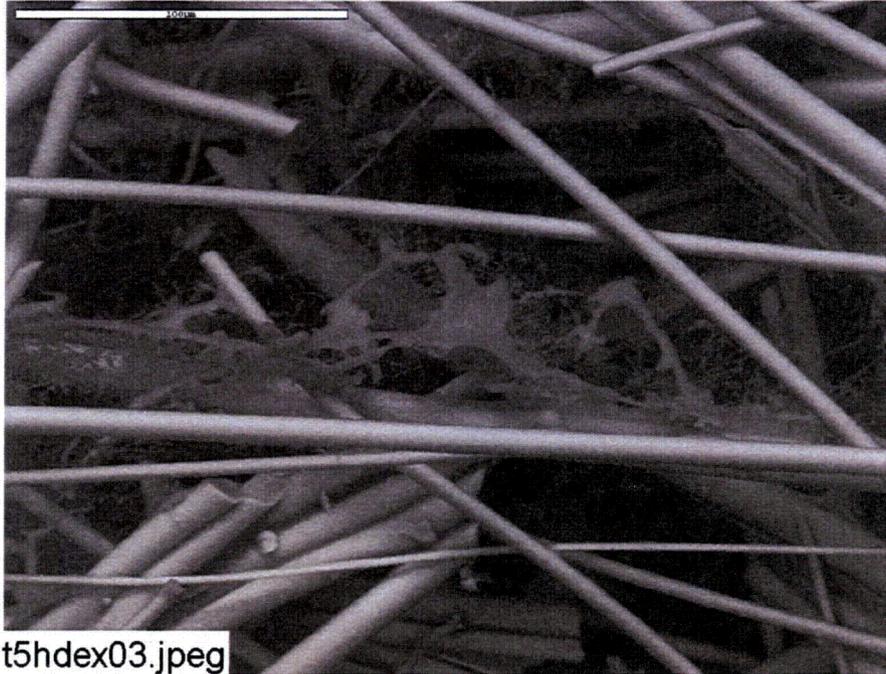
t5hdex03.jpeg

Figure C4-3. ESEM image magnified 500 times for a Test #5, Day-30 high-flow exterior fiberglass sample in front of the header. The sample was put in the tank on Day 6. (t5hdex03.jpeg)
