Preface to Appendices

ESEM/EDS Test #5 Day-4 fiberglass in low-flow zone

ESEM/EDS Data for Test #5, Day-15 Fiberglass in Low-Flow Zones

ESEM Data for Test #5, Day-15 Fiberglass in High-Flow Zones

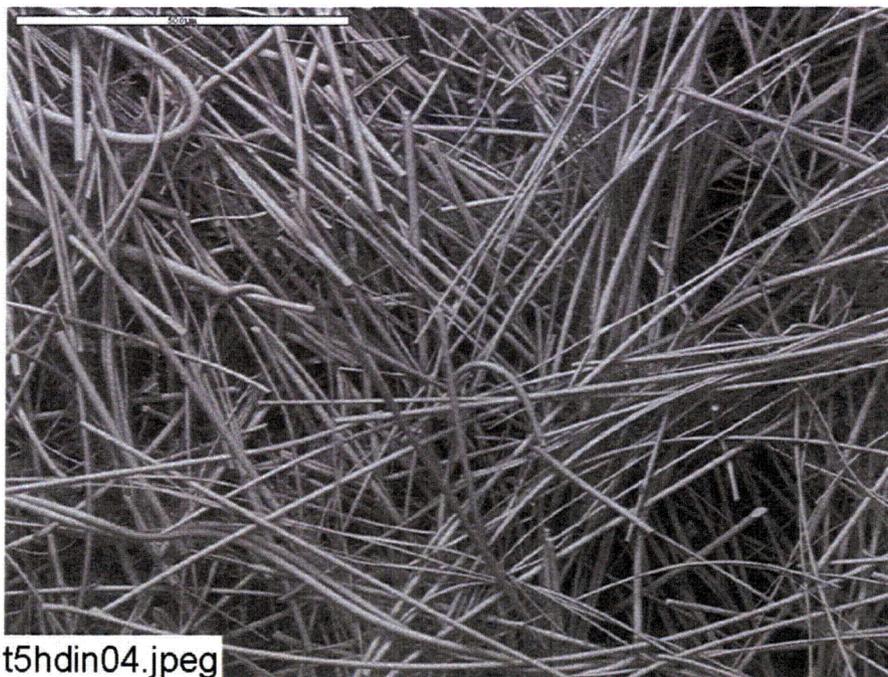
t5hdin04.jpeg

Figure C4-4. ESEM image magnified 100 times for a Test #5, Day-30 high-flow interior fiberglass sample in front of the header. The sample was put in the tank on Day 6. (t5hdin04.jpeg)

Image: t5hdin04	100 ×	ESEM image of fiberglass	Figure C4-4
t5hdin05	500 ×	ESEM image higher magnification	Figure C4-5

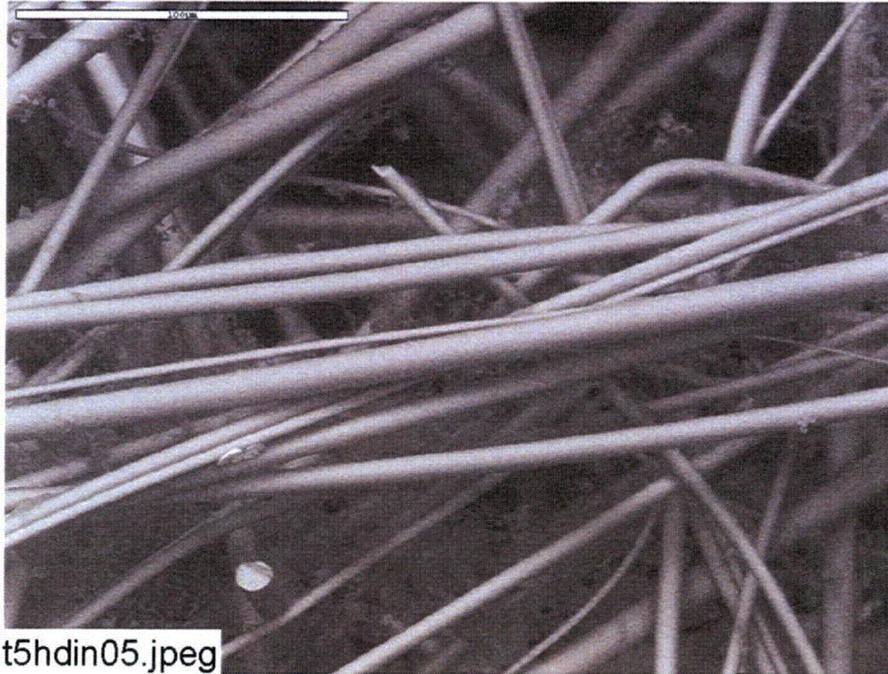
t5hdin05.jpeg

Figure C4-5. ESEM image magnified 500 times for a Test #5, Day-30 high-flow interior fiberglass sample in front of the header. The sample was put in the tank on Day 6. (t5hdin05.jpeg)

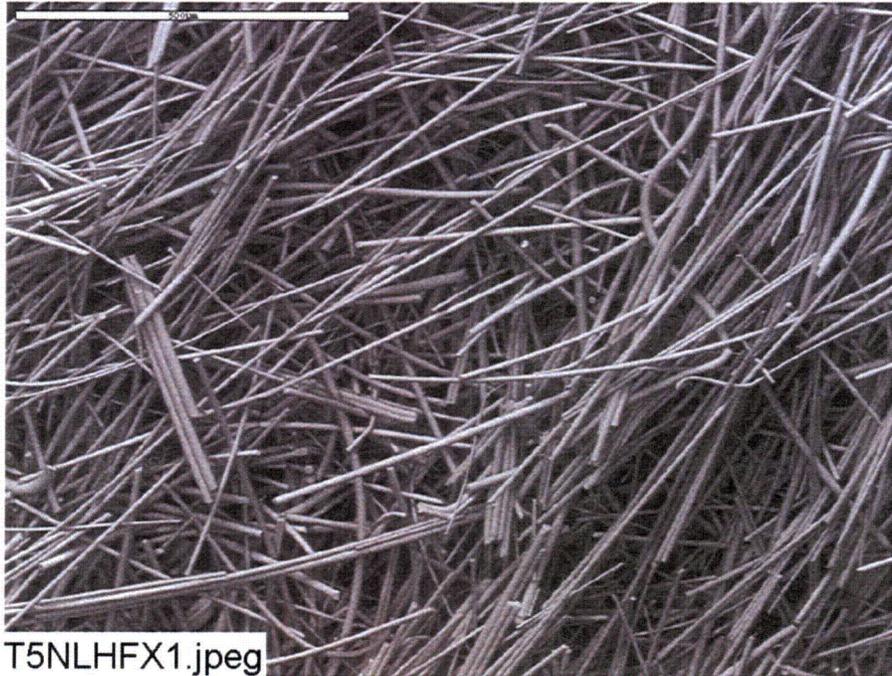
T5NLHFX1.jpeg

Figure C5-1. ESEM image magnified 100 times for a Test #5, Day-30 low-flow exterior fiberglass sample in a nylon mesh. The sample was put in the tank on Day 6. (T5NLHFX1.jpeg)

Image: T5NLHFX1 100 × ESEM image

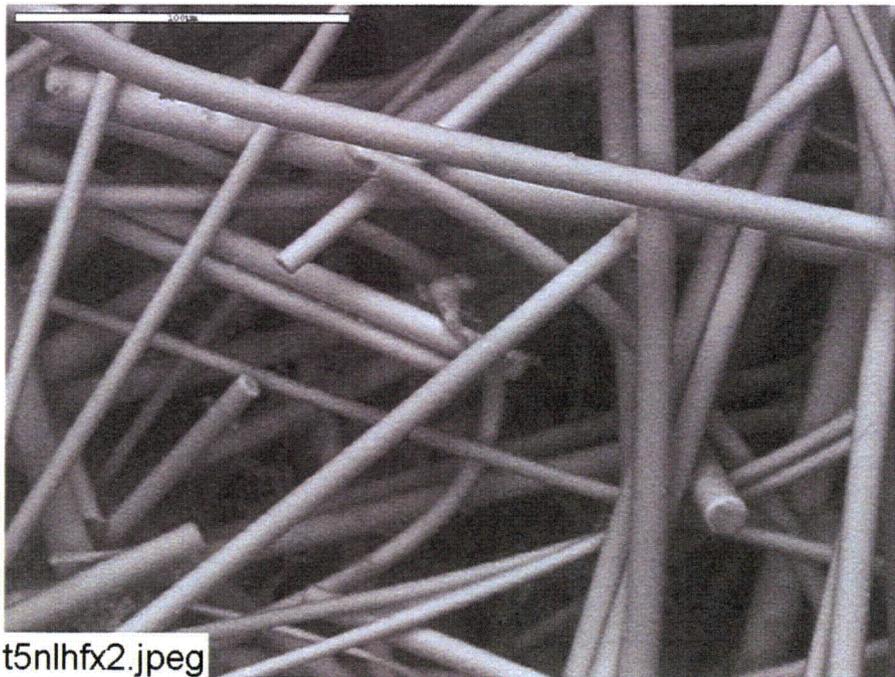
t5nlhfx2.jpeg

Figure C5-2. ESEM image magnified 500 times for a Test #5, Day-30 low-flow exterior fiberglass sample in a nylon mesh. The sample was put in the tank on Day 6. (t5nlhfx2.jpeg)

t5nlhfx1 500 × ESEM image

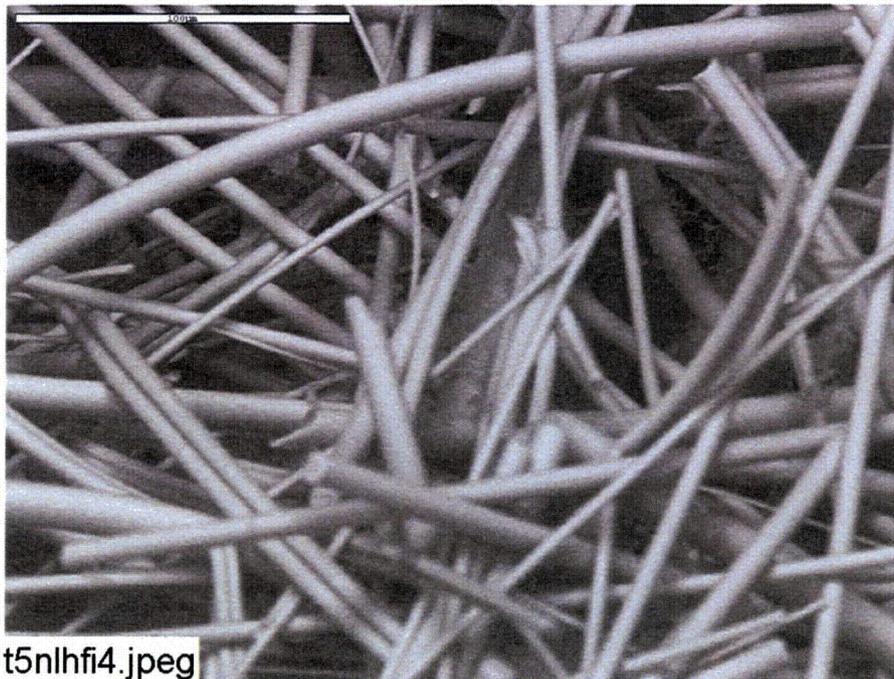
Figure C5-4. ESEM image magnified 500 times for a Test #5, Day-30 low-flow interior fiberglass sample in a nylon mesh. The sample was put in the tank on Day 6. (t5nlhfi4.jpeg)

Image:	t5nlhfi3	100 ×	ESEM image of fiberglass	Figure C5-3
	t5nlhfi4	500 ×	ESEM image higher magnification	Figure C5-4
EDS	t5nlhfi5		EDS on floc in image t5nlhfi4	Figure C5-5

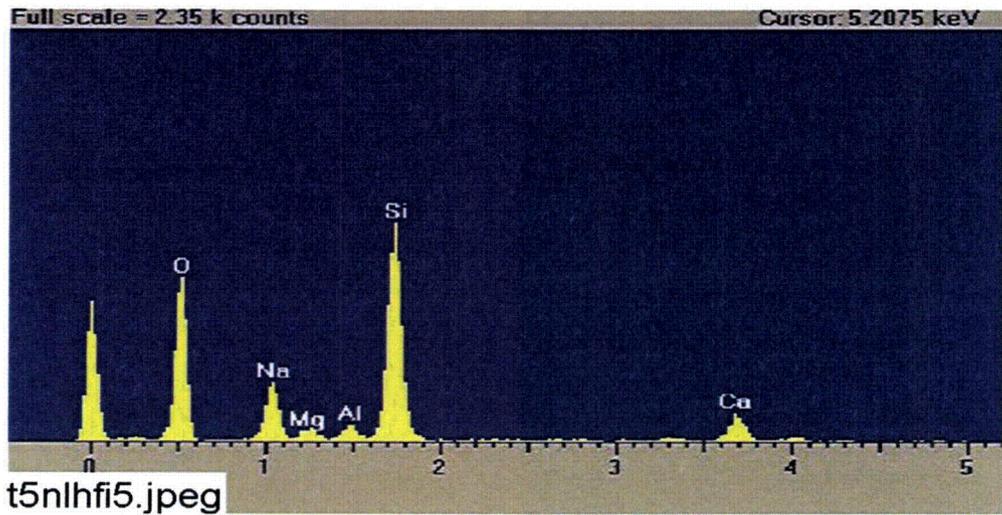
Figure C5-5. EDS counting spectrum for the deposits between the fibers shown in Figure C5-4. (t5nlhfi5.jpeg)

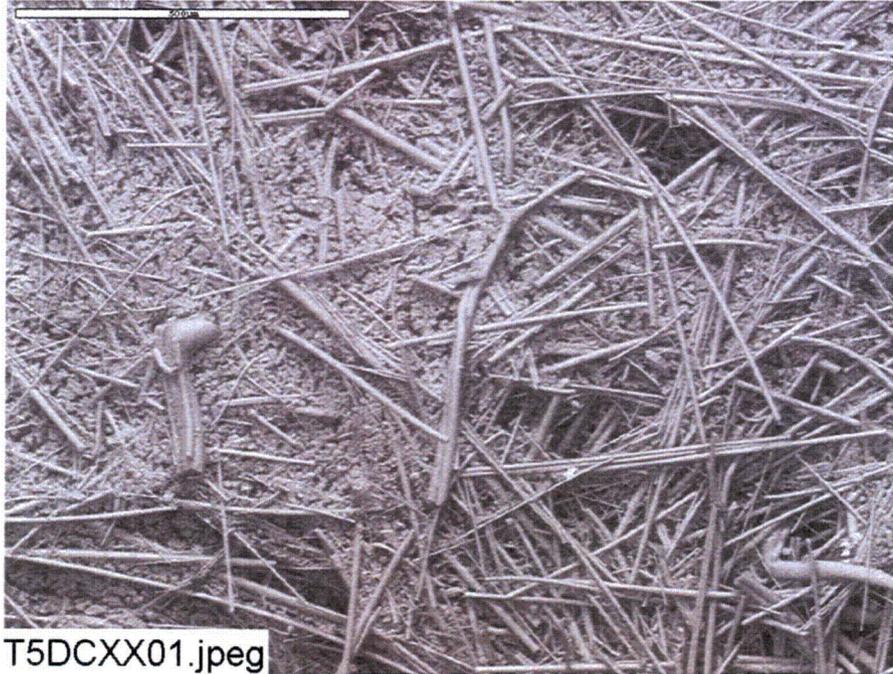
Figure C6-1. ESEM image magnified 100 times for a Test #5, Day-30 exterior drain collar fiberglass sample farthest from the drain screen. (T5DCXX01.jpeg)

Image:	T5DCXX01	100 ×	ESEM image	Figure C6-1
	t5dcxx02	100 ×	ESEM image	Figure C6-2
	t5dcxx03	500 ×	Annotated ESEM image	Figure C6-3
EDS:	t5dcxx04		EDS on particles in t5dcxx03	Figure C6-4
	t5dcxx05		EDS on particles in t5dcxx03	Figure C6-5
	T5D30Draincollar Particle16		EDS on particles on exterior of drain collar	Figure C6-6

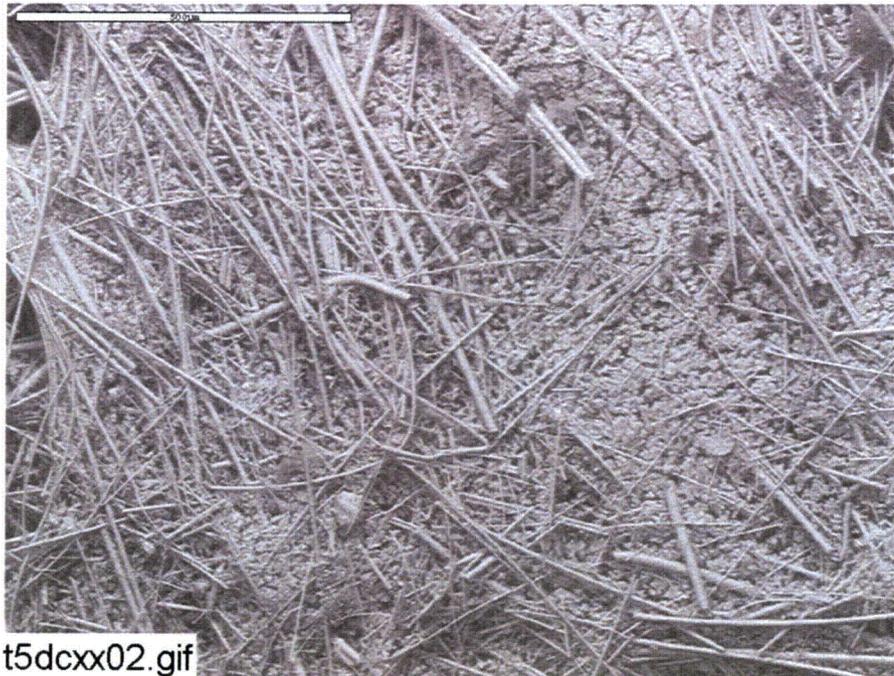
Figure C6-2. ESEM image magnified 100 times for a Test #5, Day-30 exterior drain collar fiberglass sample farthest from the drain screen. (t5dcxx02.gif)

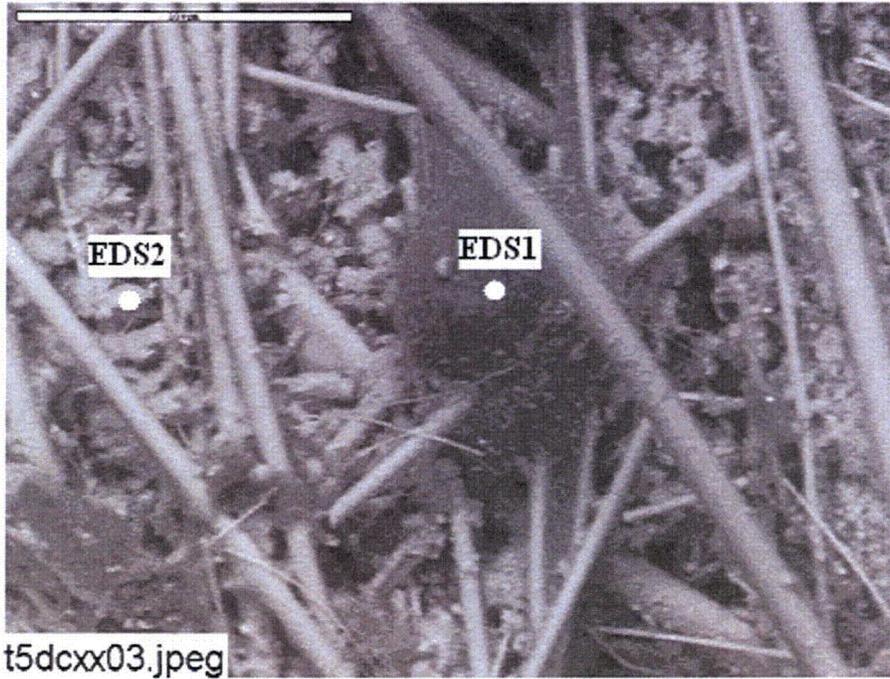
Figure C6-3. Annotated ESEM image magnified 500 times for a Test #5, Day-30 exterior drain collar fiberglass sample farthest from the drain screen. (t5dcxx03.jpeg)

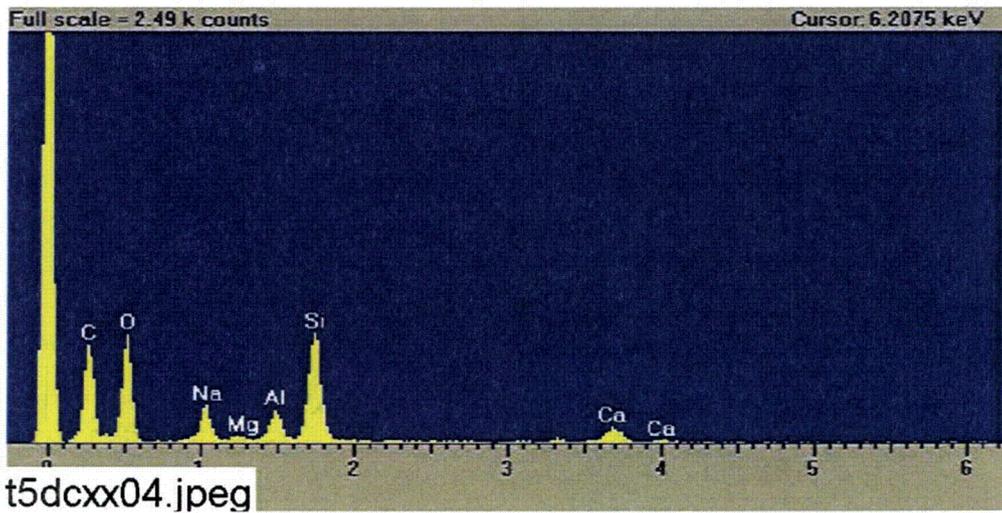
Figure C6-4. EDS counting spectrum for the dark deposits (EDS1) between fibers shown in Figure C6-3. (t5dcxx04.jpeg)

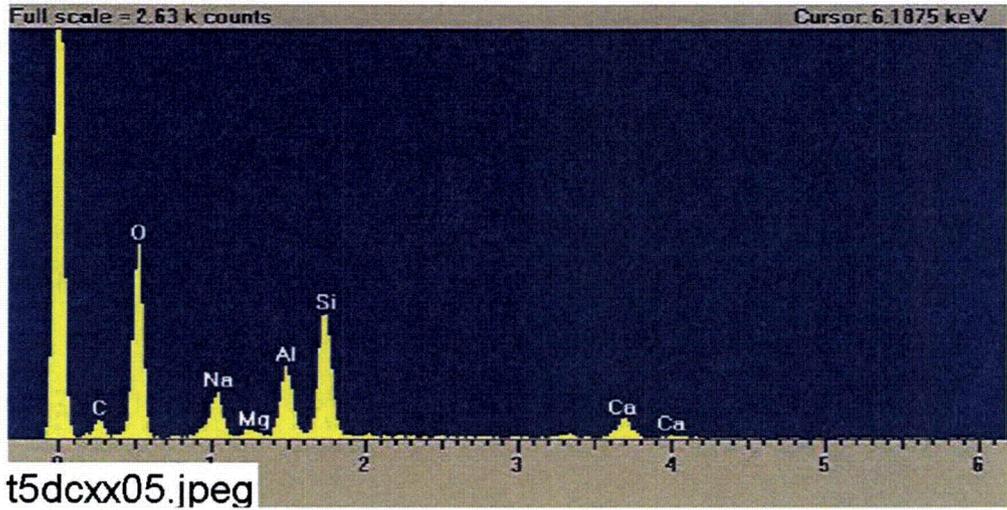
Figure C6-5. EDS counting spectrum for the small particulate deposits (EDS2) between fibers shown in Figure C6-3. (t5dcxx05.jpeg)

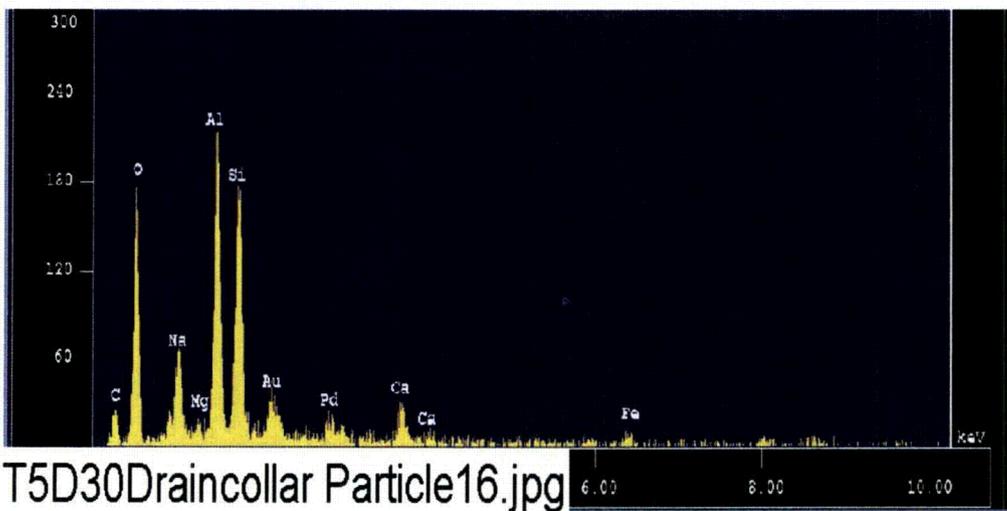
Figure C6-6. EDS counting spectrum by probe SEM for the small particulate deposits (EDS2) between fibers shown in Figure C6-3. (T5D30Draincollar Particle16.jpg)

The results from the chemical composition analysis for T5D30Draincollar Particle16.jpg are given in Table C6-1.

Group      : NRC
Sample     : T5D30 ID# : 22
Comment    : Particles on Drain collar out exterior
Condition  : Full Scale : 20KeV(10eV/ch,2Kch)
             Live Time  : 72.190 sec      Aperture #   : 1
             Acc. Volt  : 15.0 KV         Probe Current : 1.003E-09 A
             Stage Point : X=76.455 Y=54.980 Z=11.000
             Acq. Date  : Tue Aug 30 18:08:20 2005

Element	Mass%	Atomic%	ZAF	Z	A	F
Na	2.761	1.9859	1.0916	0.9815	1.1113	1.0007
Al	8.876	5.4401	1.0897	0.9899	1.1034	0.9977
Si	8.579	5.0513	1.2314	0.9822	1.2538	0.9999
Ca	2.914	1.2022	0.9700	0.9929	0.9778	0.9991
Hg	1.039	0.7068	1.4318	0.9712	1.4778	0.9976
O	42.666	44.1002	1.5030	0.9888	1.5200	1.0000
C	29.326	40.3765	0.3146	0.9920	0.3171	1.0000
Fe	3.840	1.1369	1.2115	1.2176	0.9950	1.0000

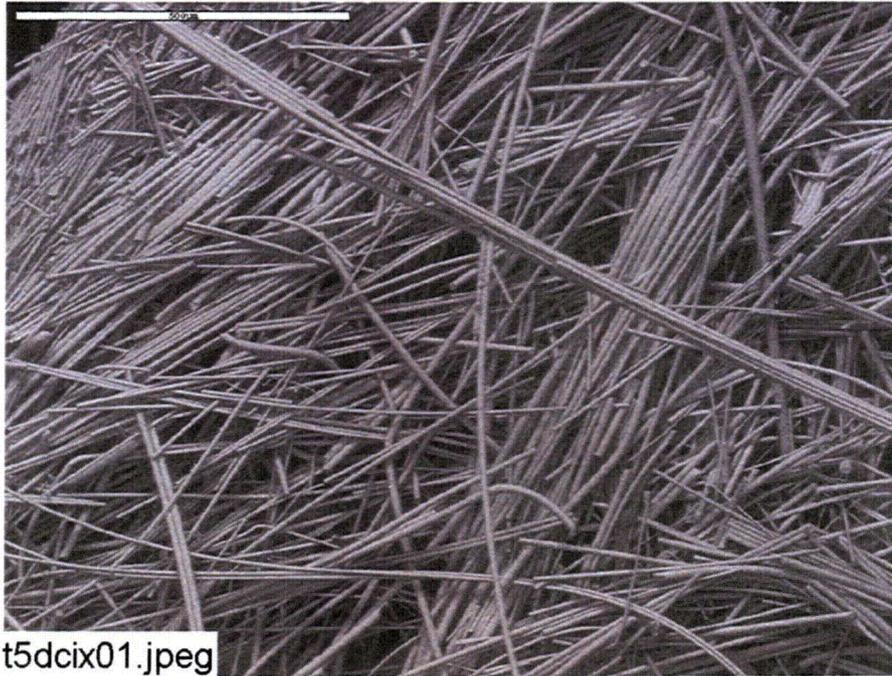
Figure C6-7. ESEM image magnified 100 times for a Test #5, Day-30 exterior drain collar fiberglass sample next to the drain screen. (t5dcix01.jpeg)

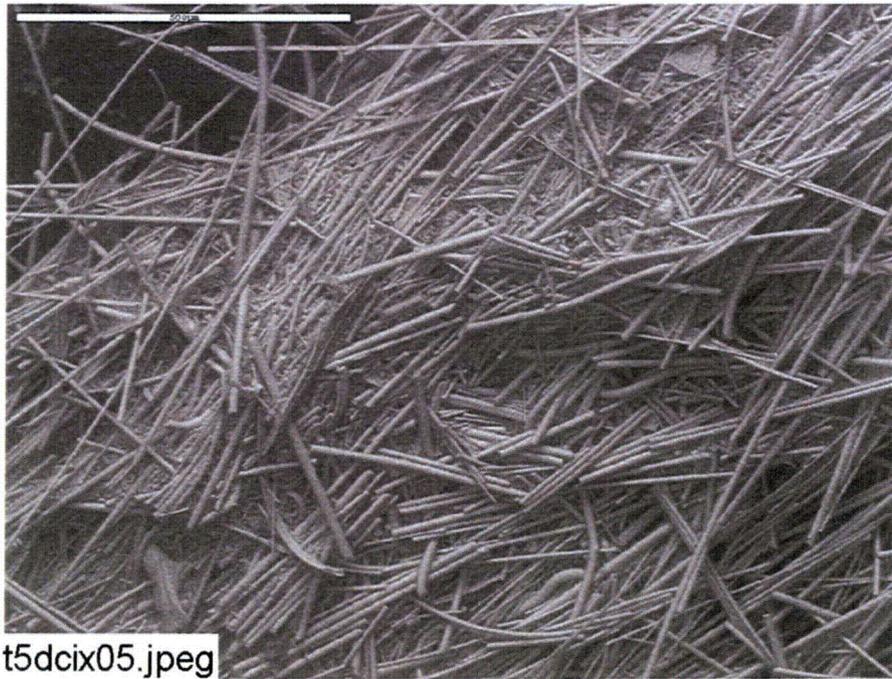
Figure C6-8. ESEM image magnified 100 times for a Test #5, Day-30 exterior drain collar fiberglass sample next to the drain screen. (t5dcix05.jpeg)

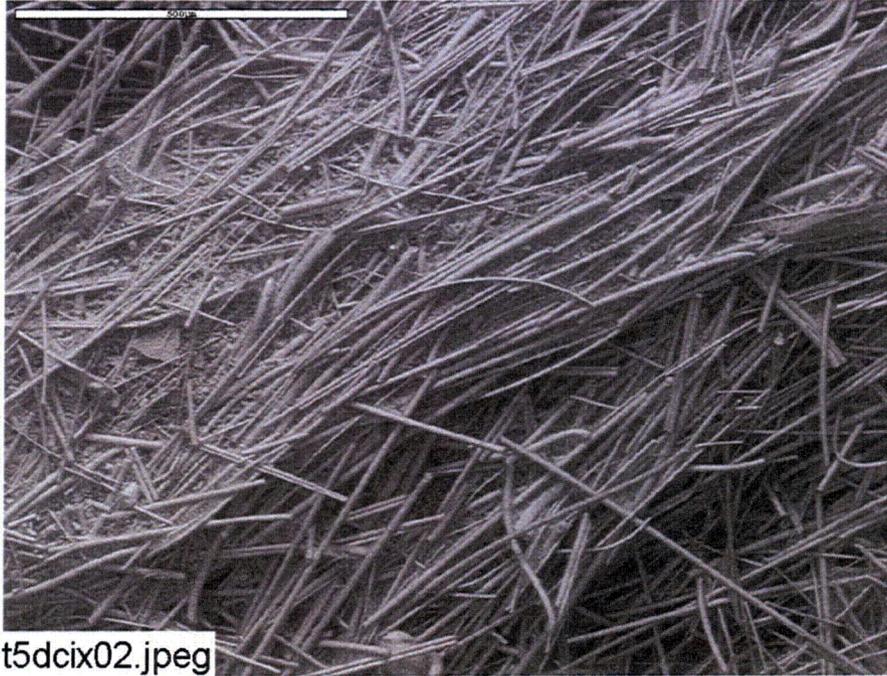
t5dcix02.jpeg

Figure C6-9. ESEM image magnified 100 times for a Test #5, Day-30 exterior drain collar fiberglass sample next to the drain screen. (t5dcix02.jpeg)

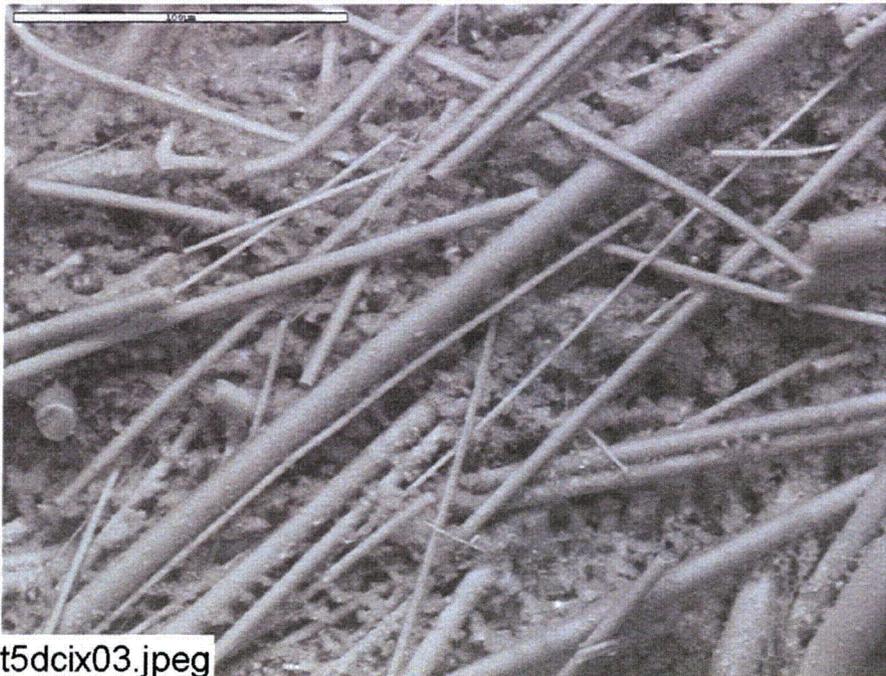
t5dcix03.jpeg

Figure C6-10. ESEM image magnified 500 times for a Test #5, Day-30 exterior drain collar fiberglass sample next to the drain screen. (t5dcix03.jpeg)

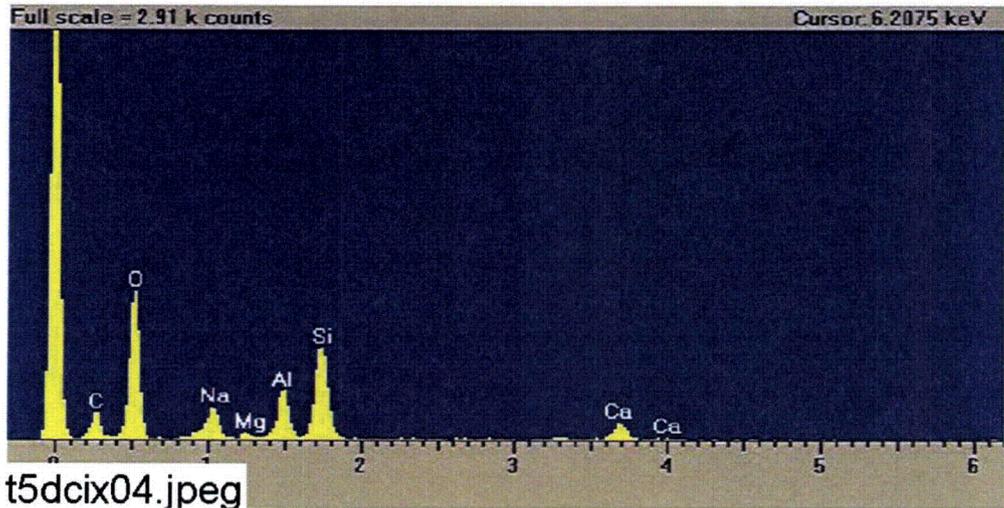
Figure C6-11. EDS counting spectrum for the particulate deposits between fibers shown in Figure C6-10. (t5dcix04.jpeg)

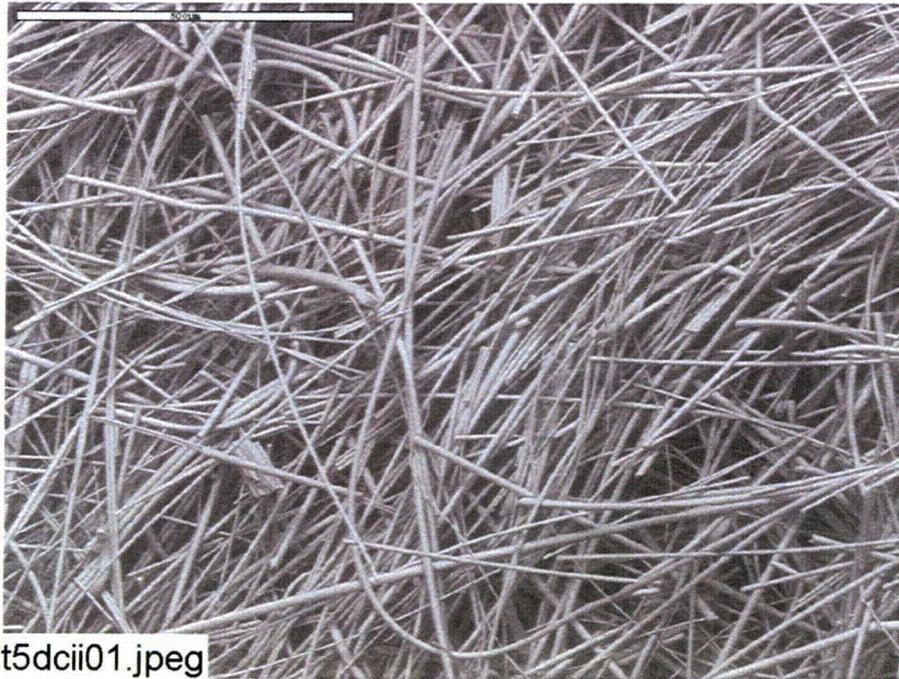
Figure C6-12. ESEM image magnified 100 times for a Test #5, Day-30 interior drain collar fiberglass sample. (t5dcii01.jpeg)

Image:	t5dcii01	100 ×	ESEM image	Figure C6-12
	T5D30DraincollarInt027	200 ×	Probe SEM image	Figure C6-13
	t5dcii02	500 ×	ESEM image	Figure C6-14
	T5D30DraincollarInt026	1000 ×	Probe SEM image higher	Figure C6-15
EDS:	T5D30fiber flocc17		EDS on particles in t4dcix08	Figure C6-16

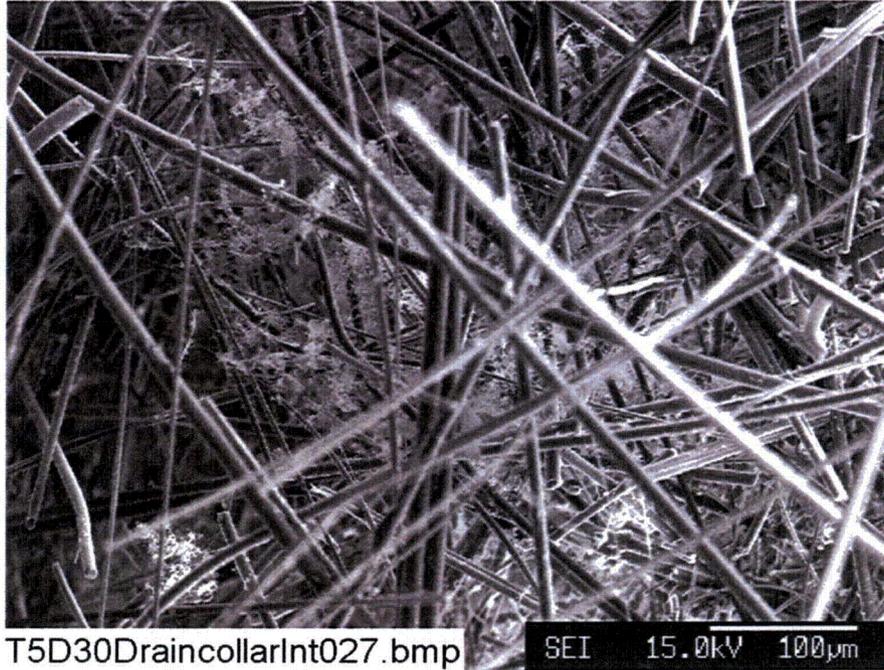
Figure C6-13. Probe SEM image magnified 200 times for a Test #5, Day-30 interior drain collar fiberglass sample. (T5D30DraincollarInt027.bmp)

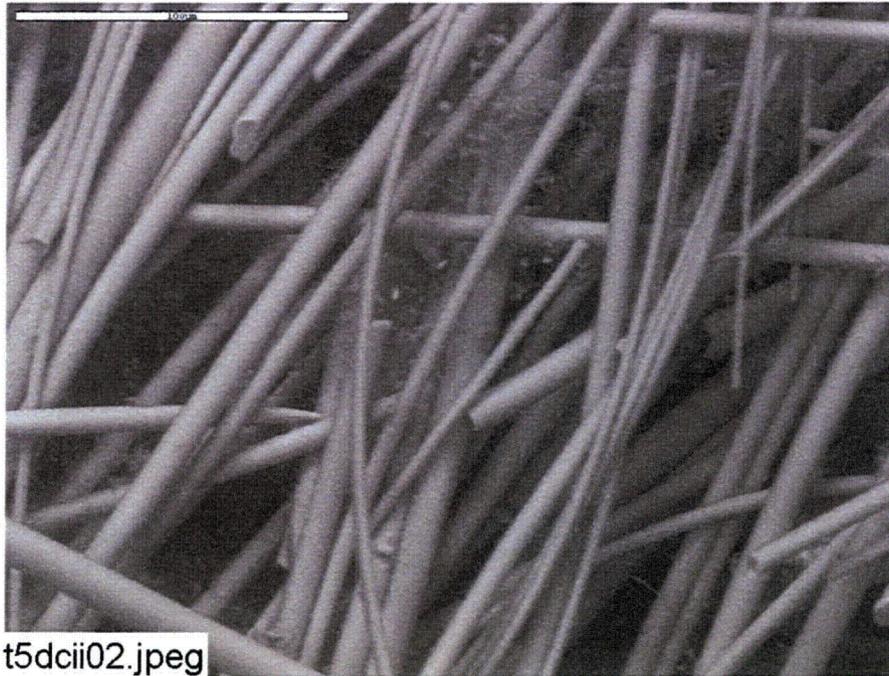
Figure C6-14. ESEM image magnified 500 times for a Test #5, Day-30 interior drain collar fiberglass sample. (t5dcii02.jpeg)

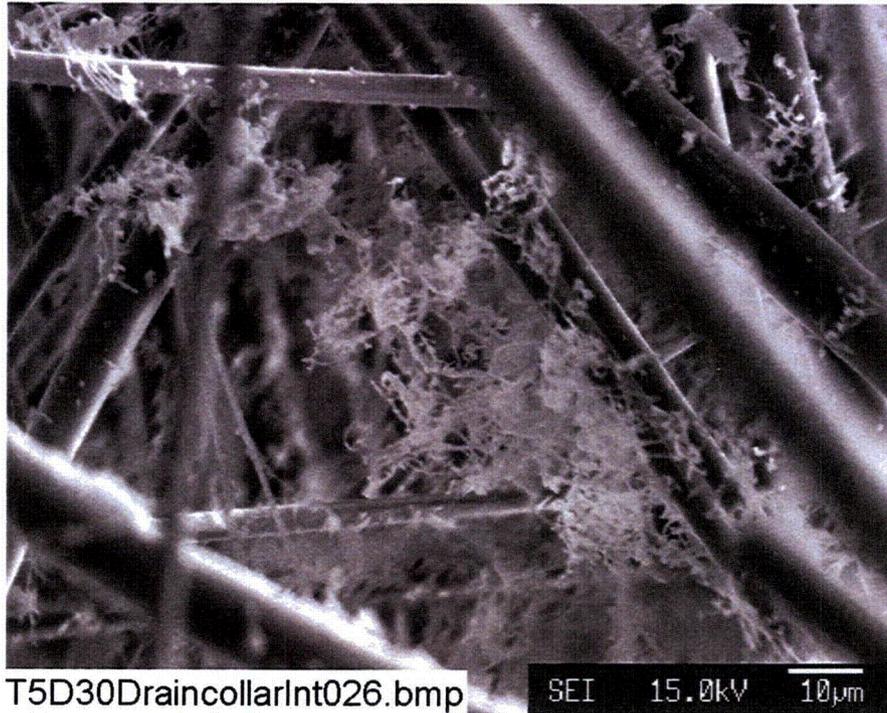
Figure C6-15. Probe SEM image magnified 1000 times for a Test #5, Day-30 interior drain collar fiberglass sample. (T5D30DraincollarInt026.bmp)

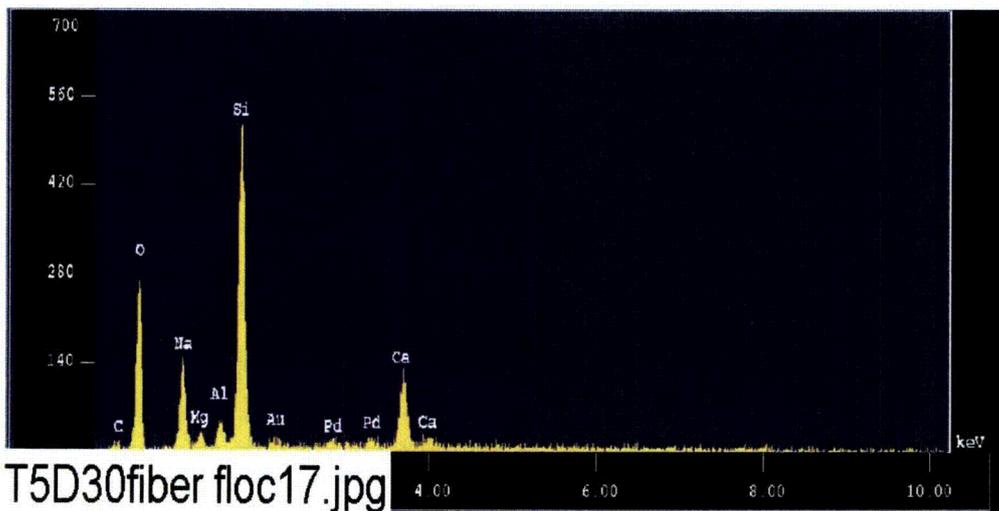
Figure C6-16. EDS counting spectrum by probe SEM for the flocculence deposits between fibers shown in Figure C6-15. (T5D30fiber flocc17.jpg)

The results from the chemical composition analysis for T5D30fiber flocc17.jpg are given in Table C6-2.

Group      : NRC
Sample     : T5D30 ID# : 23
Comment    : Flocculence on draincollar interior
Condition  : Full Scale : 20KeV(10ev/ch,2Kch)
             Live Time  : 96.780 sec      Aperture #   : 1
             Acc. Volt   : 15.0 KV        Probe Current : 1.003E-09 A
             Stage Point : X=76.455 Y=54.980 Z=11.000
             Acq. Date   : Tue Aug 30 18:19:56 2005

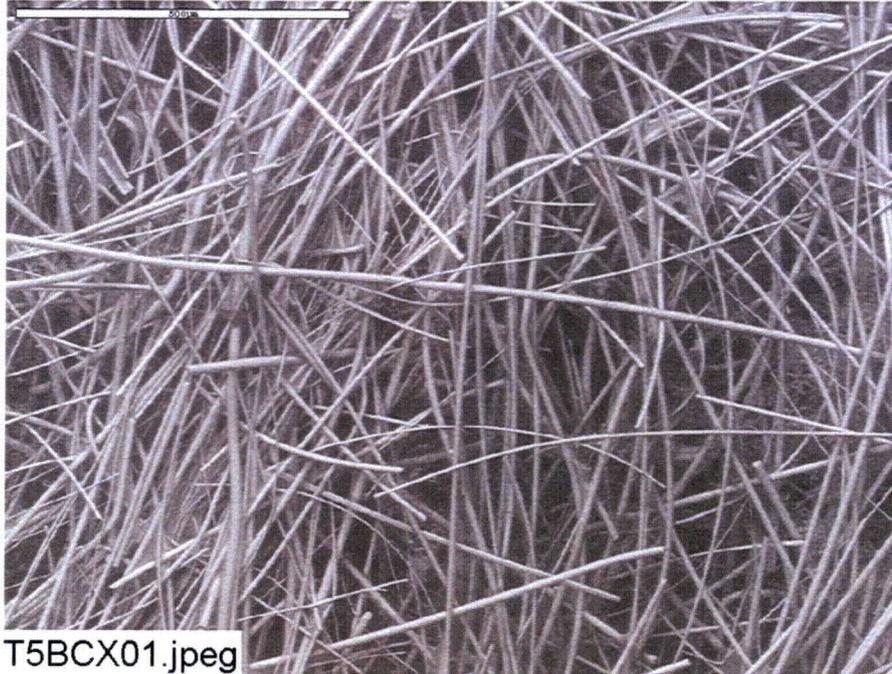
T5BCX01.jpeg

Figure C7-1. ESEM image magnified 100 times for a Test #5, Day-30 exterior fiberglass sample within the birdcage. (T5BCX01.jpeg)

Image: T5BCX01	100 ×	ESEM image	Figure C7-1
t5bcx02	100 ×	ESEM image	Figure C7-2
t5bcx03	500 ×	ESEM image higher magnification	Figure C7-3
EDS: t5bcx04		EDS on particles on t5bcx03	Figure C7-4
Image: t5bcx05	500 ×	ESEM image	Figure C7-5

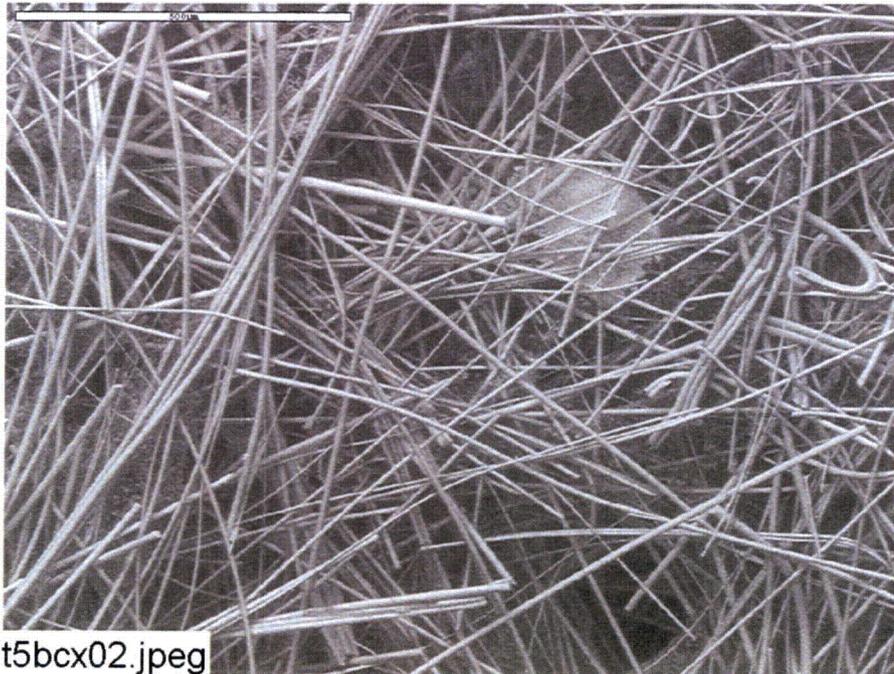
t5bcx02.jpeg

Figure C7-2. ESEM image magnified 100 times for a Test #5, Day-30 exterior fiberglass sample within the birdcage. (t5bcx02.jpeg)

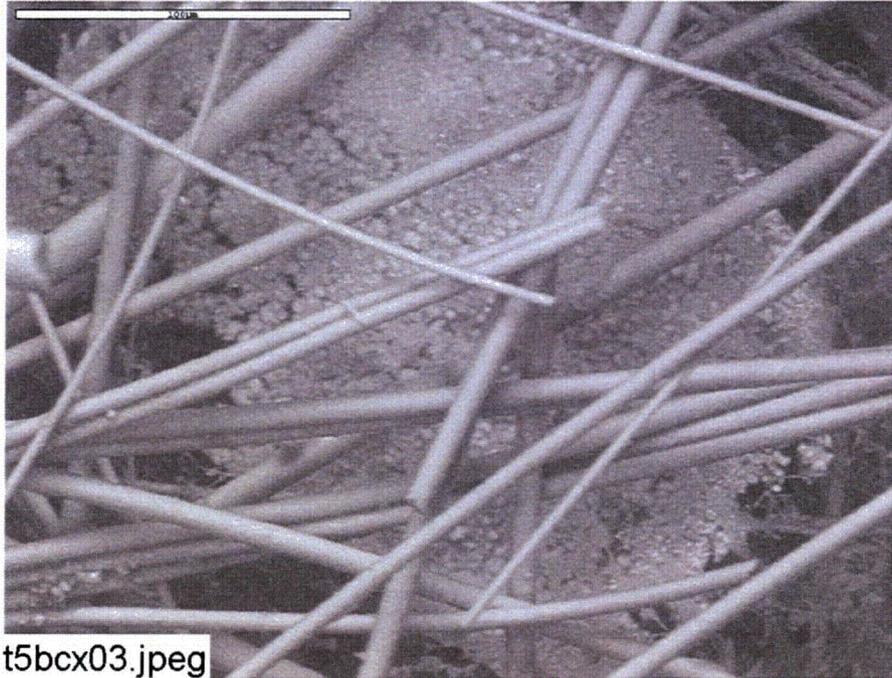
Figure C7-3. ESEM image magnified 500 times for a Test #5, Day-30 exterior fiberglass sample within the birdcage. (t5bcx03.jpeg)

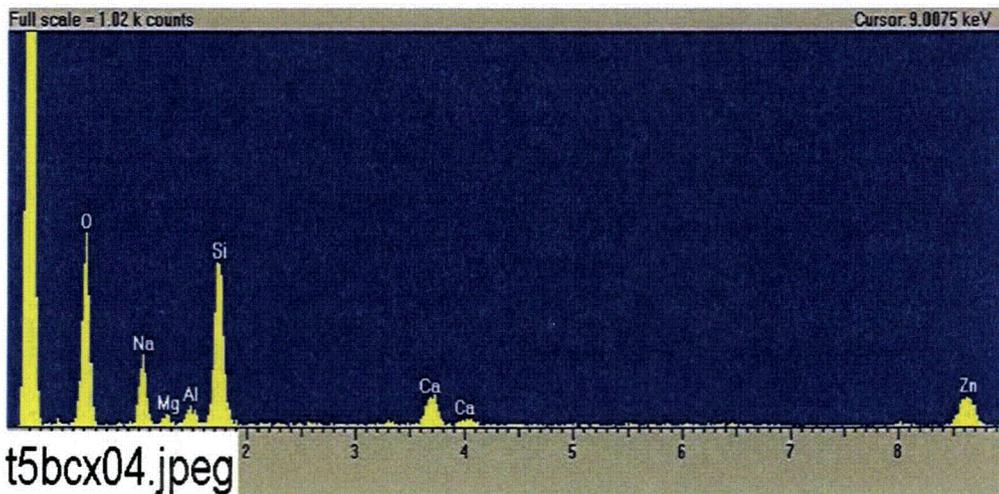
Figure C7-4. EDS counting spectrum for the deposits between fibers shown in Figure C7-3. (t5bcx04.jpeg)

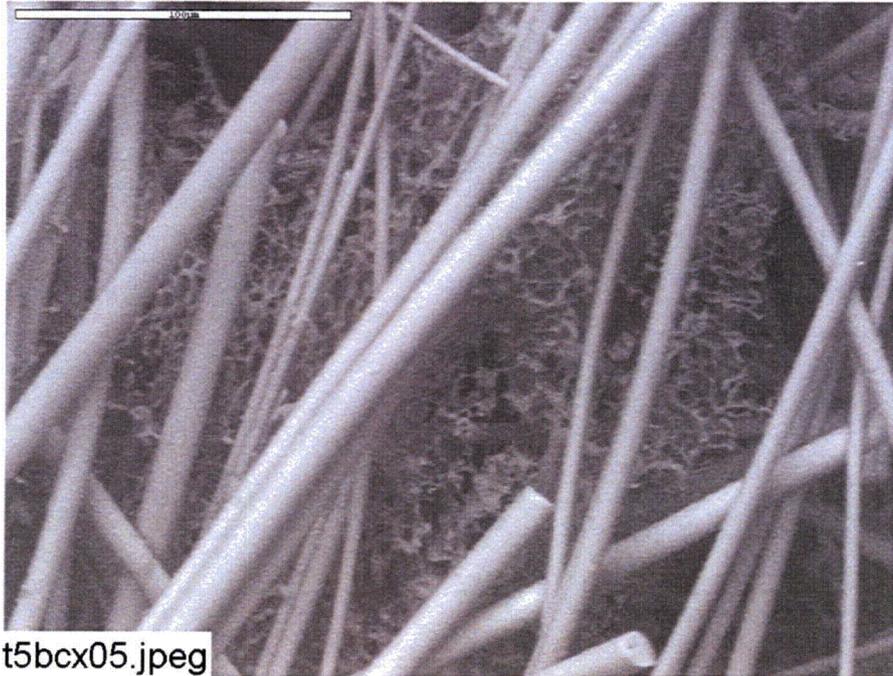
t5bcx05.jpeg

Figure C7-5. ESEM image magnified 500 times for a Test #5, Day-30 exterior fiberglass sample within the birdcage. (t5bcx05.jpeg)

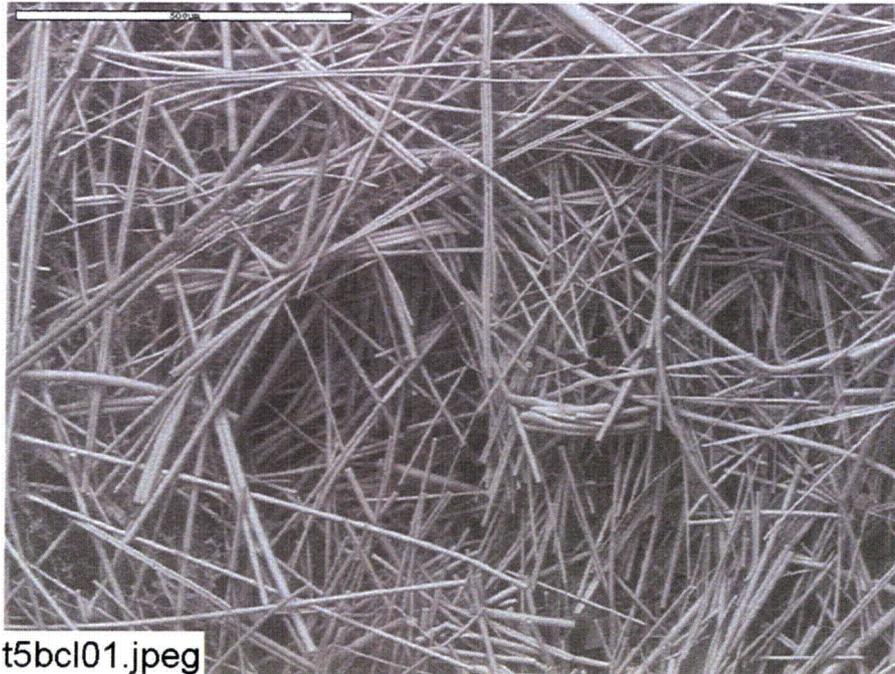
t5bcl01.jpeg

Figure C7-6. ESEM image magnified 100 times for a Test #5, Day-30 interior fiberglass sample within the birdcage. (t5bcl01.jpeg)

Image: t5bcI01	100 ×	ESEM image of fiberglass	Figure C7-6
t5bci03	100 ×	ESEM image	Figure C7-7
t5bci02	500 ×	ESEM image higher magnification	Figure C7-8

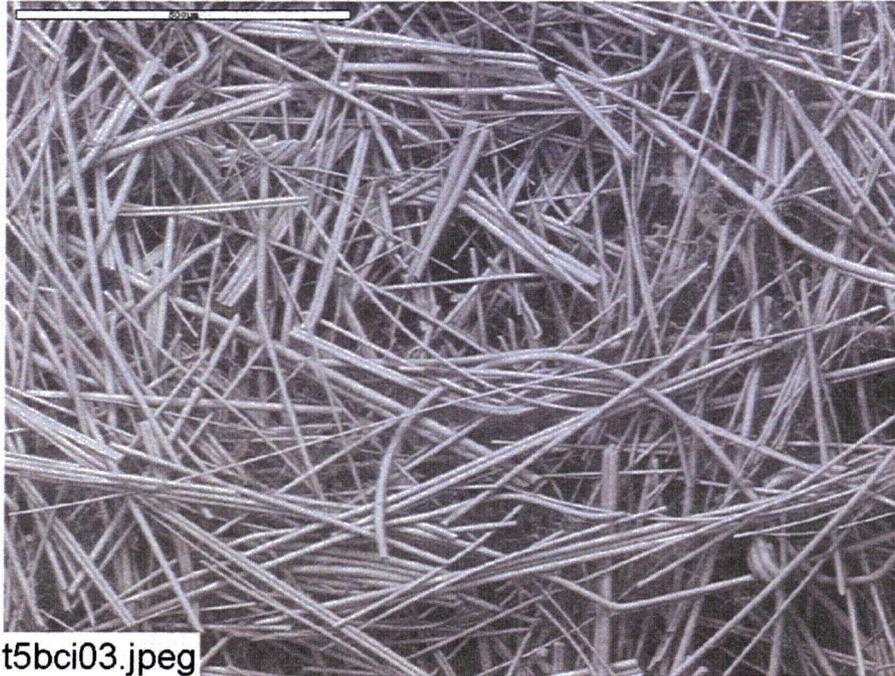
t5bci03.jpeg

Figure C7-7. ESEM image magnified 100 times for a Test #5, Day-30 interior fiberglass sample within the birdcage. (t5bci03.jpeg)

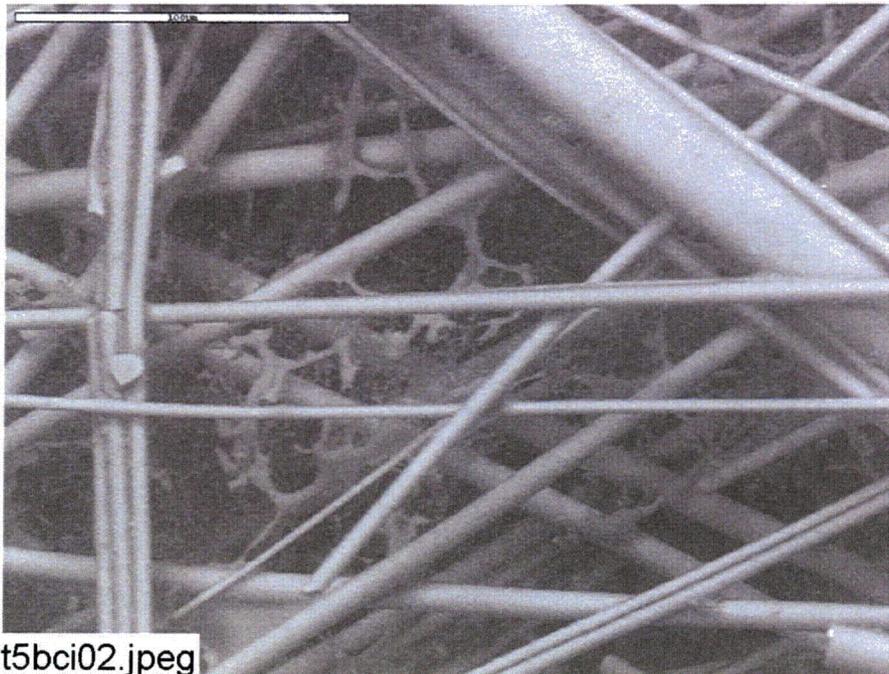
Figure C7-8. ESEM image magnified 500 times for a Test #5, Day-30 interior fiberglass sample within the birdcage. (t5bci02.jpeg)

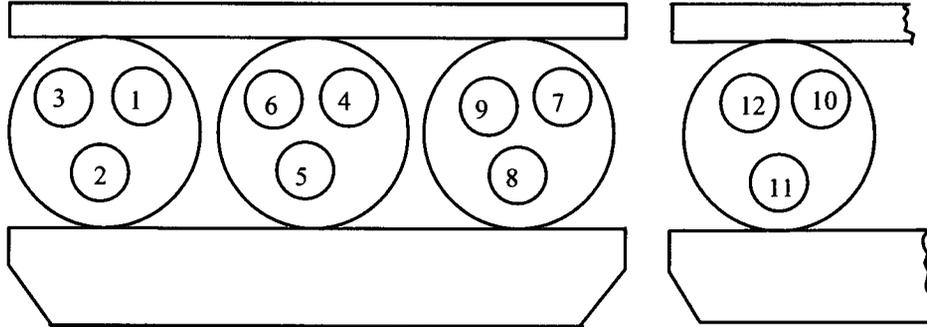
Test #5, Day-30 Deposition Products

Conditions: e=15.0kV, WD=11mm

1--Yellow Deposits on Submerged Rack	2--Sediment (T5D30)	3--Al-Suspended
4--Al-Submerged	5--Gal-Steel Suspended	6--Gal-Steel Submerged
7--Cu Suspended	8--Cu-Submerged	9--Steel-Suspended
10--Steel-Submerged	11--Drain Collar Interior	12--Drain Collar Outside Ext.

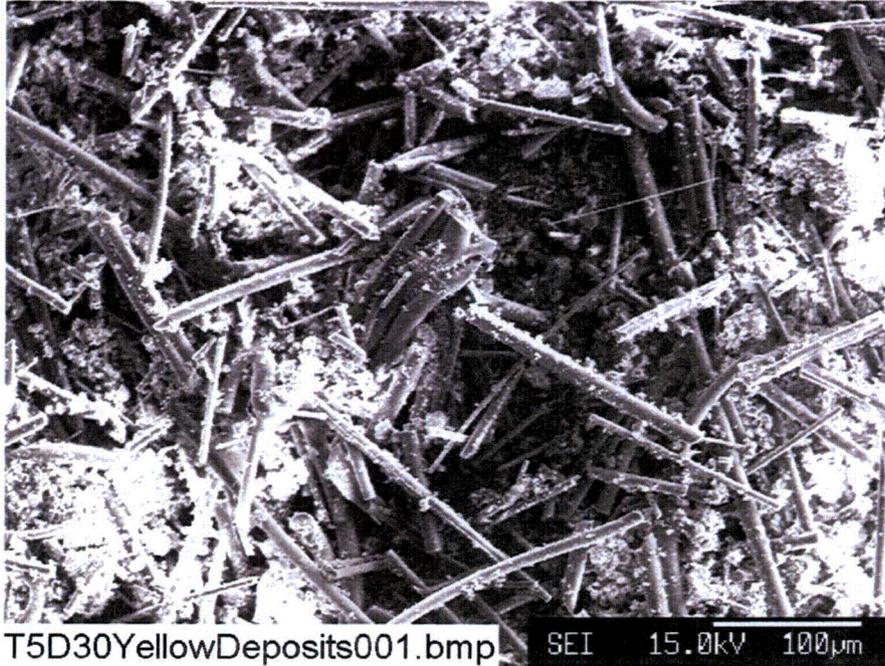
Figure D-1. SEM image magnified 100 times for the Test #5, Day-30 fine yellow powder on the submerged rack. (T5D30YellowDeposits001.bmp)

Image:	T5D30YellowDeposits001	100 ×	SEM image	Figure D-1
	T5D30YellowDeposits002	500 ×	SEM image	Figure D-2
	T5D30YellowDeposits003	1000 ×	Annotated SEM image	Figure D-3
EDS:	T5D30yllw~partcl02		EDS on particulate deposits	Figure D-4

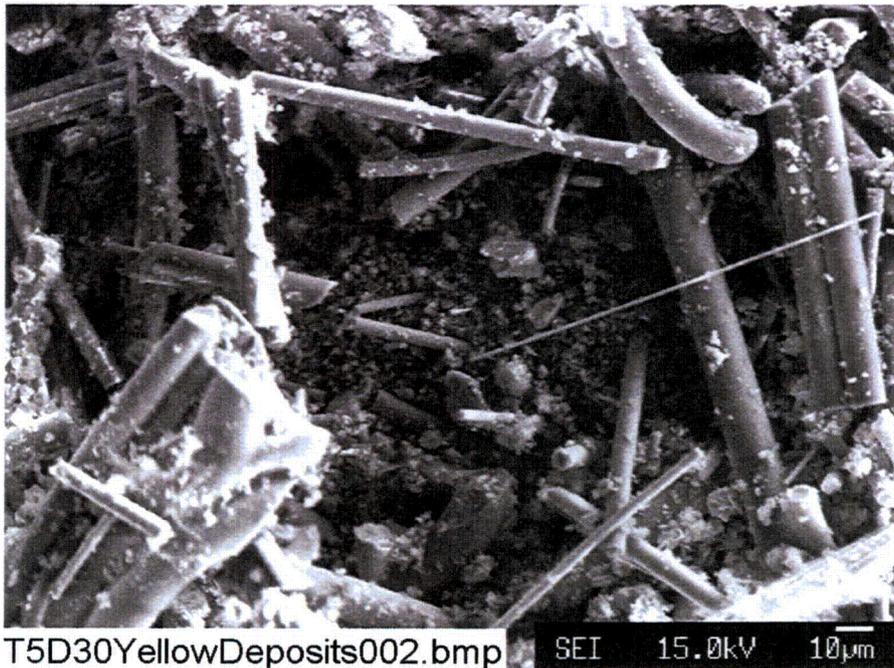
Figure D-2. SEM image magnified 200 times for the Test #5, Day-30 fine yellow powder on the submerged rack. (T5D30YellowDeposits002.bmp)

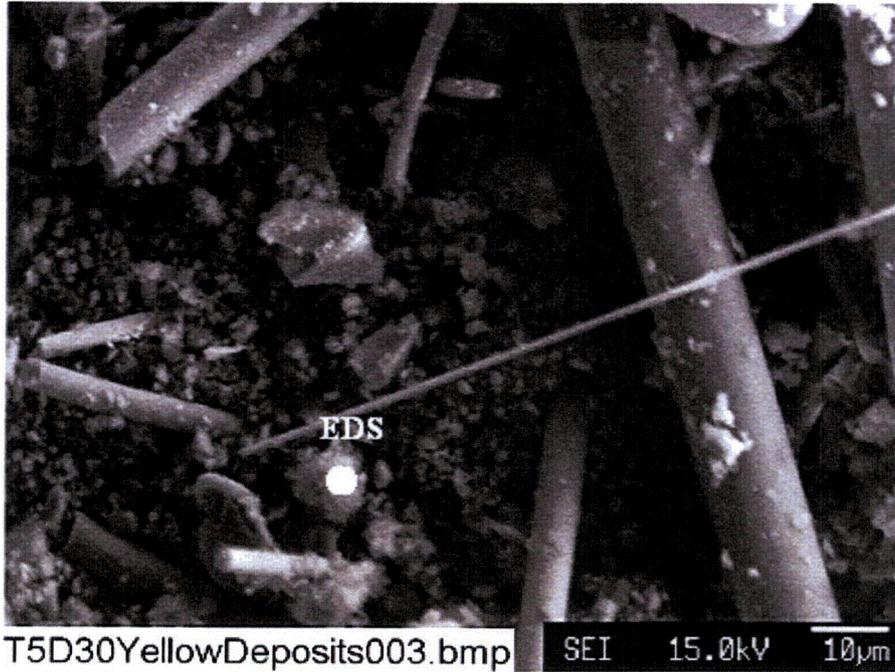
Figure D-3. Annotated SEM image magnified 1000 times for the Test #5, Day-30 fine yellow powder on the submerged rack. (T5D30YellowDeposits003.bmp)

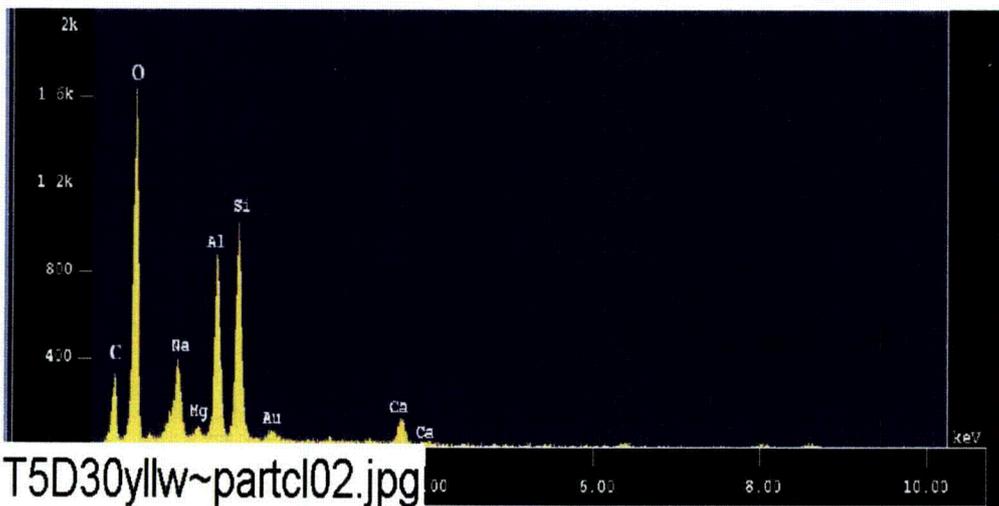
Figure D-4. EDS counting spectrum for the particulate deposit shown in Figure D-3. (T5D30yllw~partcl02.jpg)

The results from the chemical composition analysis for T5D30yllw~partcl02.jpg are given in Table D-1.

Group      : NRC
Sample     : T5D30 ID# : 30
Comment    : Yellow deposits on submerged rack
Condition  : Full Scale : 20KeV(10eV/ch,2Kch)
            Live Time  : 76.130 sec Aperture # : 5
            Acc. Volt  : 15.0 KV Probe Current : 1.996E-08 A
            Stage Point: X=45.414 Y=58.152 Z=11.027
            Acq. Date  : Tue Sep 6 10:38:29 2005
