Preface to Appendices

ESEM/EDS Test #5 Day-4 fiberglass in low-flow zone

ESEM/EDS Data for Test #5, Day-15 Fiberglass in Low-Flow Zones

ESEM Data for Test #5, Day-15 Fiberglass in High-Flow Zones

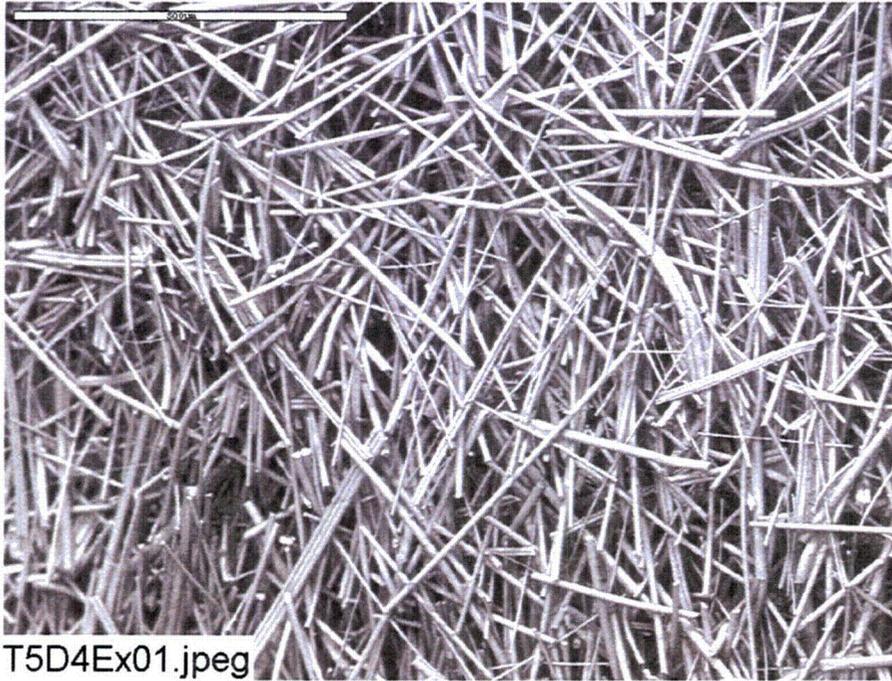
Figure A-1. ESEM image magnified 100 times for a Test #5, Day-4 low-flow exterior fiberglass sample. (T5D4Ex01.jpeg)

Image: T5D4Ex01	100 ×	ESEM image	Figure A-1
t5d4ex02	100 ×		Figure A-2
t5d4ex03	500 ×	ESEM at higher magnification	Figure A-3

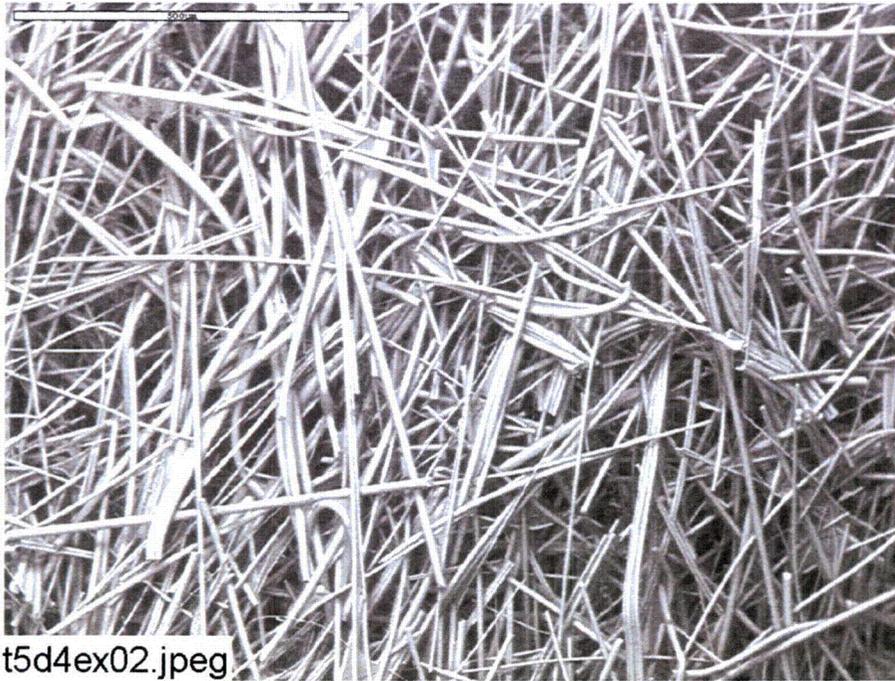
Figure A-2. ESEM image magnified 100 times for a Test #5, Day-4 low-flow exterior fiberglass sample. (t5d4ex02.jpeg)

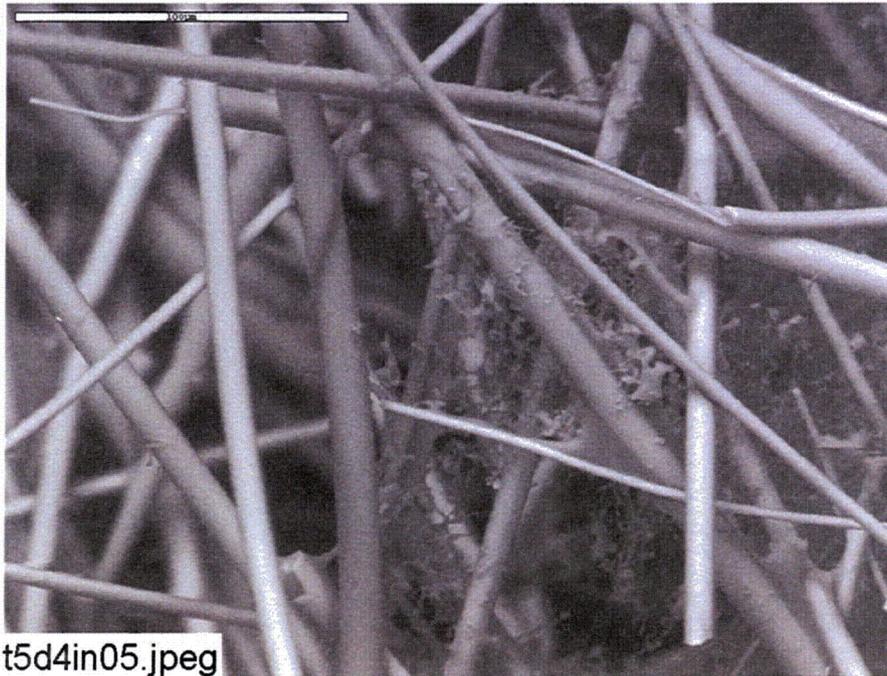
Figure A-5. ESEM image magnified 500 times for a Test #5, Day-4 low-flow interior fiberglass sample. (t5d4in05.jpeg)

Image: t5d4lfin04	100 ×	ESEM image	Figure A-4
t5d4lfin05	500 ×	ESEM of debris	Figure A-5
EDS: t5d4lfin06		EDS on flocculence deposits t5drlfin05	Figure A-6
Image: t5d4lfin07	500 ×	ESEM image	Figure A-7
EDS: t5d4lfin08		EDS on deposits on t5d4lfin07	Figure A-8

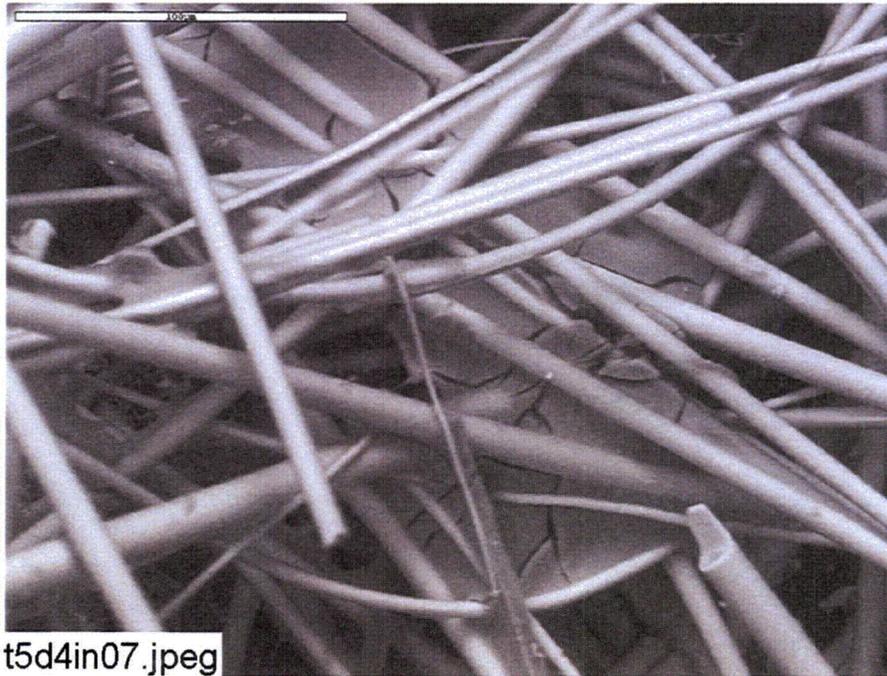
Figure A-7. ESEM image magnified 500 times for a Test #5, Day-4 low-flow interior fiberglass sample. (t5d4in07.jpeg)

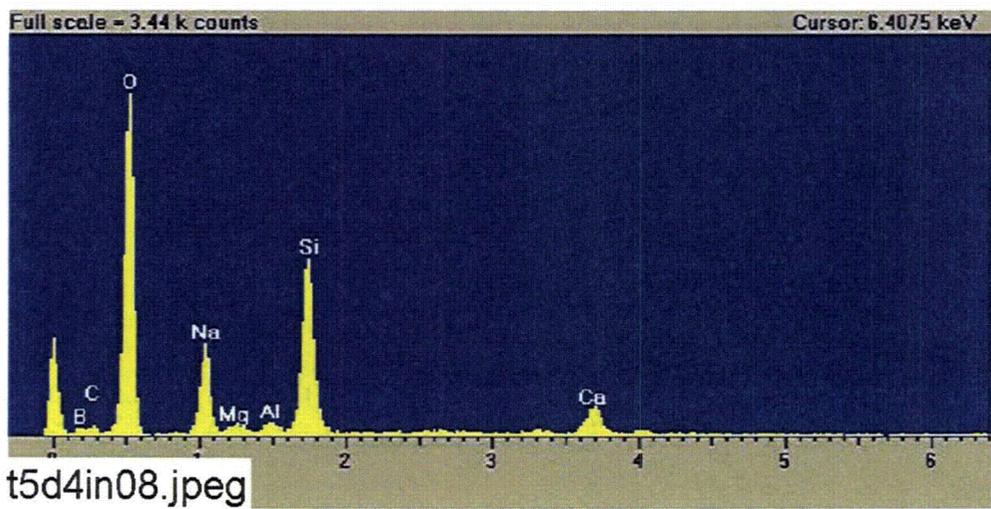
Figure A-8. EDS counting spectrum for the deposits between fibers shown in Figure A-7. (t5d4in08.jpeg)

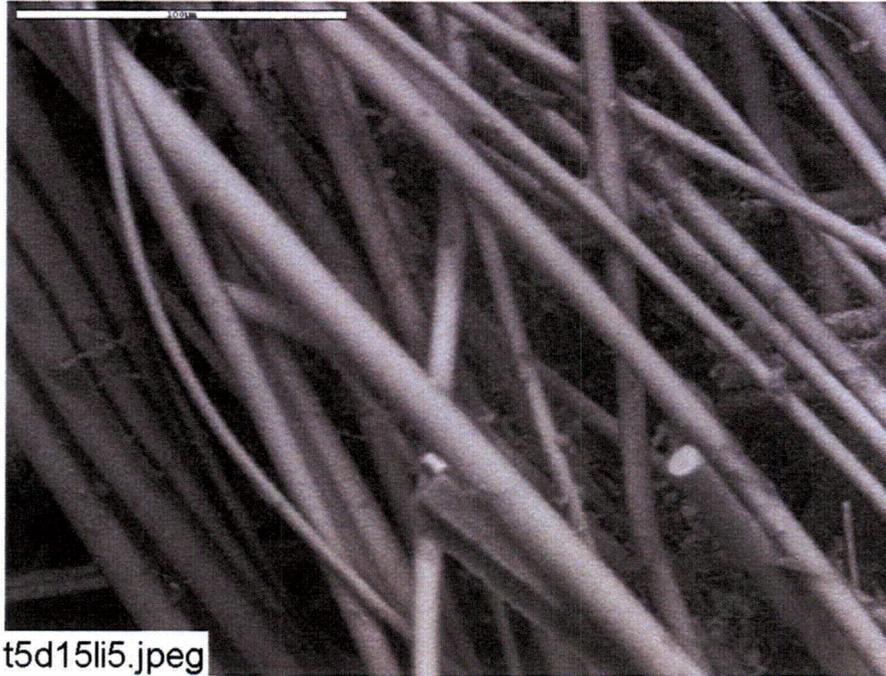
Figure B1-5. ESEM image magnified 500 times for a Test #5, Day-15 low-flow interior fiberglass sample. (t5d15li5.jpeg)

Image:	T5d15li3	100 ×	ESEM image of fiberglass	Figure B1-3
	t5d15li4	500 ×	ESEM image at higher magnification	Figure B1-4
	t5d15li5	500 ×	ESEM image	Figure B1-5
	t5d15li6	500 ×	Annotated ESEM image	Figure B1-6
EDS:	t5d15li7		EDS on deposits between fibers for t5d15li6	Figure B1-7

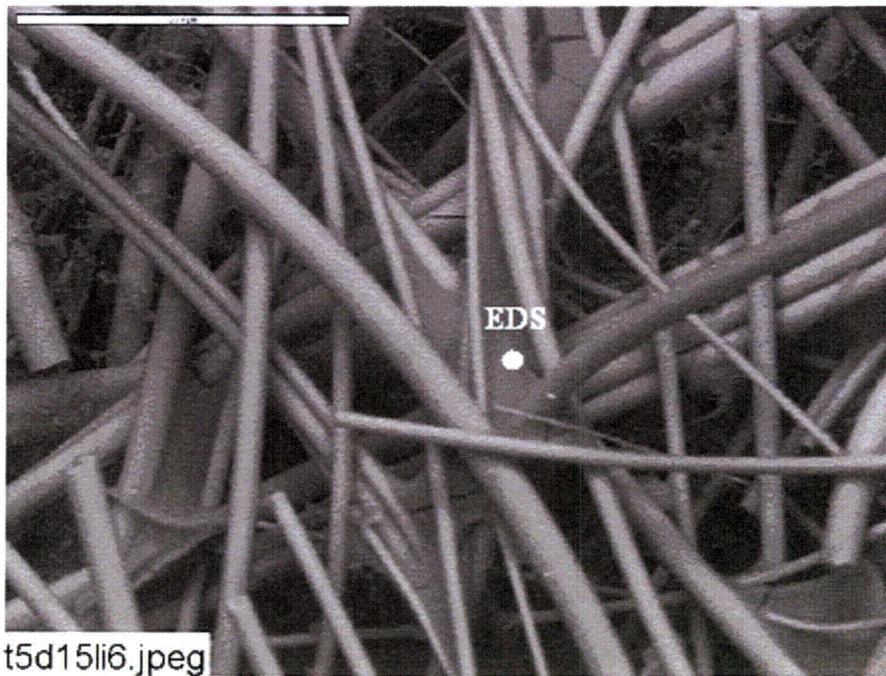
Figure B1-6. Annotated ESEM image magnified 500 times for a Test #5, Day-15 low-flow interior fiberglass sample. (t5d15li6.jpeg)

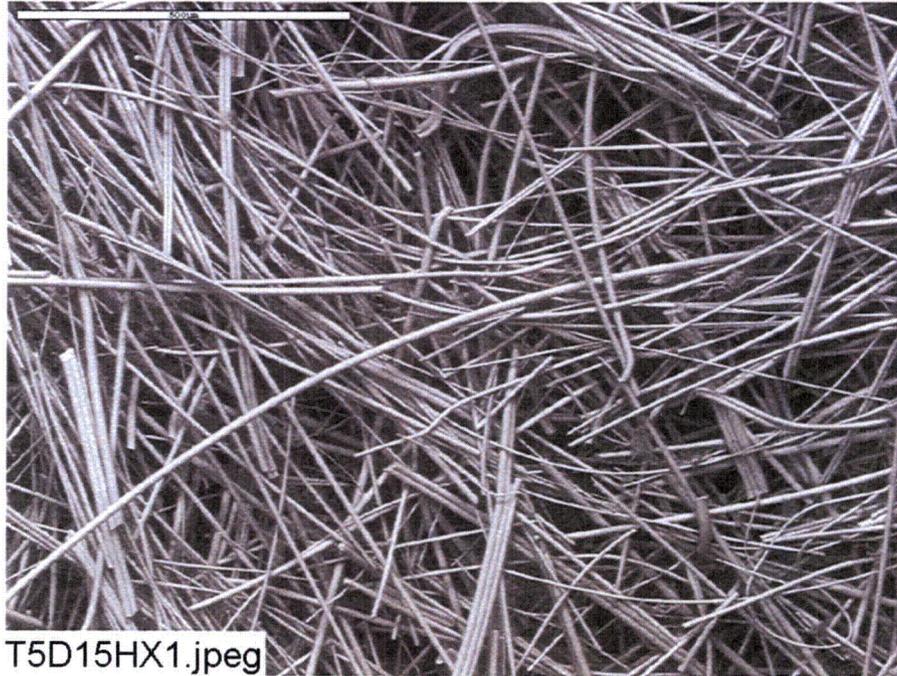
Figure B2-1. ESEM image magnified 100 times for a Test #5, Day-15 high-flow exterior fiberglass sample. (T5D15HX1.jpeg)

Image:	T5D15HX1	100 ×	ESEM image	Figure B2-1
	t5d15hx2	500 ×	ESEM image at higher magnification	Figure B2-2

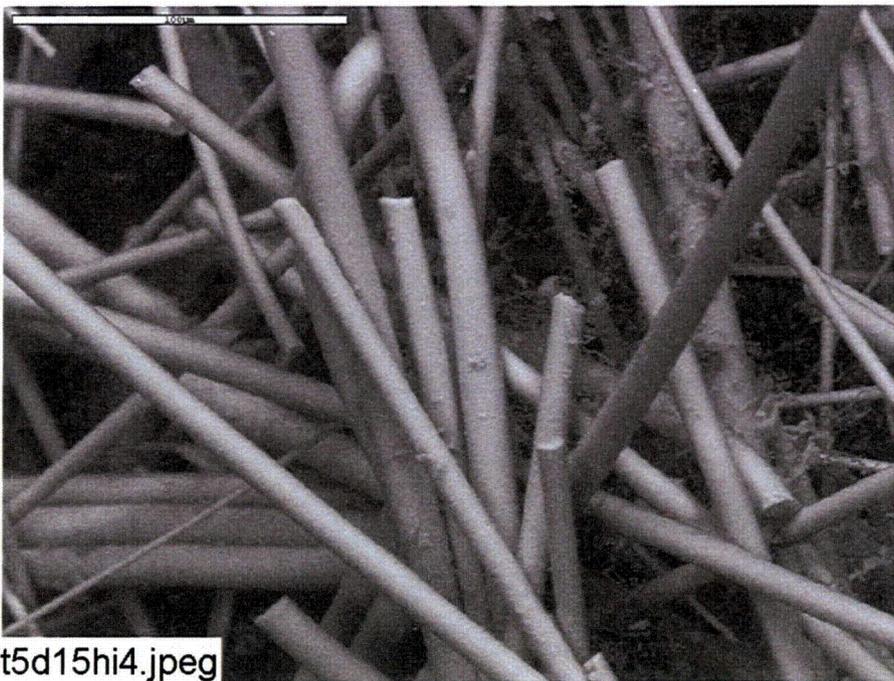
Figure B2-4. ESEM image magnified 500 times for a Test #5, Day-15 high-flow interior fiberglass sample. (t5d15hi4.jpeg)

Image:	T5D15HI3	100 ×	ESEM image	Figure B2-3
	t5d15hi4	500 ×	ESEM image at higher magnification	Figure B2-4

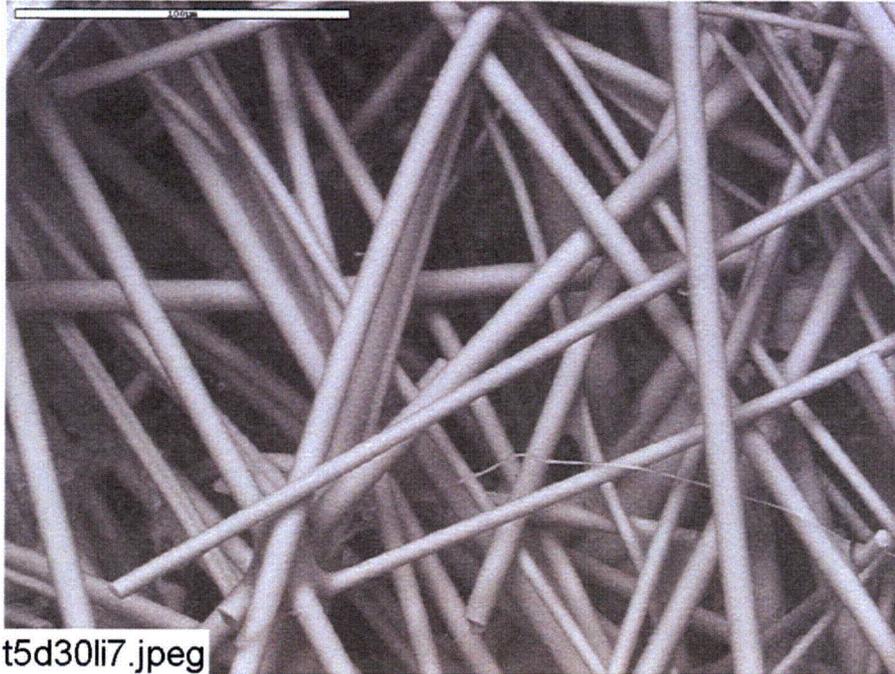
Figure C1-5. ESEM image magnified 500 times for a Test #5, Day-30 low-flow interior fiberglass sample. (t5d30li7.jpeg)

Image: t5d30li6	100 ×	ESEM image of fiberglass	Figure C1-4
t5d30li7	500 ×	ESEM image higher magnification	Figure C1-5

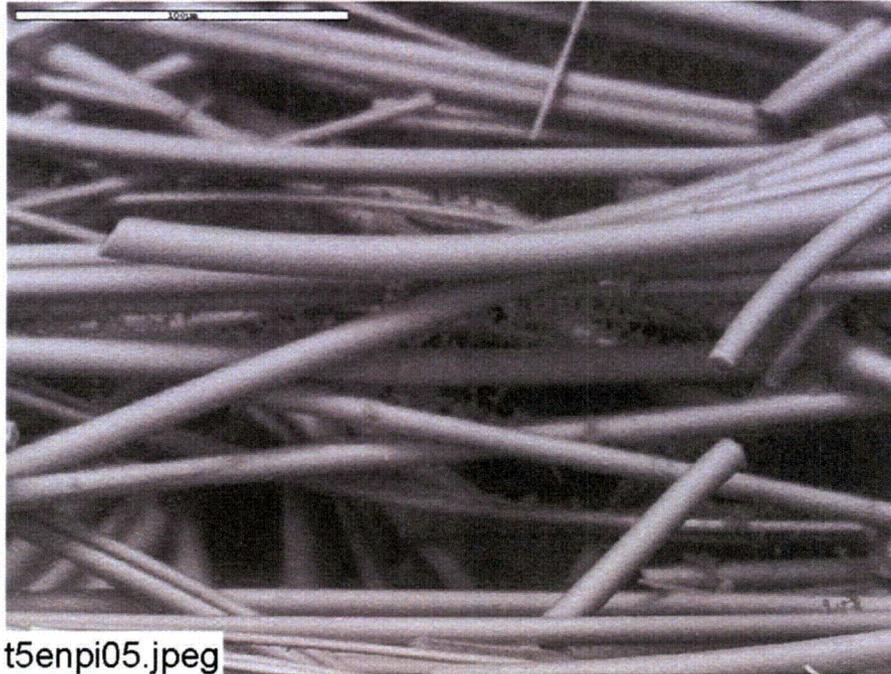
Figure C2-5. ESEM image magnified 500 times for a Test #5, Day-30 low-flow interior fiberglass sample in a big envelope. (T5enpi05.jpeg)

Image: T5empi04	100 ×	ESEM image	Figure C2-4
T5enpi05	500 ×	ESEM image higher magnification	Figure C2-5

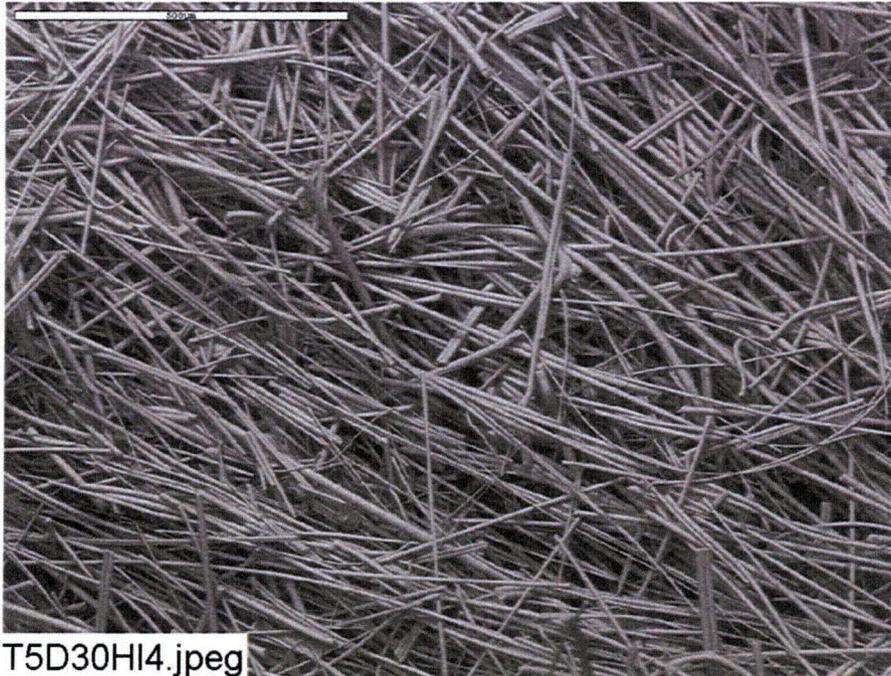
T5D30HI4.jpeg

Figure C3-4. ESEM image magnified 100 times for a Test #5, Day-30 high-flow interior fiberglass sample. (T5D30HI4.jpeg)

Image: T5D30HI4	100 ×	ESEM image	Figure C3-4
t5d30hi5	100 ×	ESEM image	Figure C3-5
t5d30hi6	500 ×	ESEM image higher magnification	Figure C3-6

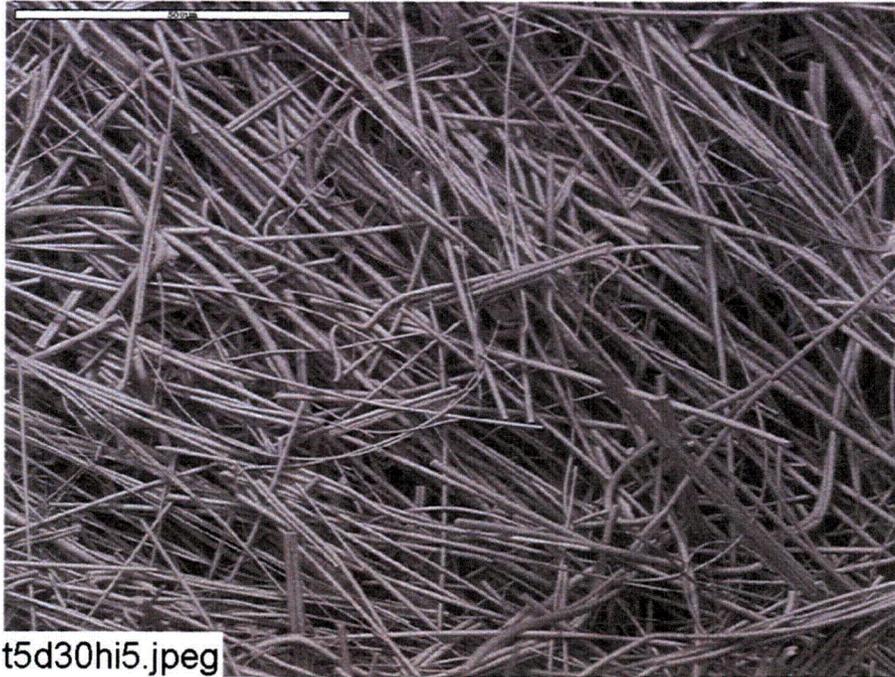
Figure C3-5. ESEM image magnified 100 times for a Test #5, Day-30 high-flow interior fiberglass sample. (t5d30hi5.jpeg)

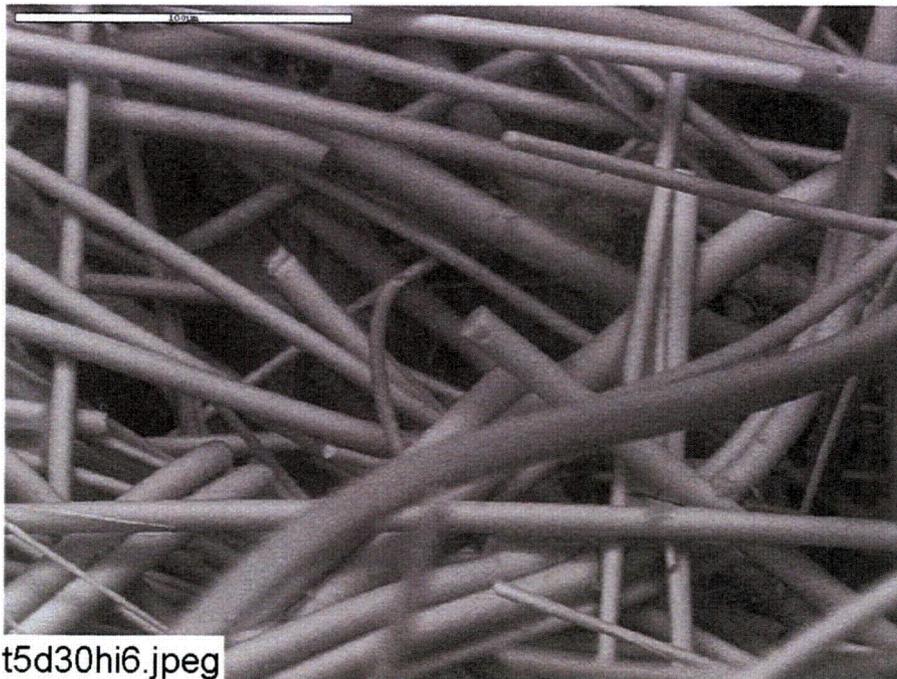
Figure C3-6. ESEM image magnified 500 times for a Test #5, Day-30 high-flow interior fiberglass sample. (t5d30hi6.jpeg)

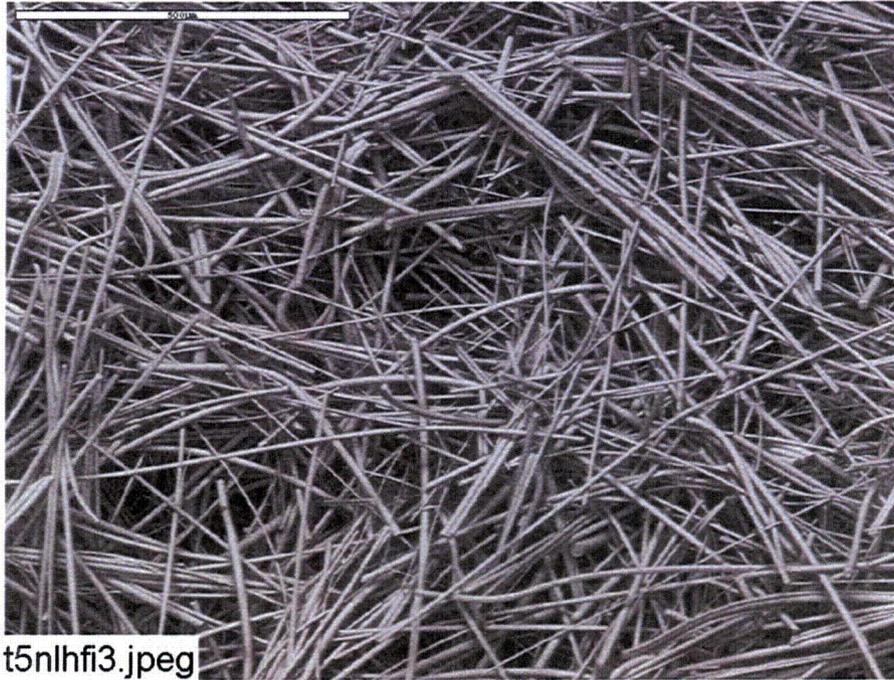
Figure C5-3. ESEM image magnified 100 times for a Test #5, Day-30 low-flow interior fiberglass sample in a nylon mesh. The sample was put in the tank on Day 6. (t5nlhfi3.jpeg)

Image:	t5nlhfi3	100 ×	ESEM image of fiberglass	Figure C5-3
	t5nlhfi4	500 ×	ESEM image higher magnification	Figure C5-4
EDS	t5nlhfi5		EDS on floc in image t5nlhfi4	Figure C5-5

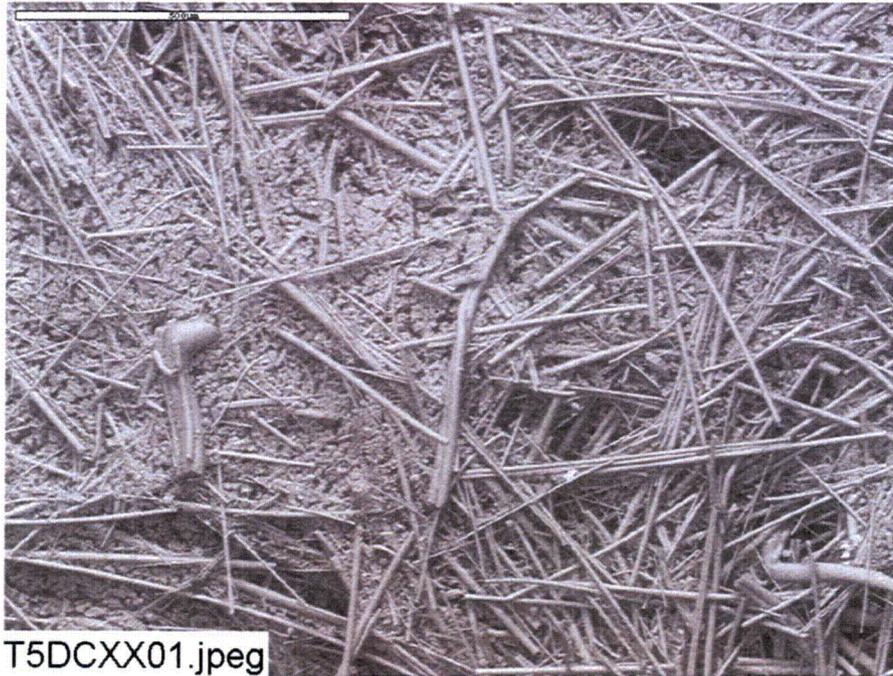
Figure C6-1. ESEM image magnified 100 times for a Test #5, Day-30 exterior drain collar fiberglass sample farthest from the drain screen. (T5DCXX01.jpeg)

Image:	T5DCXX01	100 ×	ESEM image	Figure C6-1
	t5dcxx02	100 ×	ESEM image	Figure C6-2
	t5dcxx03	500 ×	Annotated ESEM image	Figure C6-3
EDS:	t5dcxx04		EDS on particles in t5dcxx03	Figure C6-4
	t5dcxx05		EDS on particles in t5dcxx03	Figure C6-5
	T5D30Draincollar Particle16		EDS on particles on exterior of drain collar	Figure C6-6

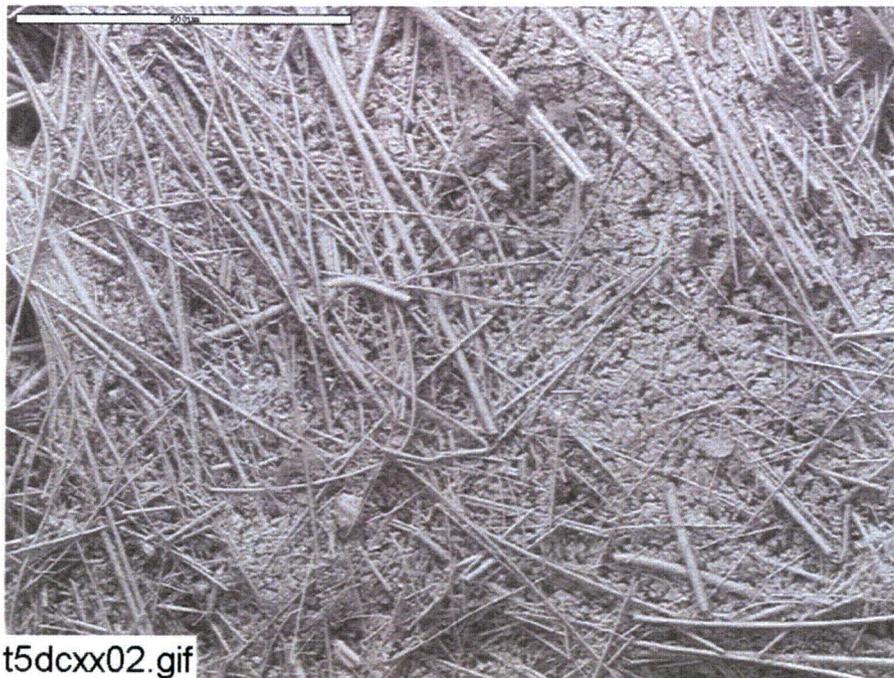
Figure C6-2. ESEM image magnified 100 times for a Test #5, Day-30 exterior drain collar fiberglass sample farthest from the drain screen. (t5dcxx02.gif)

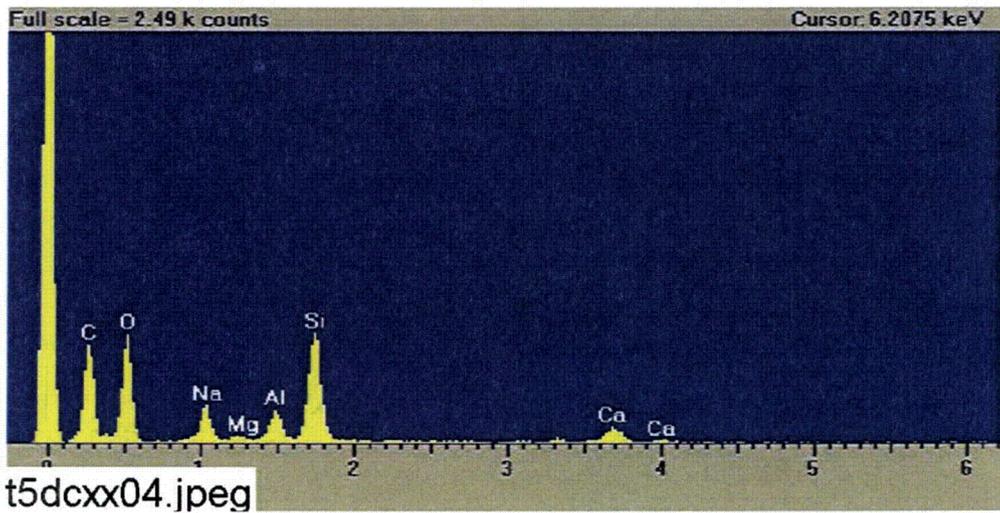
Figure C6-4. EDS counting spectrum for the dark deposits (EDS1) between fibers shown in Figure C6-3. (t5dcxx04.jpeg)

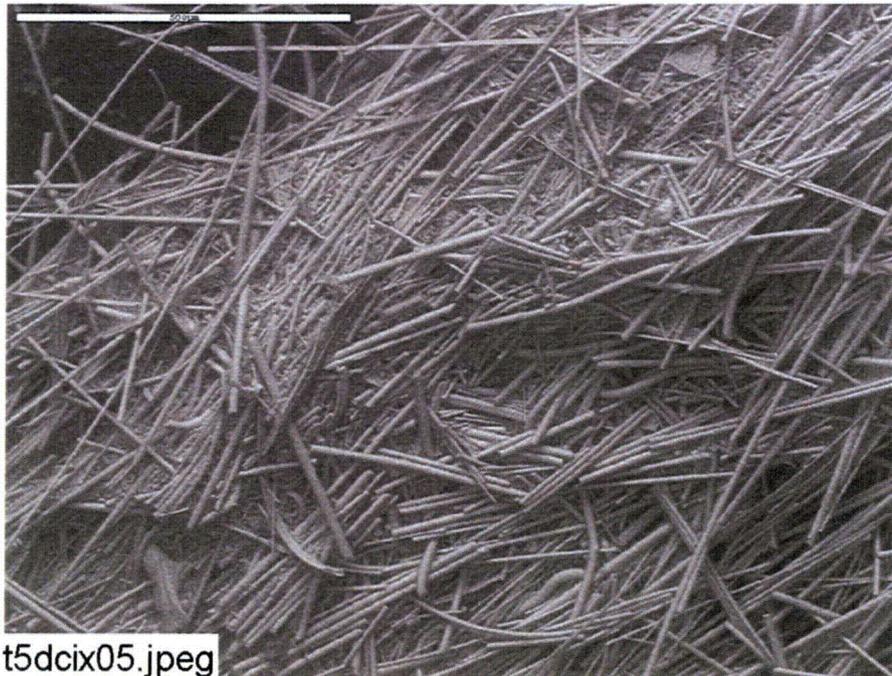
Figure C6-8. ESEM image magnified 100 times for a Test #5, Day-30 exterior drain collar fiberglass sample next to the drain screen. (t5dcix05.jpeg)

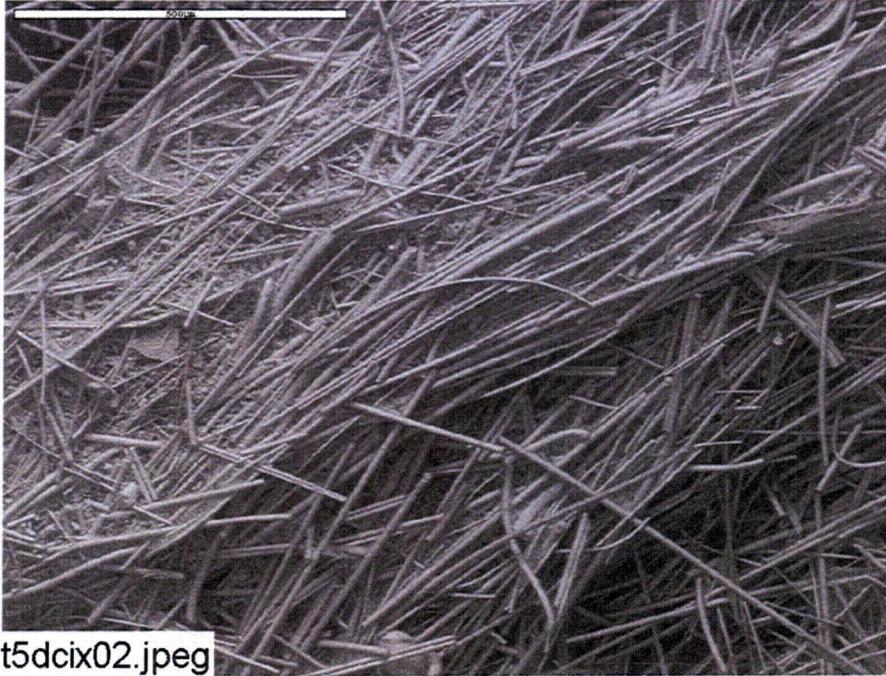
t5dcix02.jpeg

Figure C6-9. ESEM image magnified 100 times for a Test #5, Day-30 exterior drain collar fiberglass sample next to the drain screen. (t5dcix02.jpeg)

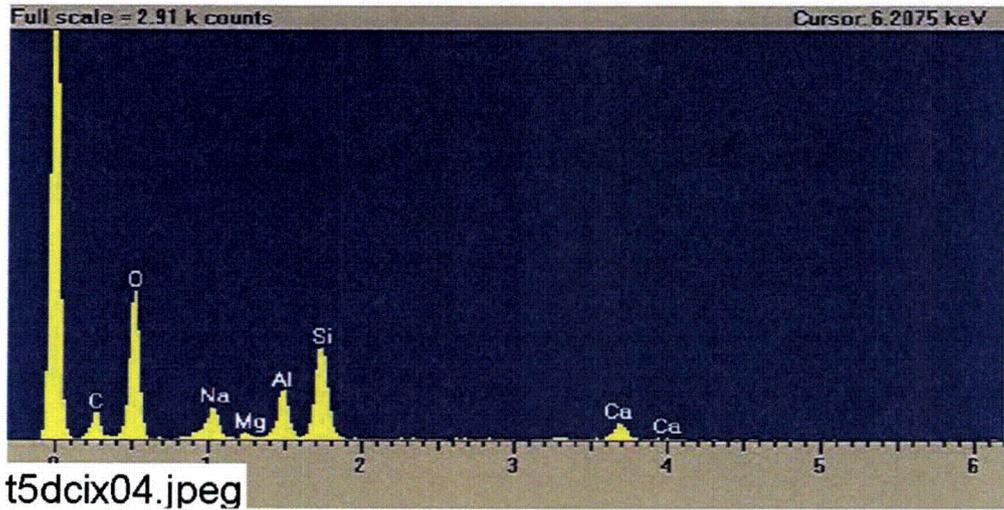
Figure C6-11. EDS counting spectrum for the particulate deposits between fibers shown in Figure C6-10. (t5dcix04.jpeg)

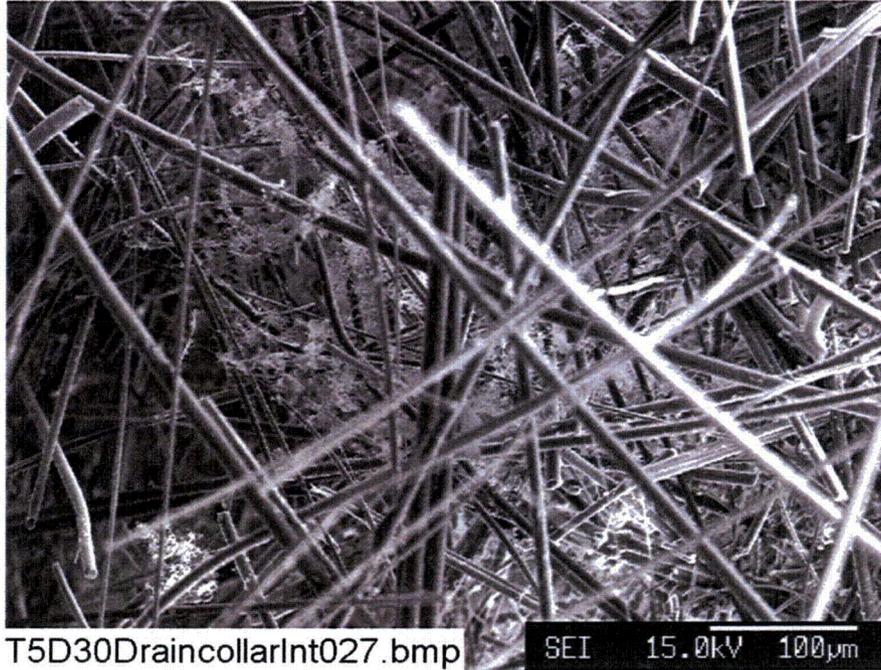
Figure C6-13. Probe SEM image magnified 200 times for a Test #5, Day-30 interior drain collar fiberglass sample. (T5D30DraincollarInt027.bmp)

Image:	t5dcii01	100 ×	ESEM image	Figure C6-12
	T5D30DraincollarInt027	200 ×	Probe SEM image	Figure C6-13
	t5dcii02	500 ×	ESEM image	Figure C6-14
	T5D30DraincollarInt026	1000 ×	Probe SEM image higher	Figure C6-15
EDS:	T5D30fiber flocc17		EDS on particles in t4dcix08	Figure C6-16

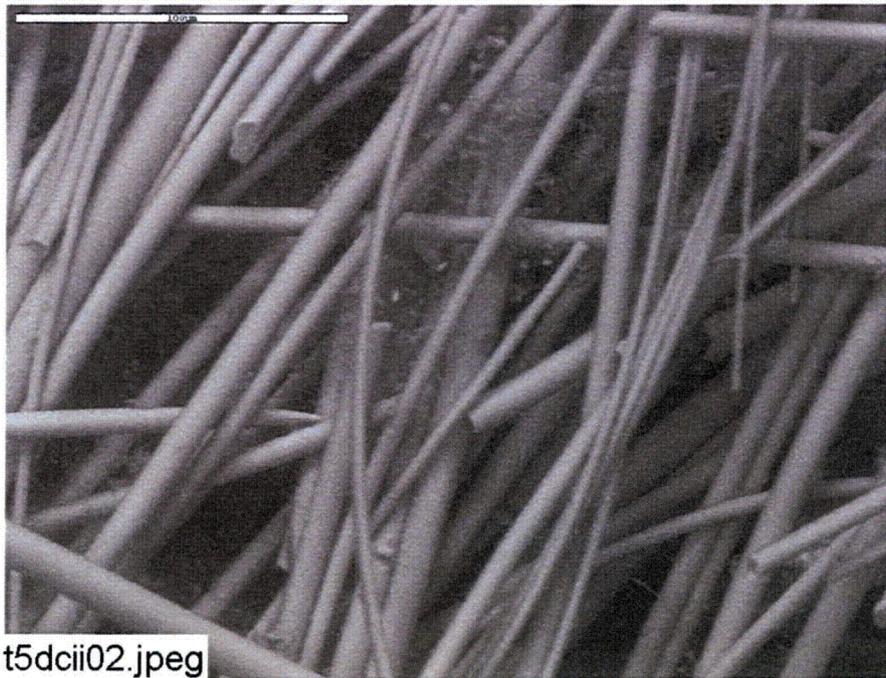
Figure C6-14. ESEM image magnified 500 times for a Test #5, Day-30 interior drain collar fiberglass sample. (t5dcii02.jpeg)

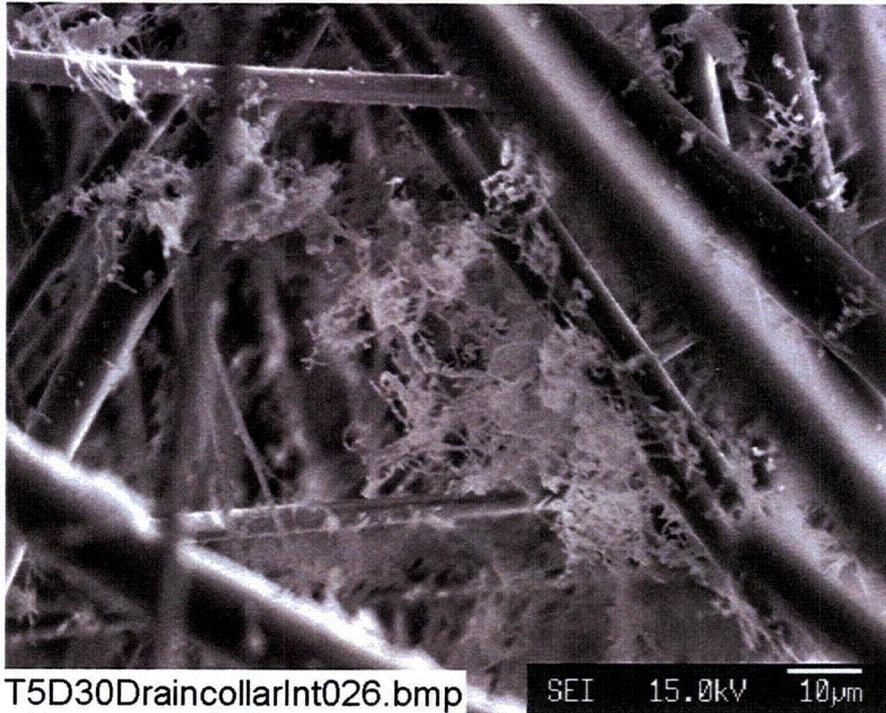
Figure C6-15. Probe SEM image magnified 1000 times for a Test #5, Day-30 interior drain collar fiberglass sample. (T5D30DraincollarInt026.bmp)

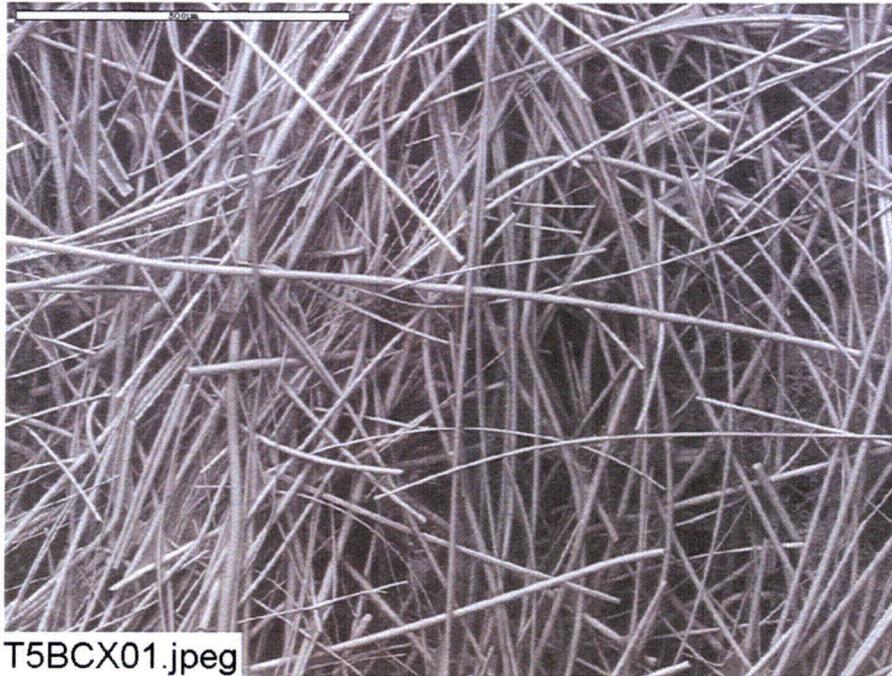
Figure C7-1. ESEM image magnified 100 times for a Test #5, Day-30 exterior fiberglass sample within the birdcage. (T5BCX01.jpeg)

Image: T5BCX01	100 ×	ESEM image	Figure C7-1
t5bcx02	100 ×	ESEM image	Figure C7-2
t5bcx03	500 ×	ESEM image higher magnification	Figure C7-3
EDS: t5bcx04		EDS on particles on t5bcx03	Figure C7-4
Image: t5bcx05	500 ×	ESEM image	Figure C7-5

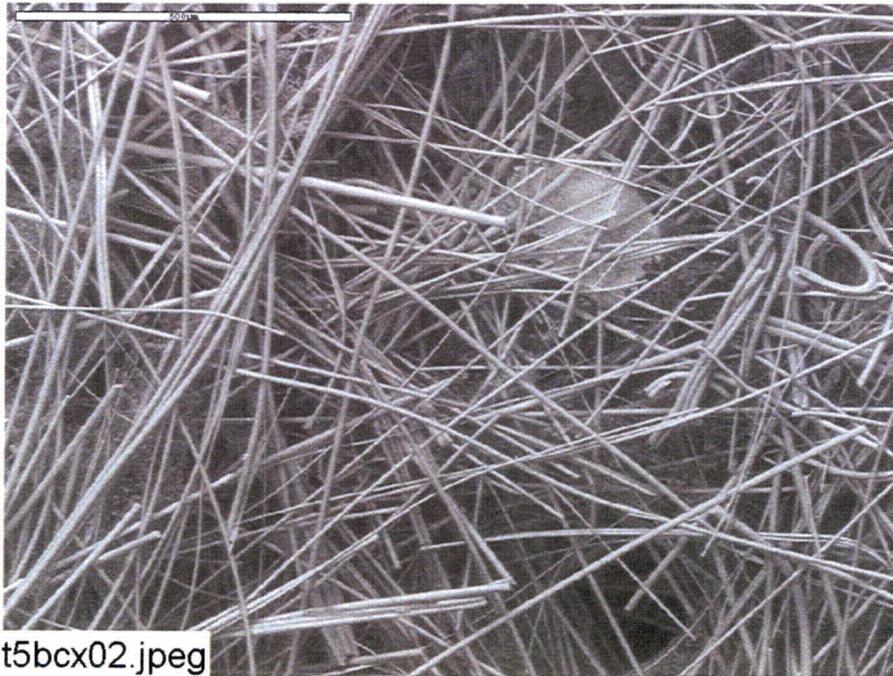
Figure C7-2. ESEM image magnified 100 times for a Test #5, Day-30 exterior fiberglass sample within the birdcage. (t5bcx02.jpeg)

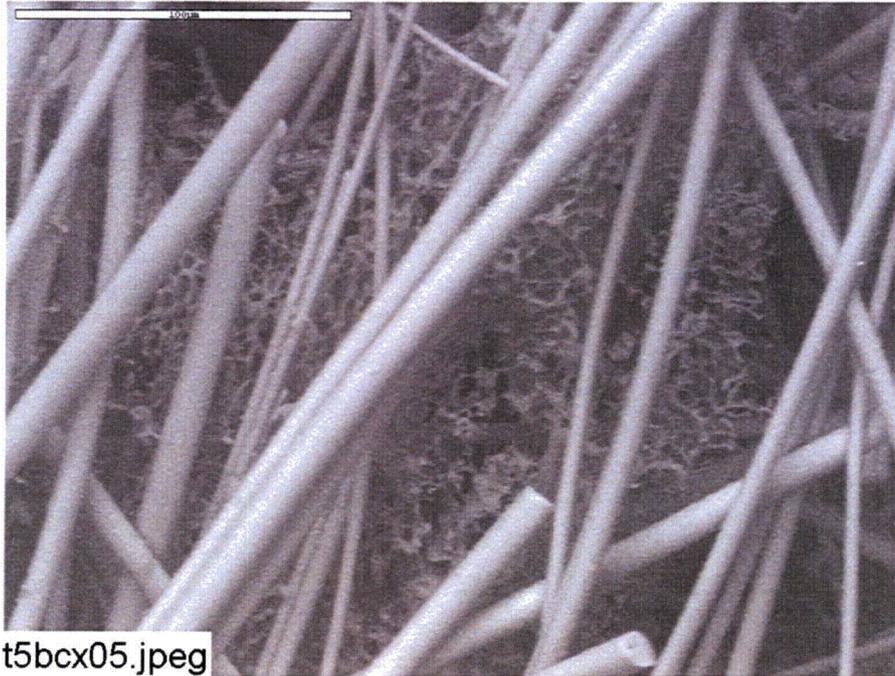
t5bcx05.jpeg

Figure C7-5. ESEM image magnified 500 times for a Test #5, Day-30 exterior fiberglass sample within the birdcage. (t5bcx05.jpeg)

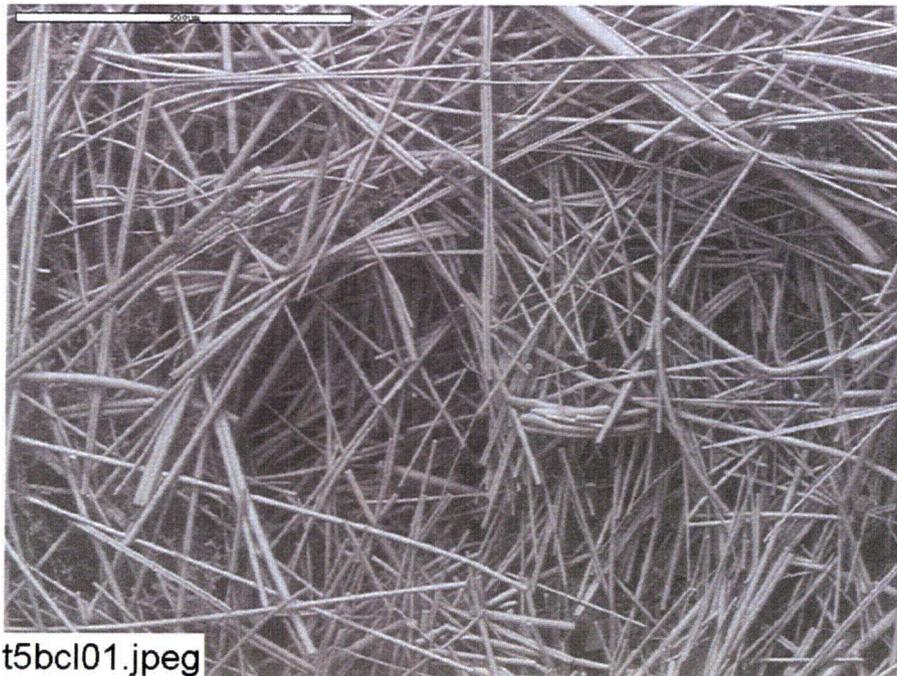
t5bcl01.jpeg

Figure C7-6. ESEM image magnified 100 times for a Test #5, Day-30 interior fiberglass sample within the birdcage. (t5bcl01.jpeg)

Image: t5bcI01	100 ×	ESEM image of fiberglass	Figure C7-6
t5bci03	100 ×	ESEM image	Figure C7-7
t5bci02	500 ×	ESEM image higher magnification	Figure C7-8

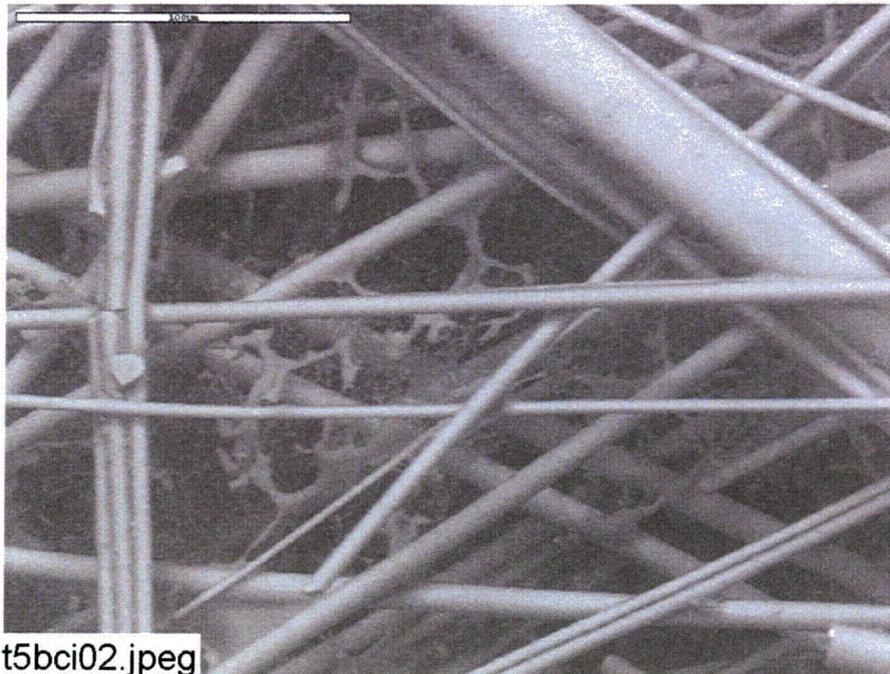
t5bci02.jpeg

Figure C7-8. ESEM image magnified 500 times for a Test #5, Day-30 interior fiberglass sample within the birdcage. (t5bci02.jpeg)

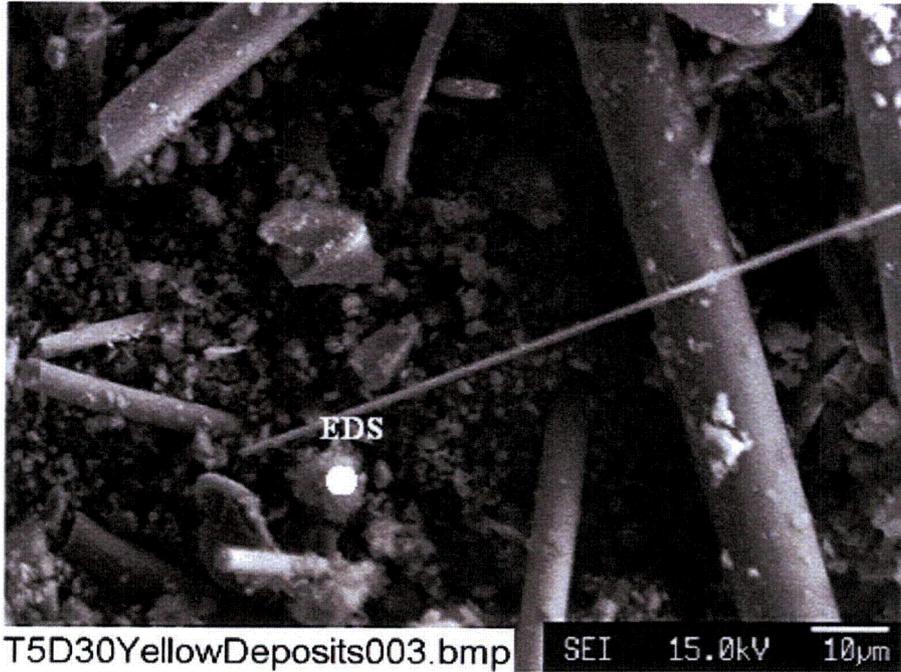
Figure D-3. Annotated SEM image magnified 1000 times for the Test #5, Day-30 fine yellow powder on the submerged rack. (T5D30YellowDeposits003.bmp)

Image:	T5D30YellowDeposits001	100 ×	SEM image	Figure D-1
	T5D30YellowDeposits002	500 ×	SEM image	Figure D-2
	T5D30YellowDeposits003	1000 ×	Annotated SEM image	Figure D-3
EDS:	T5D30yllw~partcl02		EDS on particulate deposits	Figure D-4

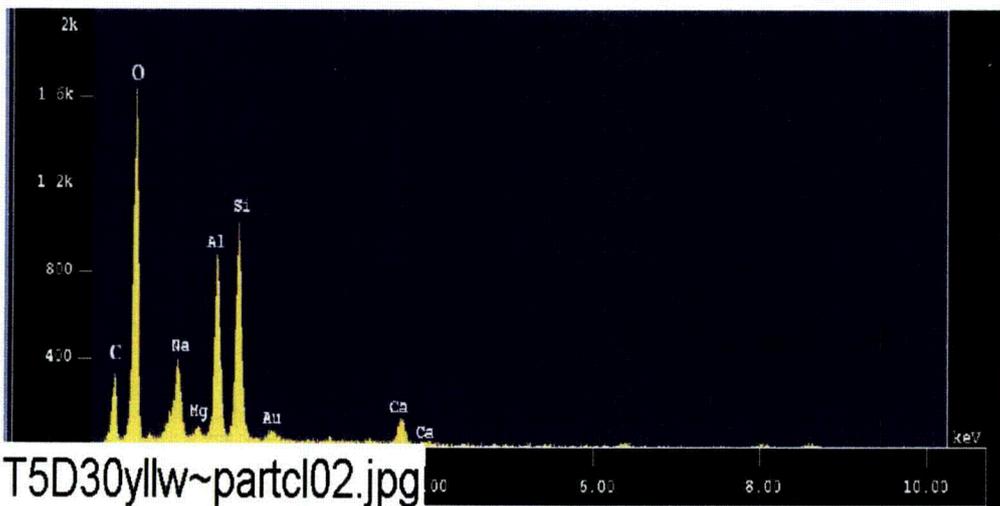
Figure D-4. EDS counting spectrum for the particulate deposit shown in Figure D-3. (T5D30yllw~partcl02.jpg)

The results from the chemical composition analysis for T5D30yllw~partcl02.jpg are given in Table D-1.

Group      : NRC
Sample     : T5D30 ID# : 30
Comment    : Yellow deposits on submerged rack
Condition  : Full Scale : 20KeV(10eV/ch,2Kch)
            Live Time  : 76.130 sec Aperture # : 5
            Acc. Volt  : 15.0 KV Probe Current : 1.996E-08 A
            Stage Point: X=45.414 Y=58.152 Z=11.027
            Acq. Date  : Tue Sep 6 10:38:29 2005
