4. SUMMARY OF KEY OBSERVATIONS

Appendix D. ESEM and SEM/EDS Data for Test #3 Day-30 Corrosion Products

ESEM & SEM Test #3, Day-4 Fiberglass.

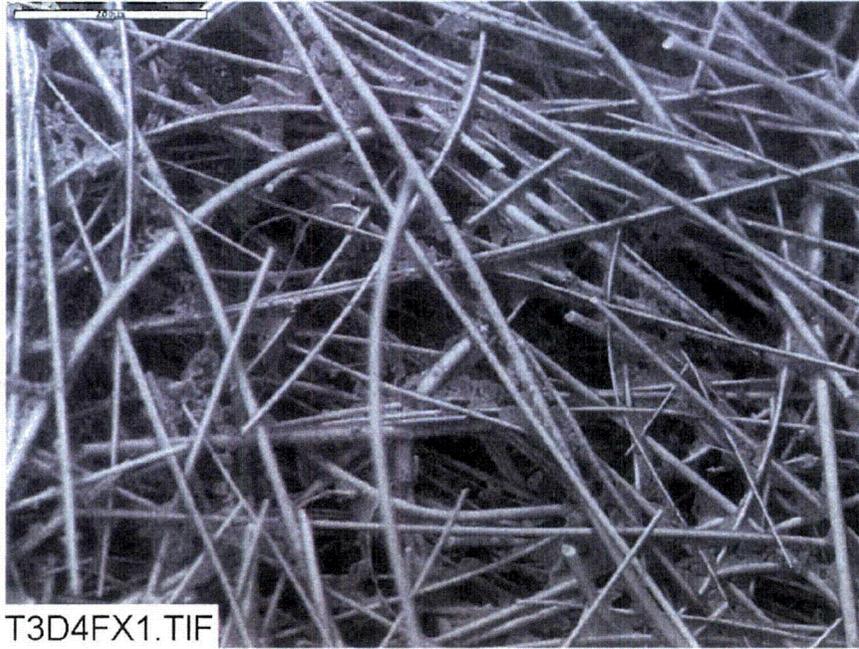
Figure A-1. Environmental SEM image magnified 150 times for a Test #3, Day-4 low-flow exterior fiberglass sample. (T3D4FX1)

Image:	T3D4FX1	150 ×	ESEM image	Figure A-1
	T3D4FX2	1000 ×	ESEM at higher magnification	Figure A-2
EDS:	T3D4FX3		Particles on Image FX2	Figure A-3
	T3D4FX4		FX2 particles after calibration with primed elemental analysis	Figure A-4
Image:	T3D4FX5	500 ×	ESEM image	Figure A-5

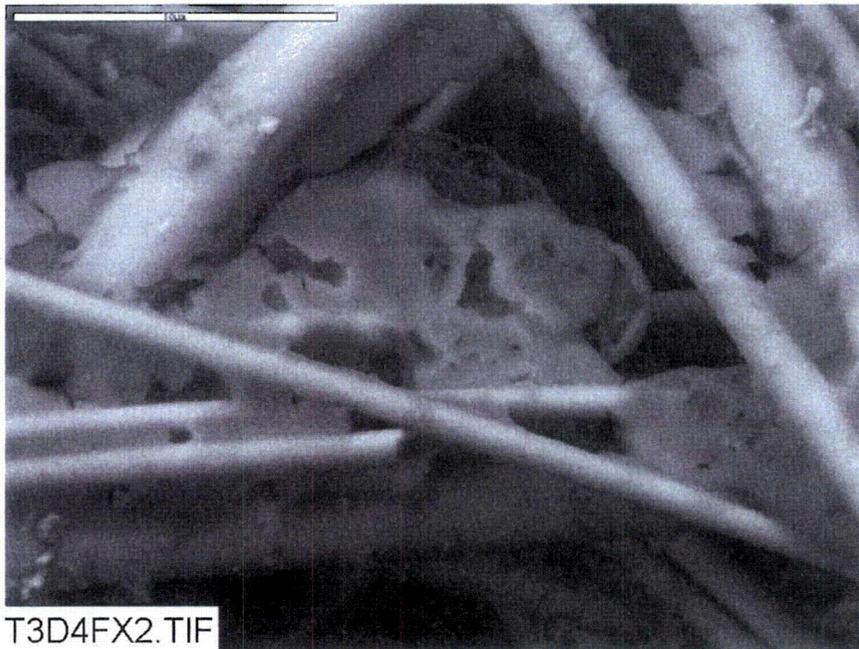
Figure A-2. Environmental SEM image magnified 1000 times for a Test #3, Day-4 low-flow exterior fiberglass sample. (T3D4FX2)

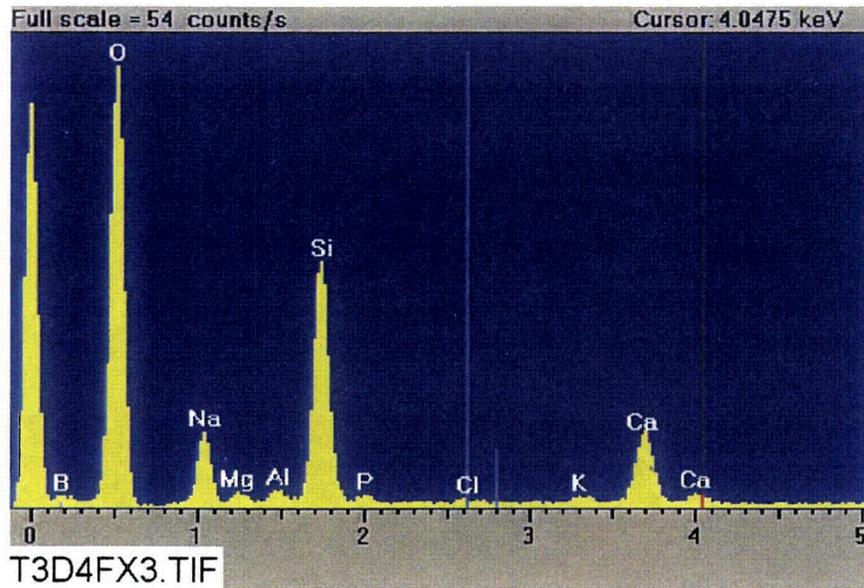
Figure A-3. EDS counting spectrum for the deposits between the fibers on ESEM image shown in Figure A-2. (T3D4FX3)

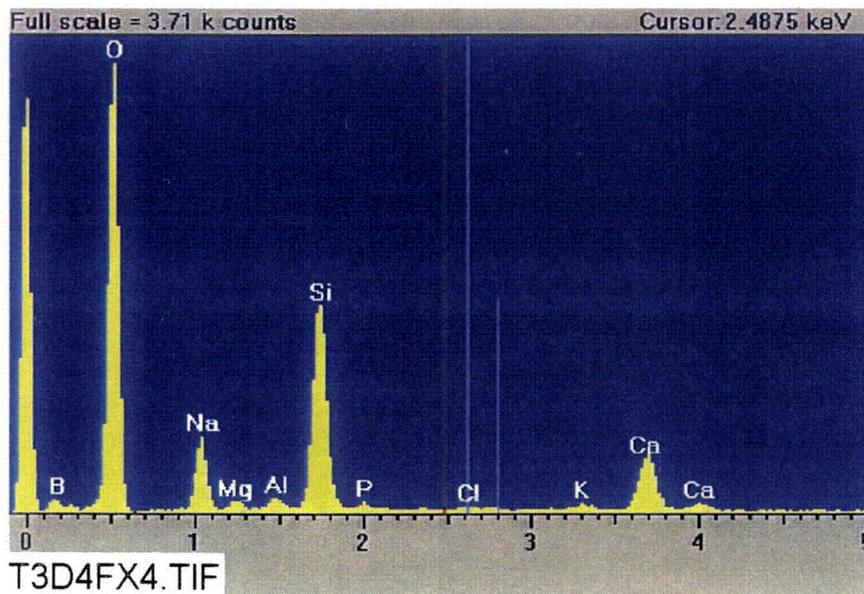
Figure A-4. EDS counting spectrum (after calibration) for the deposits between the fibers on ESEM image shown in Figure A-2. (T3D4FX4)

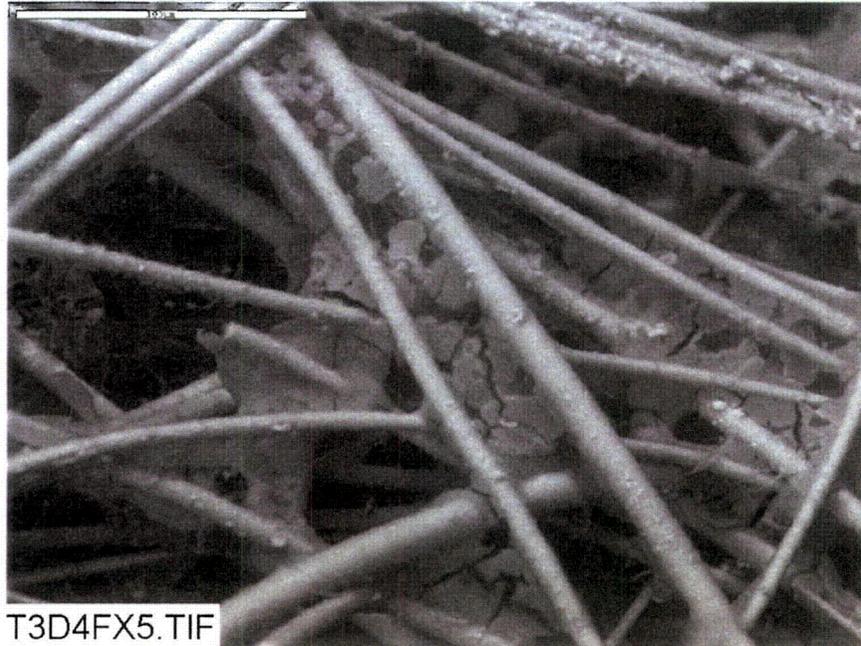
Figure A-5. Environmental SEM image magnified 500 times for a Test #3, Day-4 low-flow exterior fiberglass sample. (T3D4FX5)

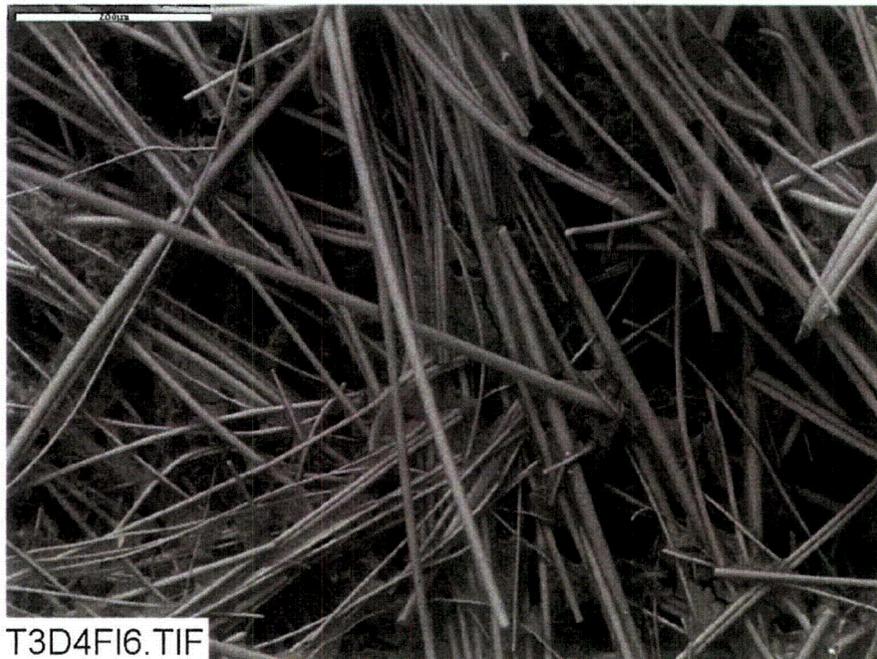
Figure A-6. Environmental SEM image magnified 150 times for a Test #3, Day-4 low-flow interior fiberglass sample. (T3D4FI6)

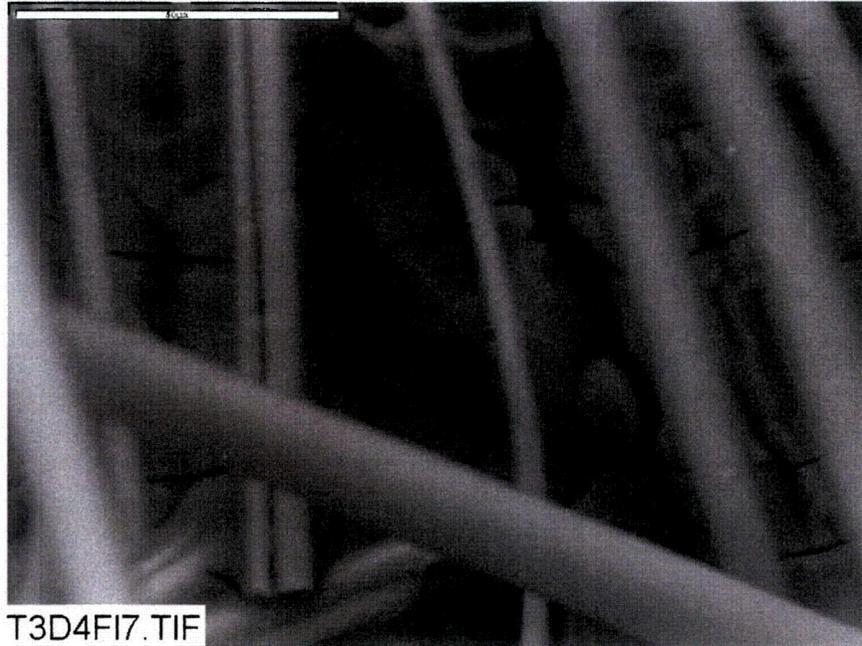
Figure A-7. Environmental SEM image magnified 1000 times for a Test #3, Day-4 low-flow interior fiberglass sample. (T3D4FI7)

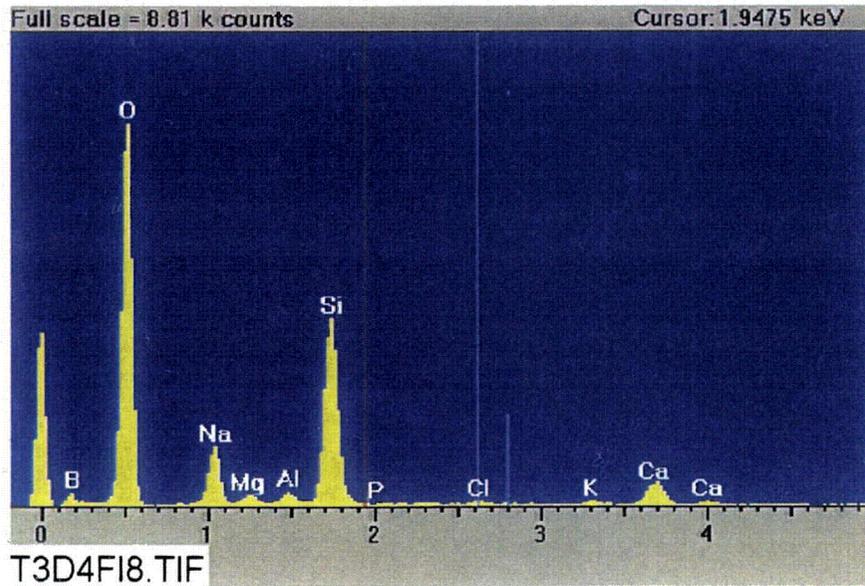
Figure A-8. EDS counting spectrum (after calibration) for the deposits between the fibers on ESEM image shown in Figure A-7. (T3D4FI8)

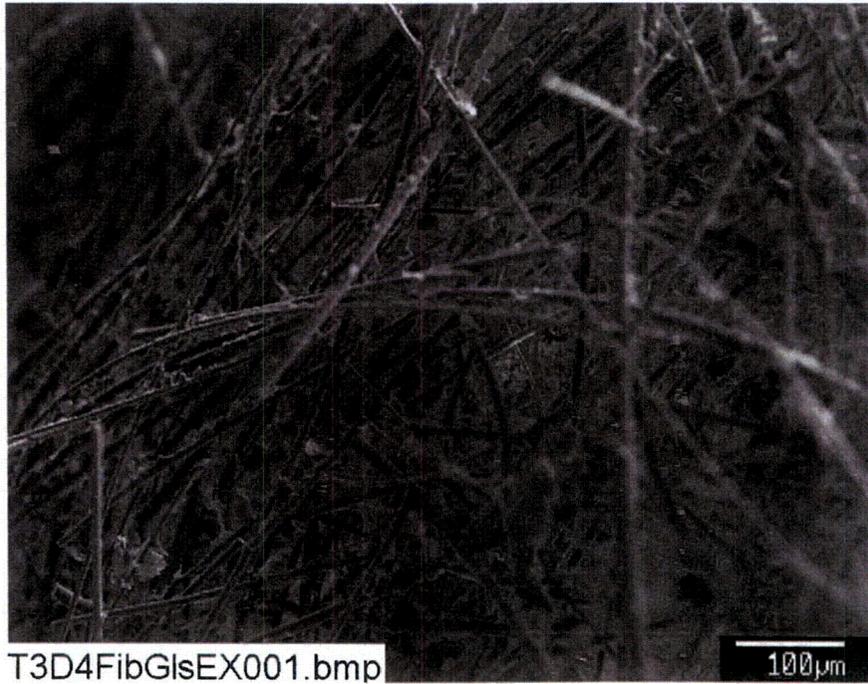
Figure A-9. SEM image magnified 150 times for a Test #3, Day-4 low-flow exterior fiberglass sample. (T3D4FibGlsEX001)

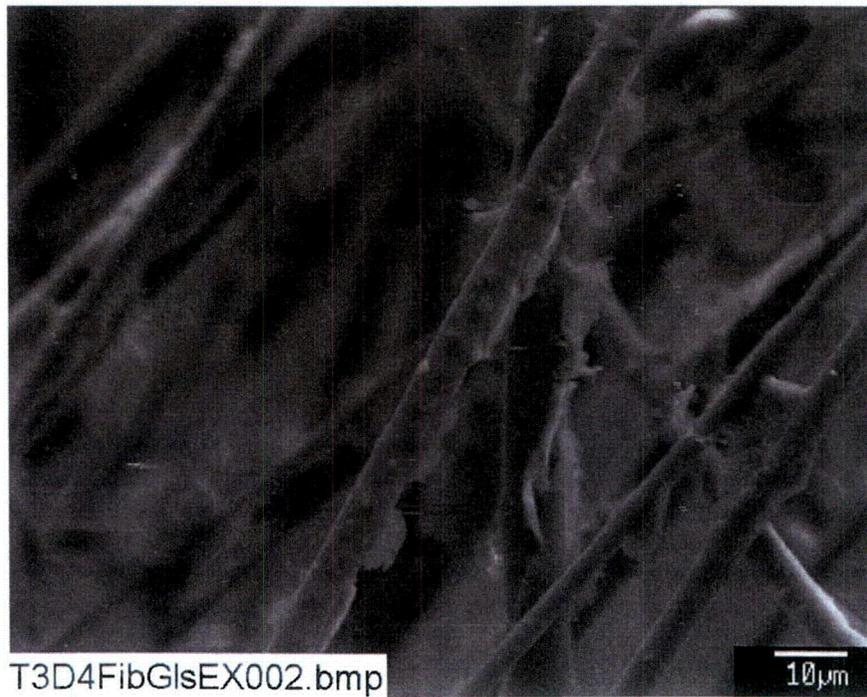
Figure A-10. SEM image magnified 1000 times for a Test #3, Day-4 low-flow exterior fiberglass sample. (T3D4FibGlsEX002)

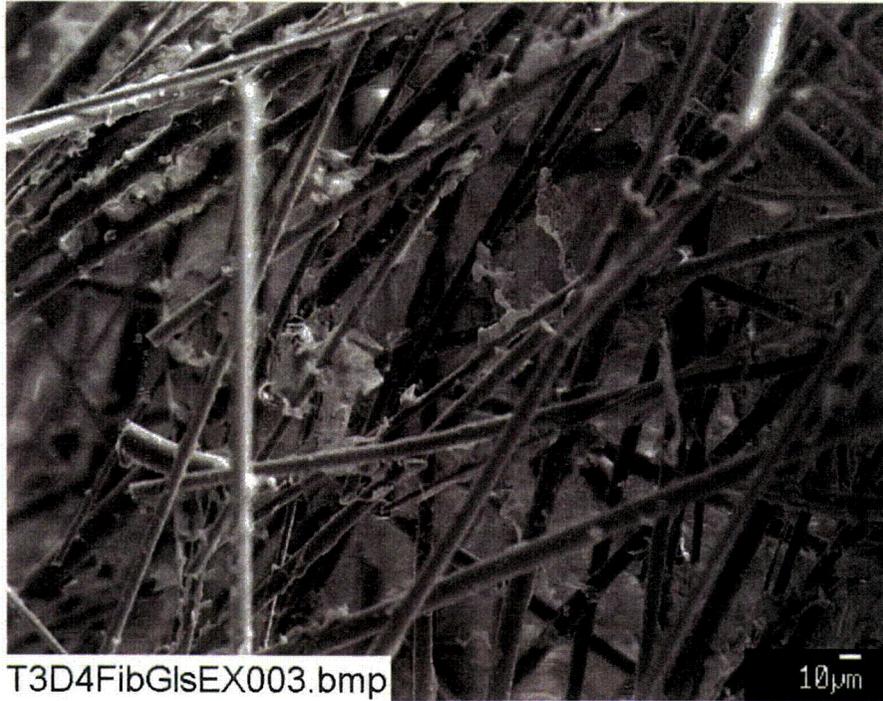
Figure A-11. SEM image magnified 300 times for a Test #3, Day-4 low-flow exterior fiberglass sample. (T3D4FibGlsEX003)

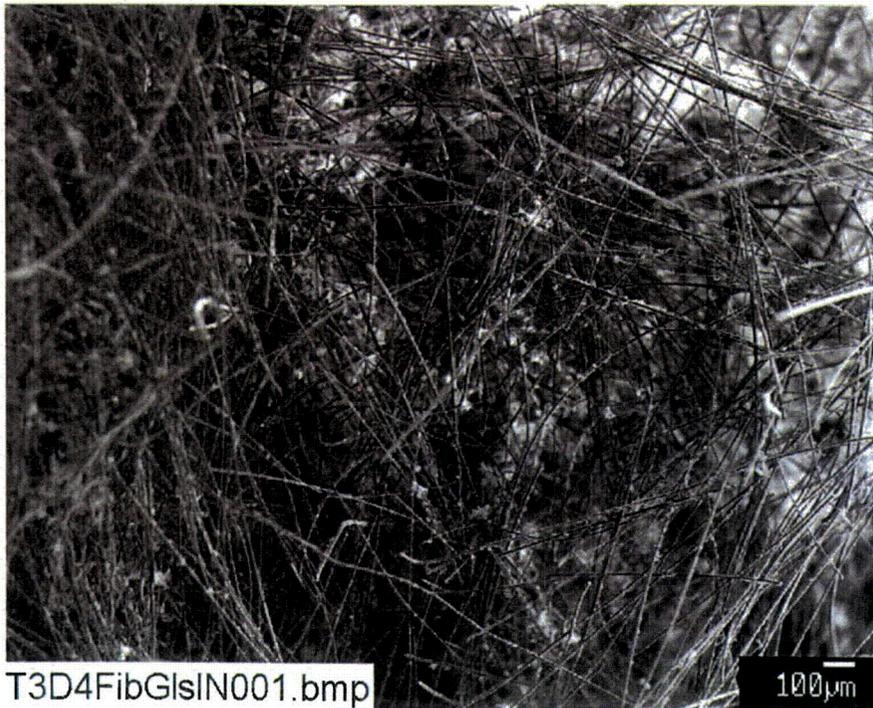
Figure A-12. SEM image magnified 50 times for a Test #3, Day-4 low-flow interior fiberglass sample. (T3D4FibGlsIN001)

Image:	T3D4FibGlsIn001	50 ×	SEM image	Figure A-12
	T3D4FibGlsIn002	150 ×	SEM image	Figure A-13
	T3D4FibGlsIn003	400 ×	SEM image	Figure A-14
	T3D4FibGlsIn004	1000 ×	SEM at higher magnification	Figure A-15

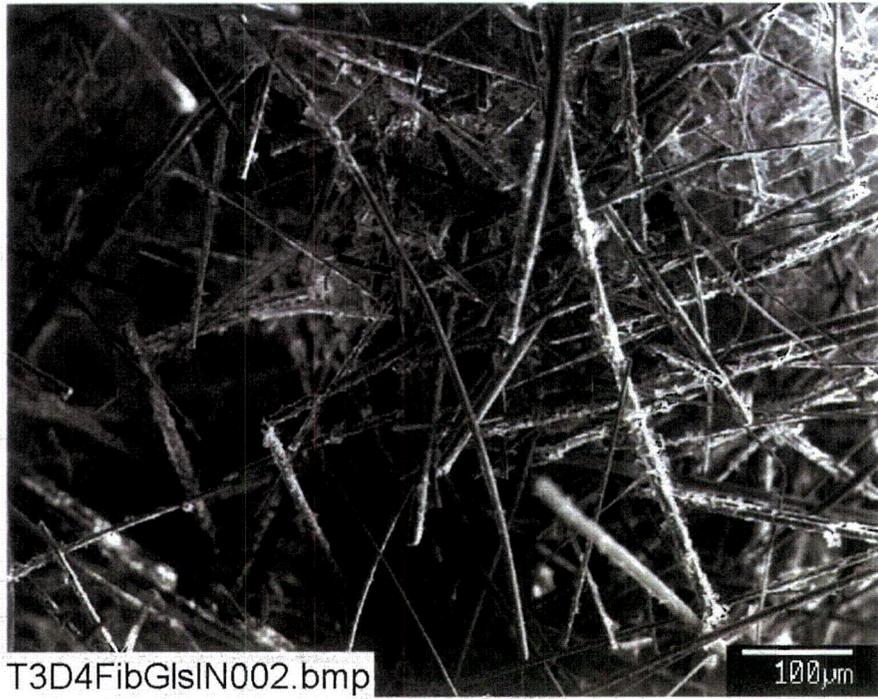
Figure A-13. SEM image magnified 150 times for a Test #3, Day-4 low-flow interior fiberglass sample. (T3D4FibGlsIN002)

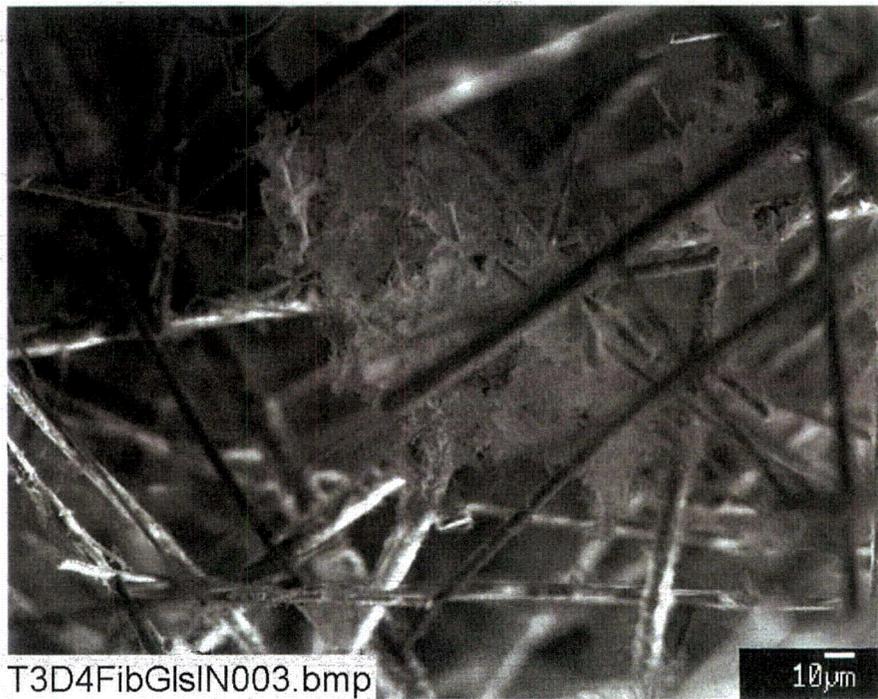
Figure A-14. SEM image magnified 400 times for a Test #3, Day-4 low-flow interior fiberglass sample. (T3D4FibGlsIN003)

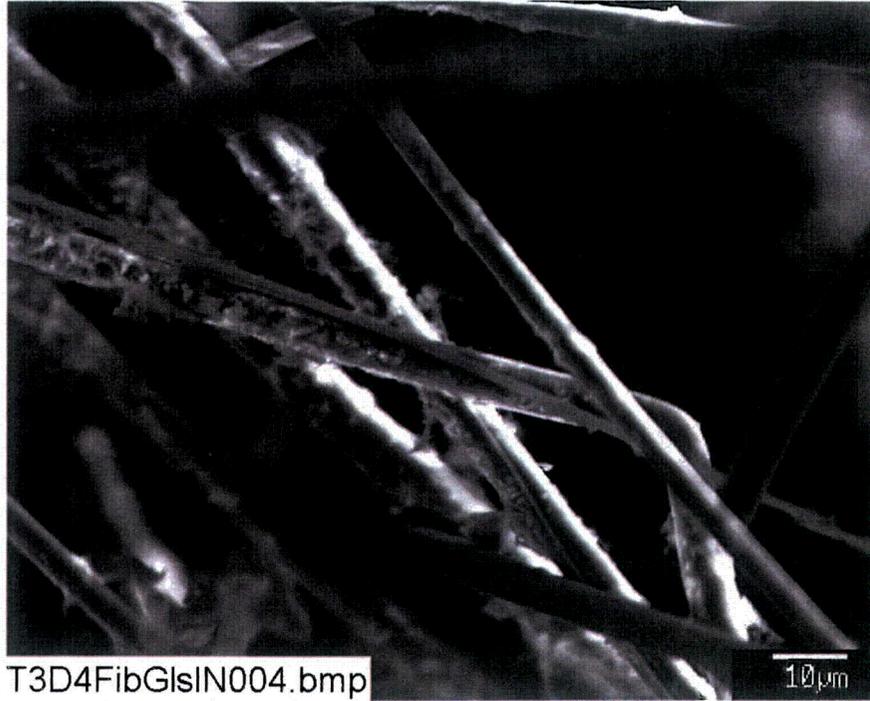
Figure A-15. SEM image magnified 1000 times for a Test #3, Day-4 low-flow interior fiberglass sample. (T3D4FibGlsIN004)

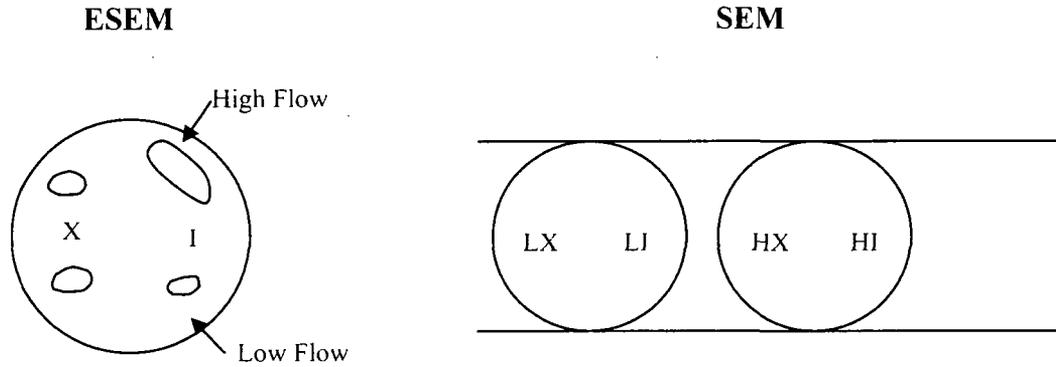
Test #3, Day-15 fiberglass in high-flow zones

Instrument Conditions: ESEM, Pressure = 80 Pa
SEM, Electron beam of 1×10^{-9} (A)

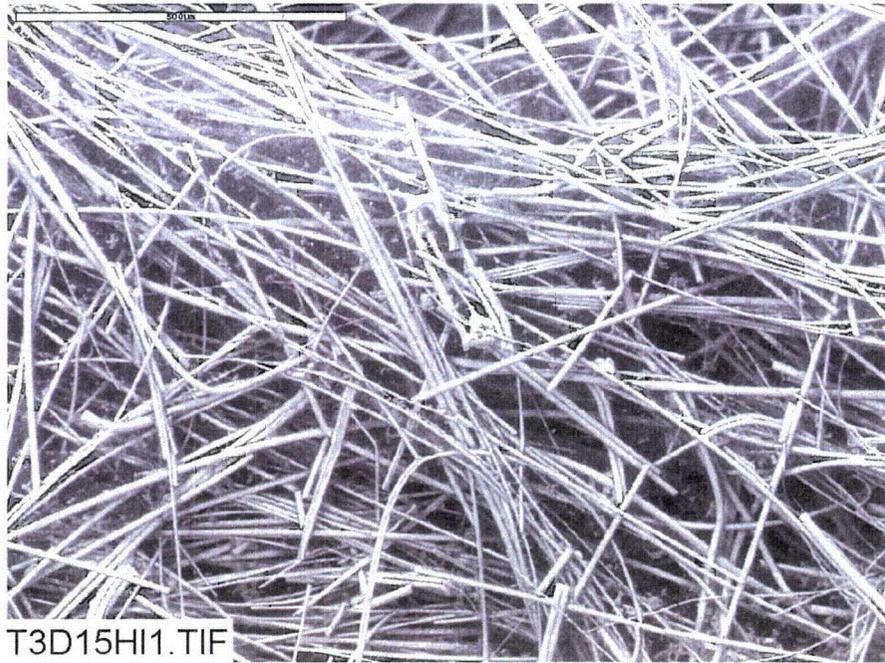
Figure B1-1. Environmental SEM image magnified 100 times for a Test #3, Day-15 high-flow interior fiberglass sample. (T3D15HI1)

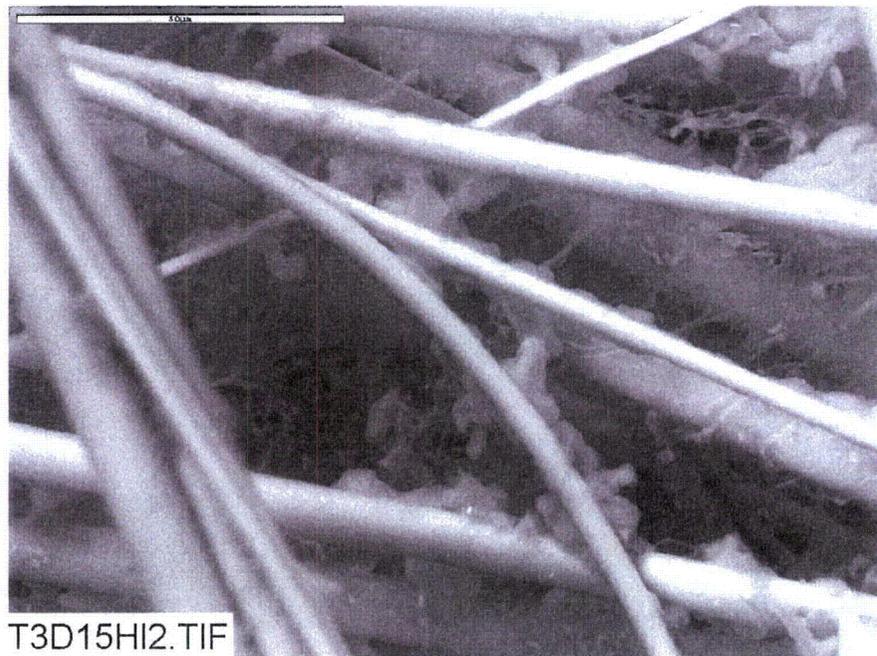
Figure B1-2. Environmental SEM image magnified 1000 times for a Test #3, Day-15 high-flow interior fiberglass sample. (T3D15HI2)

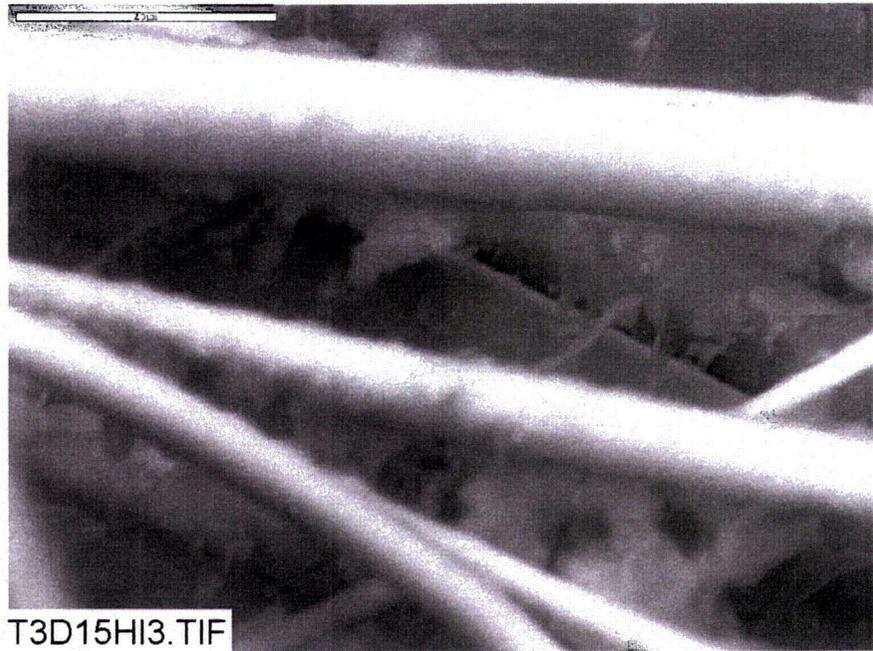
Figure B1-3. Environmental SEM image magnified 2000 times for a Test #3, Day-15 high-flow interior fiberglass sample. (T3D15HI3)

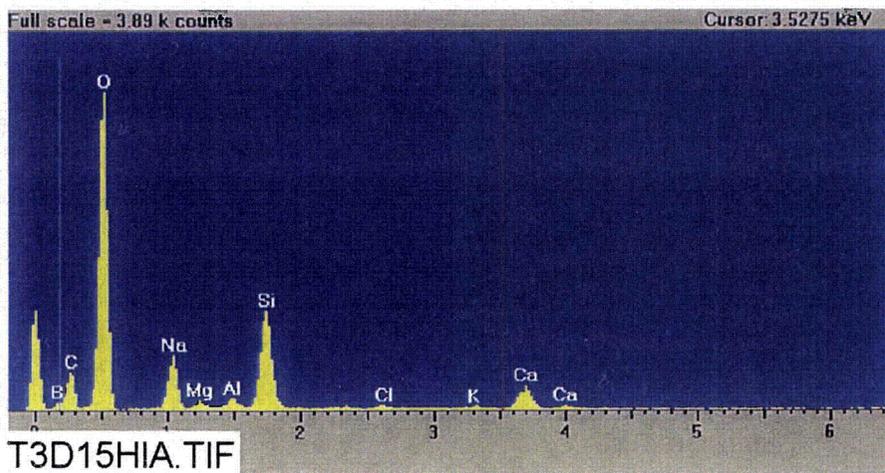
Figure B1-4. EDS counting spectrum for the flocculence deposits between the fibers on ESEM image shown in Figure B1-3. (T3D15HIA)

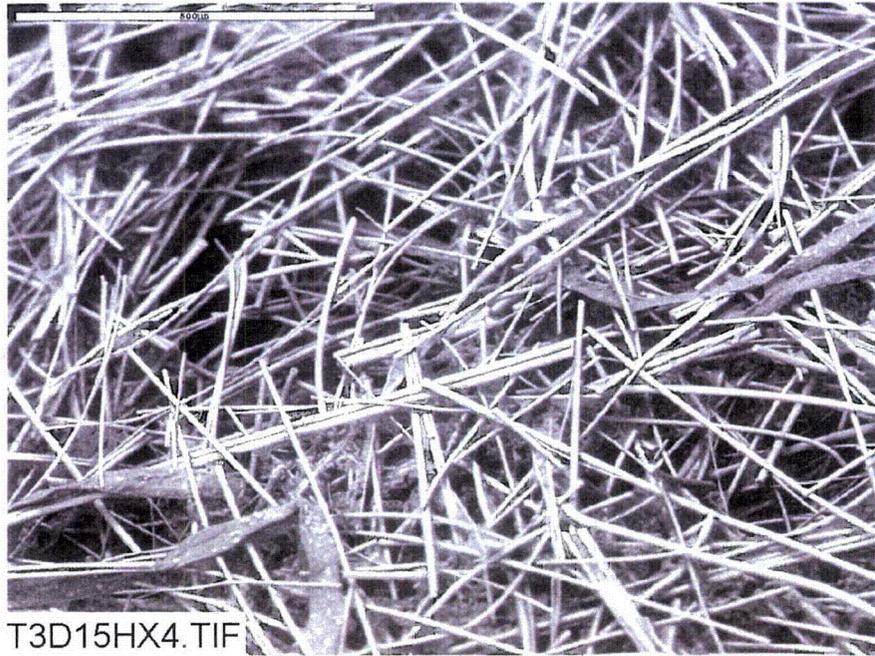
Figure B1-5. Environmental SEM image magnified 110 times for a Test #3, Day-15 high-flow exterior fiberglass sample. (T3D15HX4)

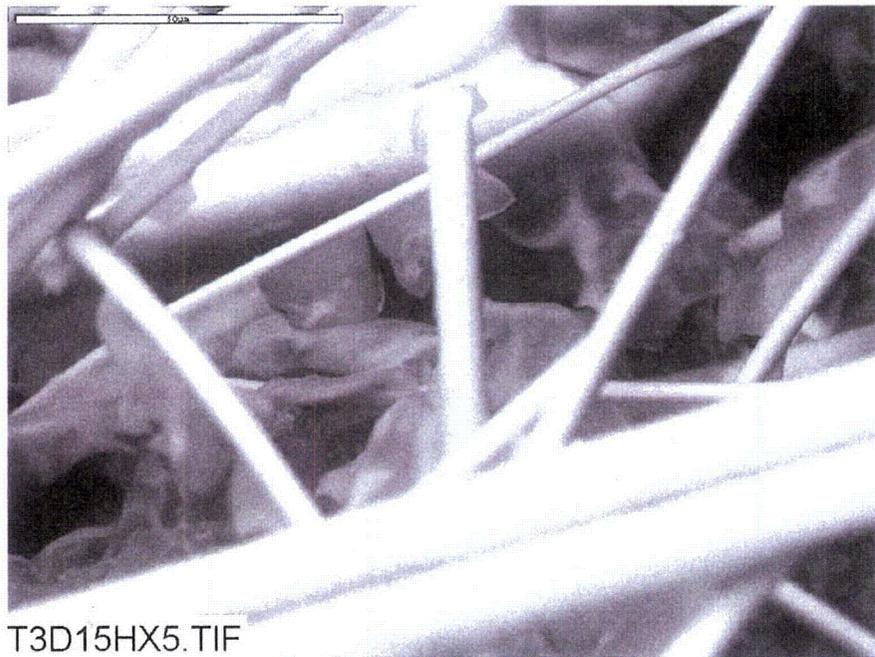
Figure B1-6. Environmental SEM image magnified 1000 times for a Test #3, Day-15 high-flow exterior fiberglass sample. (T3D15HX5)

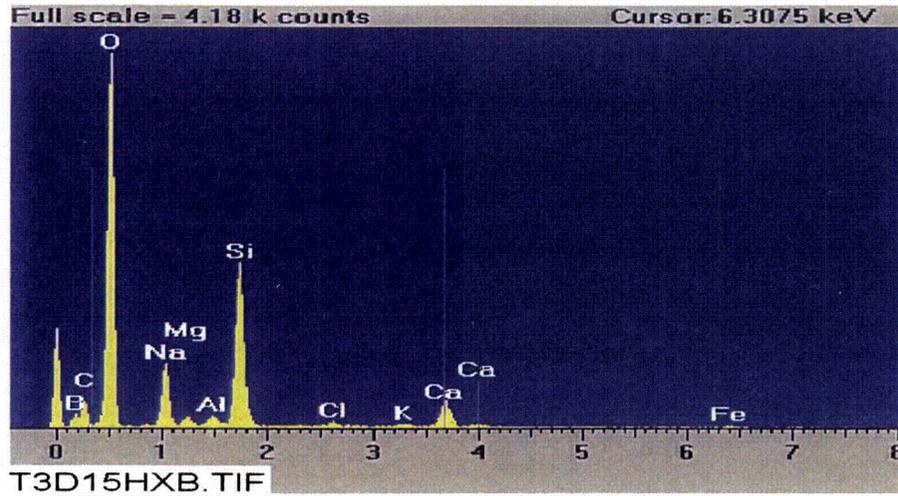
Figure B1-7. EDS counting spectrum for the deposits between the fibers on ESEM image shown in Figure B1-6. (T3D15HXB)

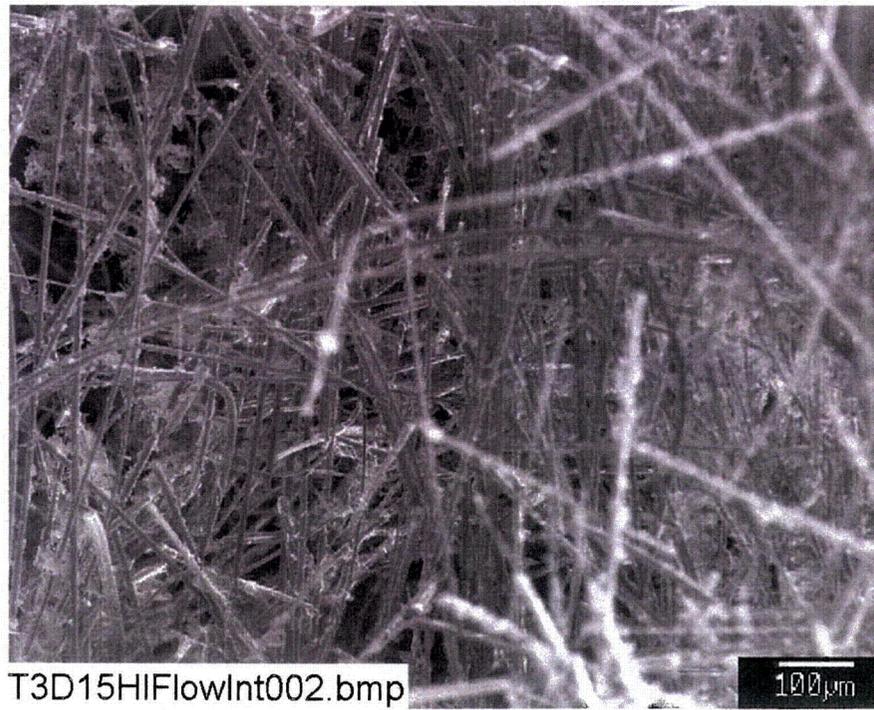
Figure B1-8. SEM image magnified 100 times for a Test #3, Day-15 high-flow interior fiberglass sample. (T3D15HIFlowInt002)

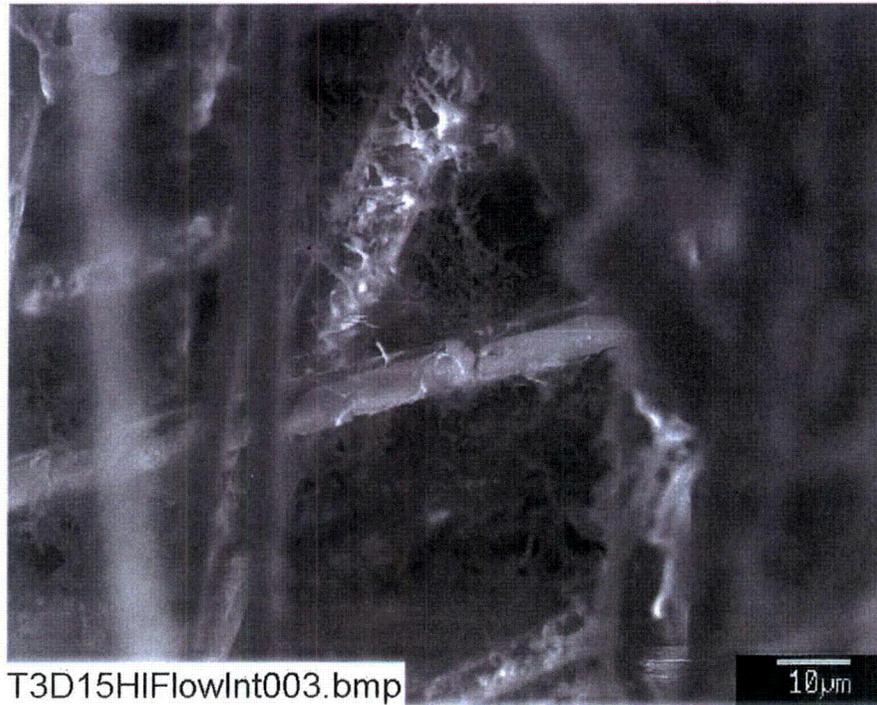
Figure B1-9. SEM image magnified 1000 times for a Test #3, Day-15 high-flow interior fiberglass sample. (T3D15HIFlowInt003)

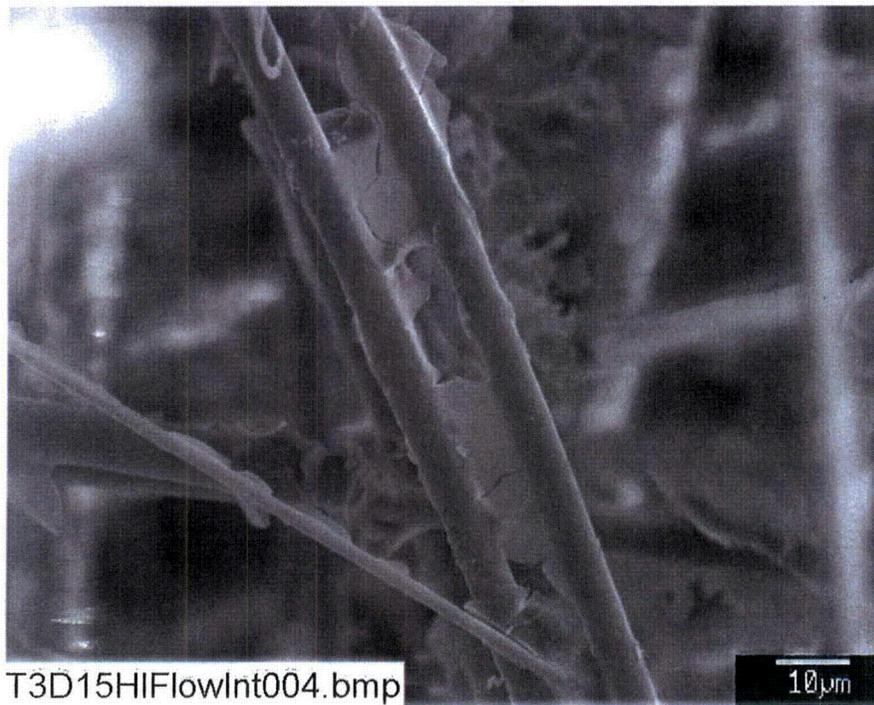
Figure B1-10. SEM image magnified 1000 times for a Test #3, Day-15 high-flow interior fiberglass sample. (T3D15HIFlowInt004)

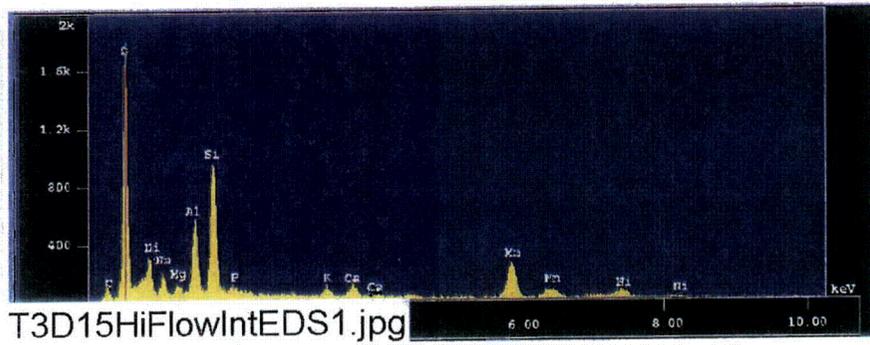
Figure B1-11. EDS counting spectrum for the flocculence deposits between the fibers on SEM image shown in Figure B1-10. (T3D15HiFlowIntEDS1)

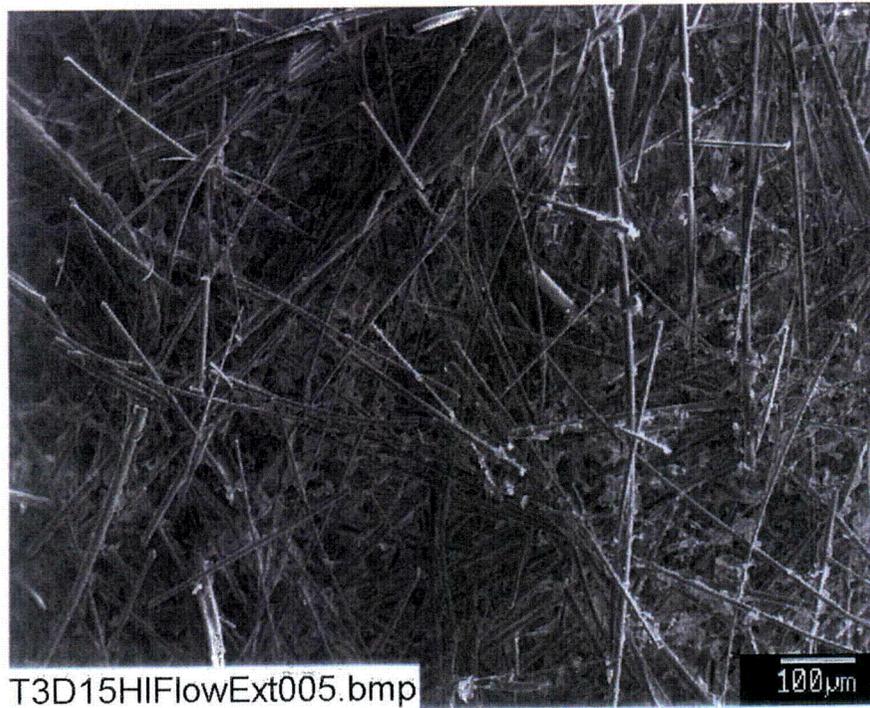
Figure B1-12. SEM image magnified 100 times for a Test #3, Day-15 high-flow exterior fiberglass sample. (T3D15HiFlowExt005)

Image:	T3D15HIFlowExt005	100 ×		Figure B1-12
	T3D15HIFlowExt006	1000 ×		Figure B1-13
	T3D15HIFlowExt007	500 ×		Figure B1-14
EDS:	T3D15HIFlowExtEDS 2		EDS on particles shown in Ext007	Figure B1-15

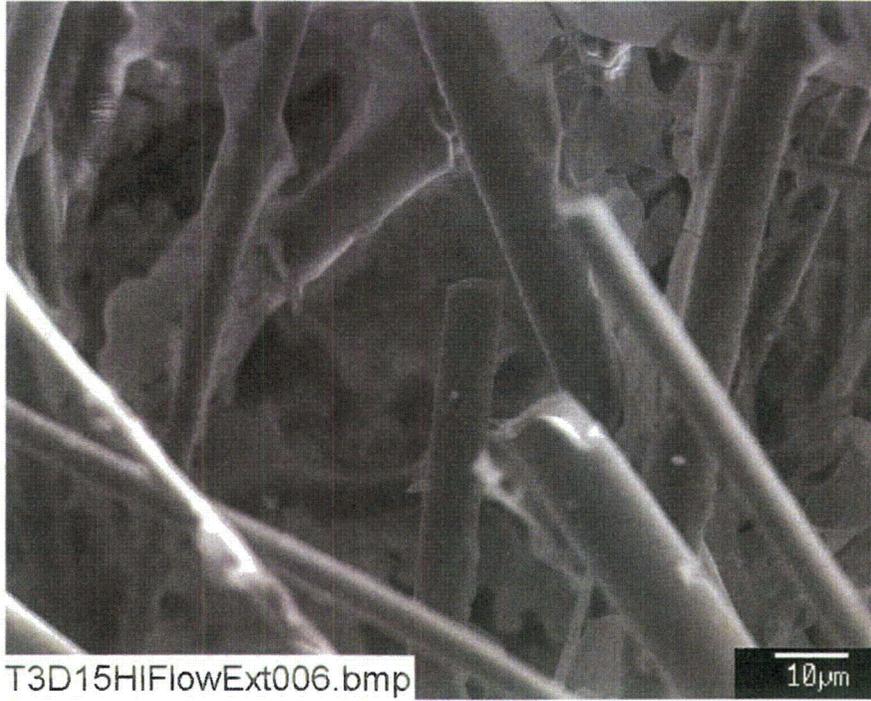
Figure B1-13. SEM image magnified 1000 times for a Test #3, Day-15 high-flow exterior fiberglass sample. (T3D15HIFlowExt006)

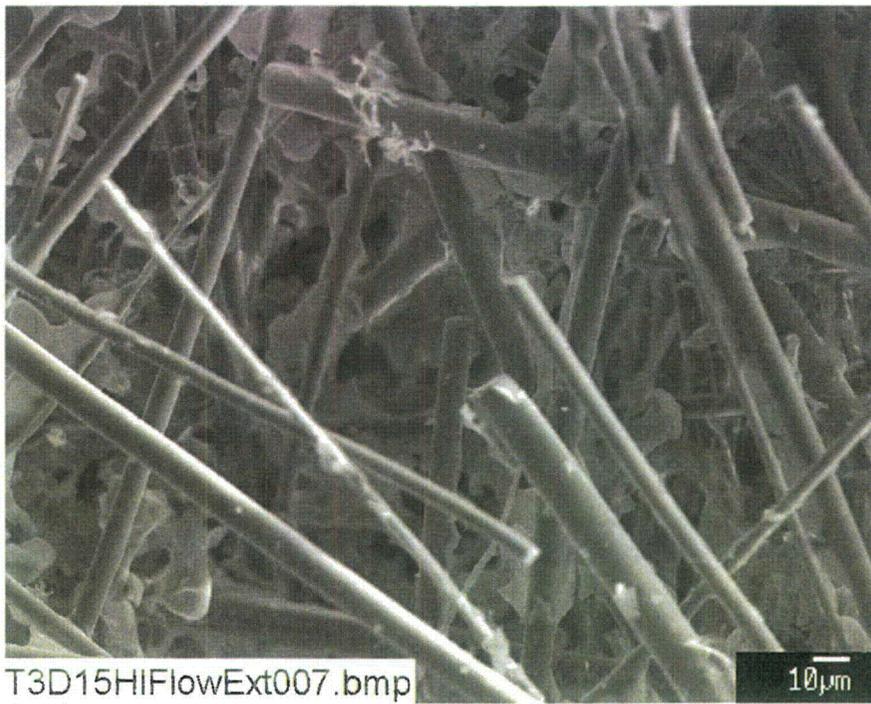
Figure B1-14. SEM image magnified 500 times for a Test #3, Day-15 high-flow exterior fiberglass sample. (T3D15HIFlowExt007)

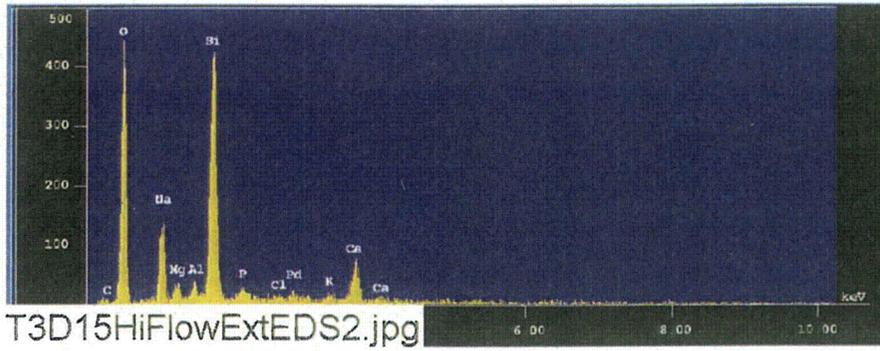
Figure B1-15. EDS counting spectrum for the flocculence deposits between the fibers on SEM image shown in Figure B1-14. (T3D15HiFlowExtEDS2)

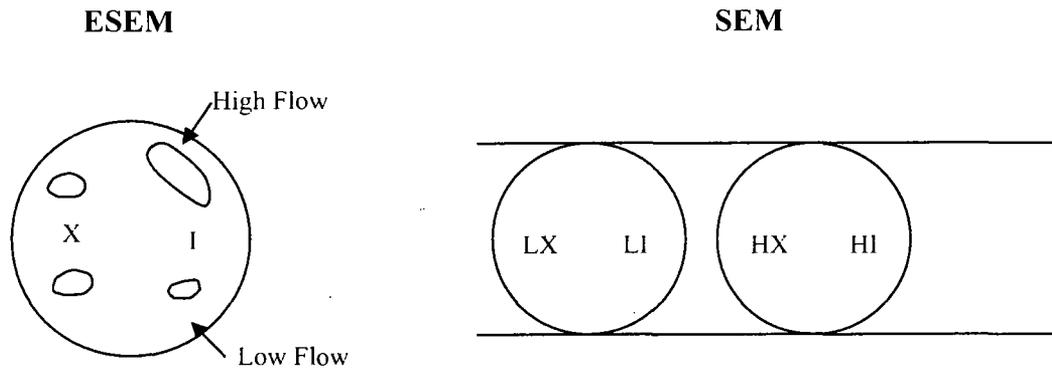
Test #3, Day-15 fiberglass in low-flow zones

Instrument Conditions: ESEM, Pressure = 80 Pa
SEM, Electron beam of 1×10^{-9} (A)

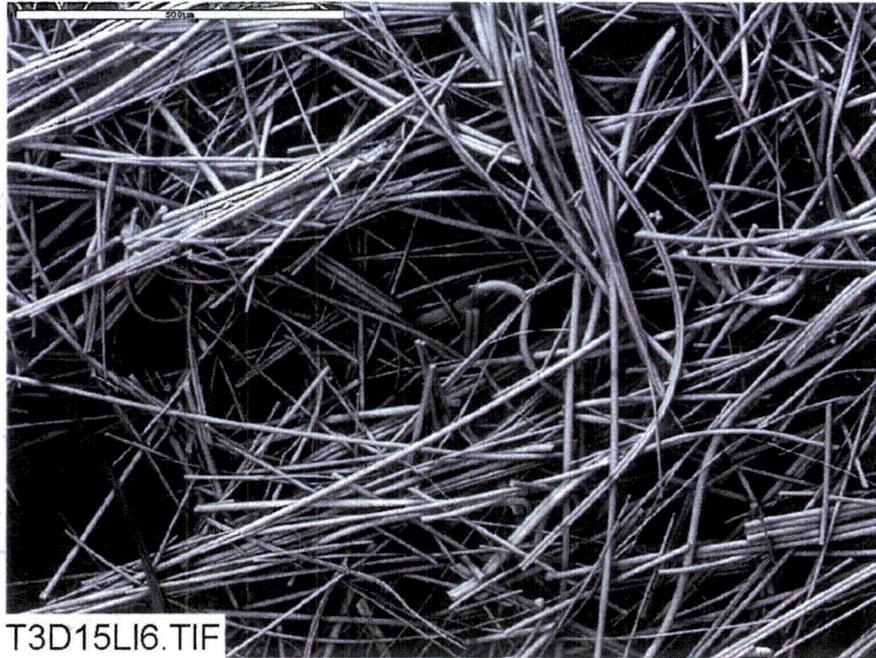
Figure B2-1. Environmental SEM image magnified 100 times for a Test #3, Day-15 low-flow interior fiberglass sample. (T3D15LI6)

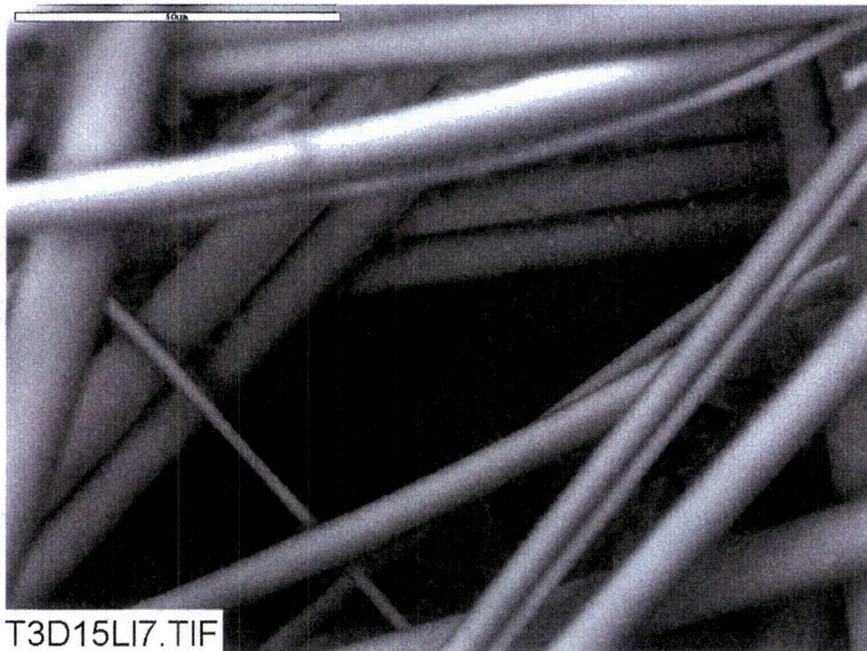
Figure B2-2. Environmental SEM image magnified 1000 times for a Test #3, Day-15 low-flow interior fiberglass sample. (T3D15LI7)

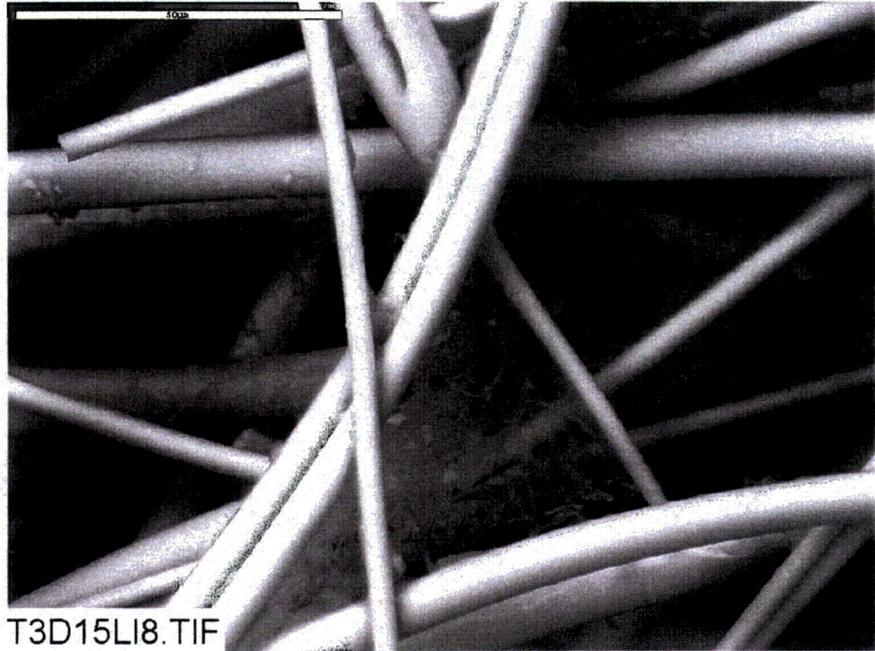
Figure B2-3. Environmental SEM image magnified 1000 times for a Test #3, Day-15 low-flow interior fiberglass sample. (T3D15LI8)

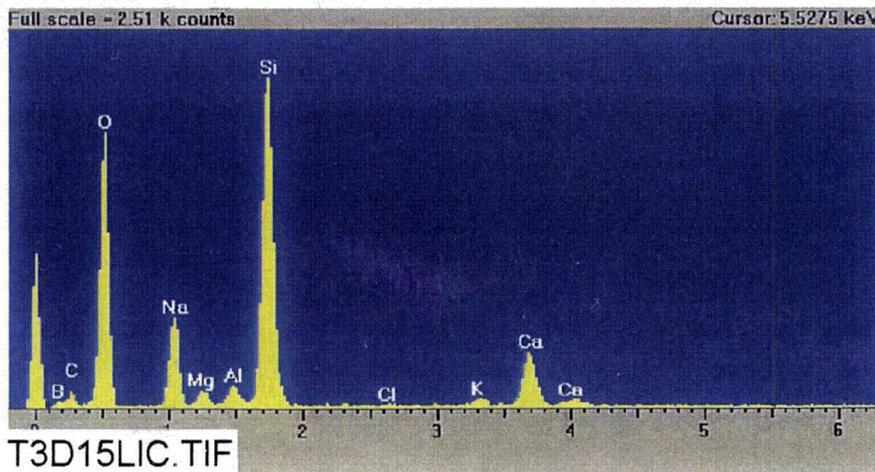
Figure B2-4. EDS counting spectrum for the flocculence deposits between the fibers on ESEM image shown in Figure B2-3. (T3D15LIC)

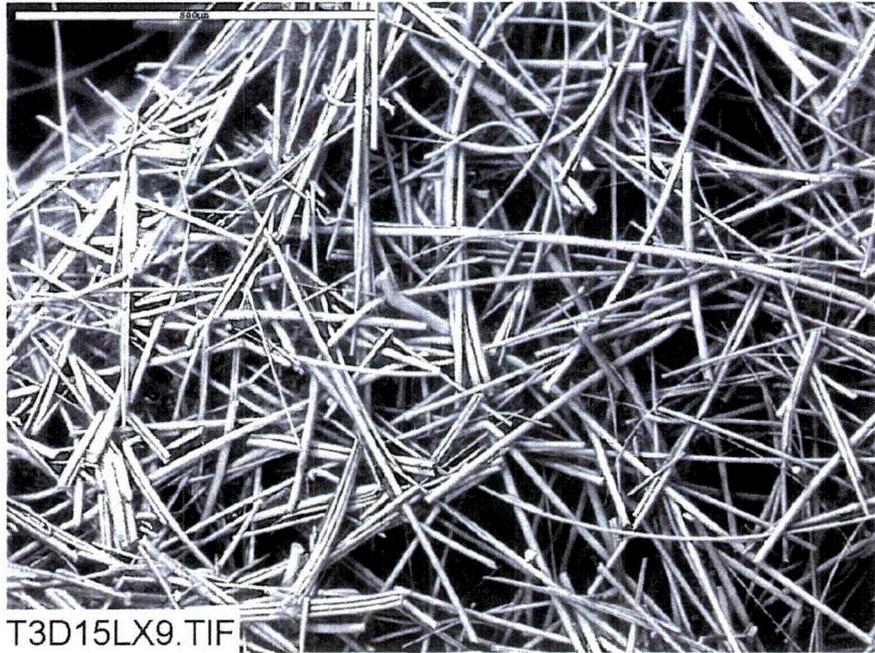
Figure B2-5. Environmental SEM image magnified 110 times for a Test #3, Day-15 low-flow exterior fiberglass sample. (T3D15LX9)

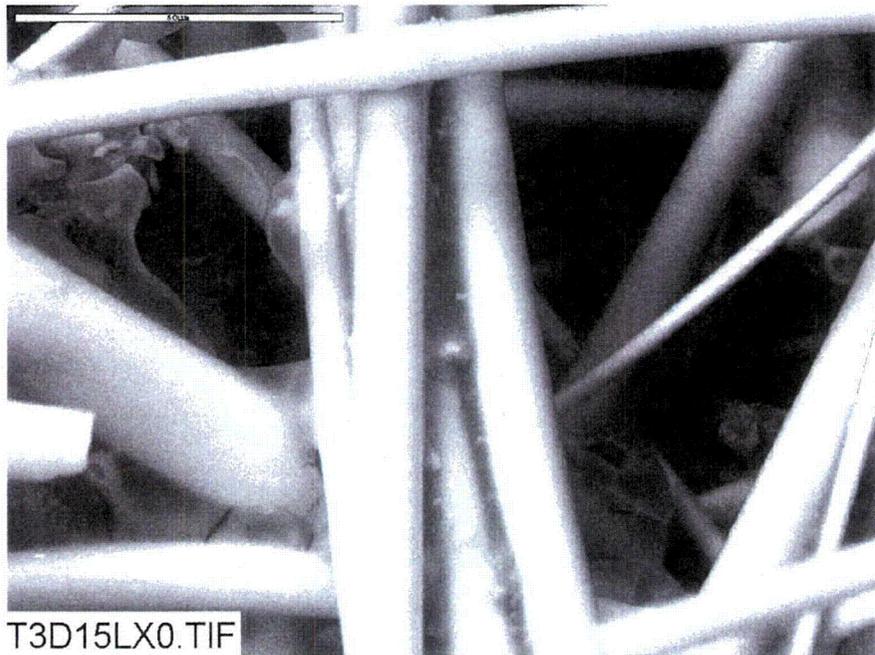
Figure B2-6. Environmental SEM image magnified 1000 times for a Test #3, Day-15 low-flow exterior fiberglass sample. (T3D15LX0)

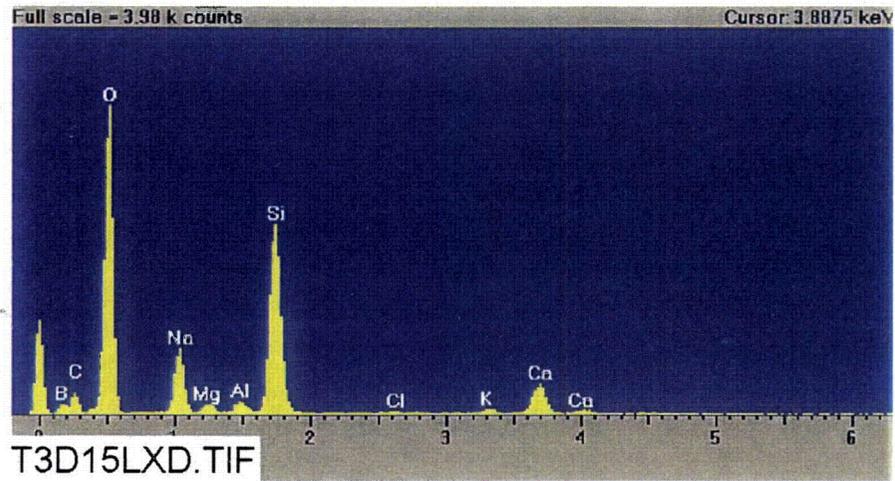
Figure B2-7. EDS counting spectrum for the deposits between the fibers on ESEM image shown in Figure B2-6. (T3D15LXD)
