4. SUMMARY OF KEY OBSERVATIONS

Appendix D. ESEM and SEM/EDS Data for Test #3 Day-30 Corrosion Products

ESEM & SEM Test #3, Day-4 Fiberglass.

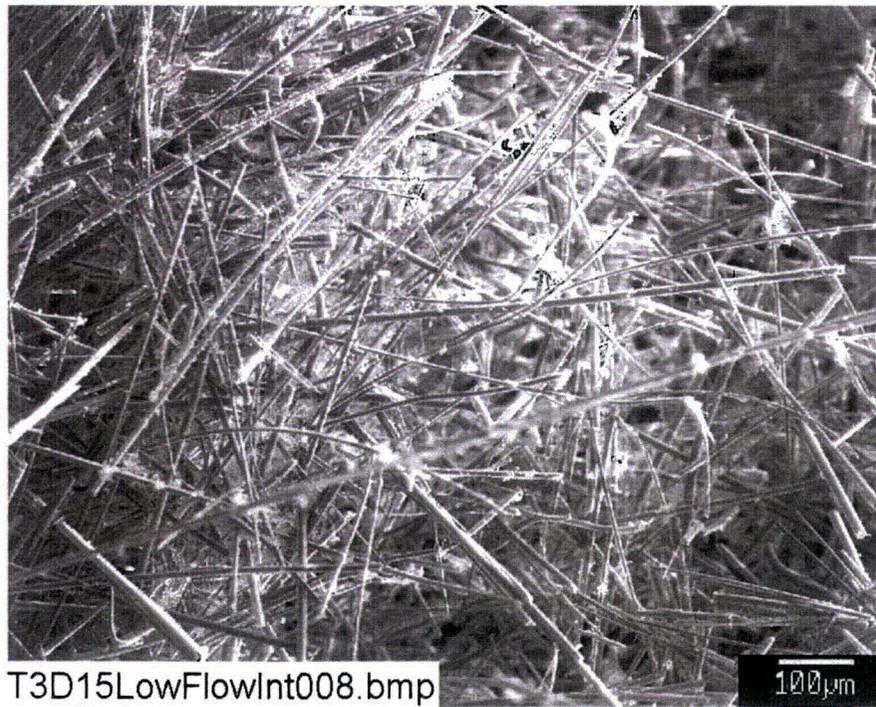
Figure B2-8. SEM image magnified 100 times for a Test #3, Day-15 low-flow interior fiberglass sample. (T3D15LowFlowInt008)

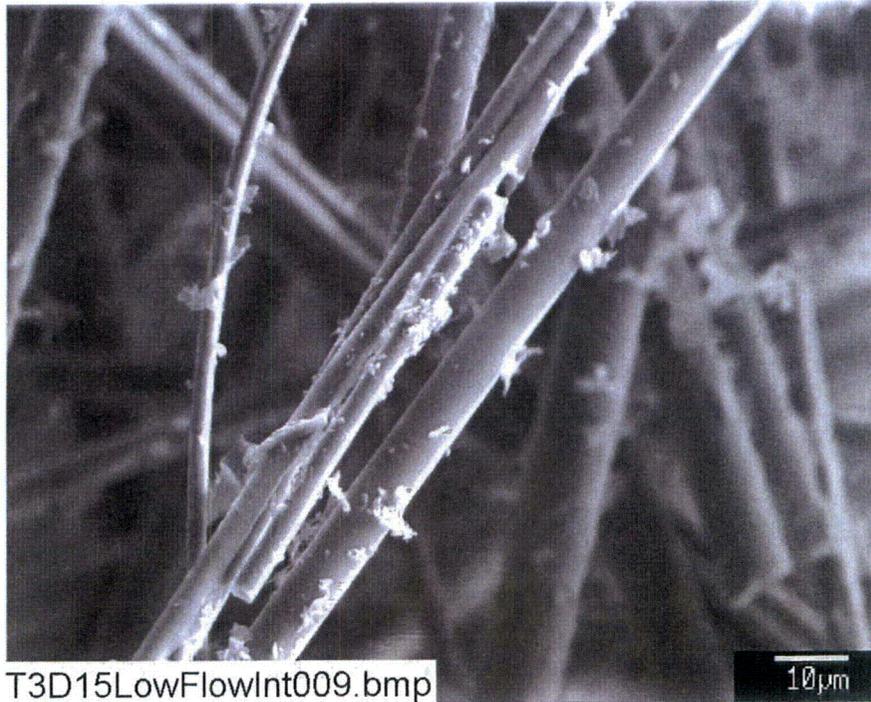
T3D15LowFlowInt009.bmp

Figure B2-9. SEM image magnified 1000 times for a Test #3, Day-15 low-flow interior fiberglass sample. (T3D15LowFlowInt009)

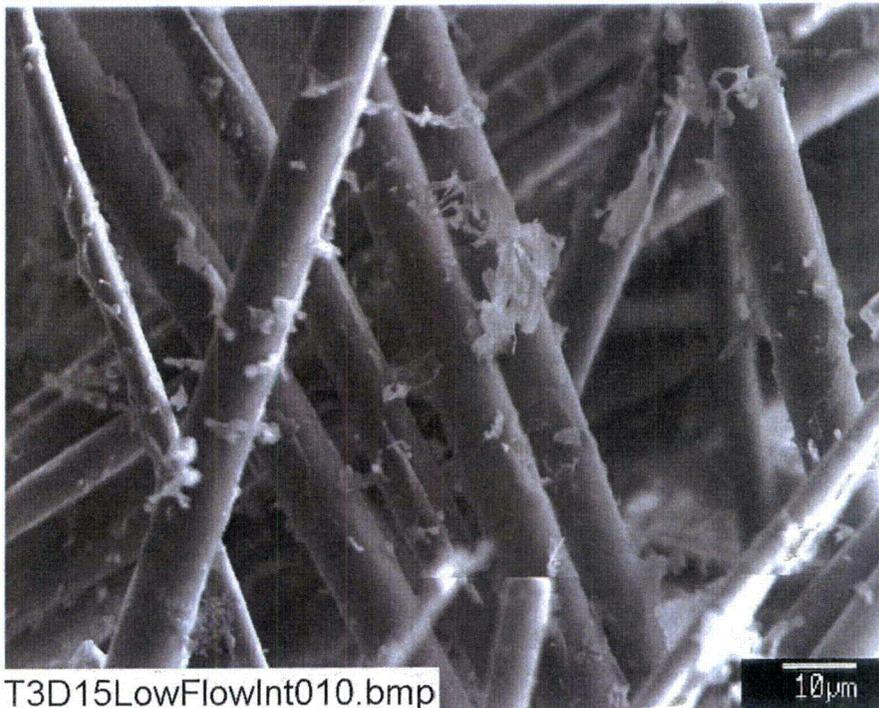
T3D15LowFlowInt010.bmp

Figure B2-10. SEM image magnified 1000 times for a Test #3, Day-15 low-flow interior fiberglass sample. (T3D15LowFlowInt010)

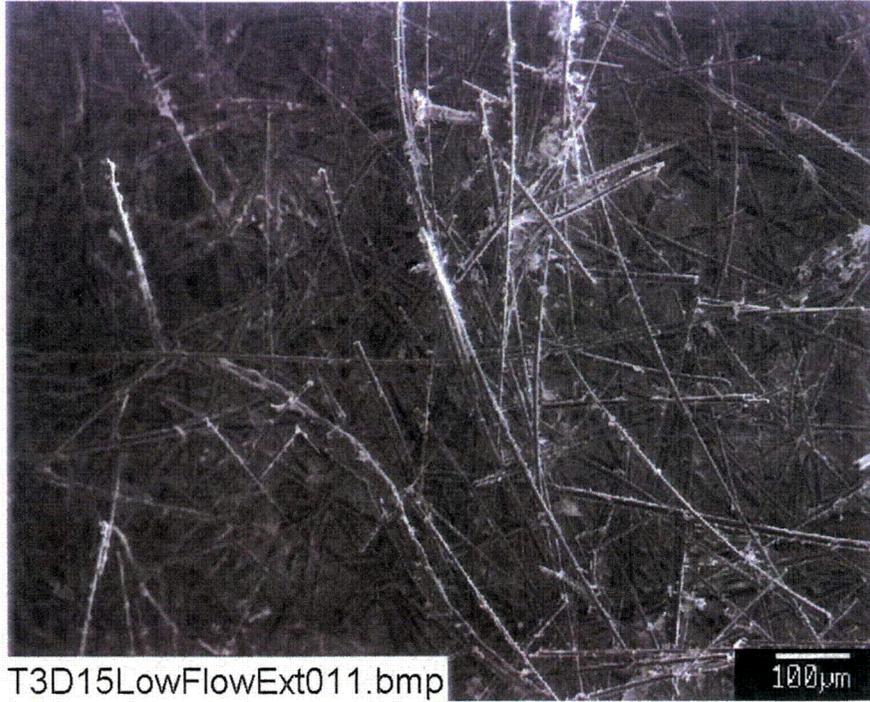
Figure B2-11. SEM image magnified 100 times for a Test #3, Day-15 low-flow exterior fiberglass sample. (T3D15LowFlowExt011)

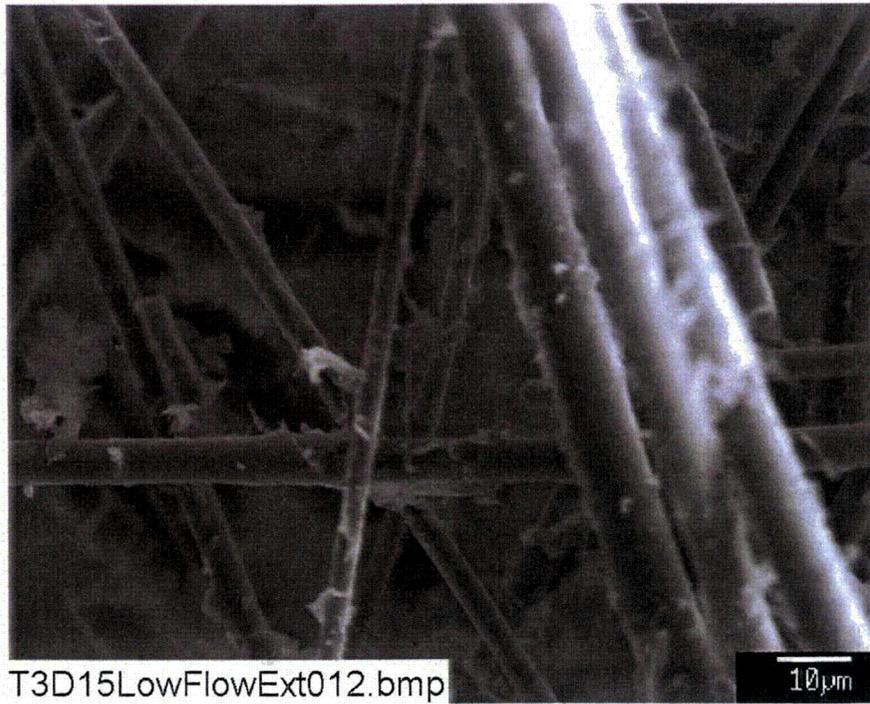
Figure B2-12. SEM image magnified 1000 times for a Test #3, Day-15 low-flow exterior fiberglass sample. (T3D15LowFlowExt012)

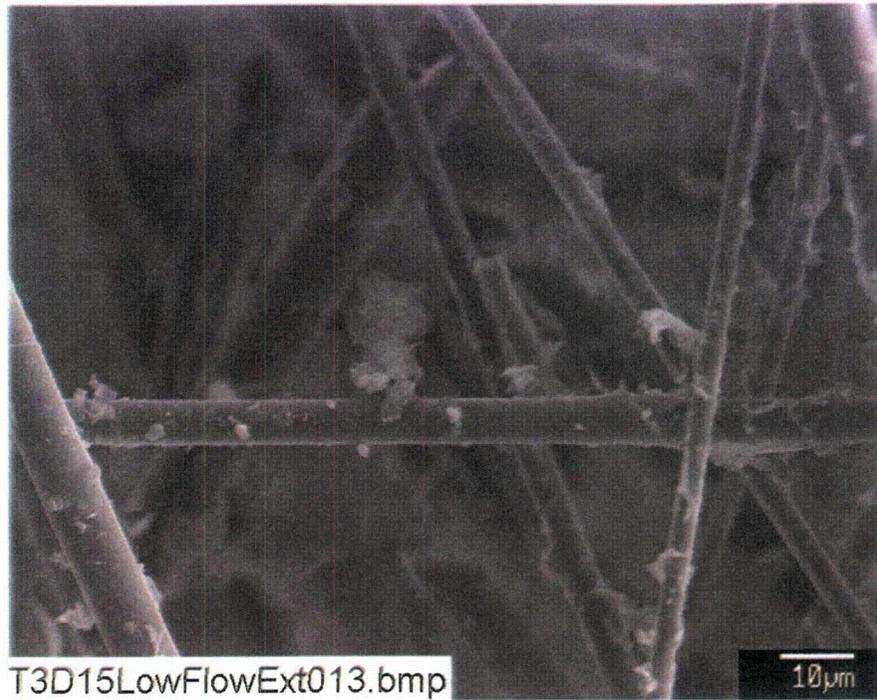
Figure B2-13. SEM image magnified 1000 times for a Test #3, Day-15 low-flow exterior fiberglass sample. (T3D15LowFlowExt013)

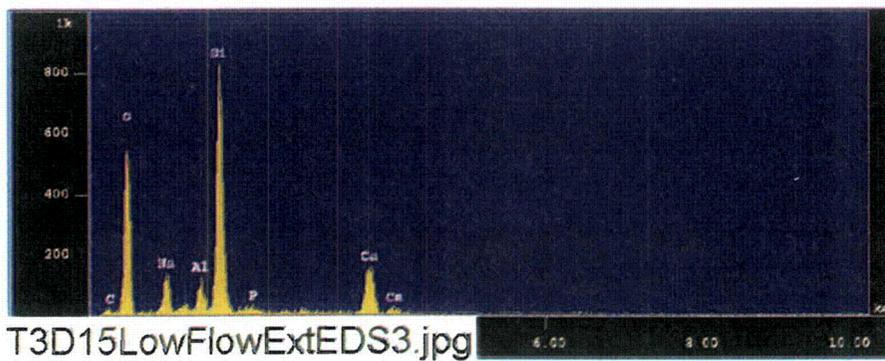
Figure B2-14. EDS counting spectrum for the flocculence deposits between the fibers on SEM image shown in Figure B2-13. (T3D15LowFlowExtEDS3)

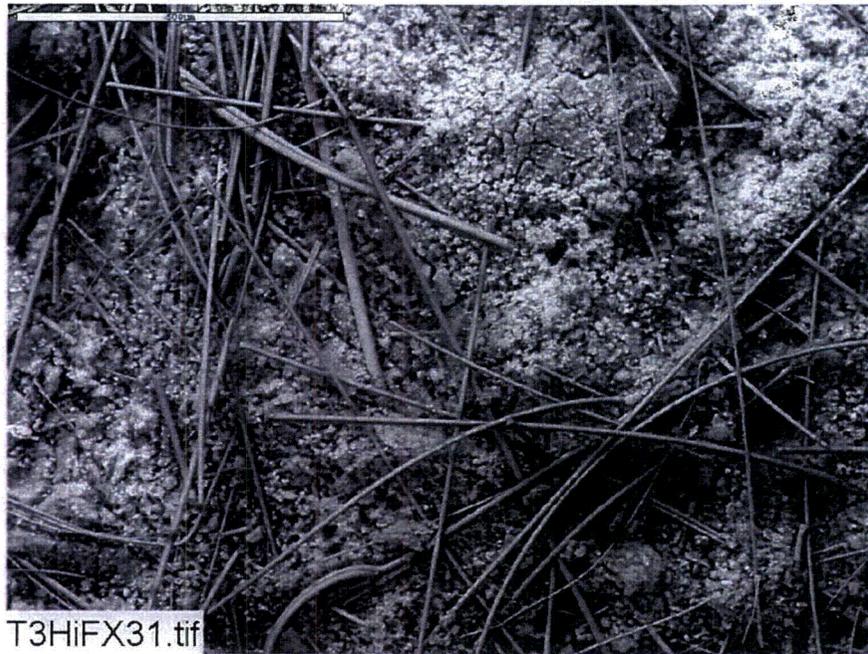
Figure C1-1. ESEM image magnified 100 times for a Test #3, Day-30 exterior high-flow fiberglass sample. (T3HiFX31)

Image: T3HiFX31	100 ×	ESEM image	Figure C1-1
t3hifX32	1000 ×	ESEM image higher magnification	Figure C1-2
t3hifX33	100 ×	ESEM image	Figure C1-3
EDS: t3hifX34		EDS on particles in T3HiFX33	Figure C1-4
Image: t3hifX35	600 ×	ESEM image on fiberglass	Figure C1-5

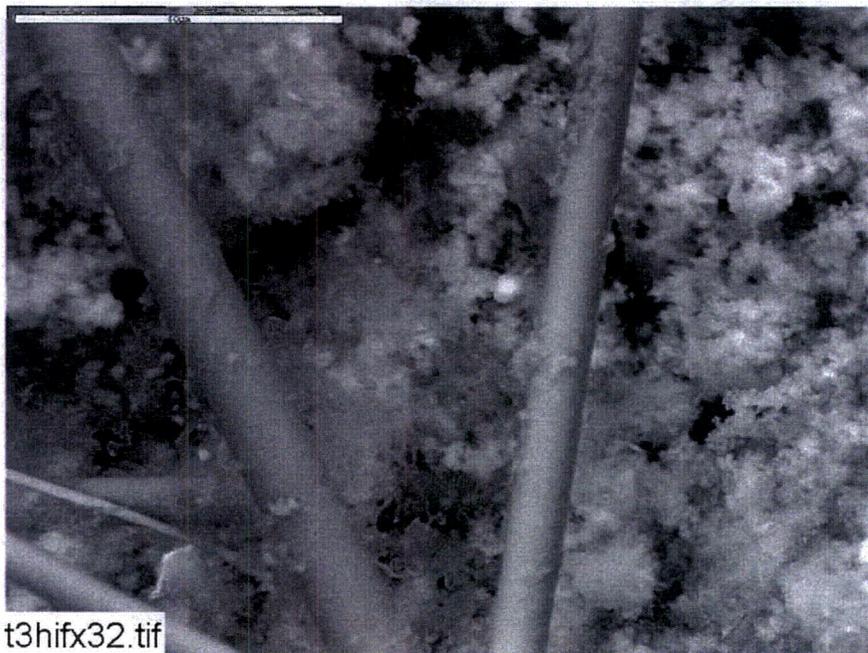
Figure C1-2. ESEM image magnified 1000 times for a Test #3, Day-30 exterior high-flow fiberglass sample. (t3hifx32)

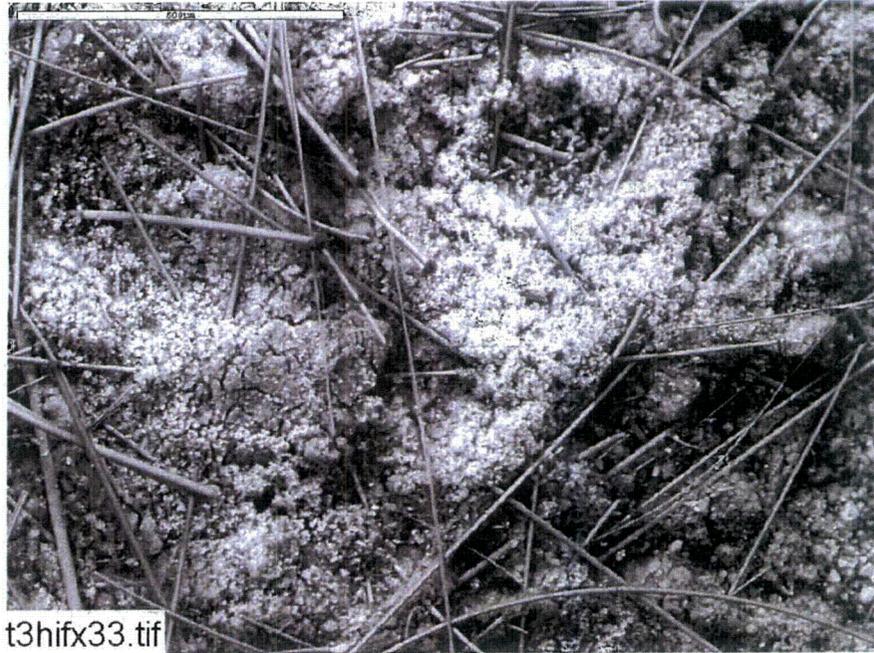
Figure C1-3. ESEM image magnified 100 times for a Test #3, Day-30 exterior high-flow fiberglass sample. (t3hifx33)

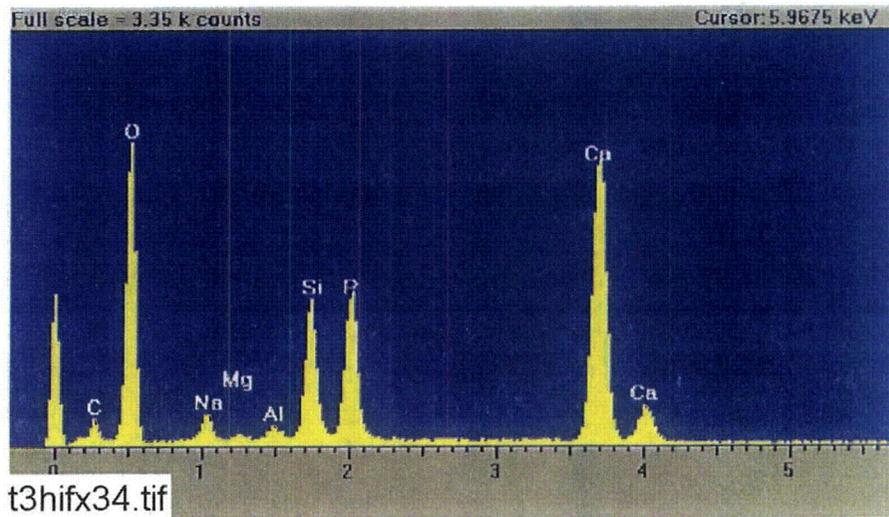
Figure C1-4. EDS counting spectrum for the large masses of particulate deposits shown in Figure C1-3. (t3hifx34)

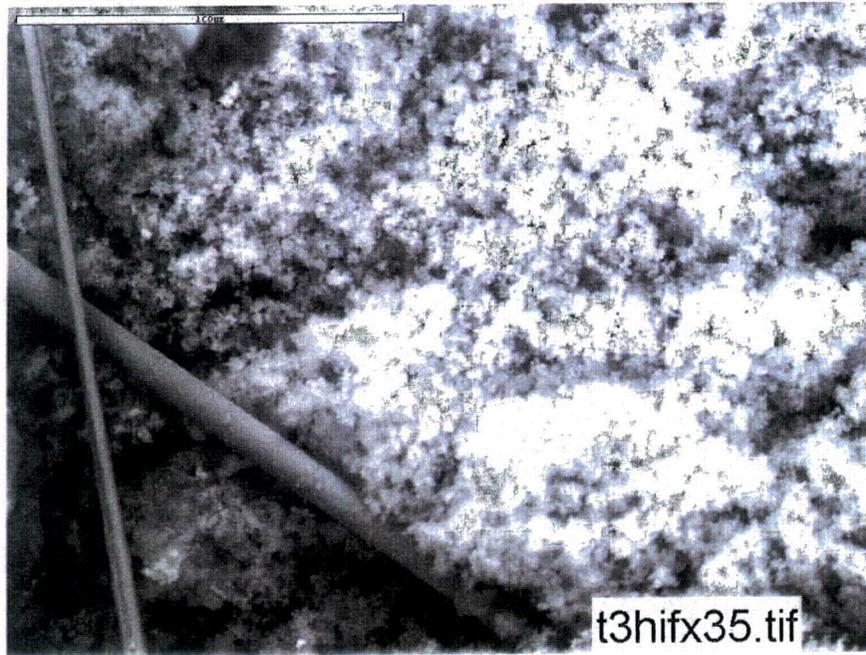
Figure C1-5. ESEM image magnified 600 times for a Test #3, Day-30 exterior high-flow fiberglass sample. (t3hifx35)

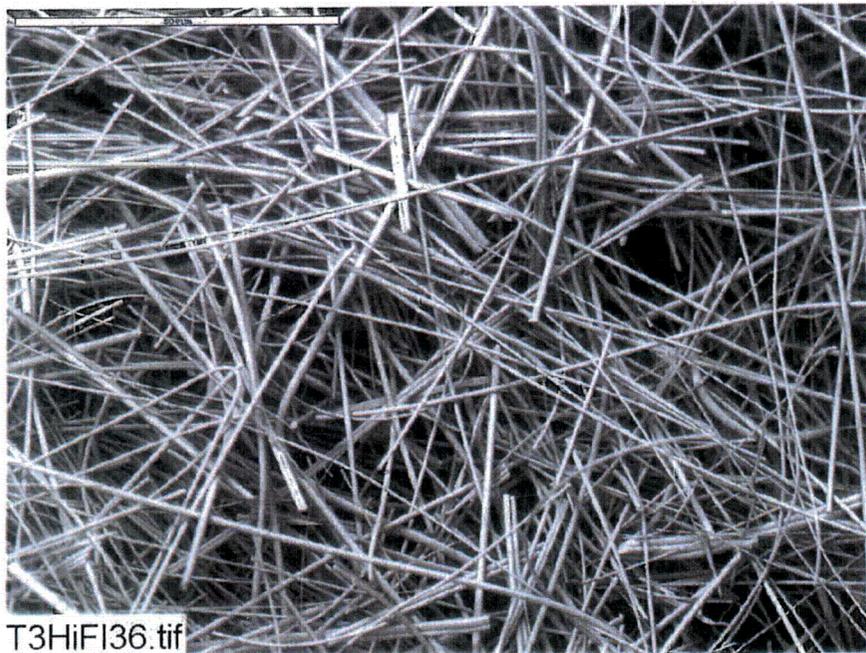
Figure C1-6. ESEM image magnified 100 times for a Test #3, Day-30 interior high-flow fiberglass sample. (T3HiFI36)

Image: T3HiFI36	100 ×	ESEM image of fiberglass	Figure C1-6
t3hifI37	1000 ×	ESEM image higher magnification	Figure C1-7
t3hifI38	100 ×	ESEM image	Figure C1-8

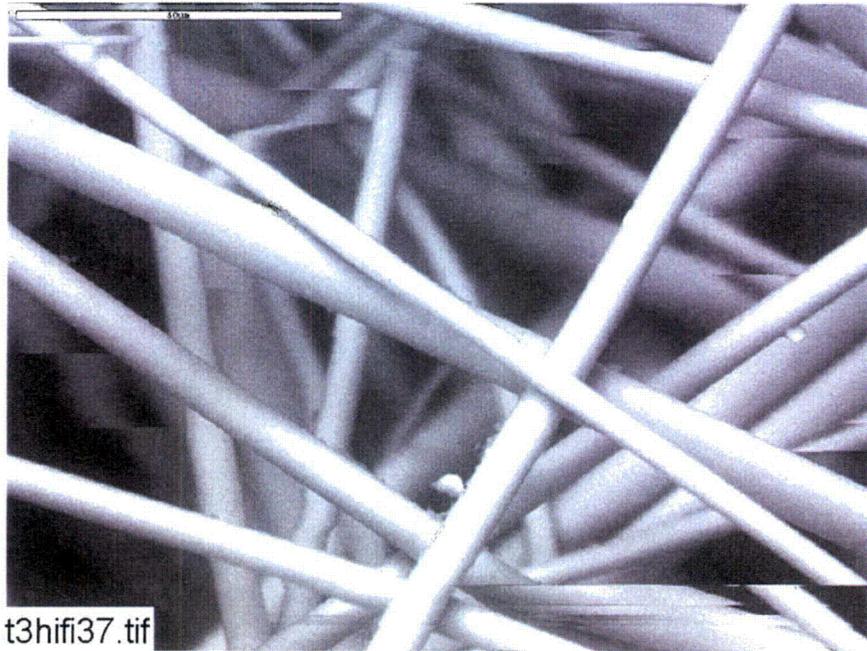
Figure C1-7. ESEM image magnified 1000 times for a Test #3, Day-30 interior high-flow fiberglass sample. (t3hifi37)

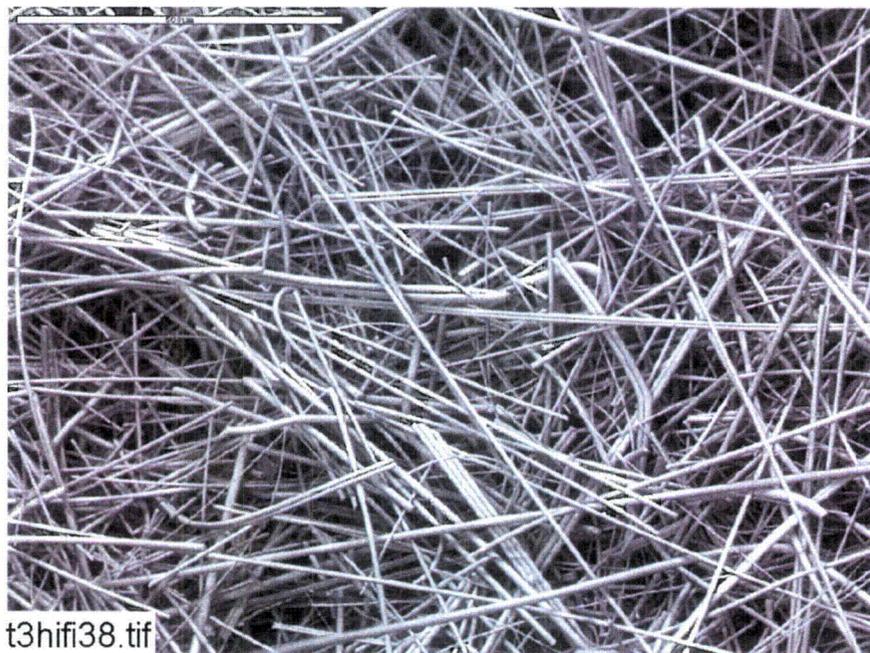
Figure C1-8. ESEM image magnified 100 times for a Test #3, Day-30 interior high-flow fiberglass sample. (t3hifi38)

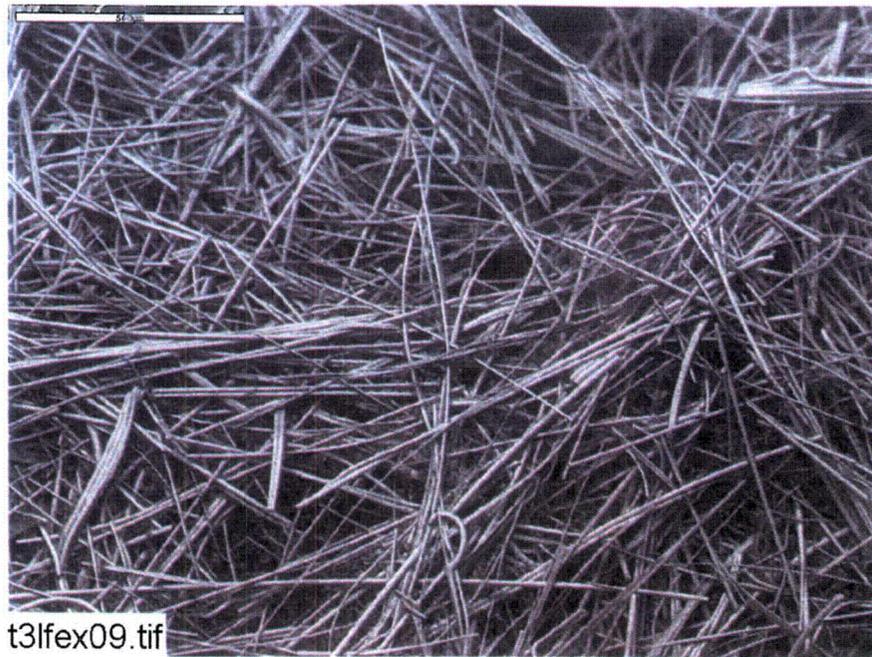
Figure C2-1. ESEM image magnified 70 times for a Test #3, Day-30 exterior low-flow fiberglass sample. (t3lfex09)

Image: t3lfex09	70 ×	ESEM image of fiberglass sample	Figure C2-1
t3lfex10	1000 ×	ESEM at higher magnification	Figure C2-2
t3lfex11	1000 ×	ESEM image	Figure C2-3

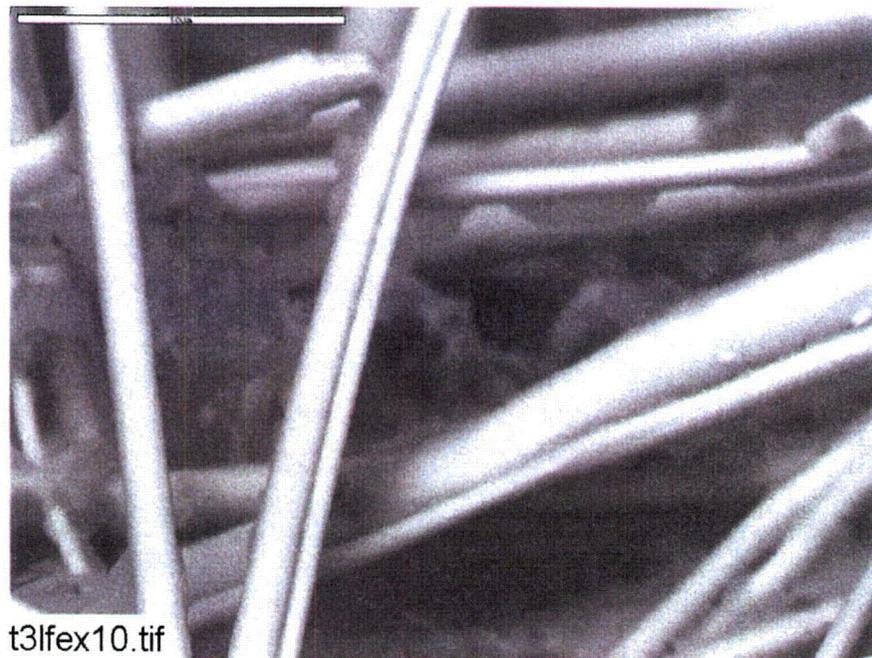
Figure C2-2. ESEM image magnified 1000 times for a Test #3, Day-30 exterior low-flow fiberglass sample. (t3lfex10)

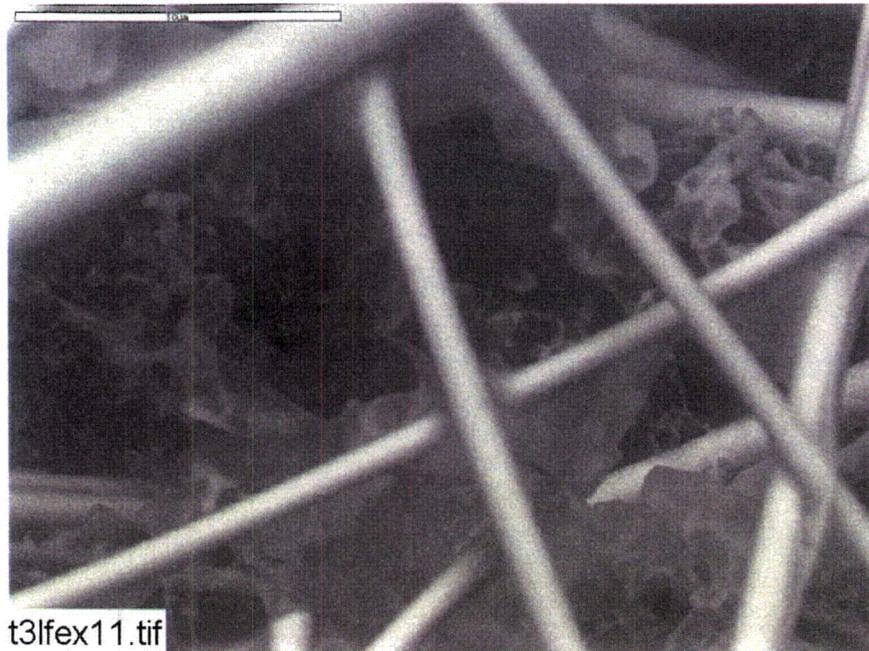
Figure C2-3. ESEM image magnified 1000 times for a Test #3, Day-30 exterior low-flow fiberglass sample. (t3lfex11)

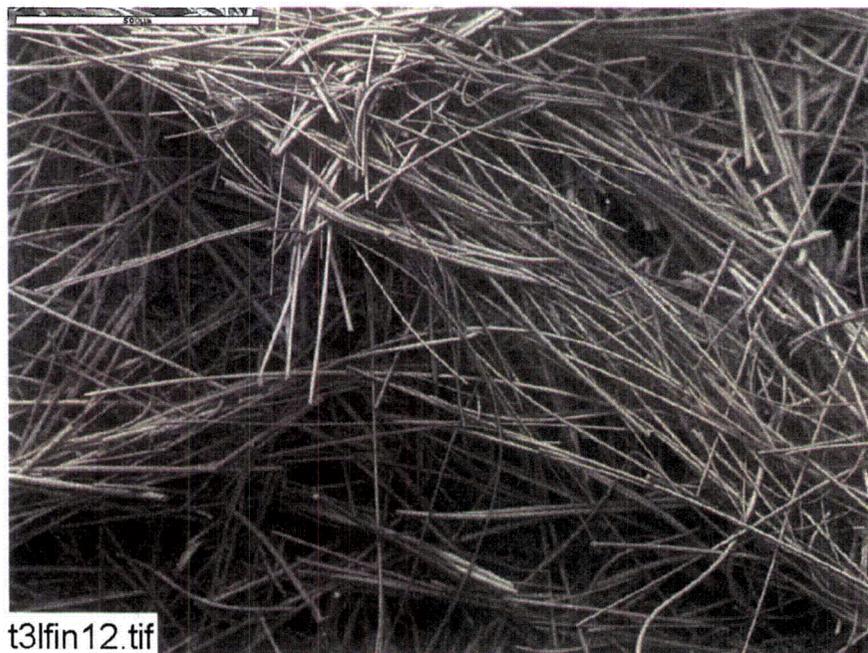
Figure C2-4. ESEM image magnified 70 times for a Test #3, Day-30 interior low-flow fiberglass sample. (t3lfin12)

Image: t3lfin12	70 ×	ESEM image of fiberglass sample	Figure C2-4
t3lfin13	1000 ×	ESEM image at higher mag.	Figure C2-5
t3lfin14	1000 ×	ESEM image	Figure C2-6
t3lfin15	1000 ×	ESEM image	Figure C2-7

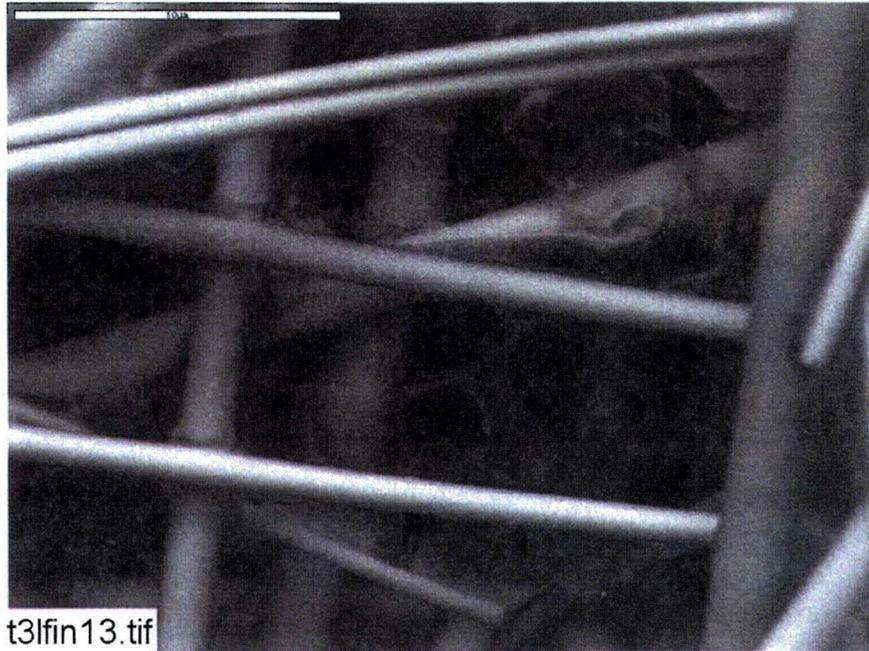
Figure C2-5. ESEM image magnified 1000 times for a Test #3, Day-30 interior low-flow fiberglass sample. (t3lfin13)

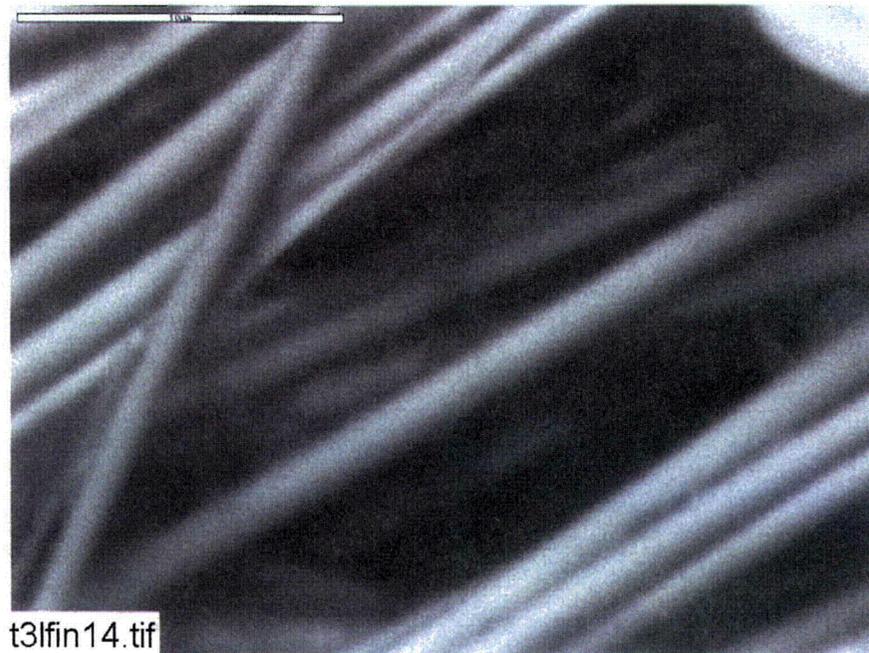
Figure C2-6. ESEM image magnified 1000 times for a Test #3, Day-30 interior low-flow fiberglass sample. (t3lfin14)

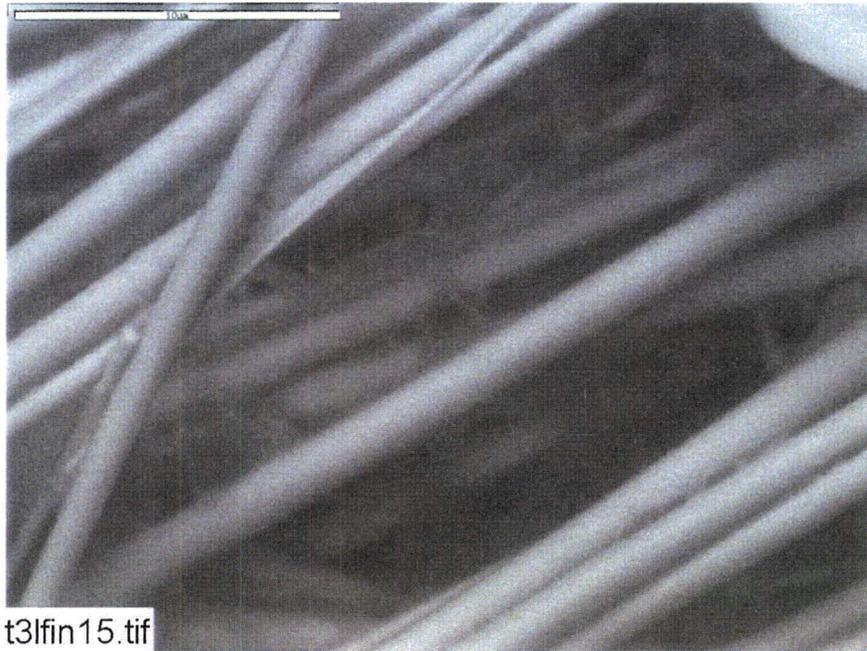
Figure C2-7. ESEM image magnified 1000 times for a Test #3, Day-30 interior low-flow fiberglass sample. (t3lfin15)

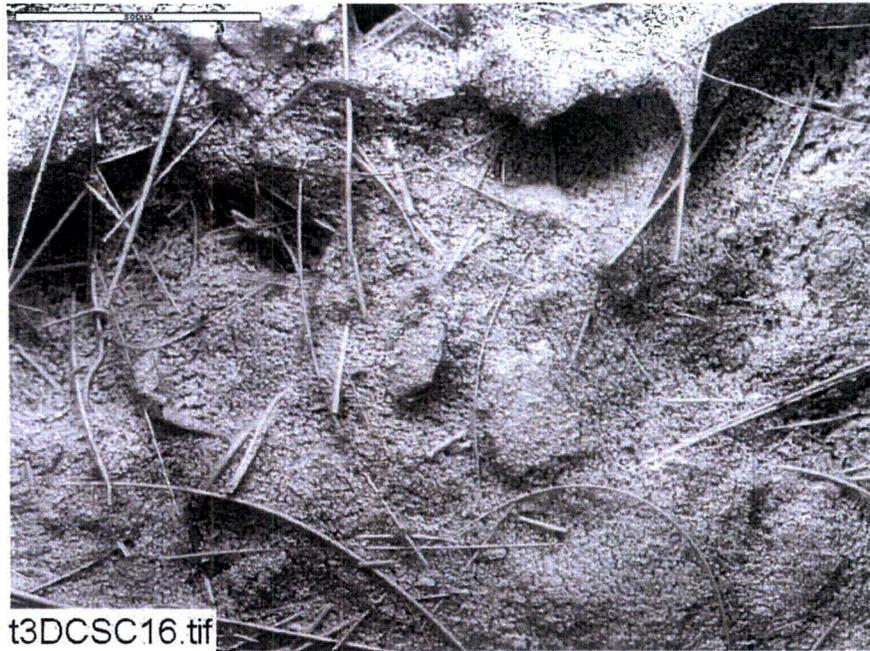
Figure C3-1. ESEM image magnified 100 times for a Test #3, Day-30 exterior fiberglass sample on the drain collar (adjacent to the drain screen). (t3DCSC16)

Image:	t3DCSC16	100 ×		Figure C3-1
	t3dcsc17	1000 ×	Particles	Figure C3-2
EDS:	t3dcsc18		EDS on particles	Figure C3-3
Image:	t3dcsc19	70 ×		Figure C3-4

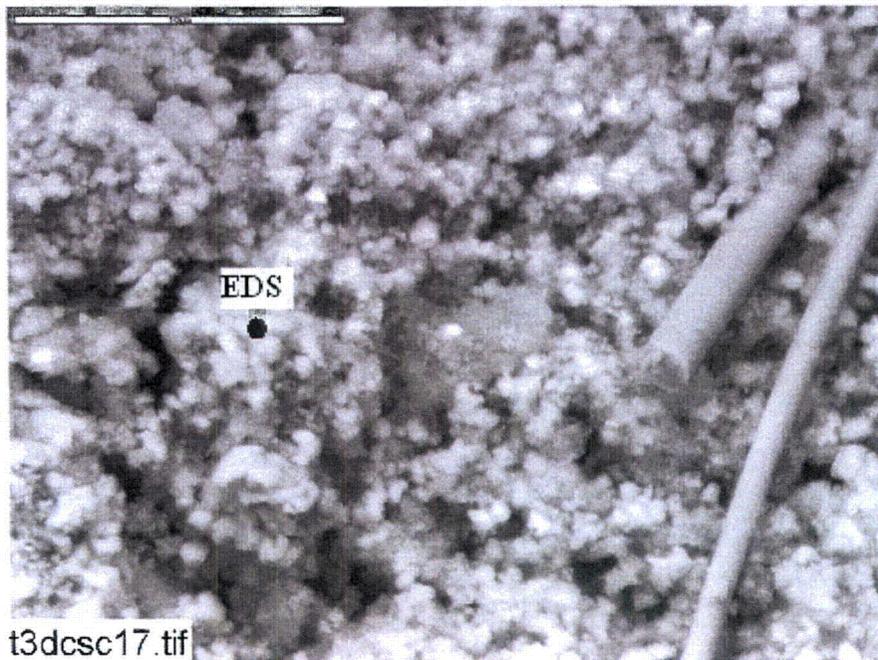
Figure C3-2. ESEM image magnified 1000 times for a Test #3, Day-30 exterior fiberglass sample on the drain collar (adjacent to the drain screen). (t3dcsc17)

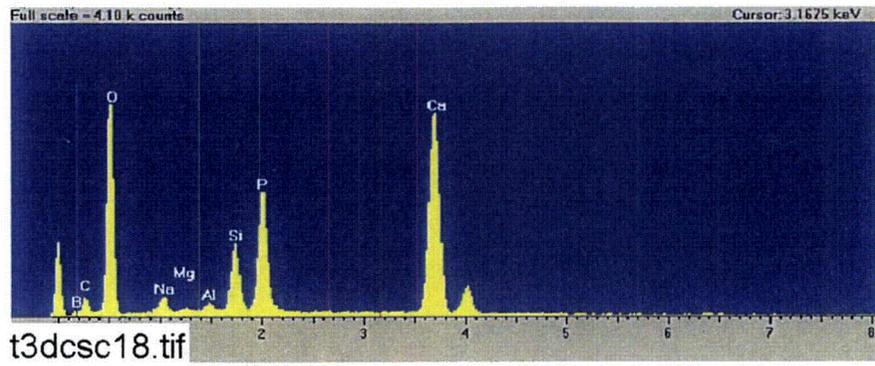
Figure C3-3. EDS counting spectrum for the particulate deposits shown in Figure C3-2. (t3dcsc18)

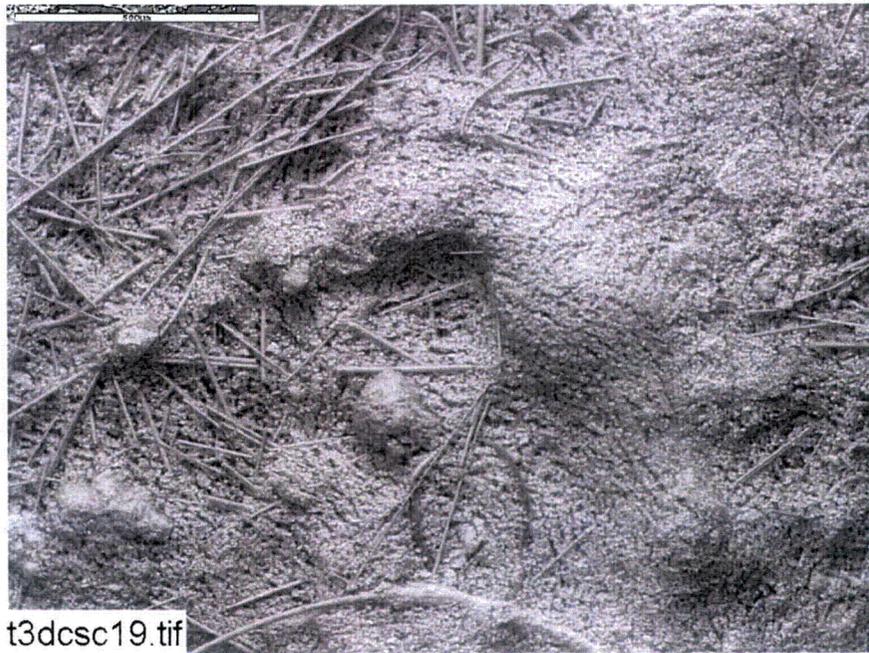
Figure C3-4. ESEM image magnified 70 times for a Test #3, Day-30 exterior fiberglass sample on the drain collar (adjacent to the drain screen). (t3dcsc19)

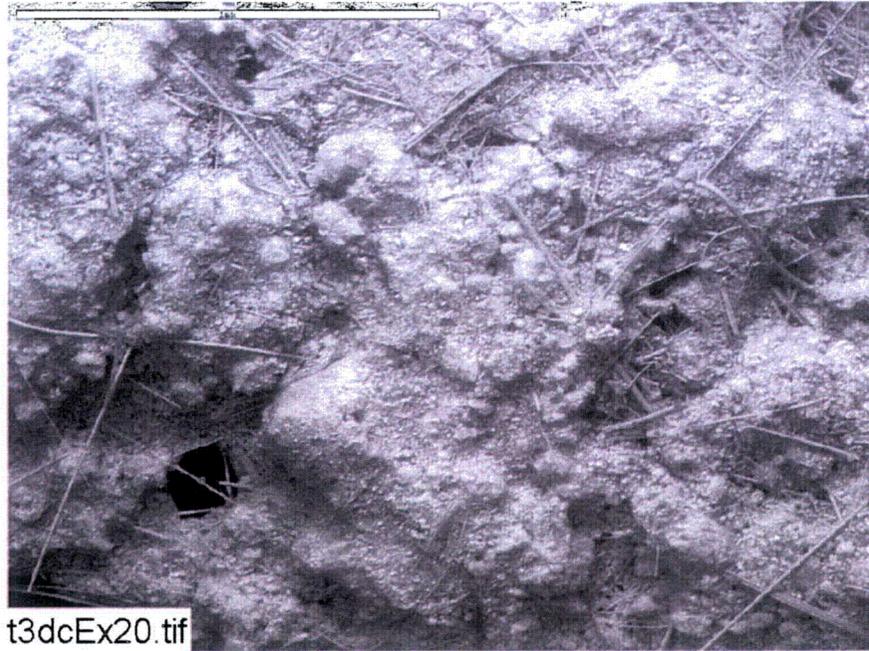
Figure C3-5. ESEM image magnified 70 times for a Test #3, Day-30 exterior fiberglass sample on the drain collar (away from the drain screen). (t3dcEx20)

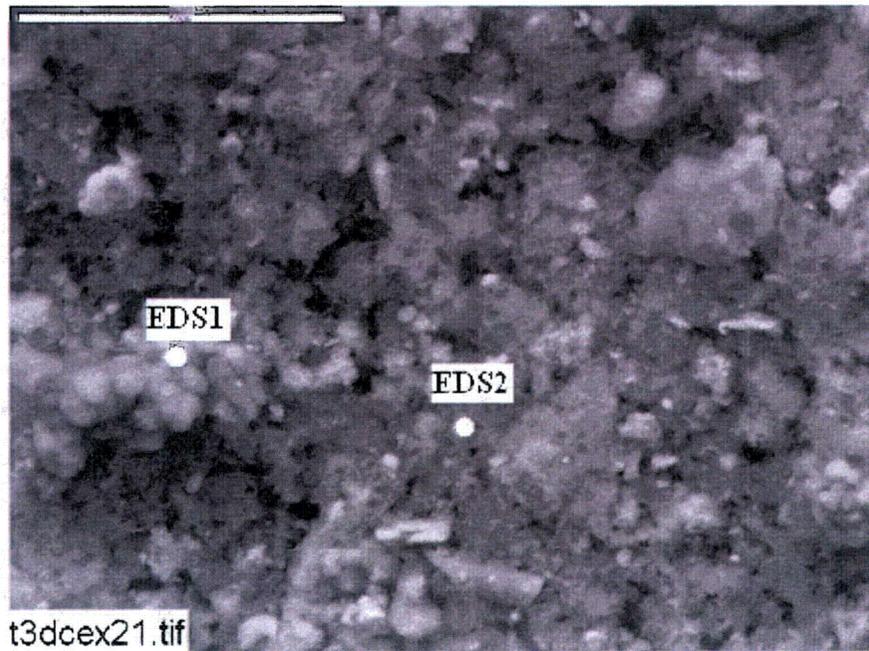
Figure C3-6. ESEM image magnified 1000 times for a Test #3, Day-30 exterior fiberglass sample on the drain collar (away from the drain screen). (t3dcex21)

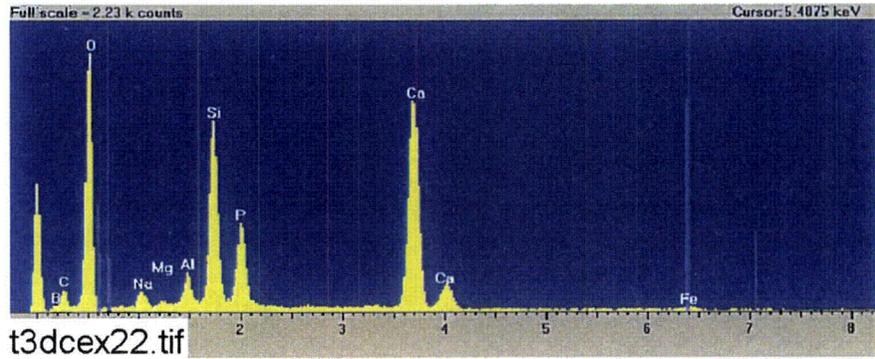
Figure C3-7. EDS counting spectrum for the light particulate deposits (EDS1) shown in Figure C3-6. (t3dcex22)

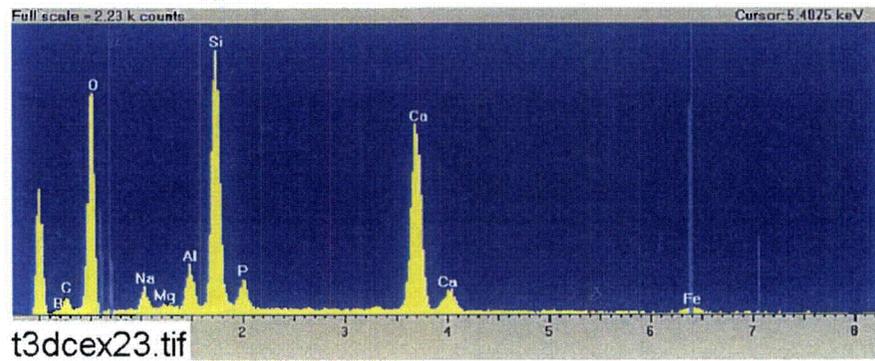
Figure C3-8. EDS counting spectrum for the dark deposits (EDS2) shown in Figure C3-6. (t3dcex23)

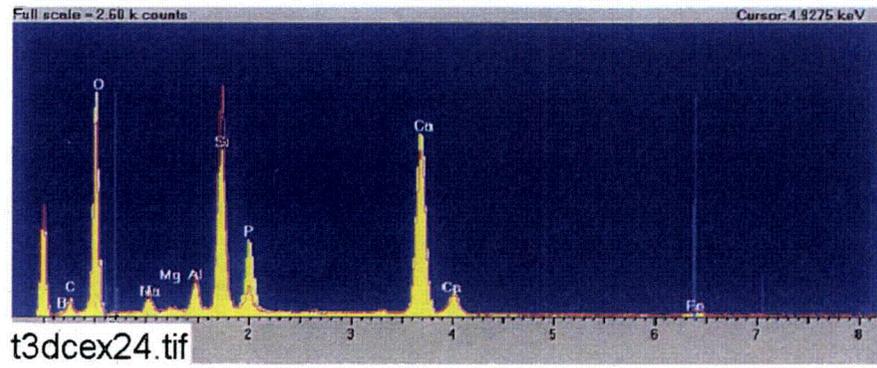
Figure C3-9. Comparison of EDS counting spectra between Figure C3-7 (yellow) and Figure C3-8 (red). (t3dcex24)

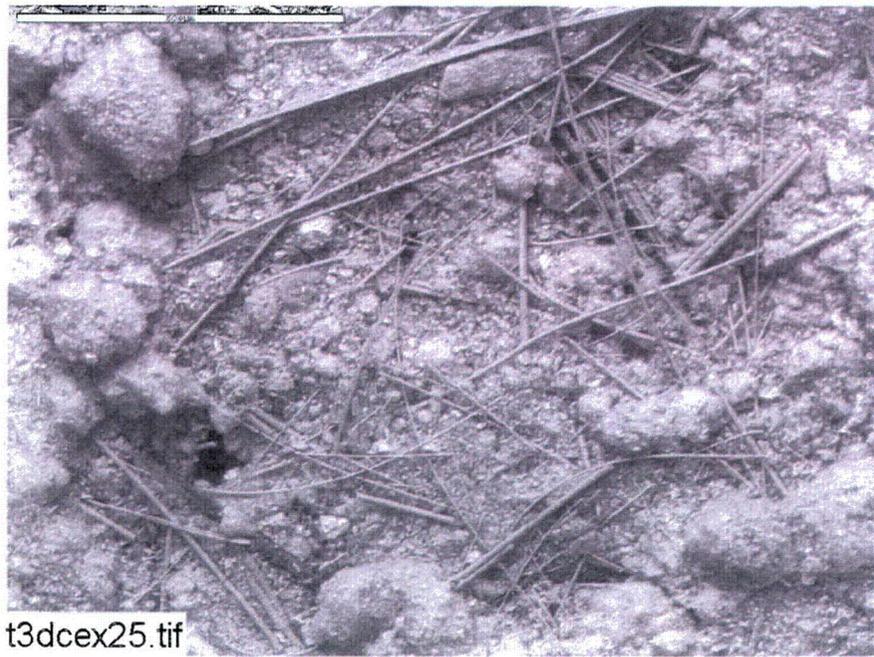
Figure C3-10. ESEM image magnified 100 times for a Test #3, Day-30 exterior fiberglass sample on the drain collar (away from the drain screen). (t3dcex25)

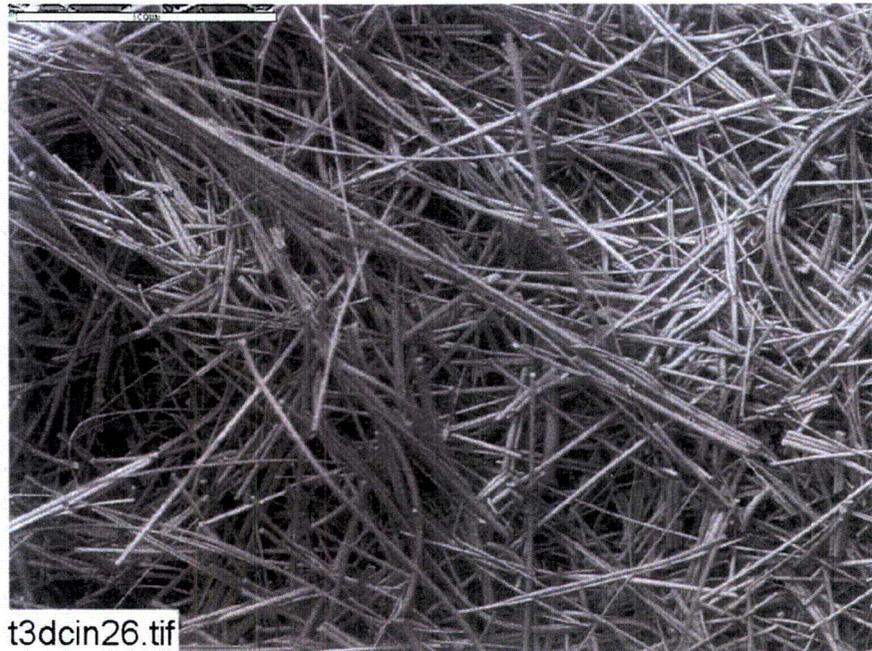
Figure C3-11. ESEM image magnified 80 times for a Test #3, Day-30 interior fiberglass sample on the drain collar. (t3dcin26)

Image:	t3dcin26	80 ×		Figure C3-11
	t3dcin27	1000 ×		Figure C3-12
	t3dcin28	100 ×		Figure C3-13

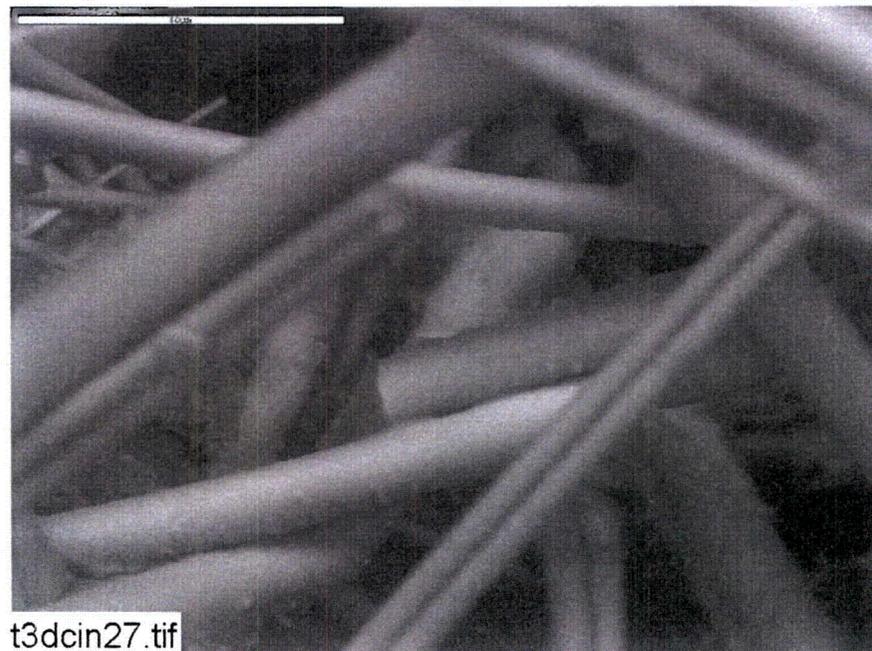
Figure C3-12. ESEM image magnified 1000 times for a Test #3, Day-30 interior fiberglass sample on the drain collar. (t3dcin27)

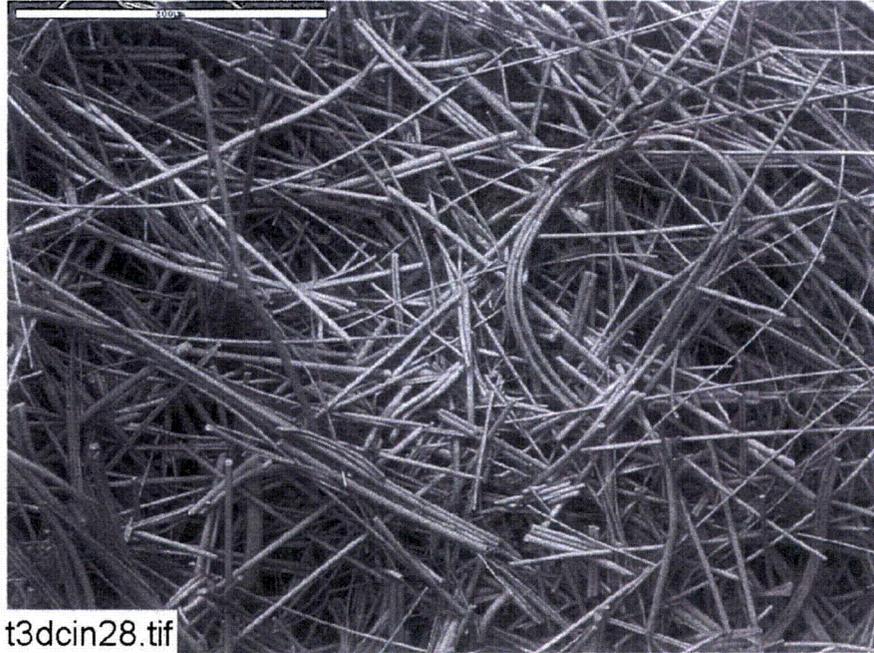
Figure C3-13. ESEM image magnified 100 times for a Test #3, Day-30 interior fiberglass sample on the drain collar. (t3dcin28)

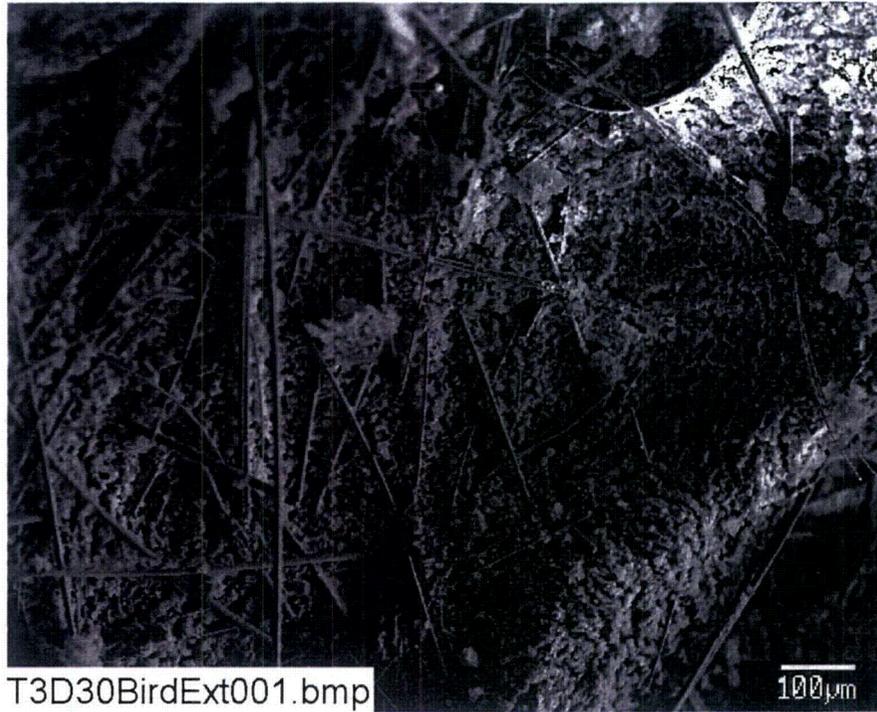
Figure C4-1. SEM image magnified 100 times for a Test #3, Day-30 exterior fiberglass sample within a birdcage. (T3D30BirdExt001)

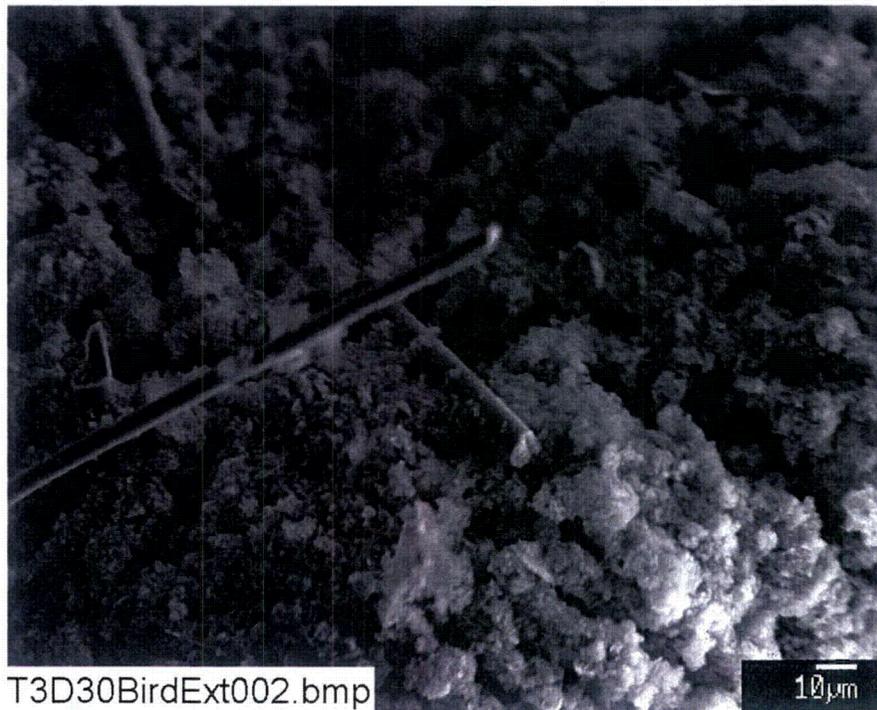
Figure C4-2. SEM image magnified 550 times for a Test #3, Day-30 exterior fiberglass sample within a birdcage. (T3D30BirdExt002)

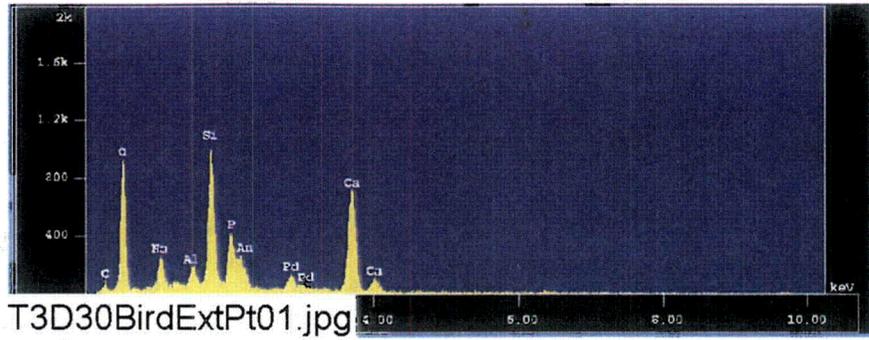
Figure C4-3. EDS counting spectrum for the large masses of particulate deposits shown in Figure C4-2. (T3D30BirdExtPt01)

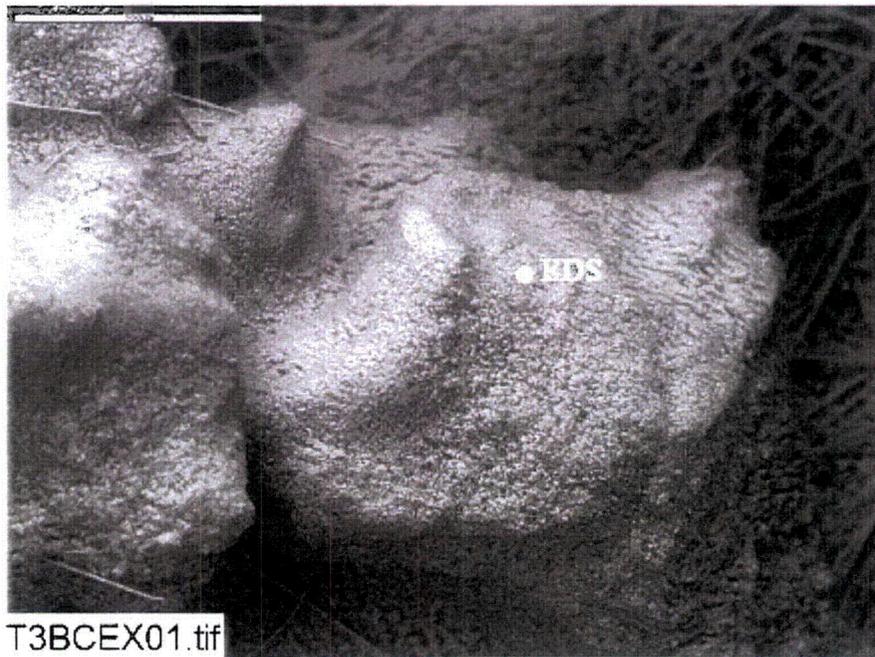
Figure C4-4. ESEM image magnified 80 times for a Test #3, Day-30 exterior fiberglass sample within a birdcage. (T3BCEX01)

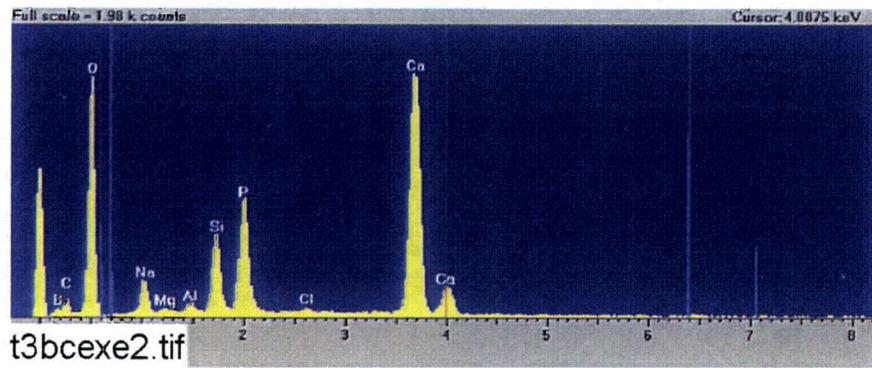
Figure C4-5. EDS counting spectrum for the the large deposits shown in Figure C4-4. (t3bcexe2)
