4. SUMMARY OF KEY OBSERVATIONS

Appendix D. ESEM and SEM/EDS Data for Test #3 Day-30 Corrosion Products

ESEM & SEM Test #3, Day-4 Fiberglass.

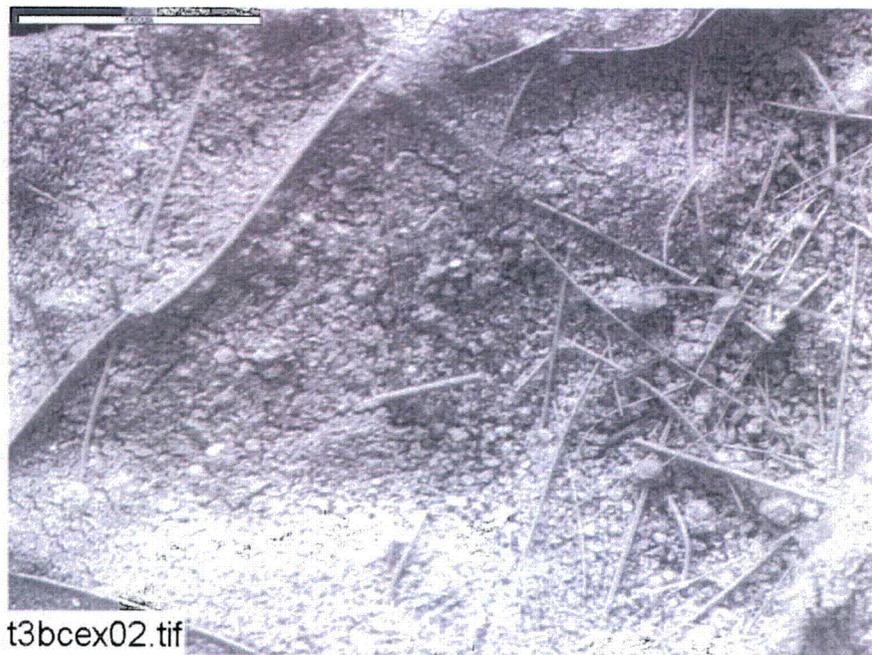
Figure C4-6. ESEM image magnified 80 times for a Test #3, Day-30 exterior fiberglass sample within a birdcage. (t3bcex02)

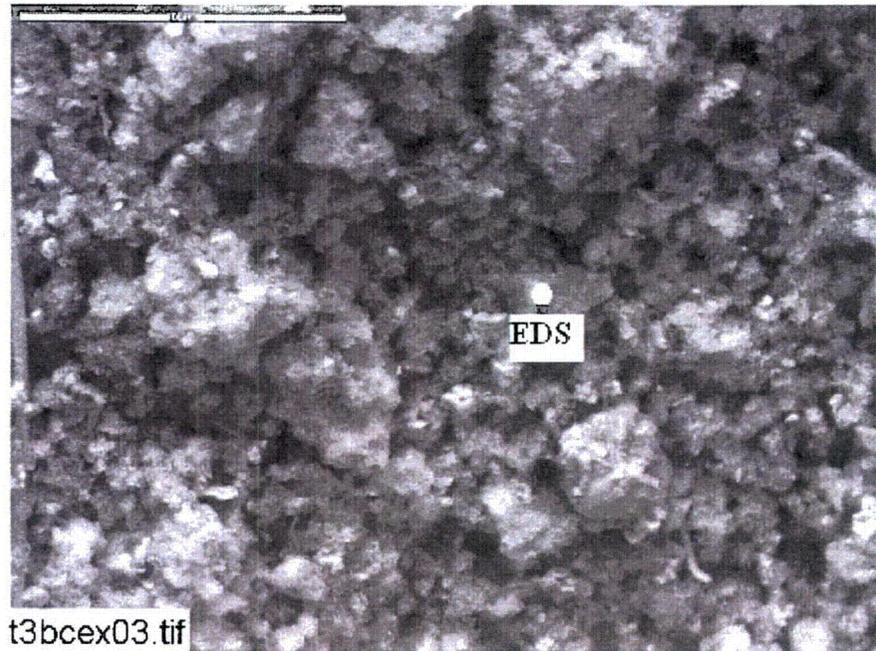
Figure C4-7. ESEM image magnified 500 times for a Test #3, Day-30 exterior fiberglass sample within a birdcage. (t3bcex03)

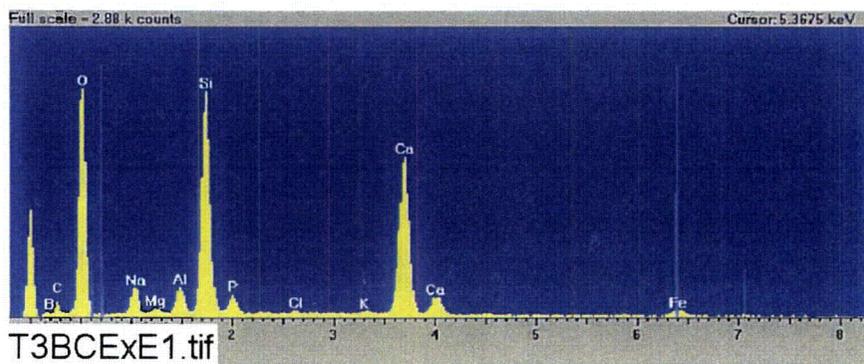
Figure C4-8. EDS counting spectrum for the deposits shown in Figure C4-7. (T3BCExE1)

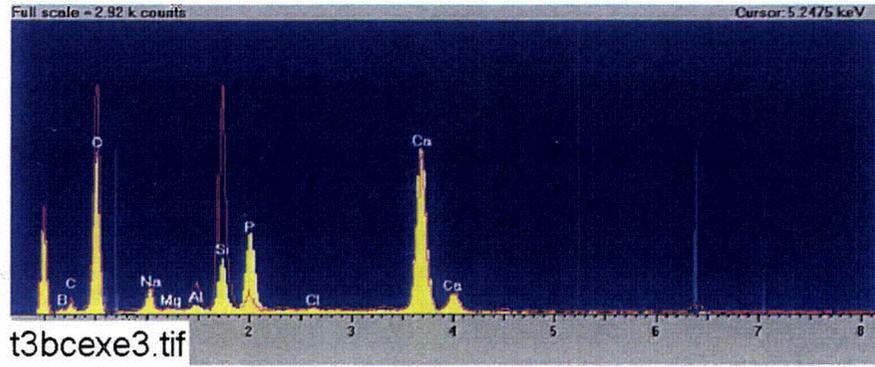
Figure C4-9. Comparison of EDS counting spectra of Figure C4-5 (yellow) and Figure C4-8 (red). (t3bcexe3)

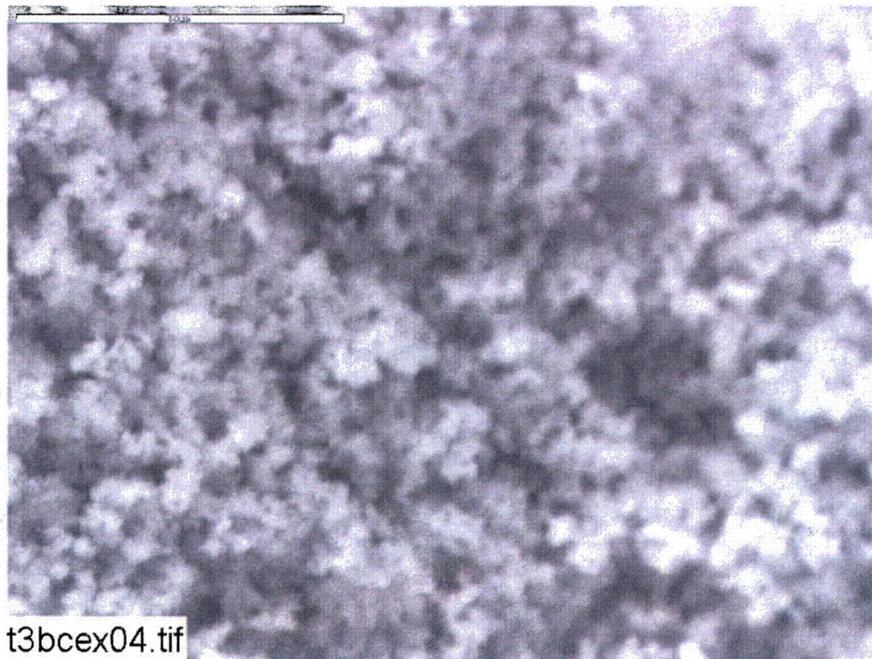
Figure C4-10. ESEM image magnified 1000 times for a Test #3, Day-30 exterior fiberglass sample within a birdcage. (t3bcex04)

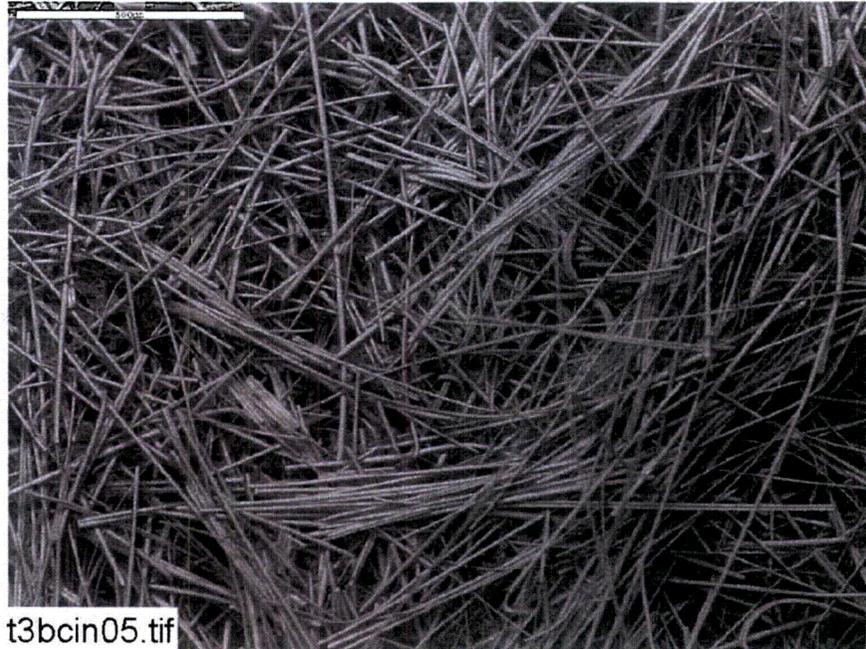
Figure C4-11. ESEM image magnified 80 times for a Test #3, Day-30 interior fiberglass sample within a birdcage. (t3bcin05)

Image: t3bcin05	80 ×		Figure C4-11
t3bcin06	950 ×		Figure C4-12
t3bcin07	1000 ×		Figure C4-13

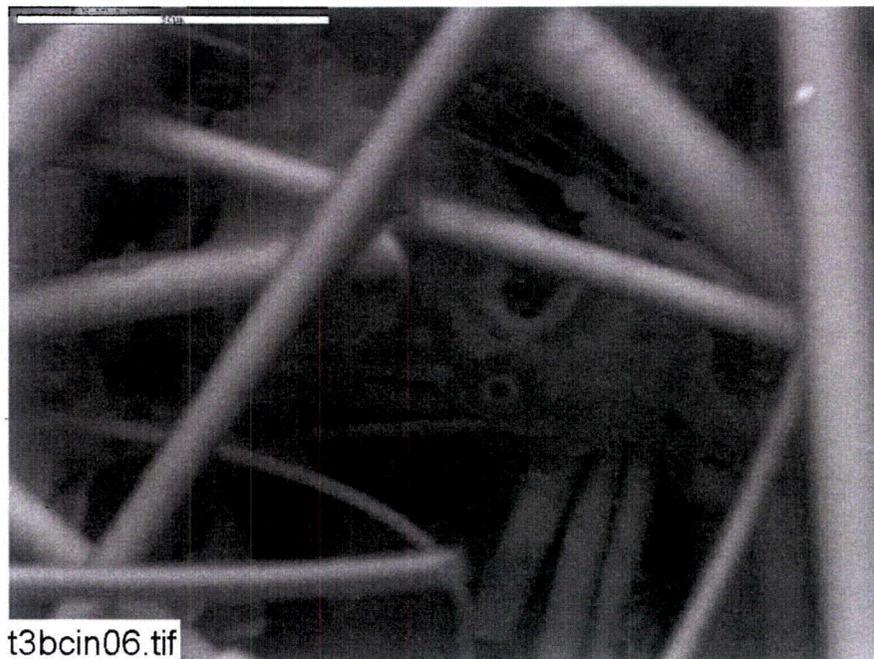
Figure C4-12. ESEM image magnified 950 times for a Test #3, Day-30 interior fiberglass sample within a birdcage. (t3bcin06)

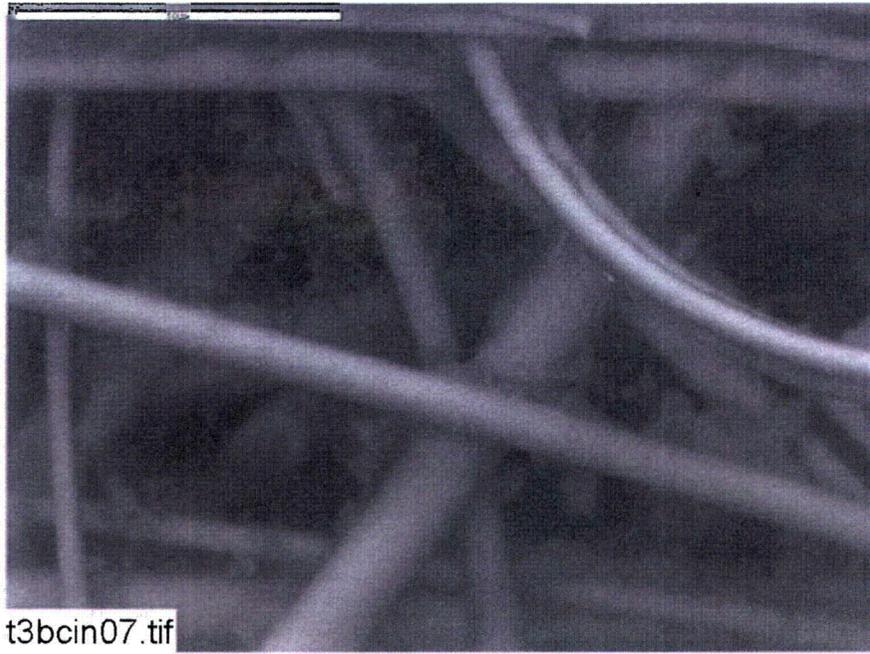
Figure C4-13. ESEM image magnified 1000 times for a Test #3, Day-30 interior fiberglass sample within a birdcage. (t3bcin07)

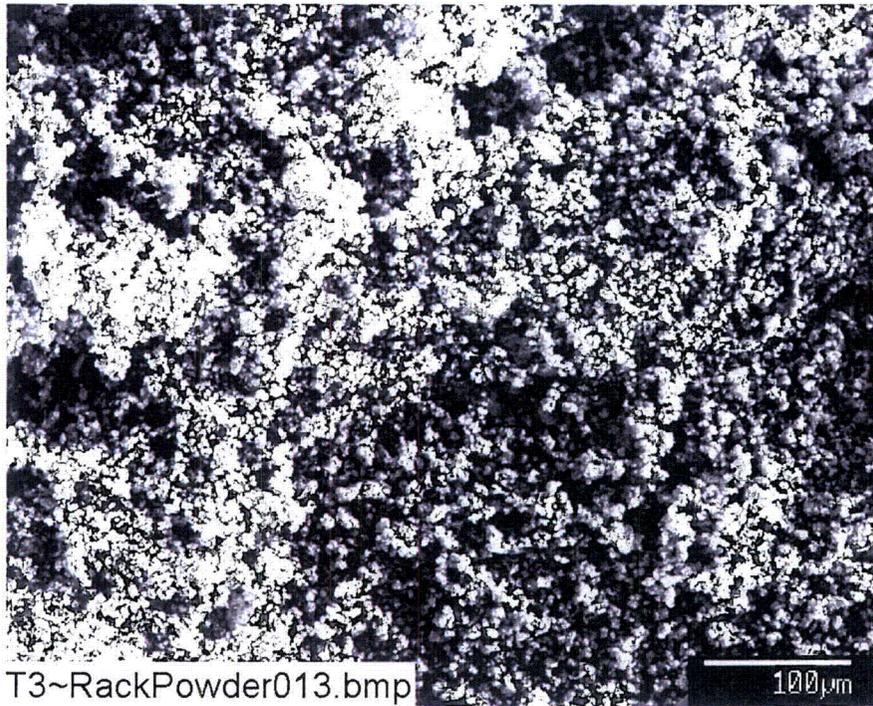
Figure D-1. SEM image magnified 200 times for a Test #3, Day-30 powder on the submerged rack. (T3~RackPowder013)

Image: T3~RackPowder013 200 ×

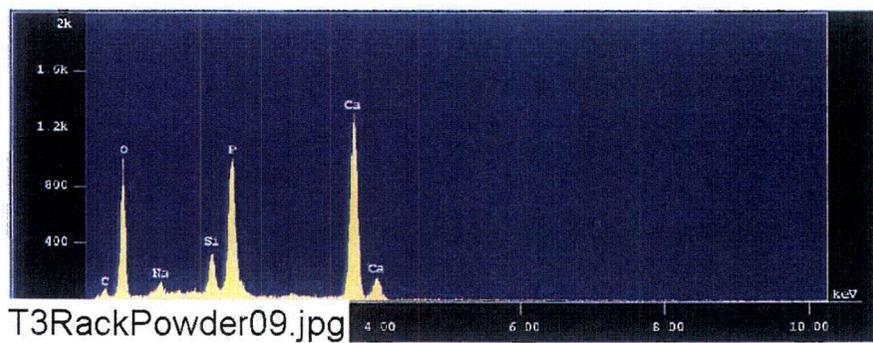
Figure D-2. EDS counting spectrum for the powder on the submerged rack shown in Figure D-1. (T3RackPowder09)

The results from the chemical composition analysis for T3RackPowder09 are given in Table D-1.

Element	Mass%	Atomic%	ZAF	Z	A	F
O	48.147	67.3988	1.8951	0.9734	1.9469	1.0000
Na	0.977	0.9516	1.5243	1.0269	1.4843	1.0000
Si	3.302	2.6332	1.1493	0.9767	1.1837	0.9941
P	13.197	9.5423	0.8517	1.1722	0.7283	0.9977
Ca	34.174	19.0962	0.9909	0.9956	0.9953	1.0000
C	0.203	0.3778	3.7963	1.0208	3.7192	0.9999

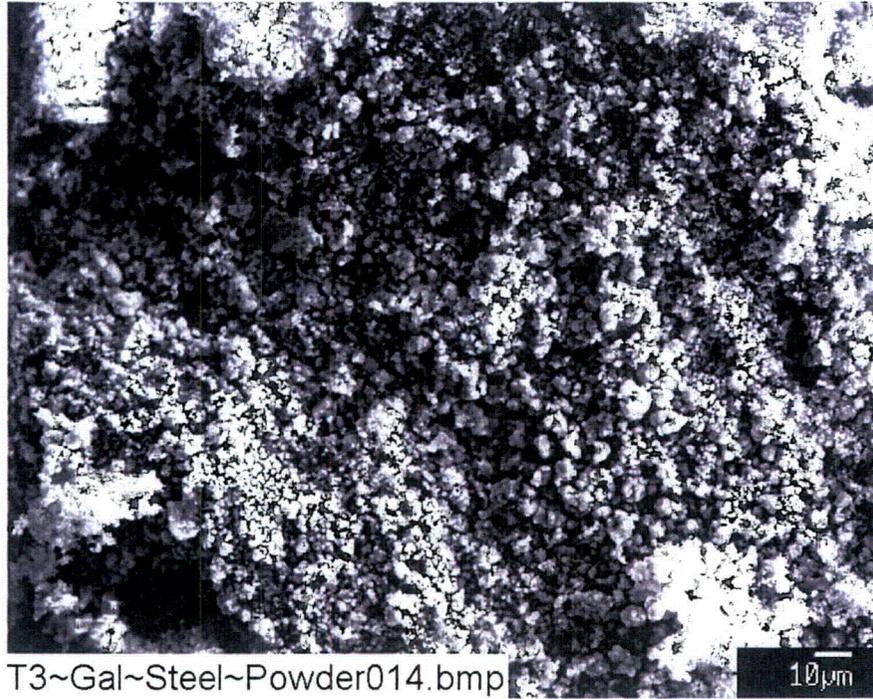
Figure D-3. SEM image magnified 500 times for a Test #3, Day-30 powder on a submerged galvanized steel coupon. (T3~Gal~Steel~Powder014)

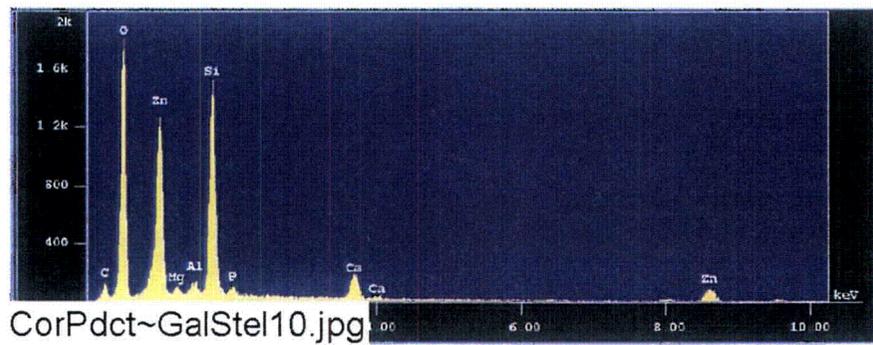
Figure D-4. EDS counting spectrum for the white powder on galvanized steel shown in Figure D-3. (CorPdct~GalStel10)

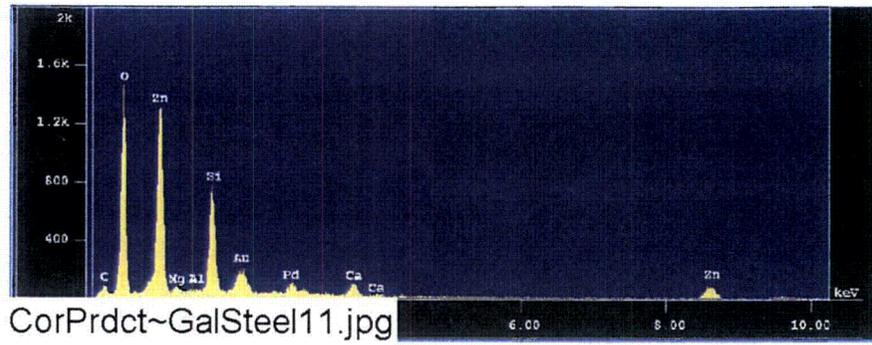
Figure D-5. EDS counting spectrum for the dark powder on galvanized steel shown in Figure D-3. (CorPrdct~GalSteel11)

The results from the chemical composition analysis for CorPrdct~GalSteel11 are given in Table D-2.

Element	Mass%	Atomic%	ZAF	Z	A	F
O	47.383	72.4077	0.9119	0.9354	0.9750	1.0000
Mg	0.655	0.6591	2.3126	0.9284	2.4928	0.9993
Si	13.143	11.4404	1.4344	0.9377	1.5298	0.9999
Ca	3.059	1.8657	0.9770	0.9542	1.0247	0.9991
Zn	35.285	13.1966	1.2102	1.2129	0.9978	1.0000
Al	0.475	0.4304	1.7897	0.9594	1.8692	0.9979
C	0.000	0.0000	5.2279	0.9811	5.3287	1.0000

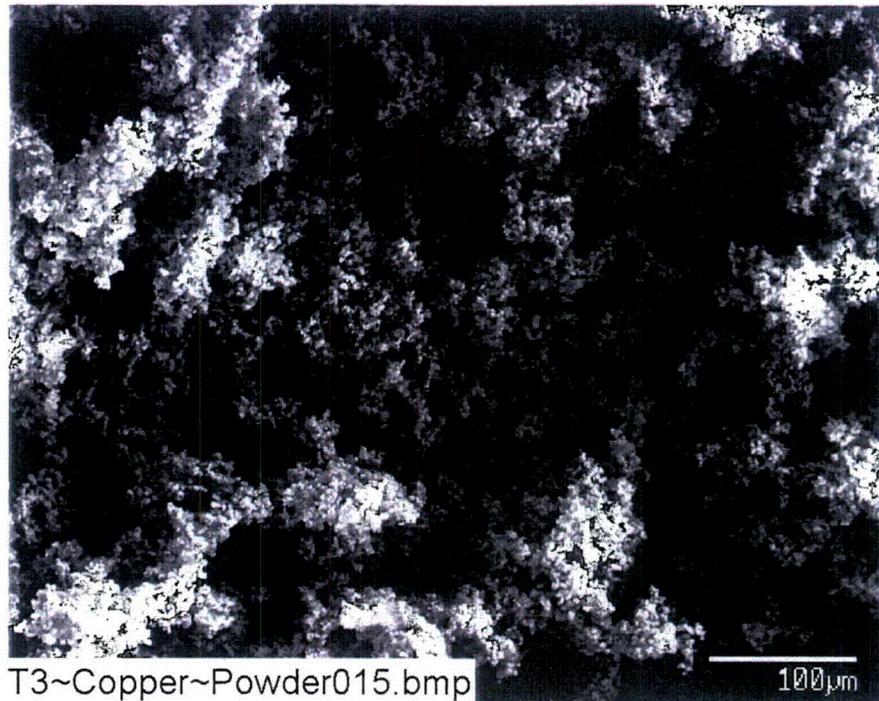
Figure D-6. SEM image magnified 500 times for a Test #3, Day-30 powder on a submerged copper coupon. (T3~Copper~Powder015)

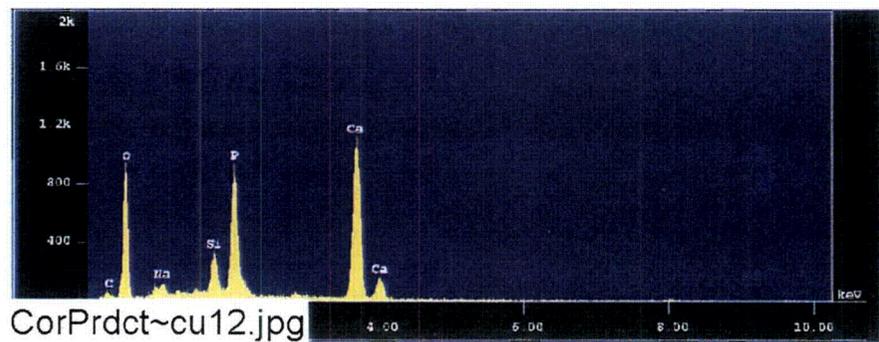
Figure D-7. EDS counting spectrum for the powder on copper shown in Figure D-6. (CorPrdct~cu12)

The results from the chemical composition analysis for CorPrdct~cu12 are given in Table D-3.

Element	Mass%	Atomic%	ZAF	Z	A	F
O	51.054	70.0693	1.8119	0.9751	1.8582	1.0000
Na	0.947	0.9045	1.5353	1.0287	1.4923	1.0000
Si	3.260	2.5484	1.1533	0.9785	1.1852	0.9945
P	12.216	8.6603	0.8538	1.1744	0.7286	0.9978
Ca	32.523	17.8176	0.9913	0.9976	0.9936	1.0000
C	0.000	0.0000	3.6900	1.0225	3.6090	0.9999

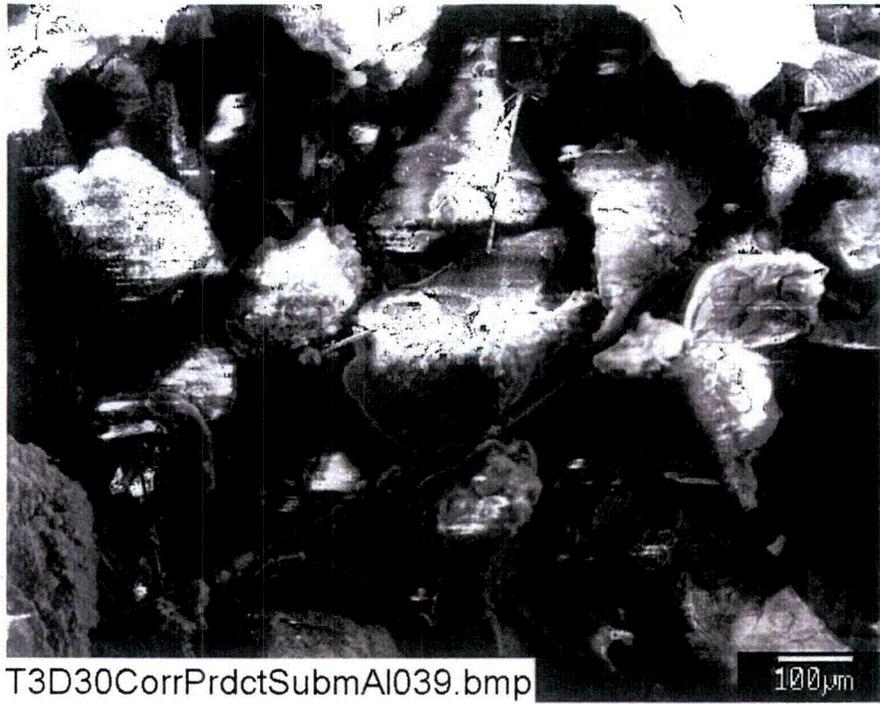
Figure D-8. SEM image magnified 100 times for Test #3, Day-30 corrosion products on a submerged aluminum coupon. (T3D30CorrPrdctSubmAl039)

- Figure D-7. EDS counting spectrum for the powder on copper shown in Figure D-6. (CorPrdct~cu12) D-11
- Figure D-8. SEM image magnified 100 times for Test #3, Day-30 corrosion products on a submerged aluminum coupon. (T3D30CorrPrdctSubmAl039)..... D-13

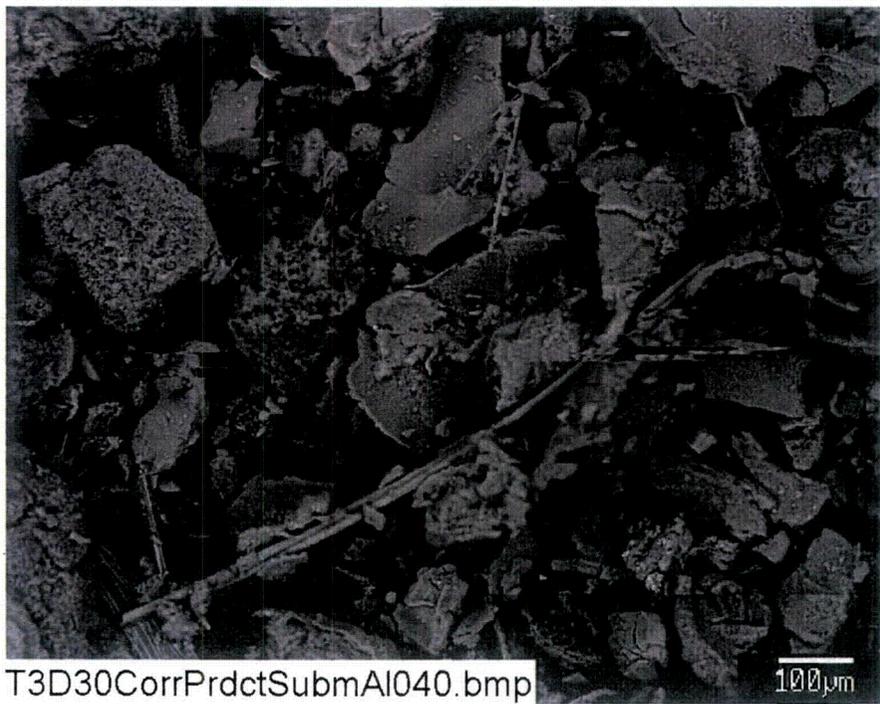
Figure D-9. Backscattered SEM image magnified 100 times for Test #3, Day-30 corrosion products on a submerged aluminum coupon. (T3D30CorrPrdct SubmAl040)

- Figure D-9. Backscattered SEM image magnified 100 times for Test #3, Day-30 corrosion products on a submerged aluminum coupon. (T3D30CorrPrdctSubmAl040)..... D-13

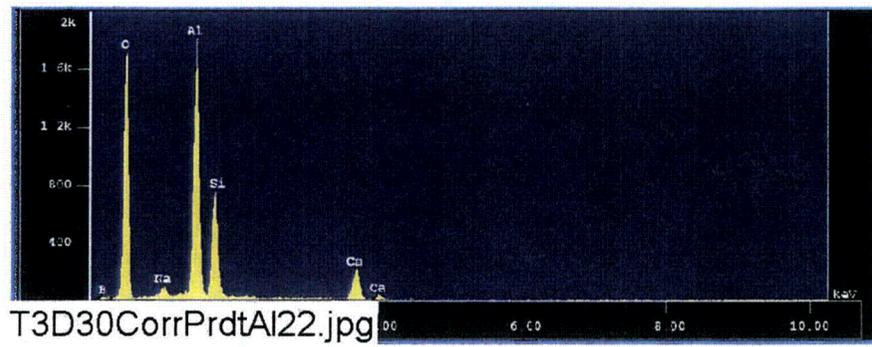
Figure D-10. EDS counting spectrum for the corrosion products (particles) shown in Figure D-9. (T3D30CorrPrdtA122)

The results from the chemical composition analysis for T3D30CorrPrdtAl22 are given in Table D-4.

- Figure D-10. EDS counting spectrum for the corrosion products (particles) shown in Figure D-9. (T3D30CorrPrdtAl22) D-14

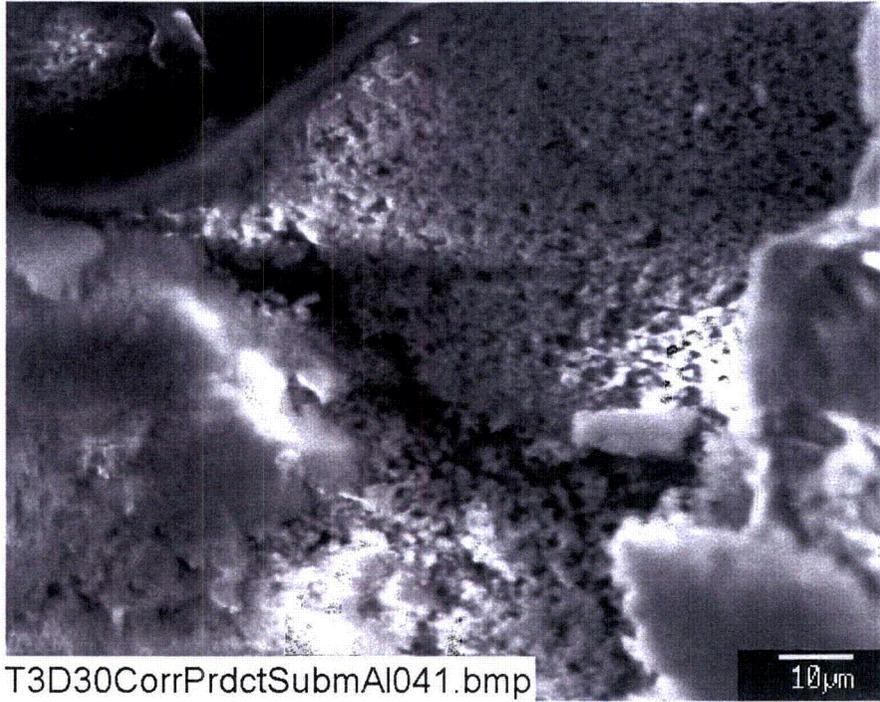
Figure D-11. SEM image magnified 1000 times for Test #3, Day-30 corrosion products on a submerged aluminum coupon. (T3D30CorrPrdctSubmAl041)

Figure D-11. SEM image magnified 1000 times for Test #3, Day-30 corrosion products on a submerged aluminum coupon. (T3D30CorrPrdctSubmAl041)..... D-16

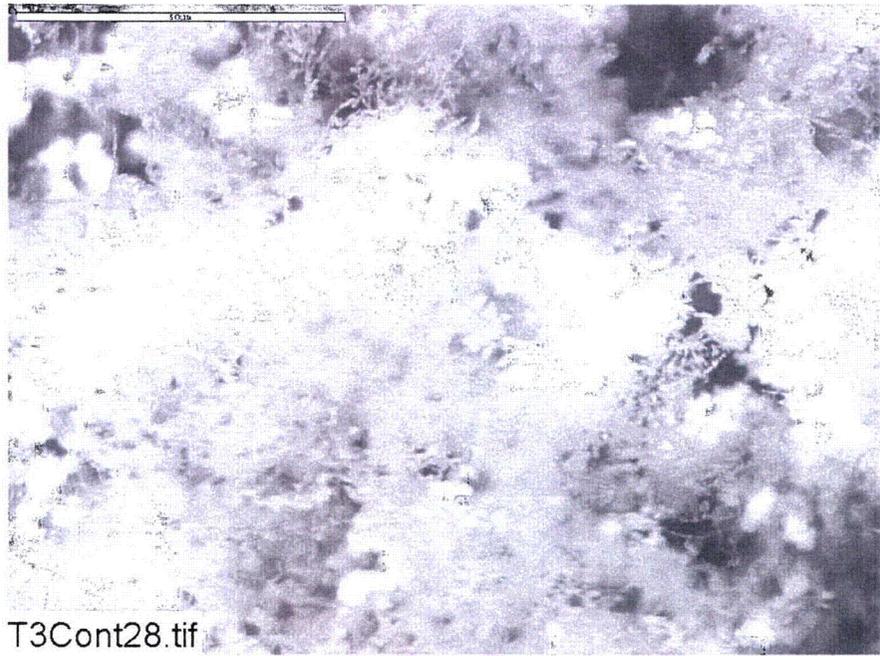
Figure D-12. ESEM image magnified 1000 times for Test #3, Day-30 corrosion products on a submerged concrete coupon. (T3cont28)

Figure D-12. ESEM image magnified 1000 times for Test #3, Day-30 corrosion products on a submerged concrete coupon. (T3cont28) D-16

Image:	T3Cont28	1000 ×		Figure D-12
	t3cont29	100 ×		Figure D-13
EDS:	t3cont30		Particles on image 29	Figure D-14

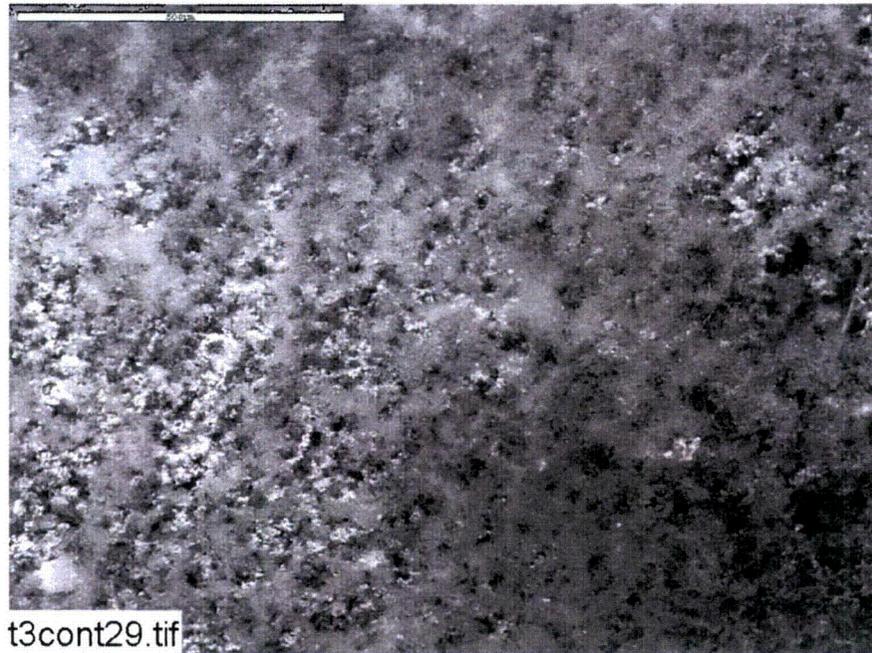
Figure D-13. ESEM image magnified 100 times for Test #3, Day-30 corrosion products on a submerged concrete coupon. (t3cont29)

Figure D-13. ESEM image magnified 100 times for Test #3, Day-30 corrosion products on a submerged concrete coupon. (t3cont29)..... D-17

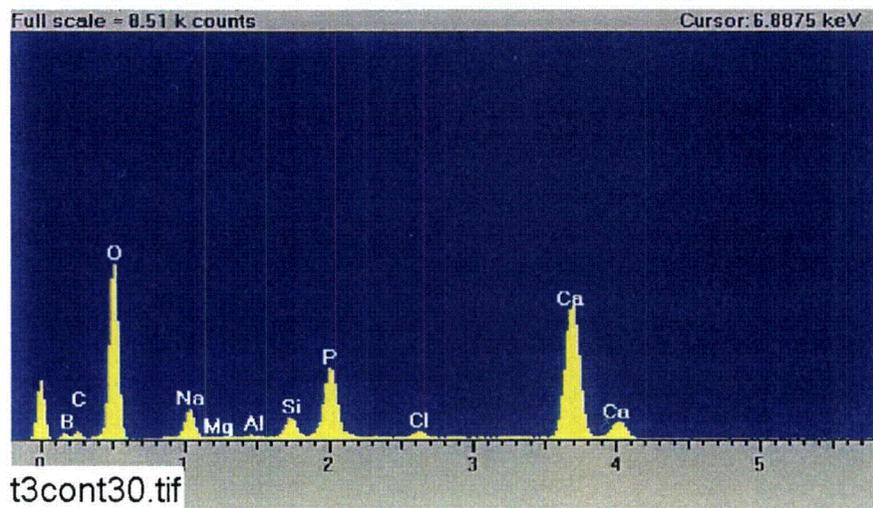
Figure D-14. EDS counting spectrum for the corrosion products (particles) shown in Figure D-13. (t3cont30)

Figure D-14. EDS counting spectrum for the corrosion products (particles) shown in Figure D-13. (t3cont30) D-17
