EAGLE 21 PROCESS PROTECTION SYSTEM
VERIFICATION AND VALIDATION AUDIT REPORT
WATTS BAR NUCLEAR PLANT UNIT 1

EAGLE 21 PROCESS PROTECTION SYSTEM

VERIFICATION AND VALIDATION AUDIT REPORT

WATTS BAR NUCLEAR PLANT UNIT 1

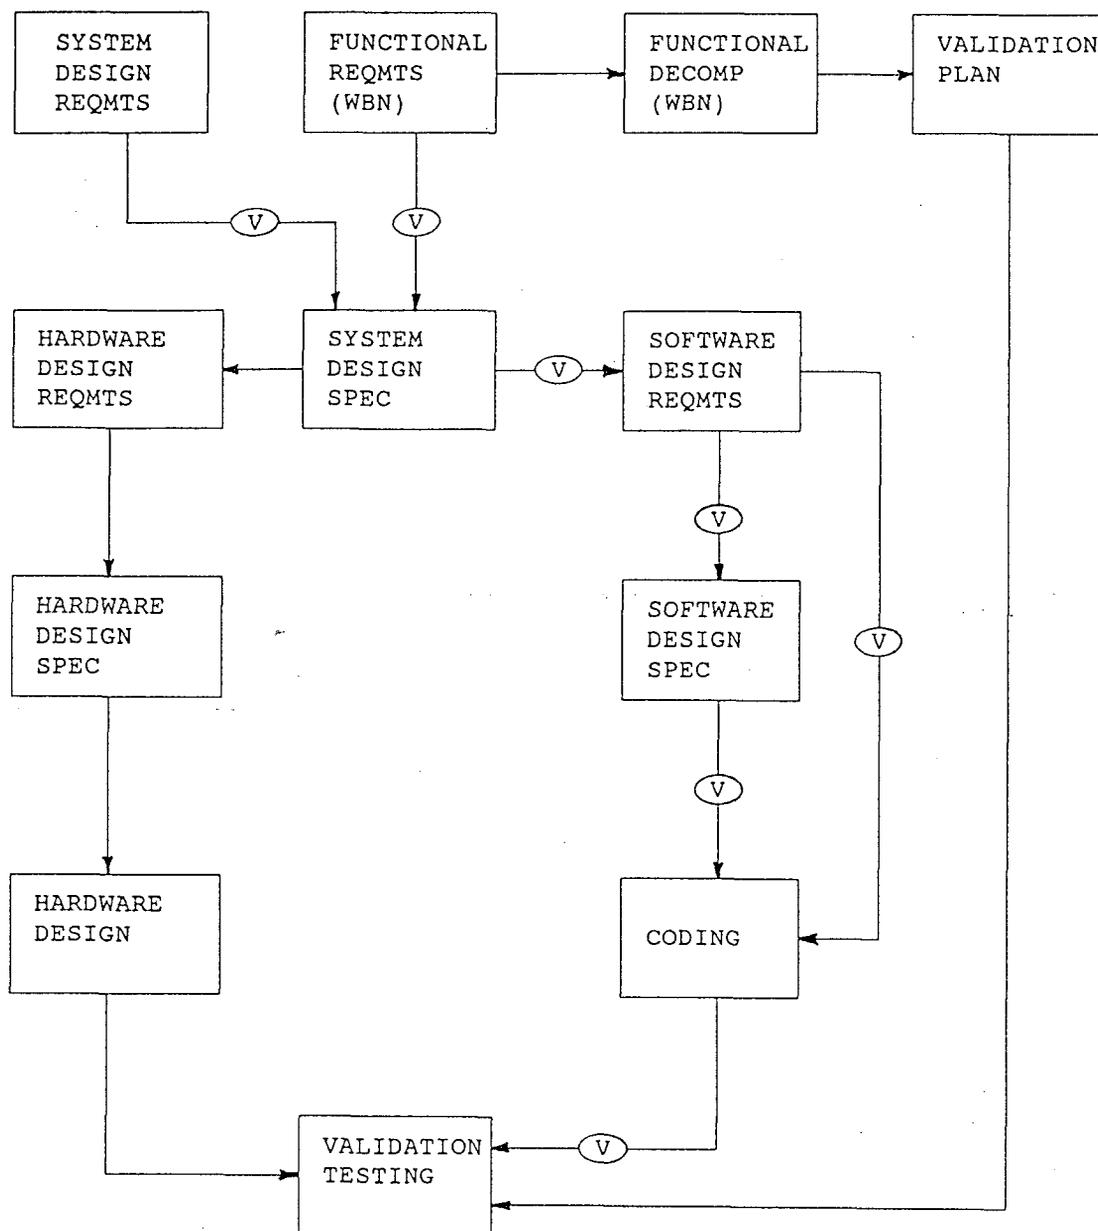
FIGURE 1 - EAGLE 21 DEVELOPMENT PROCESS

(V) = Software Verification Step

ANSI/IEEE-ANS-7-4.3.2-1982 defines an acceptable process for development of computer systems including the application of software verification and validation (V & V). The process that has been applied by Westinghouse for Eagle 21 meets the intent of ANSI/IEEE-ANS-7-4.3.2-1982 (See Figure 1). The process is procedurally controlled and contains documentation of critical steps in the hardware and software design. V & V is performed by an independent organization as a integral part of the development process. Requirements are documented at each hierarchical level and V & V ensures satisfaction of the requirements. Efforts are made at several levels to identify software hazards and verify that the software can accommodate them. The System Design Specification defines interfaces between hardware and software and lower-tier documents address interfaces where they exist.
