TENNESSEE VALLEY AUTHORITY

In the Matter of the Application of)
Tennessee Valley Authority)

Docket Nos. 50-390
50-391

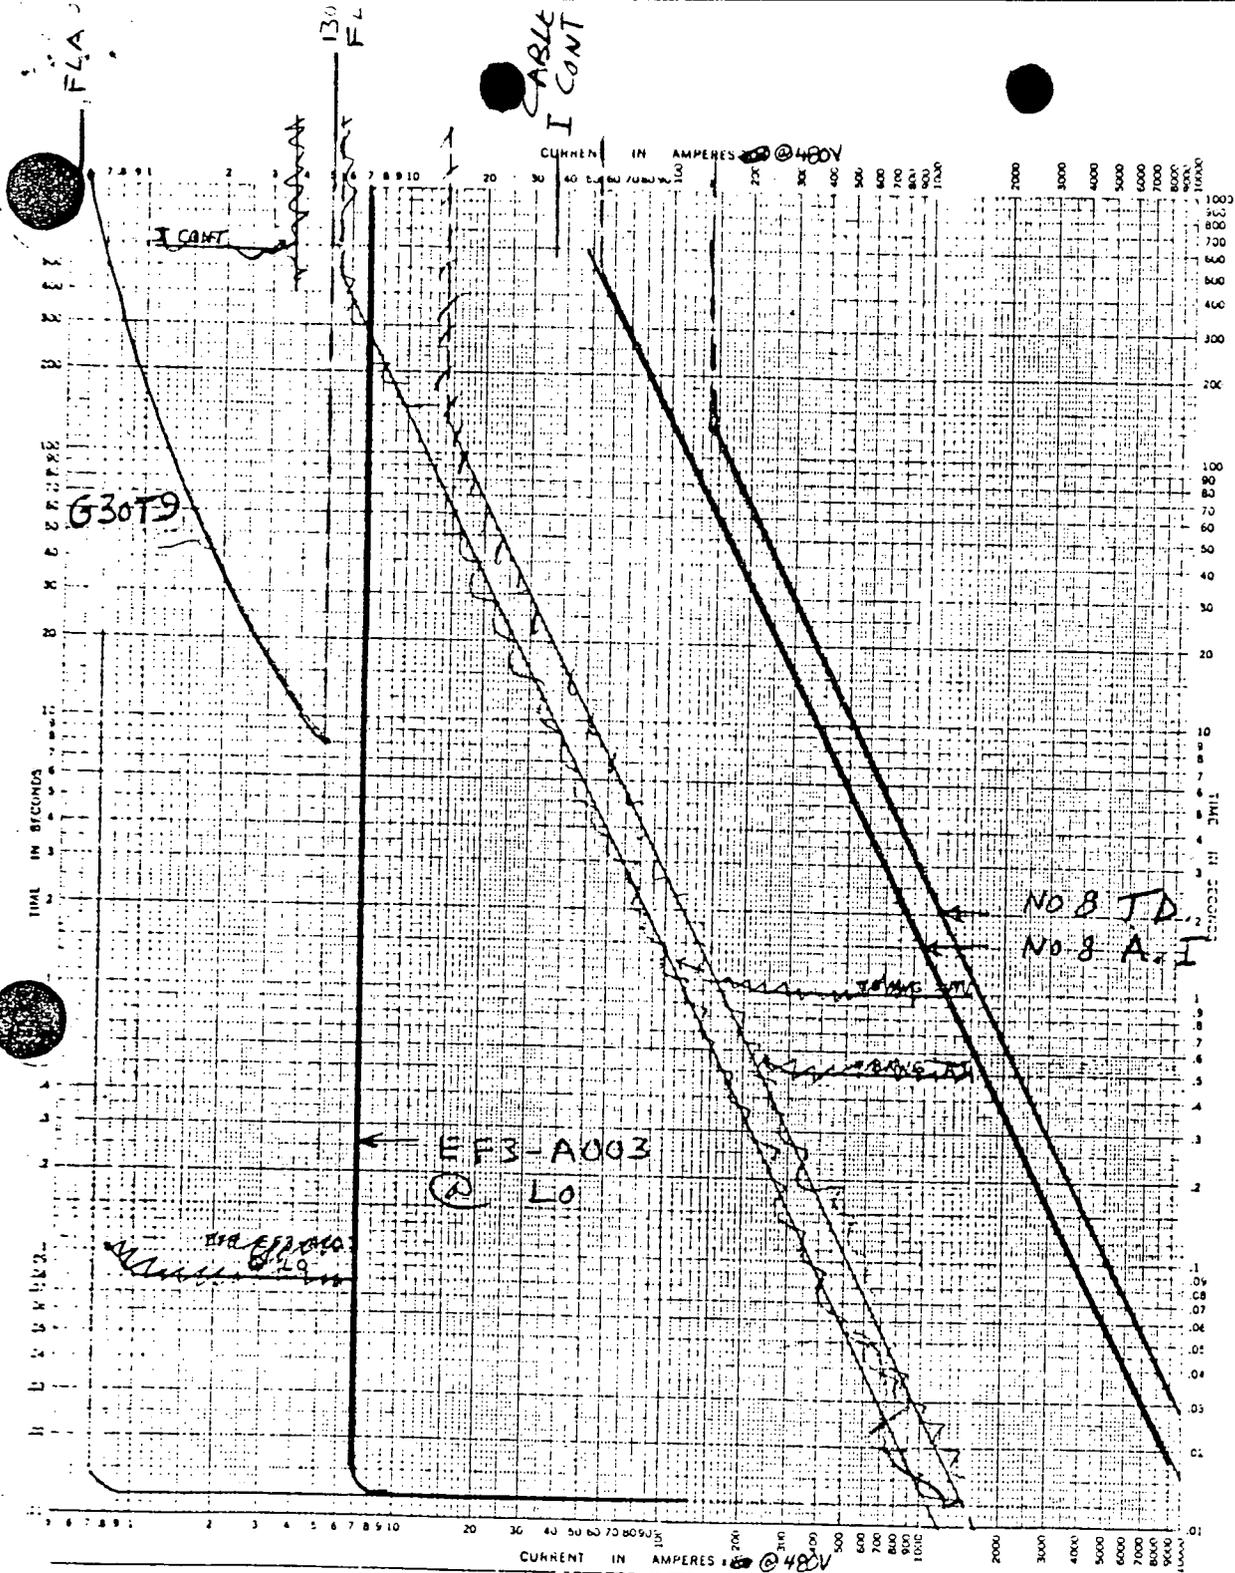
TIME-CURRENT CHARACTERISTIC 48 5258

DS0684E2
 TIME-CURRENT CHARACTERISTIC CURVES
 FUSE LINKS
 TESTS FOR DATA STANDARDS
 DATED
 TESTS MADE AT _____ Volts and at _____ p.f. starting at 25°C with no initial load
 CURVES ARE PLOTTED TO _____ Test points so variations should be
 No. MI
 Date _____

EF3-A003 @ L0
 SIZE 1 STARTER
 I/P 0.125
 FLA 0.39A
 OL 300-3

SHEET	COMPT	CURV	PASS/FAIL	REMARKS
B178	2A	75	P1	
B179	2B	M11	P2	
B180	2C	M9	FAIL	^{P2} change OL to T44
B181	10A	77	P1	
B182	2F1	15	P1	
B183	3A	75	P1	
B184	3E	M2	P1	
B185	3D	M11	P1	
B186	4A	75	P1	
B187	4E	42	P1	
B188	5A	M1	P1	
B189	10D	M21	P1	
B190	5E	42	P1	
B191	5F	10	P1	
B192	6D	M21	P1	
B193	6F	42	P1	
B194	7A	41	P1	
B195	7E	41	P1	
B196	7D	M11	P1	
B197	7F	10	P1	
B198	8A	10	P1	
B199	8E	41	P1	
B200	8F	10	P1	
B201	9A	41	P1	
B202	9B	41	P1	
B203	9F	15	P1	
B204	10B	10	P1	
B205	10F	42	P1	
B206	11A	41	P1	
B207	11B	15	P1	
B208	11D	41	P1	
B209	11E	15	P1	
B210	12A	41	P1	
B211	12E	10	P1	
B212	12D	M1	P1	
B213	12E	41	P1	
B214	13A	41	P1	
B215	13E	15	P1	
B216	13E	15	P1	
B217	14A	15	P1	
B218	14E	M3	FAIL	specify T45 OL to pass
B219	14D	42	P1	
B220	14E	41	P1	
B221	16D	42	P1	
B222	16E	M2	P1	
B223	17B	10	P1	
B224	17C	10	P1	
B225	18A	M2	FAIL	^{P2} specify T51 OL to pass
B226	18E	10	P1

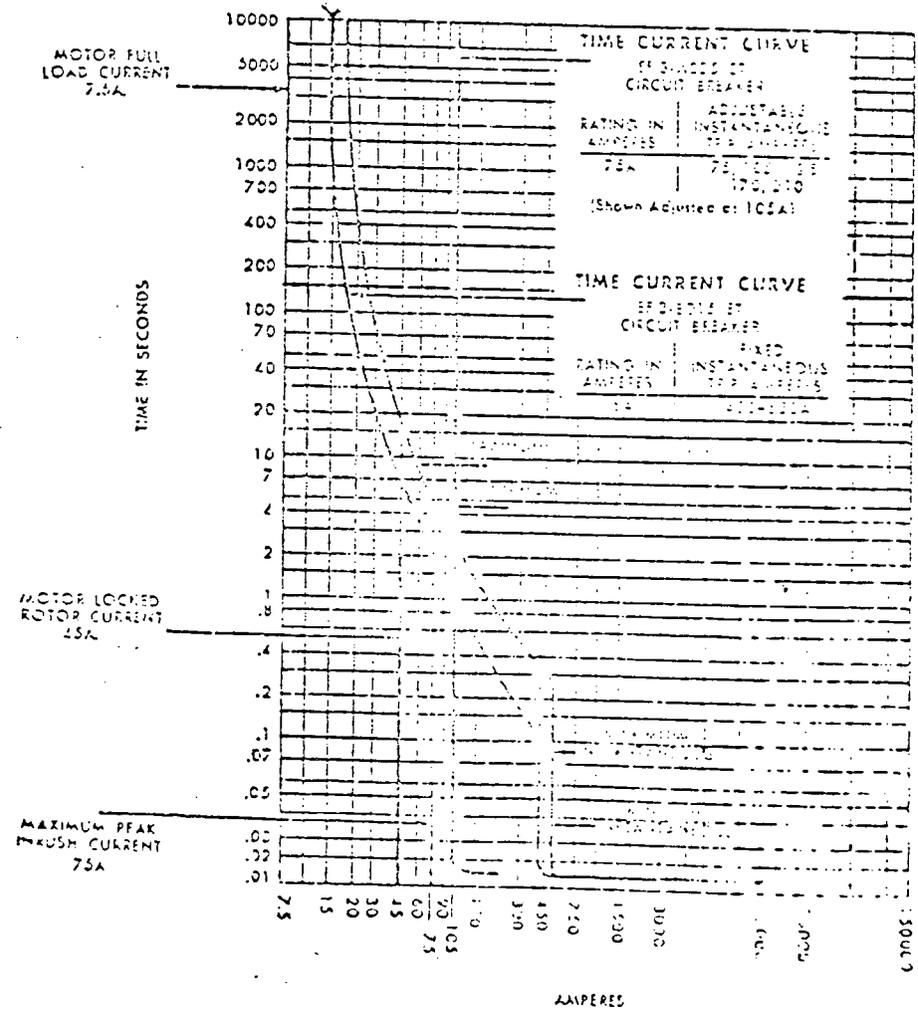
Comparisons of ETI Vs ET Instantaneous Trip Characteristics

In applications where E, EFL and EP frame thermal magnetic breakers are used, the instantaneous trip is set to trip the breaker at a predetermined, fixed current value. Usually the fixed value is far in excess of the motor inrush current, thus adequate protection of the motor and starter is not always obtained under short circuit conditions.

For example: A 15 ampere ET breaker is recommended for use with a motor starter for a 5 horsepower (440 volt ac) motor whose full load current is 7.5 amperes (See page 19, Chart 2). The instantaneous trip setting of the 15 ampere breaker is preset at approximately 500 amperes. It can readily be seen from curve below that there is a wide gap between the desirable trip setting of 11 times motor full load current and the fixed setting of 500 amperes. A high resistance fault producing a short circuit current of less than 500 amperes could do permanent damage to circuit components in the time required for the thermal devices to trip the breaker.

A 25 ampere ETI breaker, when applied as the branch circuit protective device for the above example in accordance with the table on page 18, Chart 1, would have an instantaneous trip setting of 105 amperes. Adequate short circuit protection is thus obtained.

This will give you some of basic reasons we decided to go to the ETI for on 100's Bar.
PDR
