TENNESSEE VALLEY AUTHORITY

TENNESSEE VALLEY AUTHORITY
WATTS BAR NUCLEAR PLANT
EMPLOYEE CONCERN PROGRAM
NUCLEAR REGULATORY COMMISSION LISTING

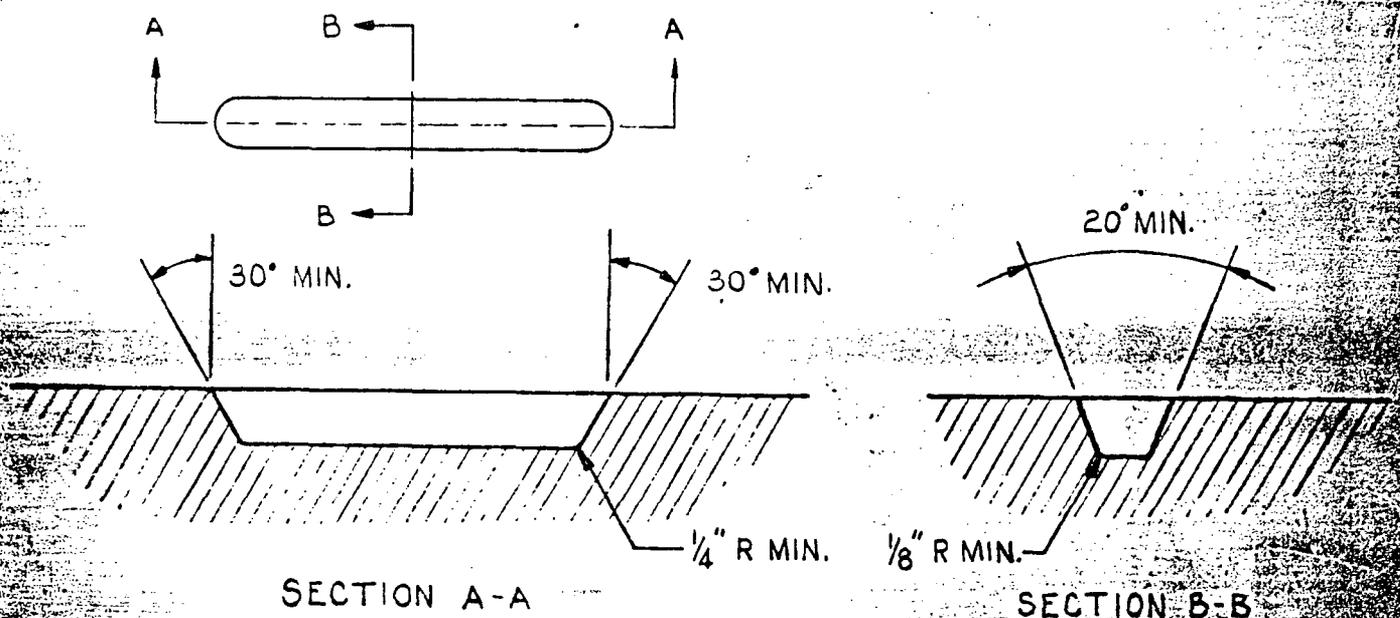
The repair area shall be contoured to produce an excavation that is fully visible to the welder and allows access of the filler metal to all groove surfaces. Sidewalls of the excavation shall be sloped so they have a minimum of 20° included angle with no sharp breaks in the contour.

Rejectable defects revealed by nondestructive examination shall be removed by arc gouging and/or by mechanical means. When gouging is used an additional 1/32-inch of material shall be removed mechanically. The area shall be dye penetrant (PT) or magnetic particle (MT) inspected. Every effort should be made to avoid the necessity for repair welding of minor defects that can be corrected by grinding. Care should also be exercised to remove only those defects that are required to bring the item within acceptable limits.

The welding process, parameters, and cleaning requirements of the originally specified welding procedure or acceptable alternate shall be followed when filling the excavation. The repair shall blend into the adjacent area and have no abrupt ridges or valleys and shall meet the finish requirements of the completed weld.
