Steam Generator Tube Inspection Report

Unit 1 – 13th Refueling Outage Steam Generator Tube Inspection Report

Palo Verde Nuclear Generating Station

UNIT 1 U1R13

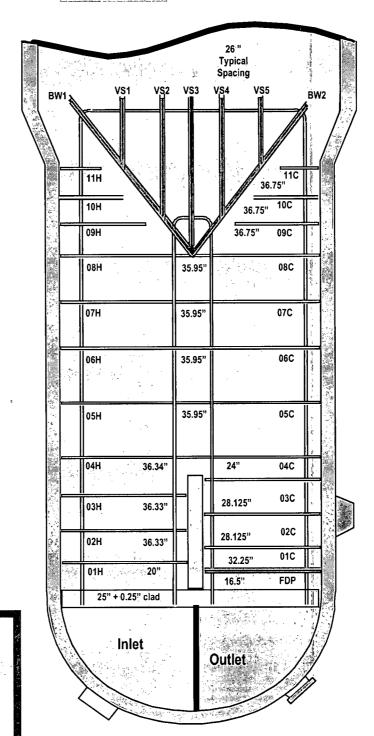
PVNGS Steam Generator

REPLACEMENTS

Center of 08H to 08C

Row 1 - 17.415

A summary of the bobbin and rotating coil (RC) examination results is located in Table 2 of this report. In addition, Appendix A contains a reference drawing of steam generator support locations. The summary data sheets of Appendix B and C list all tubes in each steam generator with indications expressed as a percent wall thickness reduction, or as an analysis code. Appendix D contains summary data sheets for tubes classified as possible loose parts.
