## FACT SHEET ON NIIGATAKEN CHUETSU-OKI EARTHQUAKE IN JAPAN

The purpose of this fact sheet is to provide an overview of the earthquake that occurred in Japan on July 16, 2007 and its impact on the Kashiwazaki Kariwa nuclear power plant. This paper also provides summary information about the design of US nuclear power plants for earthquakes.

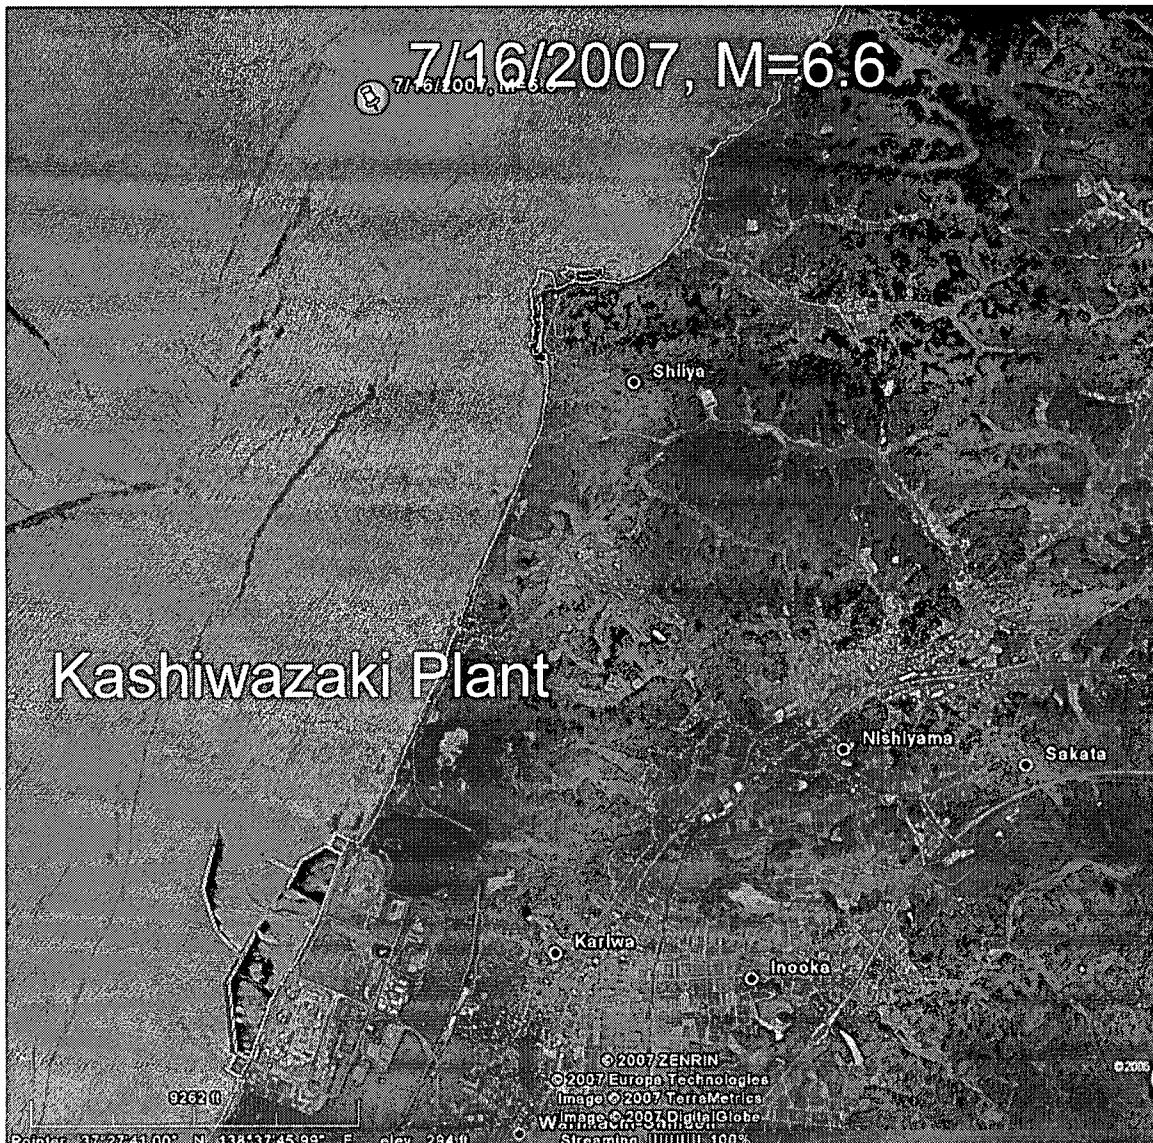
(Image from Google Earth with Overlays by NRC Staff)
