## FACT SHEET ON NIIGATAKEN CHUETSU-OKI EARTHQUAKE IN JAPAN

The purpose of this fact sheet is to provide an overview of the earthquake that occurred in Japan on July 16, 2007 and its impact on the Kashiwazaki Kariwa nuclear power plant. This paper also provides summary information about the design of US nuclear power plants for earthquakes.

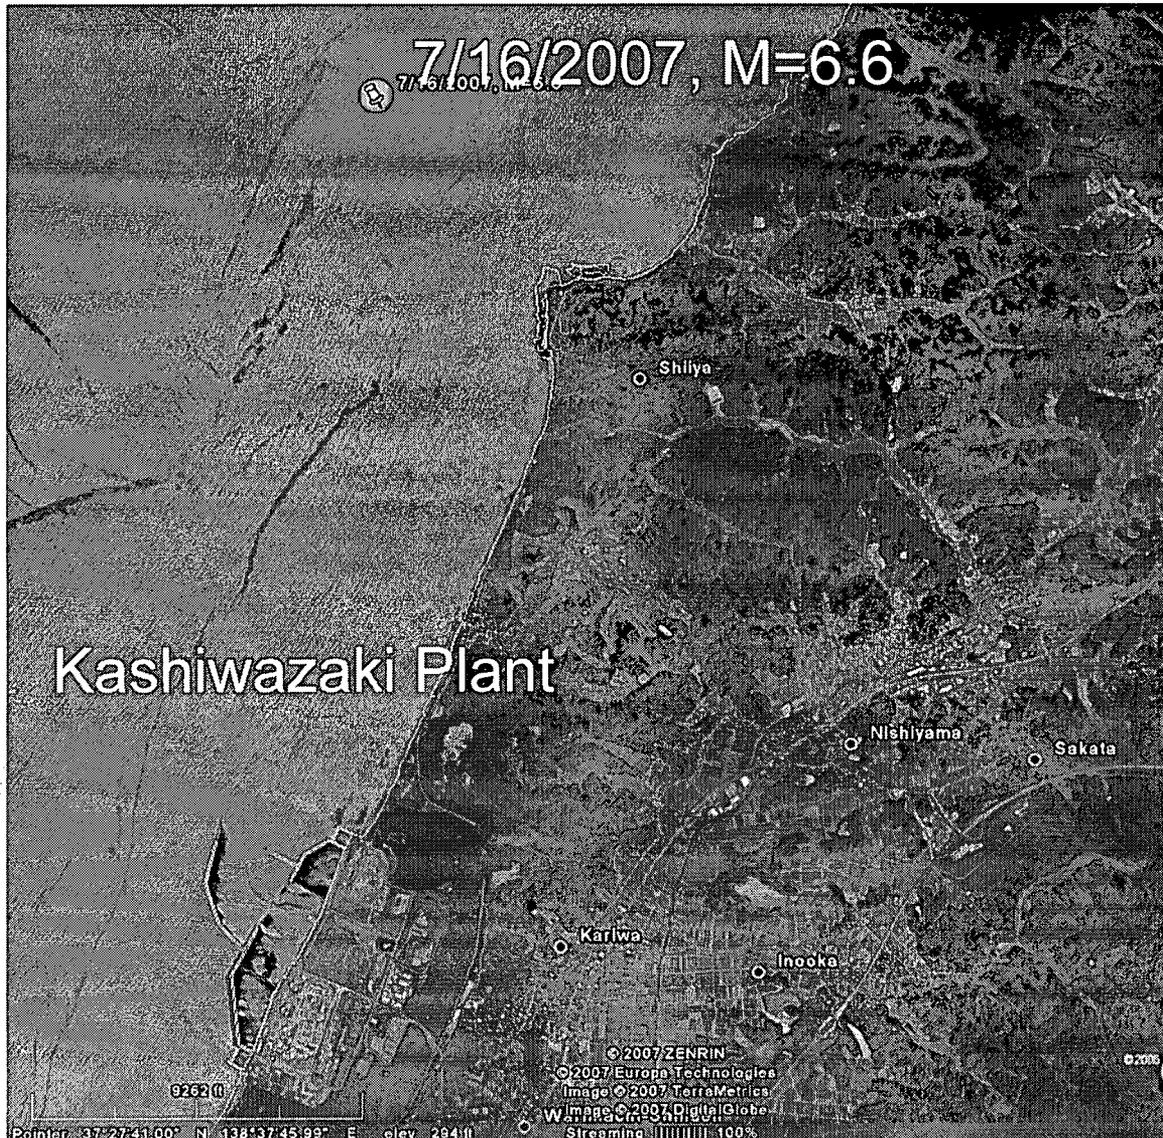
An earthquake with a magnitude 6.6 struck the west coast of Japan on July 16, 2007, at 10:13:28 AM local time, July 15, 09:13:28 PM Eastern Daylight Time. The epicenter of the main shock (37.574°N, 138.440°E) is located about 240 km North-North-West of Tokyo, Japan, and is estimated to have occurred 8-15 kilometers from the Kashiwazaki Kariwa Nuclear Power Plant. The earthquake occurred at the depth of 10 km beneath the earth's surface. The earthquake caused loss of life and multiple injuries, collapsed houses, and cracked highways.

(Image from Google Earth with Overlays by NRC Staff)
