**FIGURE 37**  
**Effects of Past and Current Pumping to Dewater Zone 3**  
**United Nuclear Corporation, Church Rock Site, Church Rock, New Mexico**

United Nuclear Corporation Church Rock Site,  
Church Rock, New Mexico

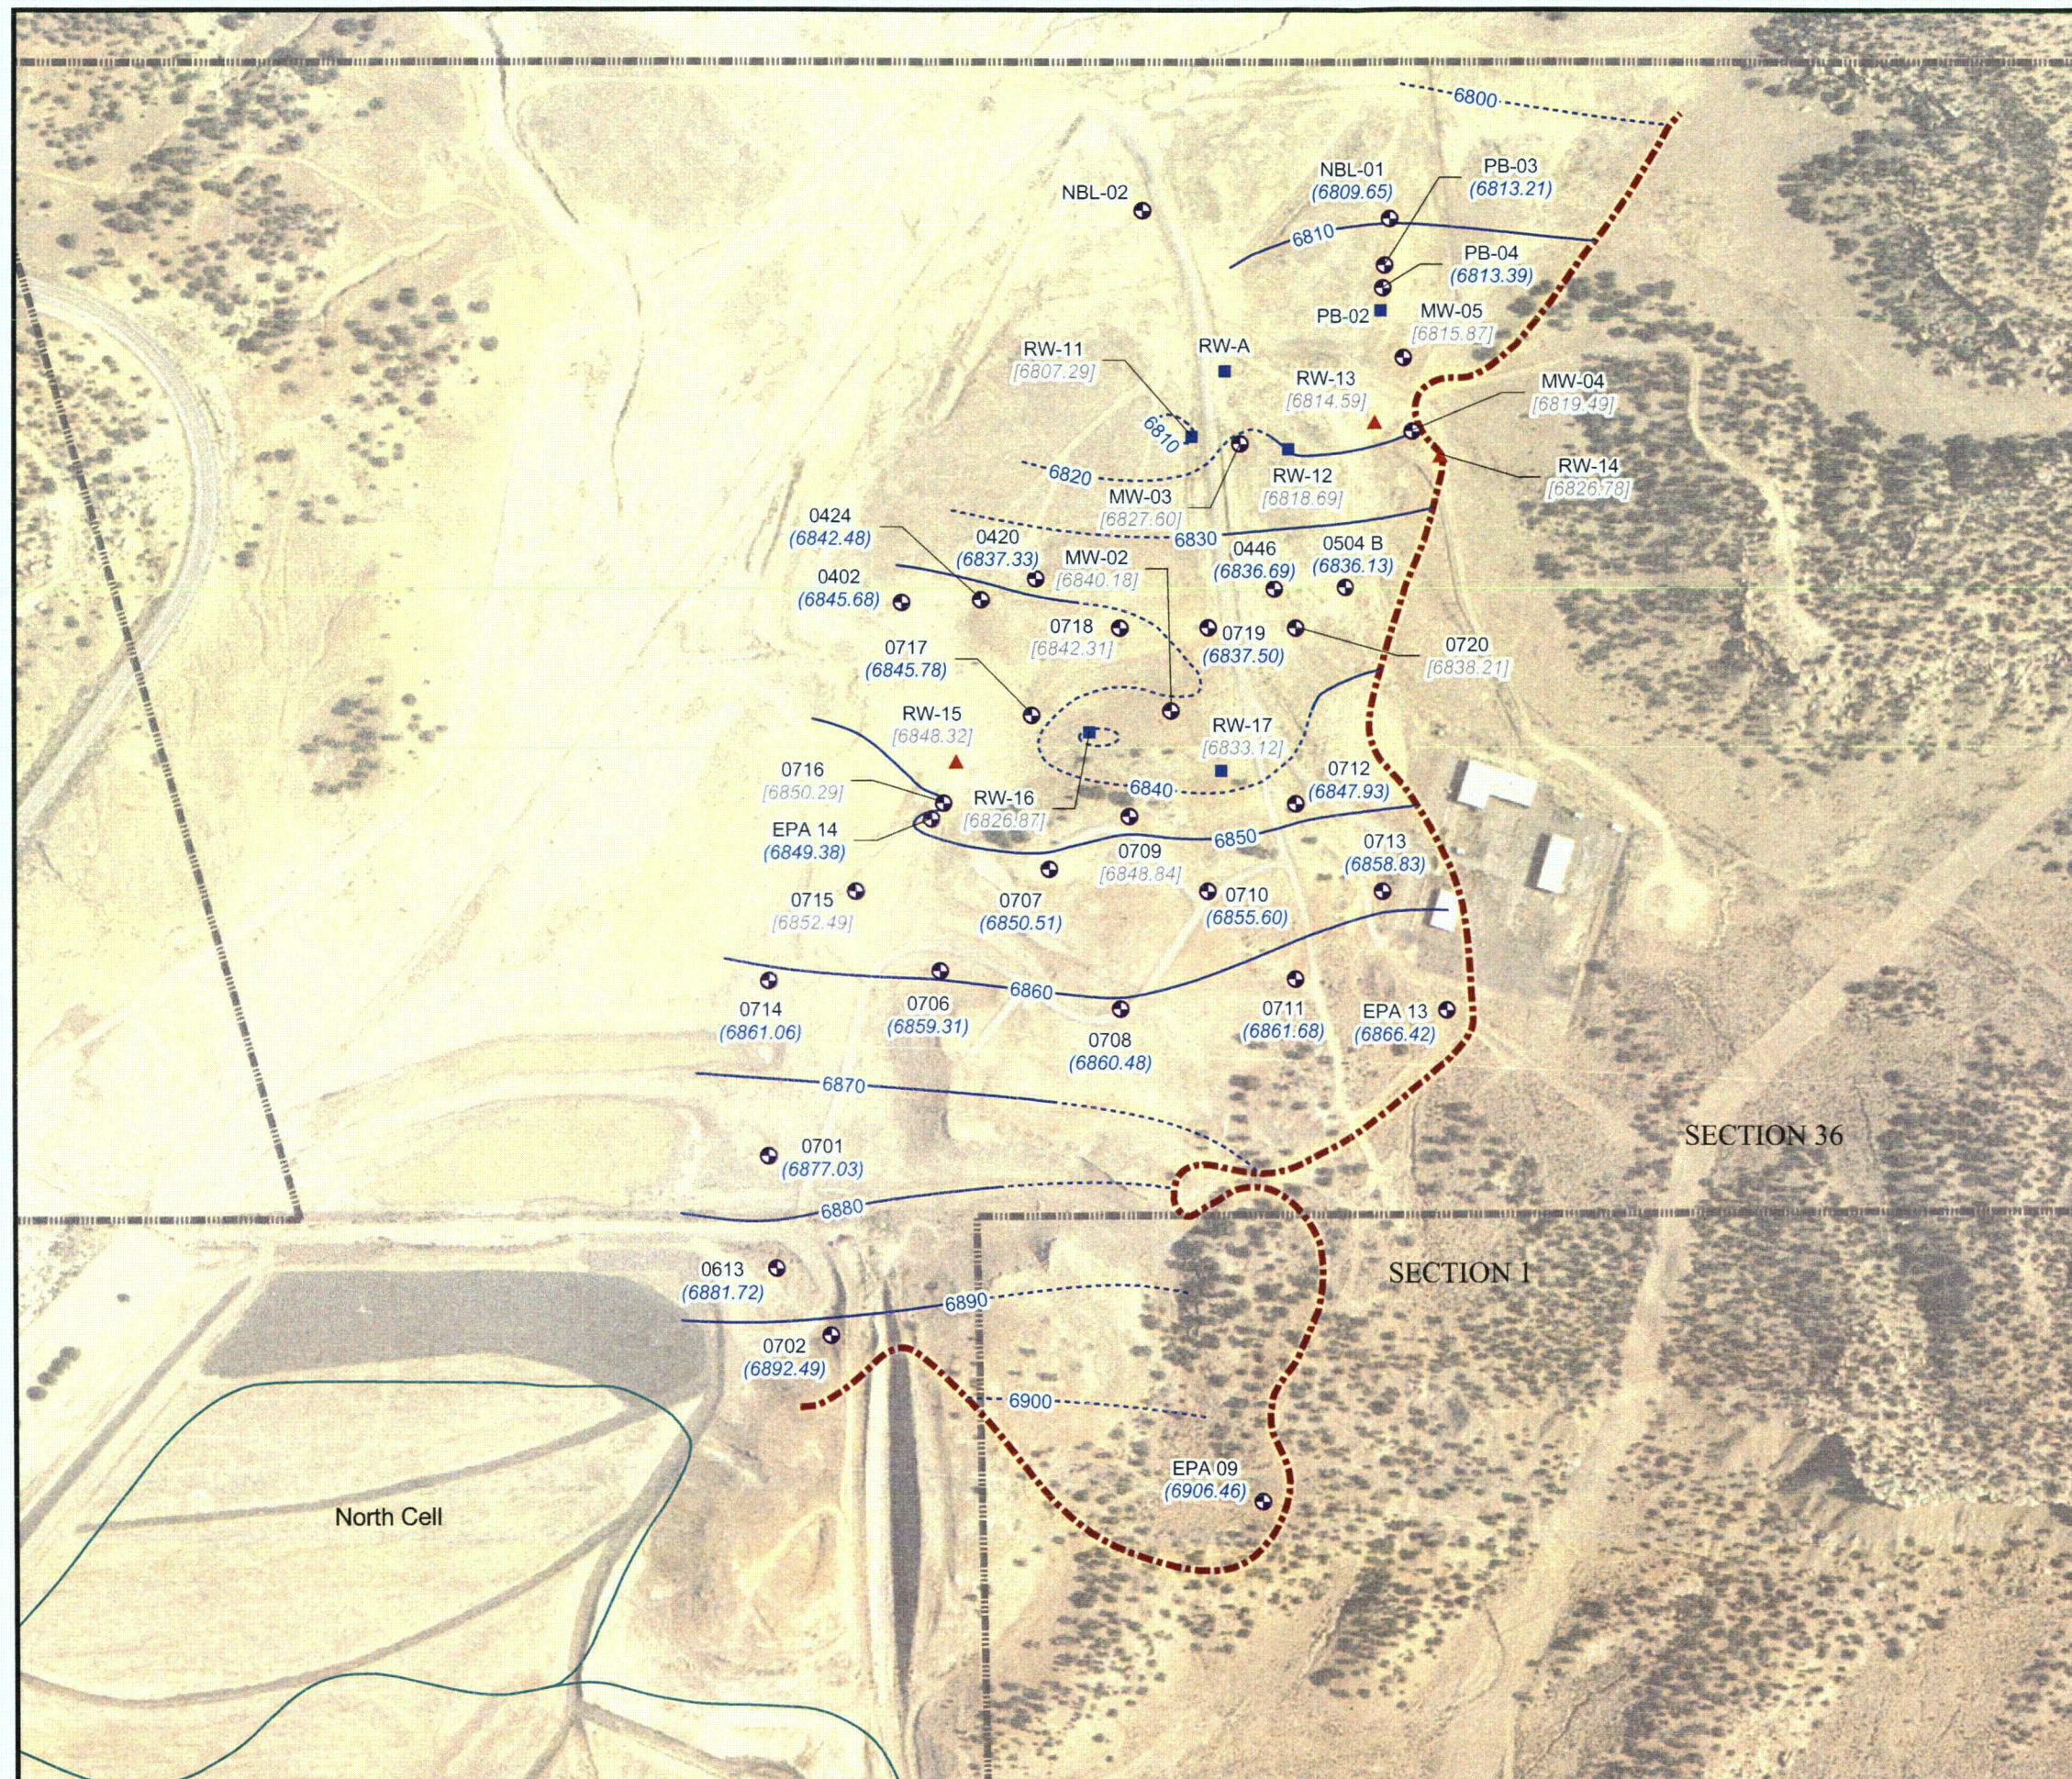
**FIGURE 38**

1. Groundwater elevation values are displayed in feet above mean sea level.
2. Well names are displayed with black text.
3. Aerial photo taken on August 1, 1996.

Zone 3 Potentiometric Surface Map  
October 2007
