In the matter of  
Entergy Corporation  
Pilgrim Nuclear Power Station  
License Renewal Application

PILGRIM WATCH PRESENTS STATEMENTS OF POSITION, DIRECT  
TESTIMONY AND EXHIBITS UNDER 10 CFR 2.1207

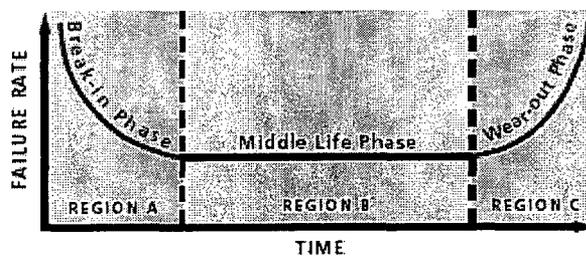
Figure 1 The Bathtub Curve

4.2. The Union of Concerned Scientists<sup>26</sup> explained the aging phenomenon by using the “Bathtub Curve,” which was developed by NASA scientists studying statistically the lifetimes of both living and non-living things to describe the likelihood of aging related problems in nuclear plants. The curve, which is a graph of failure rate versus age, shows that after a relatively stable (bottom of the bathtub) period in the middle life of the subject, a steep rise in age-related failures occurs towards the end of its life. “The right-hand side of the curve, labeled Region C, is the wear-out phase. Due to aging, it takes less stress to cause failure in this phase, just as older people are more prone to breaking bones in a fall than younger people. Thus, the chances of failure increase with time spent in Region C” [Union of Concerned Scientists Report, *supra*, at 4].

Source: NASA, 2001.

The renewal period of a nuclear plant would be its Region C, or wear-out phase. “As reactors approach or enter Region C [the wear-out phase] and become more vulnerable to failure, aging management programs should monitor the condition of the equipment and structures more frequently so as to affect repairs or replacements before minimum safety margins are compromised. Unfortunately, age-related degradation is being found too often by failures than by condition-monitoring activities” [*Id.* at 20].<sup>27</sup> Likewise, Pilgrim’s AMP’s do not provide the required “condition-monitoring activities.”

4.3. It is important to make note that the aging process is a curve, not a straight-line. This tells us that corrosion is not linear but exponential. Therefore as the pipe ages the time between inspections must necessarily be shortened [self evident].

Corrosion rates are not linear, either. As we discussed above, aging of mechanical components follow the "bath-tub" curve and the mere fact that it is a curve means that the failure rate is non linear.

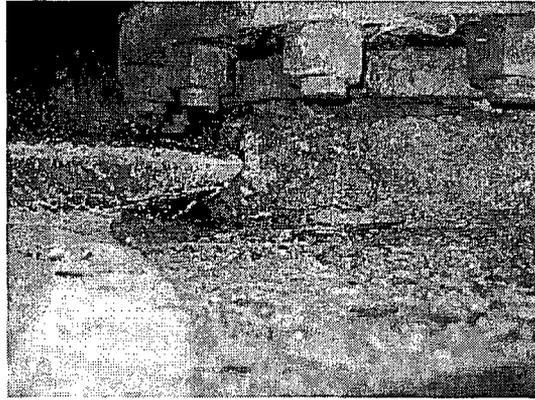
▲ The leak occurred as workers scraped rust from the heavily corroded ESW pipe. The pipe, which is specified to have a minimum wall thickness of 0.375 inches, had a measured wall thickness of 0.047 inches – before rust removal took that thickness to zero.

- **Byron:** Corroded pipes recently failed at Byron NP in Rockford Illinois<sup>32</sup>. Exhibit 7's photographs of the corroded ESW System Piping, shows the nature and location of the leak. The corrosion process thinned the pipe walls below the minimum acceptable level (0.375 inches) in some places. Workers measured the thickness of some of the pipe walls at 0.047 inches before the rust was removed. Once the rust was removed, the remaining wall thickness went to zero – in other words rust was holding it together. It is not clear at this point whether corrosion occurred from the inside or outside of the pipe. In view of the large amount of rust, which was scraped off, one might suspect that corrosion occurred from the outside due to a leaking flange. Exelon declared the ESW systems inoperable and had to shut down both reactors as a result. *If the ESW system cannot function during an accident, the ability for the plant to avoid a reactor core meltdown with concurrent loss of containment is severely impaired if not entirely prevented.* The accident is likely to become catastrophic. Although this occurred at Byron, not Pilgrim, there is not any reason for complacency.

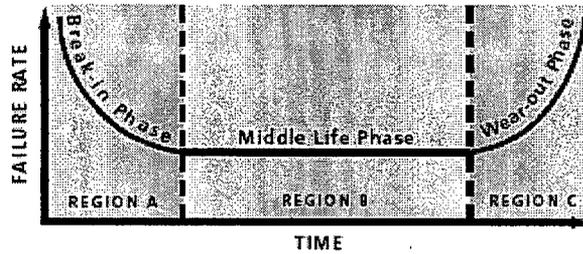
Figure 1 The Bathtub Curve

The BPTIP does not provide assurance, certainly not at the 95% confidence level. Corrosion has occurred at Pilgrim Station in less than 40 years of operations and experience has been very limited; there is no industry experience with the AMP so there is no assurance going forward about what will happen in 50 years. Deterioration of buried pipes in nuclear power plants is well established. It is axiomatic that failure rate increases over time.

Source: NASA, 2001.

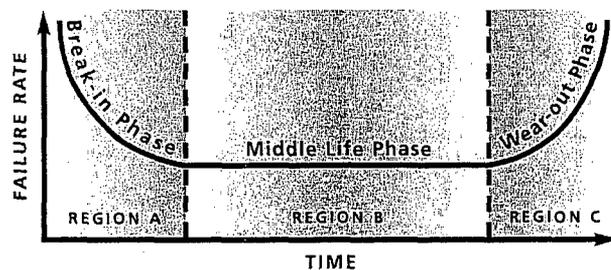
Figure 1 The Bathtub Curve

The left-hand side of the bathtub curve, labeled Region A in Figure 1, represents the infant mortality or break-in phase of life. Infants are vulnerable to numerous illnesses until they grow stronger and build up immunities. Similarly, products may fail soon after being put to use due to manufacturing defects, material imperfections, or poor workmanship (U.S. Army Corps of Engineers, 2001). The steepness of the curve in Region A depends on factors such as the effectiveness of quality control measures applied during product manufacturing.

Region B, the middle portion of the bathtub curve, represents the useful lifetime for products and the peak health years for living things. Accidents and random events still occur, but at a lower rate than in Region A. The height (i.e., how far off the floor) and size (i.e., distance between ends) of the bathtub in Region B depends, for

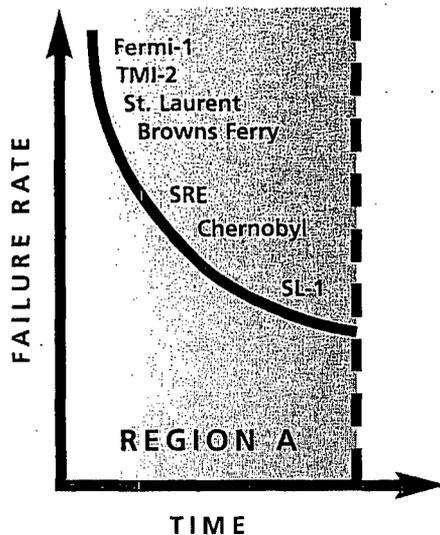
Figure 2 Major Failures at Region A Plants

Source: Adapted from NASA, 2001.

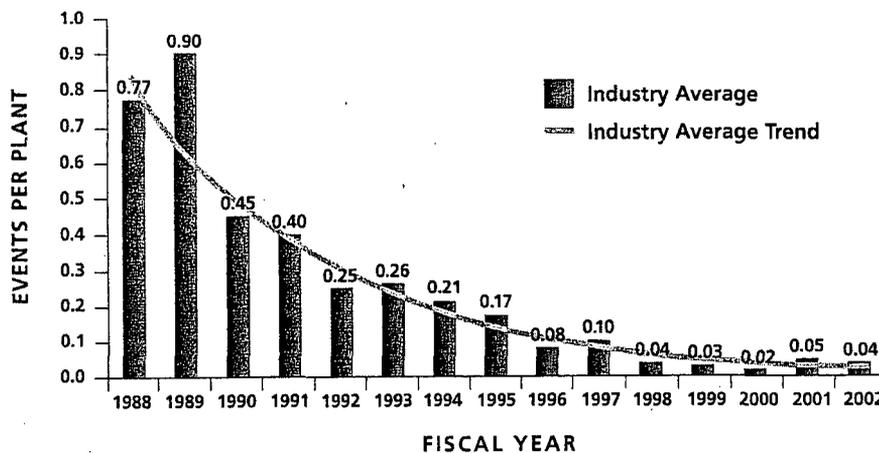
Figure 3 Significant Events at Nuclear Plants, 1988-2002

The NRC monitors trends in several areas of nuclear plant operation, including safety system failures, unplanned reactor shutdowns, emergency system starts, and significant events such as degraded fuel integrity and unplanned releases of radioactivity (Collins, 2003). The decreased occurrence of significant events over the past 15 years or so reflects the normal and expected transition of nuclear power plants from Region A to Region B (Figure 3).

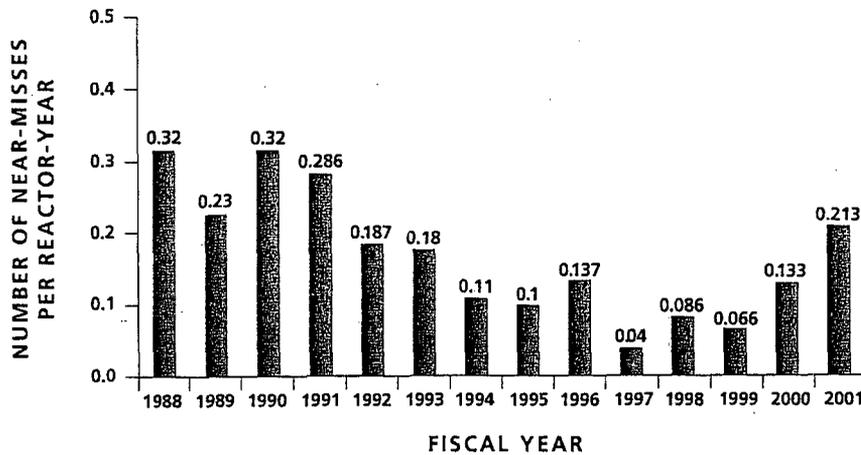
Figure 5 Significant Near-Misses at Nuclear Power Plants, 1988-2001

it). While the number of significant events has decreased in recent years, the rate of “near-misses” (elevated risks of reactor meltdown) appears to have increased in recent years (Figure 5). In other words, while the number of events is decreasing, their severity is increasing, with the near-misses getting nearer and nearer to disaster. This upward trend may simply reflect normal statistical fluctuations or increasing risk in Region B from the NRC’s flawed risk-informed decisions. More likely, the data suggest that some nuclear plants have entered Region C and are experiencing higher failure rates as expected.

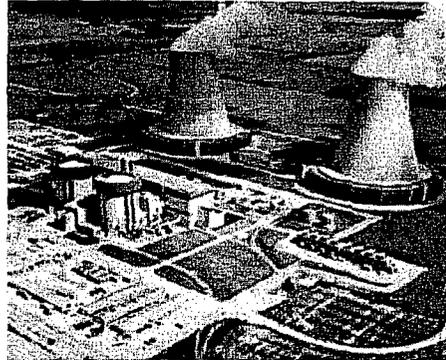
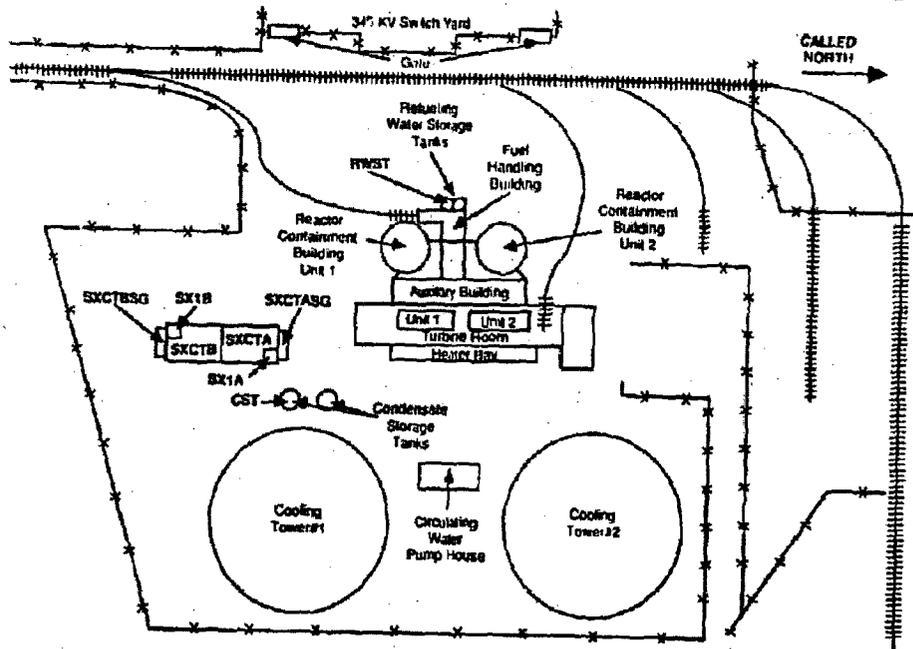
The ESW piping runs underground from the mechanical draft cooling towers to the two reactor units and back. The ESW system piping became heavily corroded. As the metal walls of the piping rusted, the water flowing through the piping eroded away some of the rust flakes. This erosion/corrosion process thinned the pipe walls below the minimum acceptable level (0.375 inches) in some places. Workers measured the thickness of some of the pipe walls using ultrasonic devices as little as 0.047 inches. As workers scraped away the rust flakes from the outside surface of the piping, a leak developed.

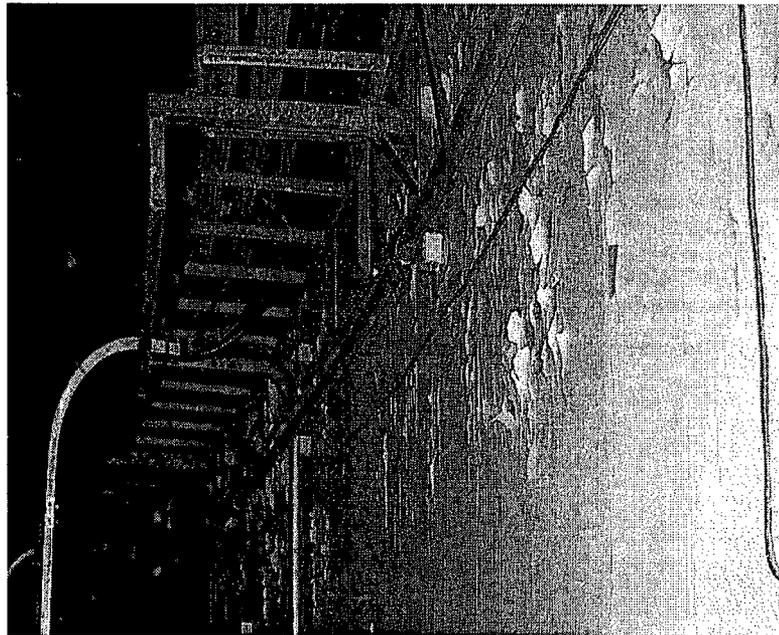
**Figure 4**  
**Example of Coatings Degradation at Oconee**

repaired. Yet, the Oconee corrective action program contained 20 entries for degraded coatings from 1995-2003.<sup>19</sup> OIG's analysis of this corrective action program indicates that the coatings aging management program had not been implemented consistent with the statements in the Oconee license renewal application. In fact, coatings degradation was a continuing problem at the Oconee Nuclear Station as of Spring 2004, the date of the photograph presented in Figure 4 below, casting doubt on the efficacy of Oconee's aging management program for coatings.

NRC license renewal reports do not indicate that NRC reviewers independently verified Oconee's operating experience for coatings. The license renewal inspection report states that the inspection included a review of the program description documents and discussion of the program with a site engineer. The inspection report concluded, based on the program document review and the
