**MSPI – Action Item 02c**  
**Proposed Clarifications Related to Counting Demands**  
Revision 1

### Mitigating Systems Performance Index, Emergency AC Power System

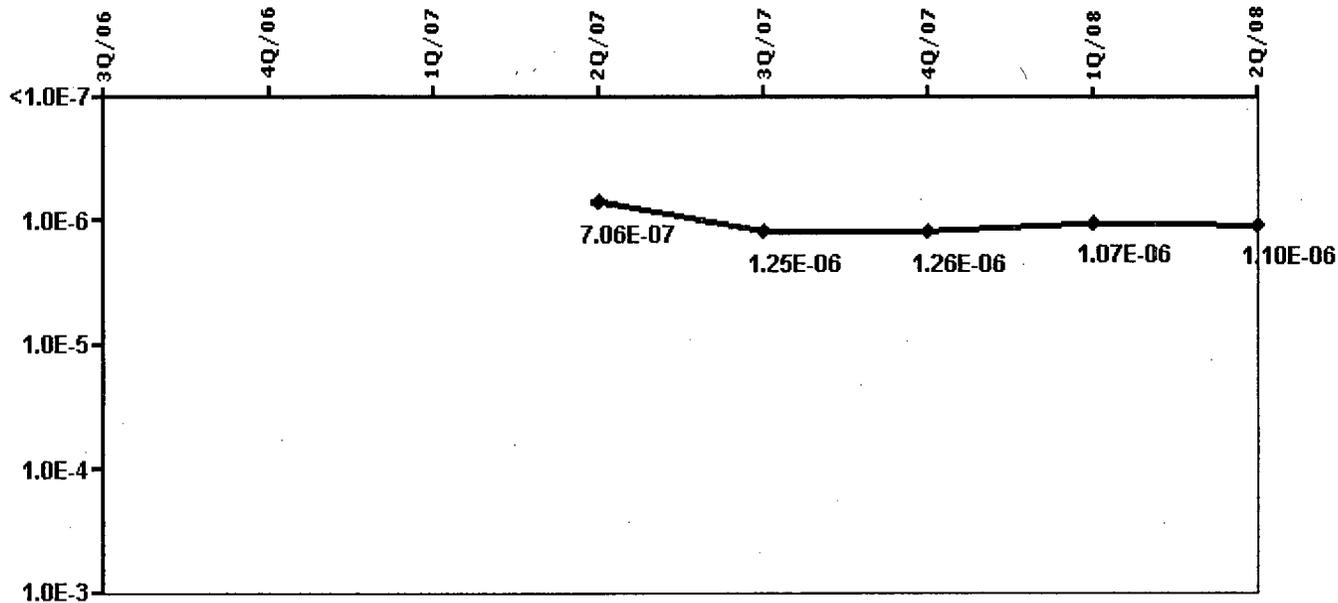
Thresholds: White > 1.00E-6 Yellow > 1.00E-5 Red > 1.00E-4

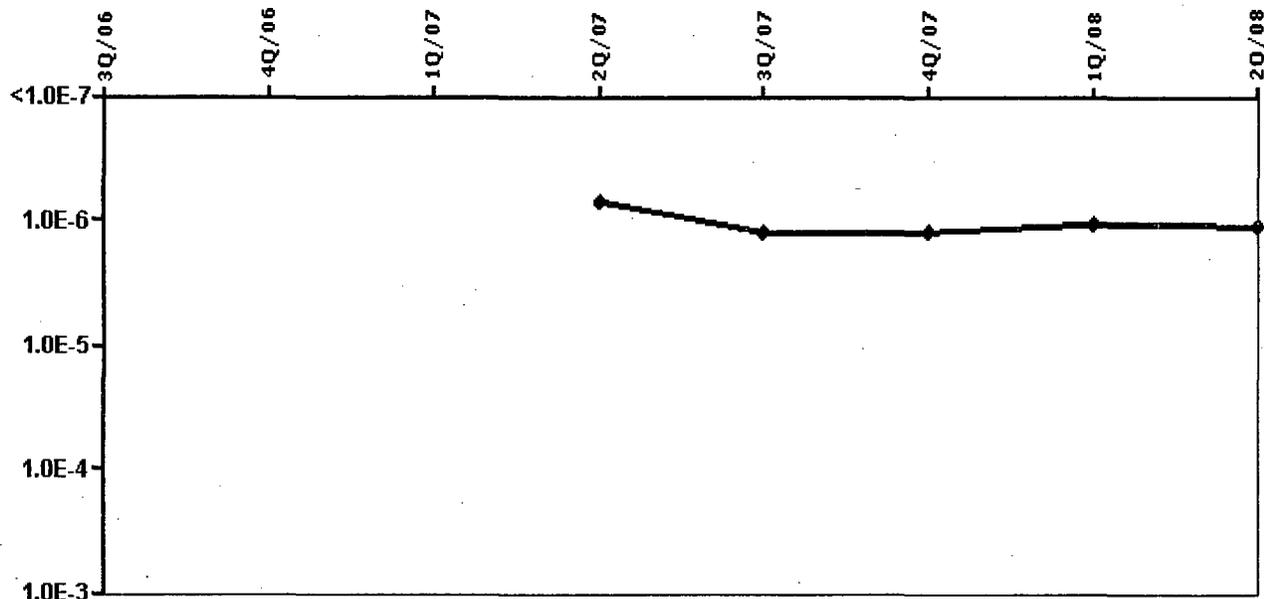
### Mitigating Systems Performance Index, Emergency AC Power System

Thresholds: White > 1.00E-6 Yellow > 1.00E-5 Red > 1.00E-4
