SUBJECT: D. C. COOK NUCLEAR POWER PLANT, UNITS 1 AND 2; NRC INSPECTION  
PROCEDURE (IP) 95002 SUPPLEMENTAL INSPECTION REPORT  
05000315/2008502; 05000316/2008502

The supplemental inspection examined your root cause evaluation, extent of condition, and extent of cause determinations, and corrective actions associated with a Yellow Alert and Notification System (ANS) performance indicator in the Emergency Preparedness cornerstone. The Yellow performance indicator placed D.C. Cook Units 1 and 2 into the Degraded Cornerstone Column of the NRC's Action Matrix for the second and third quarters of 2007.

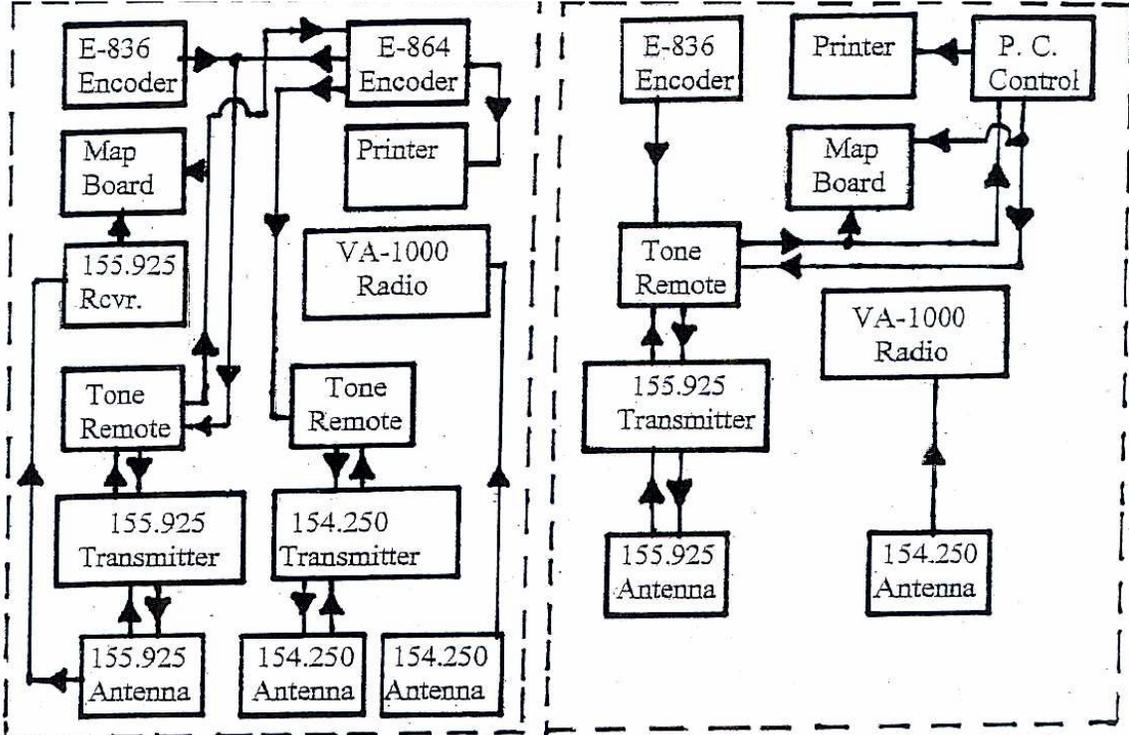
Old ANS Block Diagram

Primary Activation Center

Maintenance and Monitoring Facility
