Docket No. 50-293

Pilgrim Nuclear Power Station

License Renewal Application

PILGRIM WATCH POST-HEARING FINDINGS OF FACT

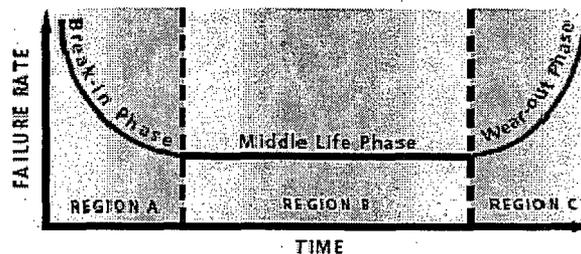
Figure 1 The Bathtub Curve

28. Engineers explain the aging phenomenon by using what is known as the “Bathtub Curve.” The curve is a graph of failure rate according to age. The failure rate due to unidentified leaks is relatively high in the beginning when “kinks” are being worked out; it flattens out during the middle life phase; and it rises again sharply in the end-of-life or at the “wear-out phase.” On average, 20- 30 years usually marks the beginning of the wear-out phase. The evidence shows that most of Pilgrim Station’s pipes, wraps and coatings would be in this “wear out phase” during the relicensed period. As Mr. Gunderson explained, the accepted standard for aging management of systems is clear that inspections at Pilgrim must increase as any component ages. Piping, coatings and wraps age, and just like human beings, require more doctor visits.

30. The Bathtub curve is more fully described for the Board in Exhibit 23, U.S. Nuclear Plants in the 21st Century: The Risk of a Lifetime, by David Lochbaum, Union of Concerned Scientists. (May 2004).⁸ Thus, the chances of failure increase with time spent in Region C” [Union of Concerned Scientists Report, *supra*, at 4]. The renewal period of a nuclear plant would be its Region C, or wear-out phase. “As reactors approach or enter Region C [the wear-out phase] and become more vulnerable to failure, aging management programs should monitor the condition of the equipment and structures more frequently so as to affect repairs or replacements before minimum safety margins are compromised. Unfortunately, age-related degradation is being found too often by failures than by condition-monitoring activities” [Tr., Exh. 14, Gundersen at 20]. Likewise, Pilgrim’s AMP’s do not provide the required “condition-monitoring activities.”

Source: NASA, 2001.

31. Entergy did not dispute the age of the piping or dispute the validity of the “Bath Tub Curve.”
