Office of the Secretary
Attn: Rulemaking and Adjudications Staff
Mail Stop O-16C1
U.S. Nuclear Regulatory Commission
Washington, D.C. 20555-0001Re: In the Matter of Entergy Nuclear Vermont Yankee, LLC and Entergy
Nuclear Operations, Inc. (Vermont Yankee Nuclear Power Station),
Docket No. 50-271-LR, ASLBP No. 06-849-03-LR**Filing Discussing Proprietary Documents**

Please find enclosed for filing in the above-stated matter New England Coalition, Inc.'s Opposition to Entergy's Motion in Limine. This filing attaches an expert witness report, NEC-UW_03, which discusses the following documents that Entergy has designated proprietary, all of which NEC has previously filed in this proceeding:

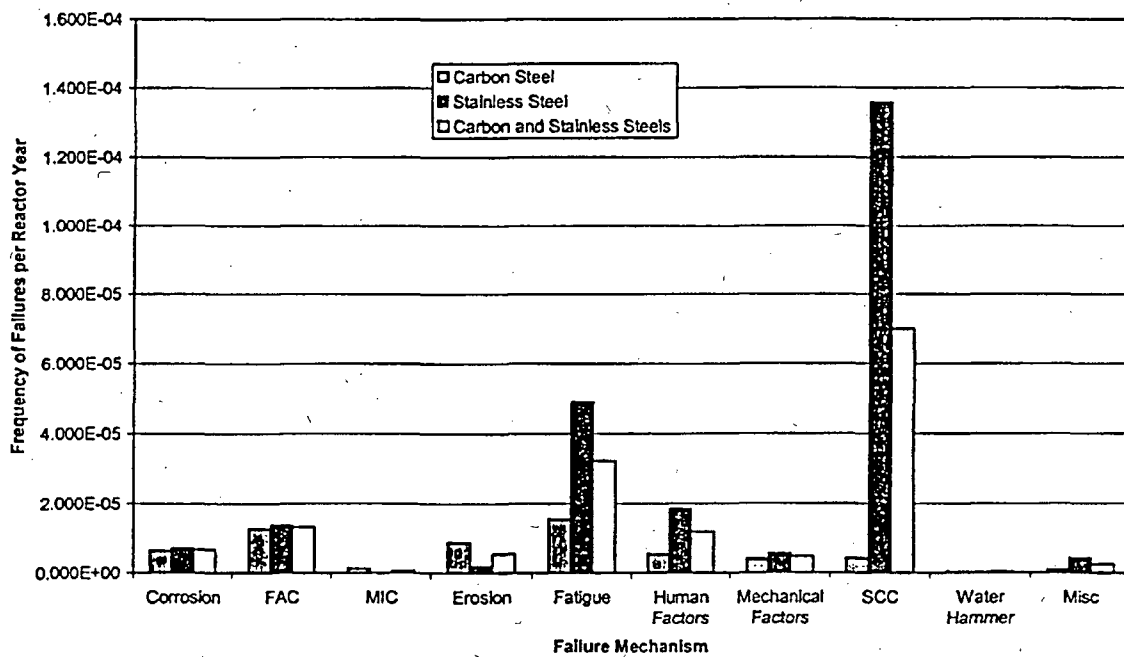
Figure 4.3-2. BWR Failure Frequency for Carbon and Stainless Steel Pipes as a Function of Failure Mechanism

This section of the report summarizes the frequency of failure mechanisms for carbon and stainless steel pipes. The information presented in figures 4.3-1 through 4.3-3 represents the normalized failure frequencies for each failure mechanism. This data is also presented in tabular form in table 4.3-1. The data was collapsed by pipe sizes and broken apart by steel type and plant type. The data was normalized for each type of steel based on the number of reactor years and the total amount of failures (carbon +stainless) for each plant.

From these plots it was determined that PWR plants are dominated by fatigue failures and BWR plants are dominated by stress corrosion cracking failures. However, in general the most frequent failure mechanisms for both plants are corrosion, fatigue, mechanical factors, and stress corrosion cracking. These four failure mechanisms were analyzed as a function of pipe size in figures 4.3-4 through 4.4-7.
