Byron Nuclear Power Station, Unit 1  
Facility Operating License NPF-37  
NRC Docket No. STN 50-454

Subject: Byron Station Unit 1 Steam Generator Inservice Inspection Summary  
Report for Refueling Outage 15

**BYRON STATION UNIT 1  
STEAM GENERATOR EDDY CURRENT INSPECTION REPORT**

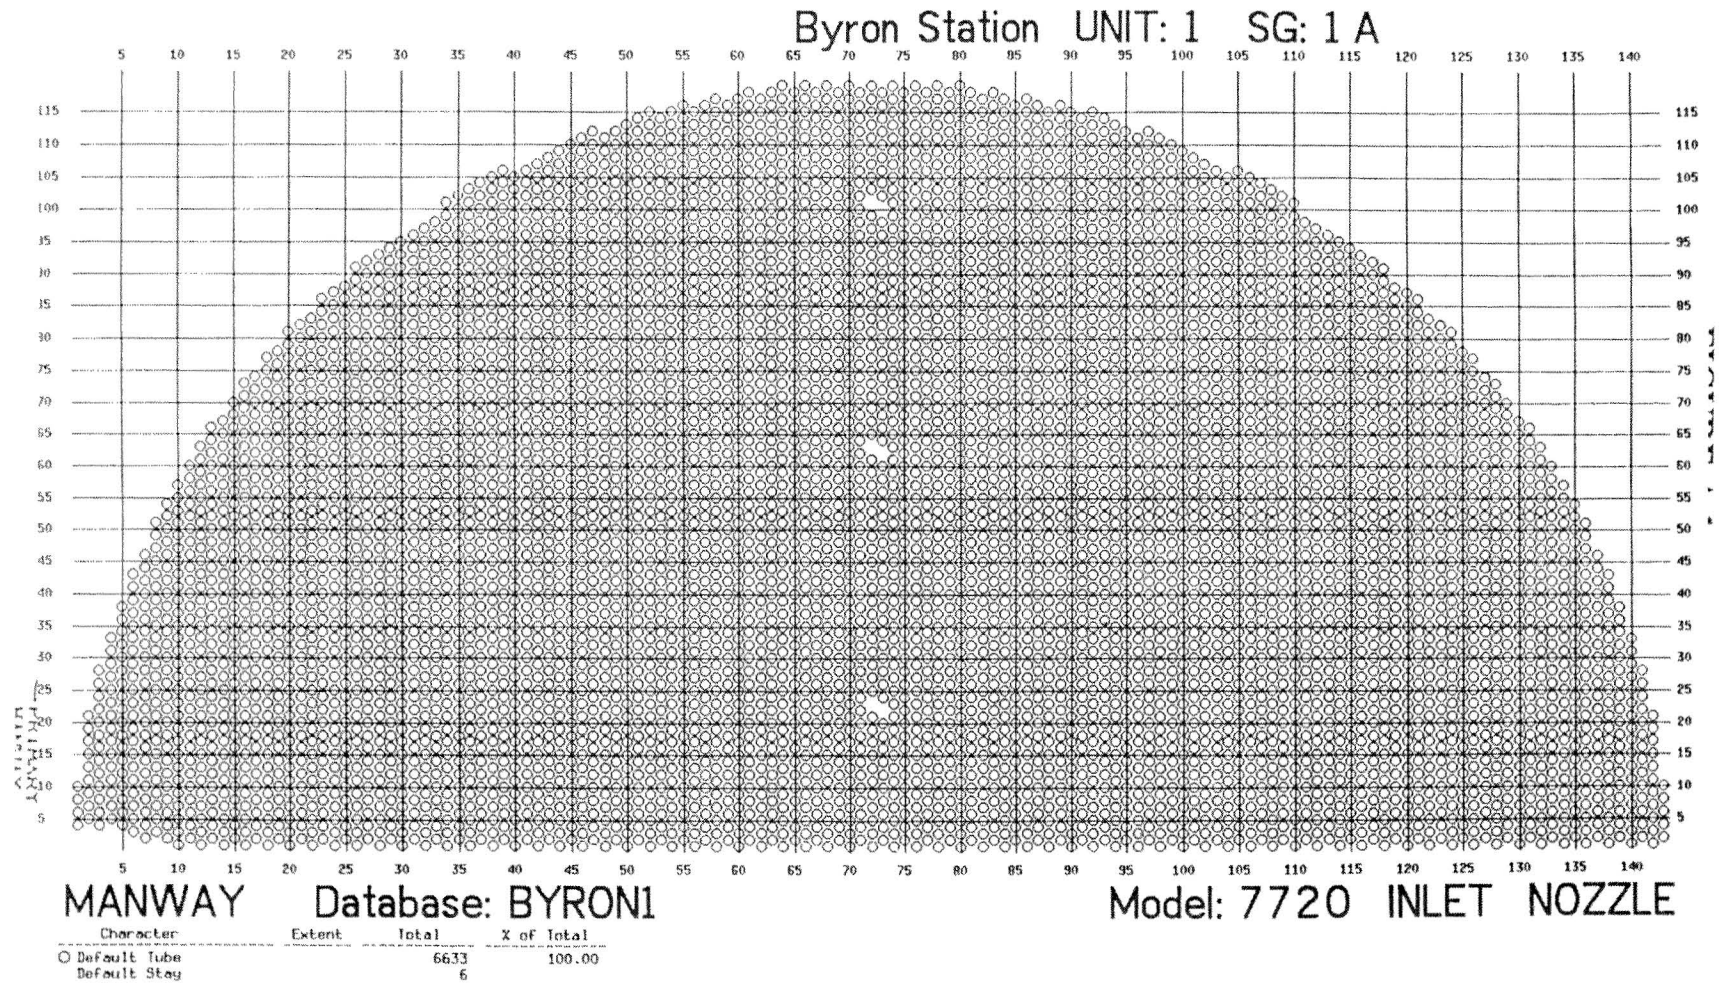
FIGURE A.2  
Byron Unit 1 Steam Generator  
Tubesheet Configuration (Typical)

Table A.1	Data Acquisition Personnel Certification List
Table A.2	Data Analysis Personnel Certification List
Figure A.1	Babcock & Wilcox Replacement Steam Generator Byron Unit 1 Configuration
Figure A.2	Byron Station Unit 1 Steam Generator Tubesheet Configuration
