Re: In the Matter of Entergy Nuclear Vermont Yankee, LLC and Entergy
Nuclear Operations, Inc. (Vermont Yankee Nuclear Power Station),
Docket No. 50-271-LR, ASLBP No. 06-849-03-LR
Filing Discussing Proprietary Documents

Please find enclosed for filing in the above-stated matter New England Coalition, Inc.'s Motion to File Corrections to Exhibits and to Withdraw Certain Testimony of Ulrich Witte. This filing attaches an expert witness report, NEC-UW_03, which discusses the following documents that Entergy has designated proprietary, all of which NEC has previously filed in this proceeding:

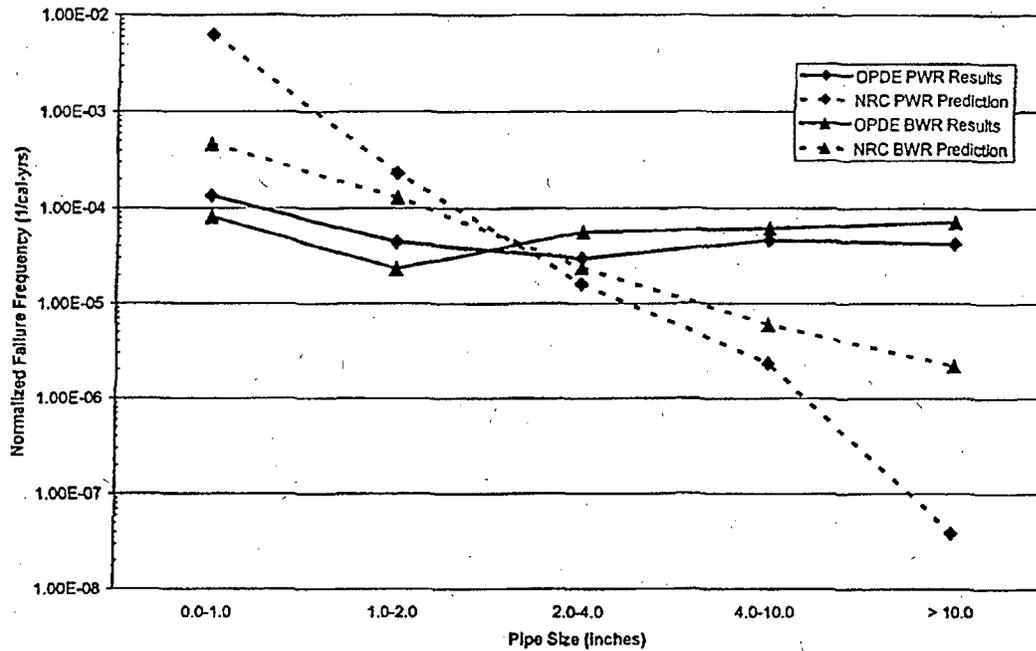
Figure 4.1-1. Normalized pipe failure frequencies as a function of pipe group size for both carbon and stainless steel pipe failures in both BWR and PWR plants.

Figure 4.1-1 displays this information graphically on a semi-log plot with normalized failure frequencies on the y-axis and the pipe size groups on the x-axis. The figure shows that the results of the OPDE database underestimate the failure frequency for the smaller pipe size groups and overestimate the failure frequency for the larger pipe size groups compared to the NRC predictions for both PWRs and BWRs. However, there is less disparity in the two BWR predictions than the two PWR predictions.

The NRC predicts that PWR plants are much more likely to have pipe failures in smaller pipes than larger pipes. This trend remains the same in NRC prediction for BWR plants, but is not nearly as drastic. The OPDE results for both PWR and BWR plants show a much more consistent failure frequency both over the range of pipe sizes and between PWR and BWR plants.

The next two plots, Figure 4.1-3 and Figure 4.1-4, present the same data as is included in Figure 4.1-1, but these figures include the ranges for the NRC prediction. It can be seen that even when the range of validity is taken into consideration, a large portion of the distribution still falls outside the boundaries for both PWRs and BWRs.

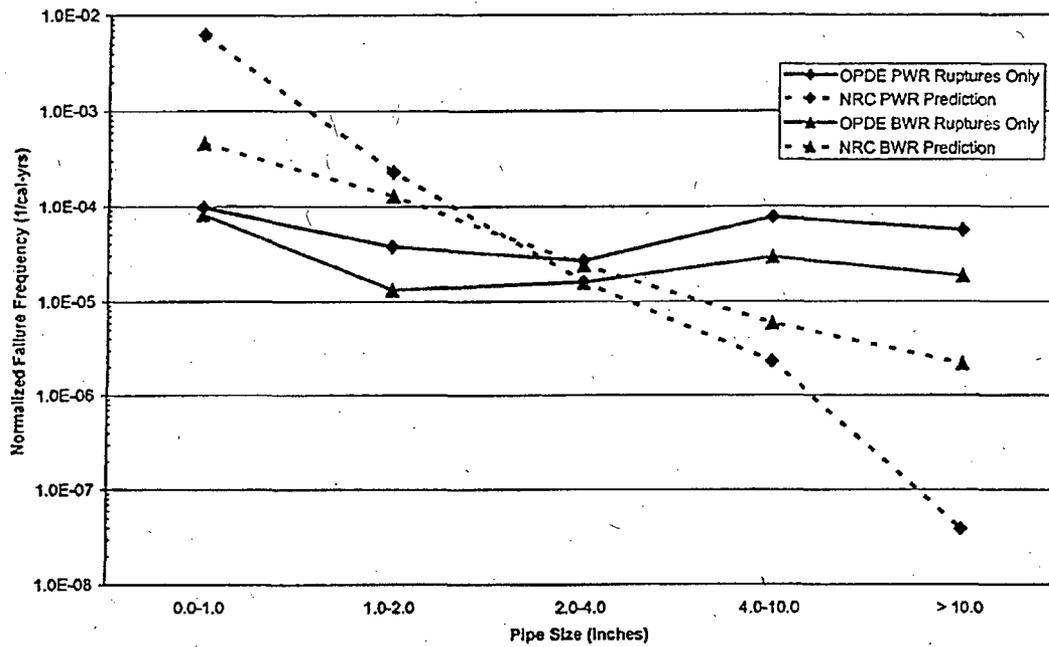
Figure 4.1-2 Normalized rupture frequencies as a function of pipe group size for both carbon and stainless steel pipe failures in both BWR and PWR plants.

There were three issues in the data analysis that were initially thought to factor into the difference in results between the analyzed OPDE database and the NRC predictions. The first assumption was that all types of cracks, leaks, ruptures, or other issues were considered to be a complete failure in the pipe. In actuality this is not true since inspections or other indicators may catch a crack or leak before a complete failure occurs. As a result, a separate analysis considering only the pipe ruptures listed in the OPDE database was conducted. However, the calculated frequency distribution considering only ruptures did not change significantly, in either trend or magnitude, from the results obtained when considering all issues to be a failure. The results of this rupture only analysis are shown below in Figure 4.1-2.

The data for this plot is shown in Table 4.1-2.

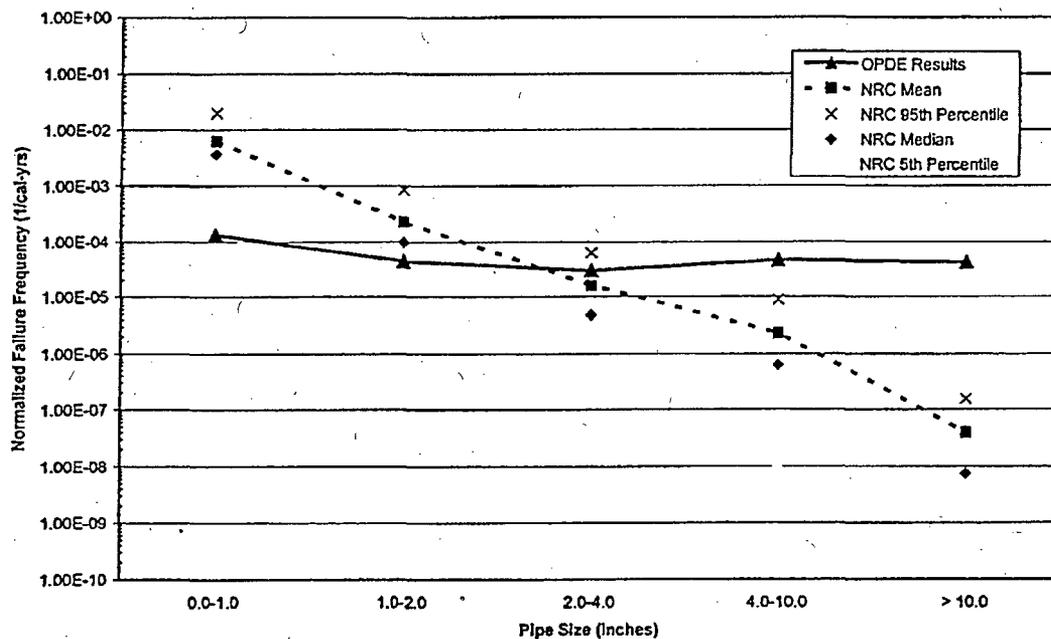
Figure 4.1-3. Normalized Failure Frequency Distribution for PWRs.

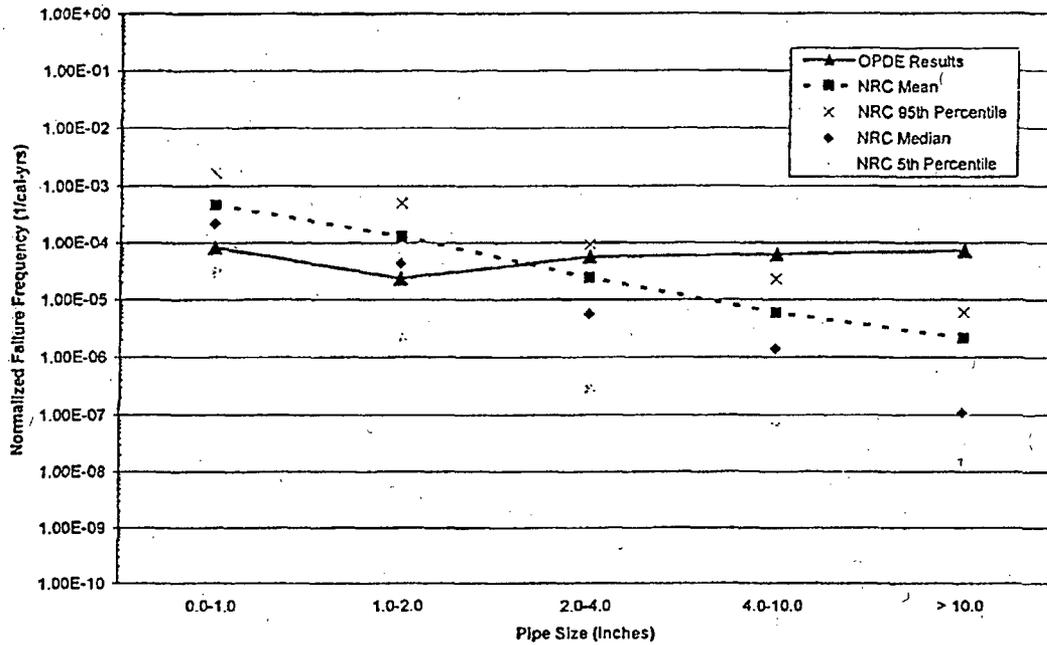
Figure 4.1-4. Normalized Failure Frequency Distribution for BWRs.

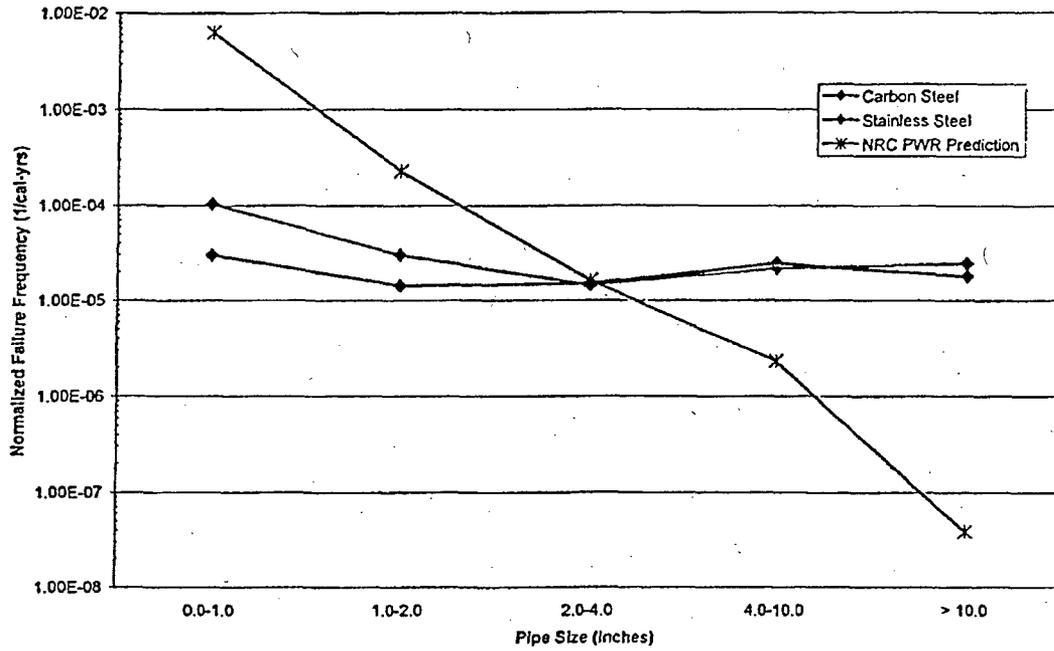
Figure 4.1-5. Normalized pipe failure frequencies as a function of pipe size for PWRs.

Figure 4.1-5 and Figure 4.1-6 shows a more detailed representation of failure frequencies as a function of pipe size for PWR plants only, and BWR plants only, respectively. These figures present the separate failure frequency distributions for carbon steel and stainless steel pipes, where the data is normalized based on the total number of failures for each plant type. Figure 4.1-5 shows that failures of stainless steel pipes are more frequent than carbon steel pipes only for smaller pipe sizes in PWRs. Figure 4.1-6 shows that stainless steel pipe failures are much more frequent than carbon steel pipe failures at all pipe sizes in BWRs.

As previously mentioned, the data for these two figures (4.1-5 and 4.1-6) was normalized using the methodology explained in the Data Analysis Section, using the total number of failures (carbon + stainless) for each plant type. Conducting the analysis in this manner allows for relative comparisons of failure frequencies to be made between the two types of pipes, however, it does not allow for the failure frequencies to be compared to the NRC predictions. As a result, a second analysis was done where the data was normalized based on the number of failures for a given pipe type in each plant type. In other words, the BWR carbon steel failures would be normalized by the total number of carbon failures in BWRs. The results of this modified analysis are given in Figure 4.1-7 and 4.1-8 for PWRs and BWRs, respectively. The summary tables, with the recalculated frequencies, have also been included as Table 4.1-5 and Table 4.1-6.

It can be seen from these two figures that conducting the analysis in this modified manner collapses the data, meaning that the failure frequencies, based strictly on pipe size, are very similar for carbon and stainless steel pipes in both types of plants. However, the fact remains that stainless pipes are still more likely to fail than carbon pipes in both plant types, based in the relative number of failures for each. More importantly, however, conducting this modified analysis did not show any substantial improvement in matching the data to the NRC predictions.

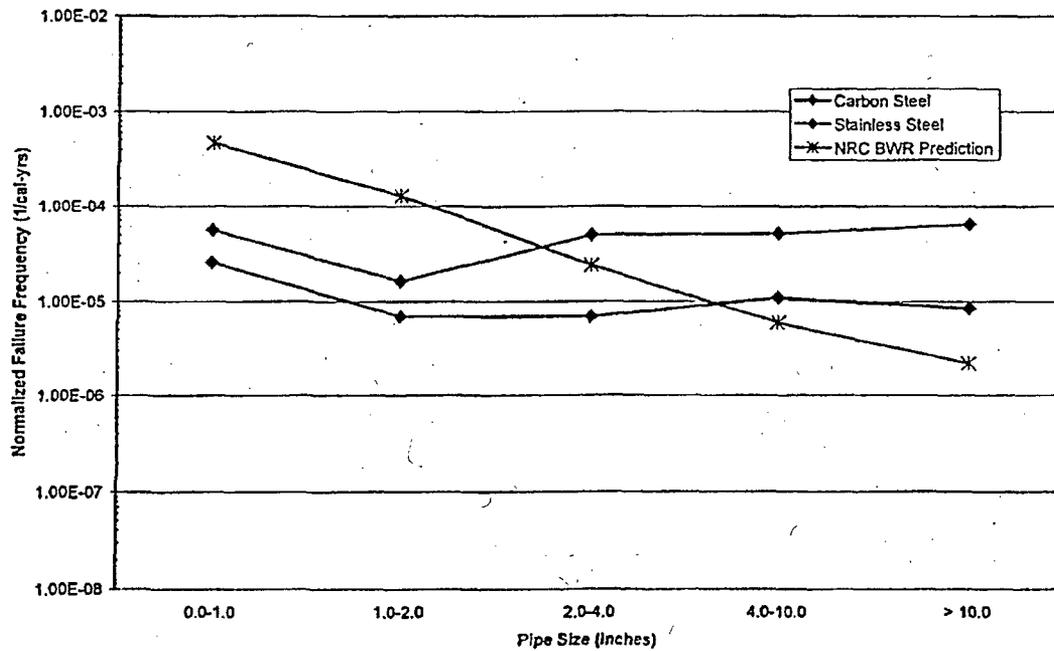
Figure 4.1-6. Normalized pipe failure frequencies as a function of pipe size for BWRs.

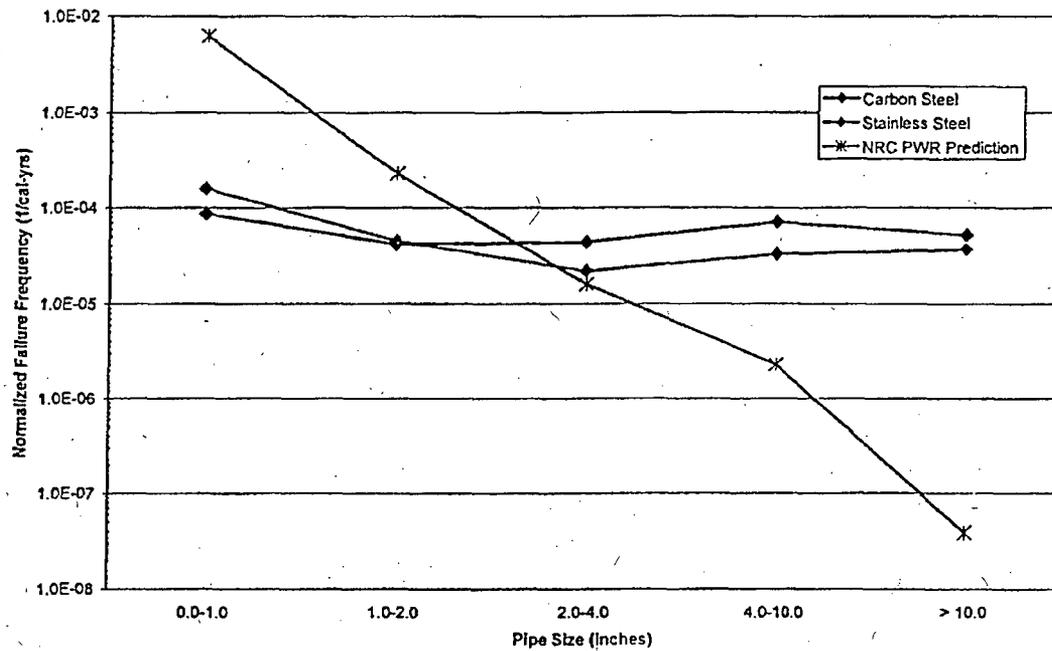
Figure 4.1-7. Normalized pipe failure frequencies as a function of pipe size for PWRs using the Modified Analysis Method.

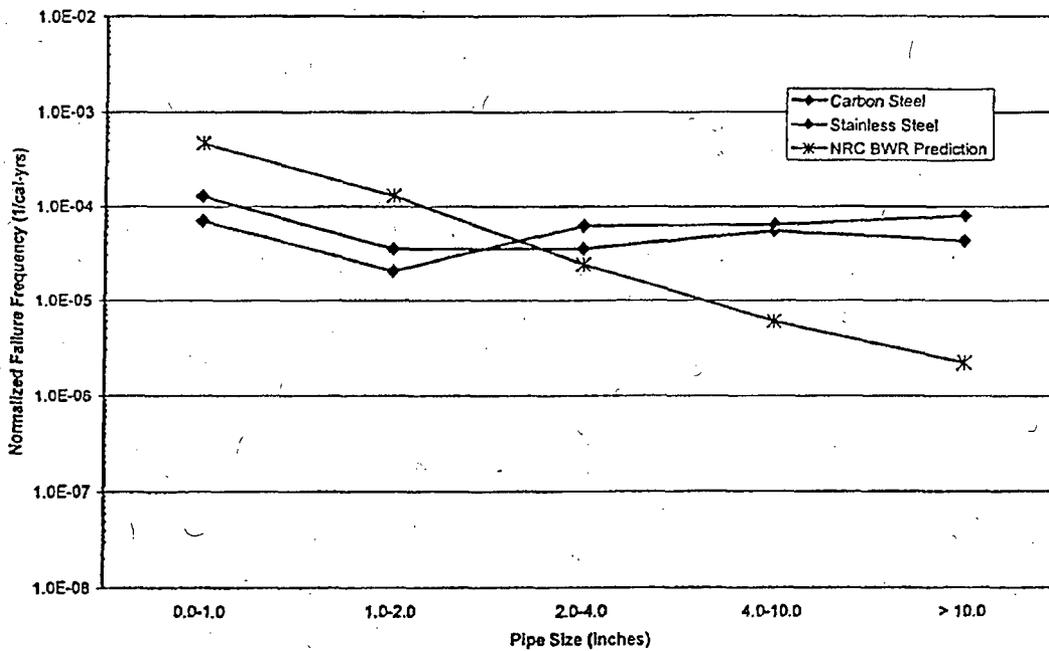
Figure 4.1-8. Normalized pipe failure frequencies as a function of pipe size for BWRs using the Modified Analysis Method.

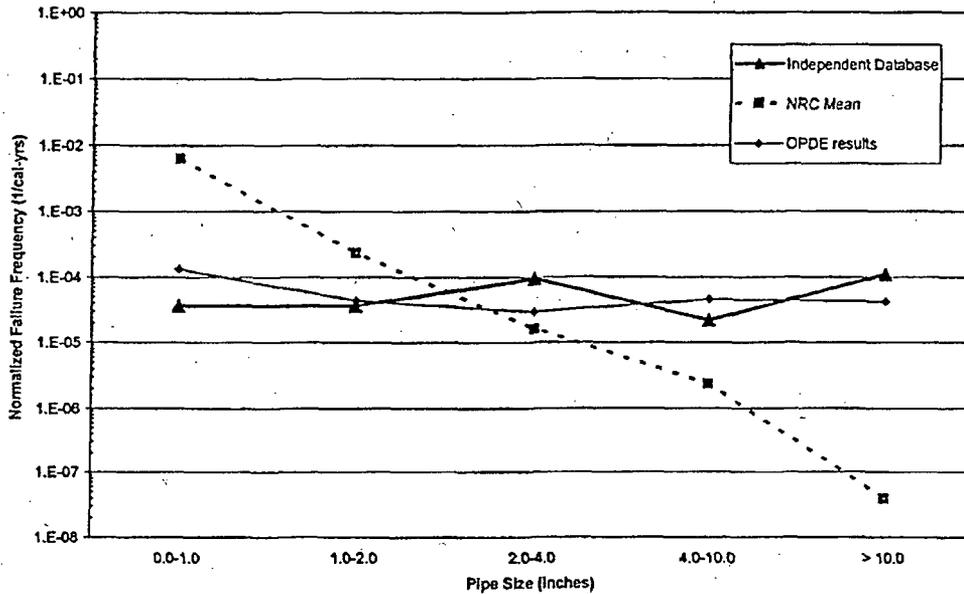
Figure 4.2-1. Normalized pipe failure frequency as a function of Pipe Group Size for PWRs.

The Figure 4.2-1 presents the overall normalized frequencies of PWR plants in the United States, and roughly 10 foreign plants for the independent database, the entire OPDE-light, and the NRC mean data given in reports. As seen, the NRC mean values of frequency decrease as the pipe size increases. Although in the two other independent sets of data obtained, the frequencies remain relatively the same throughout the pipe size groups. Pipe sizes which were less than roughly two inches had a lower frequency for the two independent data sets compared to the NRC data, and the pipe sizes above the two to four inches group size show a higher frequency compared to what the NRC's expert elicitation has predicted. This figure shows that the two independent data sources follow similar trends compared to what the NRC's prediction. The PWR frequency shows a vast difference at the higher pipe size groups which in turn contradicts the thinking that larger the pipe size have a smaller break frequency.

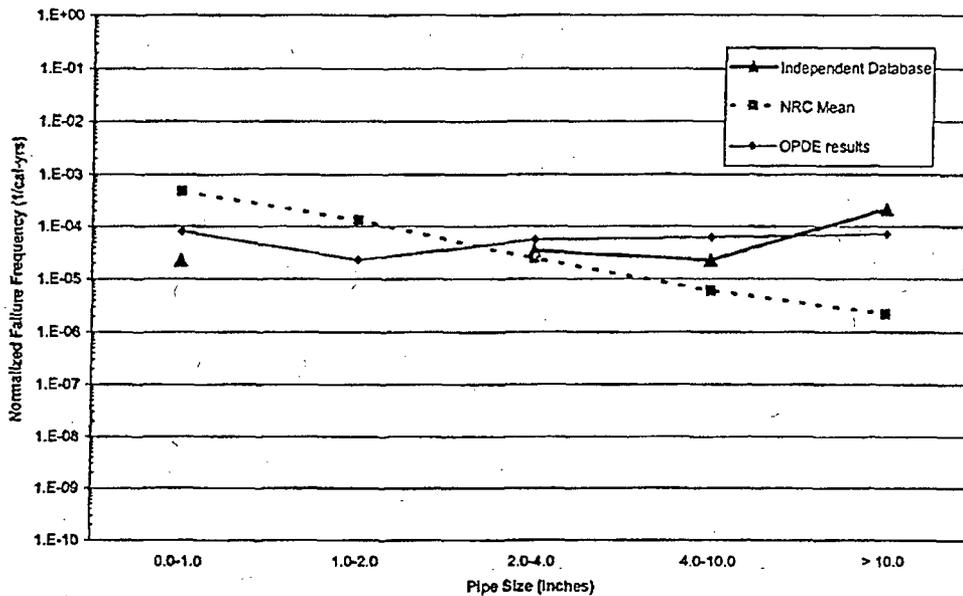
Figure 4.2-2. Normalized pipe failure frequency as a function of Pipe Group Size for BWRs.

Figure 4.2-2 presents the overall BWR data for the independent data, the OPDE-light, and the NRC data. A similar trend for each data set can be seen in BWR's as in PWR's, except that the frequency range is much smaller for BWR's than PWR's. The independent data provided no pipe failures in the pipe size group of one to two inches, and thus on a log-scale, no data point appears on the figure. Once again the independent data and the OPDE-light data coincide throughout the pipe size groups, and contradict the NRC prediction of pipe failure frequencies; except for the range of two to four inches again they are similar. Pipes which are larger than ten inches prove to have a higher frequency in the two independent data sets when compared to that of the NRC data set provided by expert elicitation.

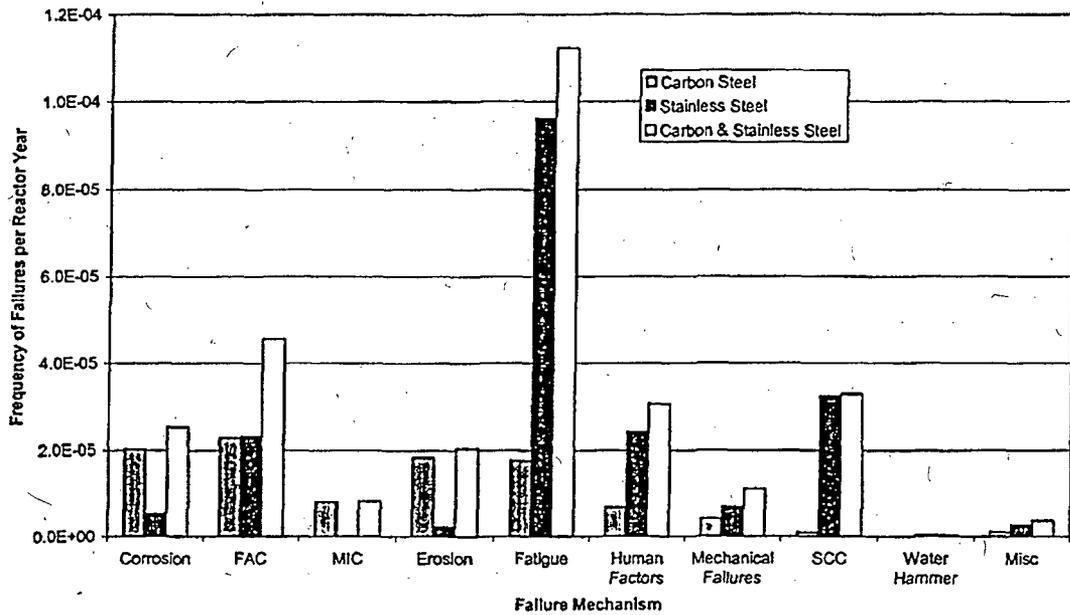
Figure 4.3-1. PWR Failure Frequency for Carbon and Stainless Steel Pipes as a Function of Failure Mechanism

This section of the report summarizes the frequency of failure mechanisms for carbon and stainless steel pipes. The information presented in figures 4.3-1 through 4.3-3 represents the normalized failure frequencies for each failure mechanism. This data is also presented in tabular form in table 4.3-1. The data was collapsed by pipe sizes and broken apart by steel type and plant type. The data was normalized for each type of steel based on the number of reactor years and the total amount of failures (carbon +stainless) for each plant.

From these plots it was determined that PWR plants are dominated by fatigue failures and BWR plants are dominated by stress corrosion cracking failures. However, in general the most frequent failure mechanisms for both plants are corrosion, fatigue, mechanical factors, and stress corrosion cracking. These four failure mechanisms were analyzed as a function of pipe size in figures 4.3-4 through 4.4-7.

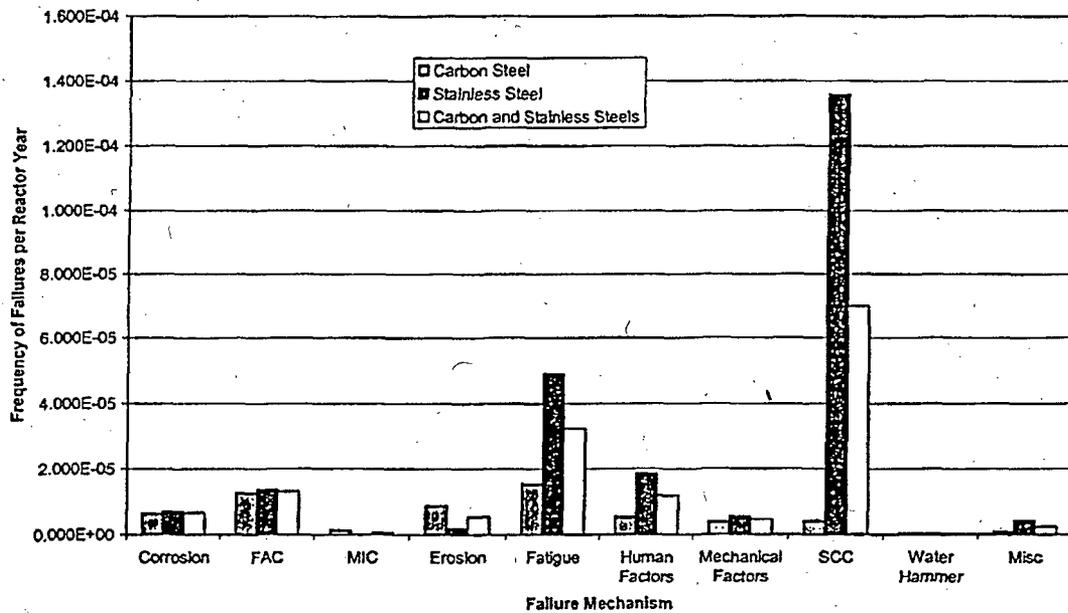
Figure 4.3-2. BWR Failure Frequency for Carbon and Stainless Steel Pipes as a Function of Failure Mechanism

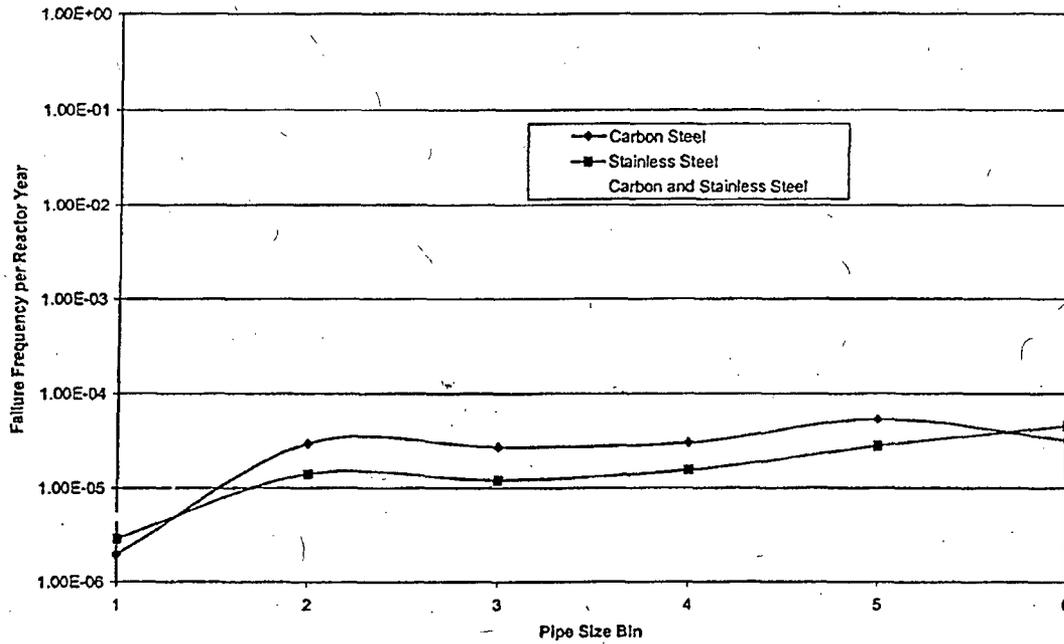
Figure 4.3-4. Pipe Failure by Corrosion as a Function of Pipe Size (PWR & BWR)

For these plots corrosion includes general corrosion, flow accelerated corrosion, and microbiological corrosion. Stress corrosion cracking was not included with corrosion because the pipe failure method for stress corrosion cracking is different than the other corrosion types. Though mechanical failure frequency was not the highest, mechanical failures were chosen because they appear to be independent of pipe type and plant type. Human factors were ignored because they are a factor of quality assurance as opposed to the other failure mechanisms which are primarily a factor of operation. In regards to human factors it is not known if they have decreased with reactor operating experience because the dates of failures was not included with the OPDE data.

The frequencies of pipe failures by corrosion shown in Figure 4.3-4 are nearly independent of pipe size. With the exception of the smallest of pipe sizes (< 1.0 inches) the frequency of failure for each type of steel is relatively constant. Stainless steel has a lower frequency of failure due to corrosion than carbon steel, which is expected because stainless steel is meant to be corrosion resistant.

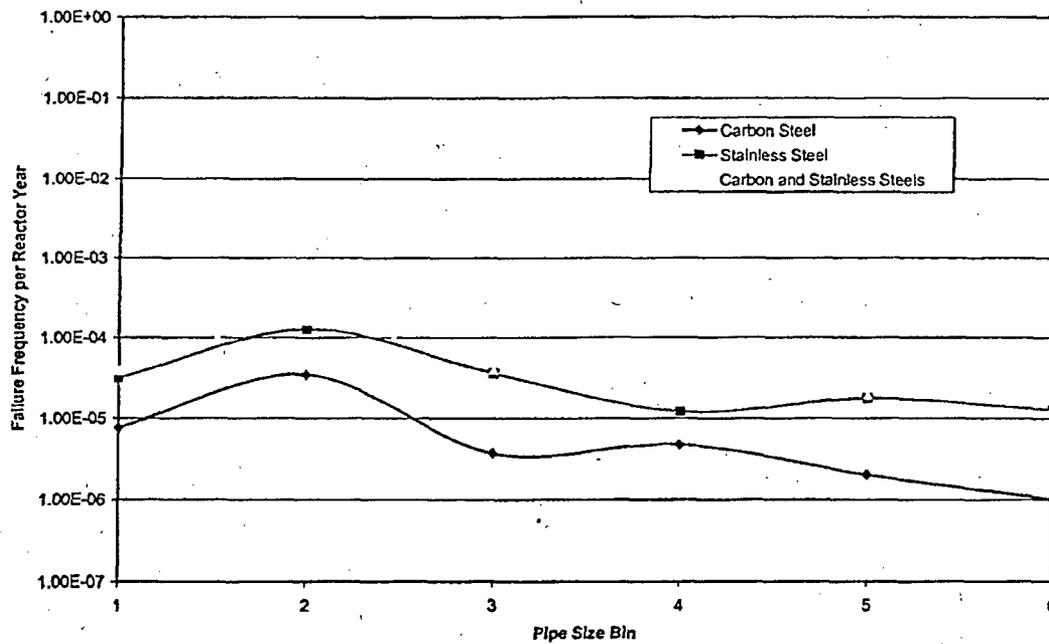
Figure 4.3-5. Pipe Failure by Fatigue as a Function of Pipe Size (PWR & BWR)

Figure 4.3-5 shows that carbon steel is less likely to fail by fatigue than stainless steel for all pipe sizes. The figure also shows that as the pipes increase in size they fail less frequently by fatigue. This is more than likely due to greater movement of the pipes as they decrease in size. The amount of force required to fatigue a larger pipe is greater than that of a smaller pipe.

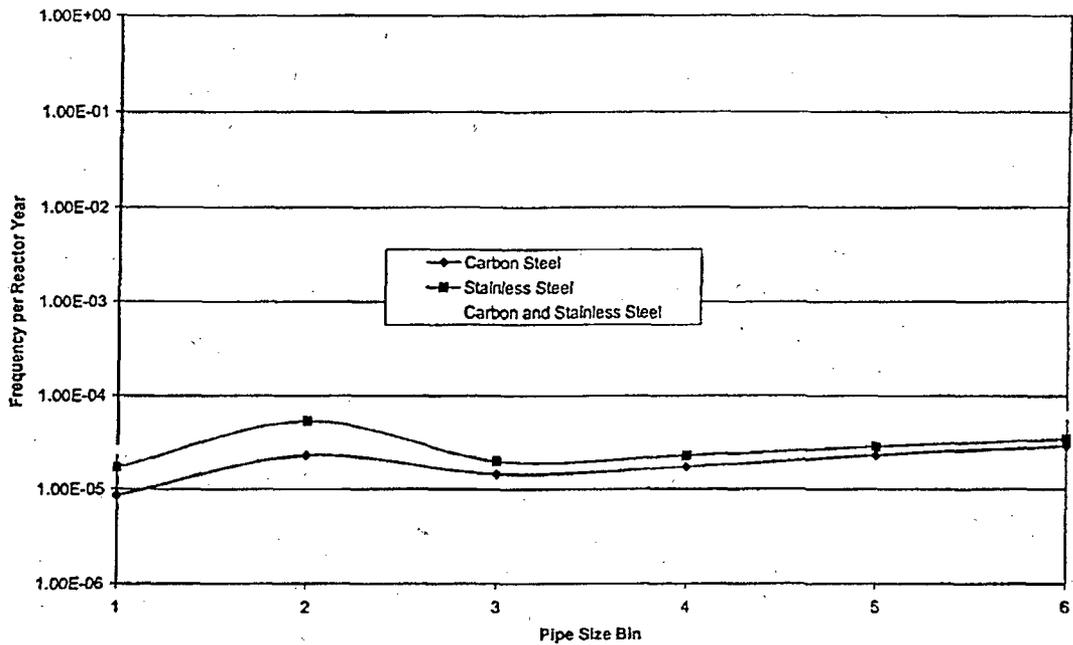
Figure 4.3-6. Pipe Failure by Mechanical Failures as a Function of Pipe Size (PWR & BWR)

Figure 4.3-6 supports the information from figure 4.3-3 that shows mechanical failures being relatively equal for all pipe sizes and types. The frequencies of the different pipes in each bin are roughly the same and they stay relatively constant across the spectrum of pipe sizes. The different failures that were grouped into mechanical failures as listed in the section 3.0 are excessive vibration, overpressurization, overstressed, and severe overloading. Though the instances of these failures are low they seem to affect all pipes relatively equally.

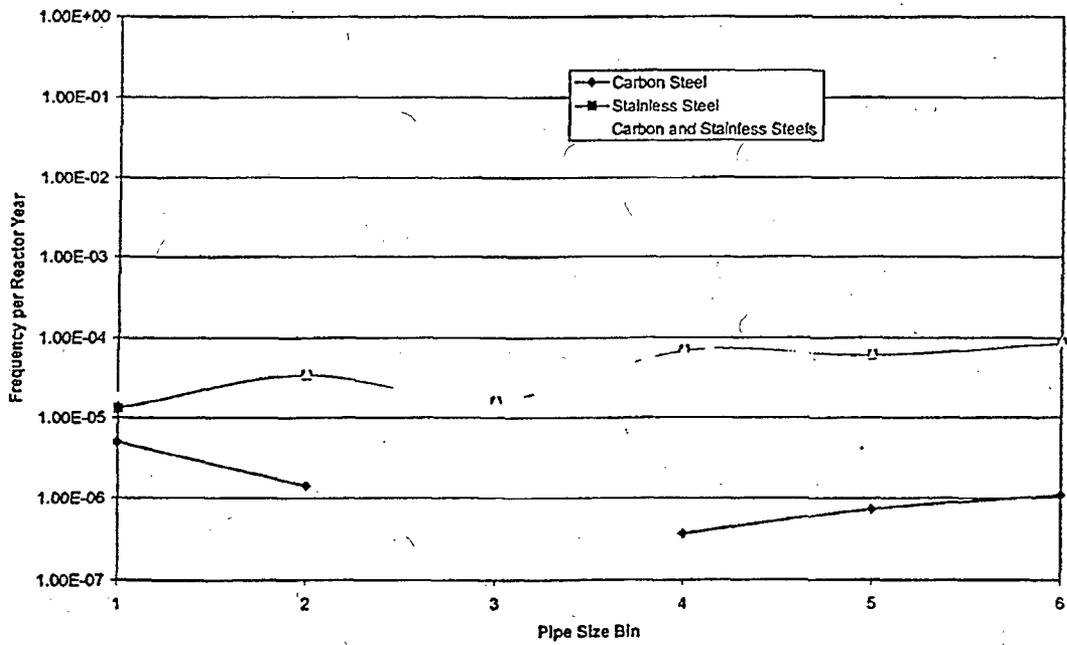
Figure 4.3-7. Pipe Failure by Stress Corrosion Cracking as a Function of Pipe Size (PWR & BWR)

Stress corrosion cracking appears to be much more prevalent in stainless steel pipes as opposed to carbon steel pipes as shown in Figure 4.3-7. The discontinuity in the carbon steel data is due to plotting a frequency of zero on a log scale. For both stainless and carbon pipes the frequency of failure increases for the largest pipe size (> 10 inches).

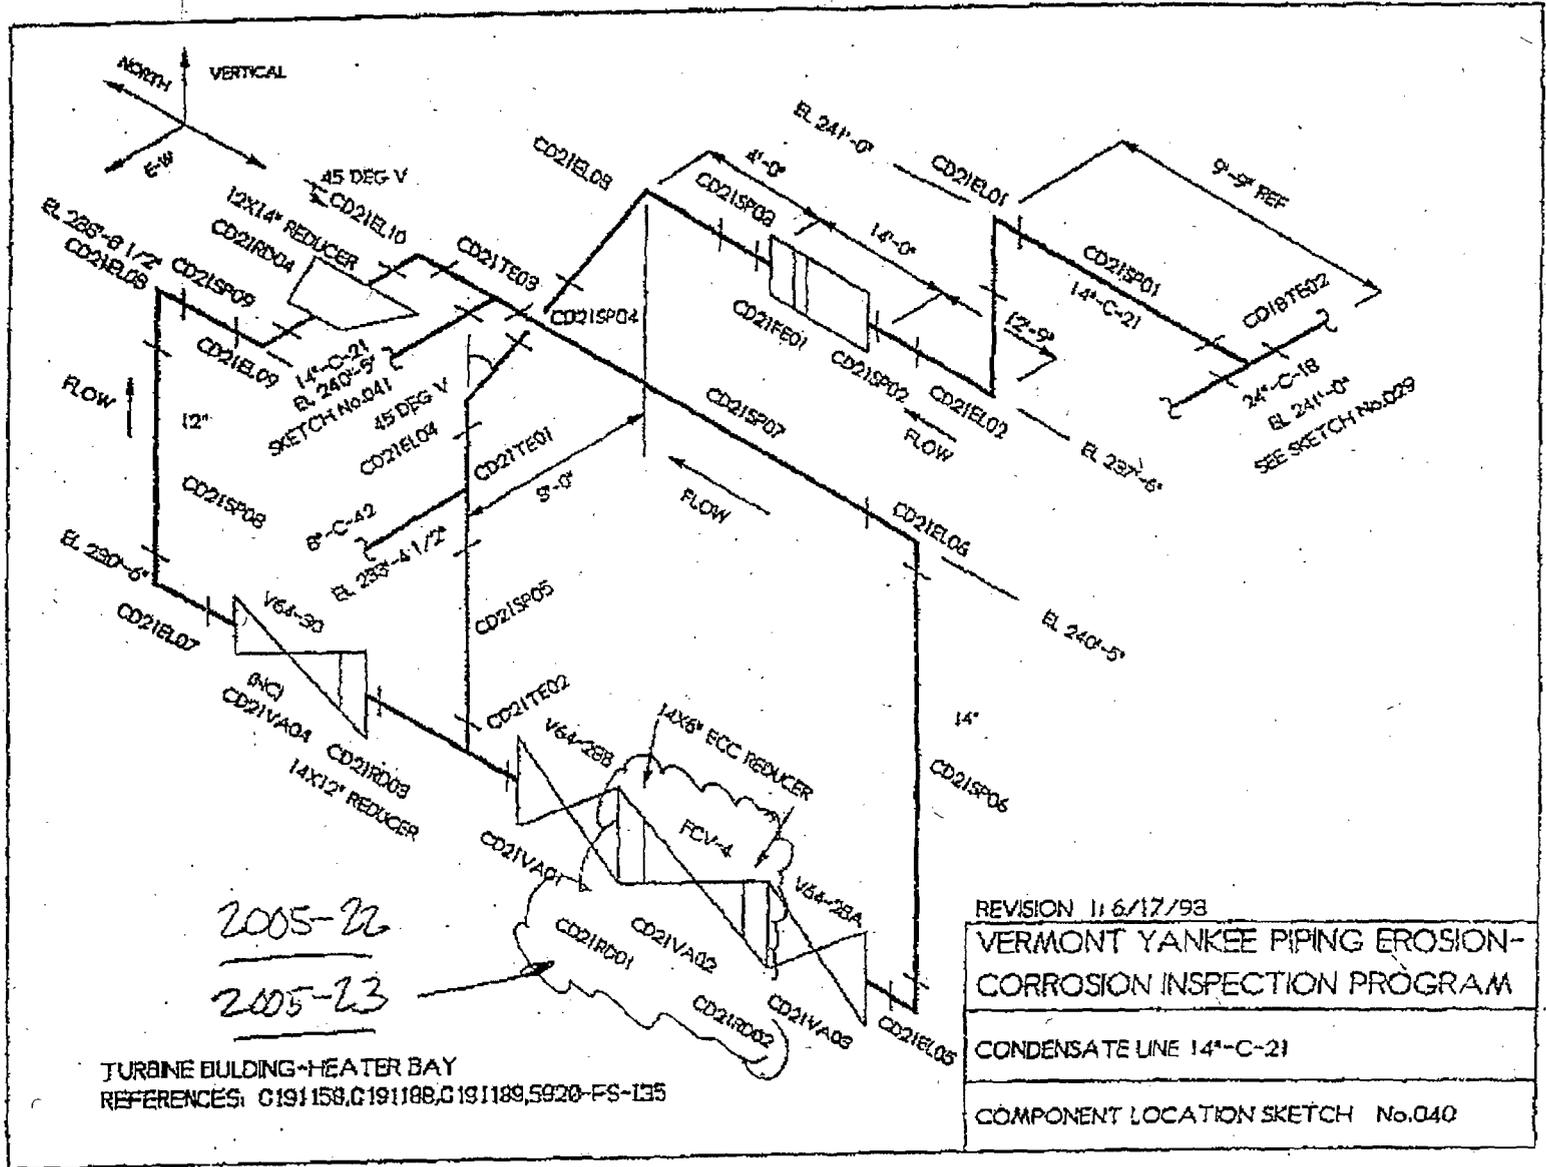
TURBINE BUILDING + HEATER BAY
 REFERENCES: C191158, C191188, C191189, 5920-FS-135

REVISION 11/6/17/98
VERMONT YANKEE PIPING EROSION-CORROSION INSPECTION PROGRAM
CONDENSATE LINE 14\"-C-21
COMPONENT LOCATION SKETCH No.040

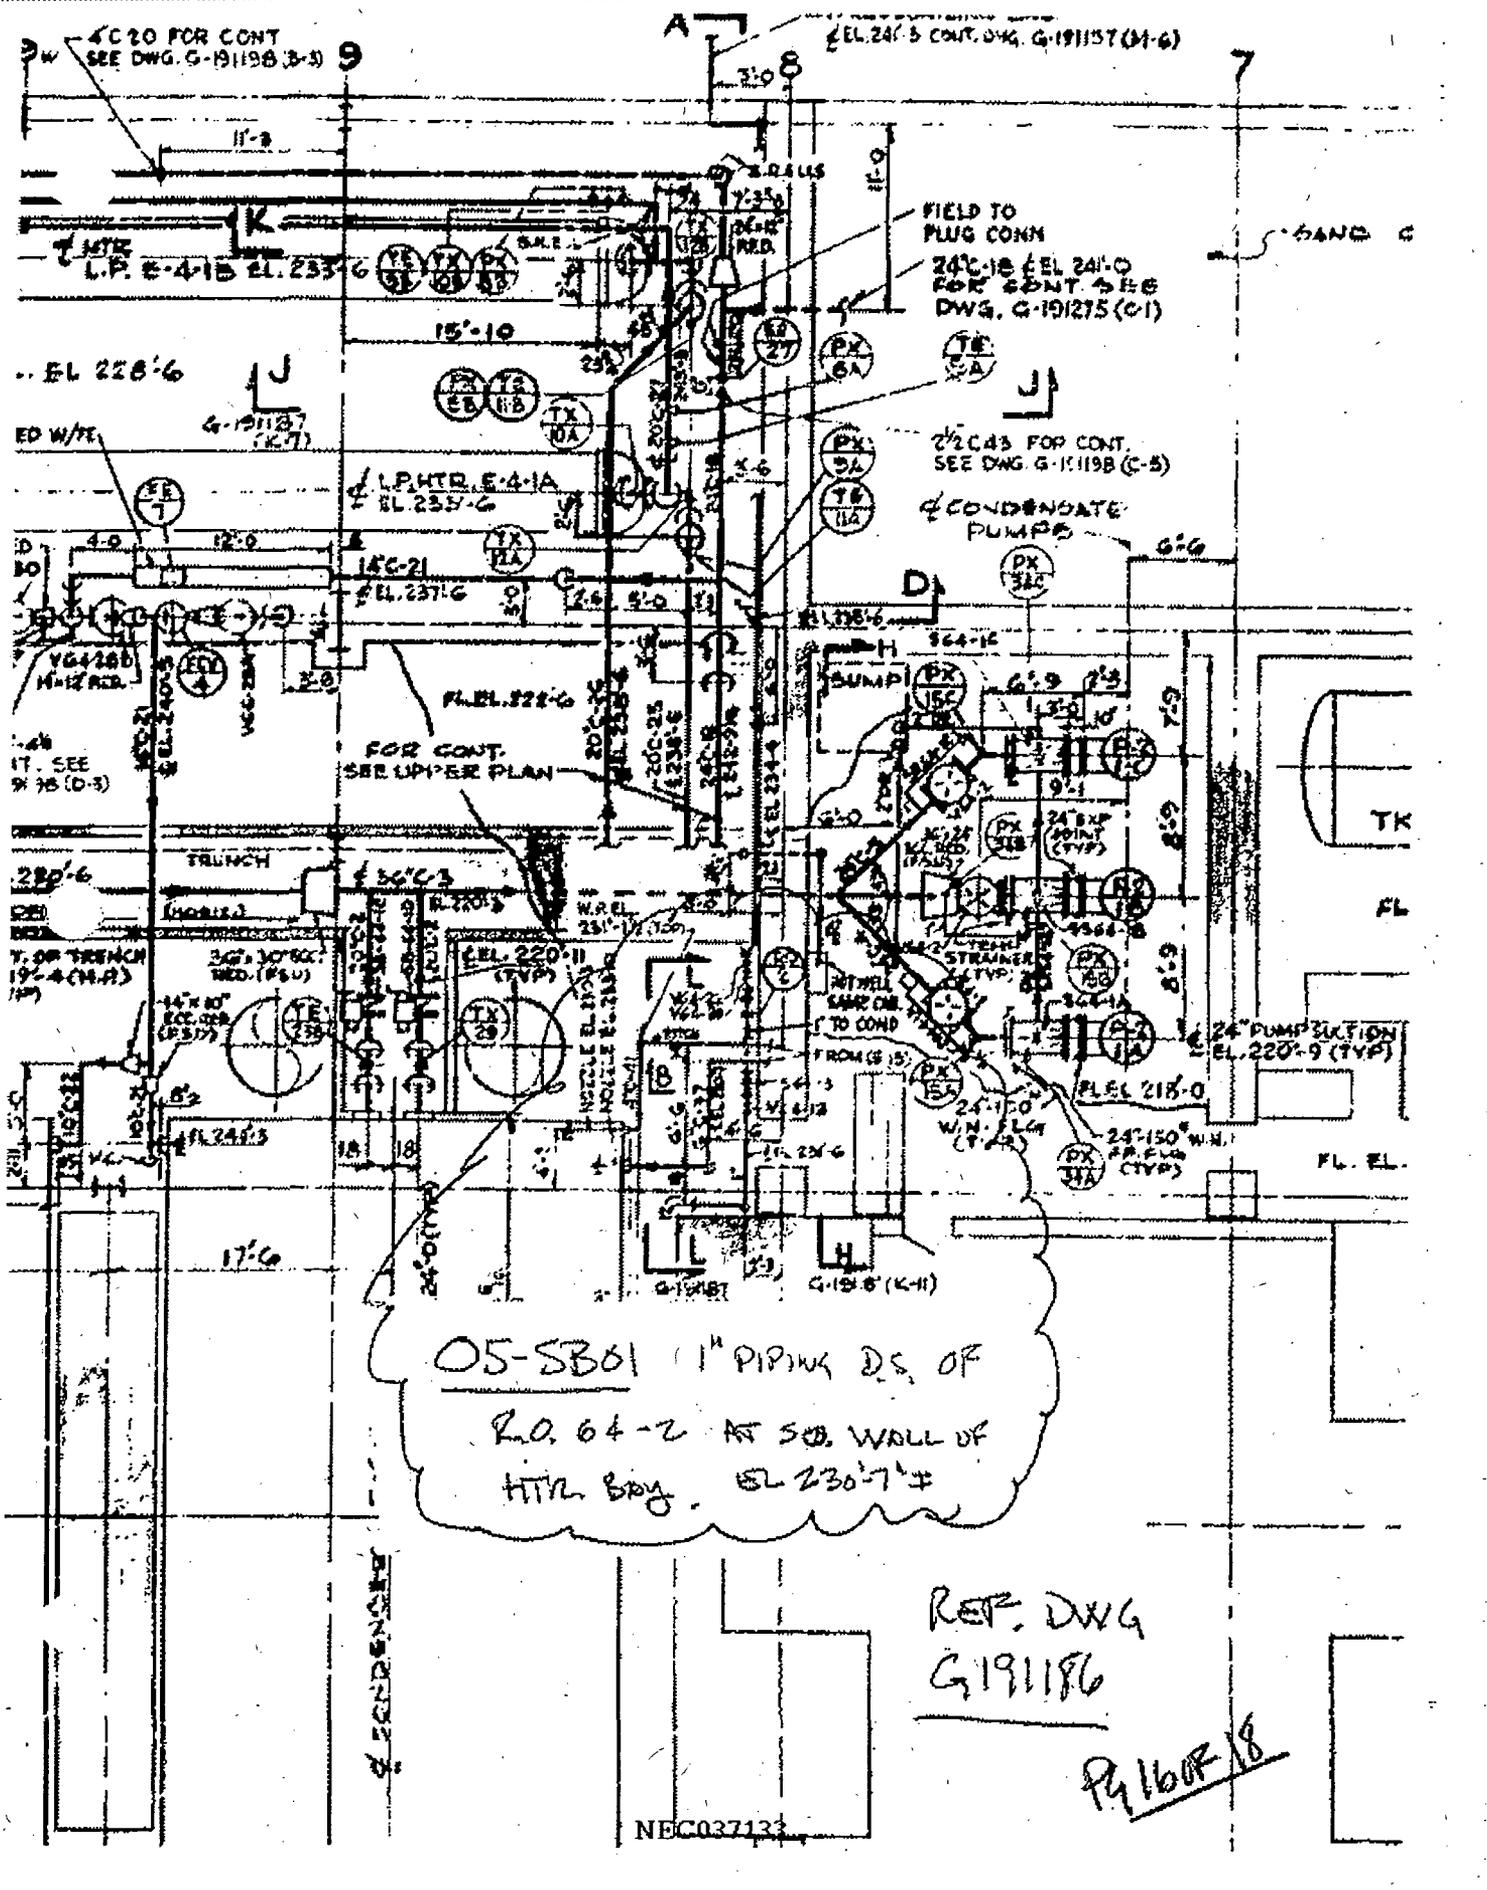
05-SB01 1" PIPING D.S. OF
 R.O. 64-2 AT SOB. WALL OF
 HTTR Bldg. EL 230'-7"±

REF. DWG
 G191186

Small Bore Inspection Number	S.B. Data Base No.	System	Description	Location	Drawings	Reason /Comments
05-SB01	119	Condensate	1" piping DS of R.O. 64-2	T.B. Heater Bay	G191157 Sht.1 5920- FSI -17	Industry OE17654
05-SB02	128	CRD	1" Piping D.S. of R.O.-3-24A	Rx. SW Elev. 232.5 P38-1A	G191170 / G191212 / G191215	Industry OE17654
05-SB03	129	CRD	1" Piping D.S. of R.O.-3-25A	Rx. SW Elev. 232.5 P38-1A	G191170 / G191212 / G191215	Industry OE17654
05-SB04	130	CRD	1" Piping D.S. of R.O.-3-24B	Rx. SW Elev. 232.5 P38-1B	G191170 / G191212 / G191215	Industry OE17654
05-SB05	131	CRD	1" Piping D.S. of R.O.-3-25B	Rx. SW Elev. 232.5 P38-1B	G191170 / G191212 / G191215	Industry OE17654
