IE Circular 81-06: POTENTIAL DEFICIENCY AFFECTING CERTAIN FOXBORO 10 to 50  
MILLIAMPERE TRANSMITTERS

**Subject:** Potential Deficiency Affecting Foxboro Transmitters,  
Model Numbers N-E11, N-E13 or E11, E13 with suffix  
Codes /MCA, /MCA/RBW, or /MCA/RE

-- ELECTRONIC SERVICING --  
Series E10 Force-Balance Transmitters  
(10 to 50 mA Signal)

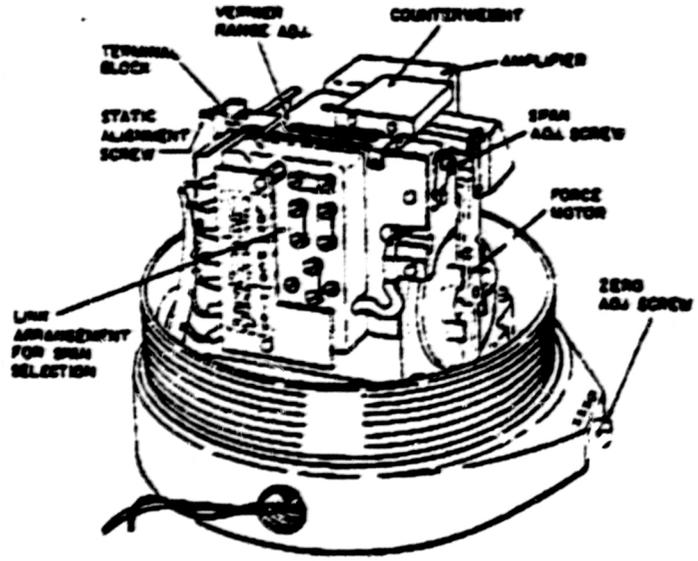
The Series E10 Electronic Force-Balance Transmitter top-works shown at right is used with various types of transmitters. The body (not shown) varies according to the type of application involved. The electrical wiring is the same for all transmitter top-works.
