Byron and Braidwood

Recent Potential Over Power Issues

November 19, 2003

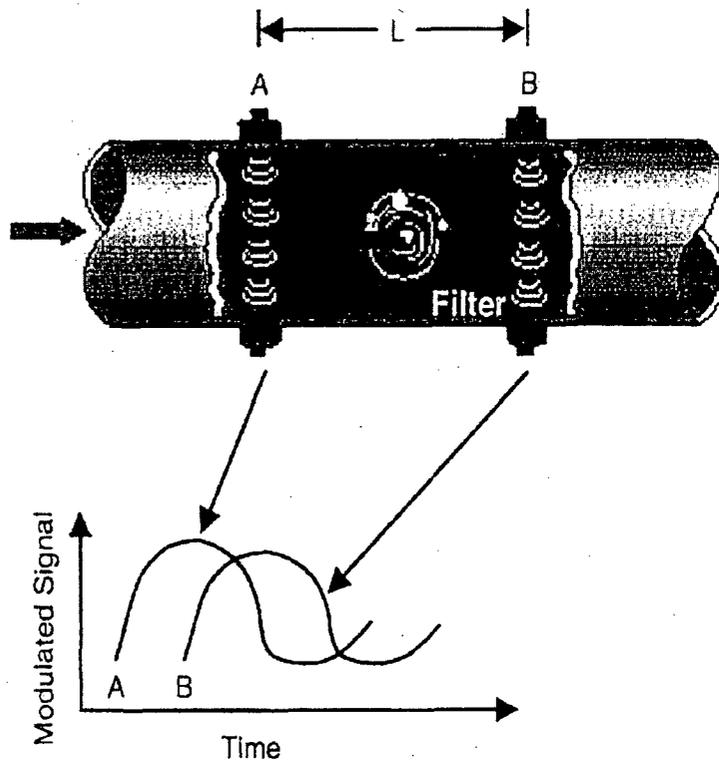
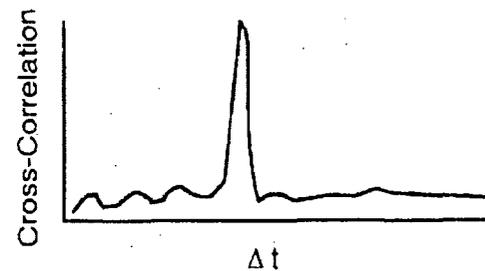
Cross-Correlation Process

- Cross-Correlation measures the velocity of eddies within the fluid using a non-intrusive transducer mounted externally on existing piping.
- For this process, an ultrasonic beam is modulated by the eddies that are present in the flowing liquid.
- As the modulated signal is processed, a random signal, which is the signature of the flowing eddies, is obtained.
- The modulated signals from the upstream and downstream transducers are displaced in time by the time that it takes for the eddies to pass between the two transducer sets.

$$\int f_A(t + \Delta t) \cdot f_B(t) dt$$

$$\text{Velocity} = \frac{L}{\Delta t}$$
