Beaver Valley Power Station, Unit No. 1
Docket No. 50-334, License No. DPR-66
Response to Request for Additional Information - 2007 Steam Generator Tube
Inspections (TAC No. MD8392)

Response to Request for Additional Information, 2007 Steam Generator Tube
Inspections, Beaver Valley Power Station, Unit No. 1

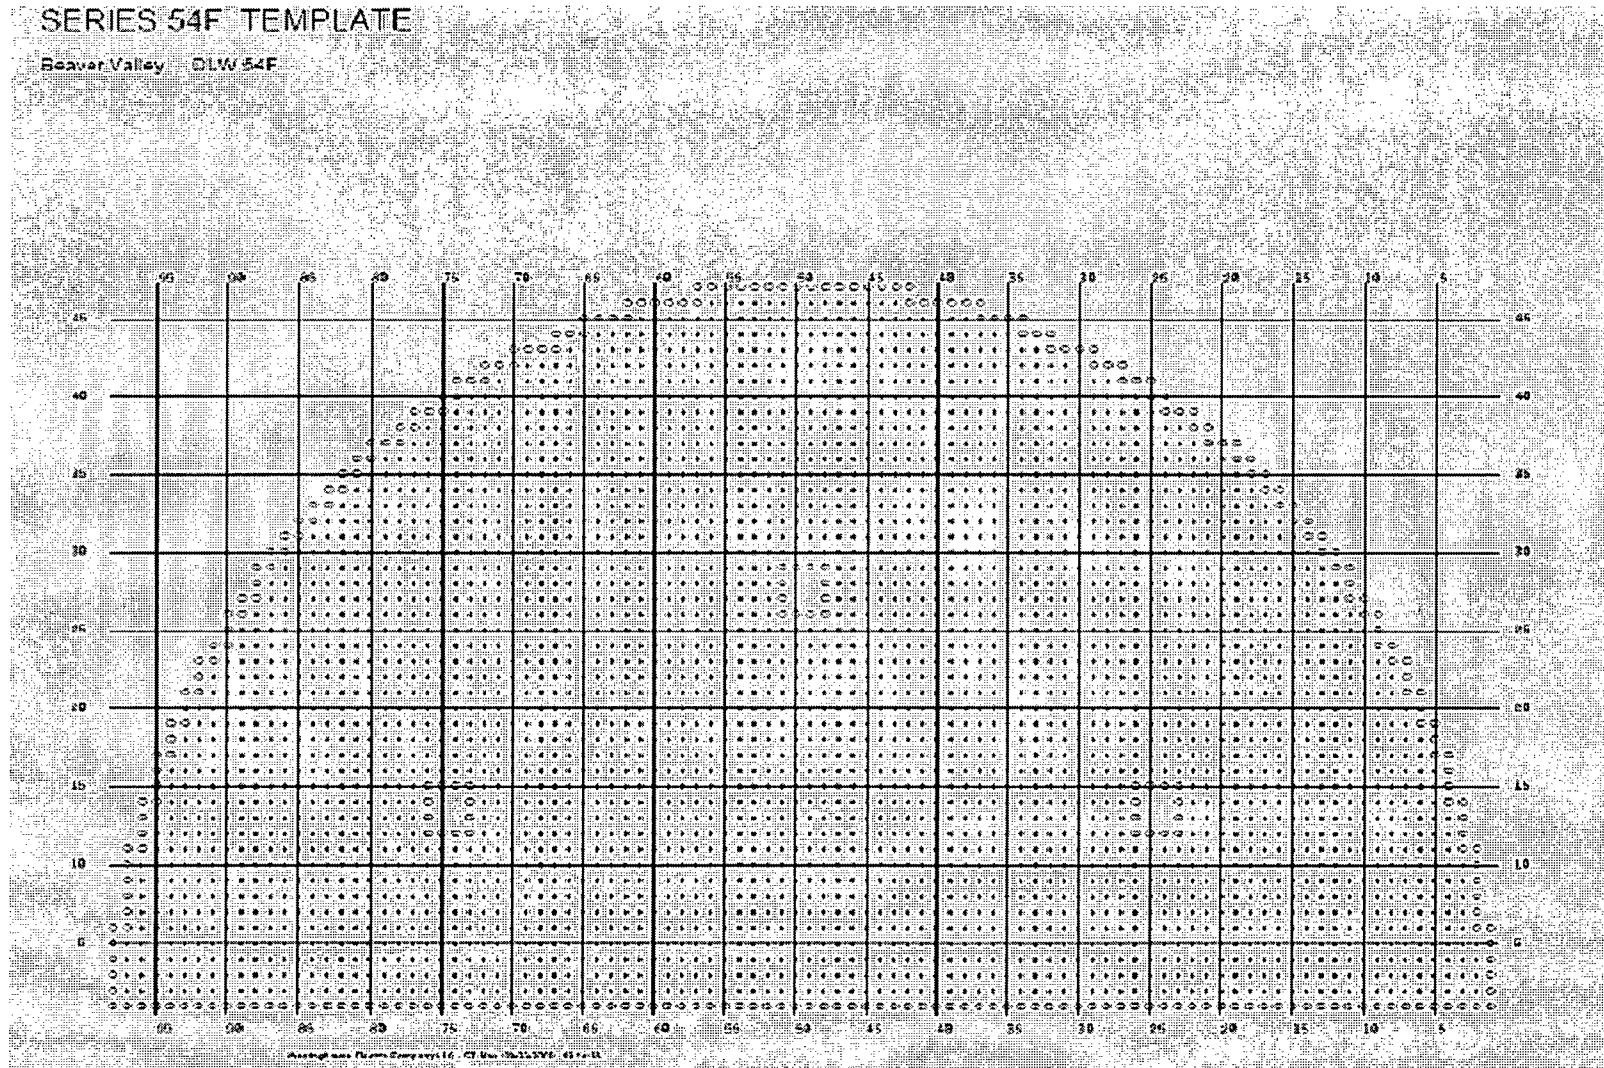
Figure 1 – BVPS-1 Steam Generator Tubesheet Map

A tubesheet map is provided in Figure 1.

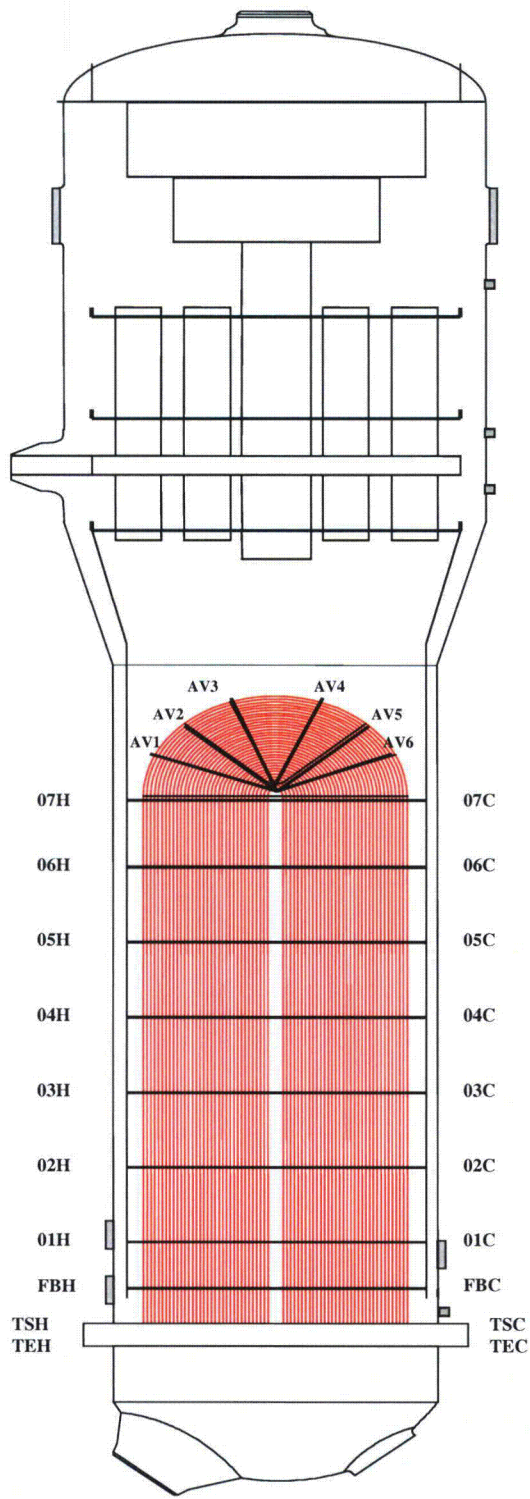
- TEH - Tube End Hot
- TSH - Tubesheet Hot
- FBH - Flow Baffle Hot
- 01H - 1st Tube Support Plate Hot
- 07H - 7th Tube Support Plate Hot
- AV1 - 1st Anti-Vibration Bar
- AV6 - 6th Anti-Vibration Bar
- 07C - 7th Tube Support Plate Cold
- 01C - 1st Tube Support Plate Cold
- FBC - Flow Baffle Cold
- TSC - Tubesheet Cold
- TEC - Tube End Cold

Figure 2 – BVPS-1 Steam Generator Support Plate Naming Convention

The SG tube support plate naming convention is illustrated in Figure 2.

The Model 54F design includes a flow distribution baffle (Labeled "FBH" and "FBC" on Figure 2) located between the top of tubesheet and first tube support plate. The flow distribution baffle (FDB) is designed to minimize the number of tubes exposed to low velocity flow in the vicinity of the tubeplate. The flow distribution baffle, fabricated from ASME SA-240, Type 405 stainless steel, has octafoil shaped broached tube holes. The effective annular flow area between

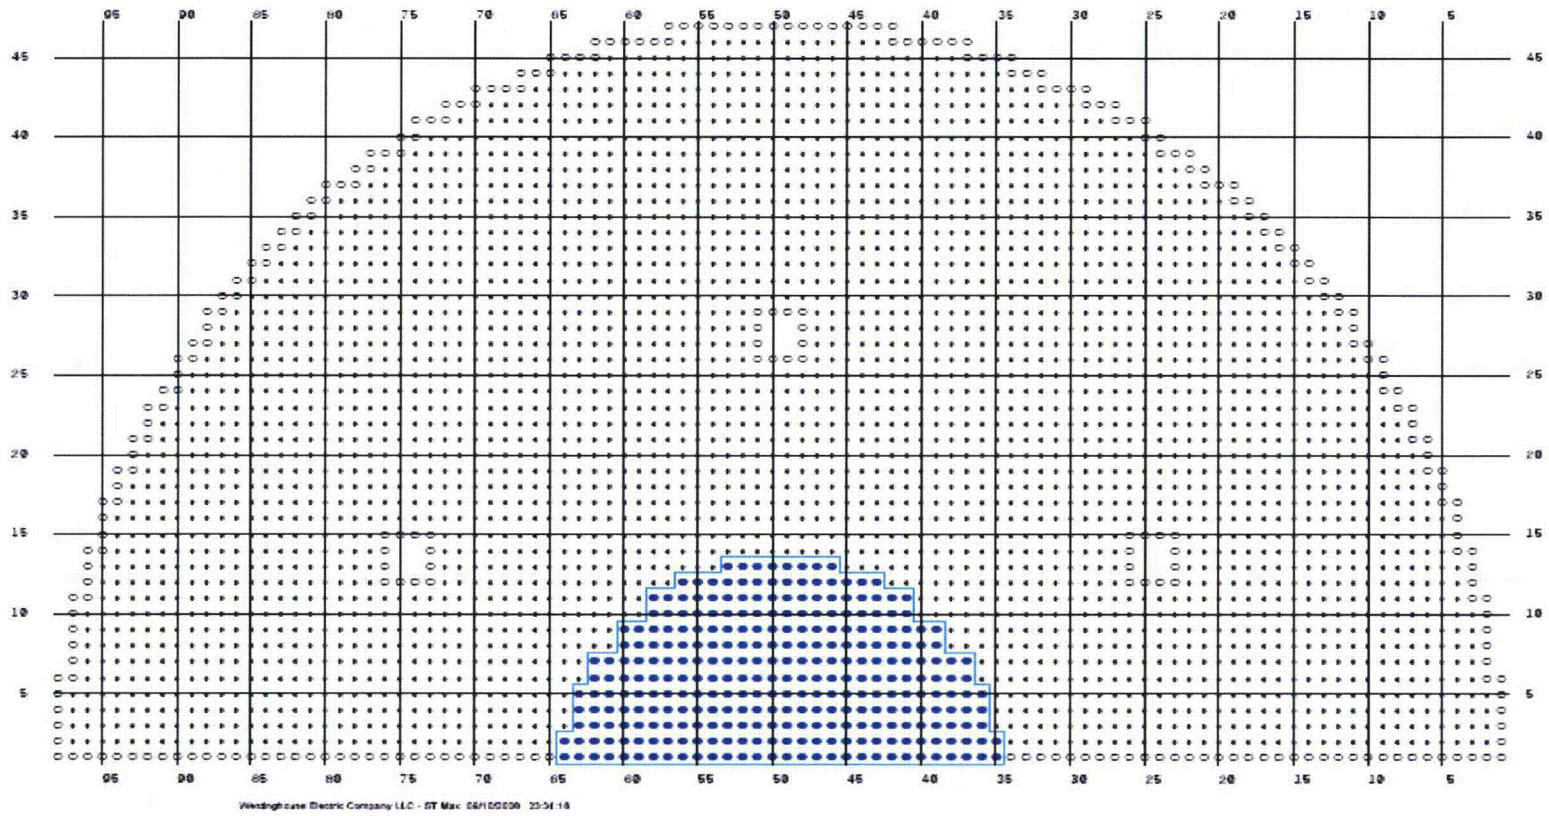
SERIES 54F CUT OUT REGION

• 298 TUBES WITHIN CUT-OUT REGION

Figure 3 – BVPS-1 Steam Generator Flow Distribution Baffle

the tube outside diameter and the effective hole inside diameter is less in the case of the flow distribution baffle than for the tube support plates. Also, the center portion of the flow distribution baffle is cut out as indicated in Figure 3. This flow distribution baffle design controls the cross-flow velocity so that the low velocity region (and sludge deposition zone) is located at the center of the tube bundle, near the blowdown intake.
