Union of Concerned Scientists

August 21, 2008

**Re: OPERATOR WORKING HOUR LIMITS AT MULTIPLE-UNIT
NUCLEAR PLANT SITE WITH AT LEAST ONE REACTOR
OPERATING AND OTHER(S) NOT**

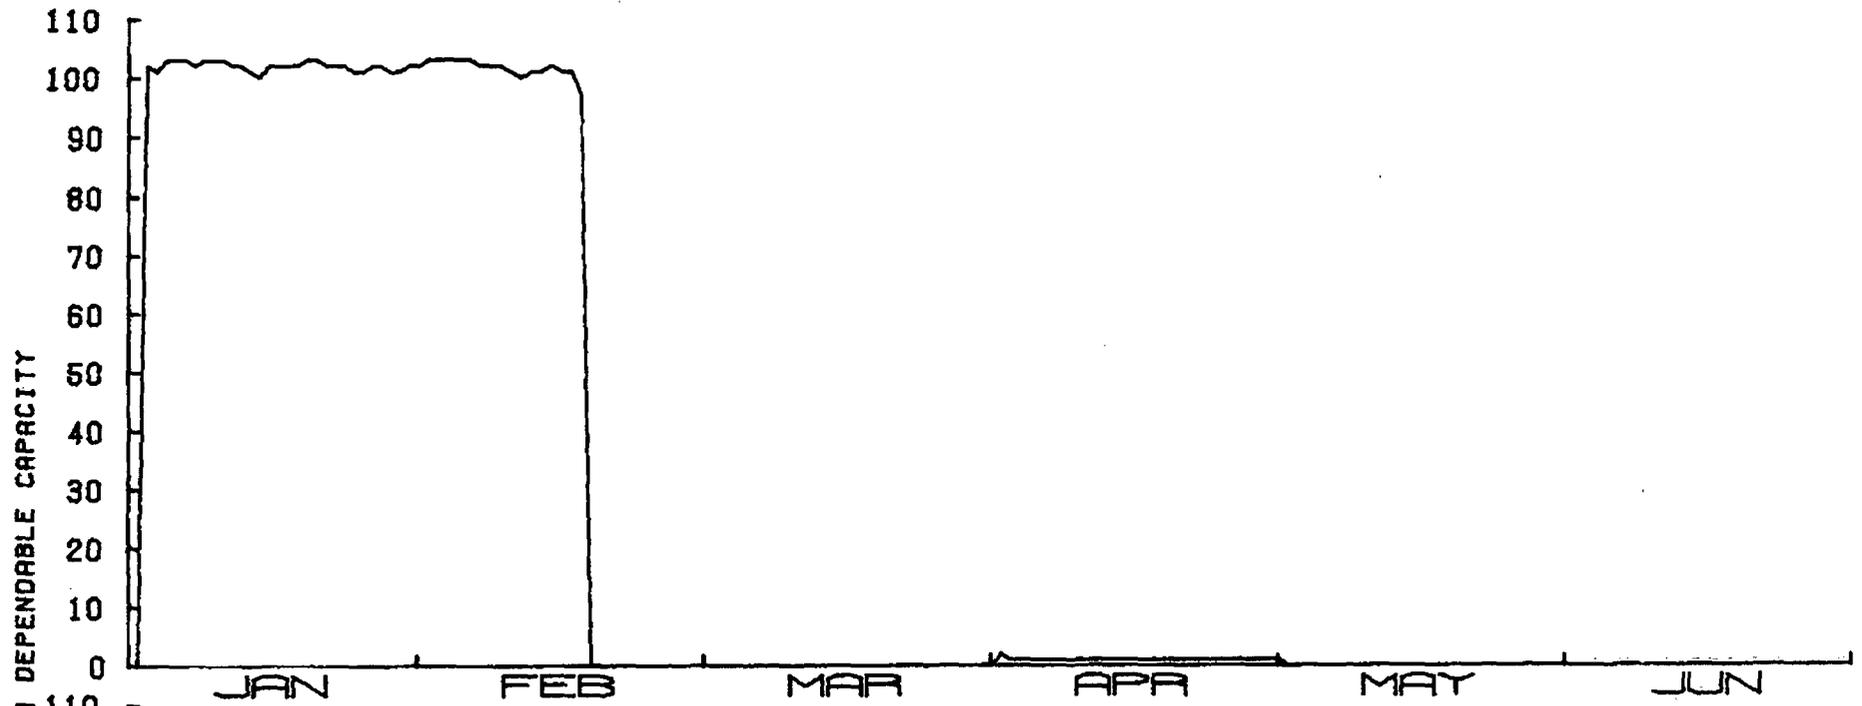
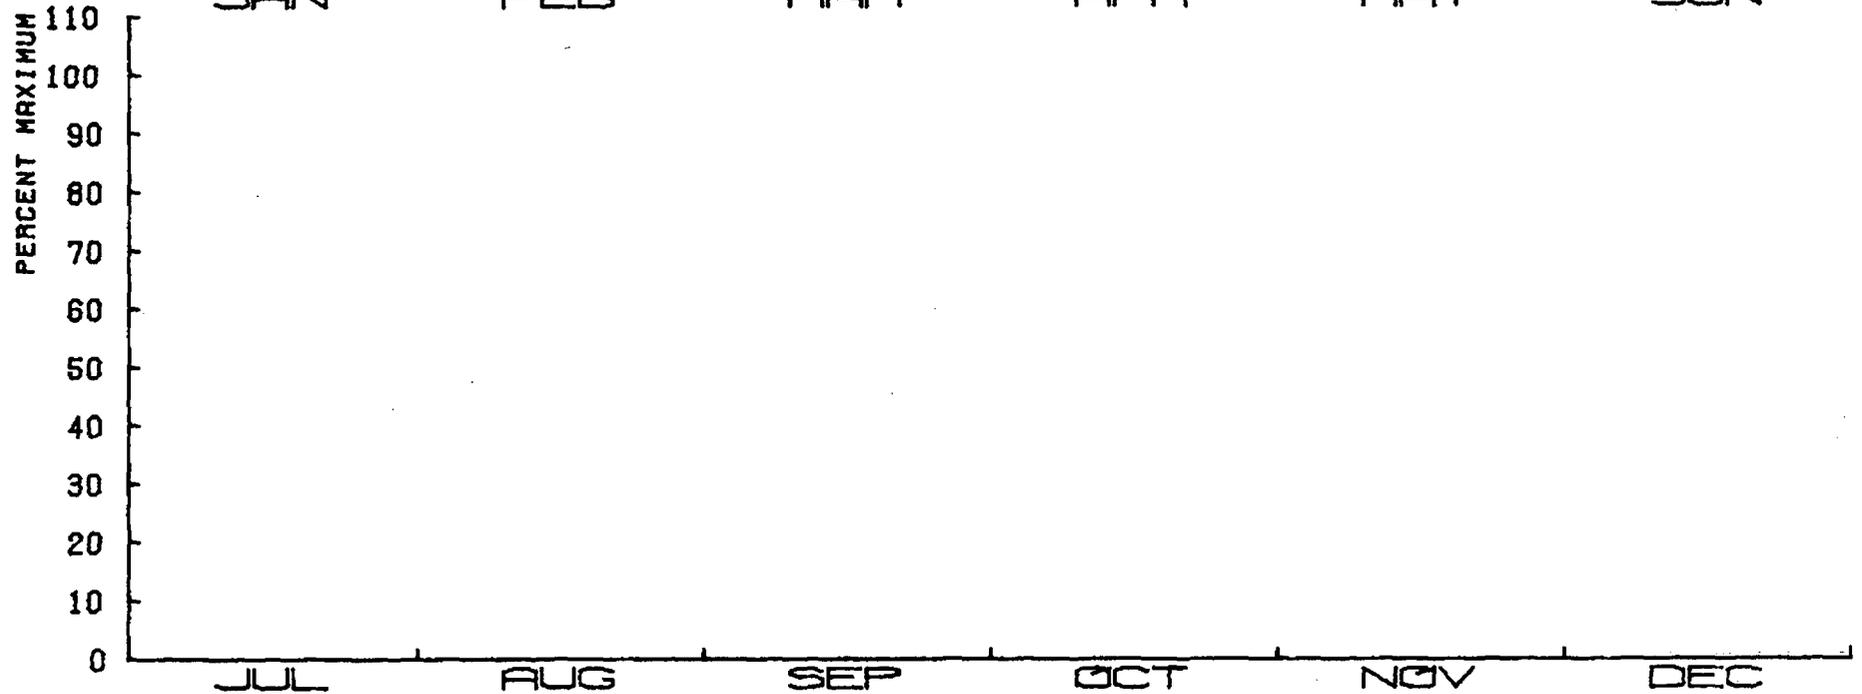
THREE MILE ISLAND 1

No.	Date (1979)	Duration (h)	Type	Description	Cause	Shutdown method	System involved	Component involved
1a)	2/17	940	S	Refueling	C	1	Reactor (RC)	Fuel elements
1b)	2/17 (cont.)	6692	F	The unit remained shut down for investigation of possible safety problems related to the TMI-2 accident	D	4	Steam and power con- version (HH)	Instrumenta- tion and controls

DESIGN ELEC. RATING = 819 MAX. DEPEND. CAP. = 776 (100%)
