Leak Path Assessment NRR Update,
Terry McAlister & William Simms

Leak Path Assessment NRR Update

11/24/2008

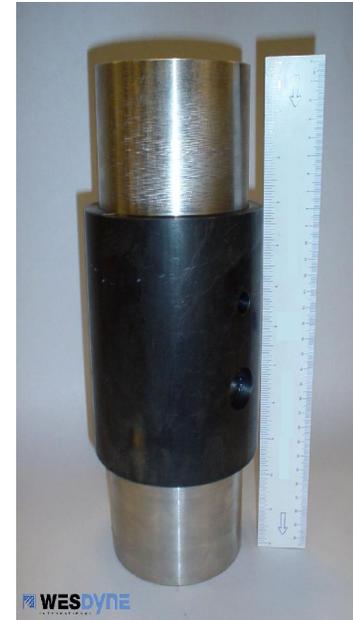
UTLP Mockups

- ⌘ 3 mockups built
 - ⌘ One with slip fit (0-0.5 mil interference)
 - ⌘ 1/8" and 1/16" wide channels made (dremel tool)
 - ⌘ Coarse machining done for "worst case"
 - ⌘ One with 2 mil shrink fit
 - ⌘ 1/8" and 1/16" wide channels made (dremel tool)
 - ⌘ Coarse machining done for "worst case"
 - ⌘ One with 5 mil shrink fit
 - ⌘ 3 grooved EDM
 - ⌘ 0.25" width X 3.75"

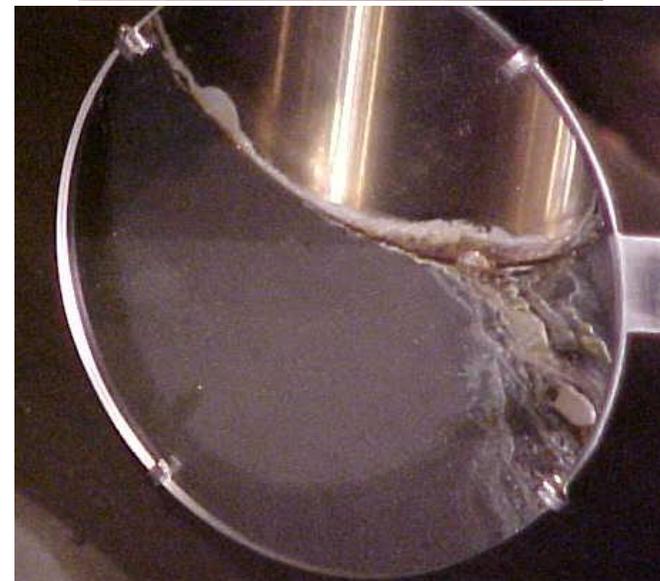
Tight Annulus w/o washed out “riverbed”

- ρ Early stage of leakage
- ρ Detected with BMV
- ρ Crack in weld, no damage to nozzle
- ρ UTLP detected with reduced amplitude riverbed at triple point aligned with weld crack
- ρ Weld crack confirmed by ET, field surface replication and He leak test
