Specification  
IS-328227-004

Specification  
for  
Oyster Creek

Functional Requirements for Drywell Containment  
Vessel  
Thickness Examinations

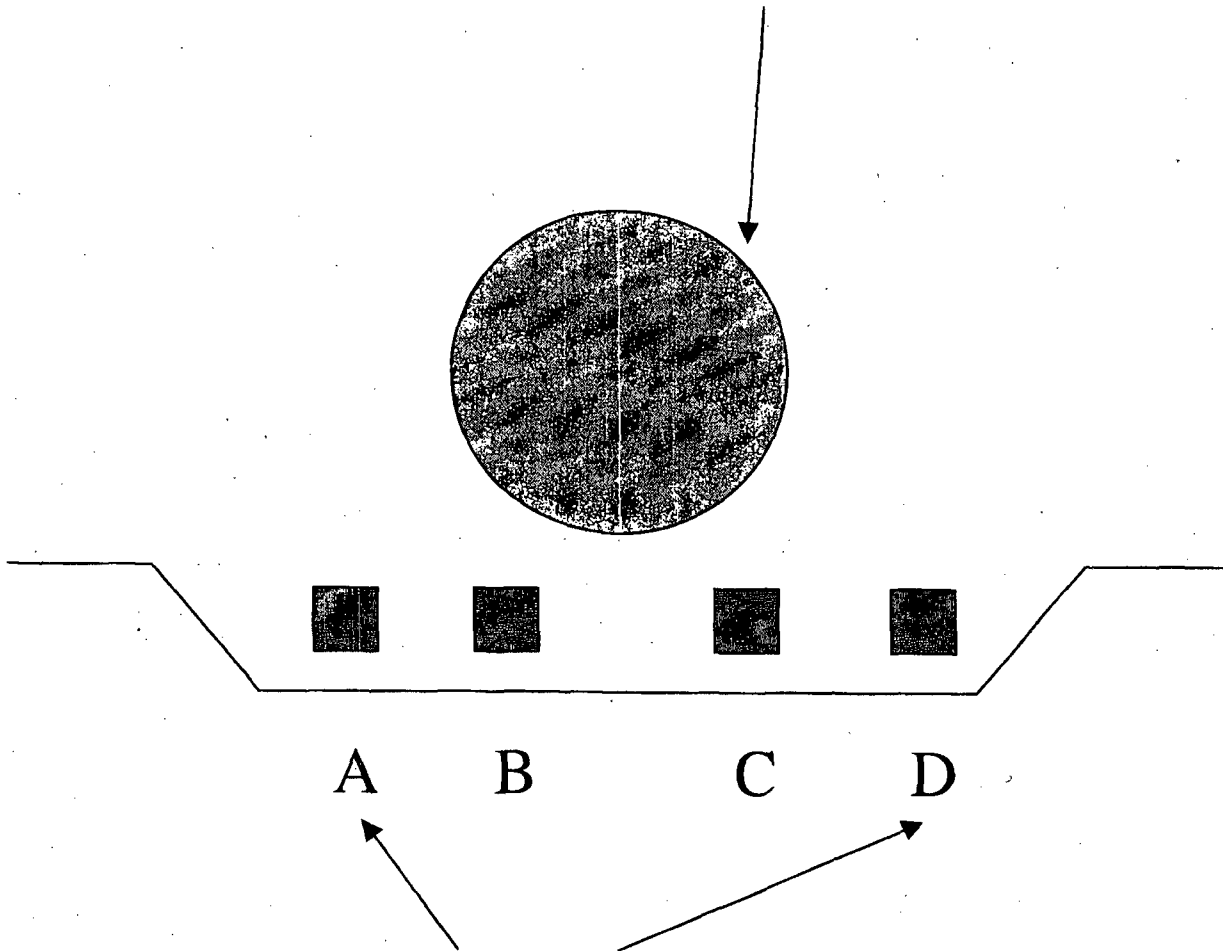
## Typical Orientation of Inspection Locations in the Sandbed Region

View - looking from inside the drywell

Location IDs = Bay Number plus one of these letters: i.e. - "11D"

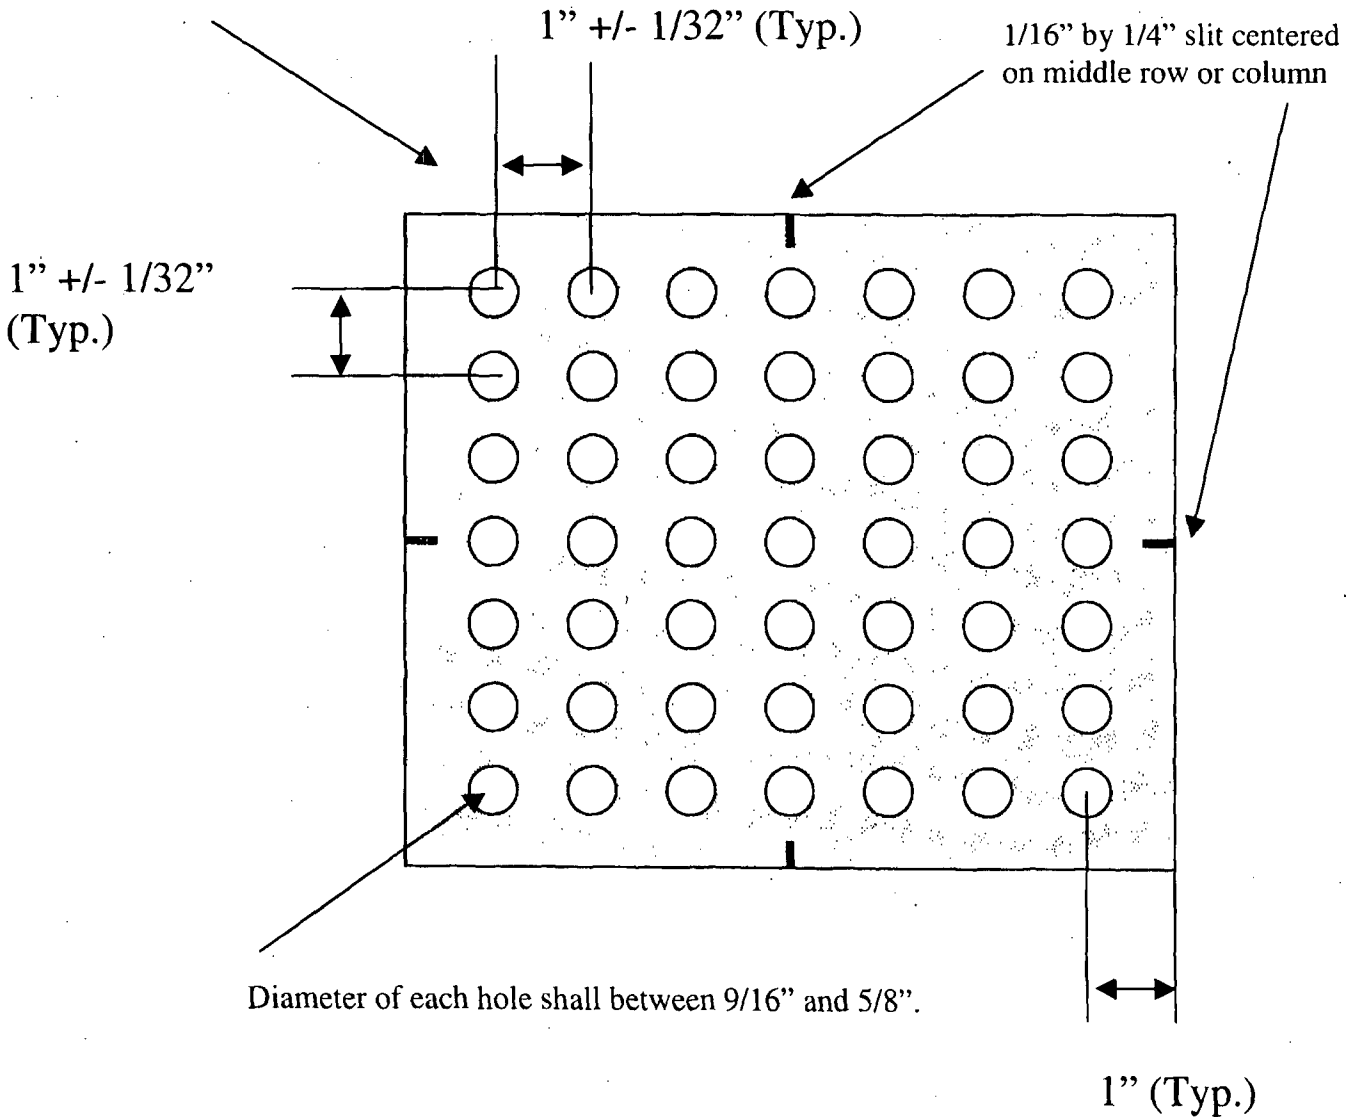
## Exhibit 2

Template shall be made of Stainless Steel, approximately 0.30 inches thick, with 49 holes centered on a 1 inch pattern.

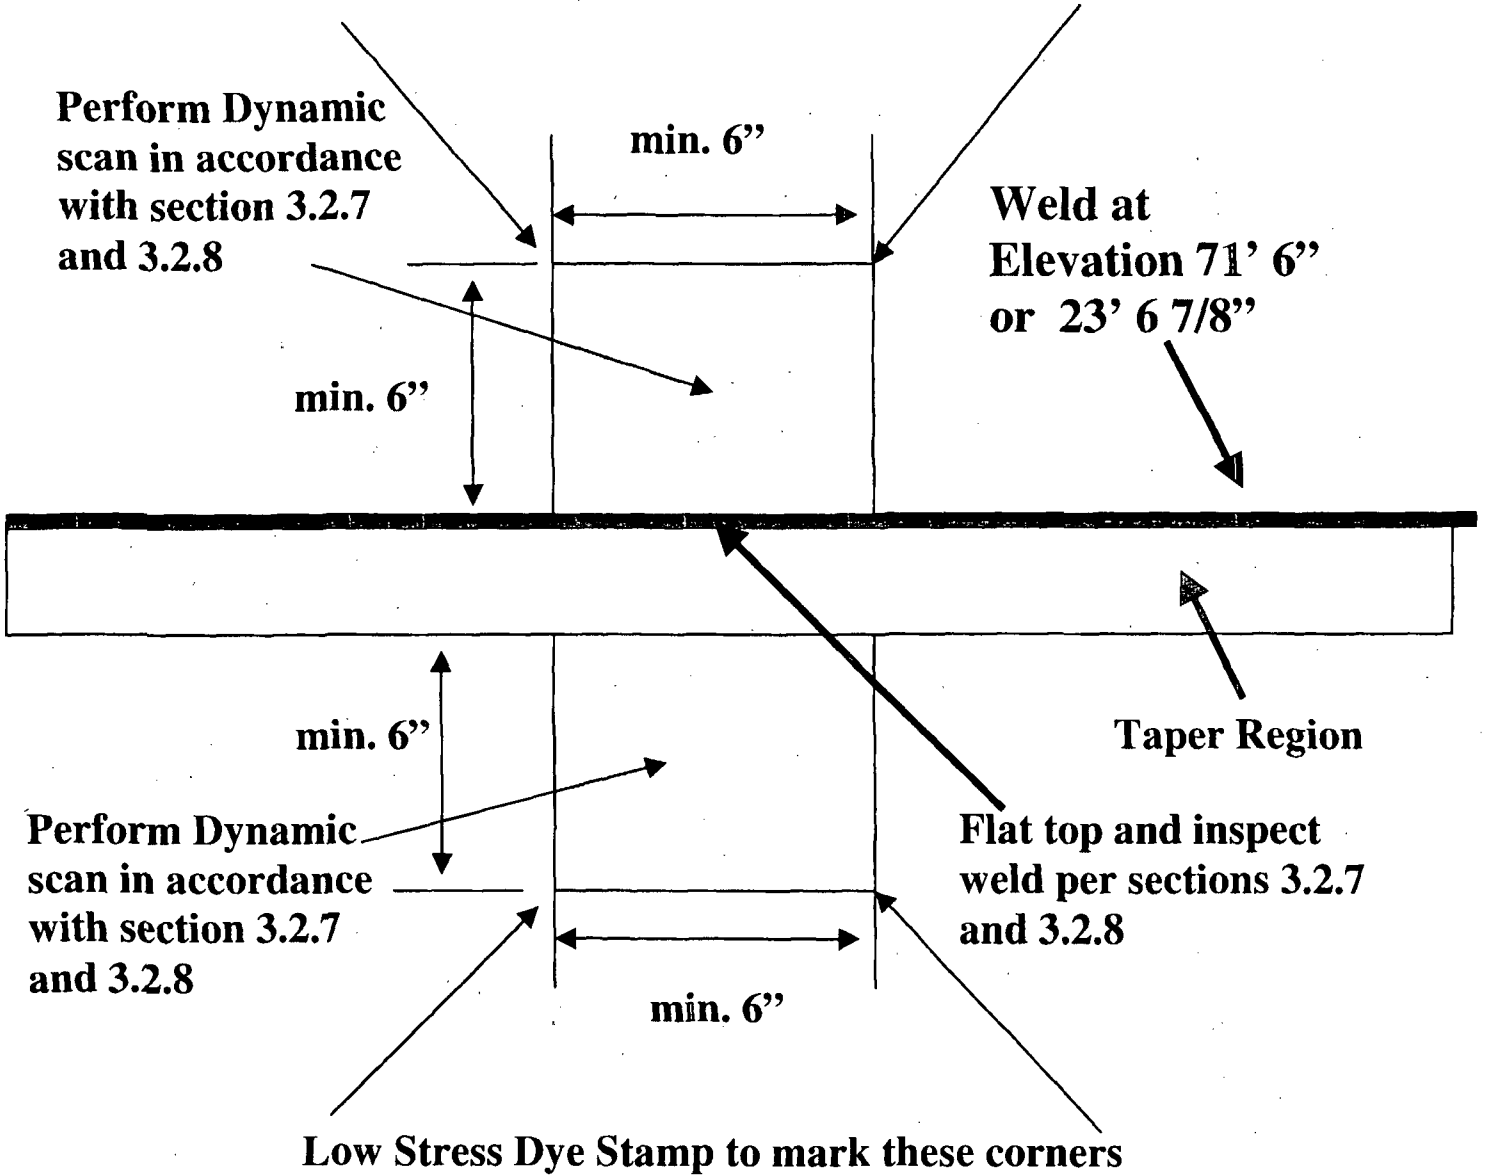
# Exhibit 6

**Low Stress Dye Stamp to mark these corners**

**Elevation View**
