Prairie Island Nuclear Generating Plant Units 1 and 2
Dockets 50-282 and 50-306
License Nos. DPR-42 and DPR-60

Response to NRC Request for Additional Information Regarding Application for Renewed Operating Licenses

Response to Follow-up RAI B2.1.38

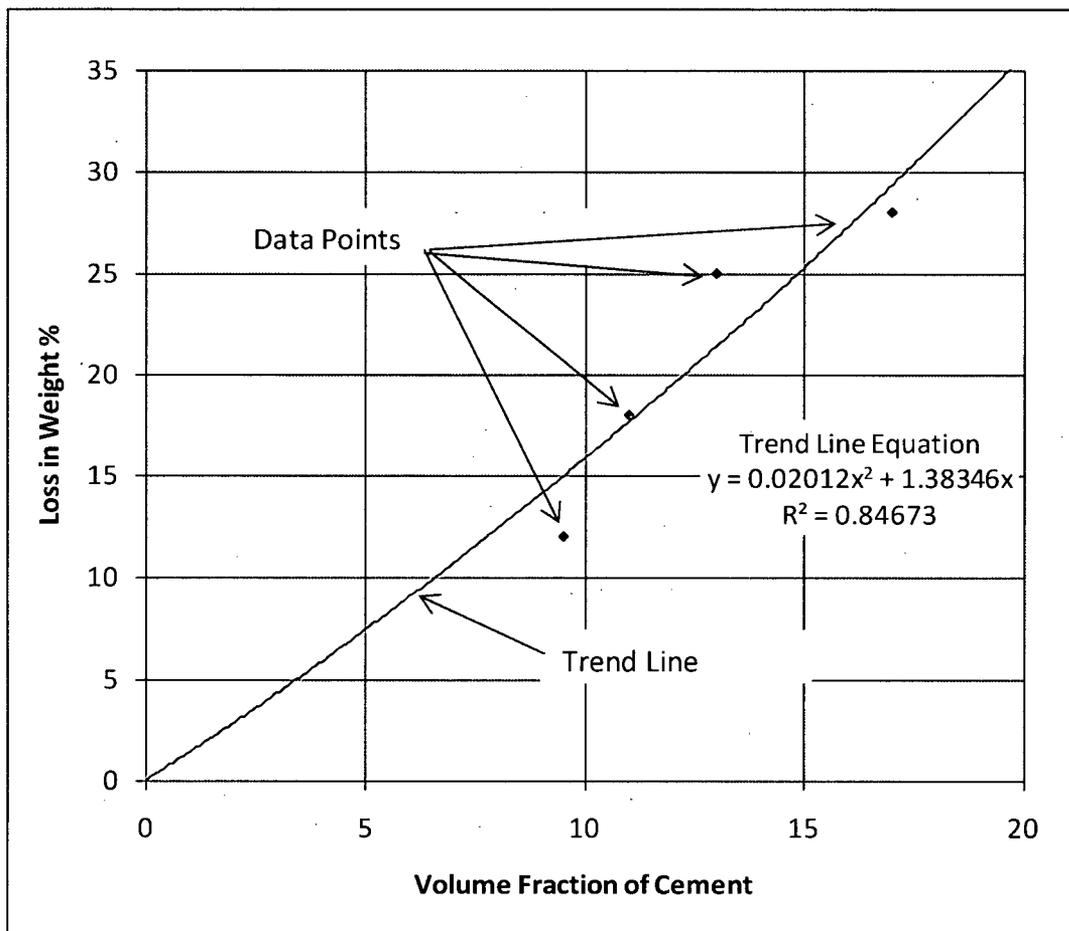
Figure 1 Weight Loss in Acid vs. Volume Fraction of Cement (based on data from Reference 7)

Quantitative data in Reference 7 for weight loss of concrete cubes when exposed to an acid concentration of 3% is shown in Figure 1. A trend line is shown on the figure that provides an equation for quantifying this dissolution behavior. As can be seen, the weight loss increases somewhat more strongly than linearly as the volume fraction of cement, (i.e., of soluble material), increases.

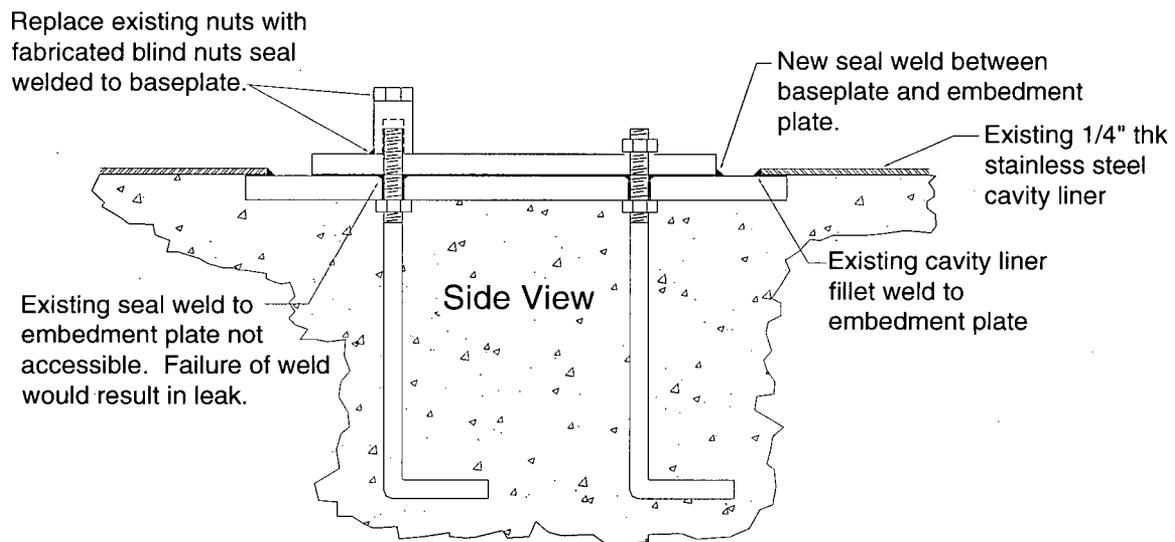
General Arrangement of Change Fixture Supports

The RCE concluded that the most likely refueling cavity leakage points are where the anchor studs for the reactor internals stands and the Rod Control Cluster (RCC) Change Fixture penetrate the associated embedment plates. The studs for these fixtures pass through holes in the embedment plates and are seal welded on the underside for the internals storage stands, and on top (then ground flush) for the RCC Change Fixture. Pinhole leaks or small cracks in one or more of the seal welds would result in a leak path through the embedment plate along the threads of the studs, allowing water under the cavity liner.

The plant management review of the Root Cause Evaluation considered the value, need and sufficiency of each recommendation. The current repair plan that emerged from these reviews is to replace the existing anchor nuts with new fabricated blind nuts that are seal welded to the existing baseplates. In addition, the existing baseplates will be seal welded to the embedment plates. The new welds will be readily accessible for examination to ensure the existing anchors and baseplates are leak tight. The following sketch depicts a typical RCC change fixture support showing the planned repairs. Similar repairs will be made to the internals stands supports.
