**SUBSECTION 2.5.3: SURFACE FAULTING
TABLE OF CONTENTS**

Turkey Point Units 6 & 7
COL Application
Part 2 — FSAR

2.5.3 SURFACE FAULTING

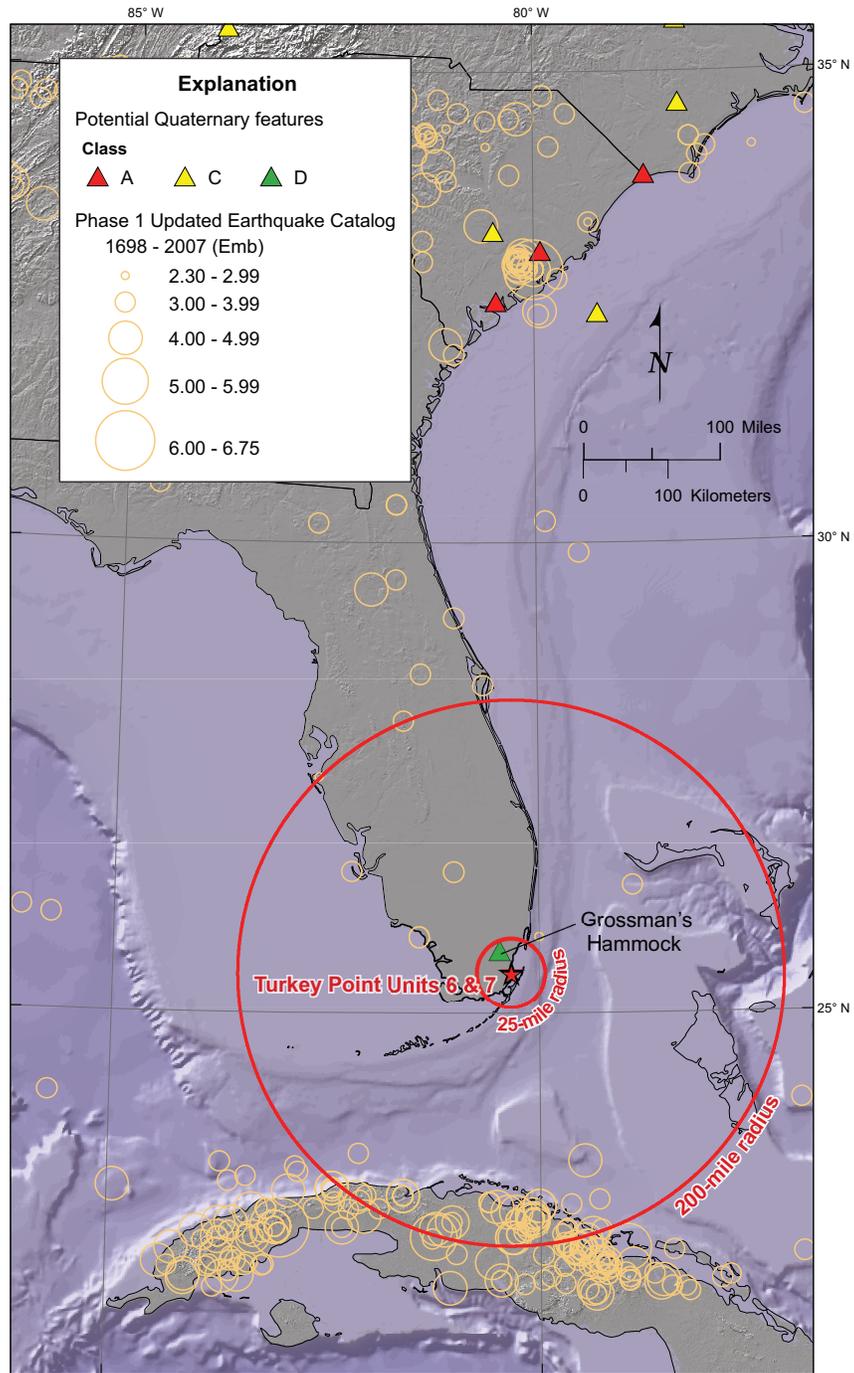
Figure 2.5.3-201 Potential Quaternary Features and Seismicity

Base source: Reference 201

Source of Quaternary features: Reference 203

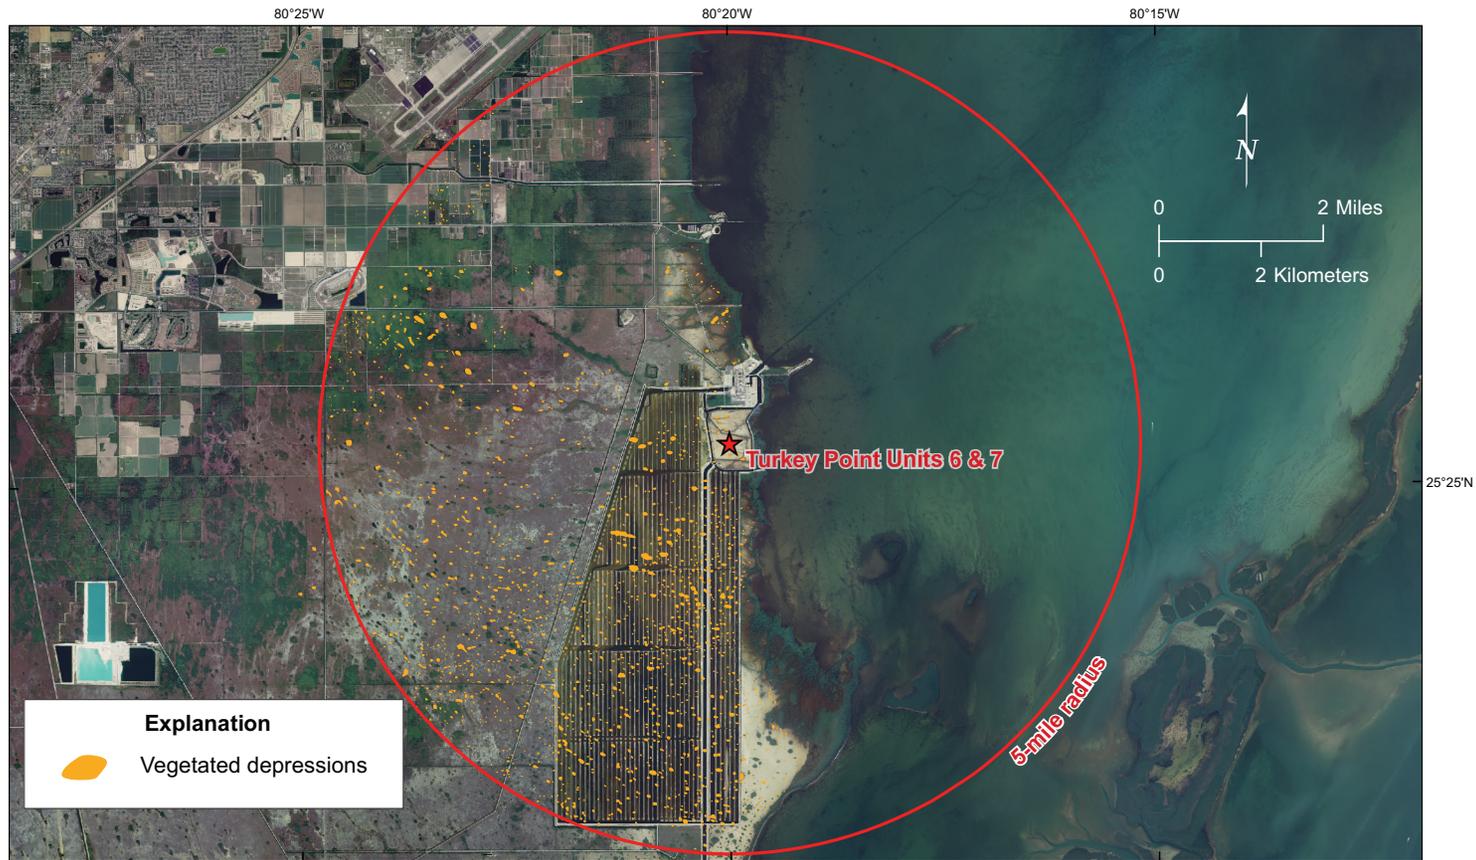
Figure 2.5.3-202 Vegetated Depressions Identified Within Site Area from Photographs Taken Before Construction of the Cooling Canals

Note: Reconnaissance mapping performed using 1940s 1:40,000 scale panchromatic stereo aerial photography (Reference 230), but shown on 2004 imagery (Reference 234) of the Units 6 & 7 site for reference.

Geologic reconnaissance and aerial photo analysis identified numerous ellipsoidal or circular features. These features consist of vegetation and water-filled areas that are generally less than 1 foot lower in elevation than the surrounding areas within the site and site area. Many of these surficial depressions observed on pre-construction photographs have been obliterated by construction of the Units 3 & 4 cooling canals (Figures 2.5.1-226 and 2.5.3-202). The underlying Miami Limestone is covered by recent deposits of organic-rich mud and silt approximately 2 to 6 feet thick. In these vegetated areas field and geotechnical work investigations have confirmed that the deposits of mud and silt reach thicknesses exceeding 6 feet, and appear to be wetter than the surrounding areas. Little information about the timing and style of formation of these features or their extent beneath the surface of the site is available. The Florida Geological Survey generally assesses a low hazard to karst features that form when limestone is exposed at the surface or beneath a thin veneer of permeable sediment, as is the case within the site area (Figure 2.5.1-238) (Reference 227). In these cases, such solution potholes are generally expected to be shallow and broad, and to develop gradually, rather than in a single, sudden collapse event. Additionally, these solution potholes are not expected to form large voids beneath the surface that would pose a hazard to the site (Reference 227). Based on information developed in this subsection and in Subsection 2.5.1, the possibility of dissolution features similar to the one reported southeast of Key Largo (Reference 226) existing at depth beneath this site area is unlikely (see Subsection 2.5.4.4.5).

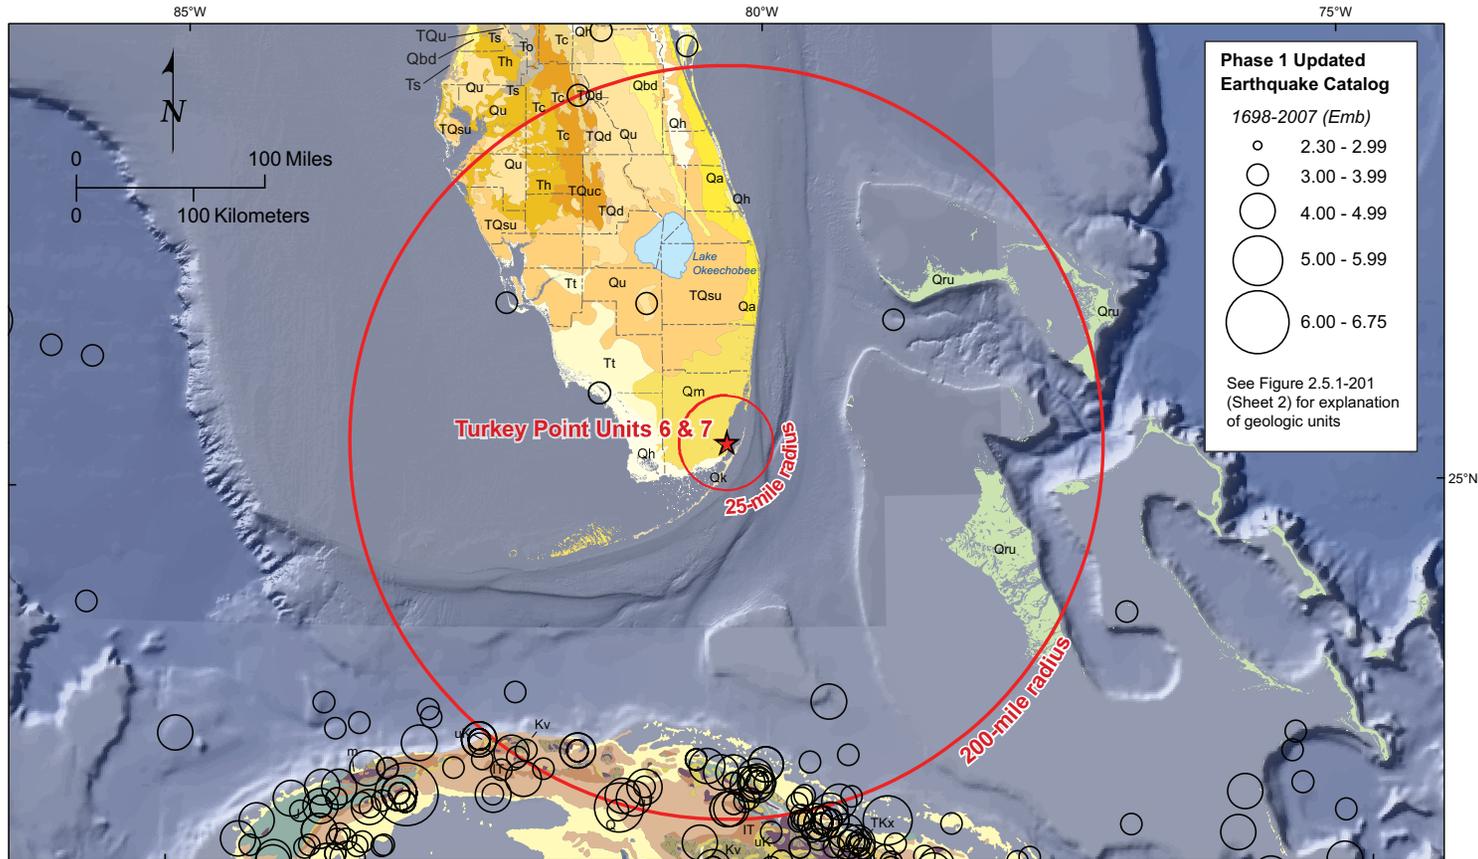
Figure 2.5.3-203 Site Region Seismicity

Base sources: Reference 201 and 219
Geologic information sources: References 210, 202, and 224
