Subject: PINGP Letter Responding to Refueling Cavity Leakage RAIs and Revising Vessel Internals Program Commitment
Sent Date: 6/24/2009 5:43:47 PM
Received Date: 6/24/2009 5:43:53 PM
From: Vincent, Robert

Response to Follow-up RAI B2.1.38

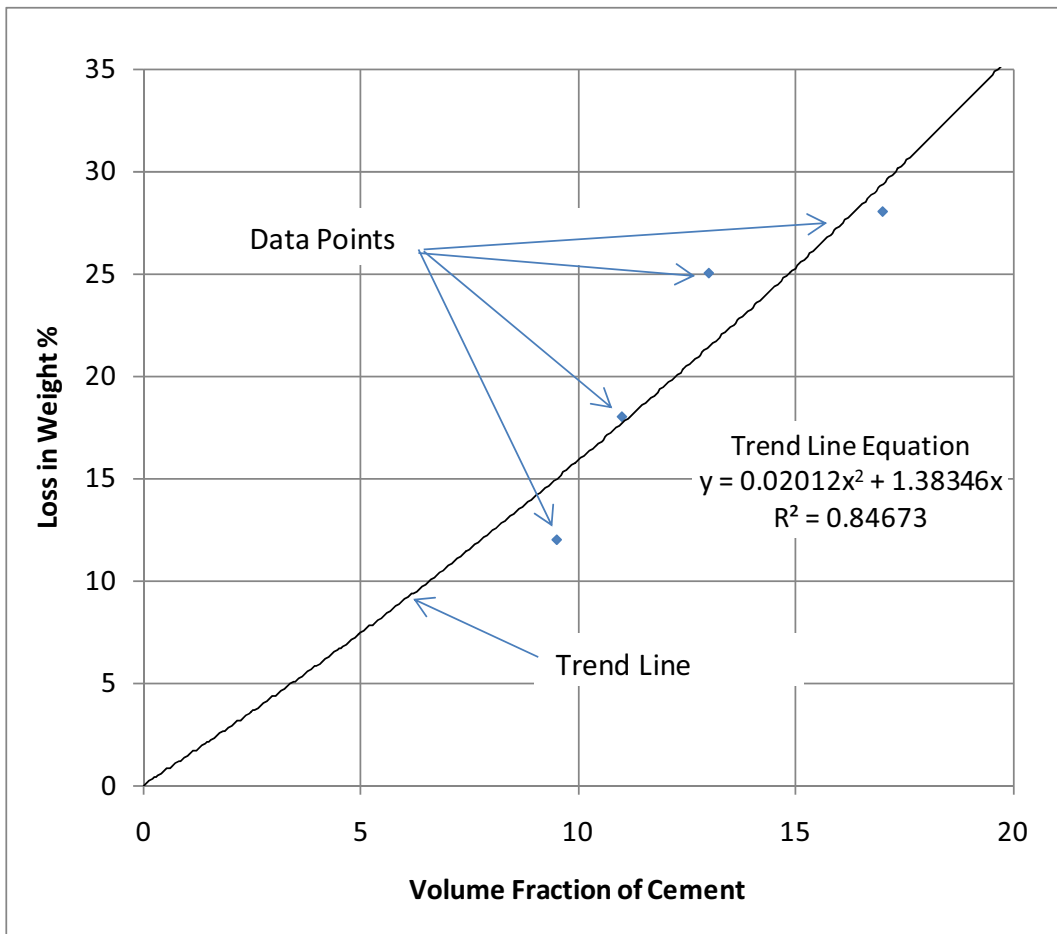
Figure 1 Weight Loss in Acid vs. Volume Fraction of Cement (based on data from Reference 7)

Quantitative data in Reference 7 for weight loss of concrete cubes when exposed to an acid concentration of 3% is shown in Figure 1. A trend line is shown on the figure that provides an equation for quantifying this dissolution behavior. As can be seen, the weight loss increases somewhat more strongly than linearly as the volume fraction of cement, (i.e., of soluble material), increases.

A footnote on page 10 of Reference 4 indicates that concrete normally contains 10 to 15% of cement, or an average of about 12.5%. As noted on page 2-2 of Reference 1, the amount of carbonaceous aggregate in the concrete used at Prairie Island was about 5%. Adding this 5% to the average 12.5% cement results in a total of 17.5% soluble material in the concrete at Prairie Island as compared to the 12.5% in a concrete with all igneous (no carbonate) based aggregate such as was used at the cited plants. (Section 8.1.3 of Reference 8) Using the trend line equation shown in Figure 1, increasing the fraction of soluble material (cement in the figure, cement plus soluble aggregate in this case) from 12.5% to 17.5% increases the weight loss by a factor of 1.49. This indicates that the assumed factor of 2.0 increase in severity of acid attack to account for the presence of 5% carbonate-based aggregate is conservative by a significant margin (2 vs. 1.49).

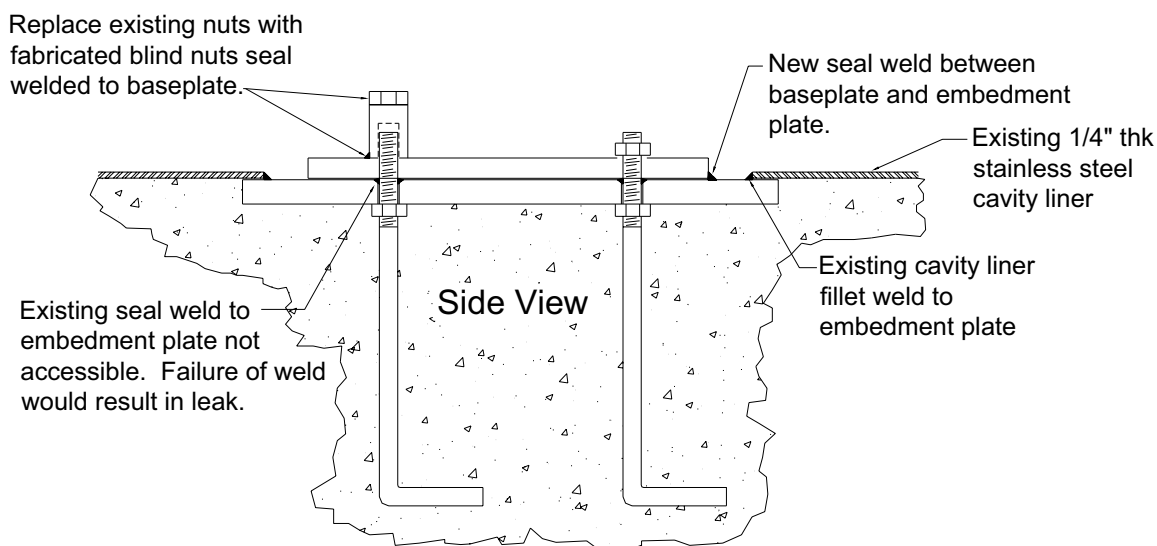
General Arrangement of Change Fixture Supports

The plant management review of the Root Cause Evaluation considered the value, need and sufficiency of each recommendation. The current repair plan that emerged from these reviews is to replace the existing anchor nuts with new fabricated blind nuts that are seal welded to the existing baseplates. In addition, the existing baseplates will be seal welded to the embedment plates. The new welds will be readily accessible for examination to ensure the existing anchors and baseplates are leak tight. The following sketch depicts a typical RCC change fixture support showing the planned repairs. Similar repairs will be made to the internals stands supports.

The RCE concluded that the most likely refueling cavity leakage points are where the anchor studs for the reactor internals stands and the Rod Control Cluster (RCC) Change Fixture penetrate the associated embedment plates. The studs for these fixtures pass through holes in the embedment plates and are seal welded on the underside for the internals storage stands, and on top (then ground flush) for the RCC Change Fixture. Pinhole leaks or small cracks in one or more of the seal welds would result in a leak path through the embedment plate along the threads of the studs, allowing water under the cavity liner.

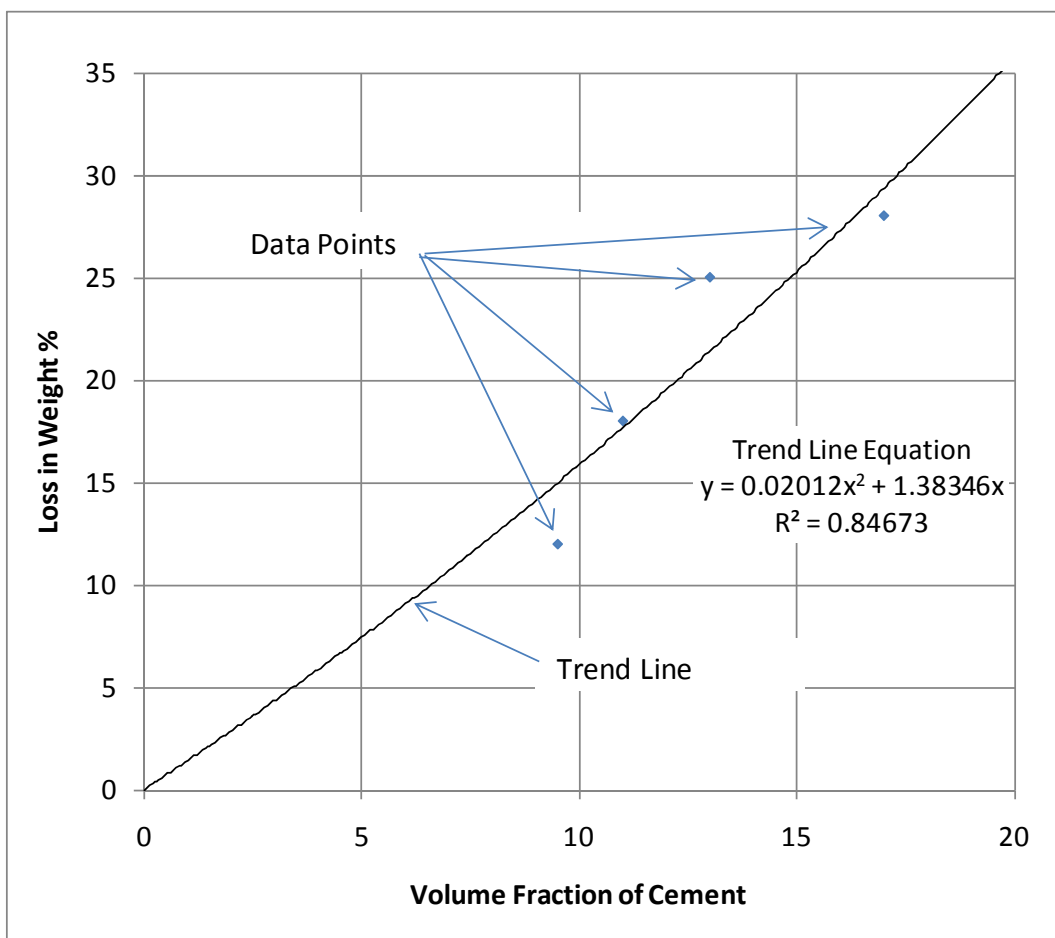
Figure 1 Weight Loss in Acid vs. Volume Fraction of Cement (based on data from Reference 7)

Quantitative data in Reference 7 for weight loss of concrete cubes when exposed to an acid concentration of 3% is shown in Figure 1. A trend line is shown on the figure that provides an equation for quantifying this dissolution behavior. As can be seen, the weight loss increases somewhat more strongly than linearly as the volume fraction of cement, (i.e., of soluble material), increases.

A footnote on page 10 of Reference 4 indicates that concrete normally contains 10 to 15% of cement, or an average of about 12.5%. As noted on page 2-2 of Reference 1, the amount of carbonaceous aggregate in the concrete used at Prairie Island was about 5%. Adding this 5% to the average 12.5% cement results in a total of 17.5% soluble material in the concrete at Prairie Island as compared to the 12.5% in a concrete with all igneous (no carbonate) based aggregate such as was used at the cited plants. (Section 8.1.3 of Reference 8) Using the trend line equation shown in Figure 1, increasing the fraction of soluble material (cement in the figure, cement plus soluble aggregate in this case) from 12.5% to 17.5% increases the weight loss by a factor of 1.49. This indicates that the assumed factor of 2.0 increase in severity of acid attack to account for the presence of 5% carbonate-based aggregate is conservative by a significant margin (2 vs. 1.49).

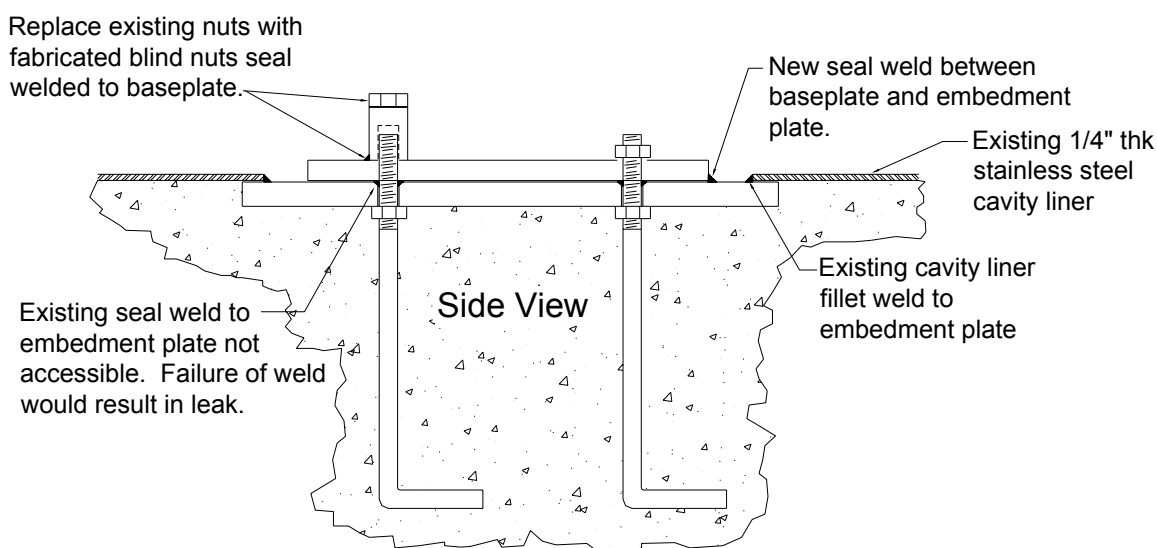
General Arrangement of Change Fixture Supports

The plant management review of the Root Cause Evaluation considered the value, need and sufficiency of each recommendation. The current repair plan that emerged from these reviews is to replace the existing anchor nuts with new fabricated blind nuts that are seal welded to the existing baseplates. In addition, the existing baseplates will be seal welded to the embedment plates. The new welds will be readily accessible for examination to ensure the existing anchors and baseplates are leak tight. The following sketch depicts a typical RCC change fixture support showing the planned repairs. Similar repairs will be made to the internals stands supports.

The RCE concluded that the most likely refueling cavity leakage points are where the anchor studs for the reactor internals stands and the Rod Control Cluster (RCC) Change Fixture penetrate the associated embedment plates. The studs for these fixtures pass through holes in the embedment plates and are seal welded on the underside for the internals storage stands, and on top (then ground flush) for the RCC Change Fixture. Pinhole leaks or small cracks in one or more of the seal welds would result in a leak path through the embedment plate along the threads of the studs, allowing water under the cavity liner.
