August 4, 2009

SUBJECT: CLOSURE OF NATIONAL FIRE PROTECTION ASSOCIATION 805
FREQUENTLY ASKED QUESTION 08-0044 MAIN FEEDWATER PUMP
OIL SPILL FIRES

The purpose of this memorandum is to close National Fire Protection Association (NFPA) Standard 805 Frequently Asked Question (FAQ) 08-0044. The enclosed position was previously sent for comment under the joint U. S. Nuclear Regulatory Commission's (NRC) Office of Nuclear Regulatory Research (RES) / Electric Power Research Institute (EPRI) Memorandum of Understanding (MOU) process. RES and the NRC's Office of Nuclear Reactor Regulation (NRR) collaborated on resolving the comments that were received from the MOU. It was later sent to the Nuclear Energy Institute's (NEI) NFPA 805 Task Force for industry and other stakeholder comment. No comments were received from the NEI Task Force. The enclosed position represents a joint resolution of this FAQ between RES and NRR.

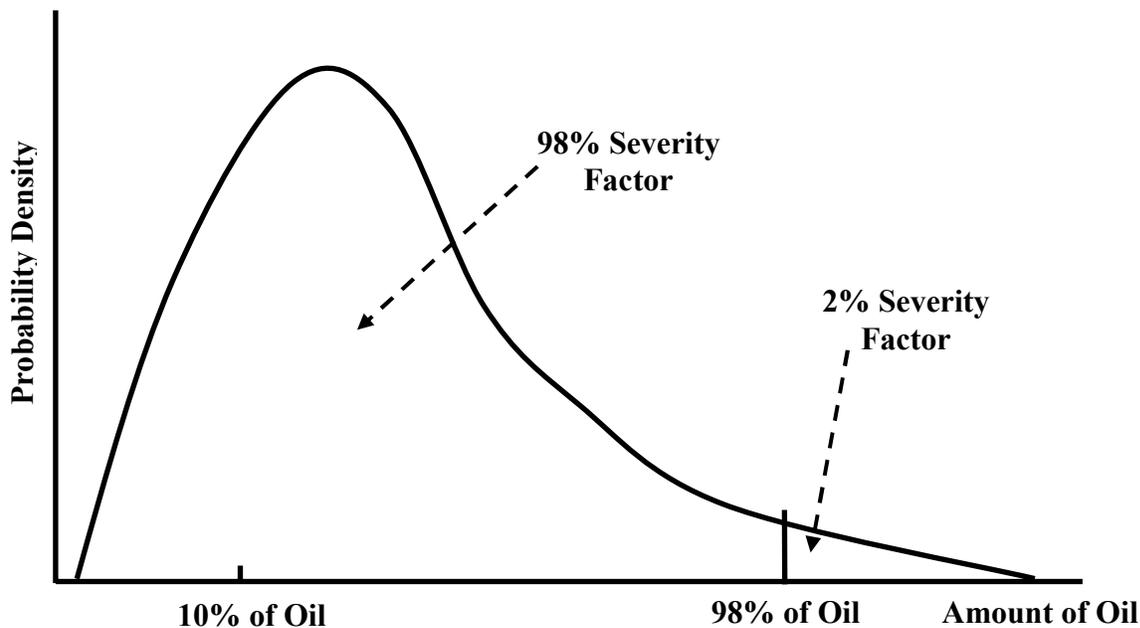
Figure 1 below provides a qualitative depiction of this guidance assuming that the amount of oil represents fire severity. The severity curve is divided into two parts: “small,” represented by 10% of the oil, and “large,” represented by 98% of the oil.

Figure 1. Oil Fire Severity Factor Guidance

The following steps are recommended for assigning the severity factor to scenarios involving oil spill fires.

1. Determine the amount of oil that can be spilled in the room.
2. Assign a severity factor of 0.02 to a scenario consisting of 98% or more of the amount of oil spilled and ignited.
3. Assign a severity factor of 0.98 to a scenario consisting of 10% of the amount of oil spilled and ignited.

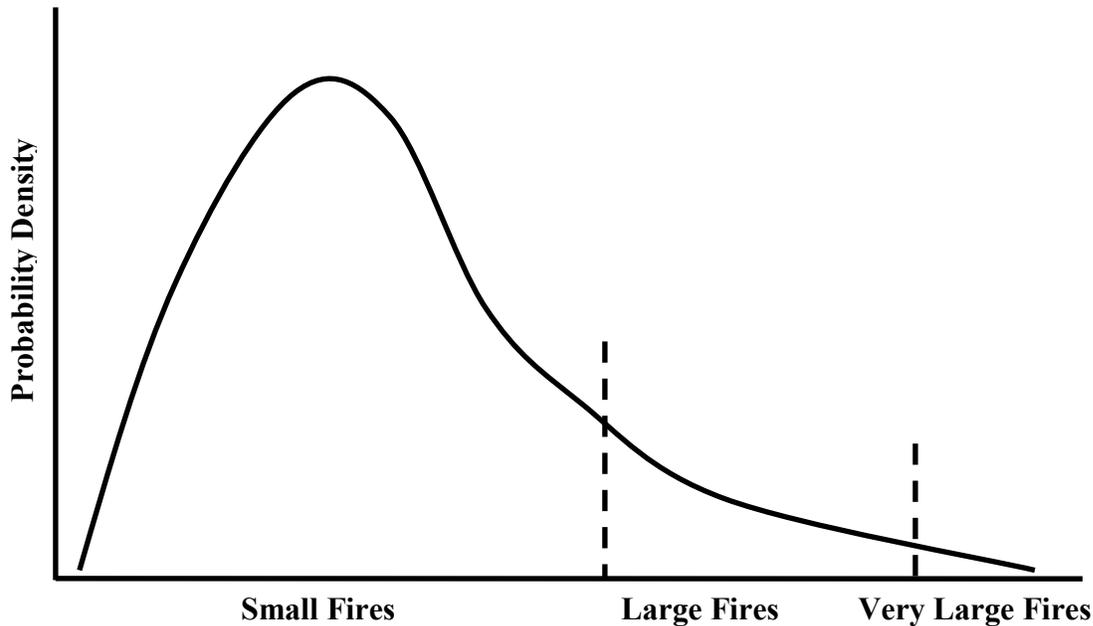
A similar partitioning approach toward fire severity is followed as documented in the original guidance, except that three severity levels are now defined instead of just two to reflect that (1) most MFW pump fire events had limited effect on the surrounding items and (2) none of them involved a large quantity of the pump lubricating oil. The three levels attempt to capture this experience and the potential for severe impact that can be experienced from an uncontrolled MFW pump oil spill. This is shown qualitatively in Figure 2 below.

Figure 2. Main Feedwater Pump Oil Fire Severity Factors

The three severity levels are defined as follows:

- *Small fires* are defined as fires involving small oil leaks leading to the ignition of oil-soaked insulation on piping and equipment. These fires will involve a fraction of the oil inventory smaller than assumed in the following fire sizes. Fire damage is expected to be limited to the MFW pump.
- *Large fires* are defined as fire events involving a spill of 10% of the oil content (consistent with the small fire category in the original oil spill severity factor guidance as cited above).
- *Very large fires* are fire events that involve a spill of up to 100% of the oil inventory (again consistent with the large fire category in the original guidance as cited above).

Thus, one can conclude that 0.034 (3.4%) represents the fraction of MFW pump oil spills/fires that would be considered *large* or *very large* per the definitions given above. As noted above, none of the MFW pump fire events could be labeled as a *very large* spill/fire. The recommended estimate recognizes that very large spills would occur, but with a lower probability than large spills, and assumes 10% of the *large* or *very large* spills/fires would actually be *very large* spills/fires. This yields a net severity factor of 0.0034 (0.34%) for the very large fire case.

4. Assign a severity factor of 0.0306 (3.06%) to *large fires*: scenarios involving 10% of the total oil inventory spilled and ignited.
5. Assign a severity factor of 0.966 (96.6%) for *small fires*: scenarios involving a leak that leads to a fire that only impacts the MFW pump.
